SECOND FIVE-YEAR REVIEW REPORT FOR WATERTOWN ARSENAL - D01MA0019 Project 02

MIDDLESEX COUNTY, MASSACHUSETTS

U.S. Army Corps of Engineers New England District

EXECUTIVE SUMMARY

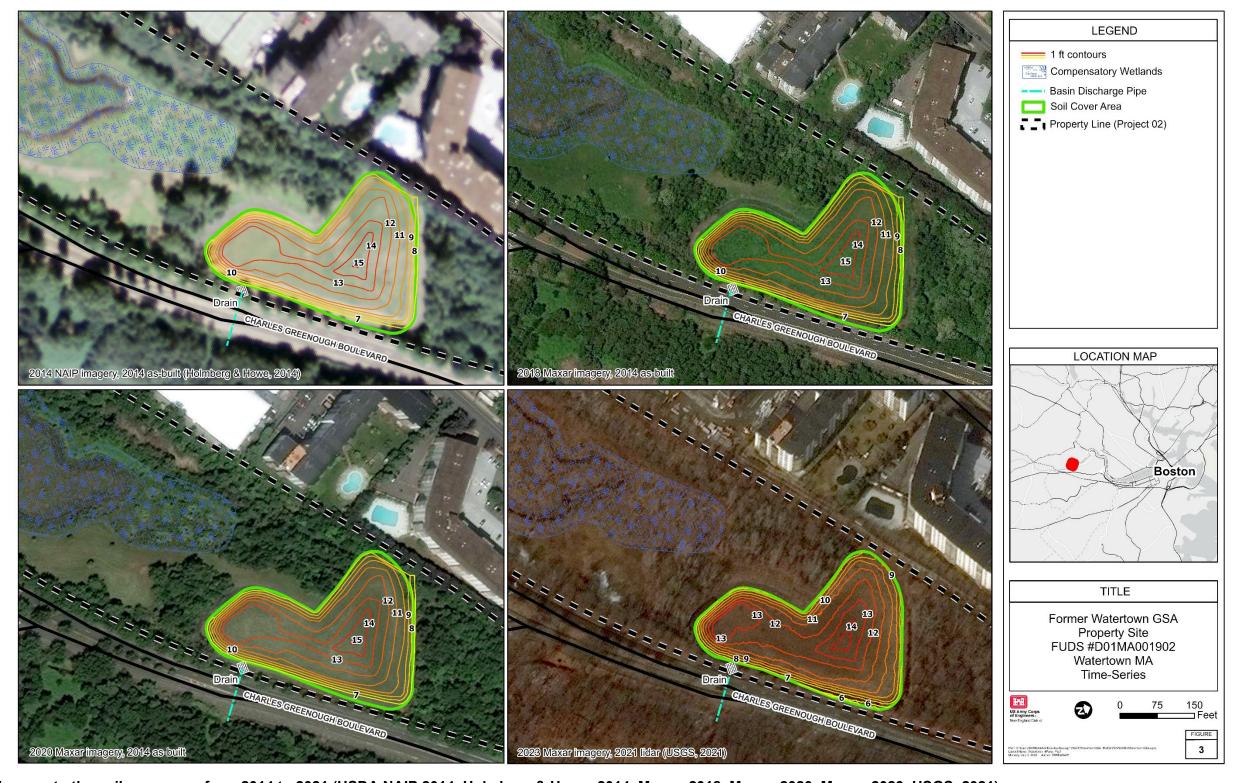
Figure 3. Changes to the soil cover area from 2014 to 2021 (USDA NAIP 2014, Holmberg & Howe, 2014, Maxar, 2018, Maxar, 2020, Maxar, 2023, USGS, 2021)
