2009 Monitoring Report For Barkers Brook, Newry, Maine

Prepared For: Maine Department of Transportation

Report No.: 02-07-08(2)

Date: March 29, 2010

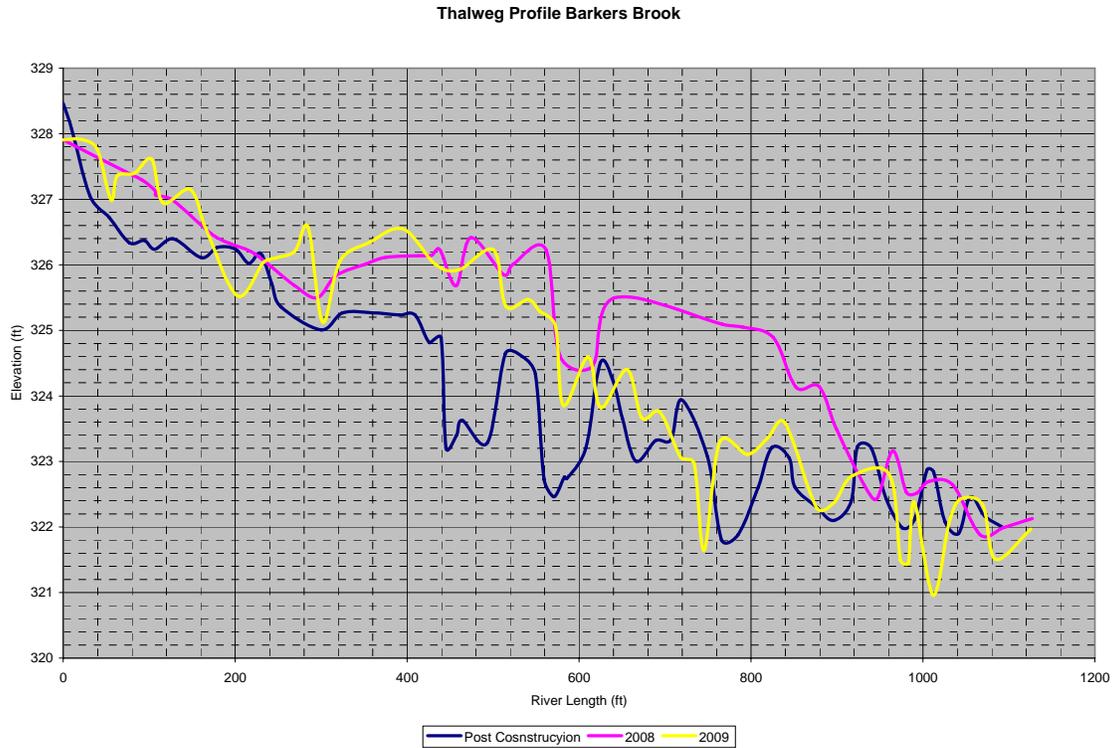
Profile

Barkers Brook was restored in the fall of 2007 using the principals of fluvial geomorphology and natural channel design to promote a dynamically stable channel. Riffles were installed to create habitat and provide grade control. Bioengineered banks and beds were designed to provide stability, but also to be flexible enough to accommodate normal fluctuation of sediment or flow regimes in the watershed. The flood and dam failure in the summer of 2007 mobilized massive amounts of sand and gravel and stored them temporarily in the stream channel and on the floodplain in the watershed above the project site. Immediately following construction, subsequent flooding events (as early as spring of 2008) moved the excess sediment into the project site. Though the restoration was designed for high flow events, the large amount of sediment introduced into the system was not anticipated at the time of the design. As a result, the project has undergone significant changes since construction, primarily the in-filling of the cross-sectional flow area with sand and gravel.
