Maidstone Slide - STP 0271 (20)

Year 1 Report

Wetland and Invasive Species Monitoring and Control Recommendations

6 December 2013

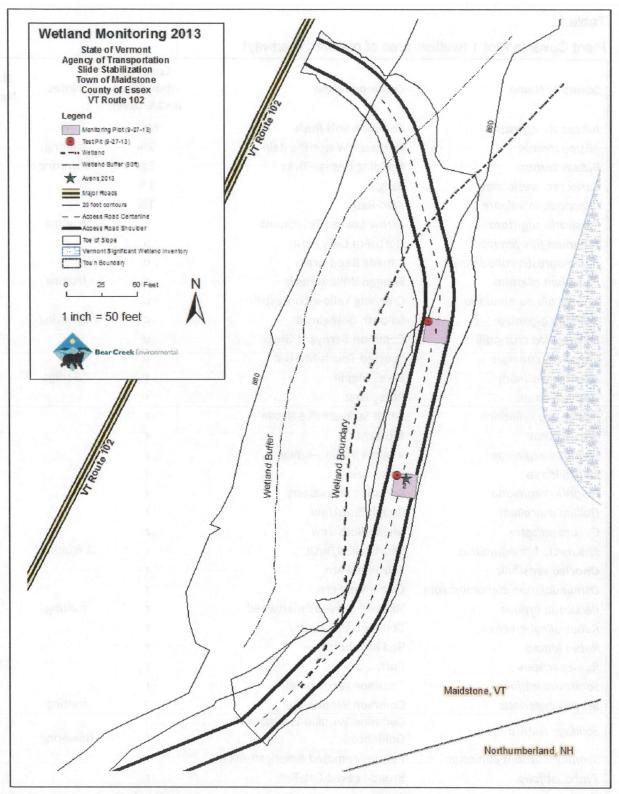
Figure 3. Wetland Monitoring Plots (September 27, 2013)

Two 5 x 5 m plots (Figure 3) were established to document vegetation and soils in a very wet portion of the restored roadway (Table 1) and a dry portion of the restored roadway (Table 2). Although there was some overlap in the common species in the two plots, each plot had different dominant species. The usefulness of a diverse native species seed mix to aid re-establishment of vegetation is apparent, since there was differential success among species along the moisture gradient.

In her wetland delineation, Gustafson⁴ documented black ash (*Fraxinus nigra*) and silver maple (*Acer saccharinum*) as tree stratum dominants. Approximately six silver maple seedlings and no black ash were observed in the 5 x 5 m Plot 1 sample. Neither species was observed in Plot 2. In the shrub stratum she recorded black ash, choke cherry (*Prunus virginiana*) and highbush-cranberry (*Viburnum trilobum*). Of these three species, only choke cherry was observed in the restored roadway; as one would expect it was in the drier area (Plot 2 and the southern part of the site) and not within the wettest part of the restored area.
