Reconstruction of Post Office Road/ Town Farm Road Enfield, Connecticut

USArmy Corps of Engineers Permit Number: NAE-2009-2773

2015 Annual Report

Year 4 Wetland Mitigation Monitoring Report Reconstruction of Post Office Road/Town Farm Road, Enfield, CT

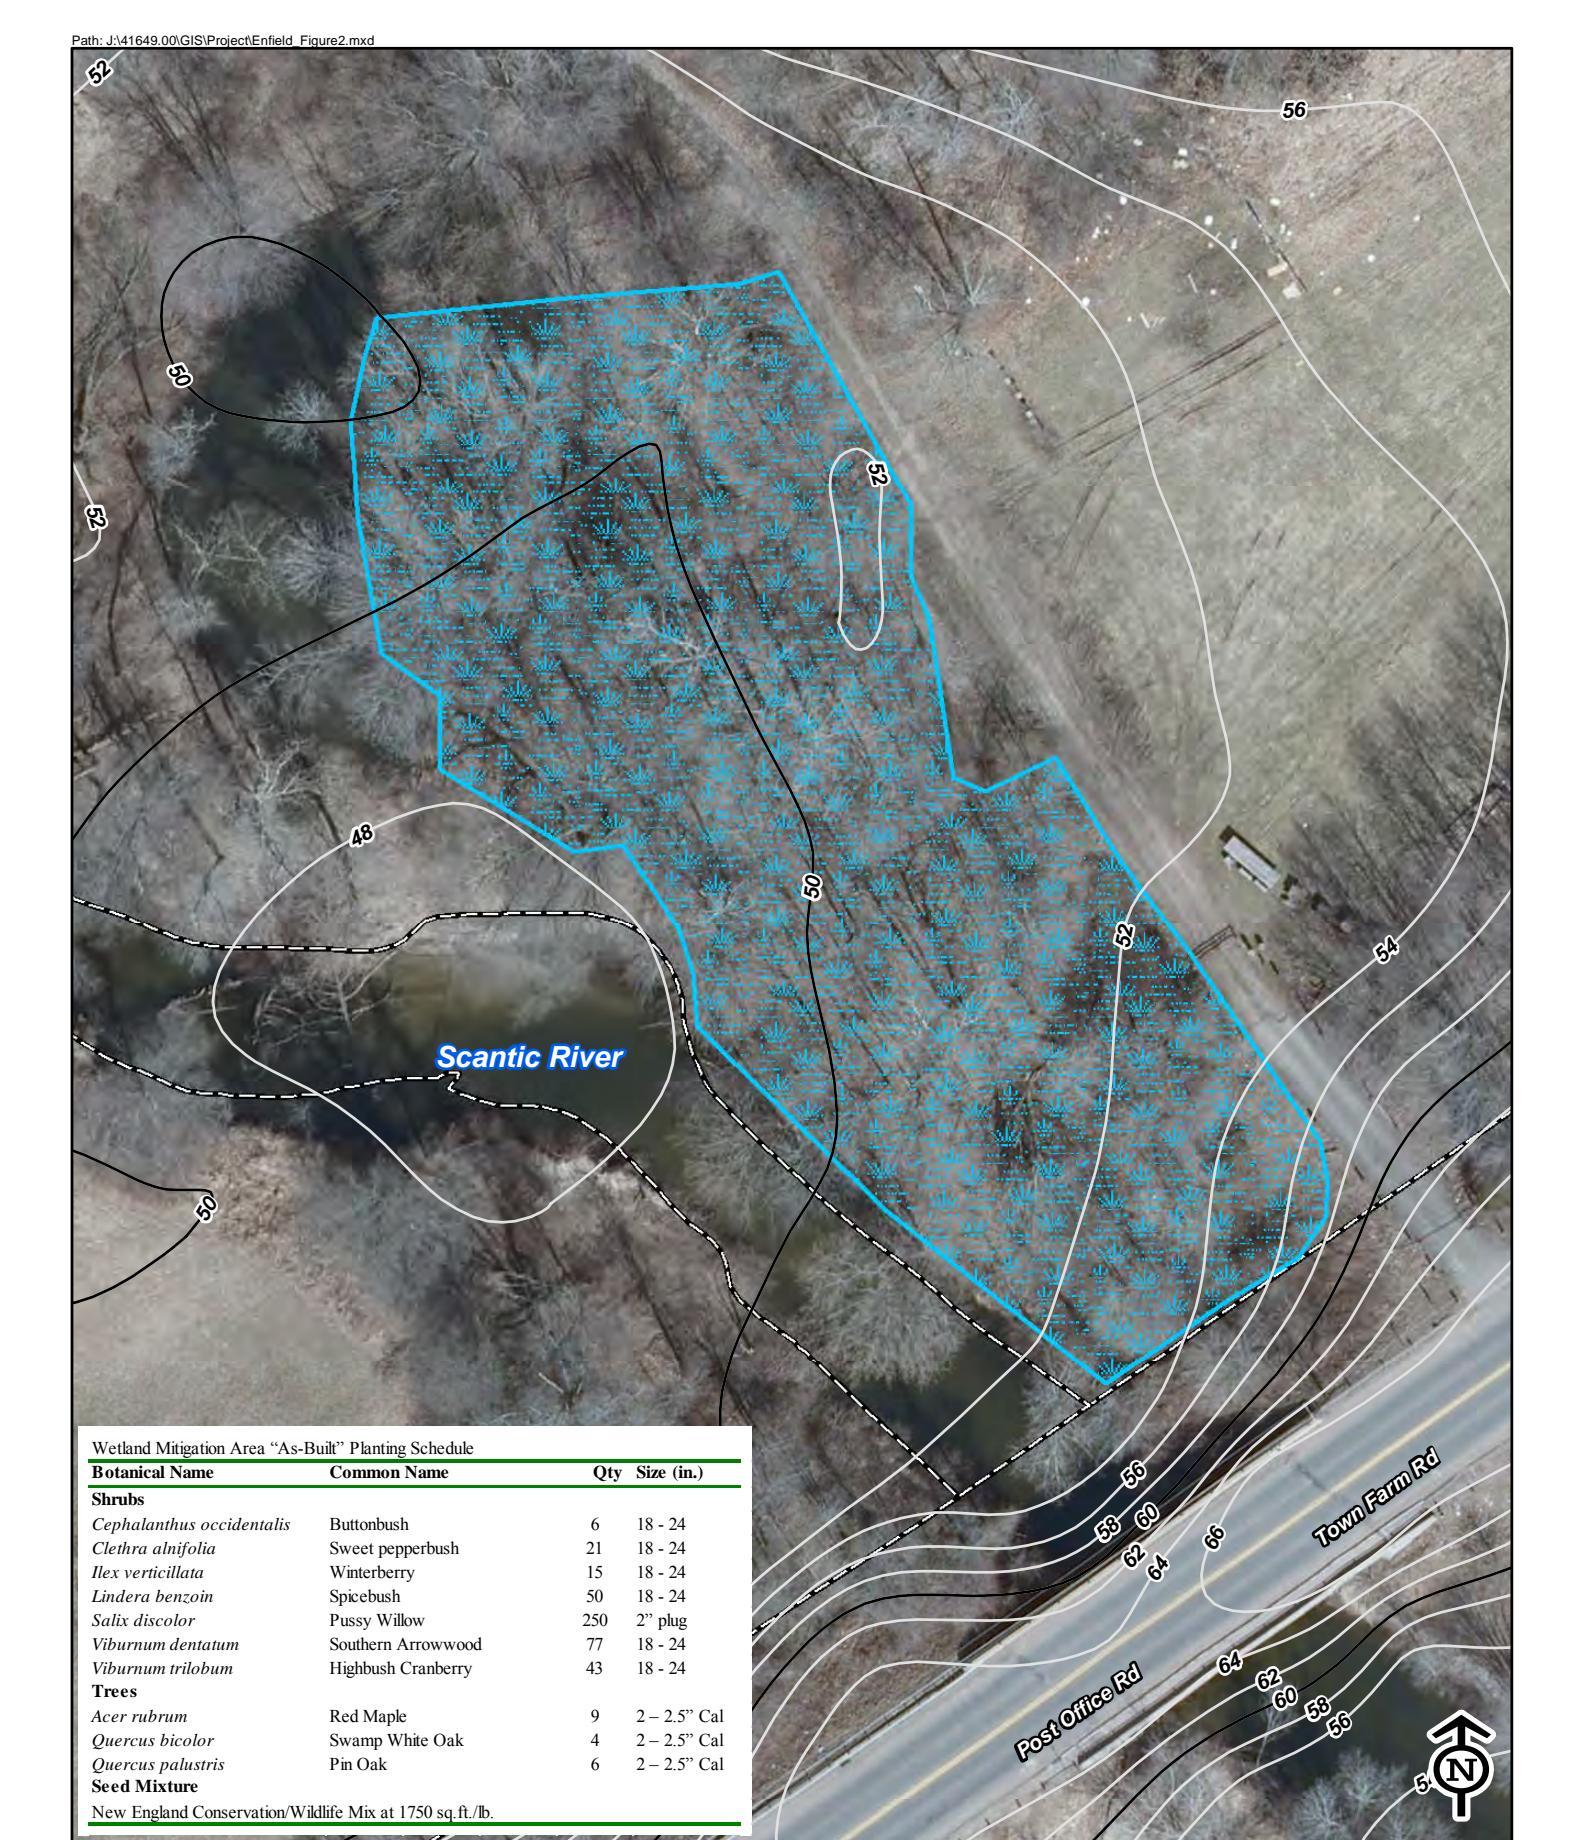
> Palustrine-forested Wetland Wetland Mitigation As-Built Plan Post Office Road/Town Farm Road Enfield, Connecticut

The Wetland Mitigation As-Built Plan used to conduct the qualitative and quantitative assessments is provided in Attachment A. Table 1 provides summary data from the October 2015 inspection. The 2015 volunteer plant inventory, which includes herbaceous species that were likely present in the applied seed mix, is provided in Attachment B. Representative photographs of the mitigation site are included in Attachment C. A corresponding Photo Location Map is provided the Maps section of the report.

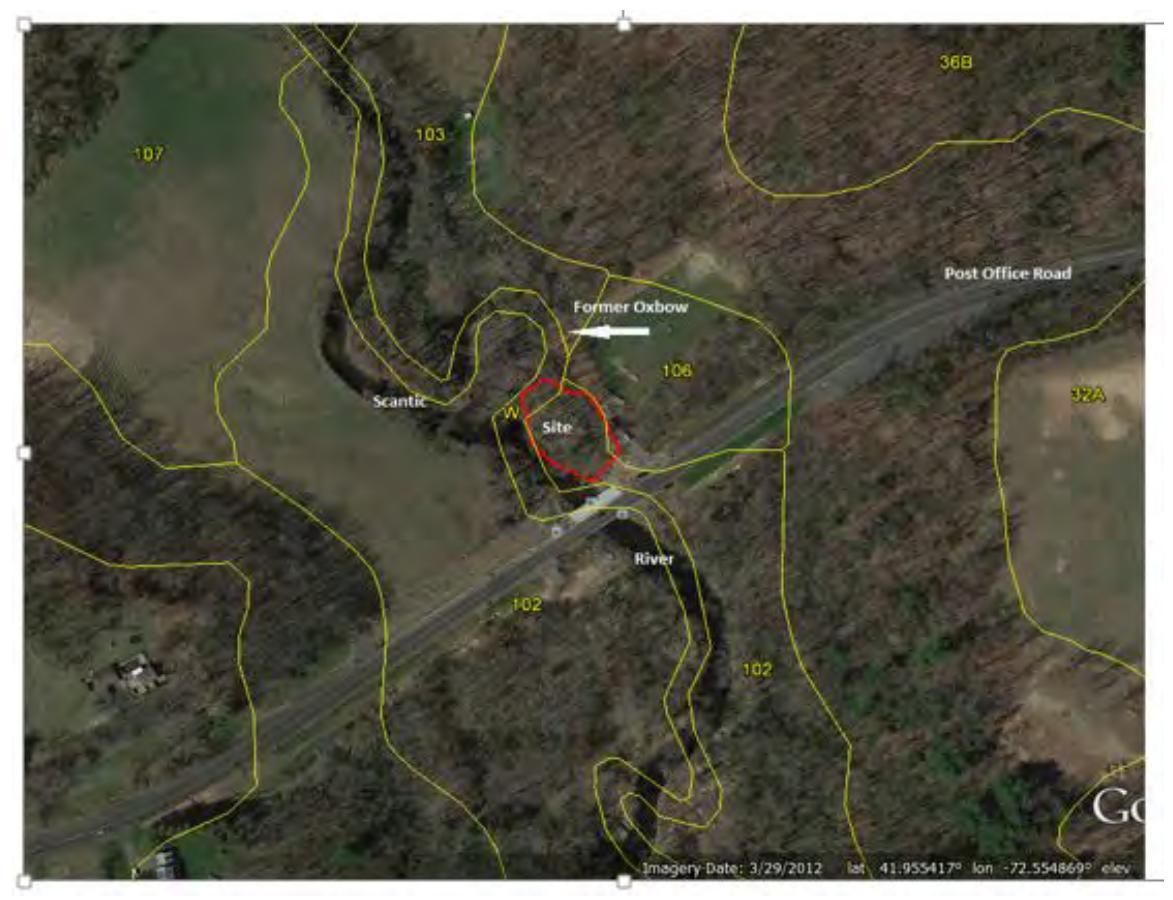
Aerial Photograph: Superimposed soil survey (completed circa 1950) placed over a 2012 aerial photograph obtained from Google Earth. Note that the meander bend which once characterized the site has been cut off and the river segment that passes through the bridge has been straightened.

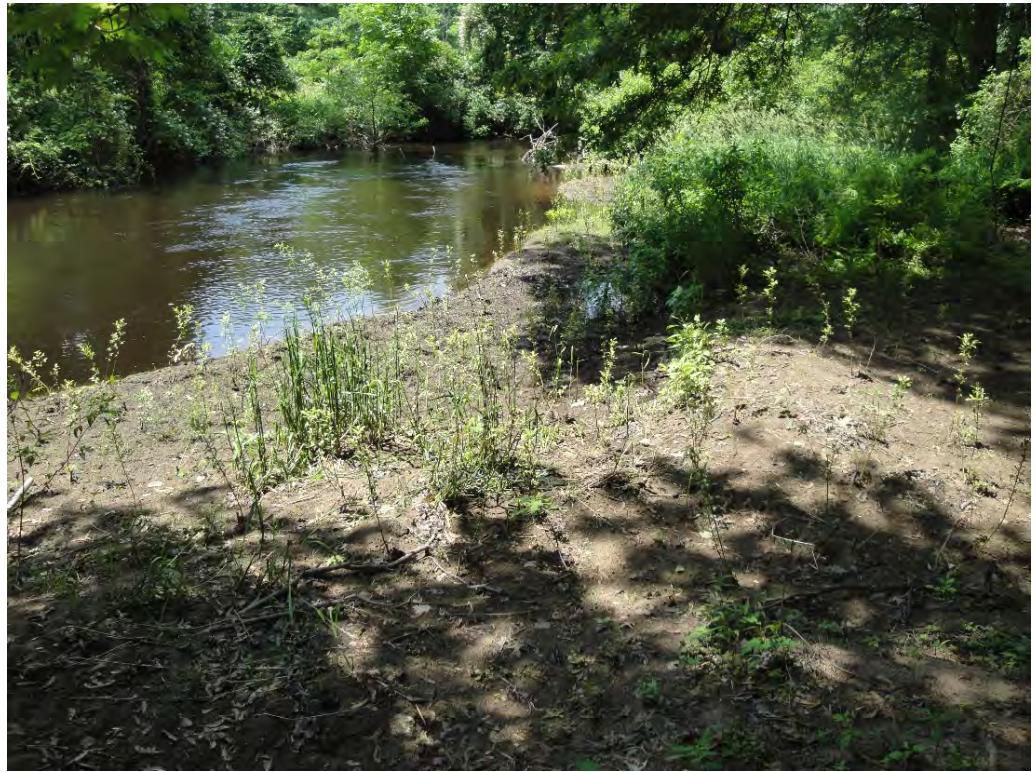
As previously reported, soils within the mitigation area support dense vegetation with the exception of an exposed portion of bank along a Scantic River meander bend. The channel and bank at the meander bend continue to shift where *Salix discolor* plugs had been installed. Like other rivers that cut through the clay rich deposits of glacial Lake Hitchcock, the river channel continues to evolve over time. This is evident in the superimposed soil survey (completed circa 1950) placed over a 2012 aerial photograph obtained from Google Earth, provided as *Aerial Photo* in *Attachment C*. Additional photographs provided in *Attachment C* (*Photo Location 1*) show a side by side comparison of this area in 2011 and 2015.

Photo Location 1: View of the eastern bank of the Scantic River on the day willow plugs were installed along the exposed meander bend, June 10, 2011.

Significant *Salix discolor* mortality (94%) has occurred where plugs were installed along an exposed bank of the Scantic River. The majority of loss is attributable to peak flows and periodic flood events that continually reshape the meander bend. The mortality in this area is considered part of natural river channel evolution and no action to replant this area is recommended.

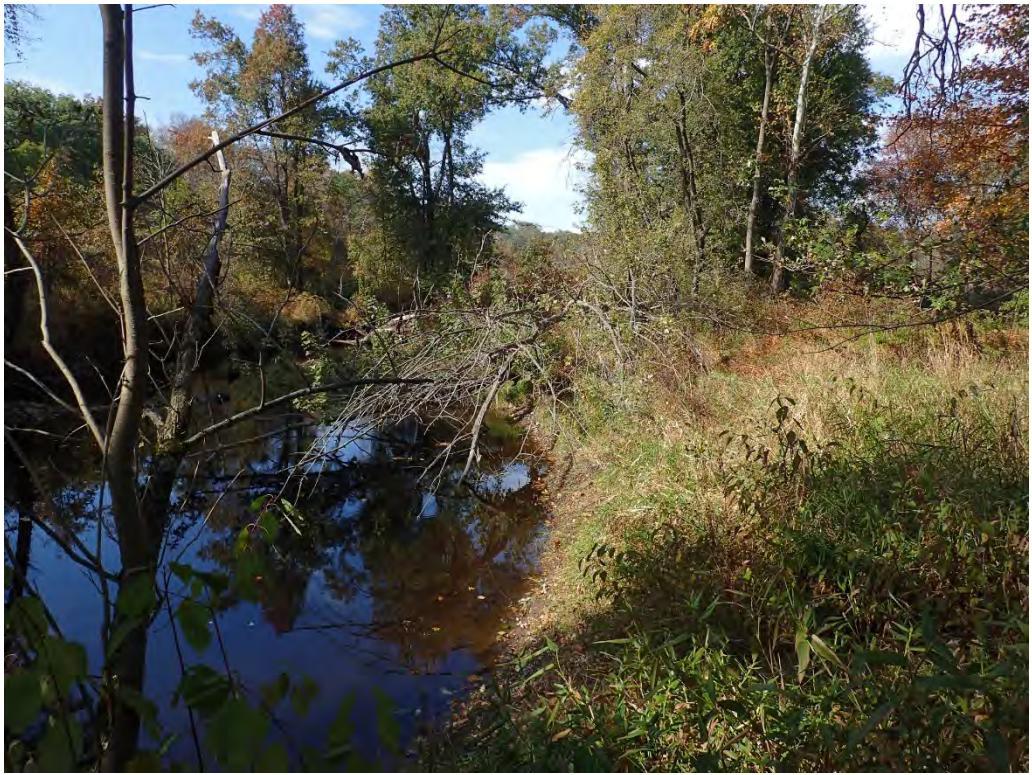
The majority of *Salix discolor* plugs (235 of 250) installed along the exposed meander bend of the Scantic River were not found during the tally. Surviving plants are stunted and display evidence of browse.

Photo Location 1: View of bank where willow plugs had been installed as seen on October 20, 2015. (Note: recent deposits of alluvium not evident in photograph).

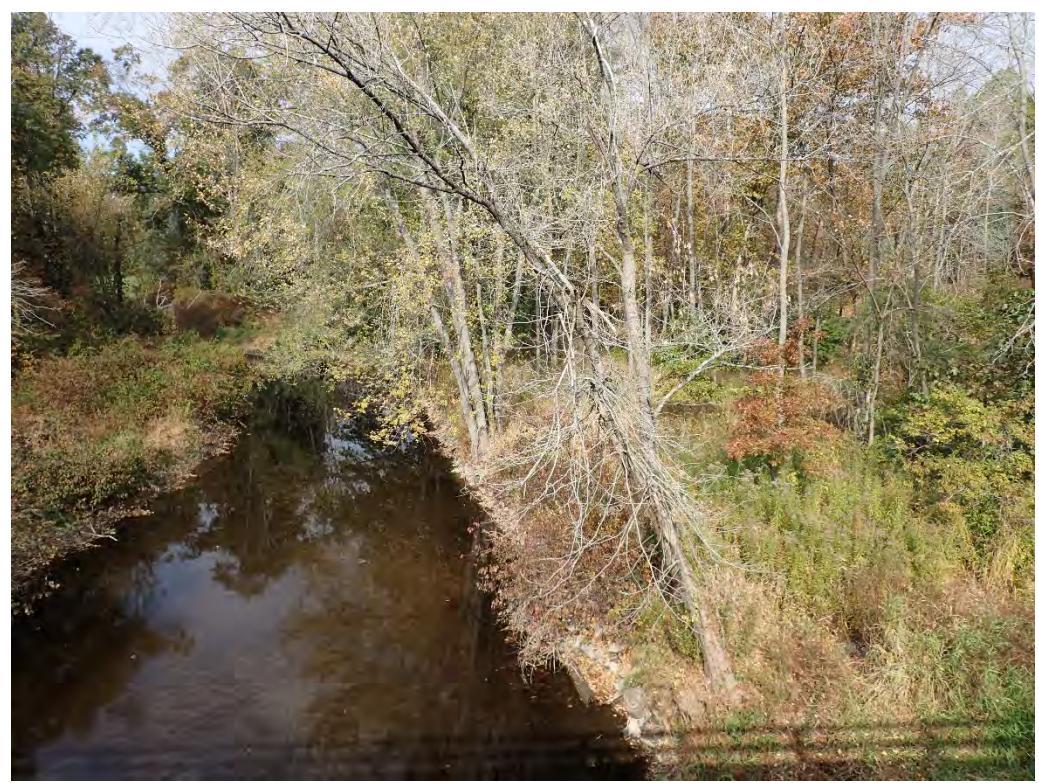
Photo Location 2: View of the mitigation area (right side of photo) looking north from Scantic River Bridge, October 20, 2015.

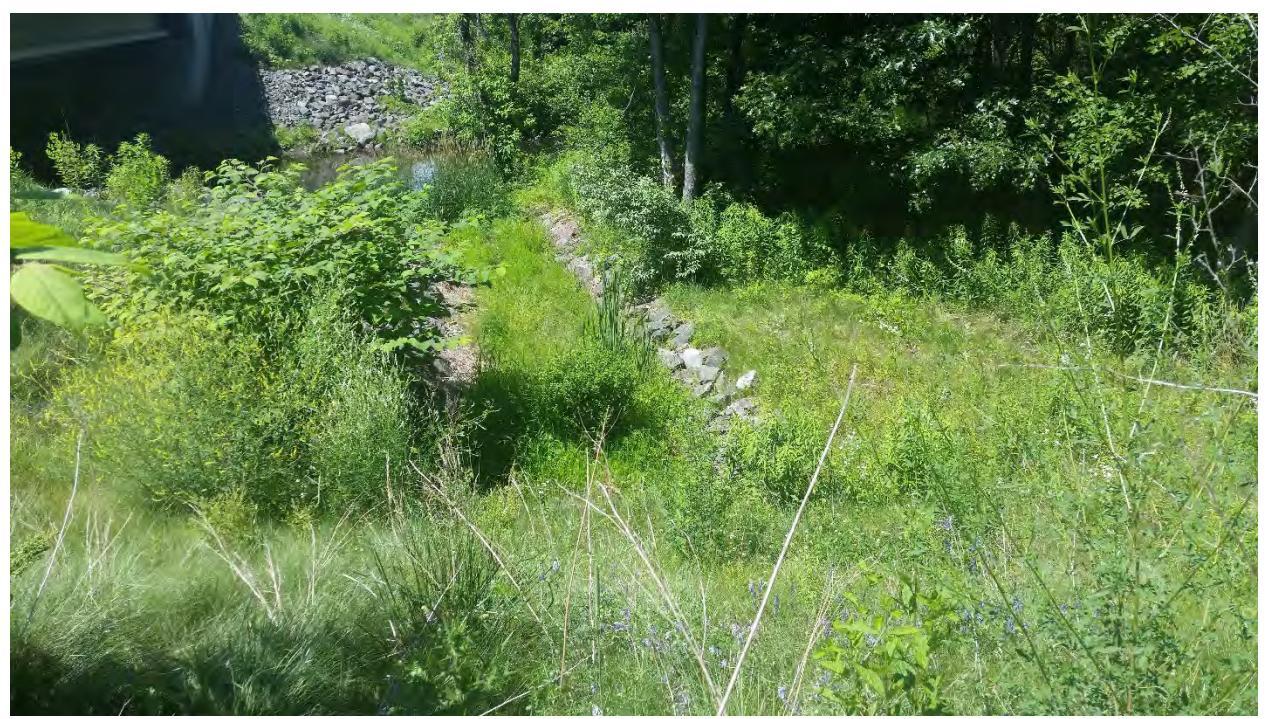
Photo Location 3: View of the stabilized slope of Post Office Road at the southern limit of the mitigation site looking west (Scantic River Bridge upper left of photo), June 22, 2015.

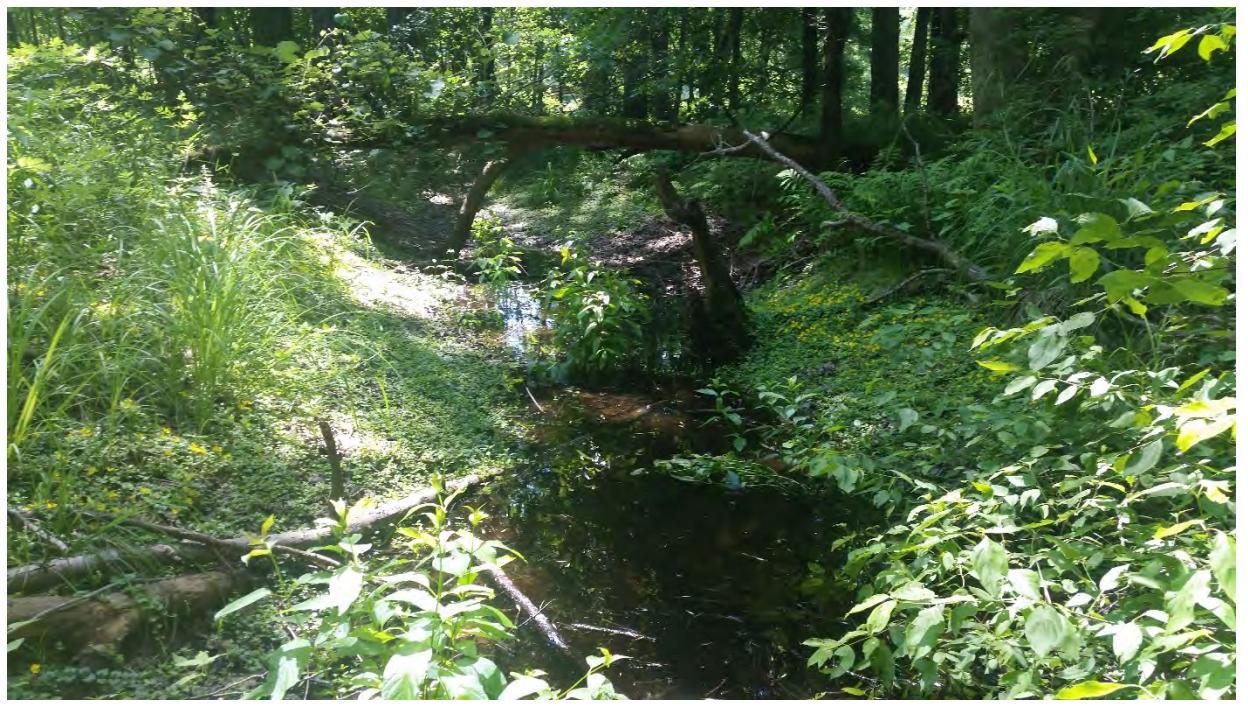
Cephalanthus occidentalis and *Ilex verticillata* shrubs were found to be healthy and thriving.

Photo Location 4: View of thriving *Cephalanthus occidentalis* shrubs planted in seasonally flooded backwater depression looking south, June 22, 2015.

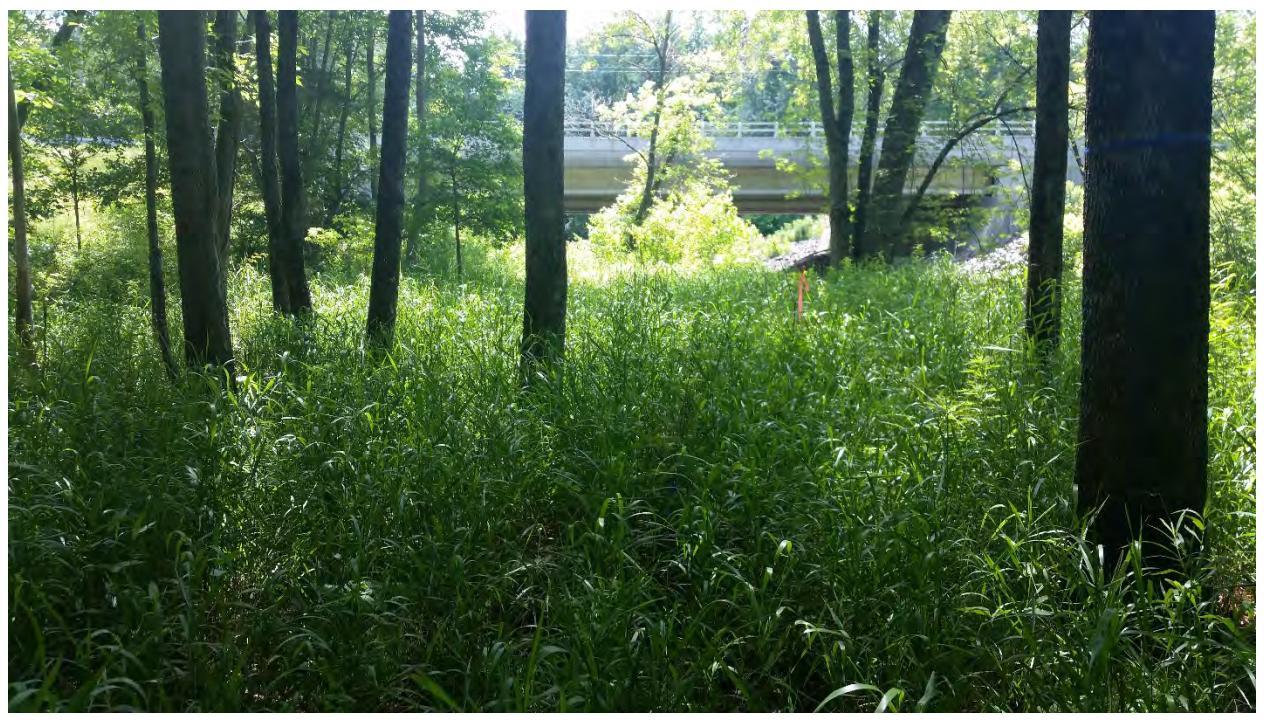
Photo Location 5: View of dense herbaceous layer looking south (Scantic River Bridge in photo background), June 22, 2015. Note lush cover of *Elymus virginicus* and absence of invasive species.

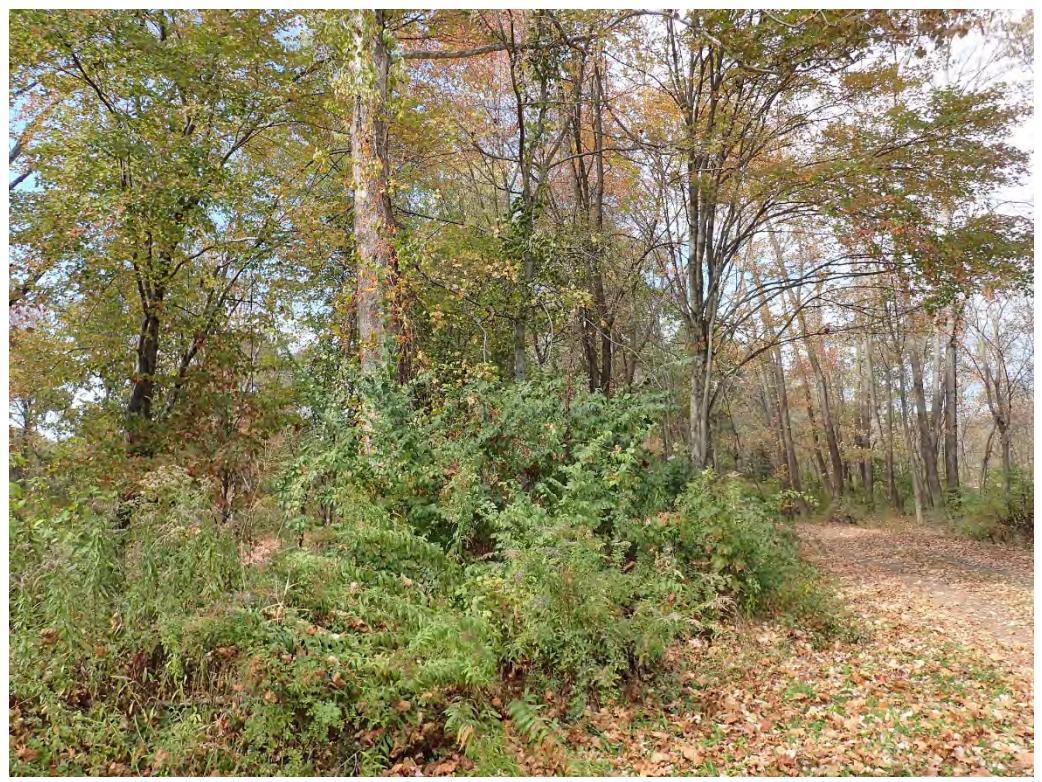
The percent cover of invasive vegetation was estimated at approximately 5% after the fall 2015 inspection. Morrow's honeysuckle (*Lonicera morrowii*), multiflora rose (*Rosa multiflora*), and Asiatic bittersweet (*Celastrus orbiculatus*) have reestablished along the edge of the mitigation area adjacent to the Enfield Hunters Club driveway. Other invasive species identified with the mitigation area include: burning bush (*Euonymus alatus*) and autumn-olive (*Elaeagnus umbellate*) near the southern portion of the mitigation site; creeping yellow-loosestrife (*Lysimachia nummularia*) and Japanese stiltgrass (*Microstegium vimineum*) along the riverbank near the exposed bank; reed canary grass (*Phalaris arundinacea*) along the lower end of the stone swale near the river; purple loosestrife (*Lythrum salicaria*) higher up the stone swale; and, Japanese knotweed (*Fallopia japonica*) in the upland slopes below Town Farm Road.

Photo Location 6: View of invasive plant species (*Lonicera morrowii, Rosa Multiflora* and *Celastrus orbiculatus*) along edge of Enfield Hunters Clue drivew ay, October 20, 2015.

<u>Recommendations for Additional Remedial Actions</u>: Conduct pesticide spot application on scattered occurrences of invasive species, especially persistent: Asiatic bittersweet (*Celastrus orbiculatus*), Morrow's honeysuckle (*Lonicera morrowii*), multiflora rose (*Rosa multiflora*); burning bush (*Euonymus alatus*), autumn-olive (*Elaeagnus umbellate*), creeping yellow-loosestrife (*Lysimachia nummularia*), Japanese stiltgrass (*Microstegium vimineum*), reed canary grass (*Phalaris arundinacea*), purple loosestrife (*Lythrum salicaria*), and Japanese knotweed (*Fallopia japonica*). Details regarding the locations of these invasive species within the mitigation site is provided in the *Conclusion* section of this report.

The effectiveness of the invasive species management program is evident in comparison to the untreated western floodplain. The mitigation site consists of approximately five percent cover by invasive species. Patches of invasive plant infection were observed in a variety of places within the mitigation area. The highest concentrations of invasive plant species within the mitigation area are located in the vicinity of the Enfield Hunters Club driveway. VHB recommends that the Town of Enfield retain the services of a licensed pesticide applicator to complete additional treatments in 2016 to arrest establishment of invasive species.

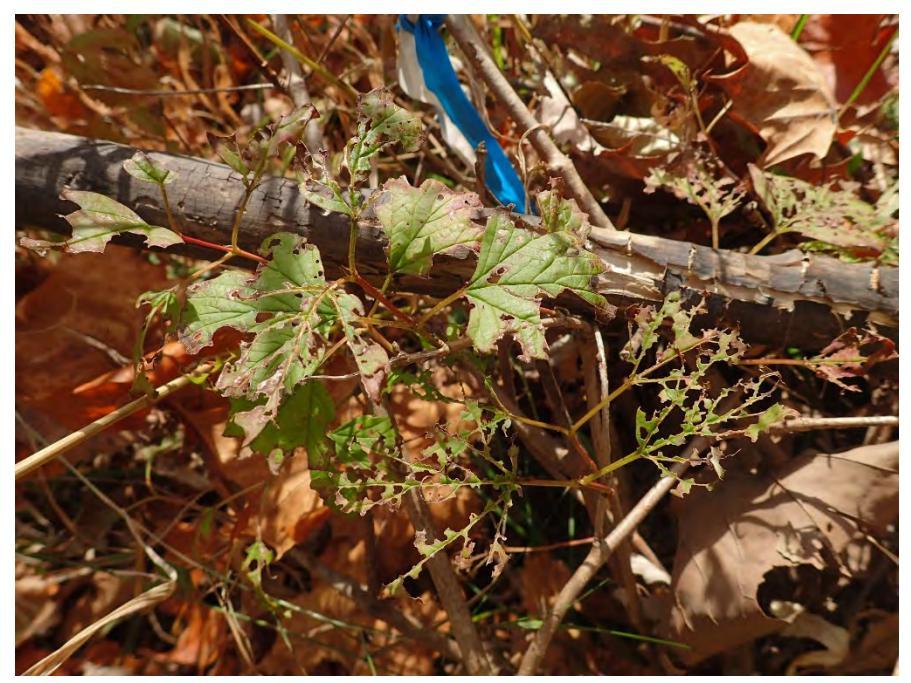
Inspection results for *Viburnum dentatum* and *Viburnum trilobum* shrubs were grouped together due to the large quantity of missing shrubs and difficulty distinguishing between the two species, particularly the dead and feeble individuals. Approximately 50% of the planted *Viburnum* shrubs (59 of 120) were confirmed living as of the fall 2015 inspection. The condition of the surviving shrubs ranged from vigorous to feeble due to varying degrees of insect and deer damage. Twenty-two (22) shrubs appear to have succumbed to repeated insect defoliation and/or deer browse. Many of these shrubs have been browsed down to heights of 18 inches or less. Four (4) of the *Viburnum* shrubs succumbed from a fallen tree. *Viburnum* shrubs that were not found during the inspection may have been obscured by dense herbaceous growth, tangles of fallen tree and tree limbs, and/or loss of foliage.

Photo Location 7: Close-up of planted Viburnum spp. with severe insect damage, October 20, 2015.

Approximately 50% percent of the *Viburnum spp.* plantings were either unaccounted for, observed decimated by deer browse or insect defoliations, and/or shaded out by fallen tree debris. The health of remaining 50% ranged widely from thriving to feeble. Nevertheless, vigorous growth of herbaceous vegetation and native volunteer shrubs has emerged within the mitigation site. The growth of these species within the mitigation area provide the permit required enhanced wetland habitat over preconstruction conditions. As such, replacement of these shrubs is not recommended as a necessary or prudent remedial action.

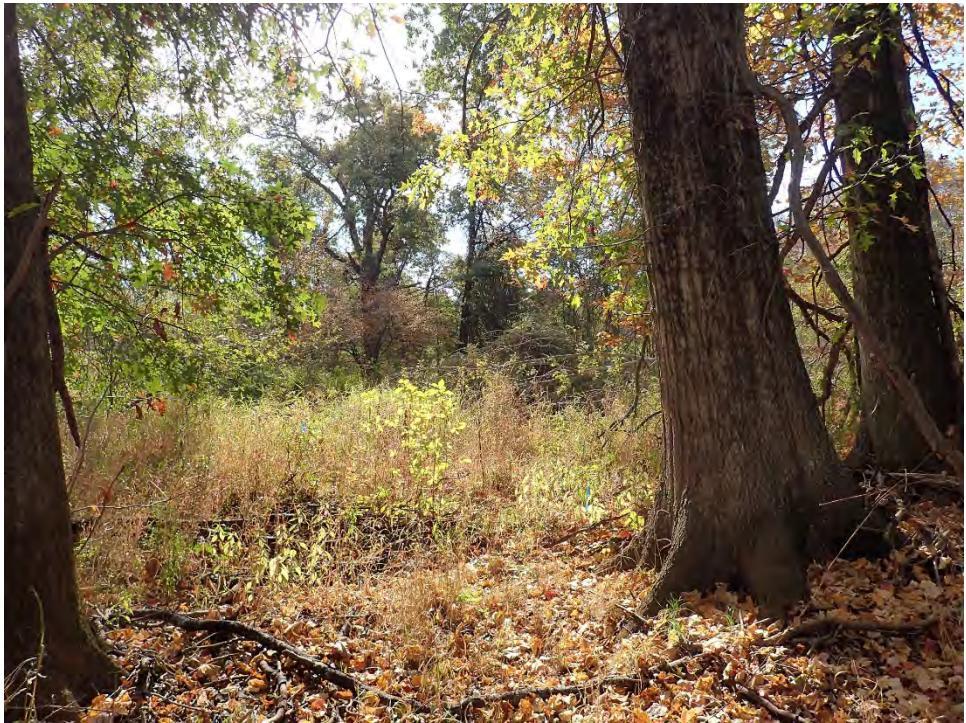
Photo Location 8: Northern portion of mitigation area looking west, October 20, 2015.
