Explanation of Significant Differences

Former Cape Poge Little Neck Bomb Target Land and Inland Water Munitions Response Sites

> FUDS Project No. D01MA0595 Projects MRS01 and MRS02

> > Martha's Vineyard, MA

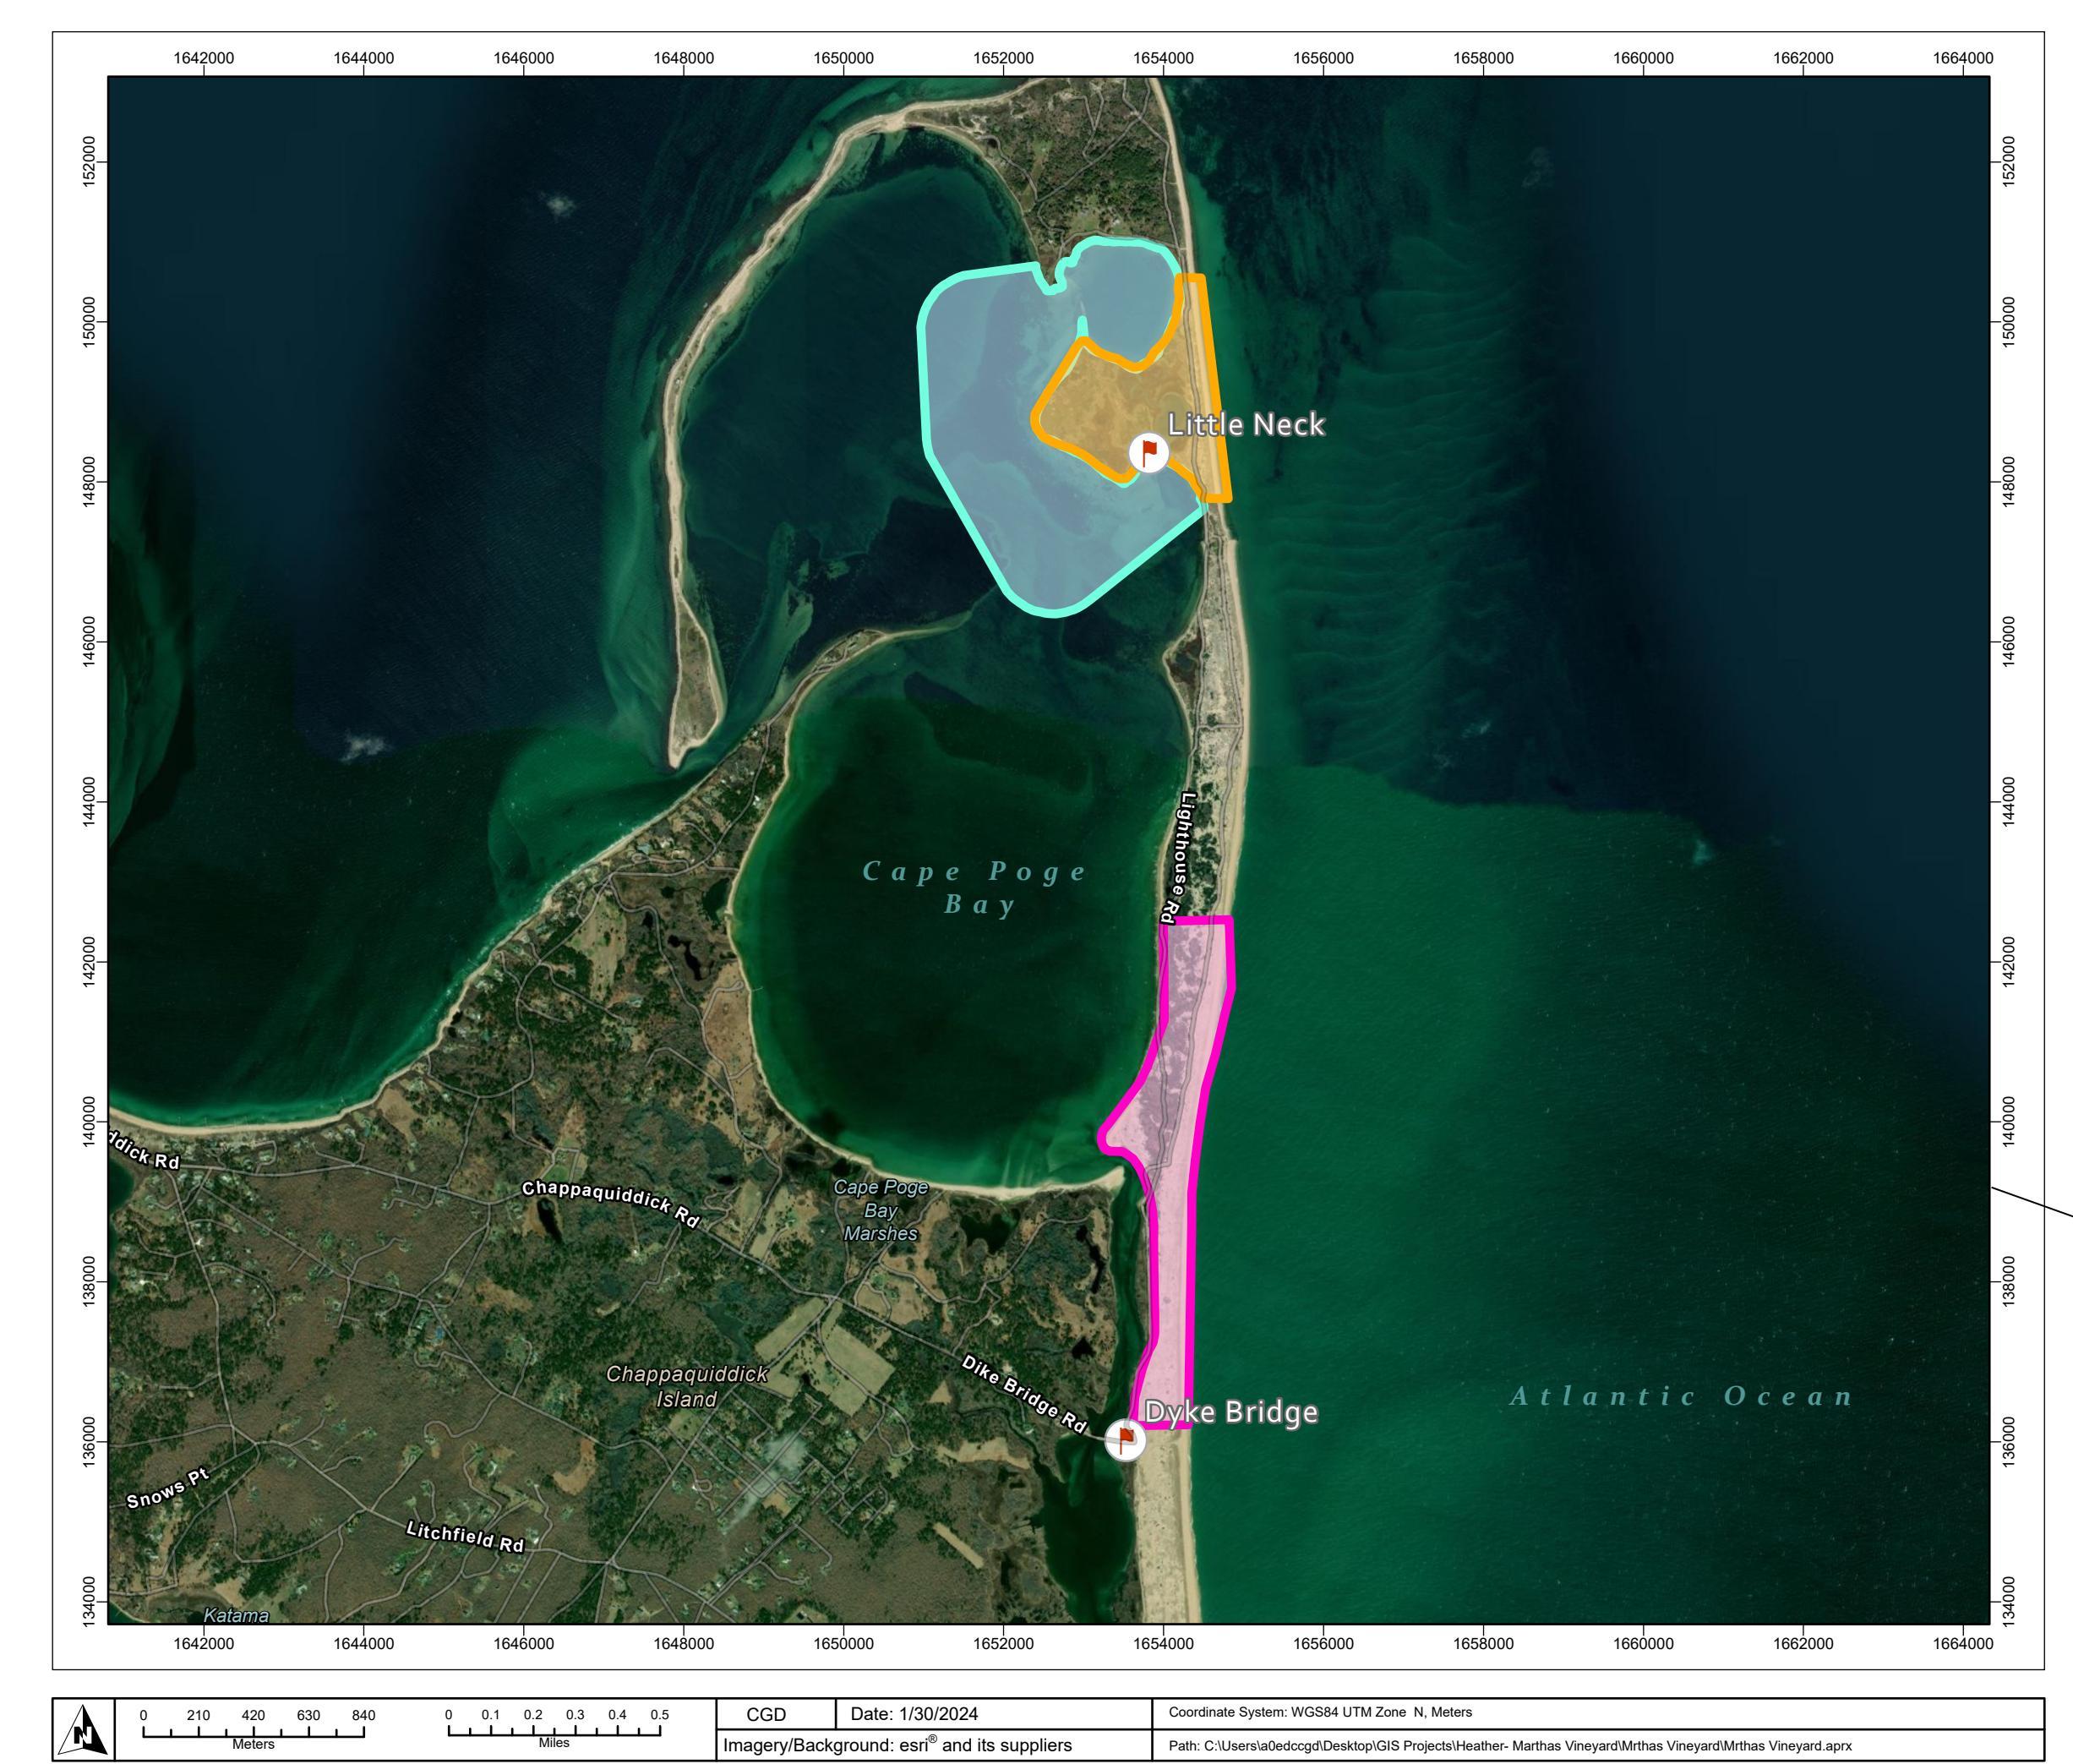
Exhibit A

Former Cape Poge Little Neck Bomb Target Martha's Vineyard, MA

(police and fire department personnel), distributing explosives safety educational materials provided by USACE to first responders and to TToR, conducting interviews with local officials and property owners, obtaining a summary of UXO related activity at the MRS, and inspecting and maintaining UXO hazard awareness signs. Currently, there are two signs, located at the Dyke Bridge and at Little Neck (Figure A), however the number of signs may change in the future in order to adequately cover any new access pathways to the beach as they are established.

A LUCIP has been in place since 2019 and will be updated by September 30, 2025. All signs as described in the LUCIP were installed in 2019 and continue to be monitored/maintained annually. Training was initiated in 2019 and continues annually. The safety brochures have been delivered.
