September 26, 2016

Re: Fourth Five-Year Review Report (2011-2016) for the Former Ft. Devens-Sudbury Training Annex

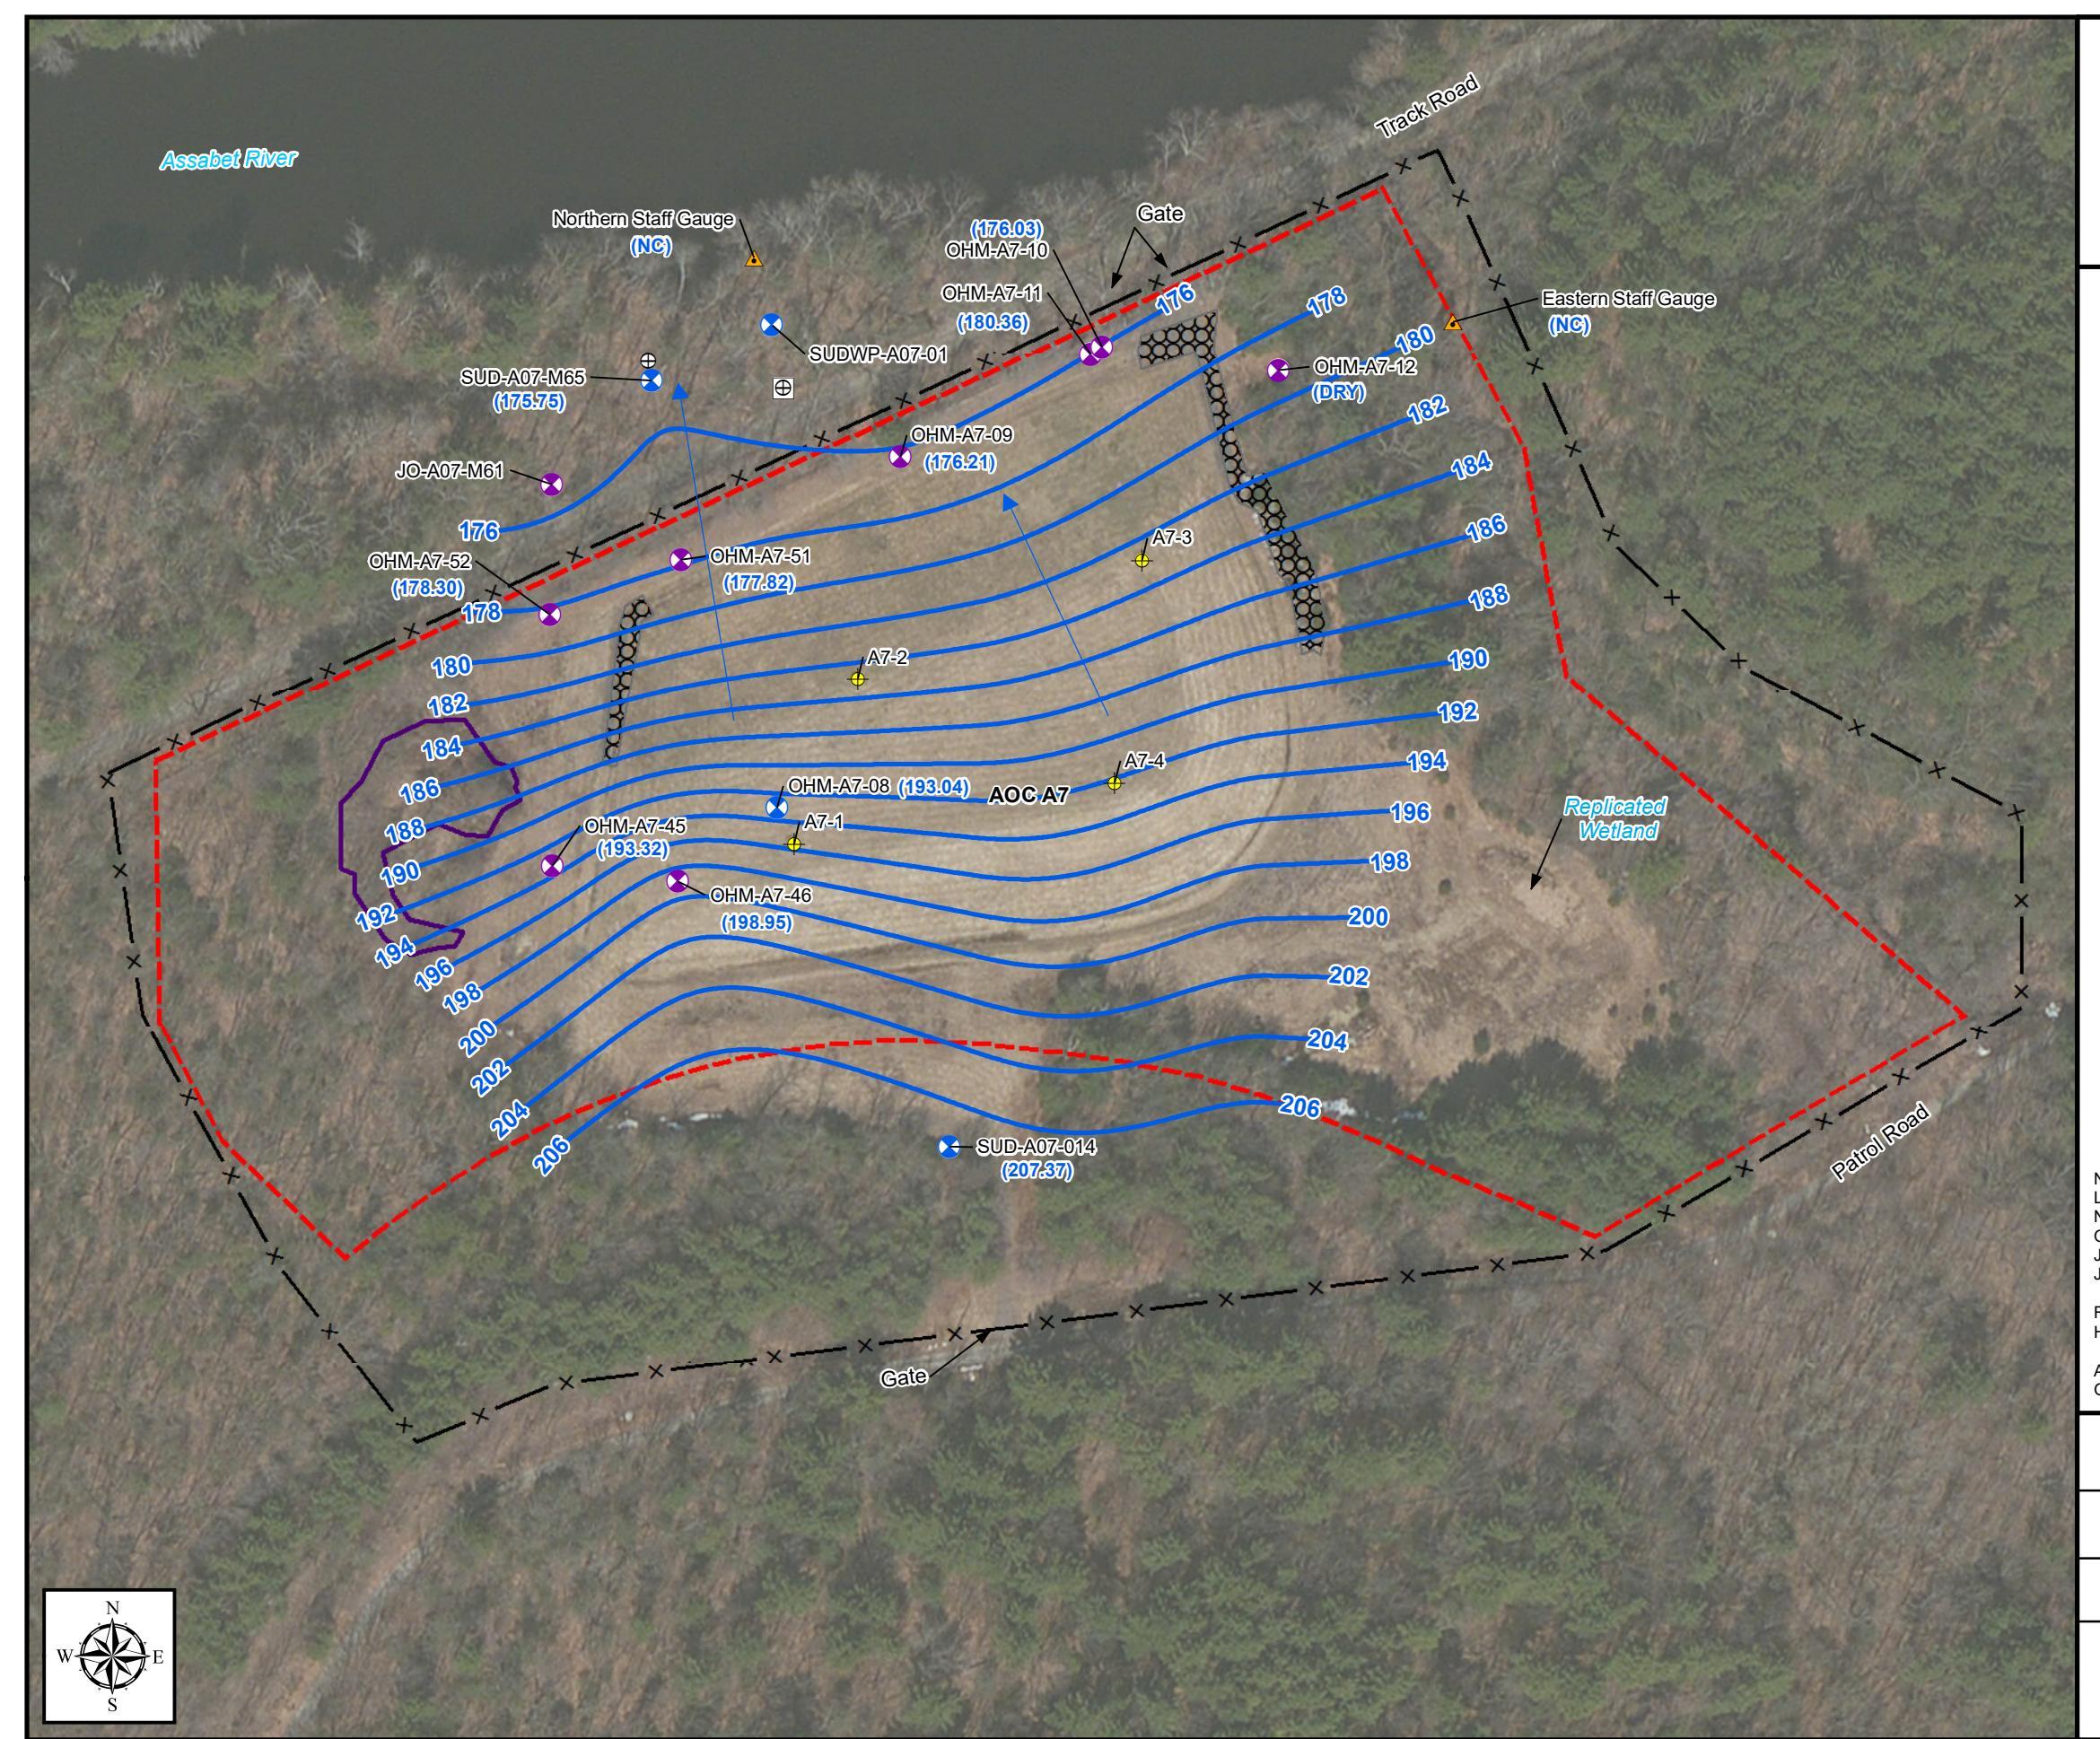
Figure 5 Interpretive Water Table Elevation Sudbury Annex - AOC A7 October 9, 2015

Groundwater elevations are monitored annually for compliance with RAOs, which require a demonstration that groundwater levels and gradients remain low within the landfill limiting infiltration to the underlying waste.

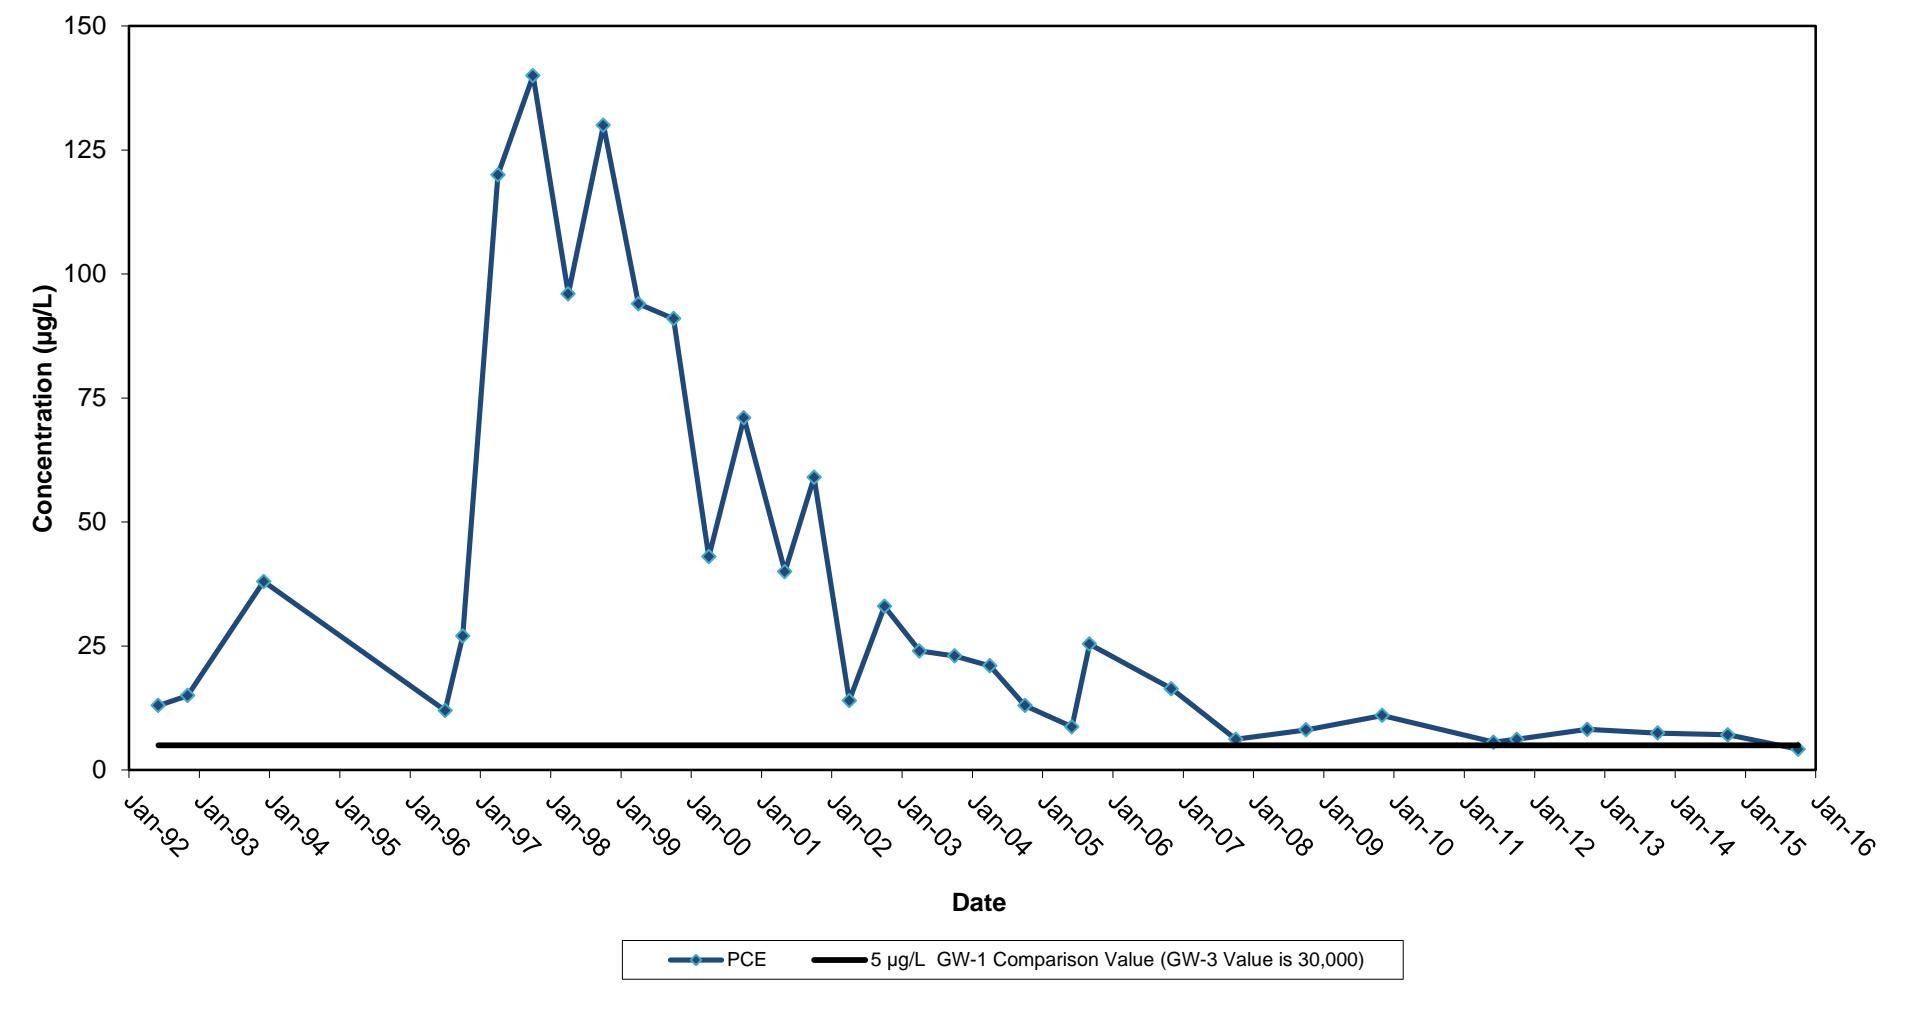
Appendix C-2 Long-Term Trends Wells JO-A7-M63/SUD-A07-065 Trichloroethene Area of Contamination A7

Contaminants detected in groundwater continue to show downward trends at AOC A7. The landfill at AOC A7 remains in good condition and continues to function as intended by the 1995 ROD. Some
