NO FURTHER ACTION DECISION DOCUMENT

FORMER MARKLEY SMALL ARMS FIRING RANGE

FORMER FORT DEVENS ARMY INSTALLATION, DEVENS, MA

AUGUST 2013

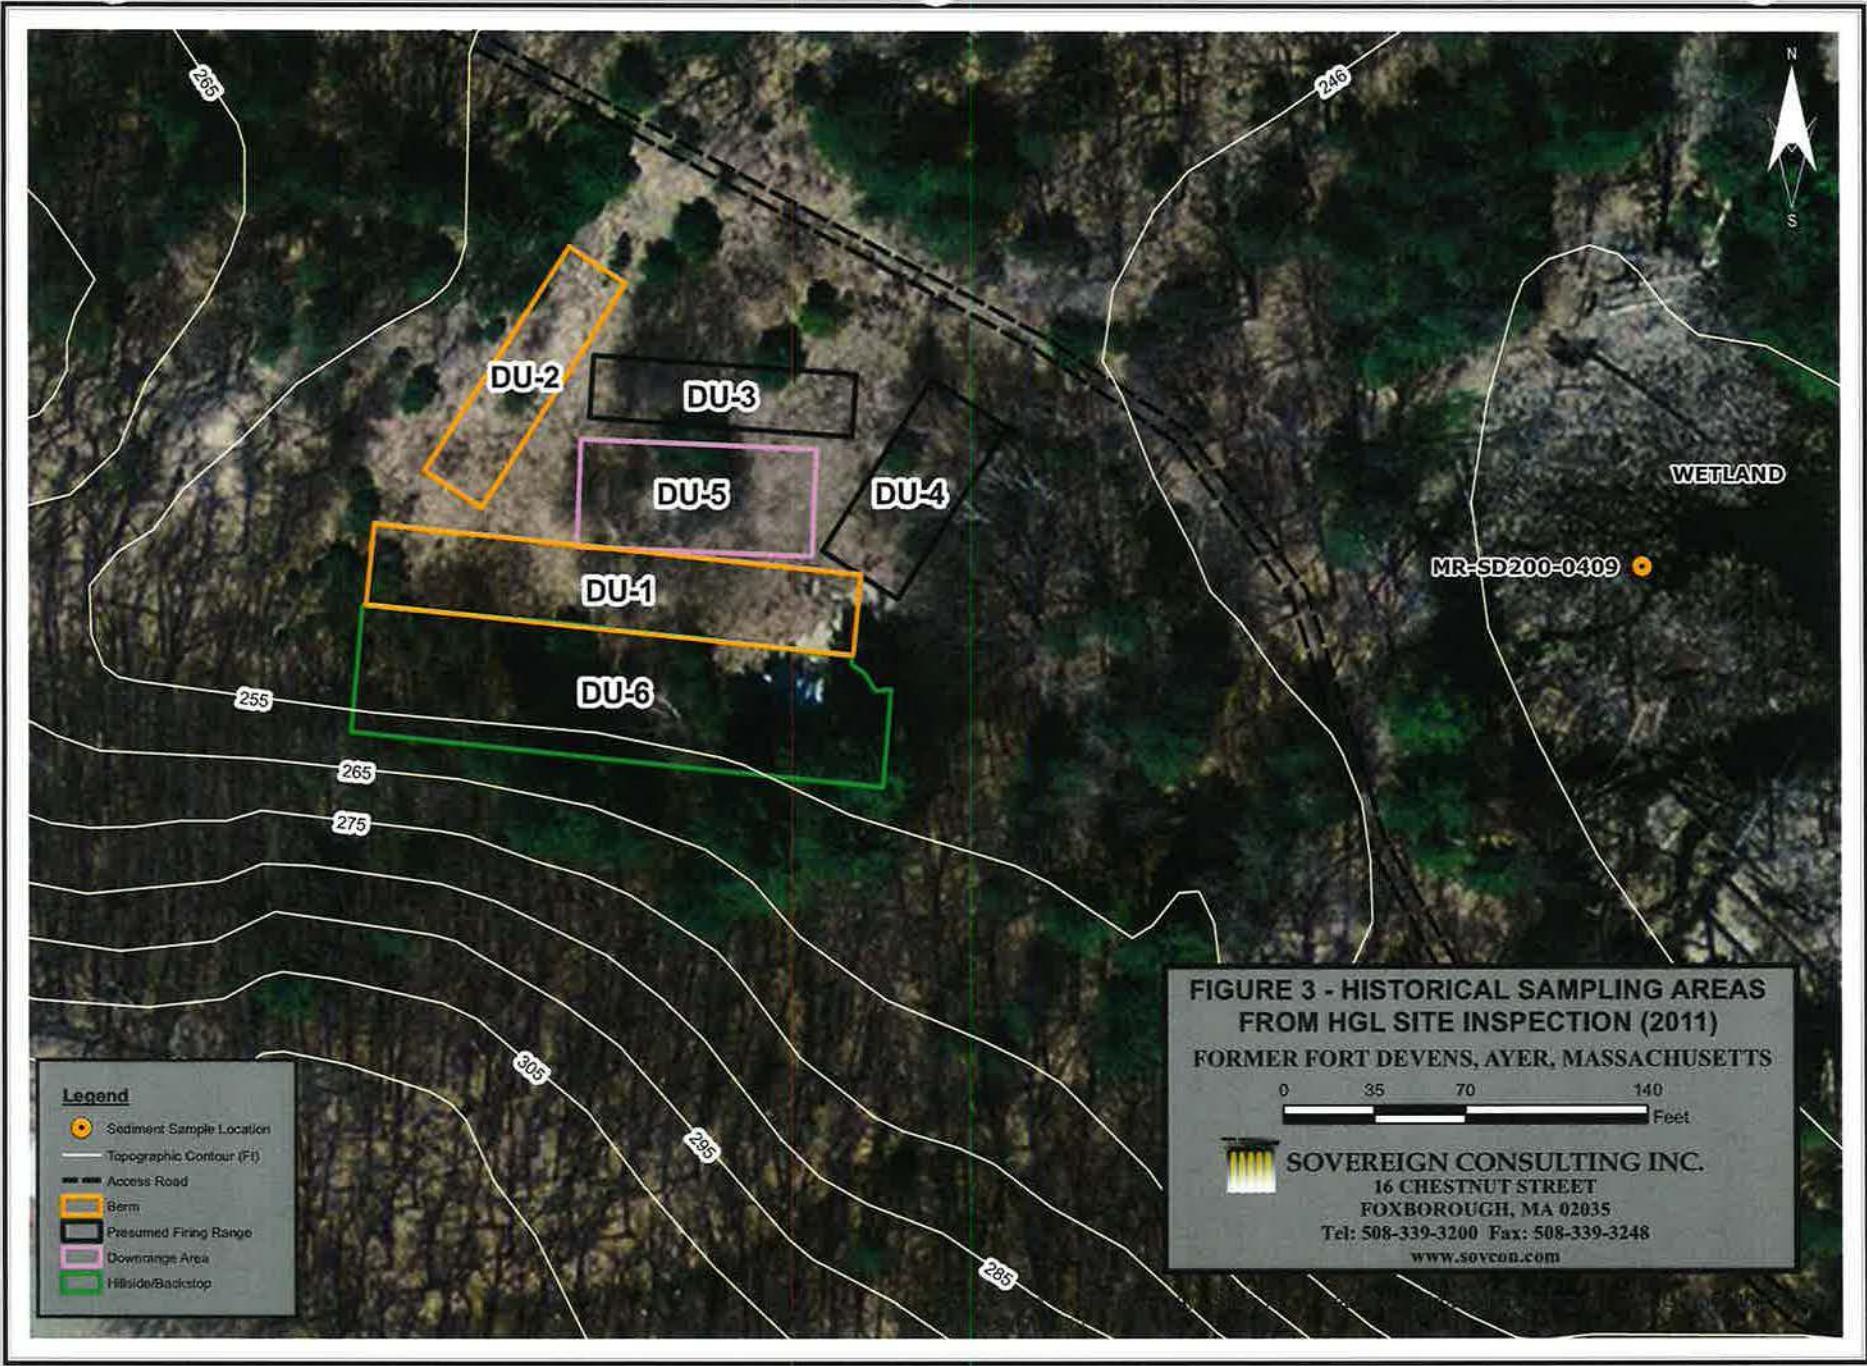
Figure 3: Historical Sampling Areas from HGL Site Inspection 2011

A review of historical aerial photographs for the years 1965, 1980, and 2007 was performed as part of the August 2011 *Final Site Inspection Report, Markley Range, Former Fort Devens Army Installation, Devens, Massachusetts,* prepared by HGL (HGL, 2011). This review indicated that the Markley Range may have been active in the early 1960s, due to ground scarring and the absence of vegetation observed in the 1965 aerial photograph; however, the construction of the Davao housing area immediately downrange (south) of the Markley range in the early 1960s suggests the range was largely abandoned once the housing area was developed. Based on observations made of the 1980 and 2007 aerial photographs, HGL confirmed the likely firing line was located at the northern end of the range with a backstop at the southern end. The South Berm (DU-1) was historically a sandy former backstop/berm area at the southern end of the range which was removed at an unknown date (**Figure 3**).

Shallow soil samples were collected in six (6) DUs (DU-1 through DU-6) across the Markley Range including the presumed berm areas (DU-1 and DU-2), the firing areas (DU-3 and DU-4), the down range area (DU-5), and the uphill area (DU-6) at multiple depth intervals up to 18 inches below grade (Figure 3). As part of an Incremental Sampling Method (ISM) approach (USACE, 2009), a systematic, random sampling grid was developed for each DU where 80 or more increments were collected between depths of 0 to 18 inches below grade and combined into one (1) composite sample. For each DU, one (1) composite sample (1 kilogram or larger) was submitted for metals analysis and select samples from three (3) of the six (6) DUs (DU-3, DU-4, and DU-5) were submitted for explosives analysis. To assess additional ecological risk of grit ingestion by fowl, HGL conducted a lead fragment count analysis of samples collected from three (3) DUs (DU-1, DU-2, and DU-6) where lead shot would likely be found. One (1) sediment sample (MR-SD200-0409) was also collected from the wetland located to the east of the former range and analyzed for metals and explosives (Figure 3).

In order to confirm the results of the one (1) sediment sample collected by HGL during the SI (Figure 3) and document whether or not sediment conditions are potentially harmful to ecological receptors, four (4) sediment samples (MR-SD001 through MR-SD004) were collected from the wetland sediments located to the east of the site. Sediment samples were collected from the nearby wetland in drainage locations in-line with the presumed groundwater flowpath from the Markley Range. Sample locations were also based on the direction of stormwater runoff from the area of contamination, in-line with the potential locations where eroded soils from the impacted area enter the wetland. Samples were submitted to the laboratory for analysis of target analyte list (TAL) metals.

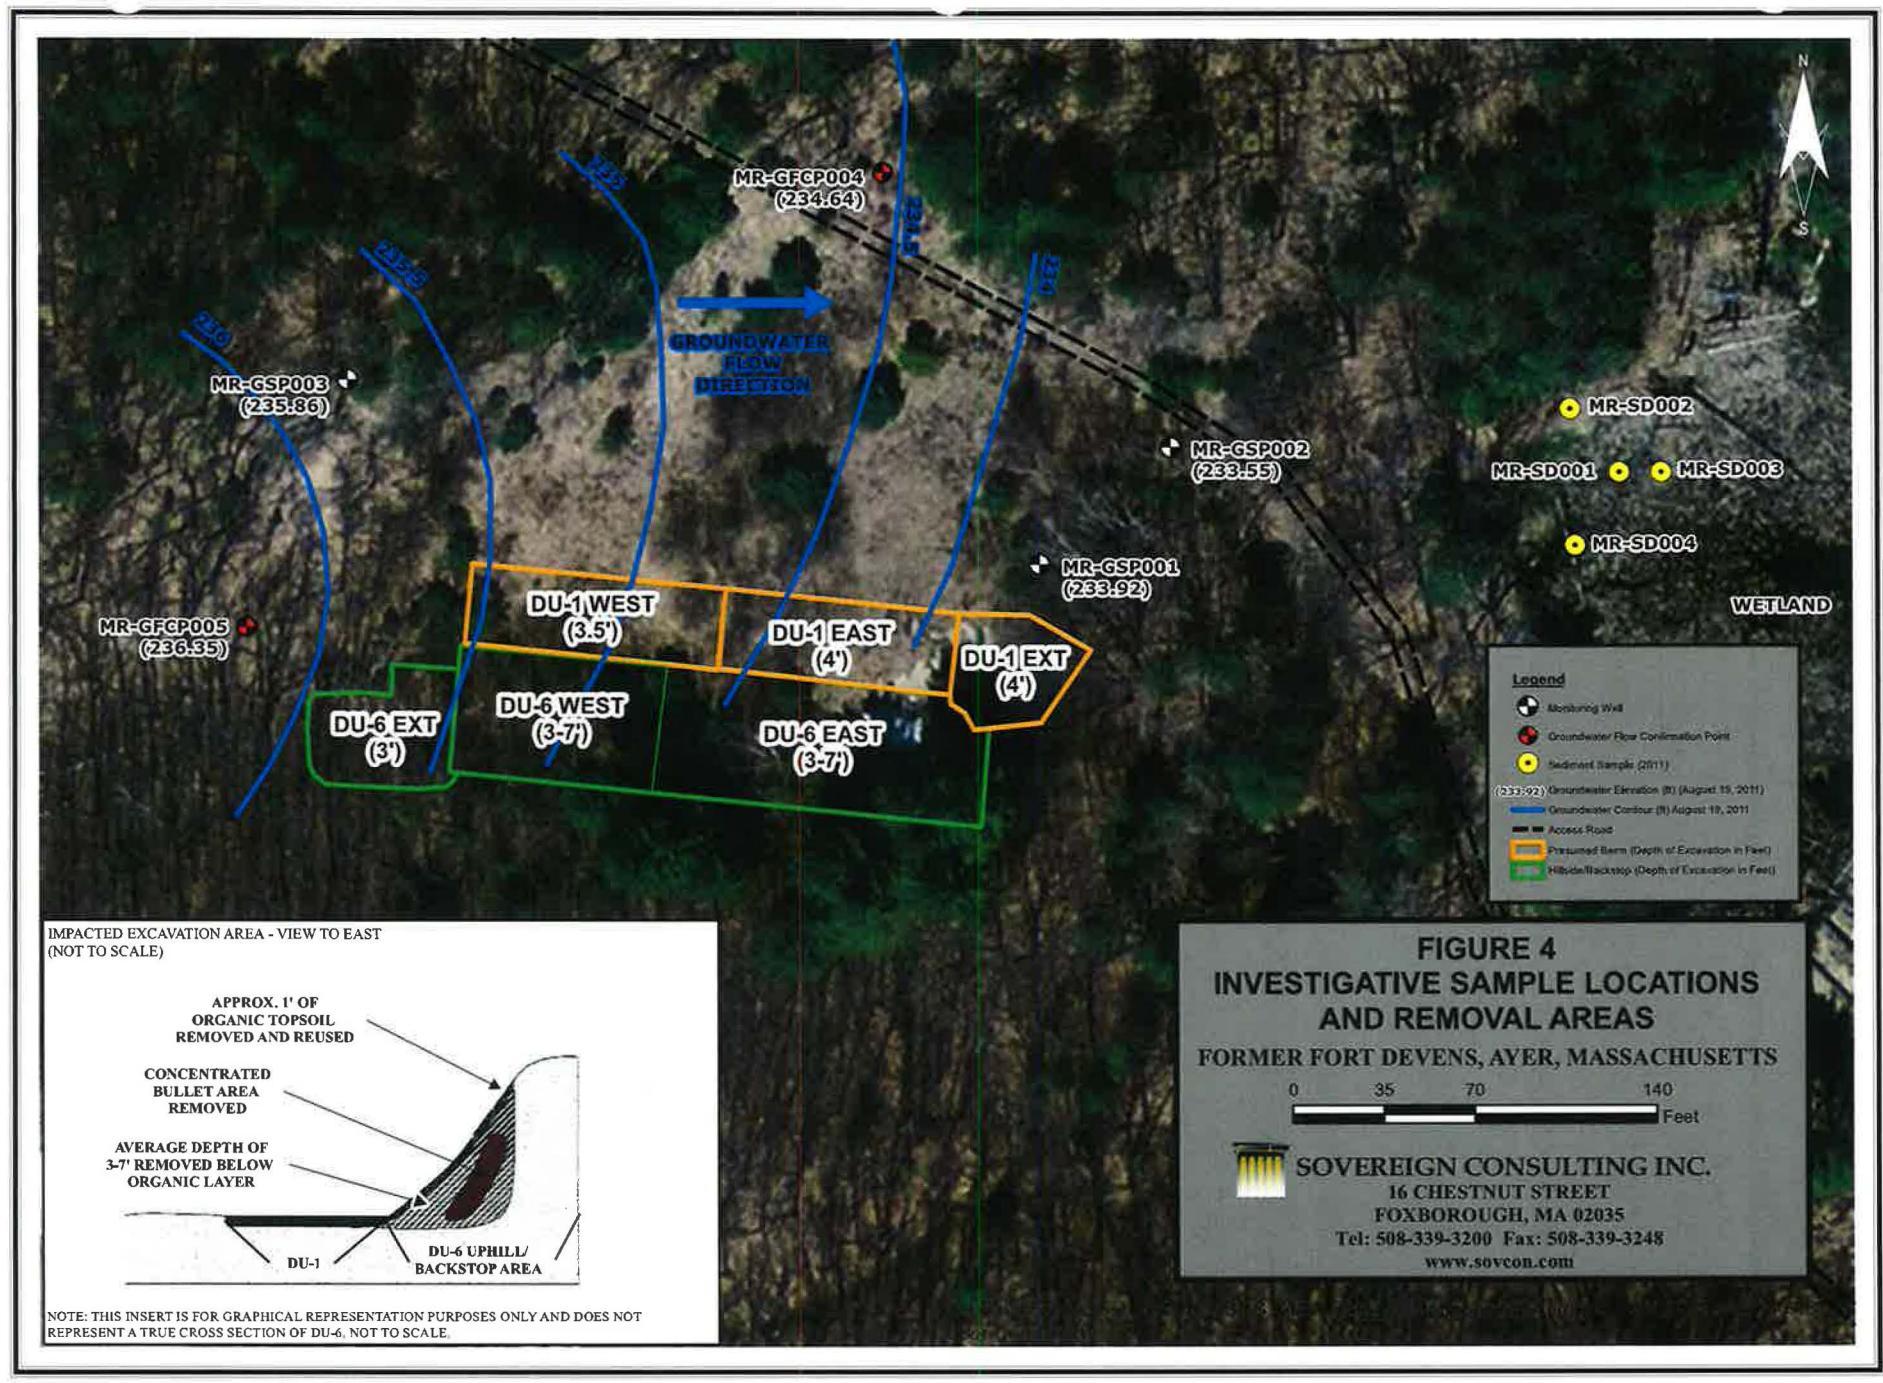
Figure 4: Investigative Sample Locations and Removal Areas

The removal action included the excavation of lead-impacted soil from existing decision units DU-1 and DU-6 and from two (2) extension areas adjacent to the decision units. The DU-1 Extension (DU-1 EXT) was located to the east of DU-1 and the DU-6 Extension (DU-6 EXT) was located to the west of DU-6 (Figure 4).

The DU-6 excavation area measured approximately 200 x 50 ft, to an approximate depth of 3-7 ft below grade, varying based on the elevation change of the DU-6 hillside (Figure 4). Where

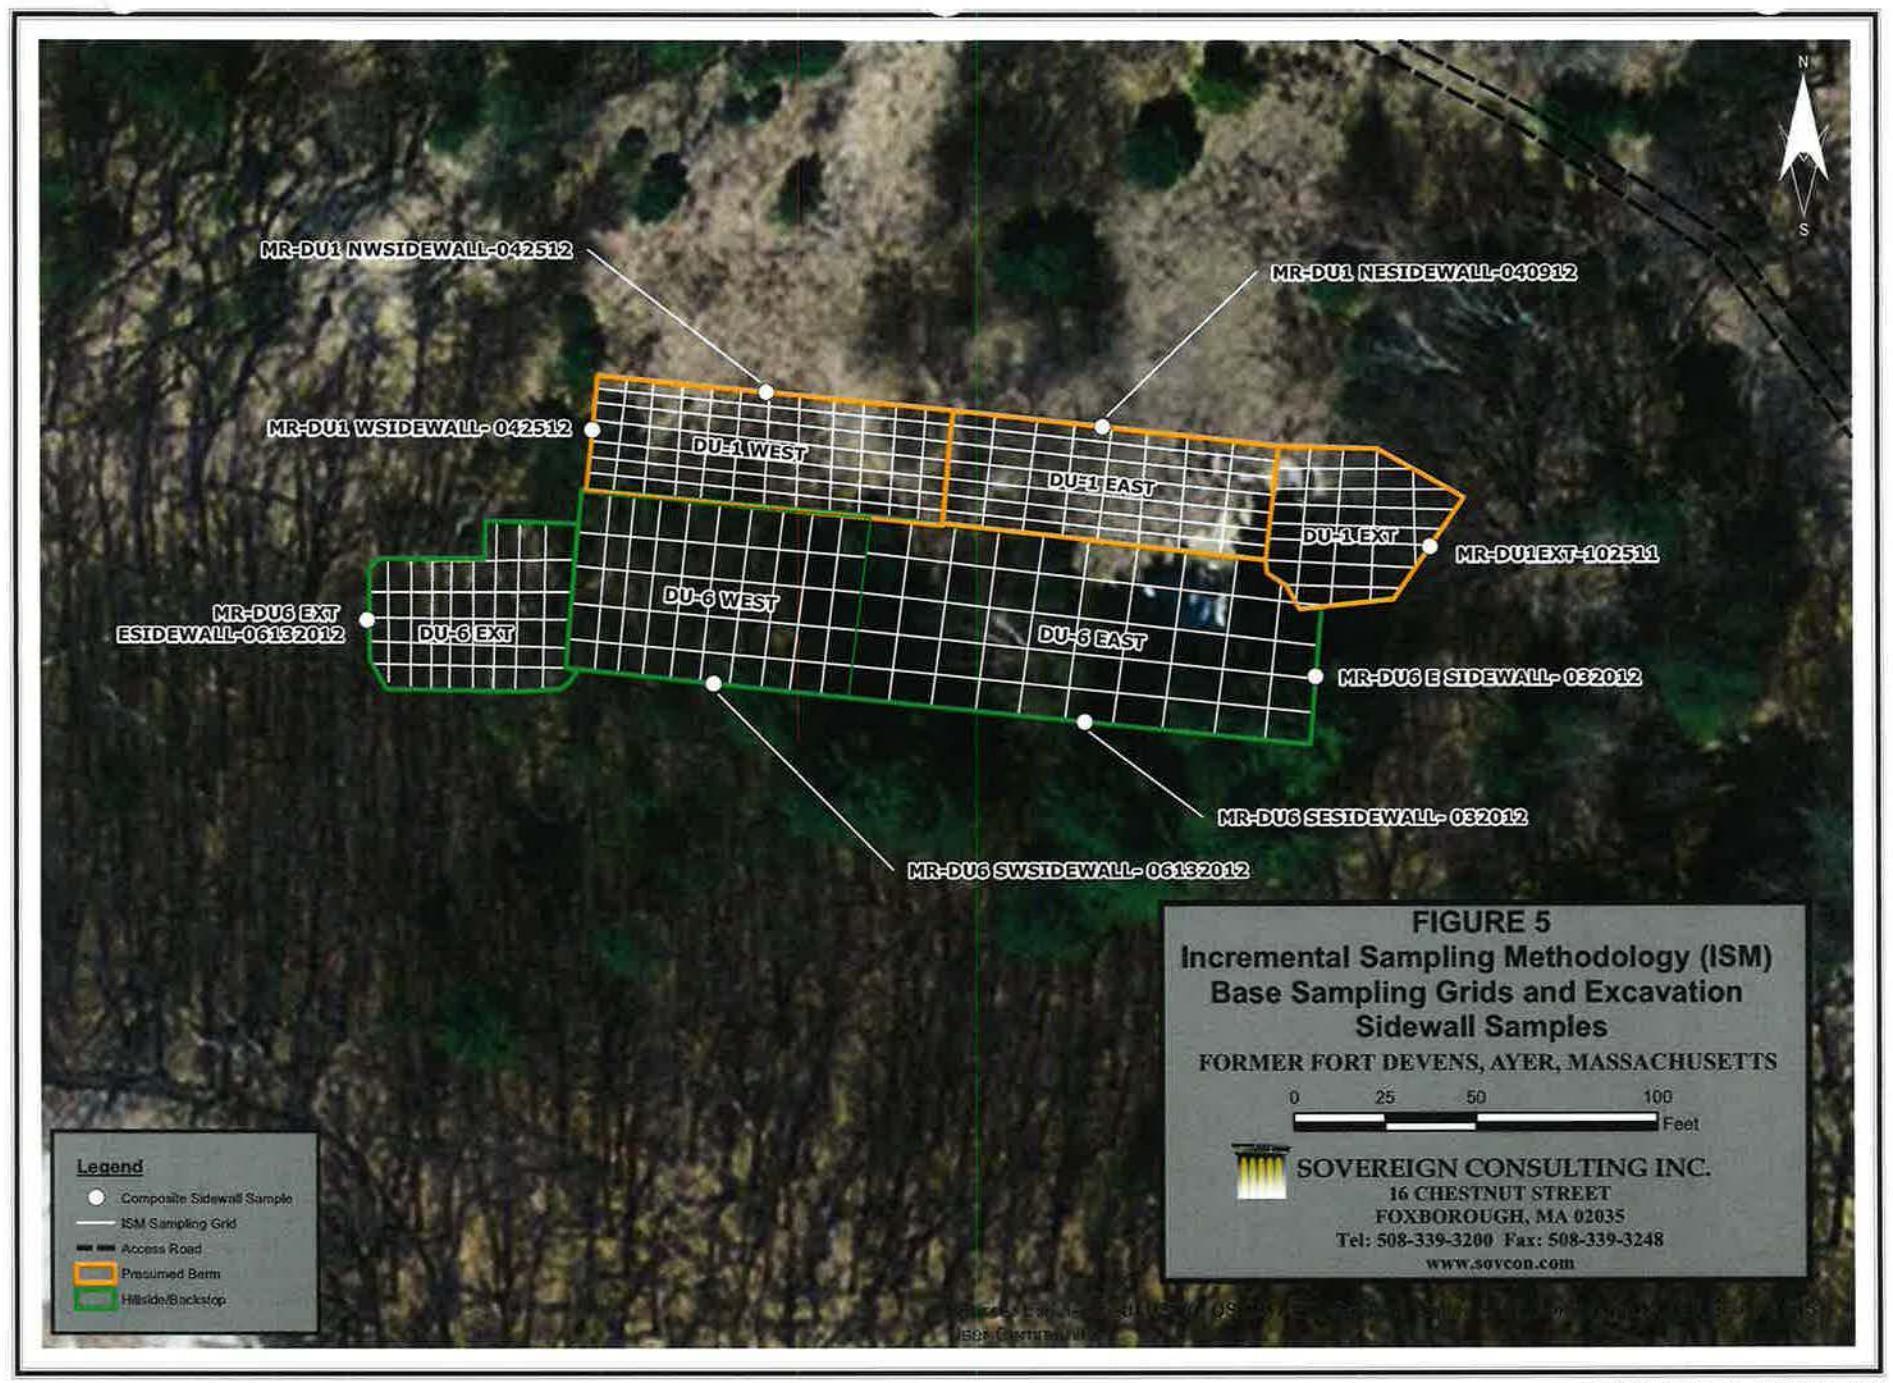
Figure 5: Incremental Sampling Methodology (ISM) Base Sampling Grids and Excavation Sidewall Samples

The collection of confirmatory soil samples was completed in all excavation areas. An ISM approach (USACE, 2009) was conducted at the base of each excavation. One (1) composite sample (at approximately 1 kilogram) was submitted based on incremental samples collected from within a systematic, random grid set up within each of the excavation bases for DU-1 EXT, DU-6 EXT, DU-1, and DU-6. Due to the size of DU-6 and DU-1, each of these units was separated into east and west sampling grids. In total, six (6) ISM sampling grids, or decision units, were created. The number of incremental sample points per grid varied from 37 to 85 depending upon the size of the particular excavation area. Refer to Figure 5 for a depiction of the sampling grids for each DU. For each grid, a duplicate and triplicate sample was collected, according to ISM protocol and the approved RAWP. The collection location of the incremental sample in each grid square varied based on the sample's designation as the primary, duplicate or triplicate, according to ISM protocol. ISM soil samples were submitted to TestAmerica Laboratories, Inc. (TestAmerica) in Burlington, Vermont for lead analysis following laboratory preparation by Method 8330B protocol, including air drying and sieving, however the samples were not ground with a puck mill by the laboratory, due to possible positive bias of metals data due to the wear metals of the case iron puck mill grinder contaminating the incremental soil sample. The low chromium case ion puck mill grinder bowl and disc that TestAmerica uses contains known concentrations of lead and other metals. Subsequent analysis of lead was performed using USEPA Method 6010B, which also includes a thorough homogenization procedure as well as a sub-sampling procedure of the entire incremental sample.

Confirmatory sidewall samples were collected from each outer wall of the excavation areas. The shallow depth of the sidewall samples was consistent at 18-24 inches so as to be relevant for the ecological risk evaluation for the Markley Range. Grab samples were collected along each sidewall at a rate of approximately one (1) per 20 lateral feet and composited into one (1) sample per sidewall. Soil samples were composited and homogenized using stainless steel
