# NO FURTHER ACTION DECISION UNDER CERCLA

# STUDY AREA 43K HISTORIC GAS STATION SITES

# FORT DEVENS, MASSACHUSETTS

JANUARY 1995

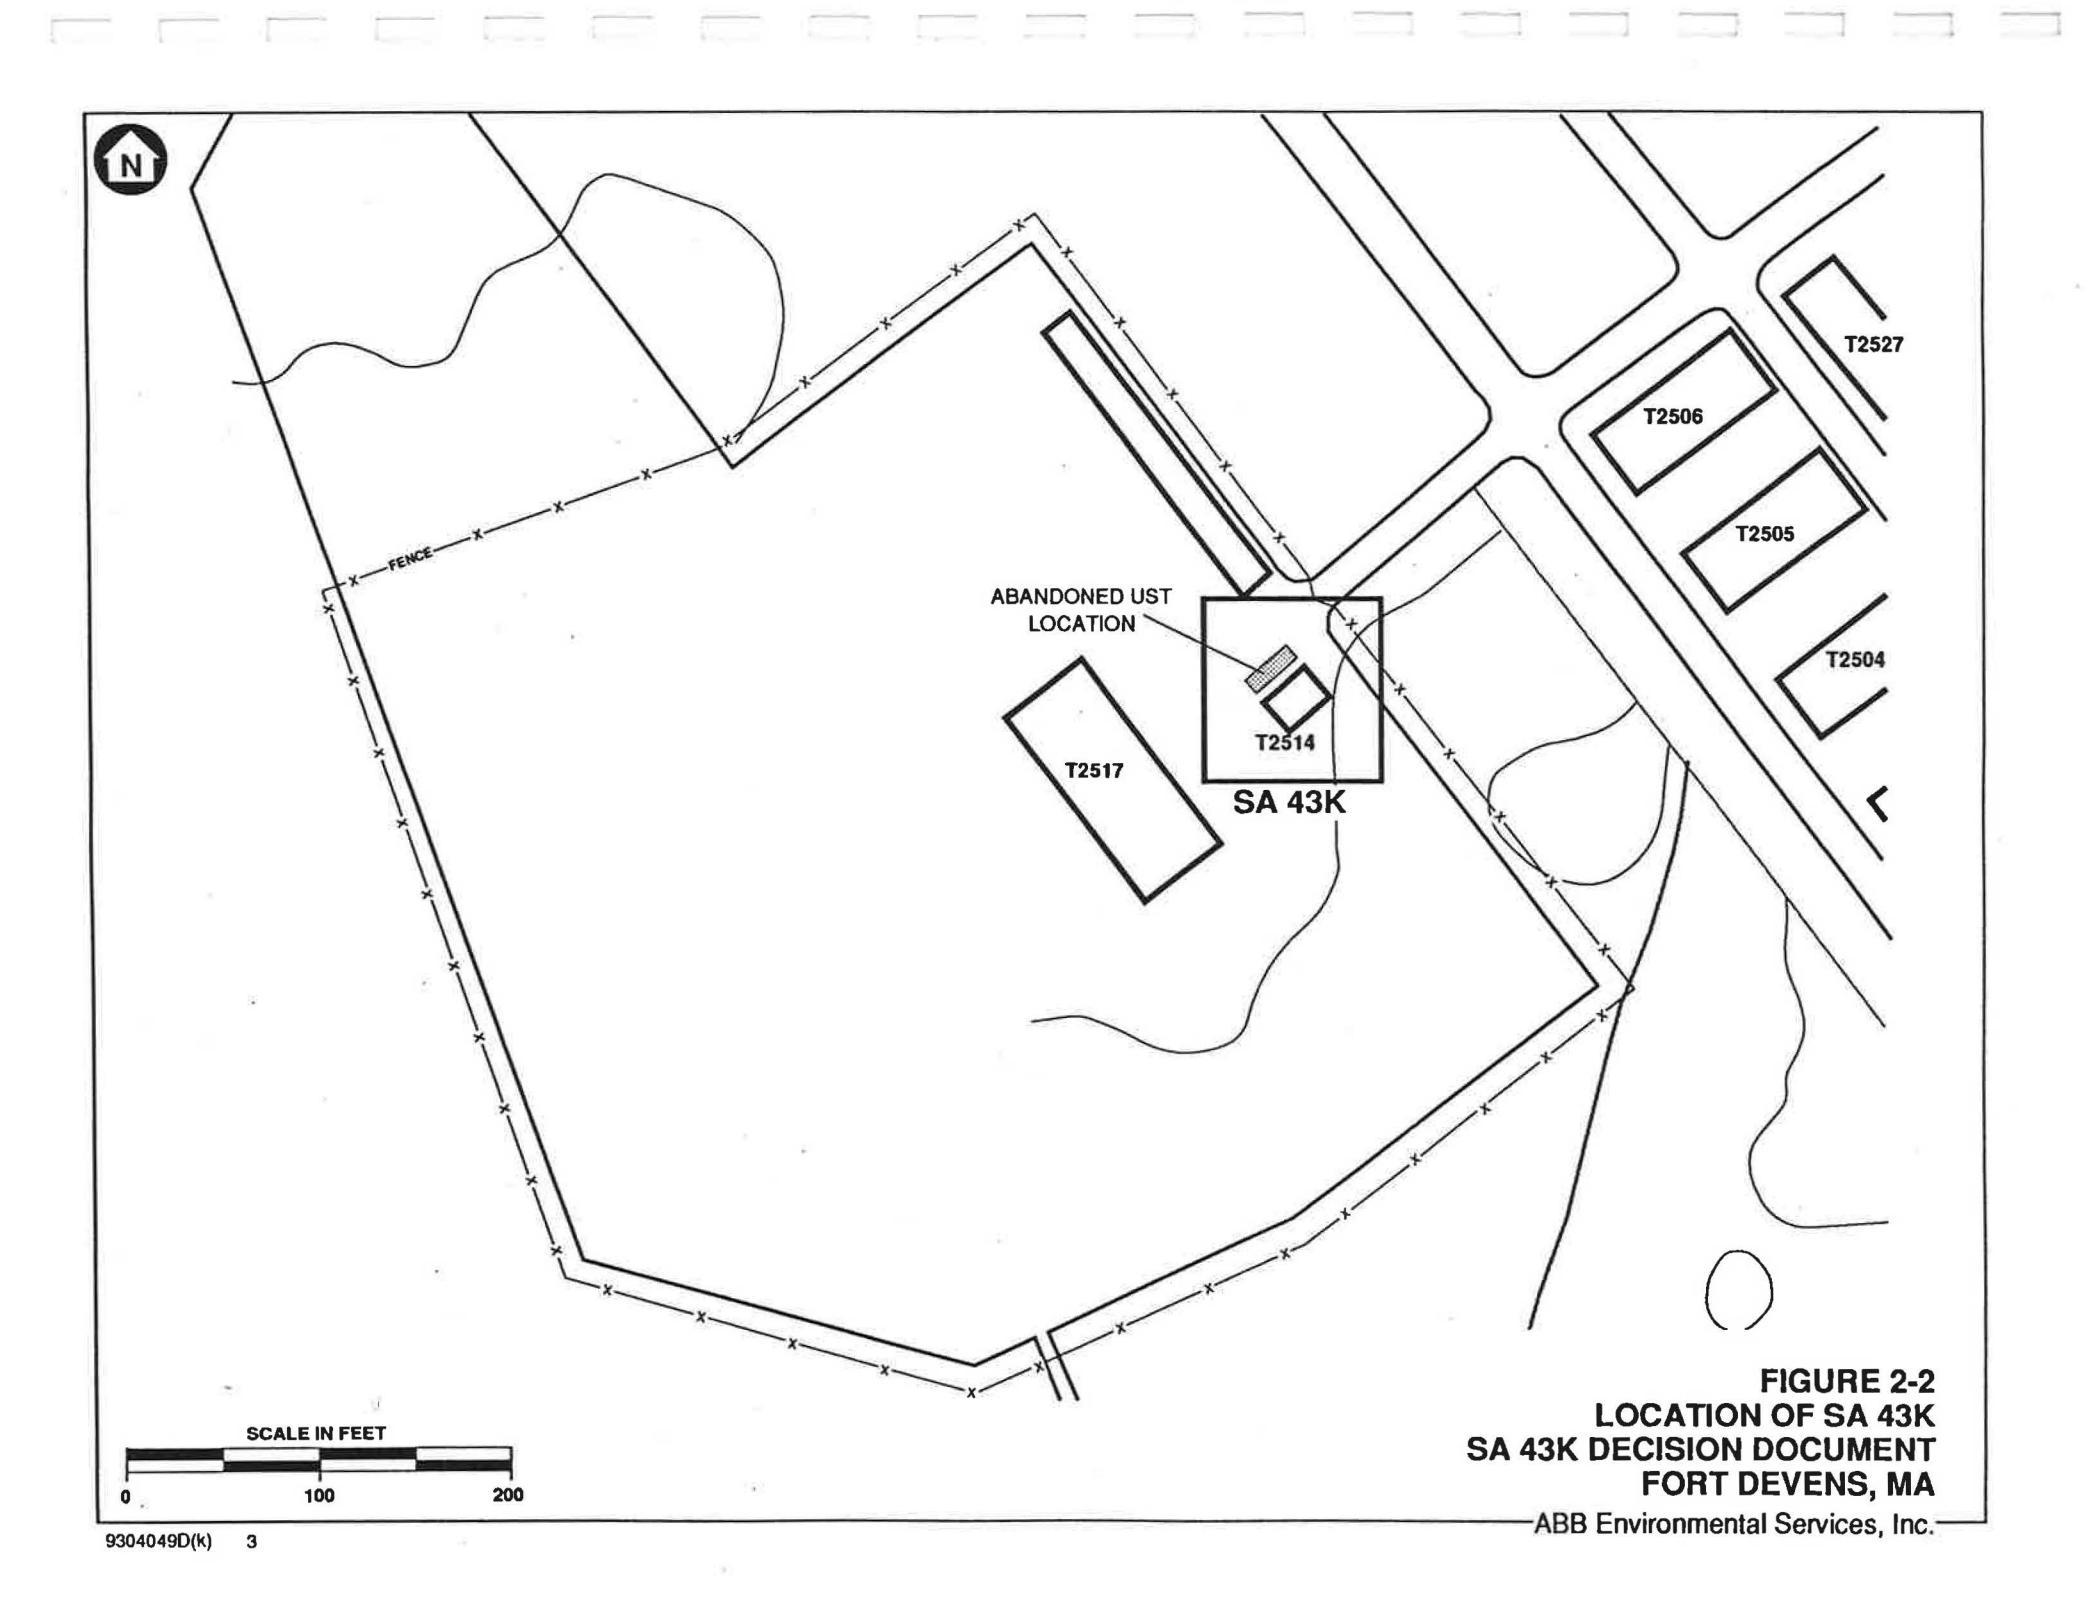
SA 43K, one of the 19 Historic Gas Station Sites, is included in the Group 2 SAs located on the Main Post. The structures of the historic gas station at SA 43K consisted of a pump island and a small gasoline pumphouse. This gas station was a Type A station which had one 5,000 gallon underground storage tank (UST) located between the gasoline pumphouse and pump island. The station was used during World War II as a vehicle motor pool to support military operations. The motor pool operations were discontinued during the late 1940s or early 1950s. No records were available on the decommissioning of this motor pool or the removal of the associated UST. SA 43K is located on an access road off Patton Road. The area around SA 43K is currently a recreational vehicle storage yard and maintenance facility for Fort Devens Directorate of Logistics. The pumphouse associated with the historic gas station (Building T-2514) appears to still be present at the site. The yard and maintenance facility is paved and surrounded by a chain-link fence with a locked gate located on the northeast side of the yard (Figure 2-2).

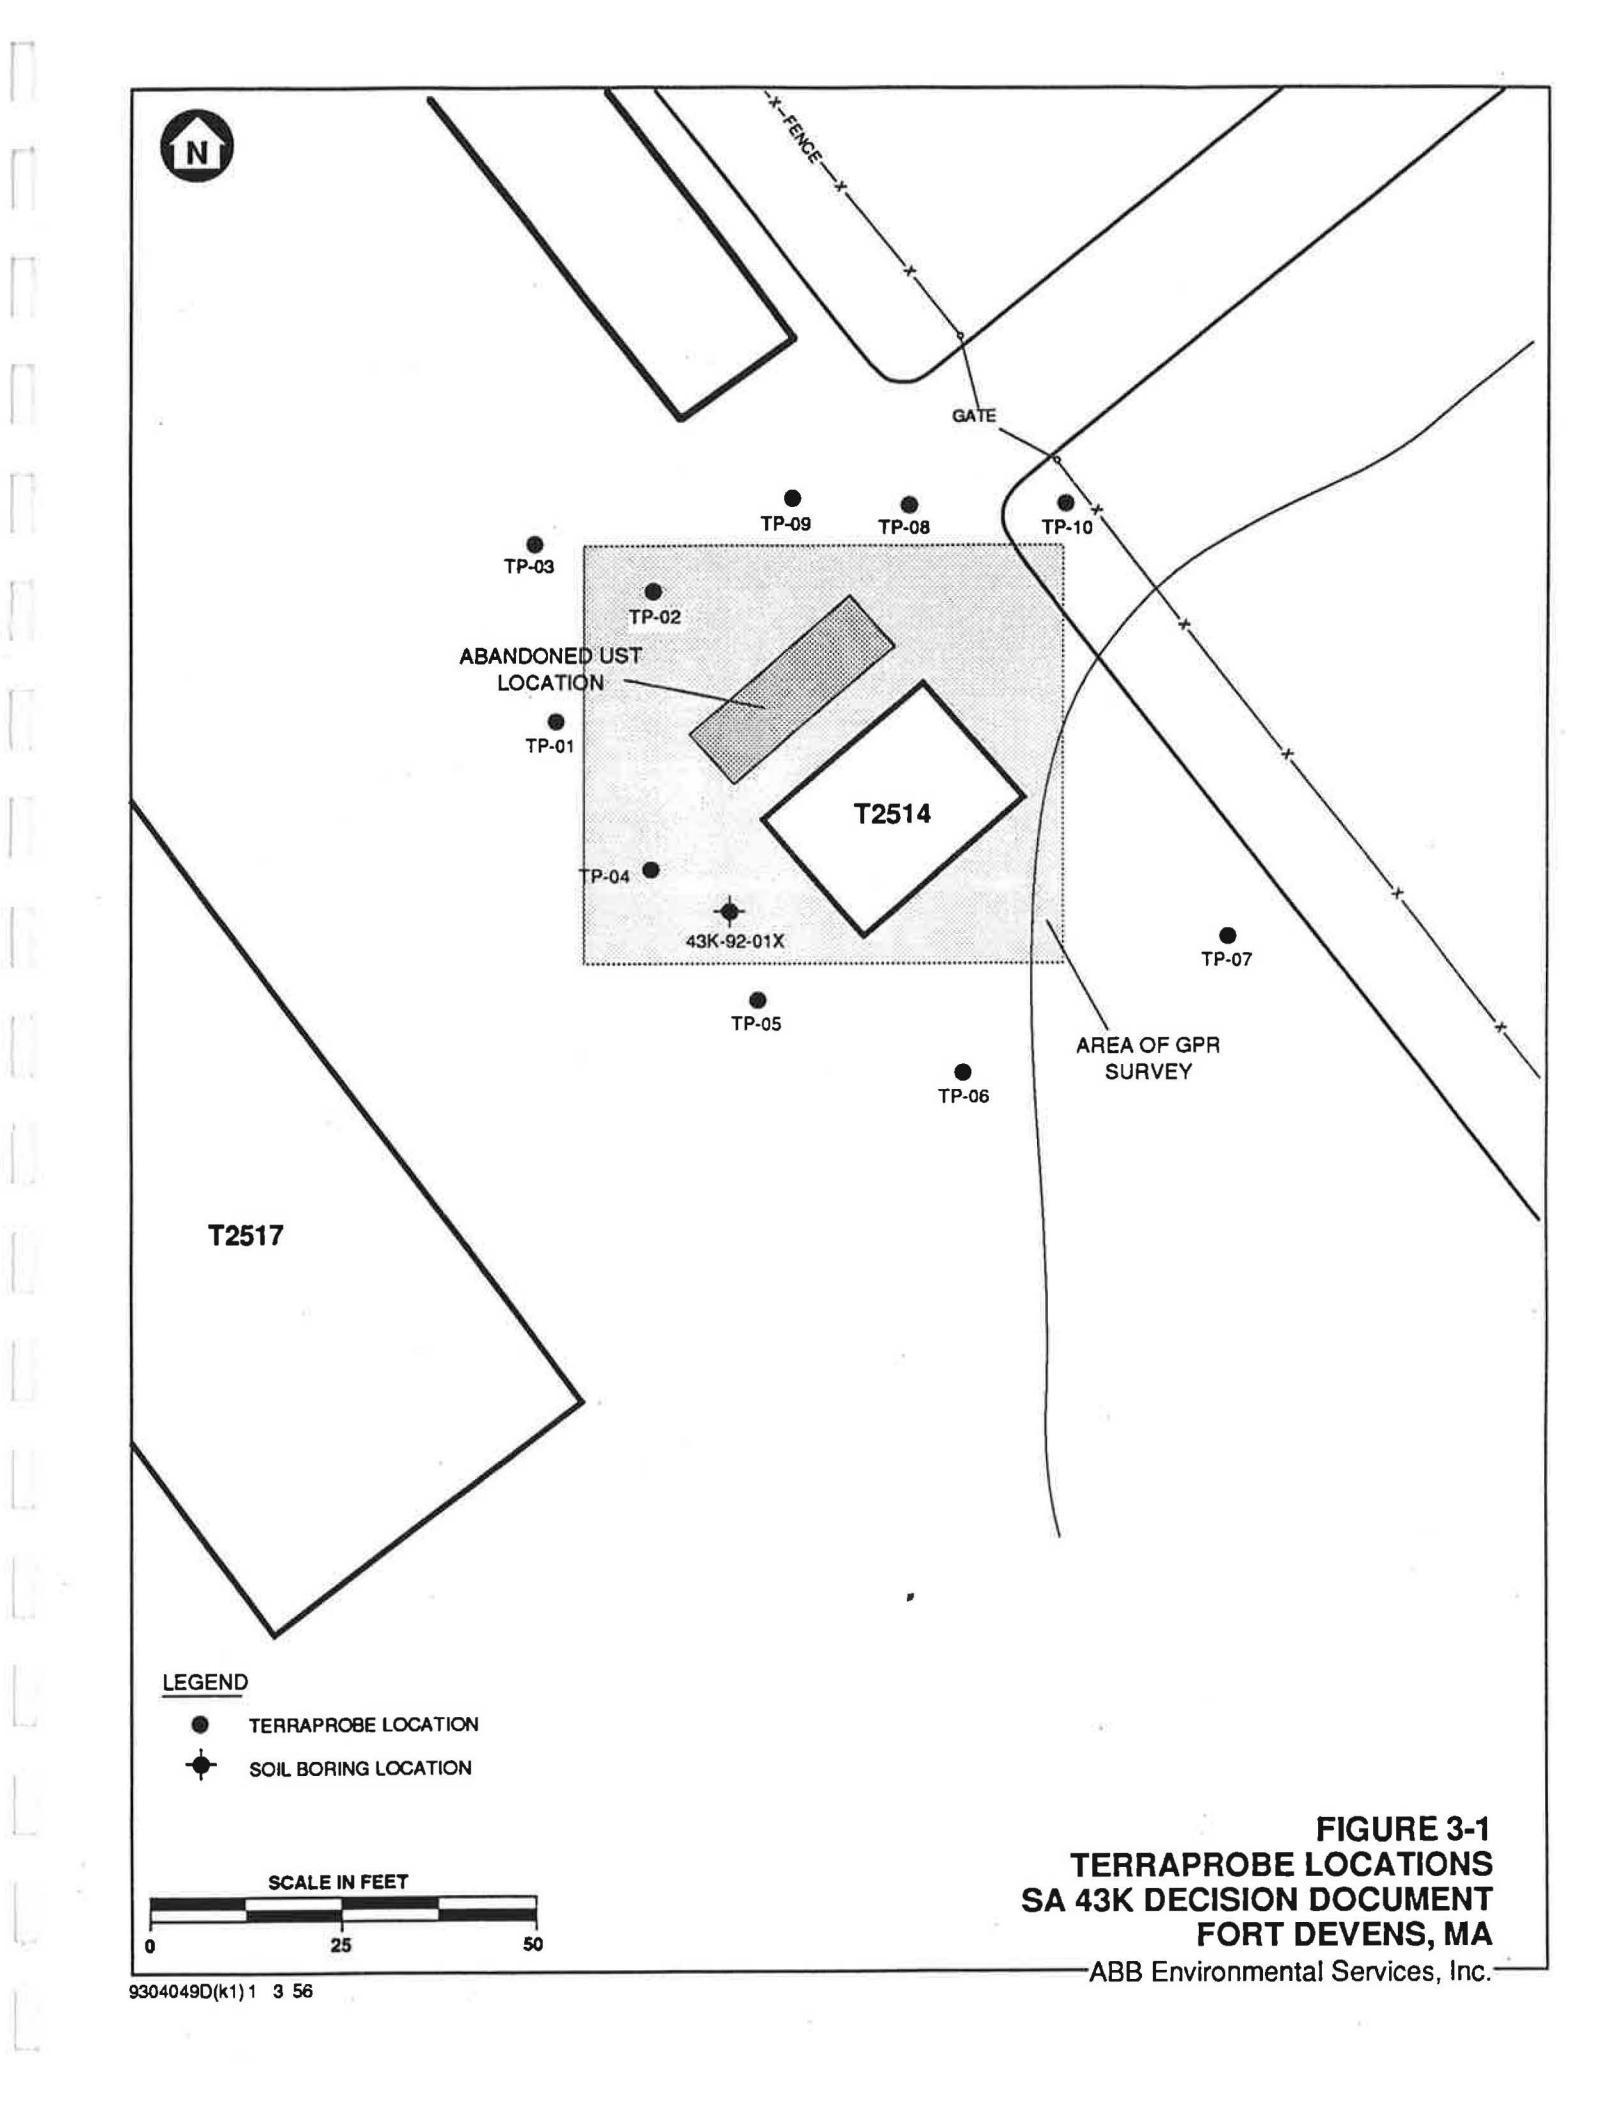
The geophysical survey at SA 43K consisted of a metal detector and ground penetrating radar survey. The results of the geophysical survey at SA 43K indicated that one abandoned UST was present at the site (Figure 3-1). The results of the geophysical surveys are presented in Appendix L of the SI Report (ABB-ES, 1993).

Ten TerraProbe points were advanced to the water table and a single subsurface soil sample was collected from each point (see Figure 3-1). All of the subsurface soil

To determine whether contamination had migrated laterally along the water table, 11 soil samples were collected at ten TerraProbe points around the excavation at SA 43K (see Figure 3-1). The results of the field analyses indicated that no BTEX or TPHC was present in the subsurface soil samples around the excavation (Table 4-2; Figure 4-2).

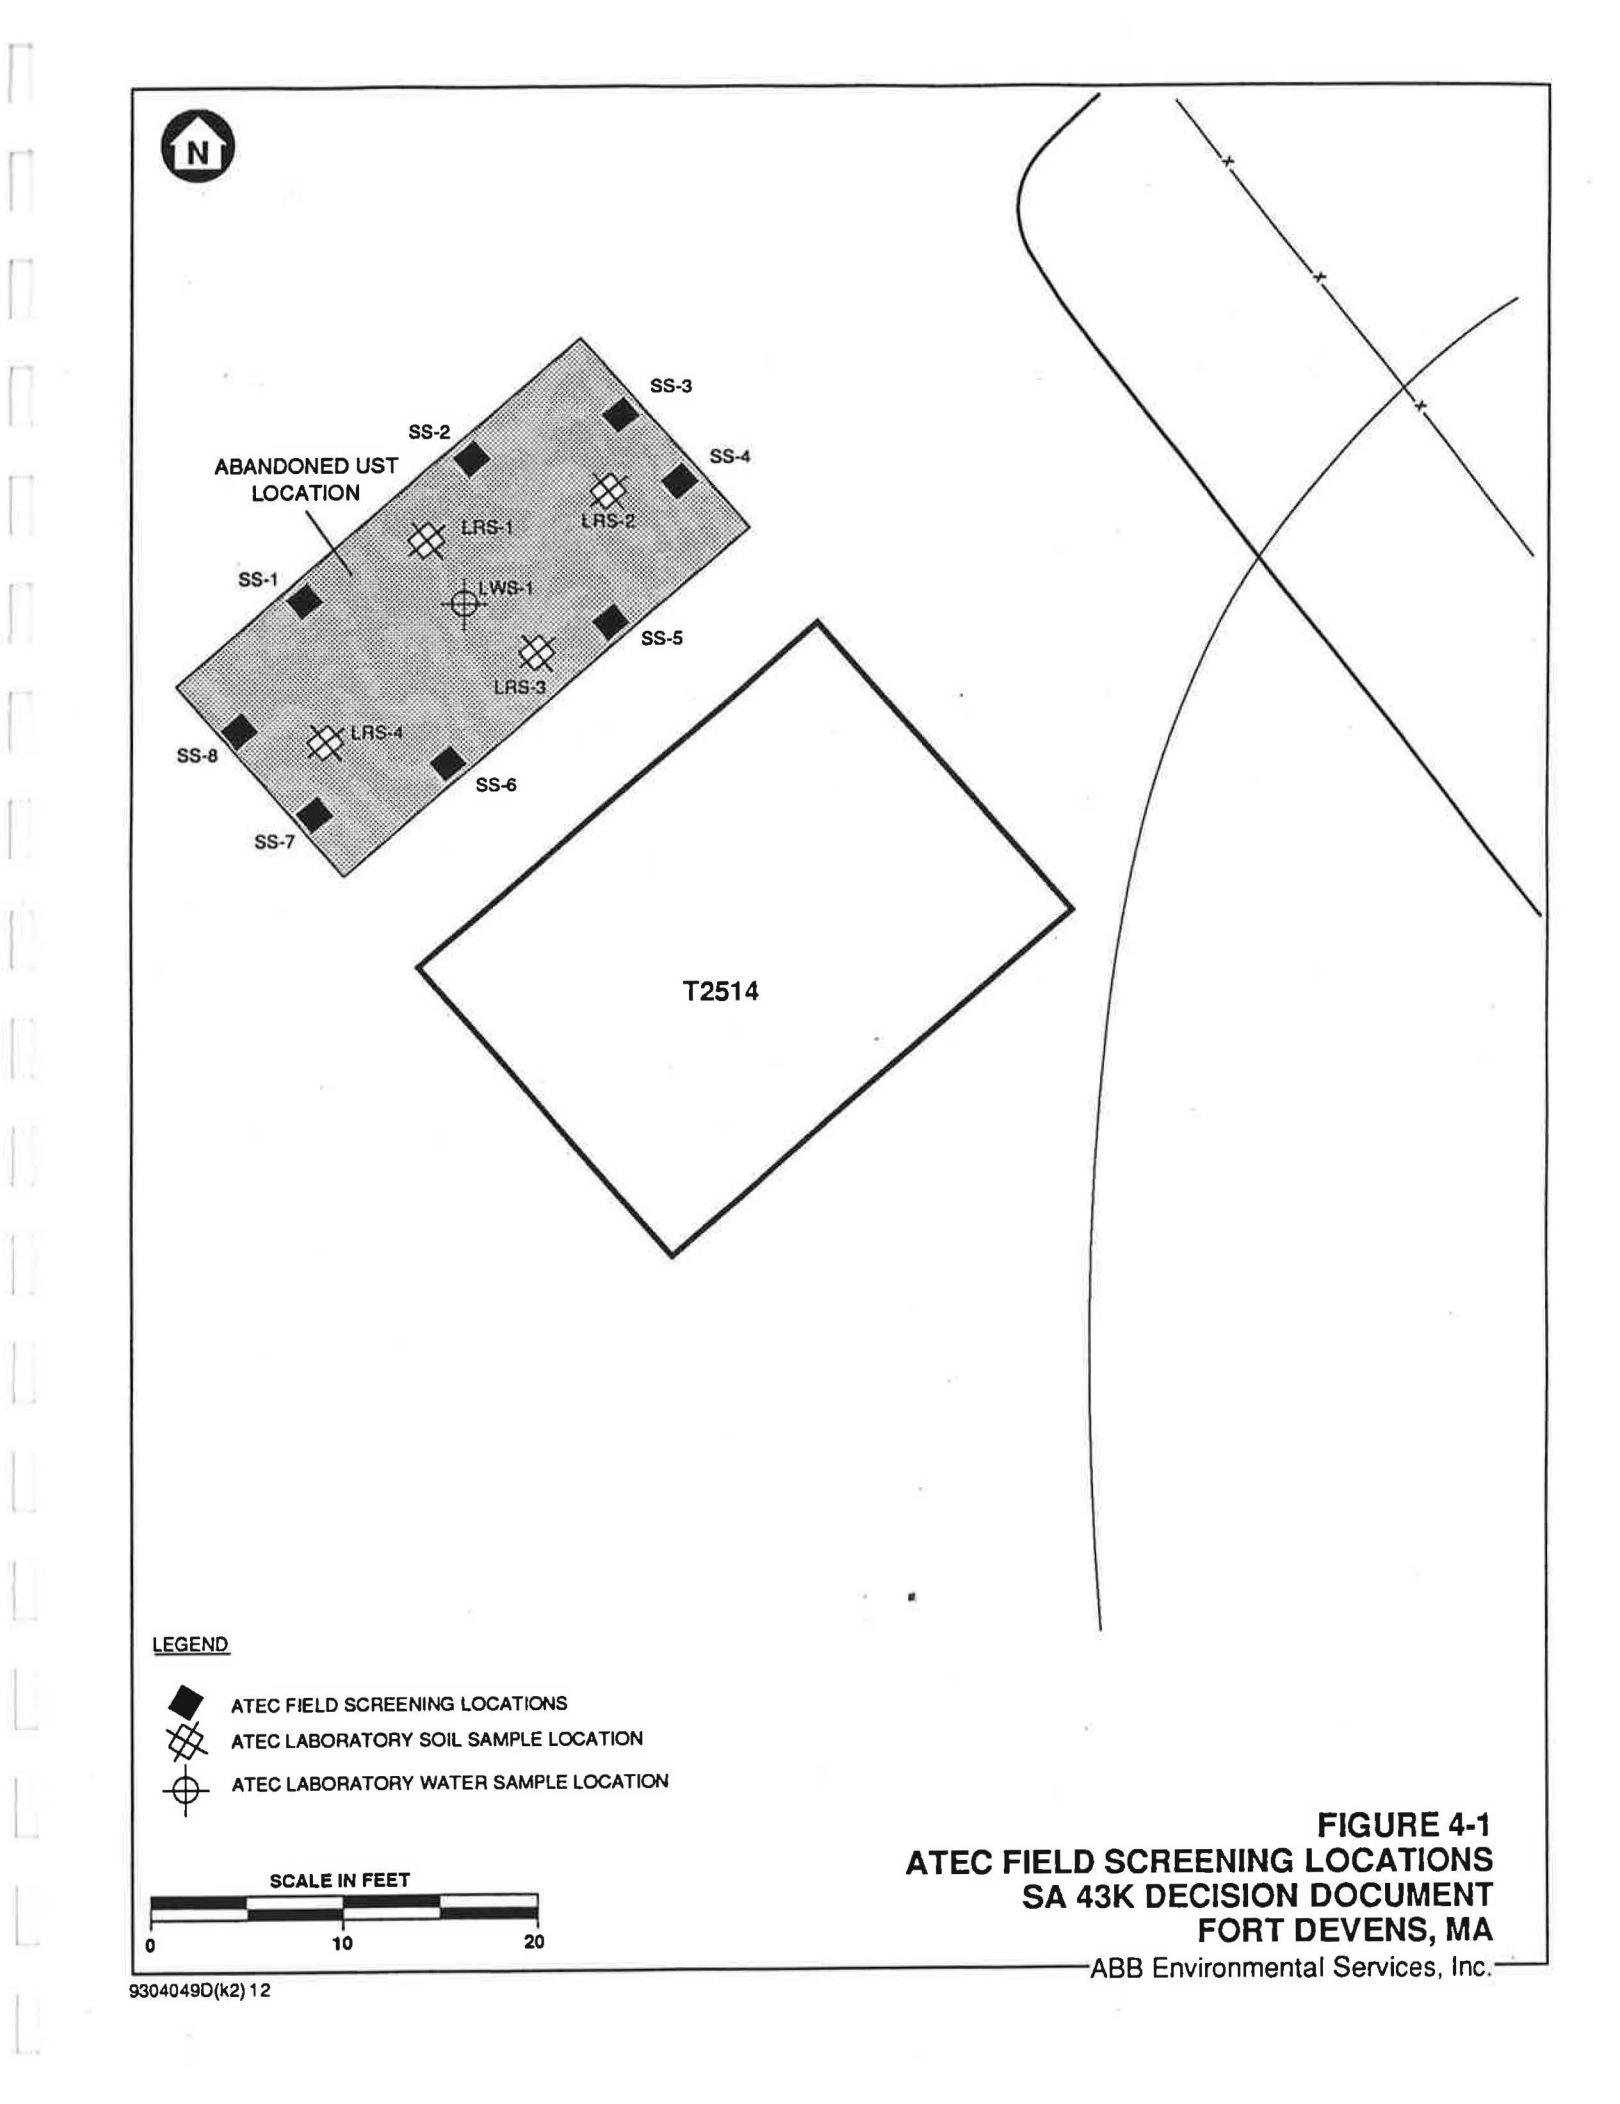
ATEC performed field screening on eight soil samples (SS-1 through SS-8) collected from the excavation at 5 to 6 feet below ground surface (bgs) (Figure 4-1). VOC concentrations (measured by photoionization detector in soil headspace) ranged from 0.5 to 190 parts per million (ppm), and TPHC levels, measured on a Non-Dispersive Infrared (NDIR) Analyzer, were from 22.1 to 88.7 ppm (ATEC, 1992) (Table 4-1). Based on these results, ATEC removed approximately 140 tons of soil from the excavation and collected four additional soil samples (LRS-1 through LRS-4) (see Figure 4-1). VOCs ranged from 1 to 4 ppm in the soil headspace and TPHC concentrations (measured in the laboratory) ranged from 15 to 58 ppm (see Table 4-1). The 58 ppm of TPHC was found in the southeast corner of the excavation. No VOCs were detected in the one soil sample (LRS-3) analyzed in the laboratory for VOCs. Due to these results, ATEC lined the southeast corner of the excavation with polyethylene sheeting and backfilled the entire excavation with approximately 600 tons of clean fill. Based on the results of the ATEC field screening, this UST removal was classified as a successful UST removal and no further soil removal or remediation was conducted.

One groundwater sample (LWS-1) was collected from the excavation and analyzed in the laboratory for TPHC only (see Figure 4-1). A concentration of 22 milligrams per liter of TPHC was detected in LWS-1 (Table 4-1).

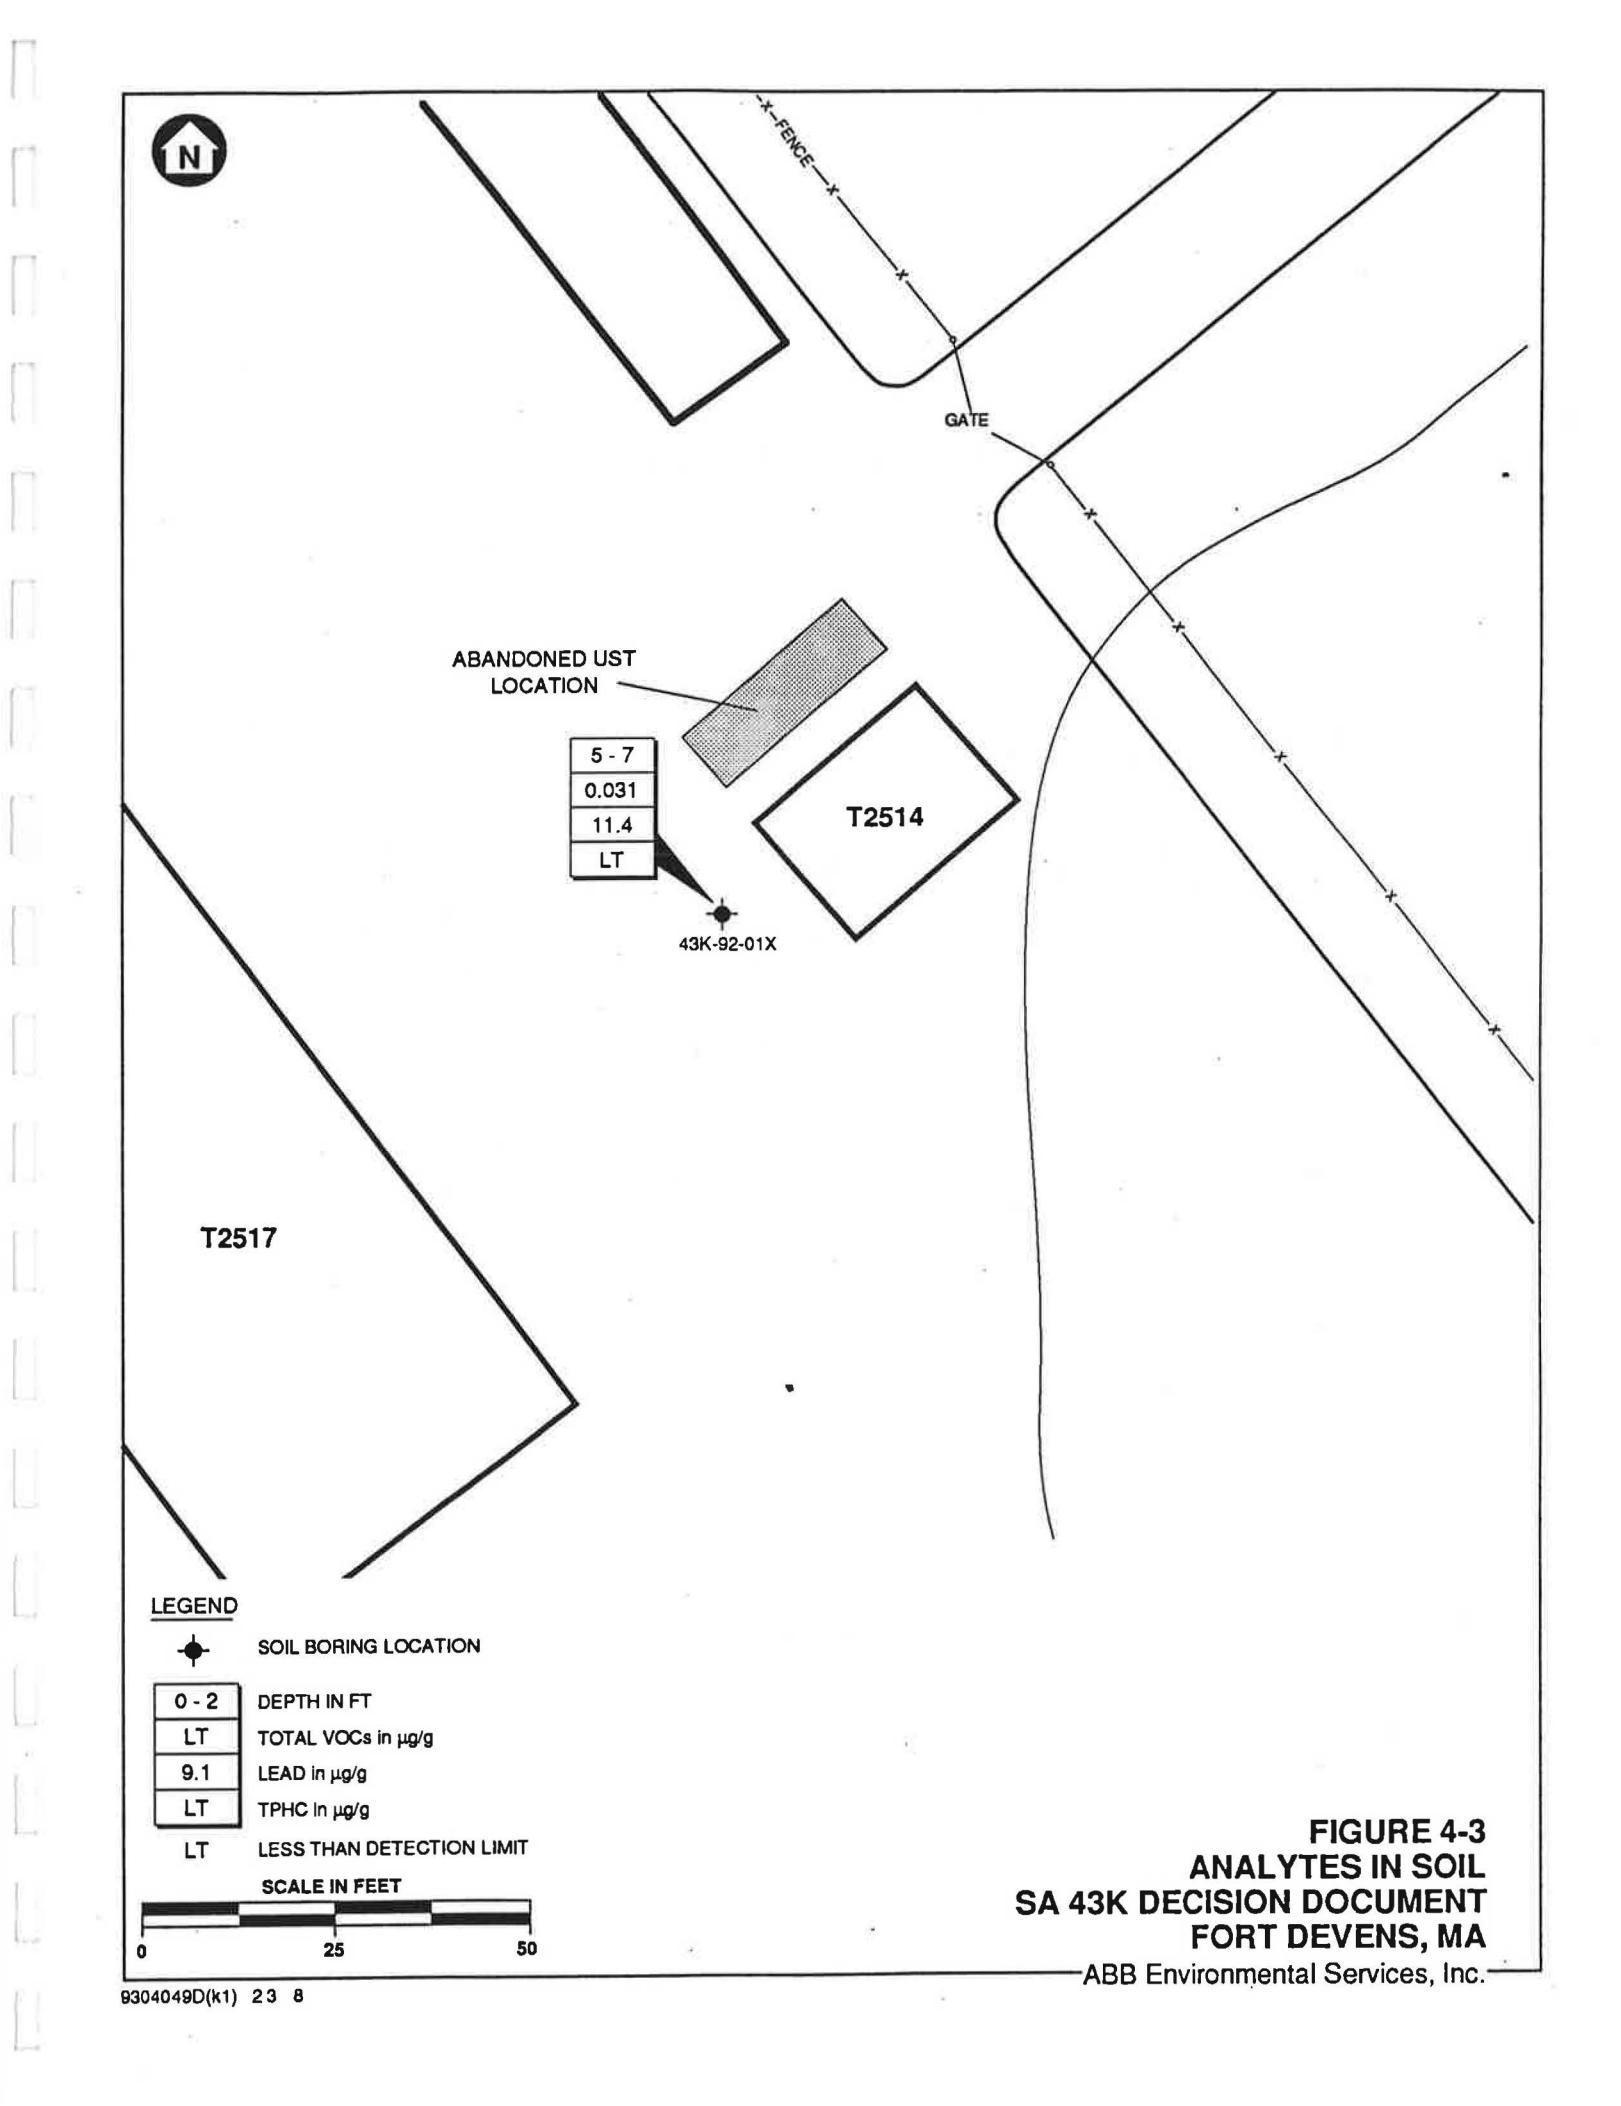
One soil boring (43K-92-01X) was drilled to the water table to confirm the field screening results. No VOCs or TPHC were detected in the soil sample collected from the water table, and lead was present below established Fort Devens background concentrations (Table 4-3; Figure 4-3).
