CLOSURE REPORT EMO UST SITES FORT DEVENS, MASSACHUSETTS

U.S. Army Corps of Engineers New England Division Waltham, Massachusetts Contract Number DACW45-89-D-0506

OHM Remediation Services Corp. Hopkinton, Massachusetts

December 24, 1996 OHM Project #16208

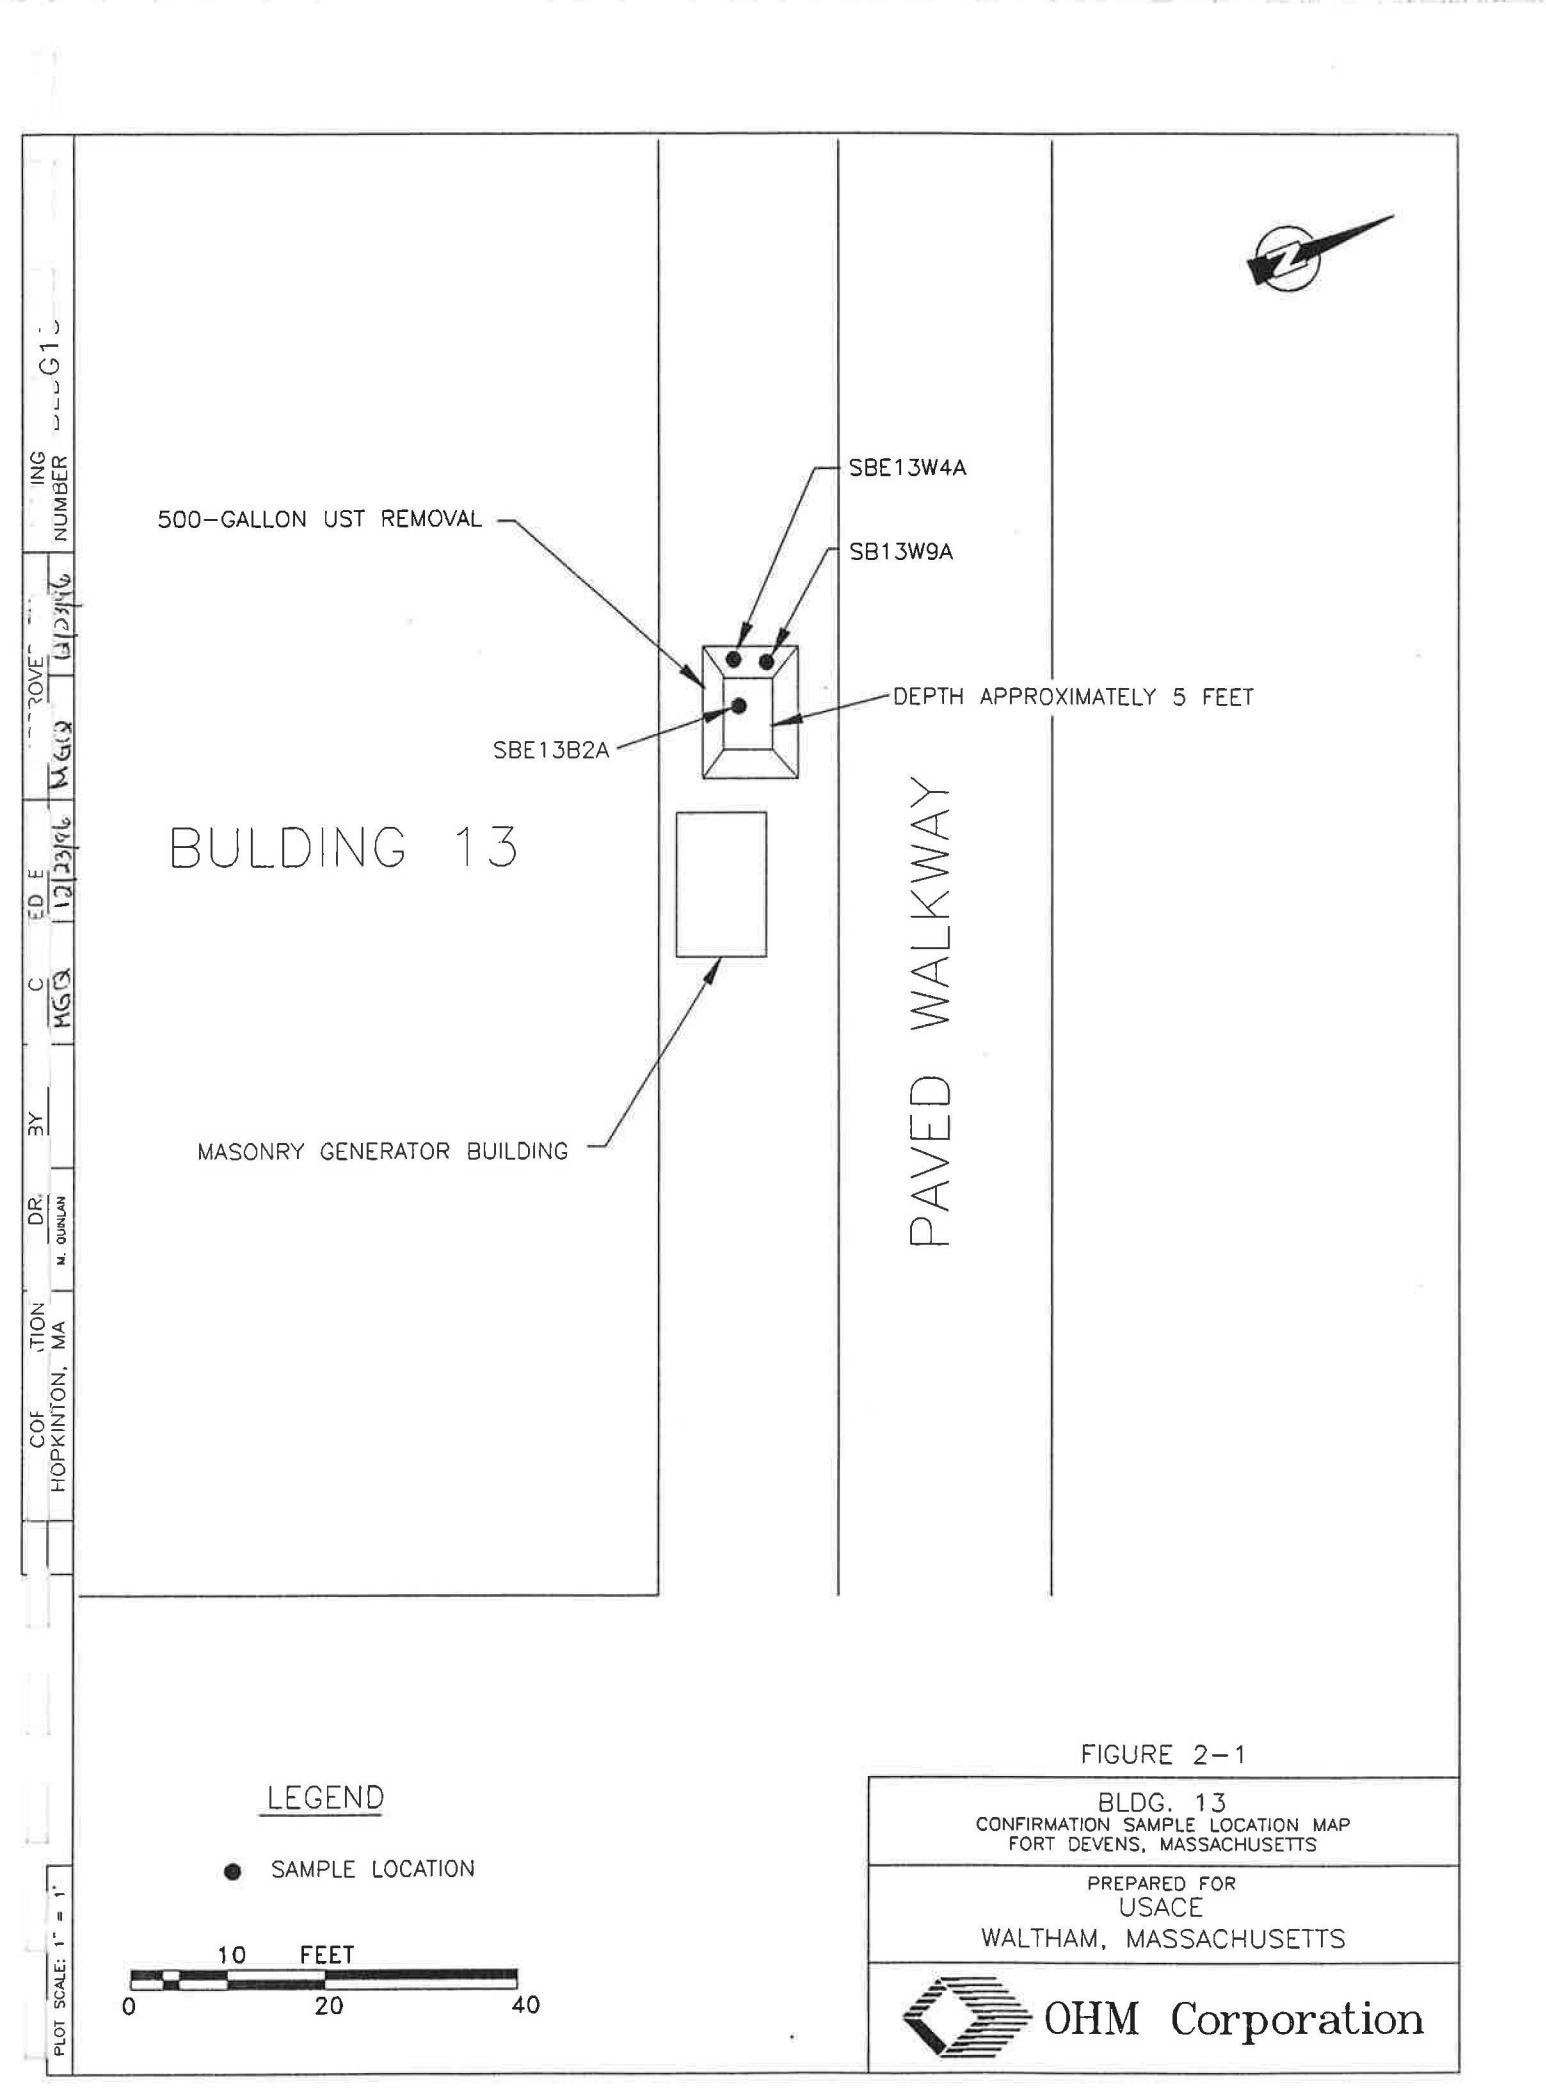
Two confirmation samples, one from the excavation bottom and one from the west sidewall, were collected from the Bldg. 13 excavation on June 15, 1995. They were submitted to AENI for analysis of total TPH, VOCs, and BNAs in order to confirm that cleanup goals had been attained. Refer to Figure 2-1 for confirmation sample locations. Both confirmation sampling locations were sampled for on-site TPH/IR screening prior to confirmation sampling to minimize any unnecessary off-site analyses.

Confirmation sampling results indicated non-detectable levels of TPH and VOCs with the exception of methylene chloride ($MeCl_2$), a common laboratory artifact. Several PAH compounds were detected in the west sidewall sample at concentrations slightly exceeding their respective MCP S1/GW1 standards. Additional soil was removed from the west wall until action levels for these PAH compounds were attained. In addition, a composite sample was collected from the north, east, and south sidewalls to verify that the PAHs were confined to the west sidewall. PAH confirmation sampling results are summarized in Table 2-2b, and the AENI analytical report is contained in Appendix B.

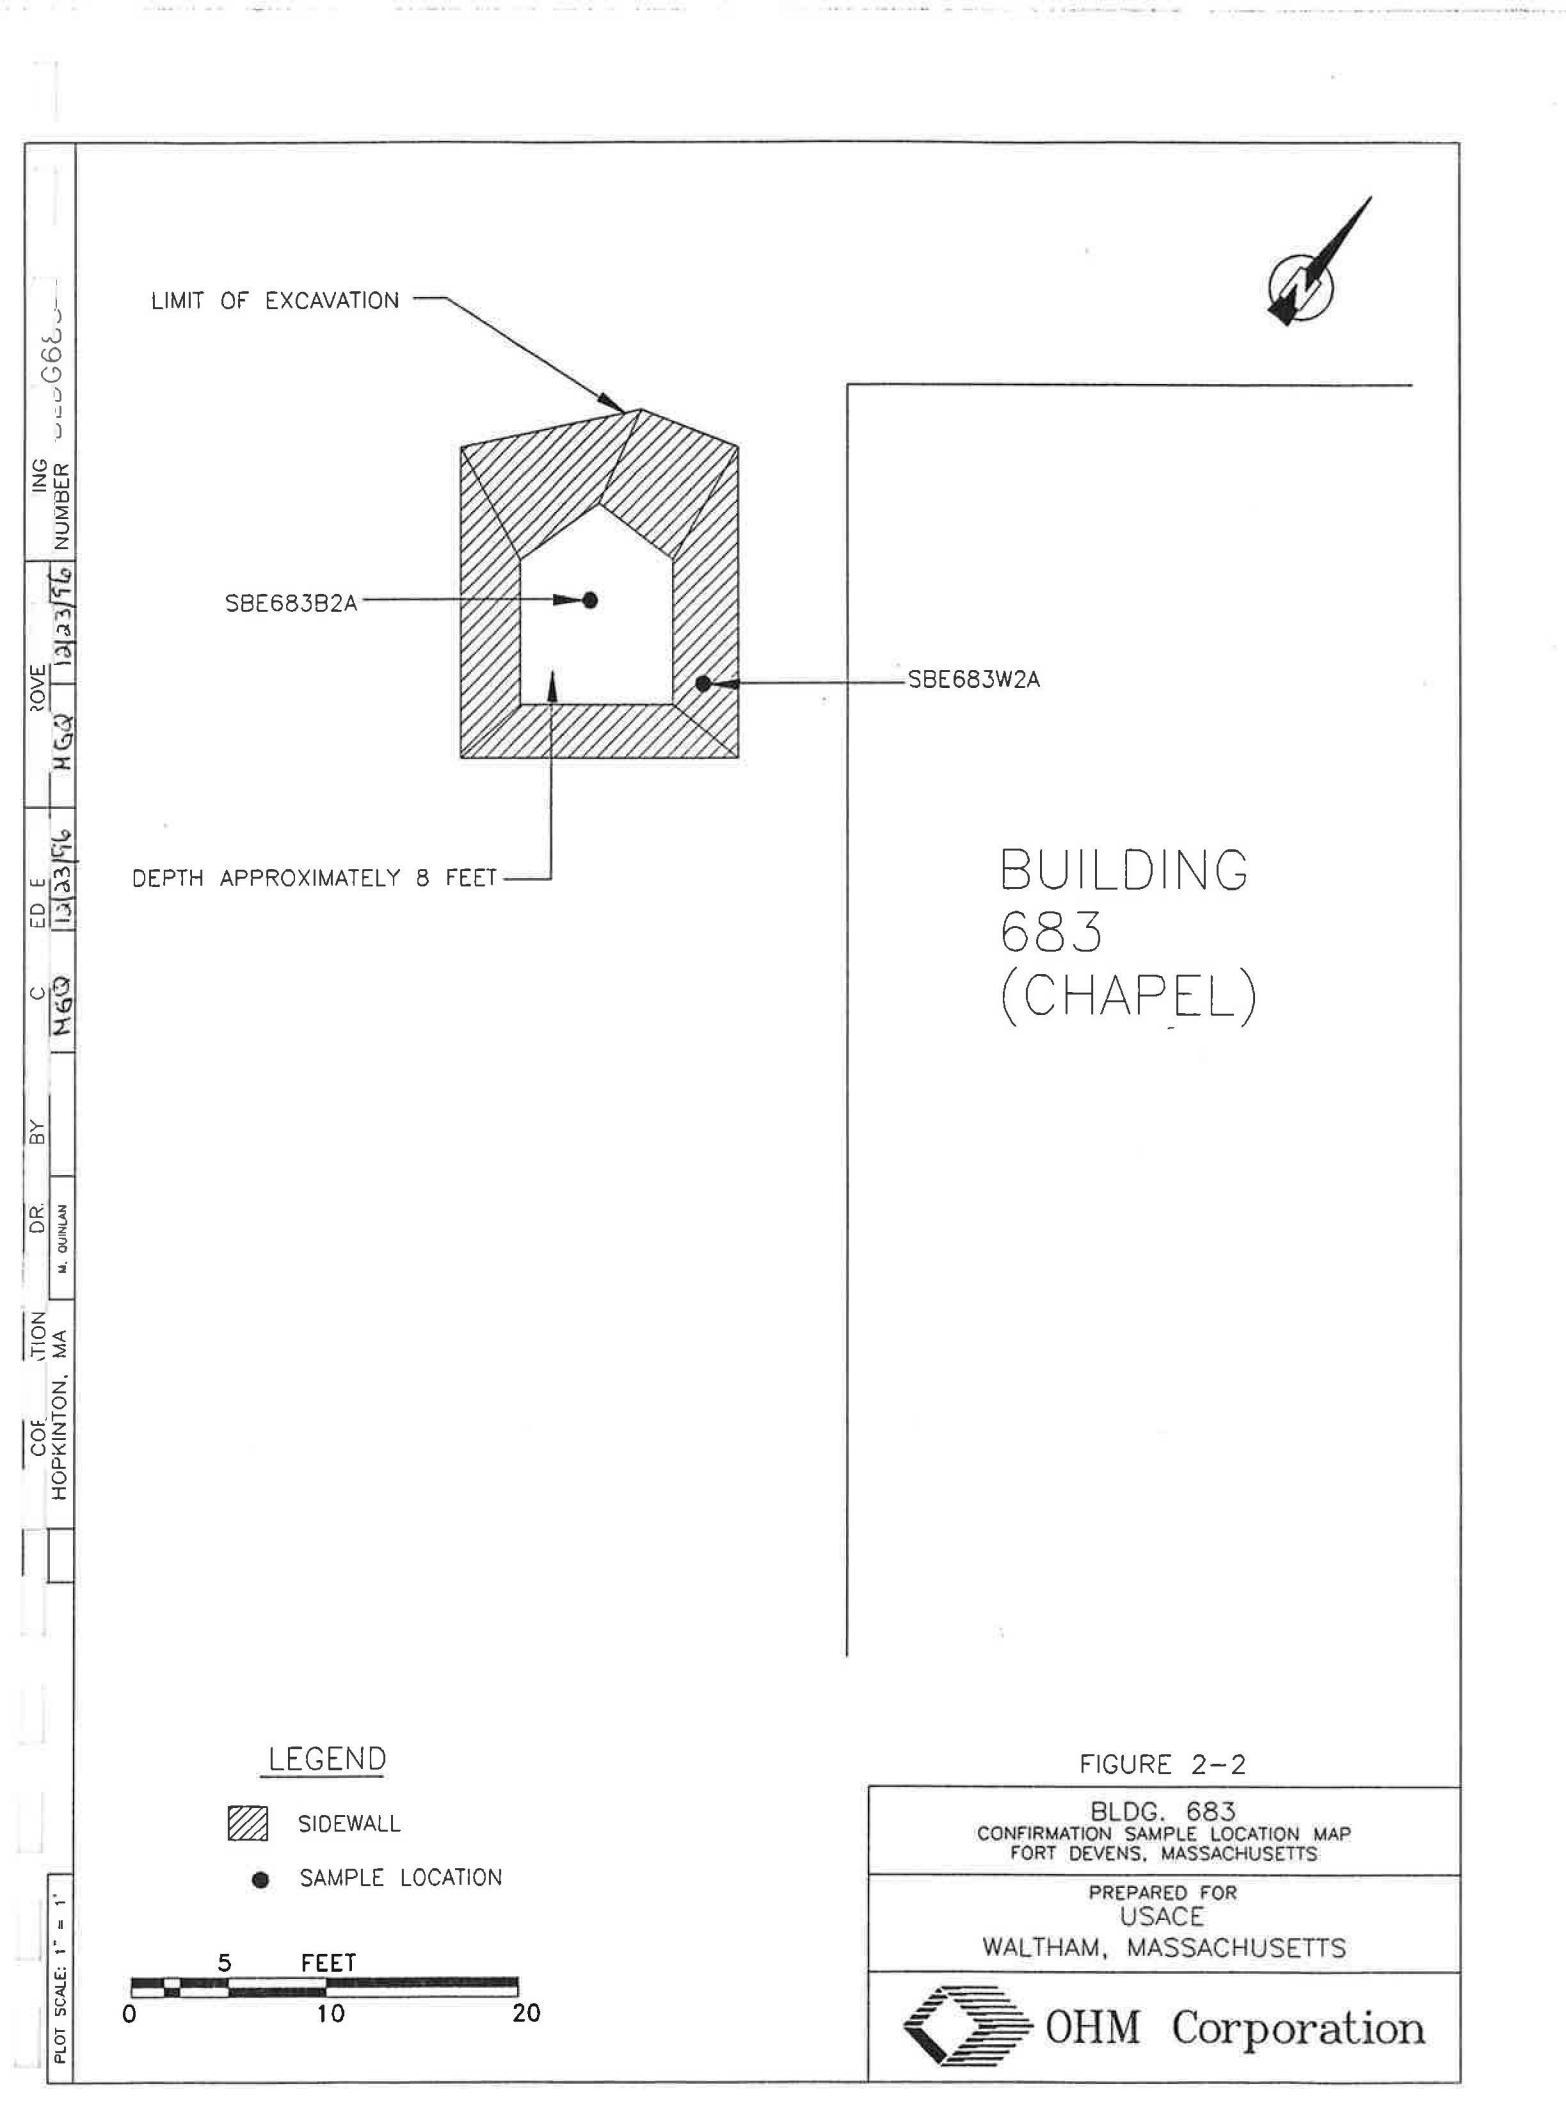
Confirmation samples were collected from the bottom and from the northeast sidewall of the excavation on June 5, 1995 in accordance with the Fort Devens UST removal protocol. They were submitted to AENI for total TPH, VOC, and BNA analyses to confirm that cleanup goals had been met. Refer to Figure 2-2 for confirmation sampling locations. No detectable levels of TPH were found in either sample. The VOC and BNA results indicated that cleanup goals had been met for all contaminants of concern, however, several organic constituents were detected at concentrations below their respective MCP S1/GW1 standards. These results are summarized in Table 2-3b. The AENI analytical report is contained in Appendix B.

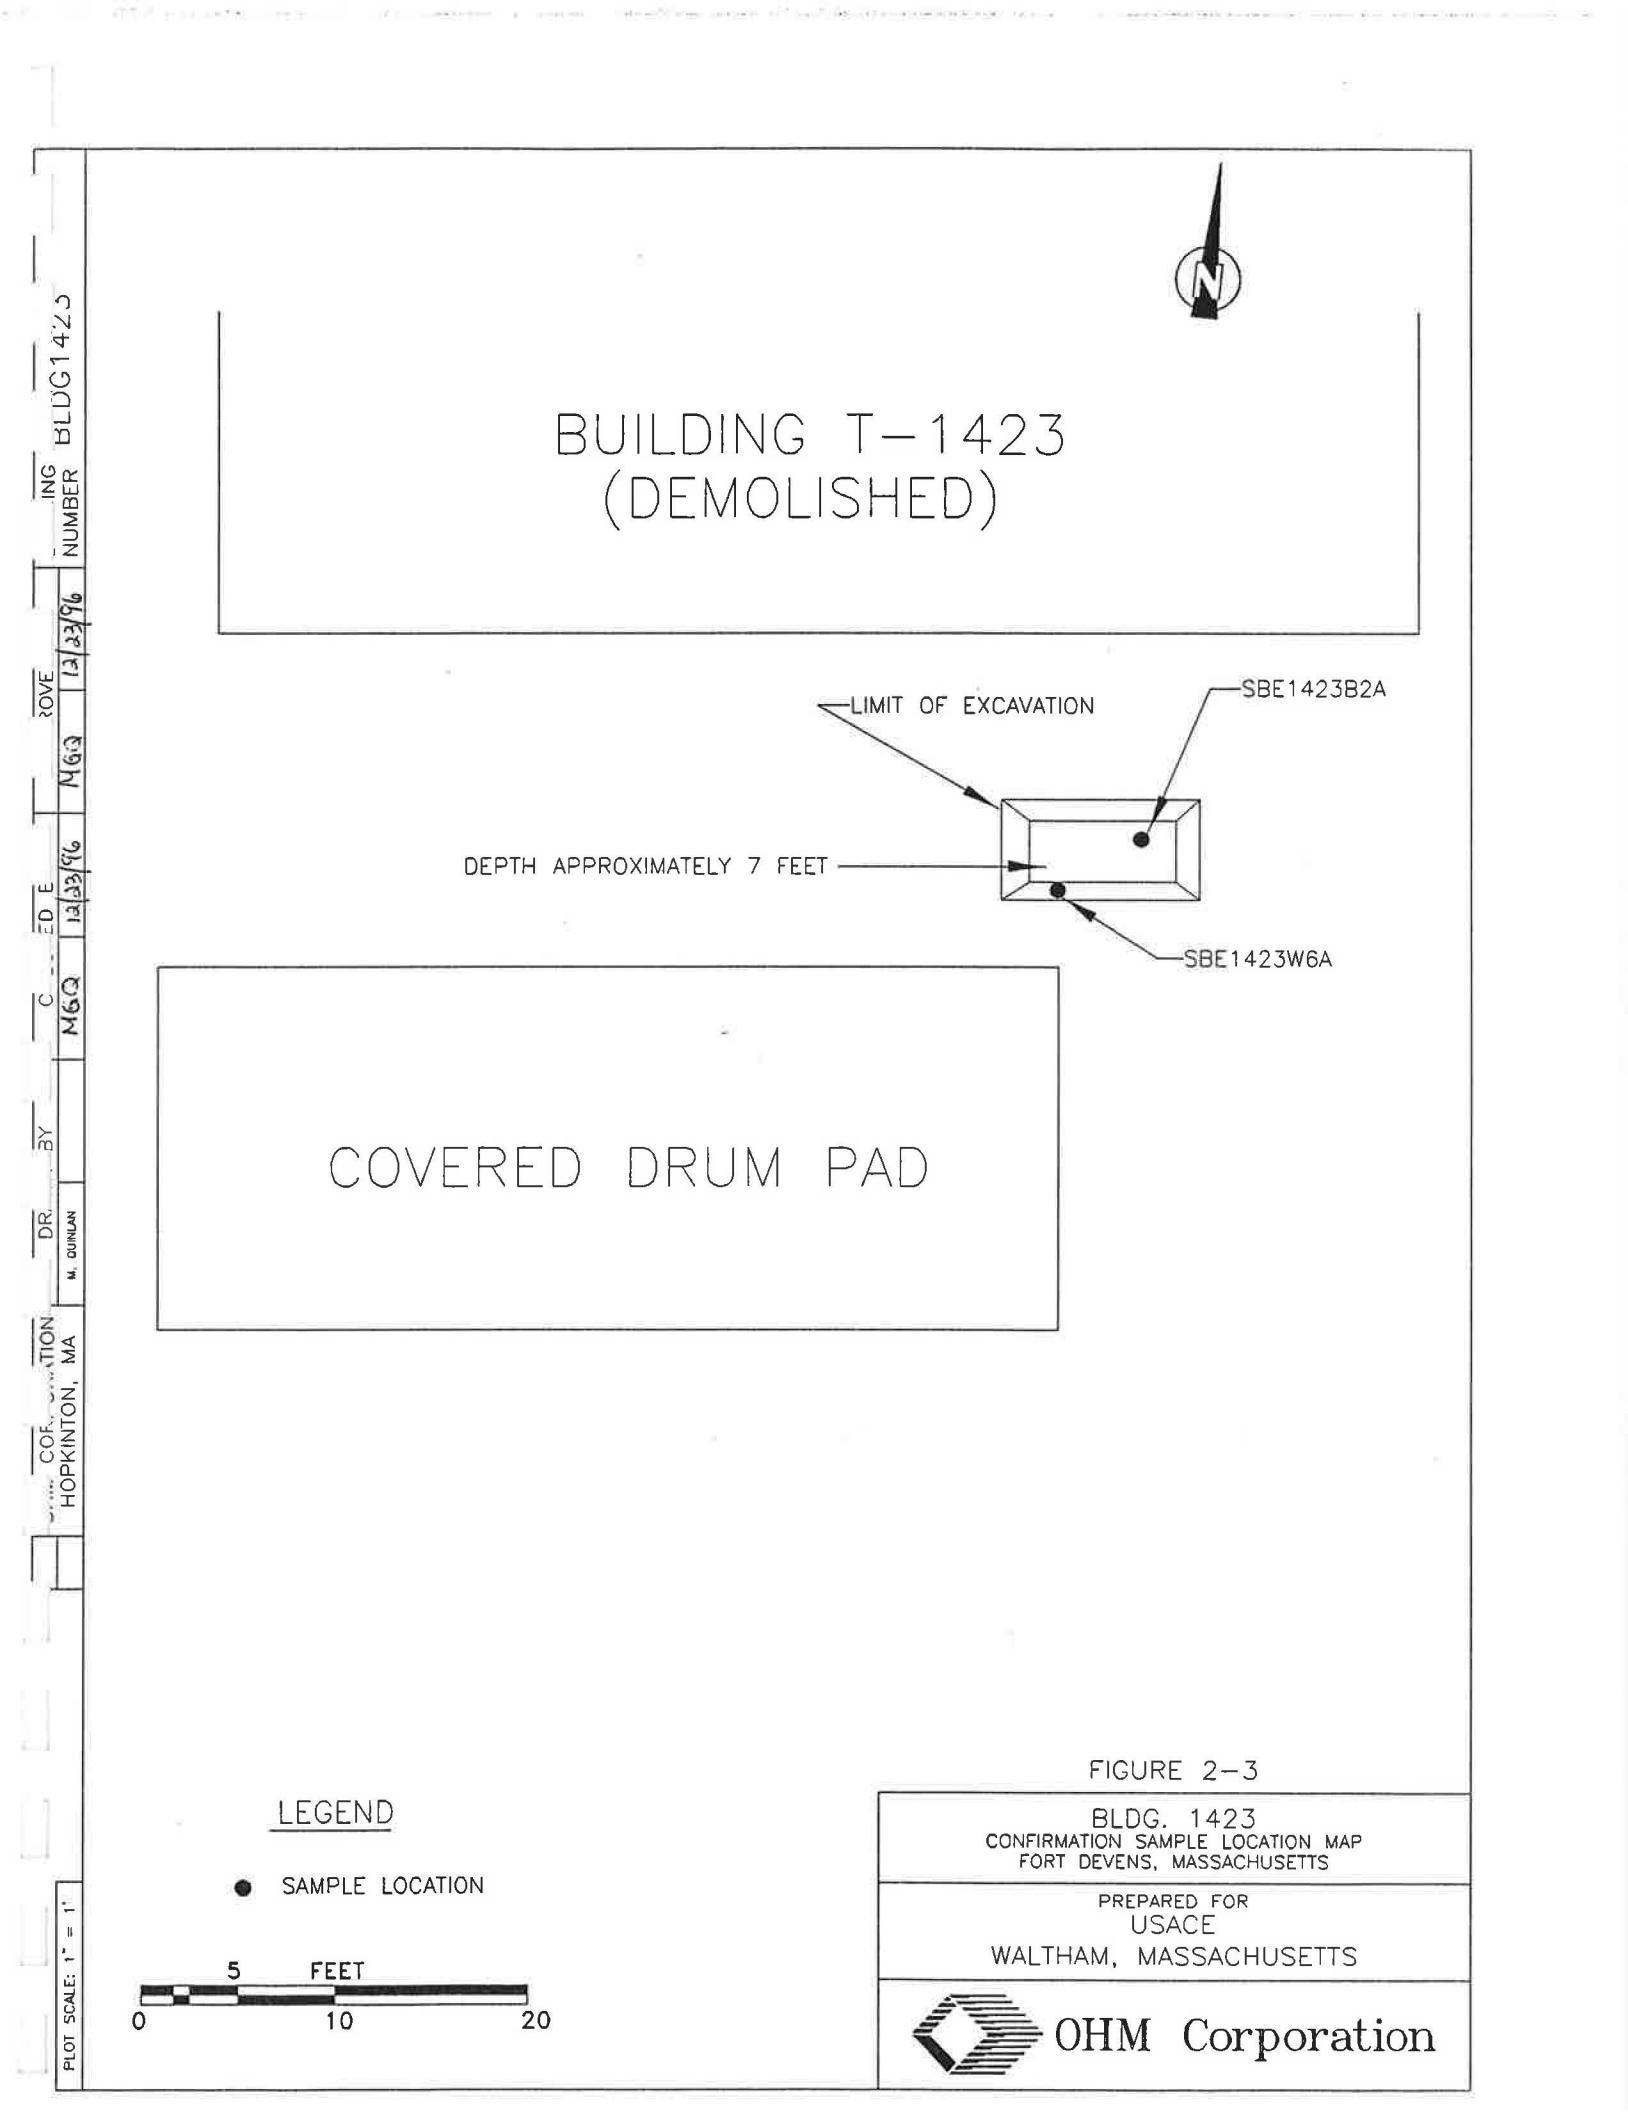
Two confirmation samples were collected from the excavation on June 12, 1995. One sample was collected from the excavation bottom and one from the south sidewall. The soil samples were submitted to AENI for TPH, VOC, and BNA analyses to confirm that cleanup goals had been met. Refer to Figure 2-3 for confirmation sample locations.

The analytical results indicated that there were no exceedances of applicable MCP S1/GWI standards. TPH was detected at 130 mg/kg in sidewall sample SBE1423W6A but was not detected in bottom sample SBE1423B2A. The PAHs 2-methlynaphthalene (47 micrograms per kilogram (ug/kg)), indeno(1,2,3-cd)pyrene (350 ug/kg), and benzo(g,h,i)perylene (350 ug/kg) were detected in sidewall sample SBE1423W6A. Bis(2-ethylhexyl)phthalate (DEHP), a common laboratory contaminant, was detected in the sidewall sample at a concentration of 1200 ug/kg and in the bottom sample at a concentration of 550 ug/kg. No other BNAs were detected. MeCl₂, a common laboratory contaminant, was detected in sidewall sample SBE1423W6A at a concentration of 7.1 ug/kg. No other VOCs were detected in either sample. The AENI analytical report is provided as Appendix B.

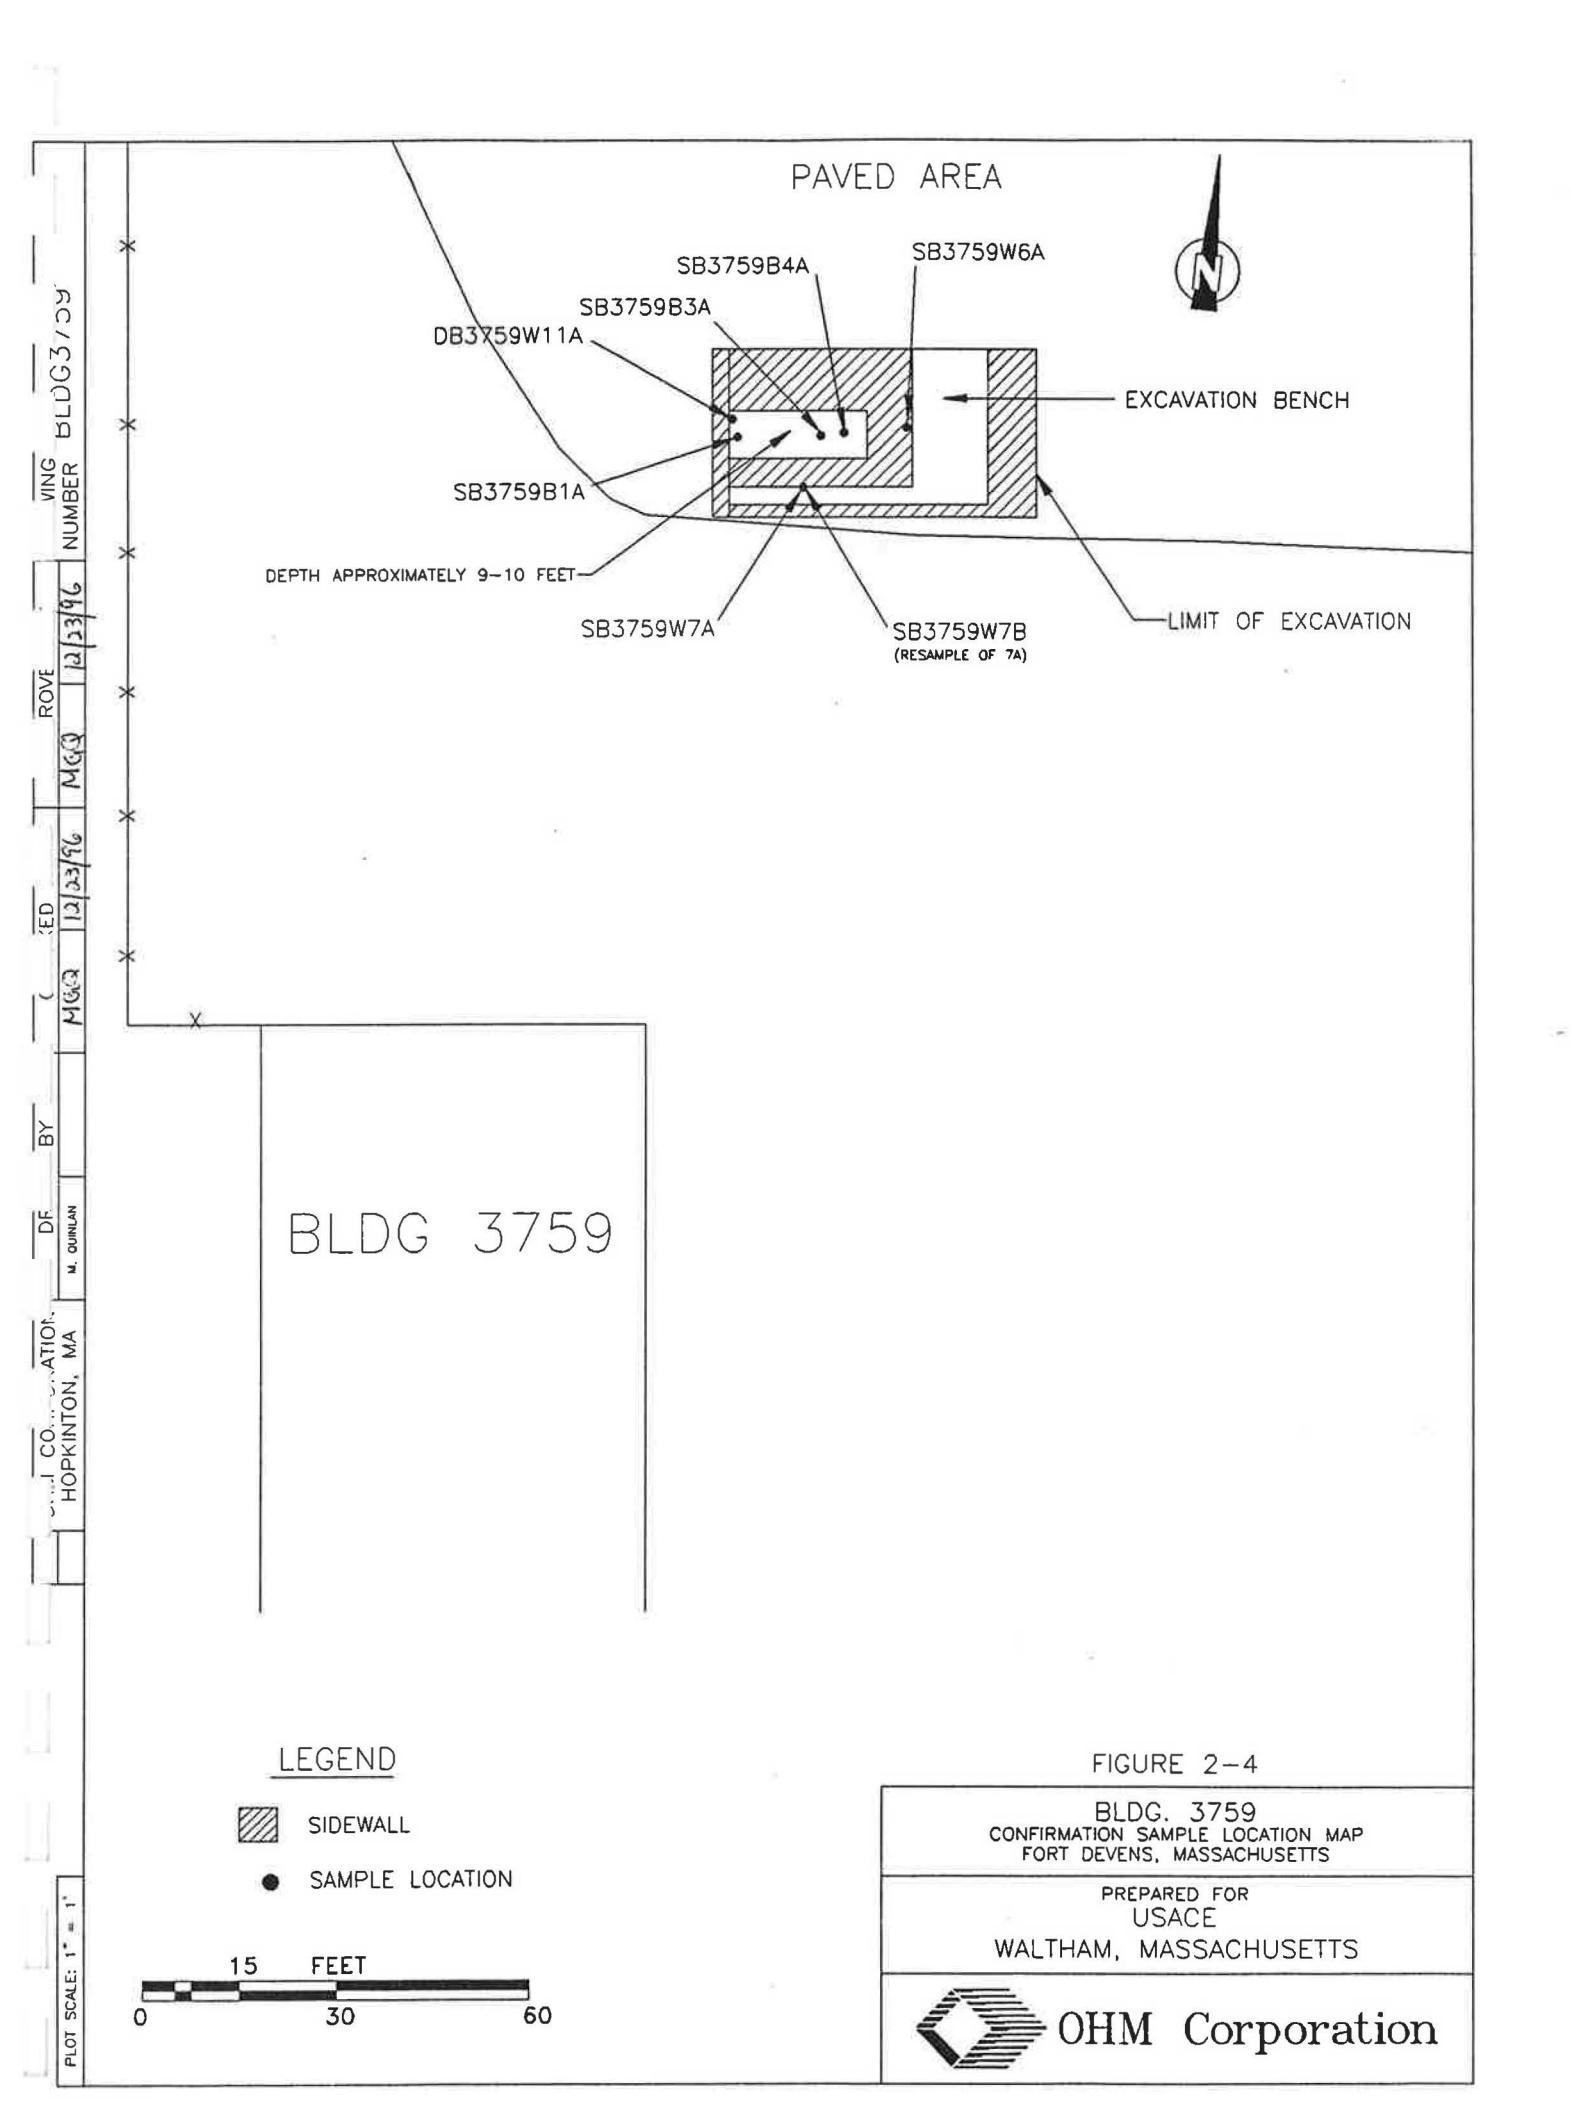
Four confirmation samples were collected from the excavation on June 22, 1995. Two samples were collected from the bottom and two from the sidewalls of the excavation (Figure 2-4). The samples were submitted to AENI for TPH, VOCs plus MTBE, BNAs, and lead analyses to confirm that cleanup goals had been met.

The results showed a TPH concentration of 870 mg/kg in the duplicate (SB3759DUPB) of sidewall sample SB3759W7A (480 mg/kg). After reviewing the field notes it was discovered that small pieces of asphalt had been noted in this pair of samples. Confirmation resampling was conducted on July 6th, and the sample was sieved to remove the asphalt material. No detectable levels of TPH were found in the second sample. TPH was also detected in bottom sample SB3759B4A at a concentration of 37 mg/kg. The following PAHs were also detected in duplicate sample SB3759DUPB at residual concentrations well below their respective MCP S1/GW1 standards: fluoranthene (71ug/kg J), pyrene (50ug/kg J), benzo(a)anthracene (43 ug/kg J), chrysene (64 ug/kg J), benzo(b)fluoranthene (65g/kg J), benzo(k)fluoranthene (77 ug/kg J), benzo(a)pyrene (51 ug/kg J), indeno(1,2,3-cd)pyrene (39 ug/kg J), and benzo(g,h,i)perylene (45 ug/kg J).

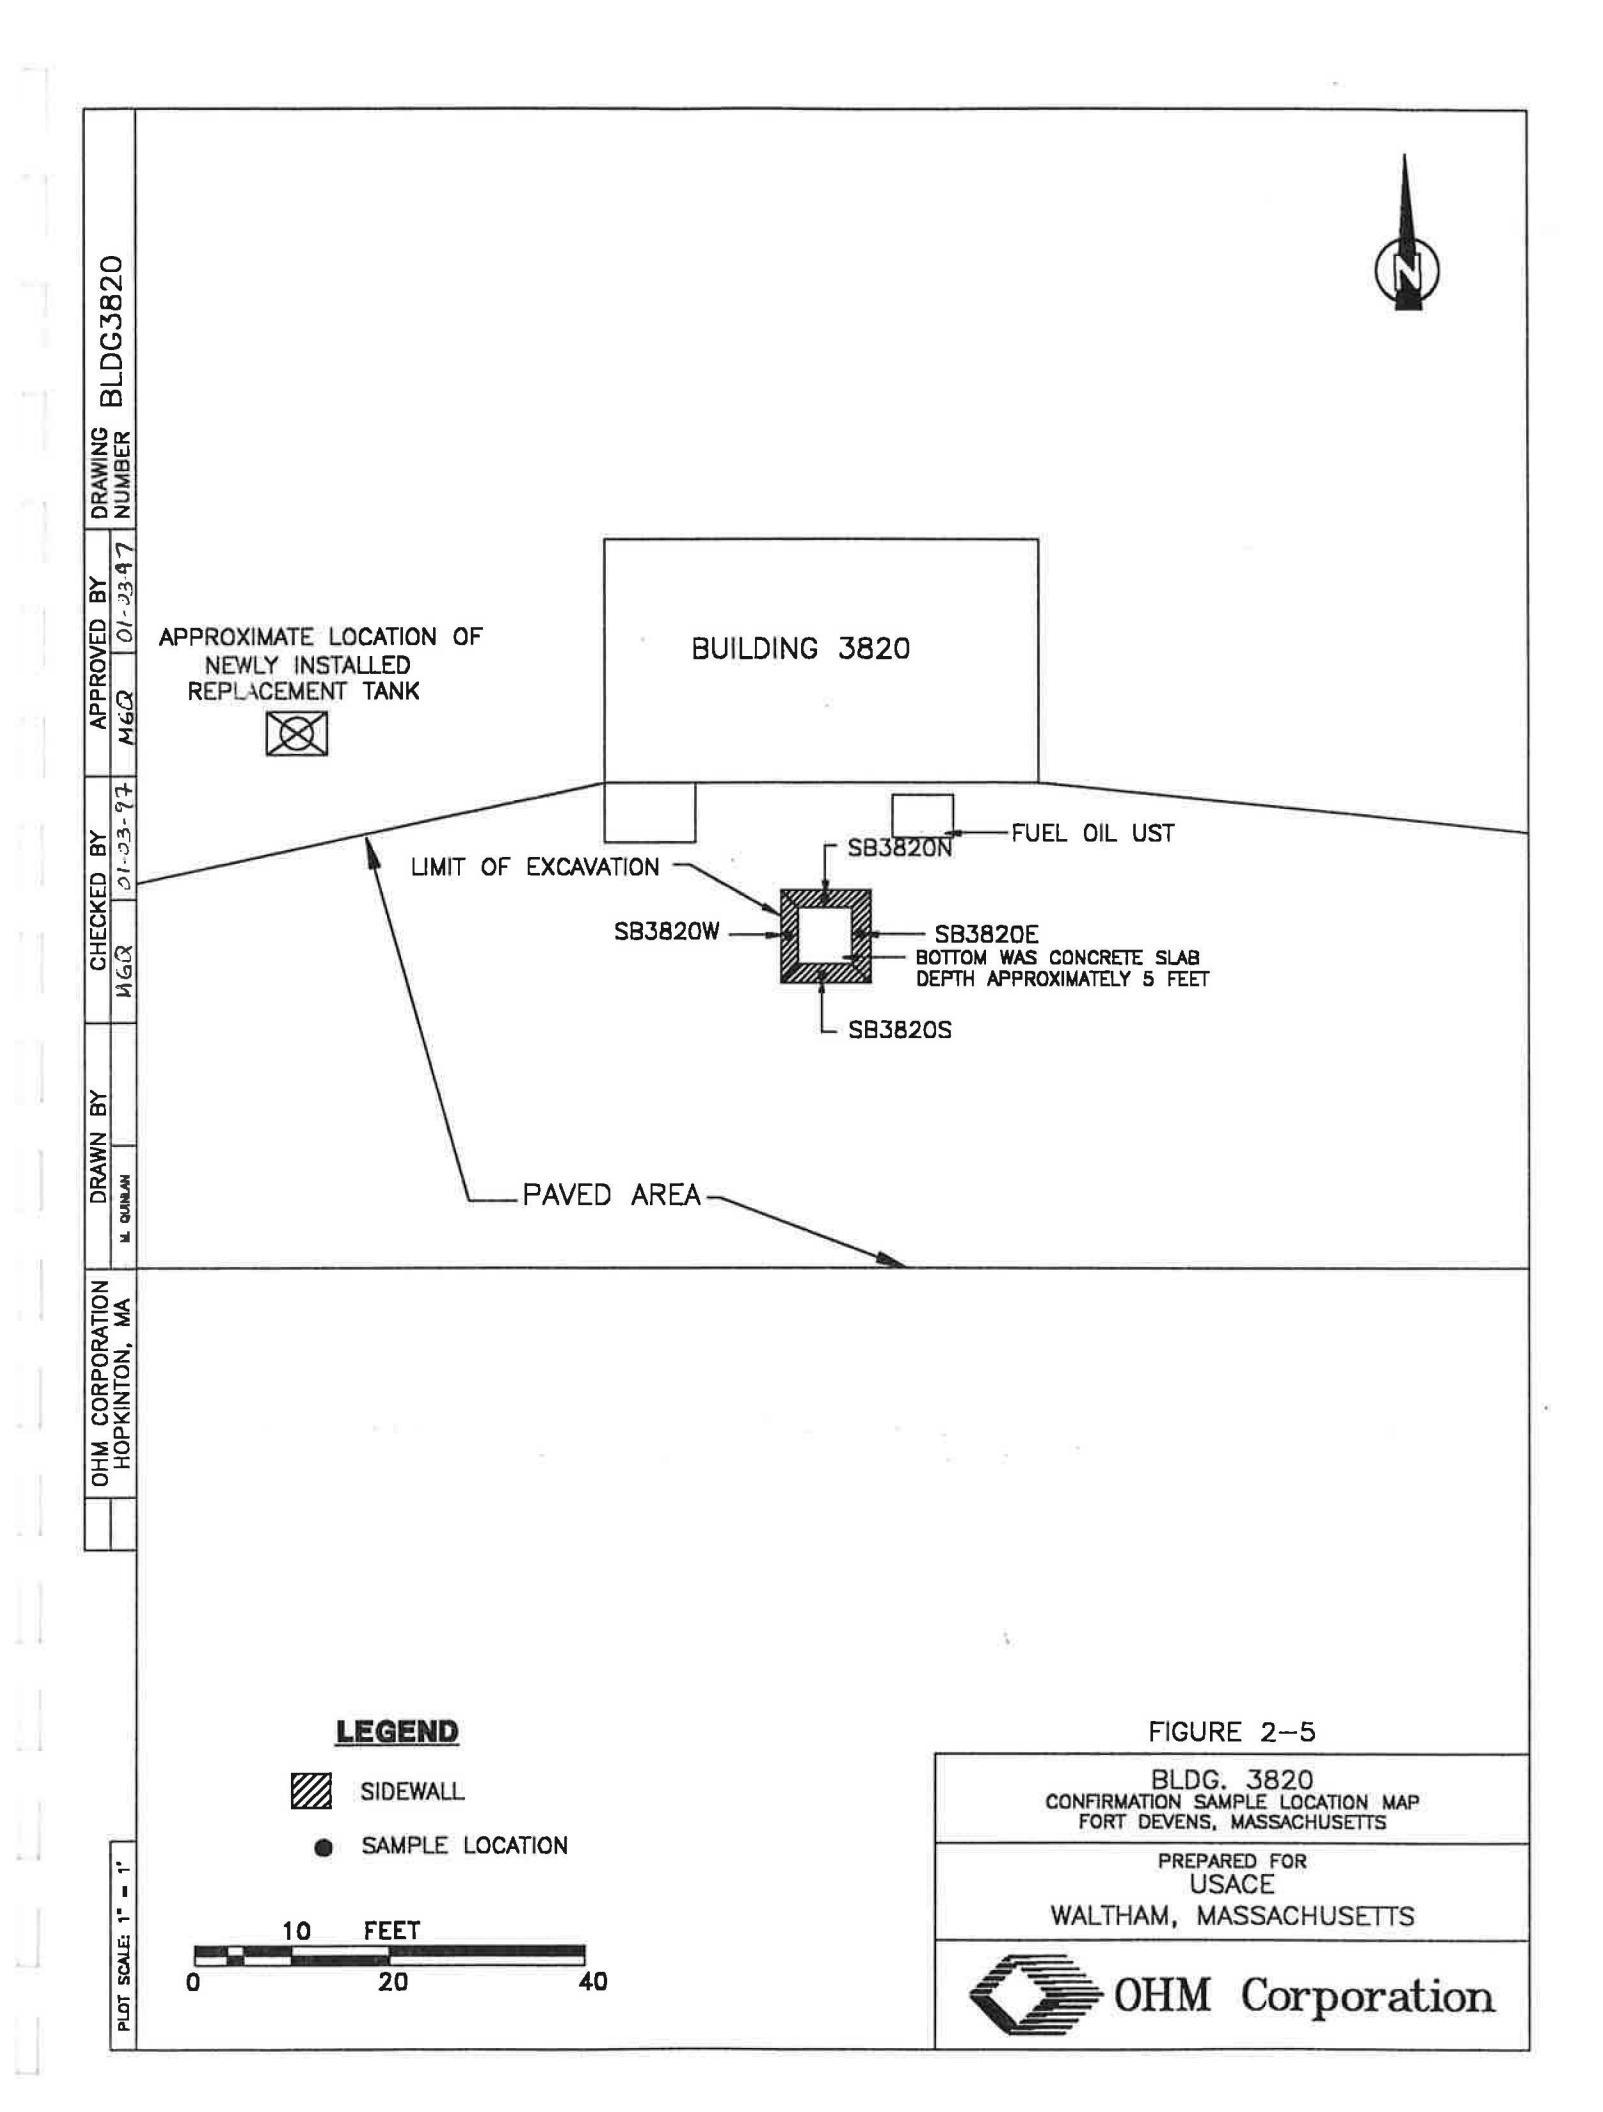
Since no screening samples had been collected from the excavation, confirmation samples were collected from each sidewall of the excavation on December 19. The base of the excavation was a concrete pad, therefore no bottom sample was collected. Each sample was submitted to AENI for TPH, BTEX, MTBE and lead analyses. The confirmation sample locations are shown in Figure 2-6 and the AENI analytical report is included in Appendix C.

No organic analytes were detected in any of the confirmation samples. Lead was detected at concentrations ranging from 5.8 to 6.6 mg/kg.
