Post-Removal Report Underground Storage Tank Closure 1,000 Gallon No. 2 Fuel Oil UST No. 0026 Building 1666 Fort Devens, Massachusetts

United States Army Reserve Center Building 1666 Fort Devens, Massachusetts ATEC Project No. 37.07.91.07451

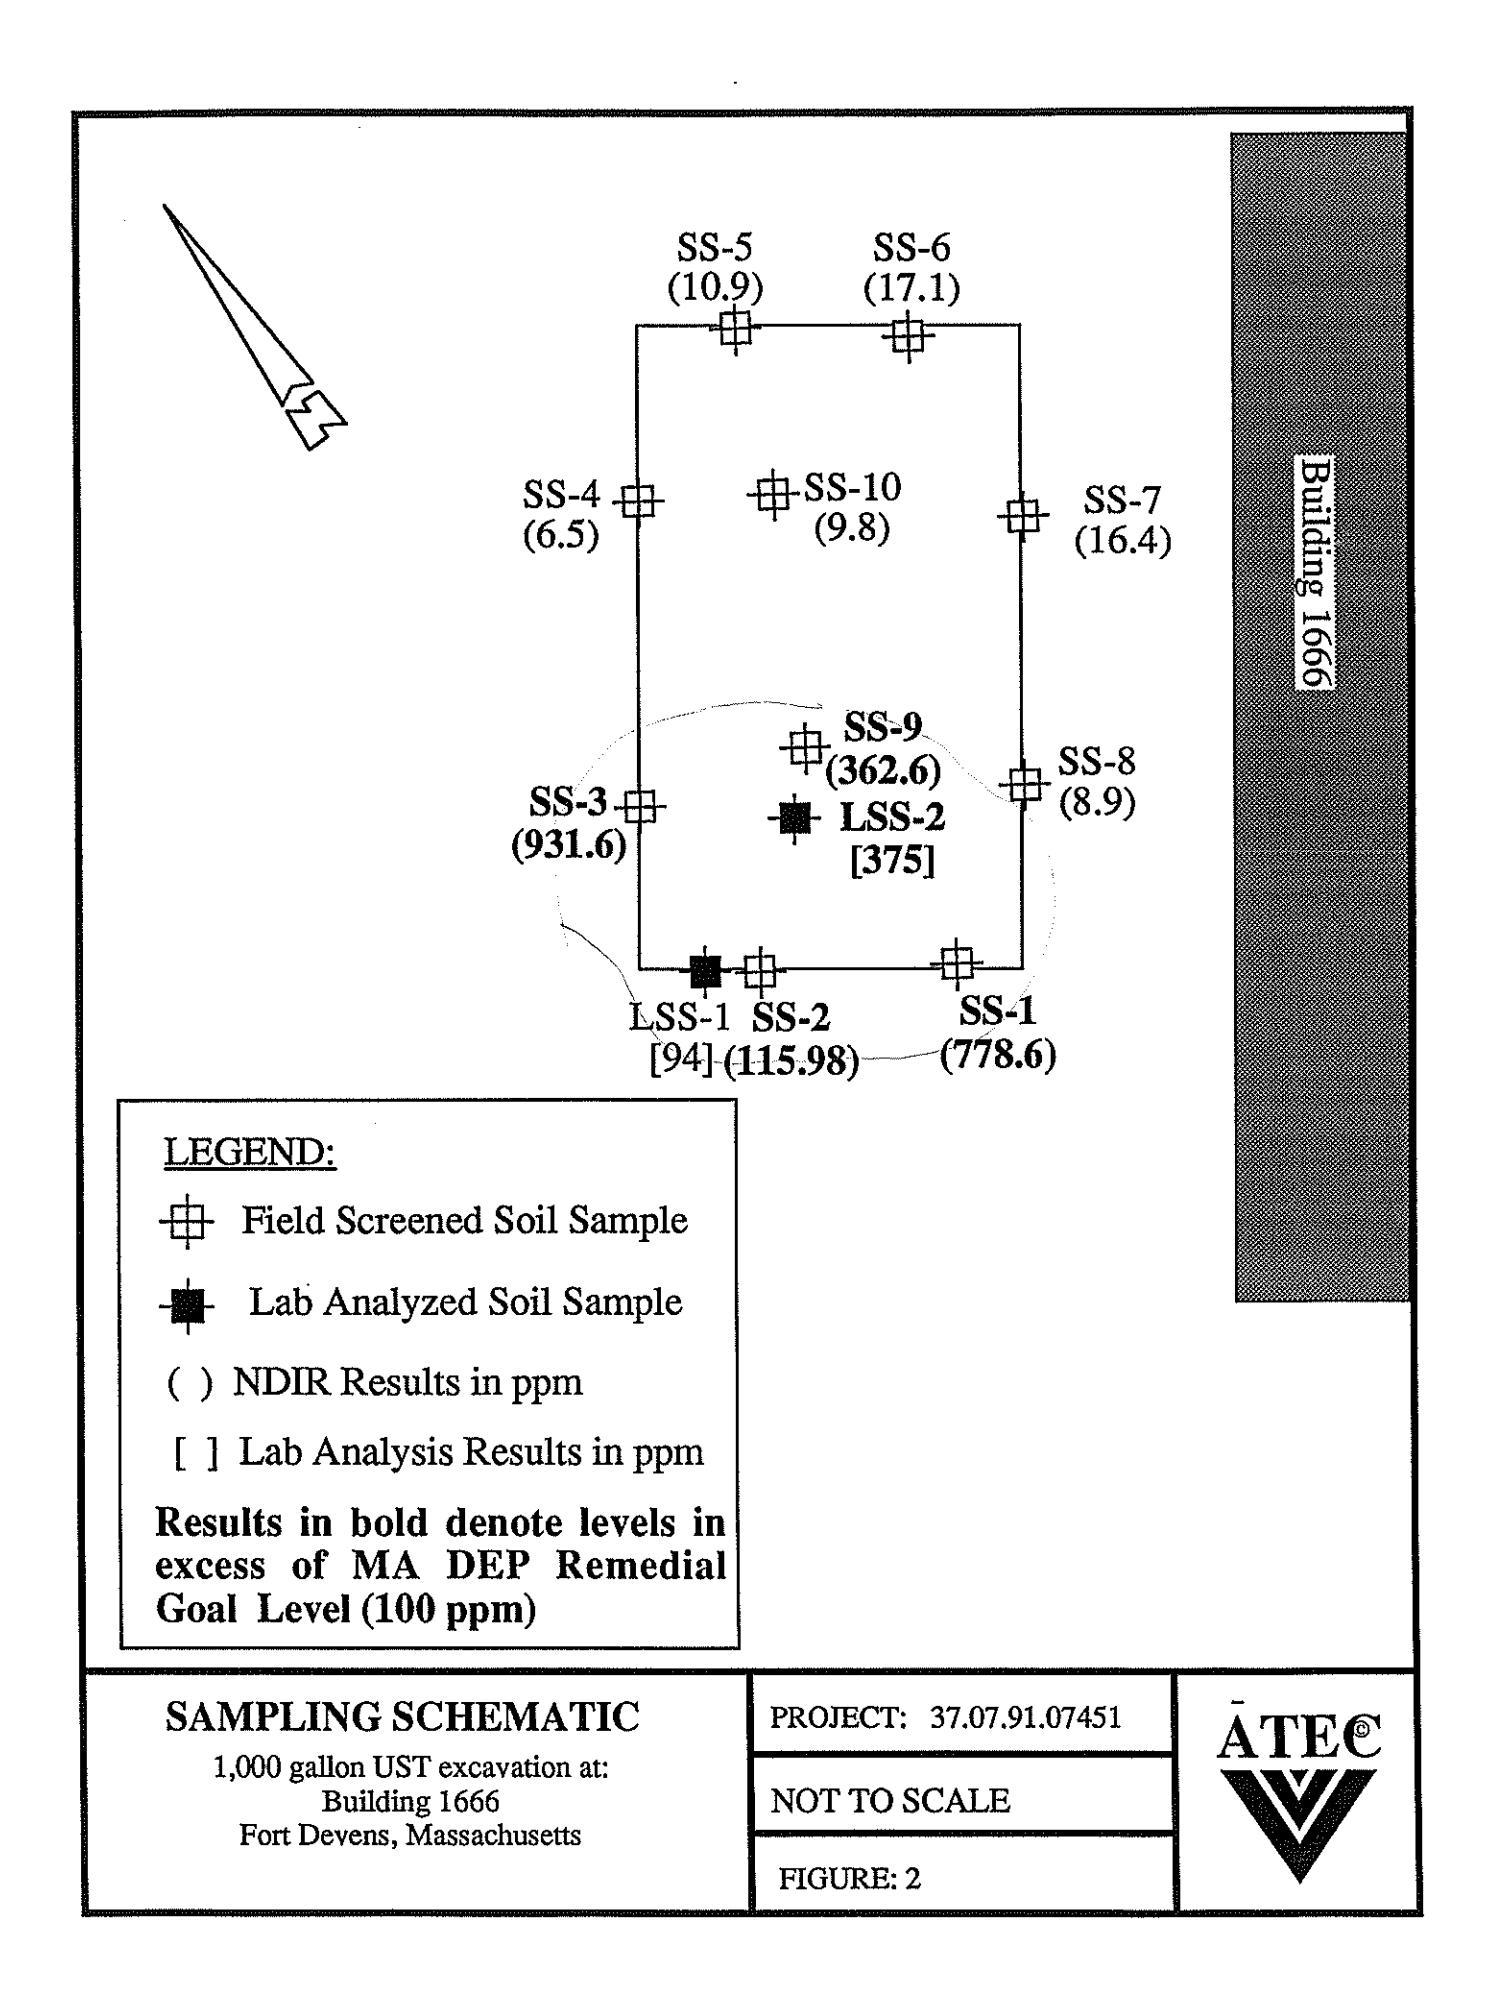
Eight (8) of the samples (SS-1 to SS-8) were obtained from the excavation walls at a depth of approximately 2.5 - 3.5 feet below grade. Two (2) of the samples (SS-9 and SS-10) were obtained from the bottom of the excavation at a depth of approximately 5.5 feet below grade. Two (2) composite soil samples (Stock-1 and Stock-2) were obtained from stockpiled soils for PID and NDIR field screening. Sampling locations for the excavation are depicted on the Sampling Schematic attached as Figure 2.

Two (2) soil samples (LSS-1 and LSS-2) were obtained from the excavation for laboratory analysis. Soil Sample LSS-1 was obtained from the southwest wall of the excavation. Soil sample LSS-2 was obtained from the bottom of the excavation. One (1) composite, soil sample (LSS-3) was obtained from stockpiled soils required to free the tank. These samples were analyzed for TPH utilizing USEPA Extraction Method 9071 and Analysis Method (draft) 9073. Sampling locations are depicted on the Sampling Schematic attached as Figure 2.

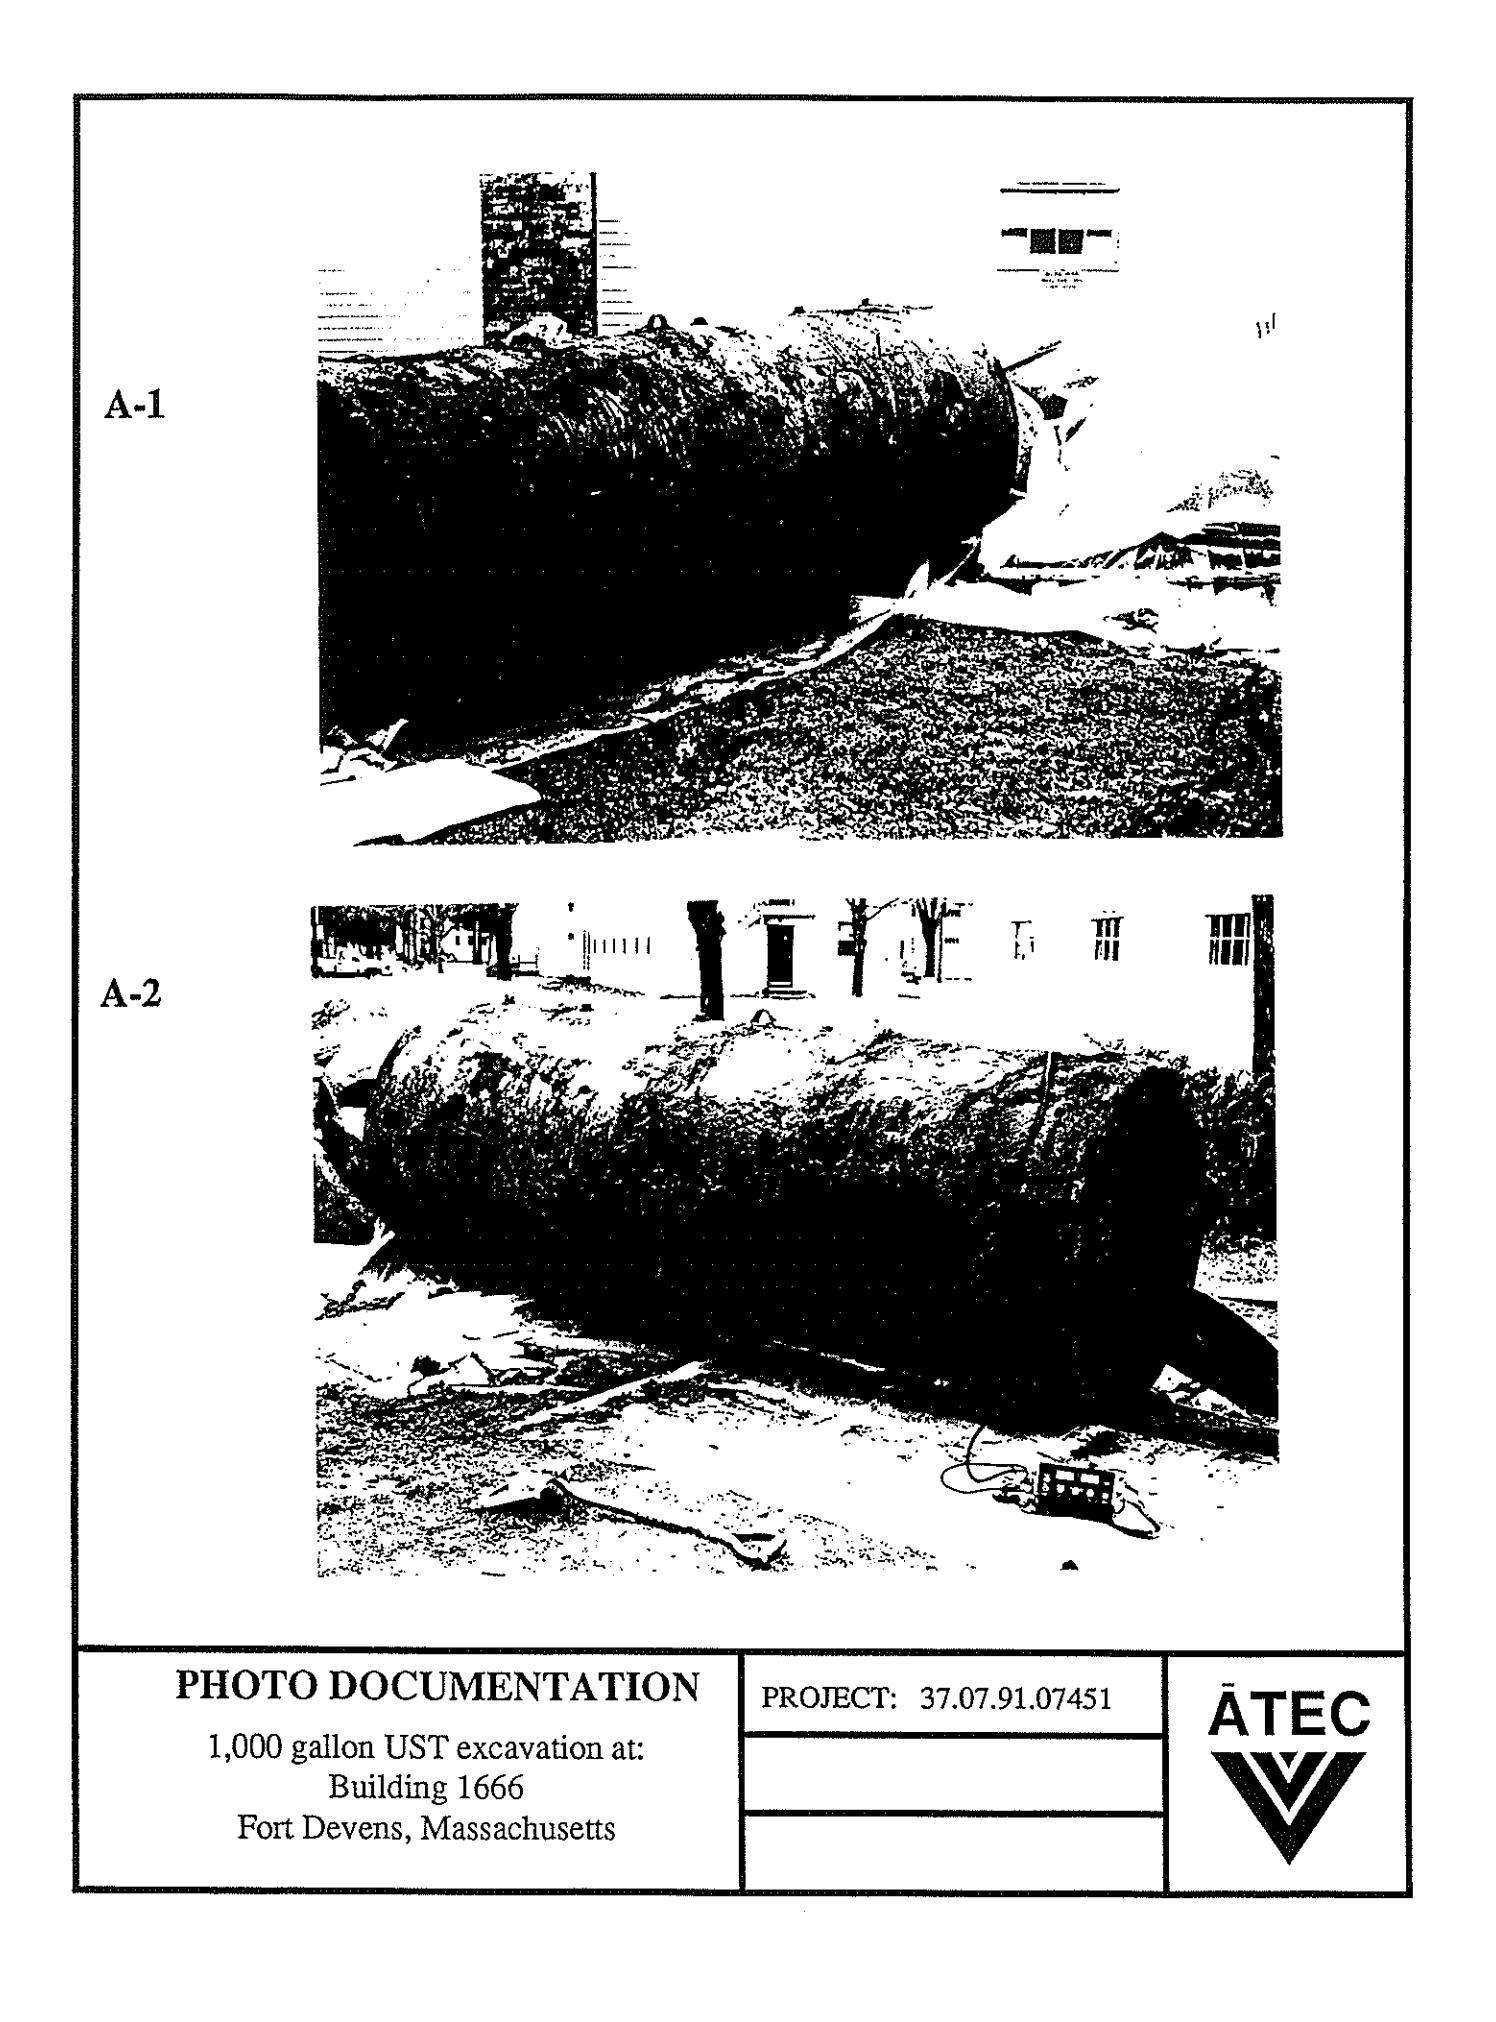
APPENDIX A: PHOTOGRAPHIC DOCUMENTATION

- 1. Upon excavation and removal, the tank was observed to be in good condition with no signs of perforations, punctures, or severe corrosion.
- 2. Ground water was not encountered within the excavation.

- 3. No soils were visibly contaminated. However, fragments of the tank's asphalt coating were evident within the soil matrix of the walls and bottom of the excavat ion.

- A-1: One (1) side of removed tank.
- A-2: Opposite side of removed tank.
- A-3: Excavation as viewed from north, facing south.
- A-4: Excavation as viewed from south, facing north.
