Technical Report Underground Storage Tank Closure UST Nos. 0035 - 0037 Building Nos. 2452, 2458, 2461 respectively Fort Devens, Massachusetts

ATEC File: 37.07.91.00451 Contract No. DAK31-91-D-00015

January 14, 1994

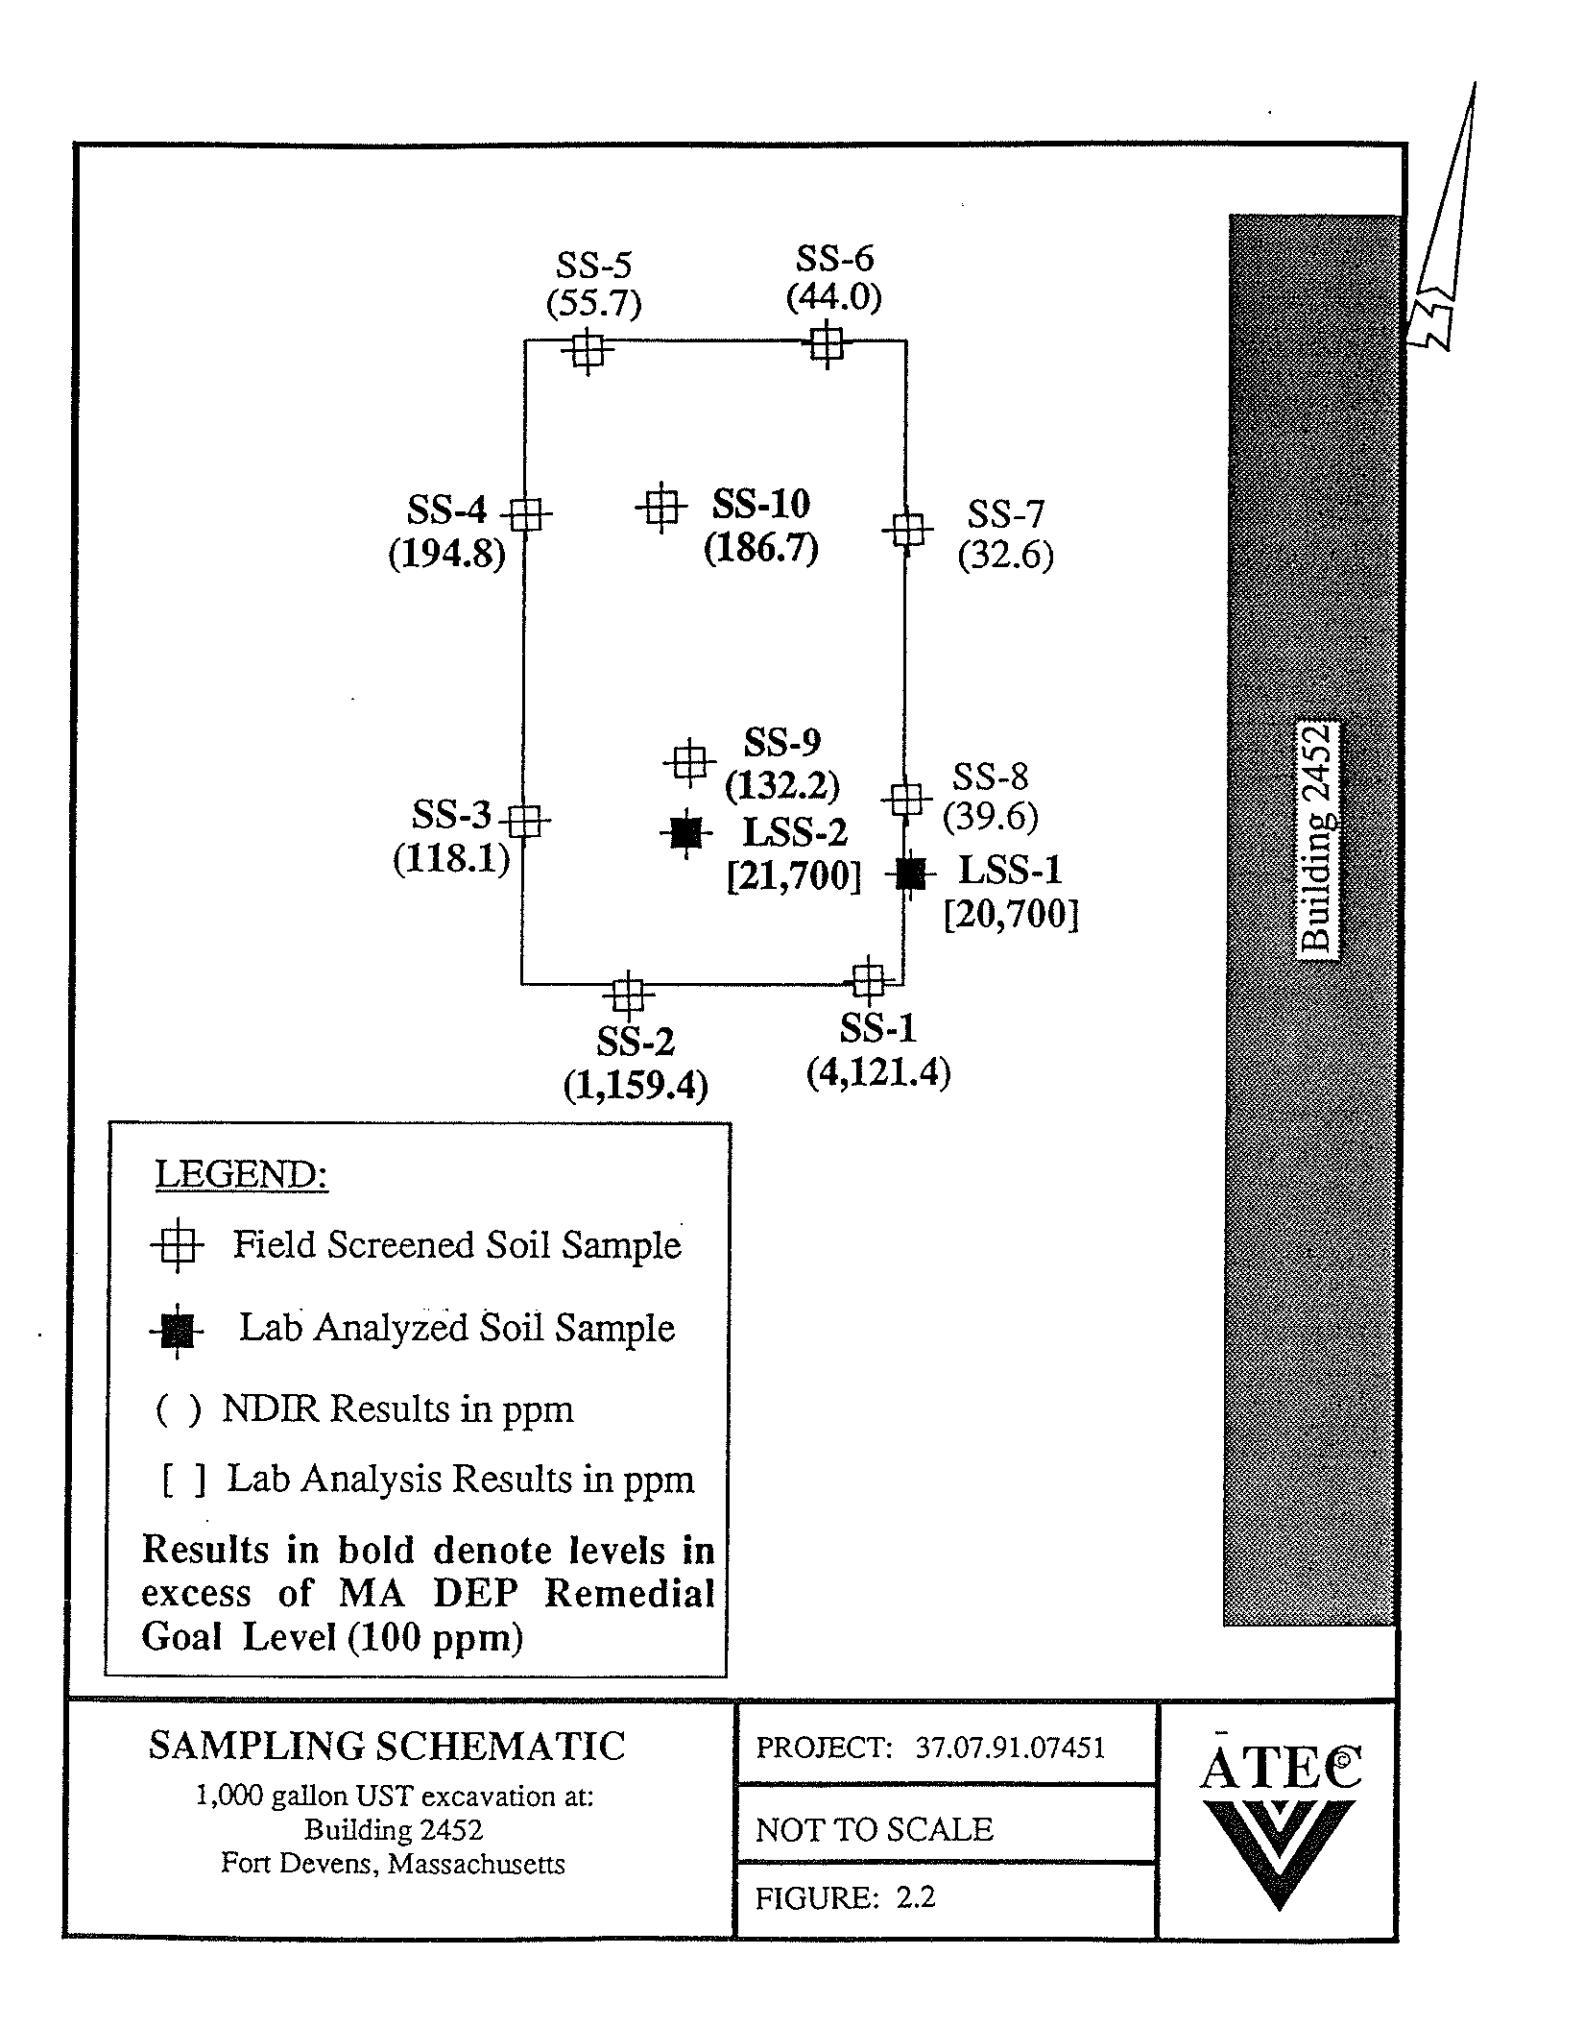
Two soil samples (LSS-1 and LSS-2) were obtained from the excavation for laboratory analysis. Soil Sample LSS-1 was obtained from the southeast wall of the excavation.

Soil sample LSS-2 was obtained from the bottom of the excavation. One composite, soil sample (LSS-3) was obtained from stockpiled soils required to free the tank. These samples were analyzed for TPH.

Sampling locations are depicted on the Sampling Schematic attached as Figure 2.2. The applicable chain of custody forms are included in Section 2.9.

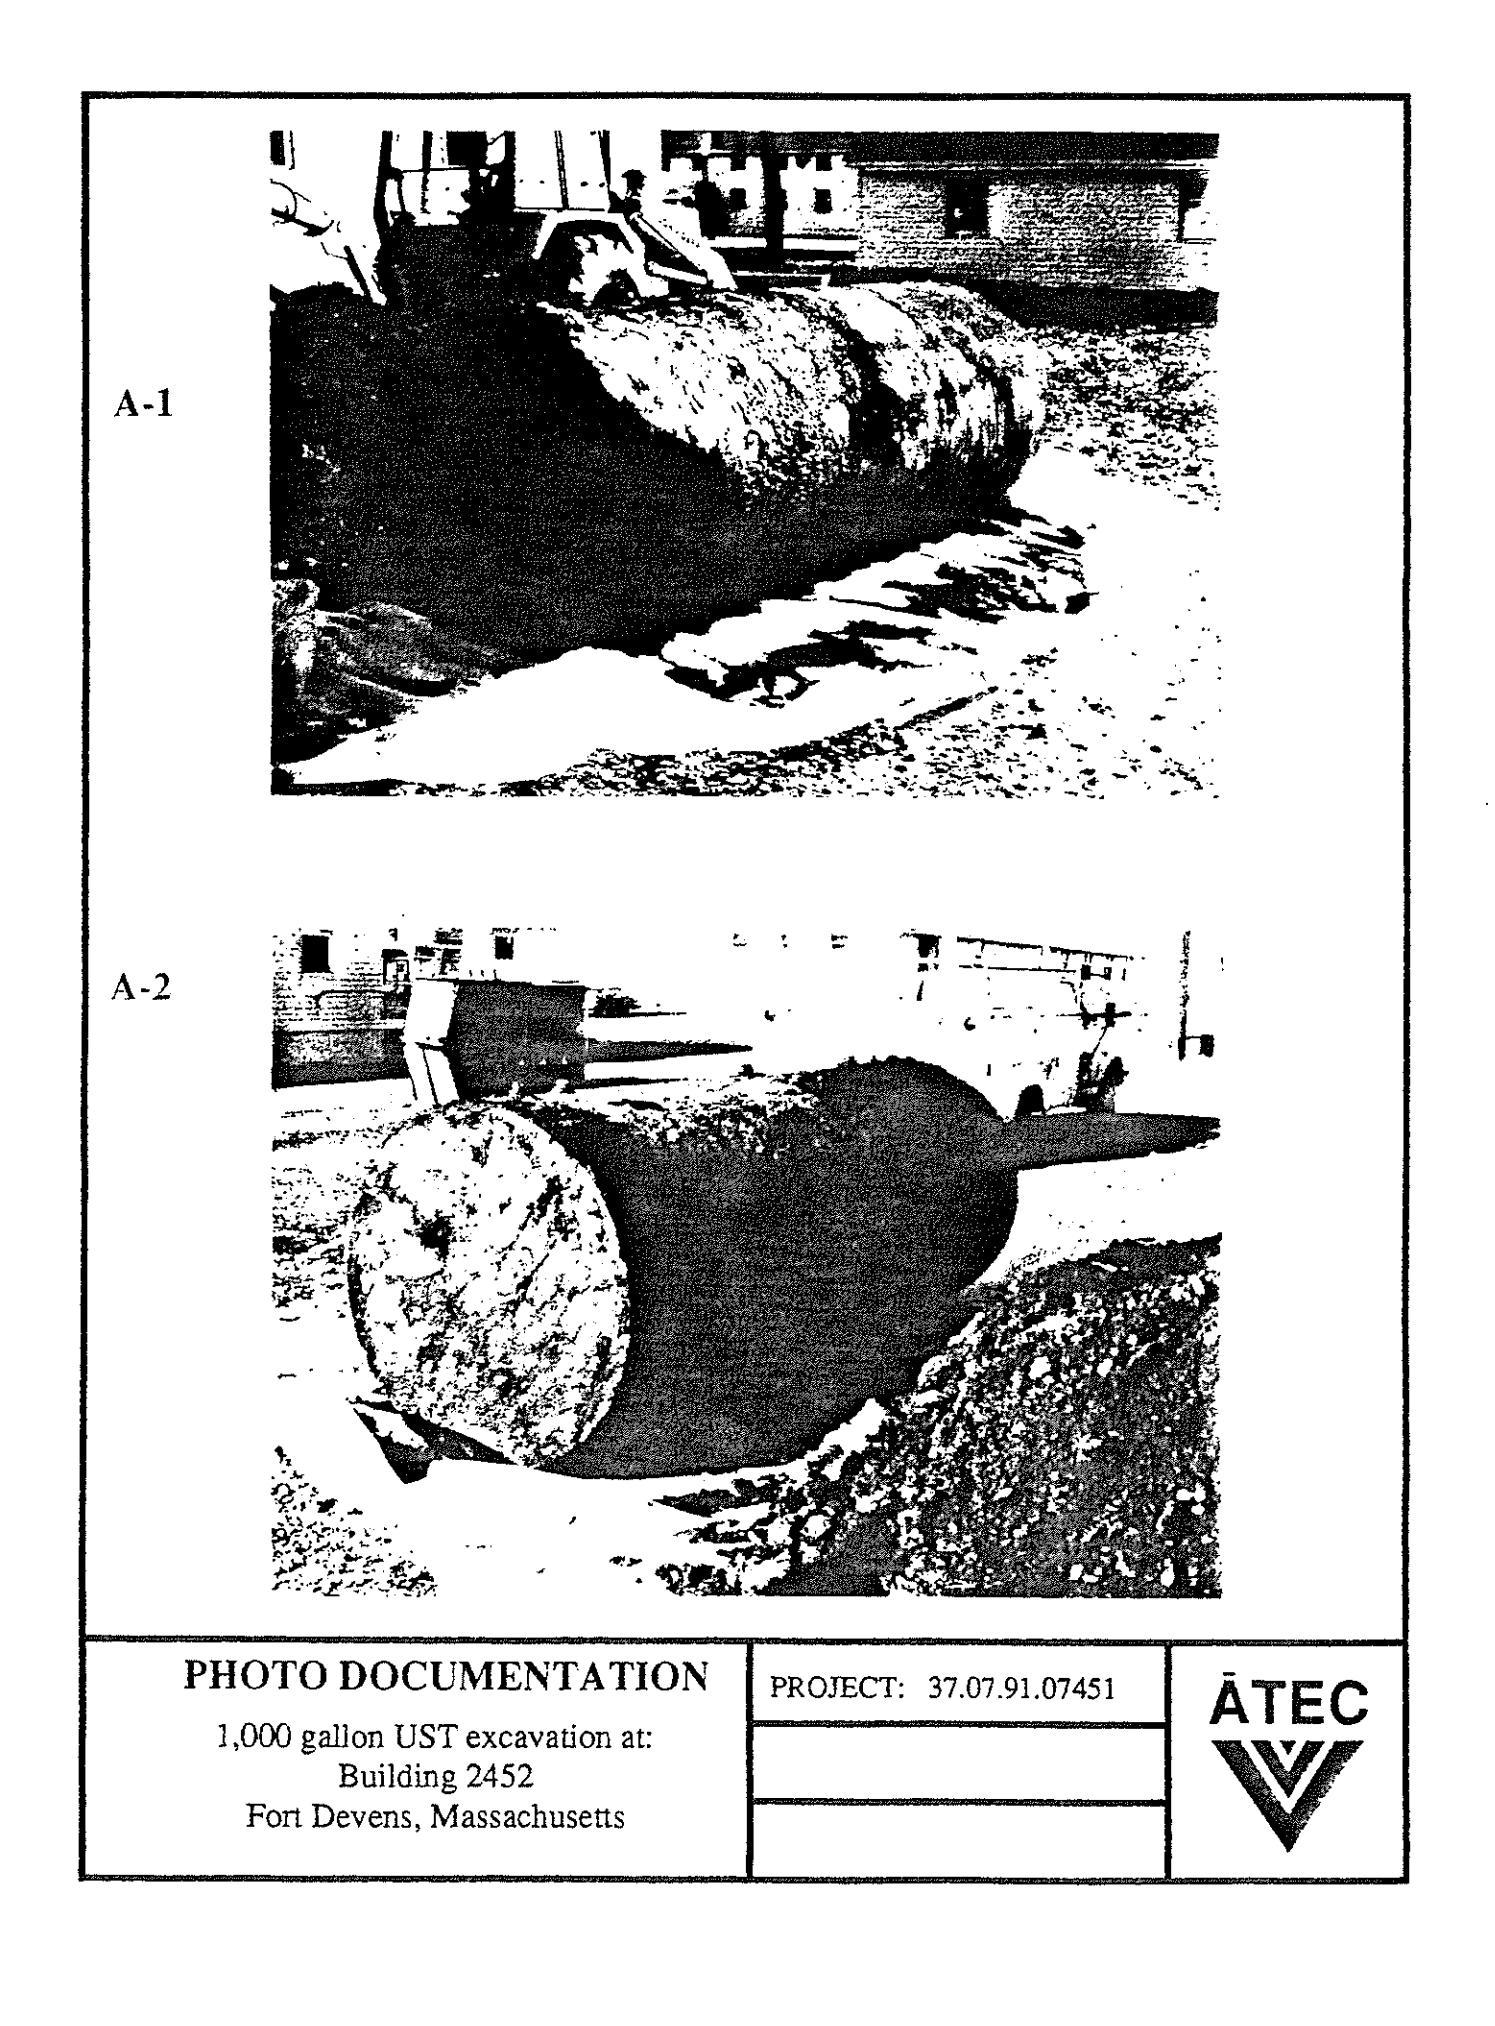
- A-1: One side of removed tank.
- A-2: Opposite side of removed tank.
- A-3: Excavation as viewed from north, facing south.
- A-4: Excavation as viewed from south, facing north.

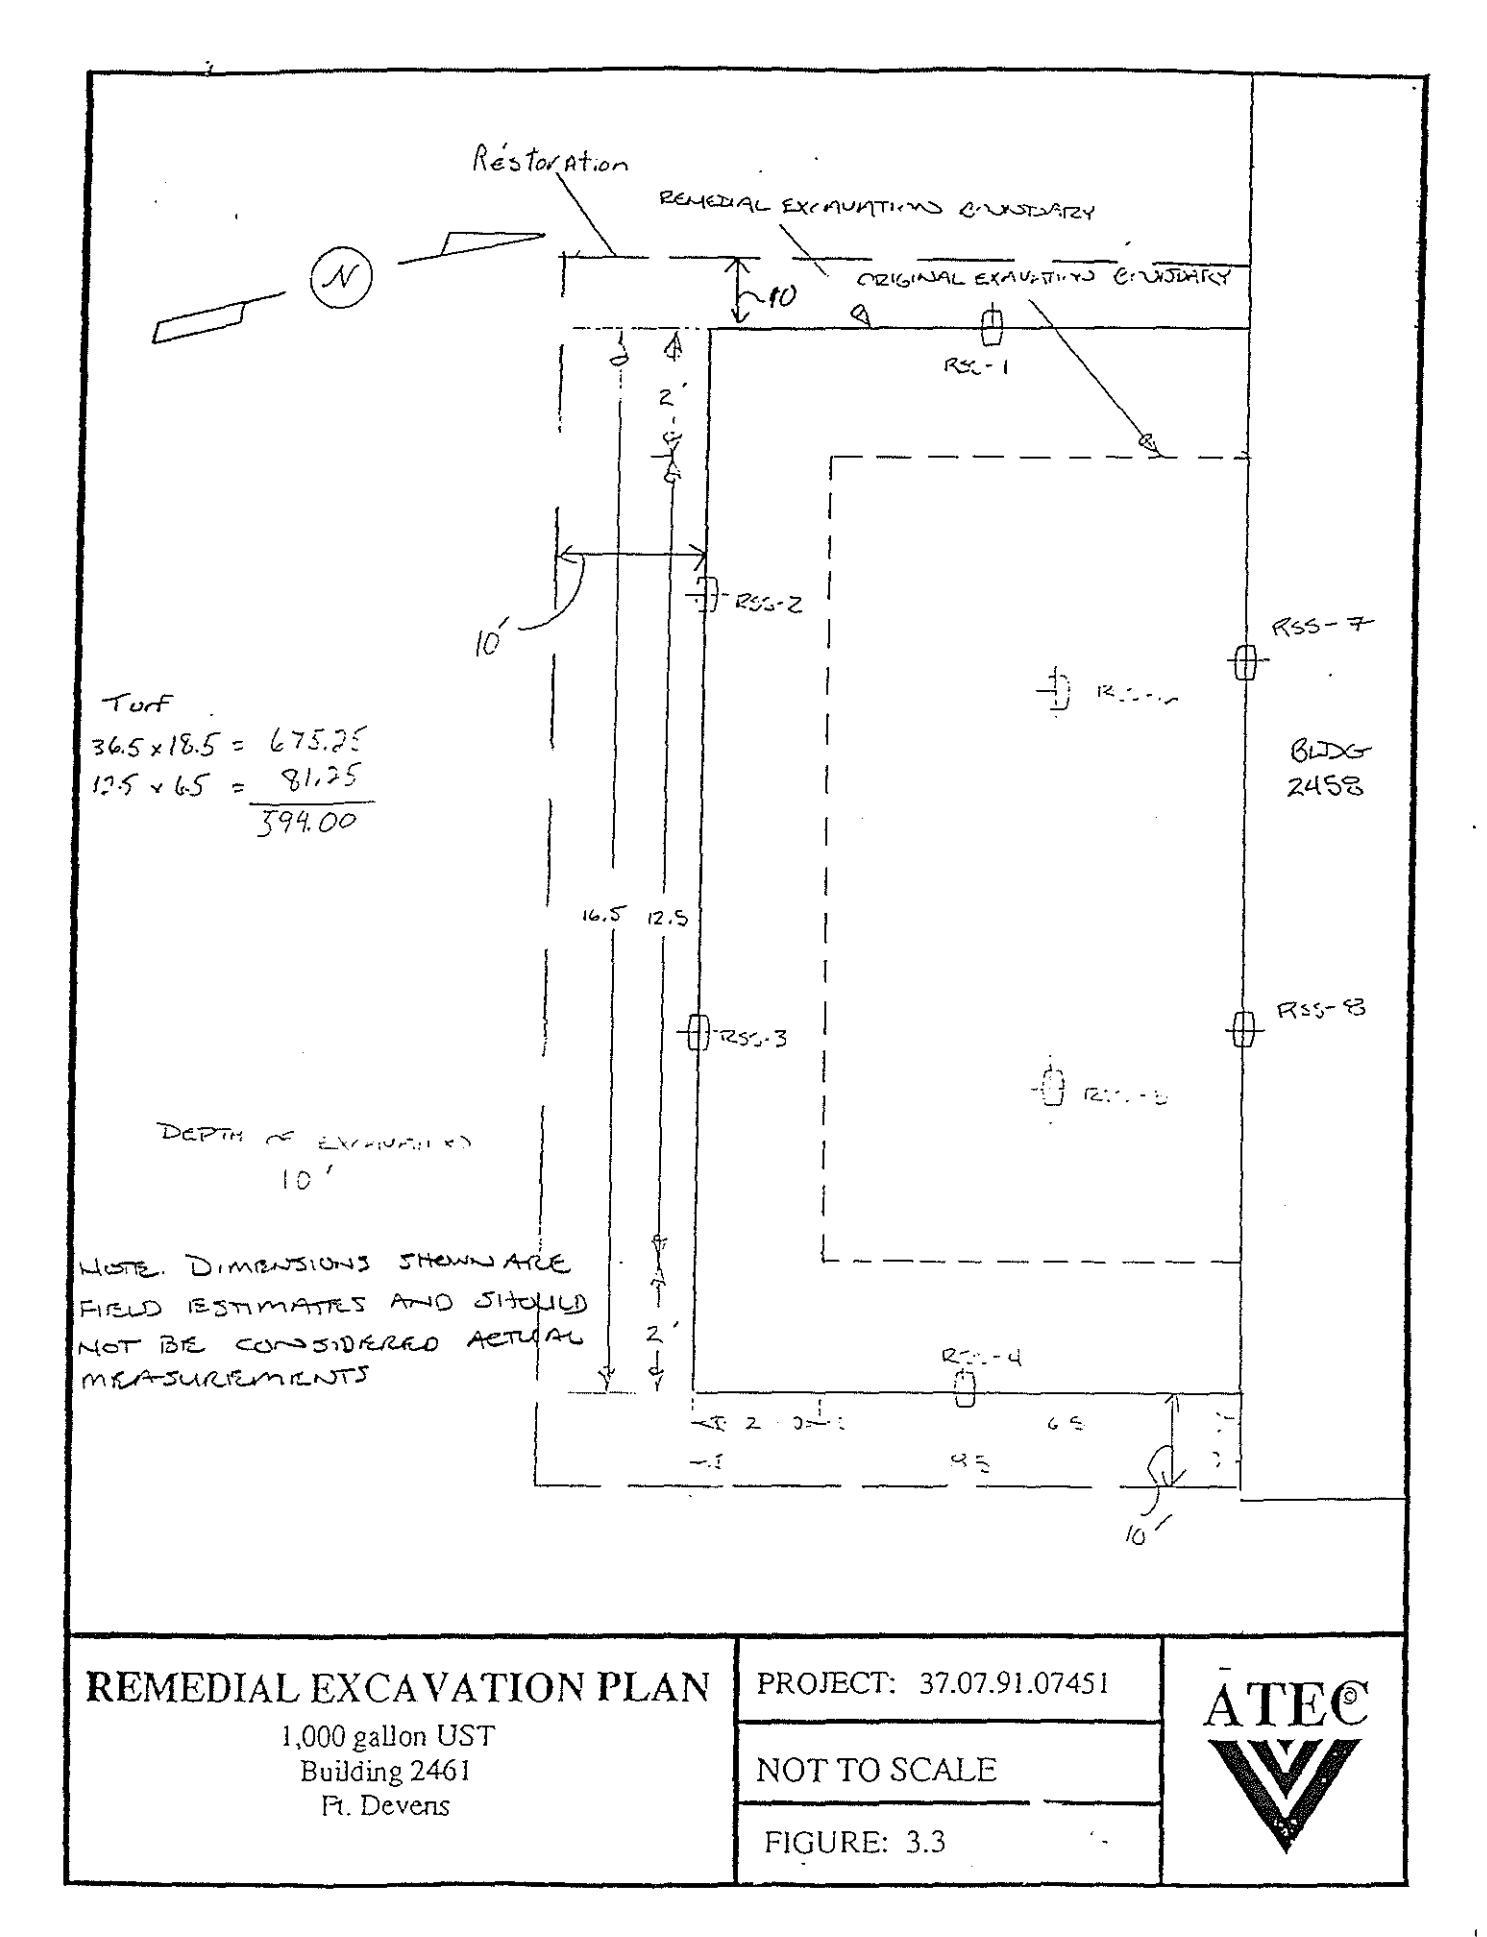
An additional 1 foot of soil was removed from the excavation sidewall and at the bottom of the excavation. Following the removal of the additional one foot of soil, soil samples (RSS -1B through RSS-6B) were obtained from the excavation. RSS-1B through RSS-4B were obtained from sidewalls at a depth of approximately 4 feet below grade. RSS-5B and RSS-6B were obtained from the bottom of the excavation at a depth of approximately seven feet below grade. Soil samples from the north wall were not obtained due to access restrictions. Groundwater was encountered at a depth of approximately 7 feet within the central portion of the excavation. Soil samples were screened and TOV concentrations ranged from 6.4 ppm to 120 ppm. A remedial Excavation Plan is attached as Figure 3.3. Further excavation was not conducted per

order of the Contracting Officer's Representative. Remedial excavation PID screening results are listed in Table 3.2 as follows:

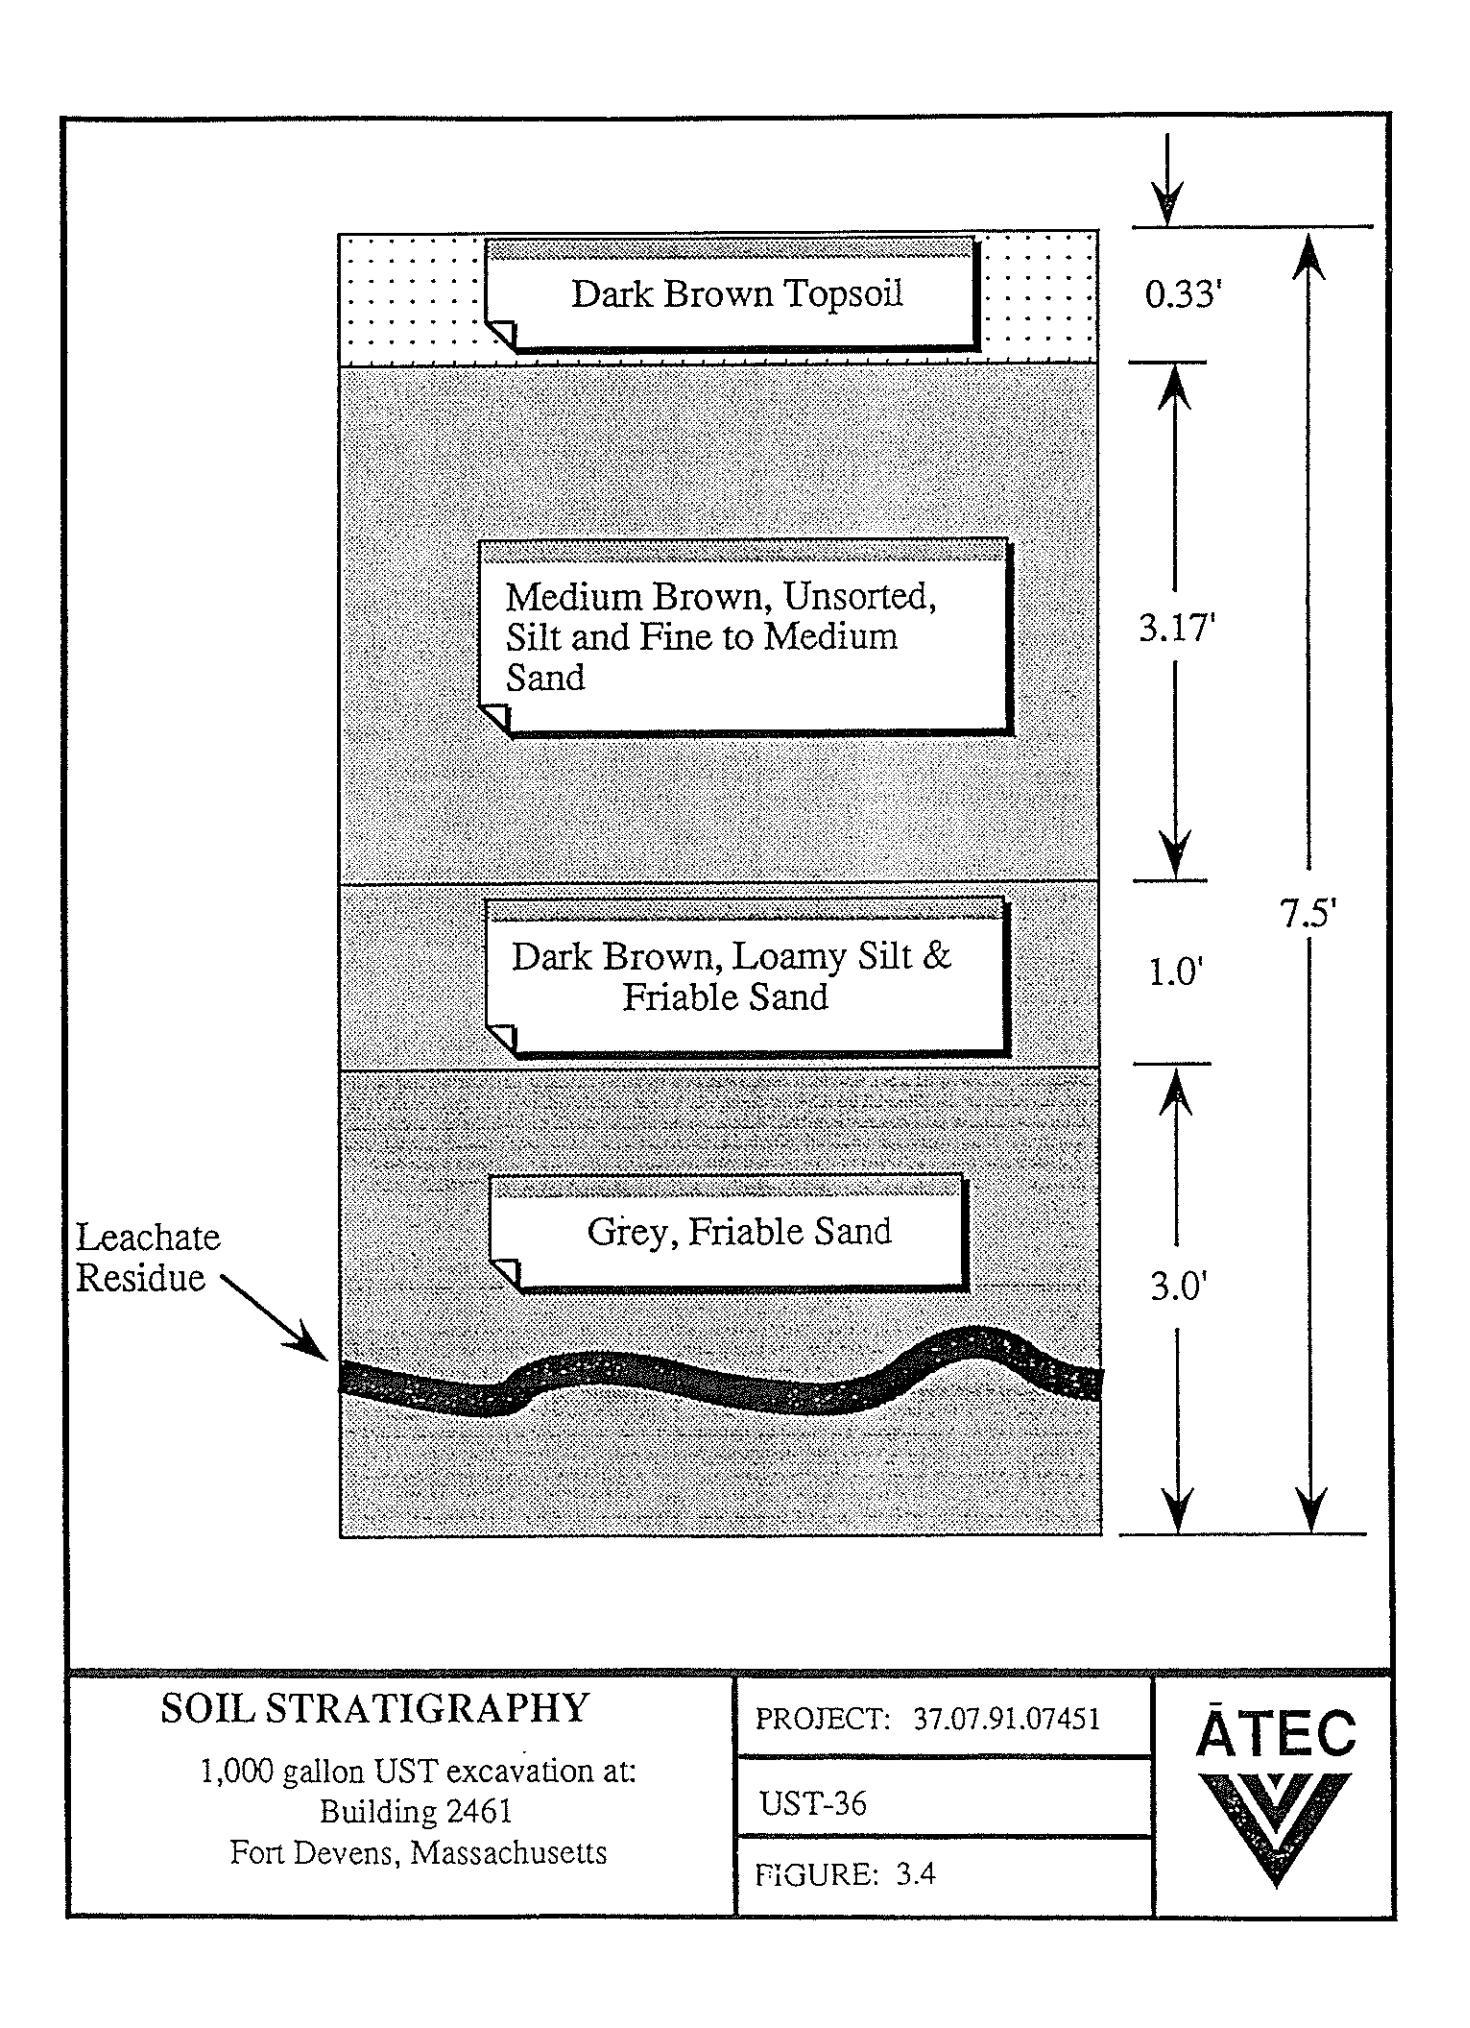
The soil stratigraphy for the excavation consisted of an initial 4 inches of dark brown topsoil. The following 3 feet of excavation was a mixture of medium brown, unsorted, silt and fine to medium grain sand. The next foot of the excavation consisted of dark brown, loamy silt and sand. The remaining 3 feet of the excavation consisted of grey

sand. A layer of stained soil was present as a result of within the bottom 3 feet of the excavation. (See Figure 3.4 - Soil Stratigraphy).

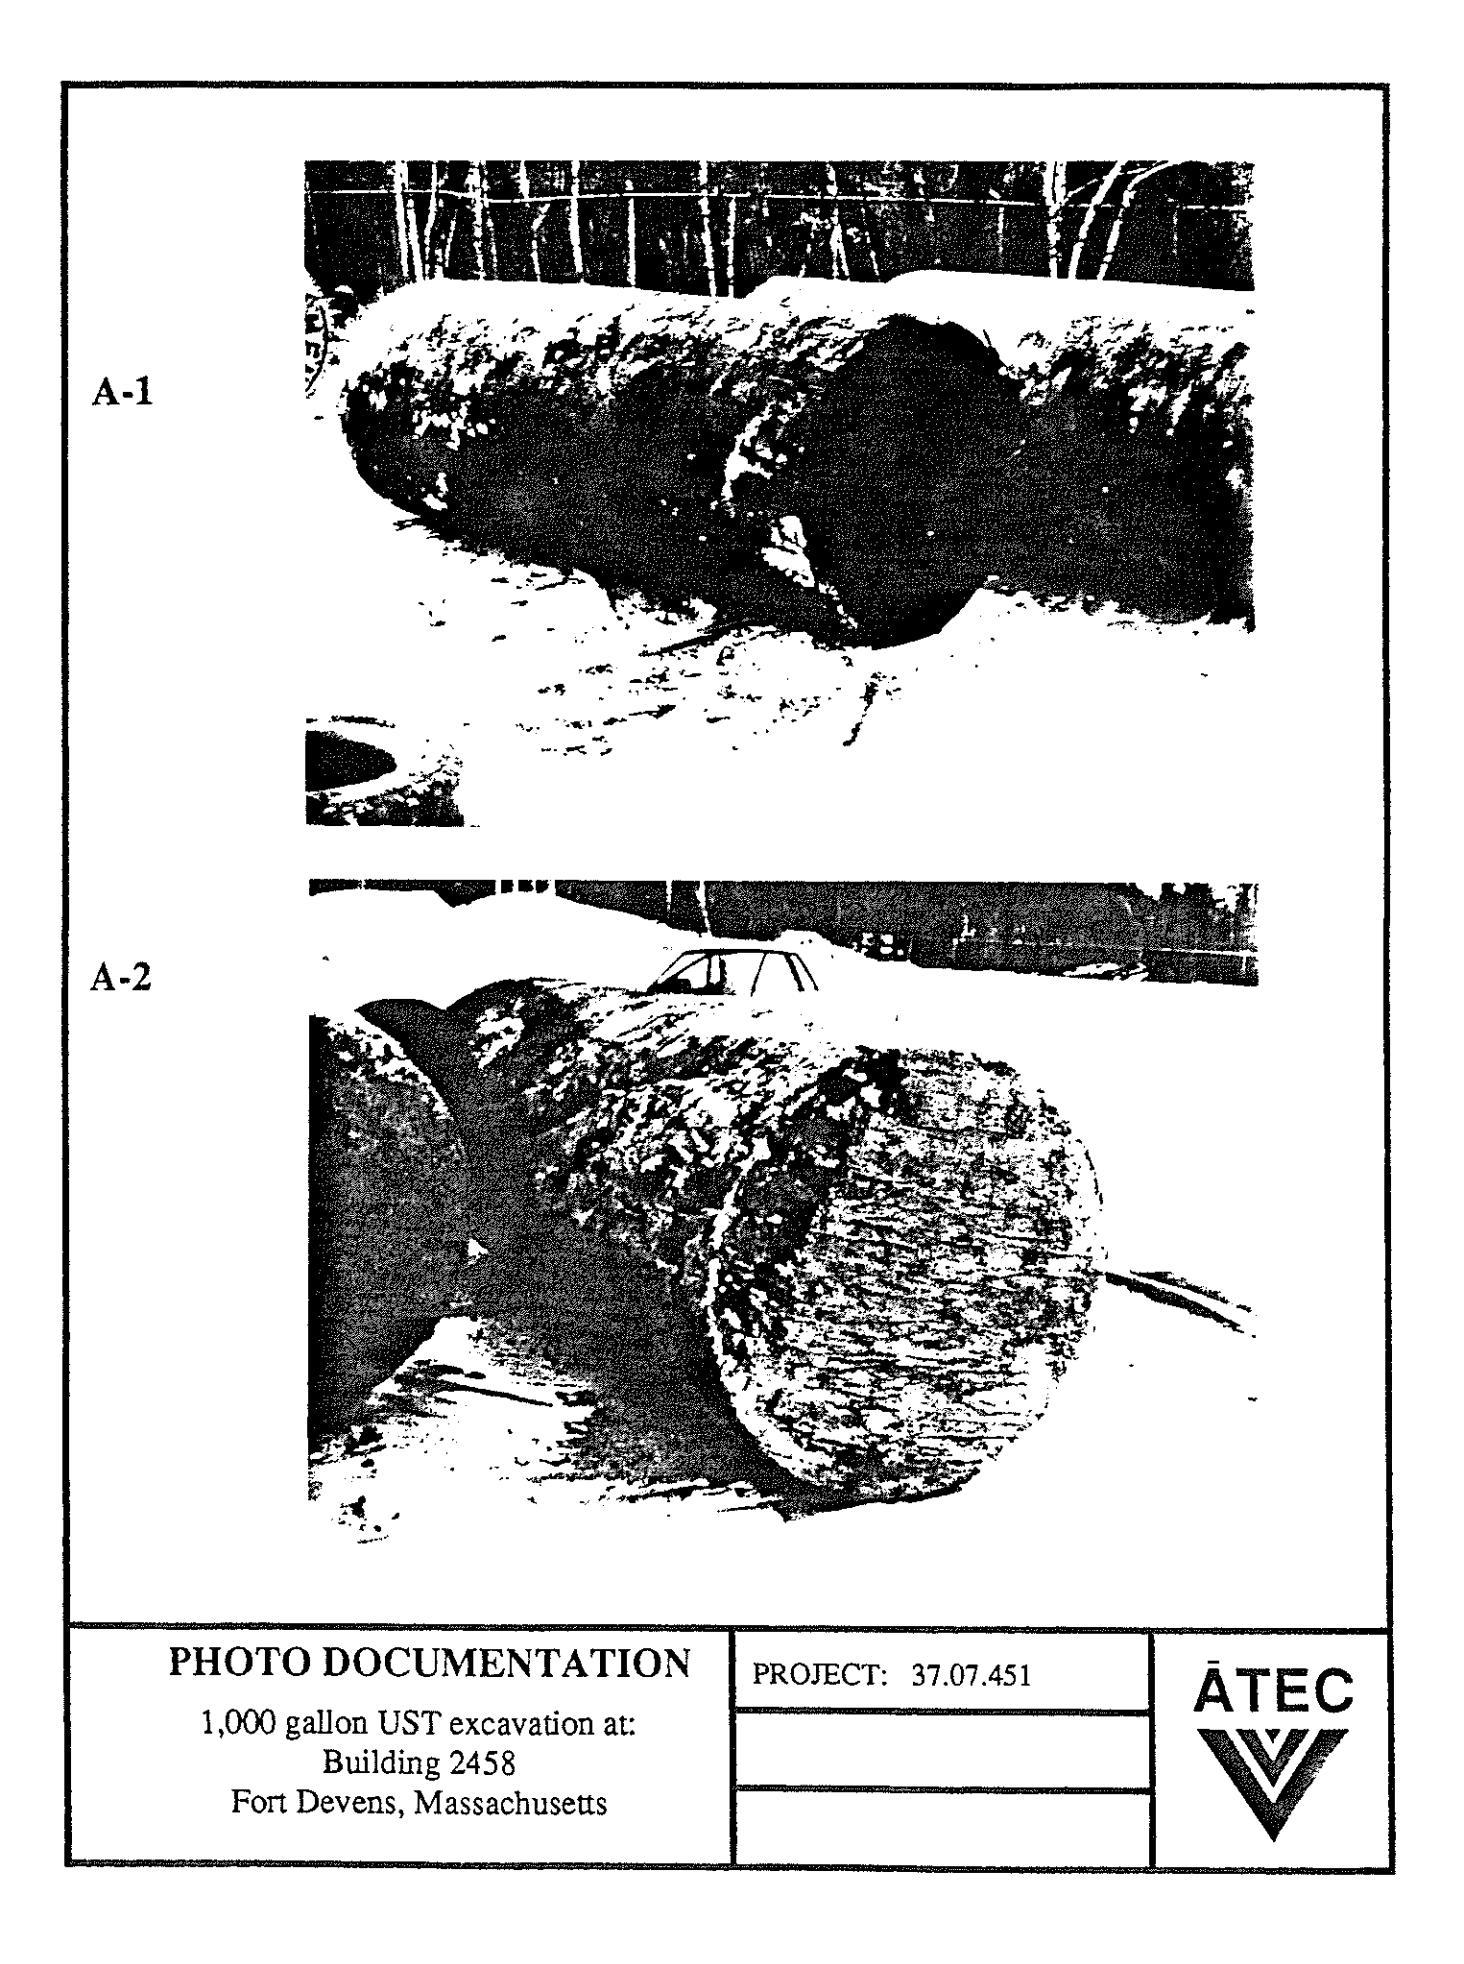
- A-1: One side of removed tank.
- A-2: Opposite side of removed tank.
- A-3: Excavation as viewed from north, facing south.
- A-4: Excavation as viewed from south, facing north.

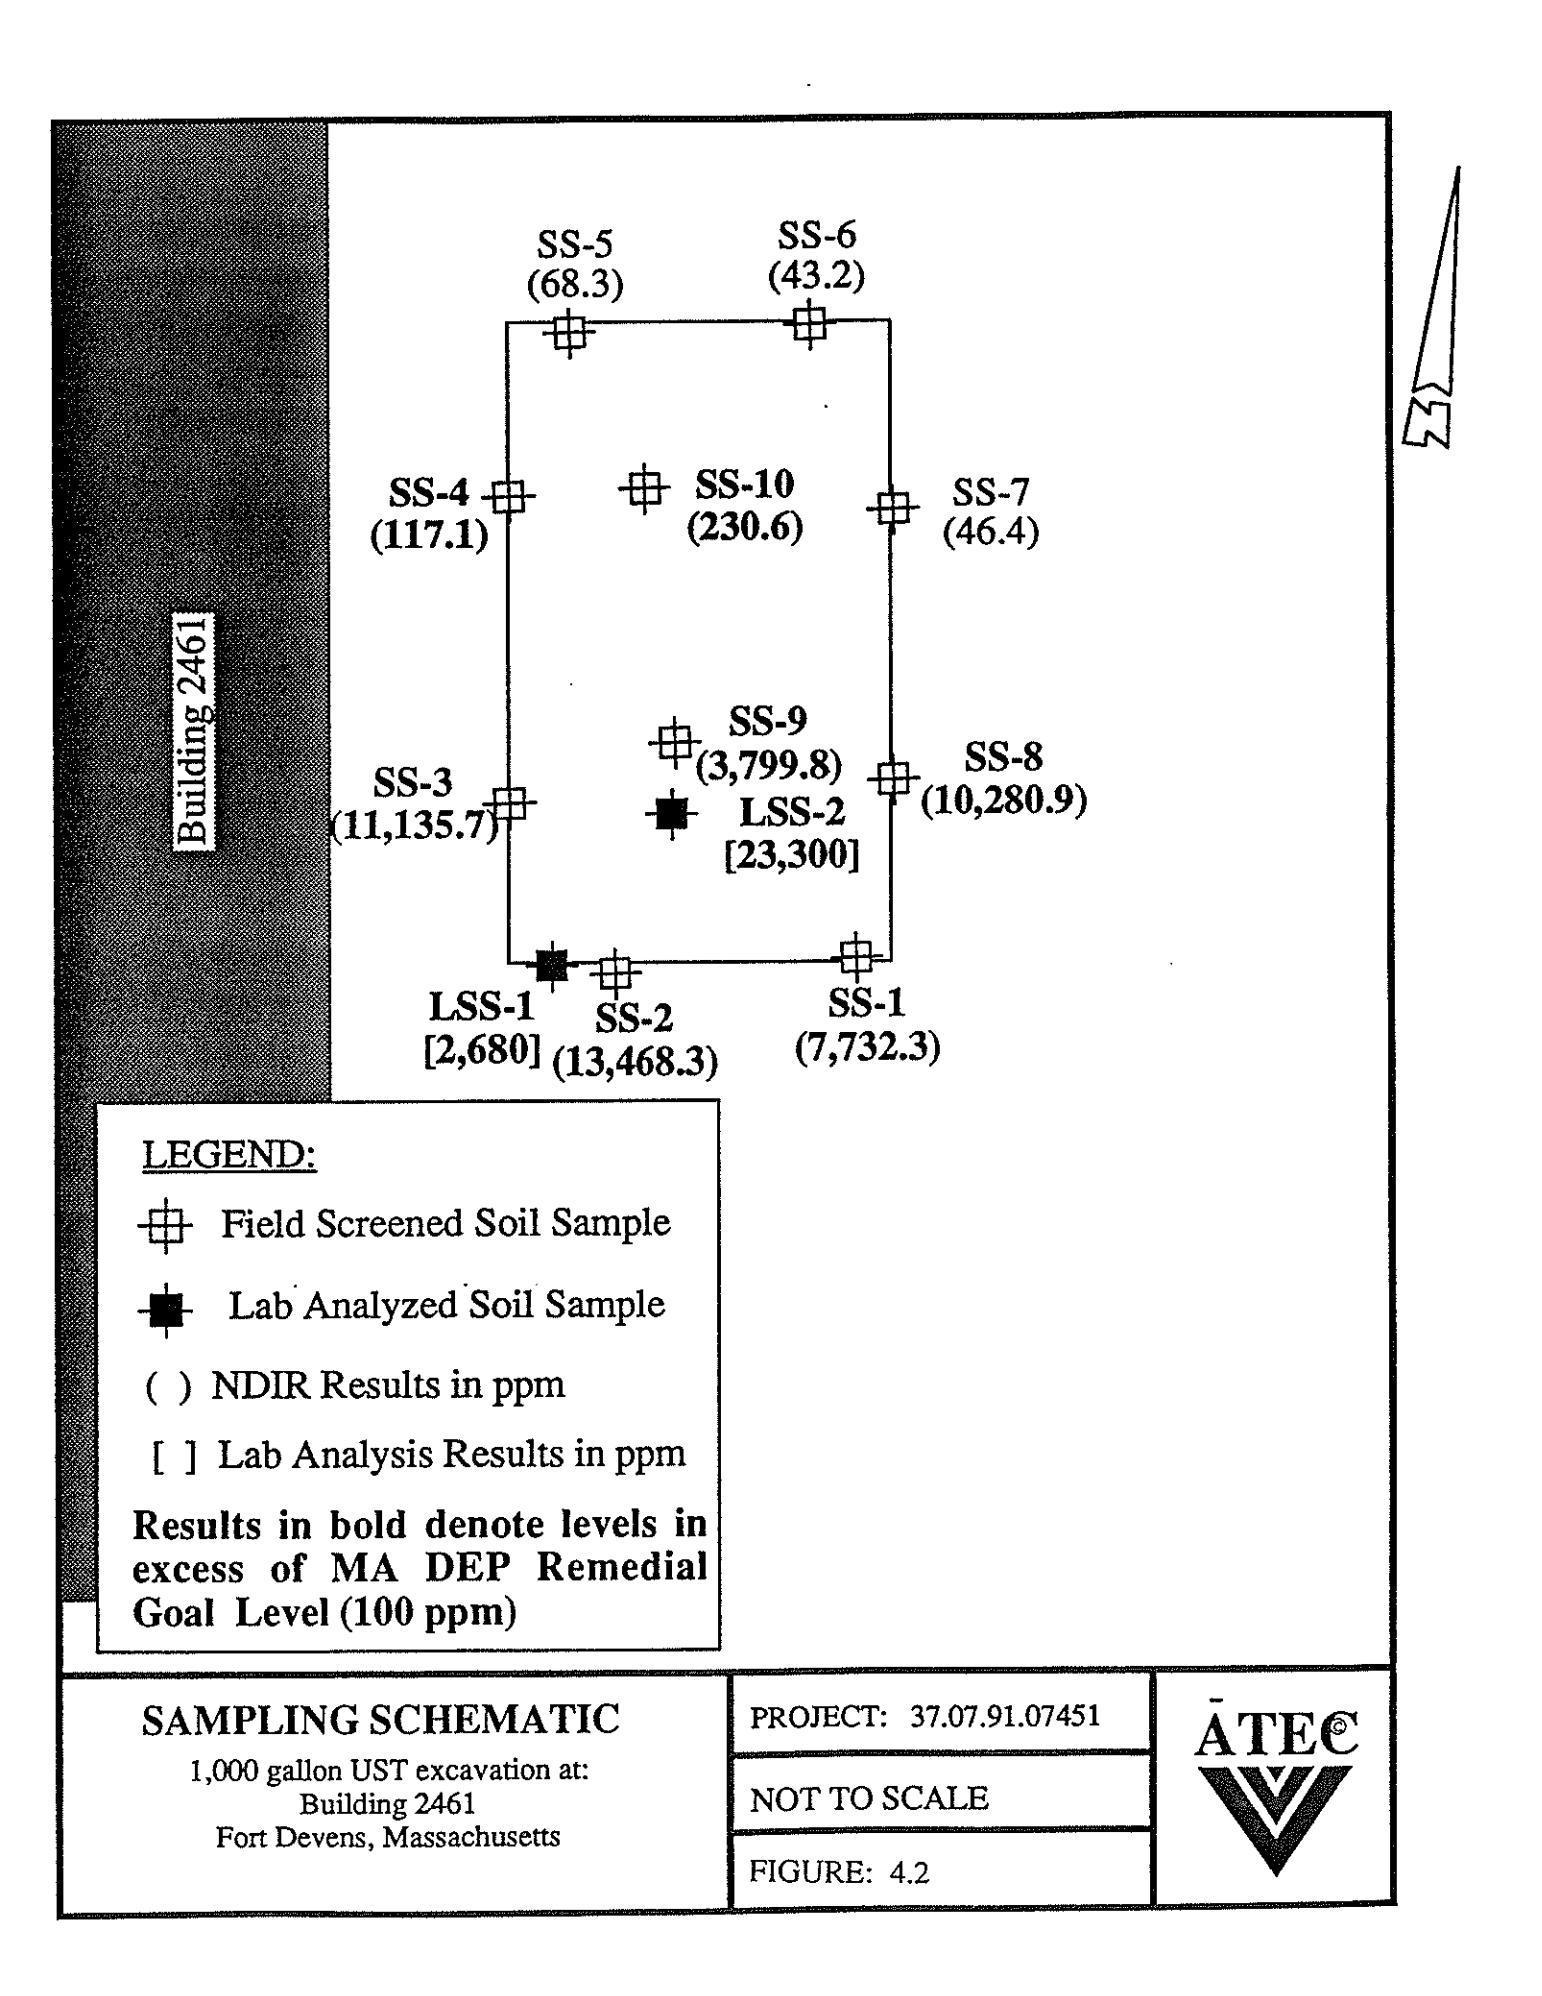
Two soil samples (LSS-1 and LSS-2) were obtained from the excavation for laboratory analysis. Soil Sample LSS-1 was obtained from the south wall of the excavation at a depth of 7 feet below grade. Soil sample LSS-2 was obtained from the bottom of the excavation at a depth of 4.5 feet below grade. One composite, soil sample (LSS-3) was obtained from stockpiled soils required to free the tank. These samples were analyzed for TPH.

Sampling locations are depicted on the Sampling Schematic attached as Figure 4.2. The applicable chain of custody forms are included in section 4.9.

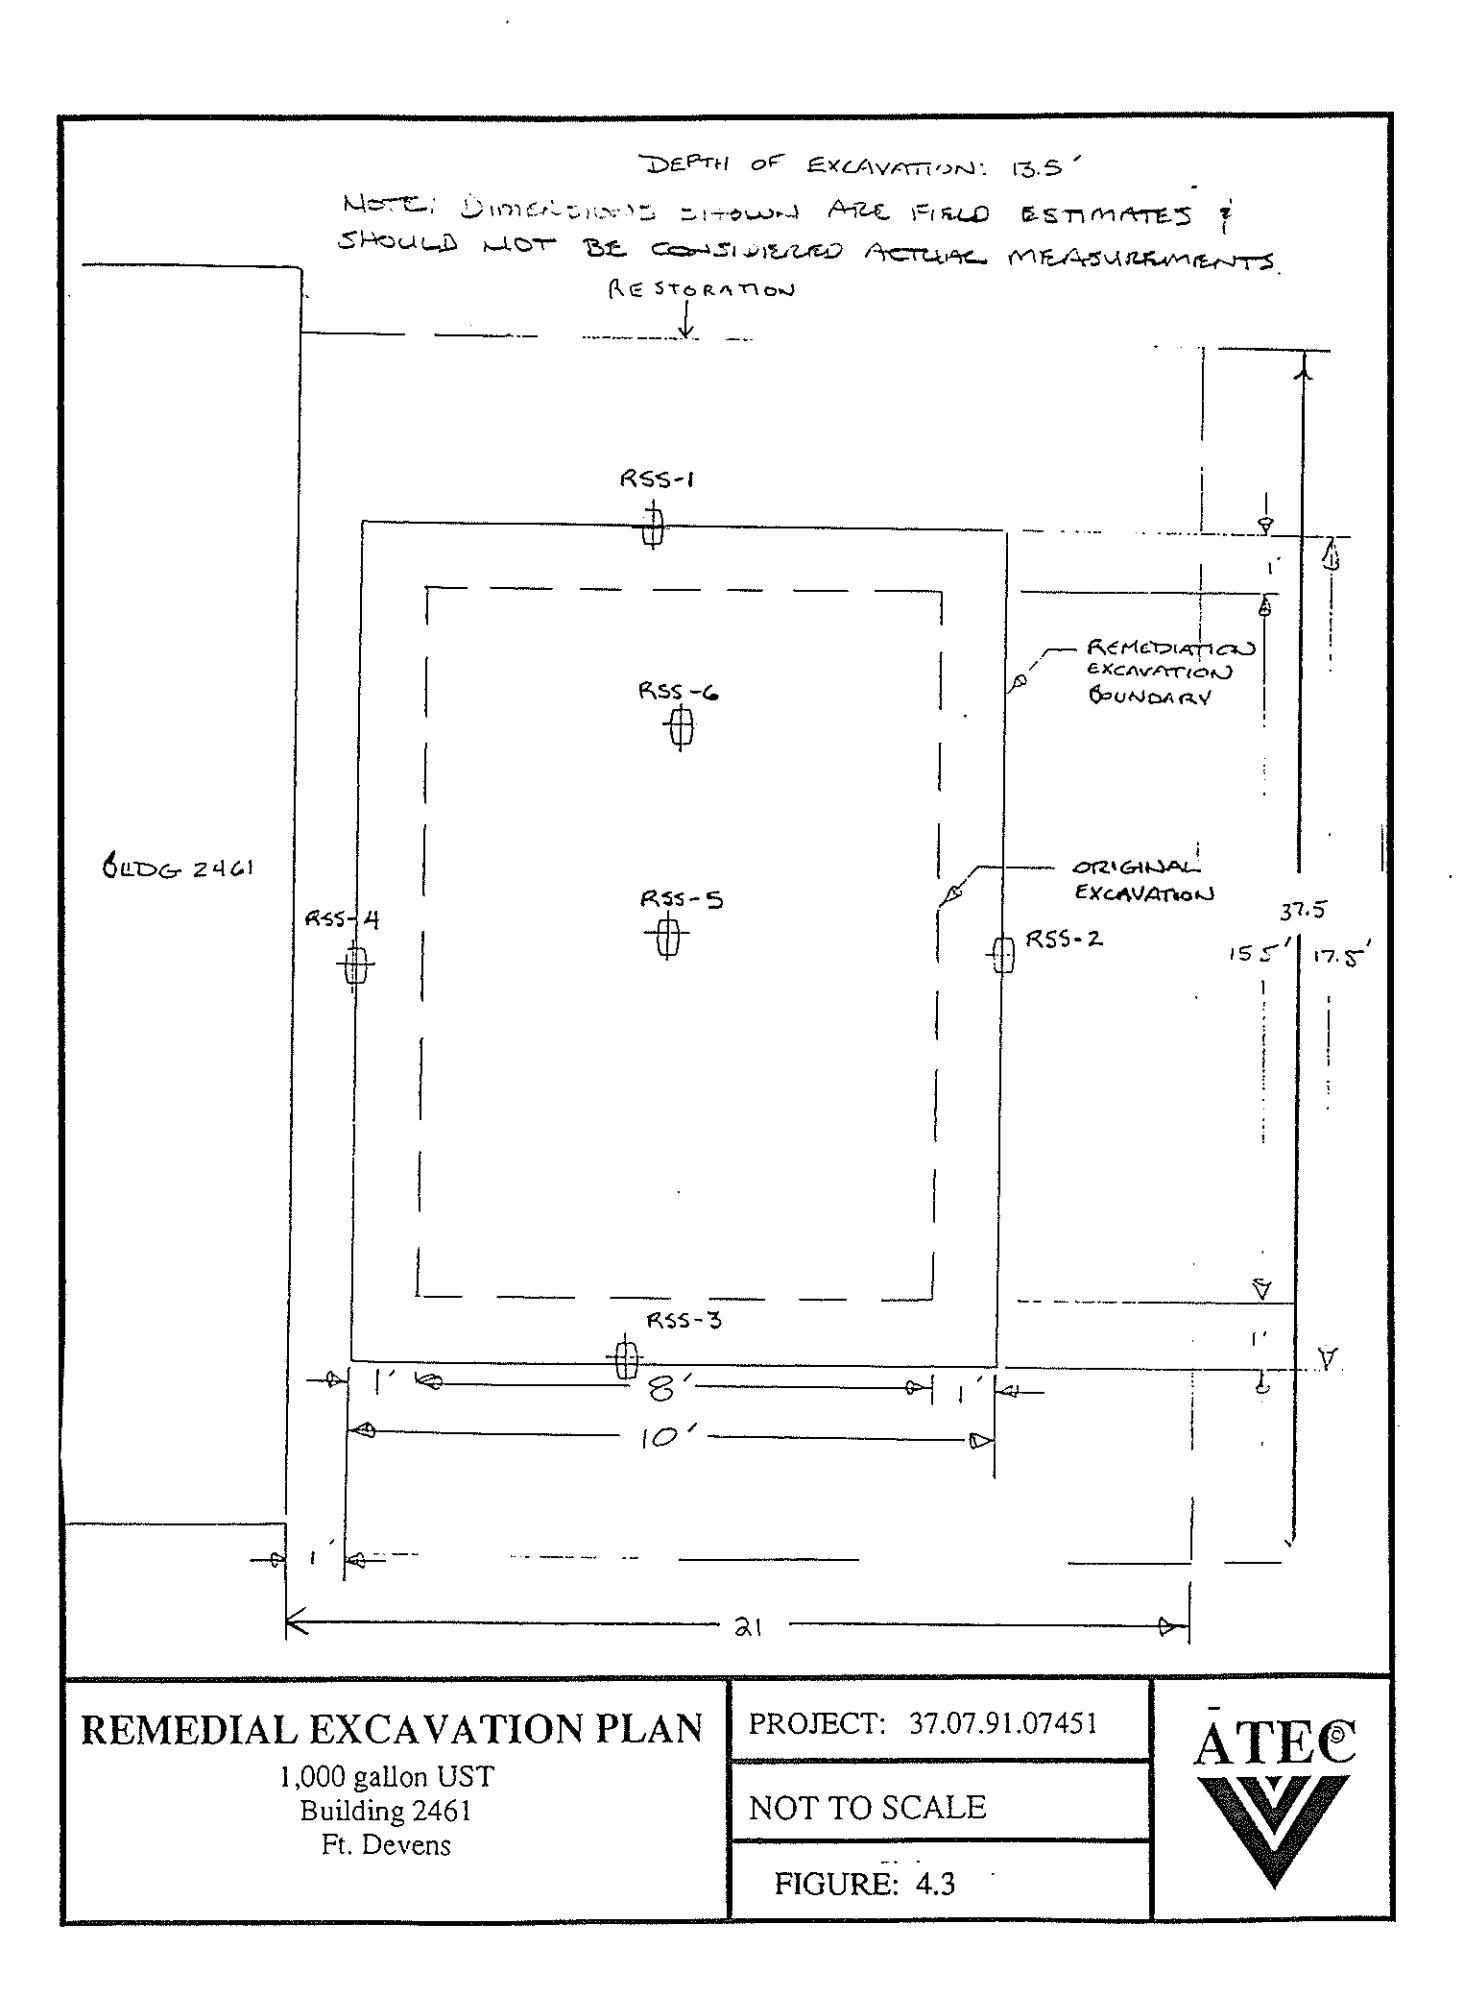
Following initial PID screening, additional excavation to remove contaminated soil and reach background levels by PID (<1 ppm) was conducted per order of the Contracting Officer's Representative and David Salvadore of the Massachusetts Department of Environmental Protection (DEP). A total of approximately 102 tons of

contaminated soil were removed from the bottom of the excavation and sidewalls during remedial excavation on July 31, 1992 (See Remedial Excavation Plan, Figure 4.3).
