Technical Report Underground Storage Tank Closure UST Nos. 0035 - 0037 Building Nos. 2452, 2458, 2461 respectively Fort Devens, Massachusetts

ATEC File: 37.07.91.00451 Contract No. DAK31-91-D-00015

January 14, 1994

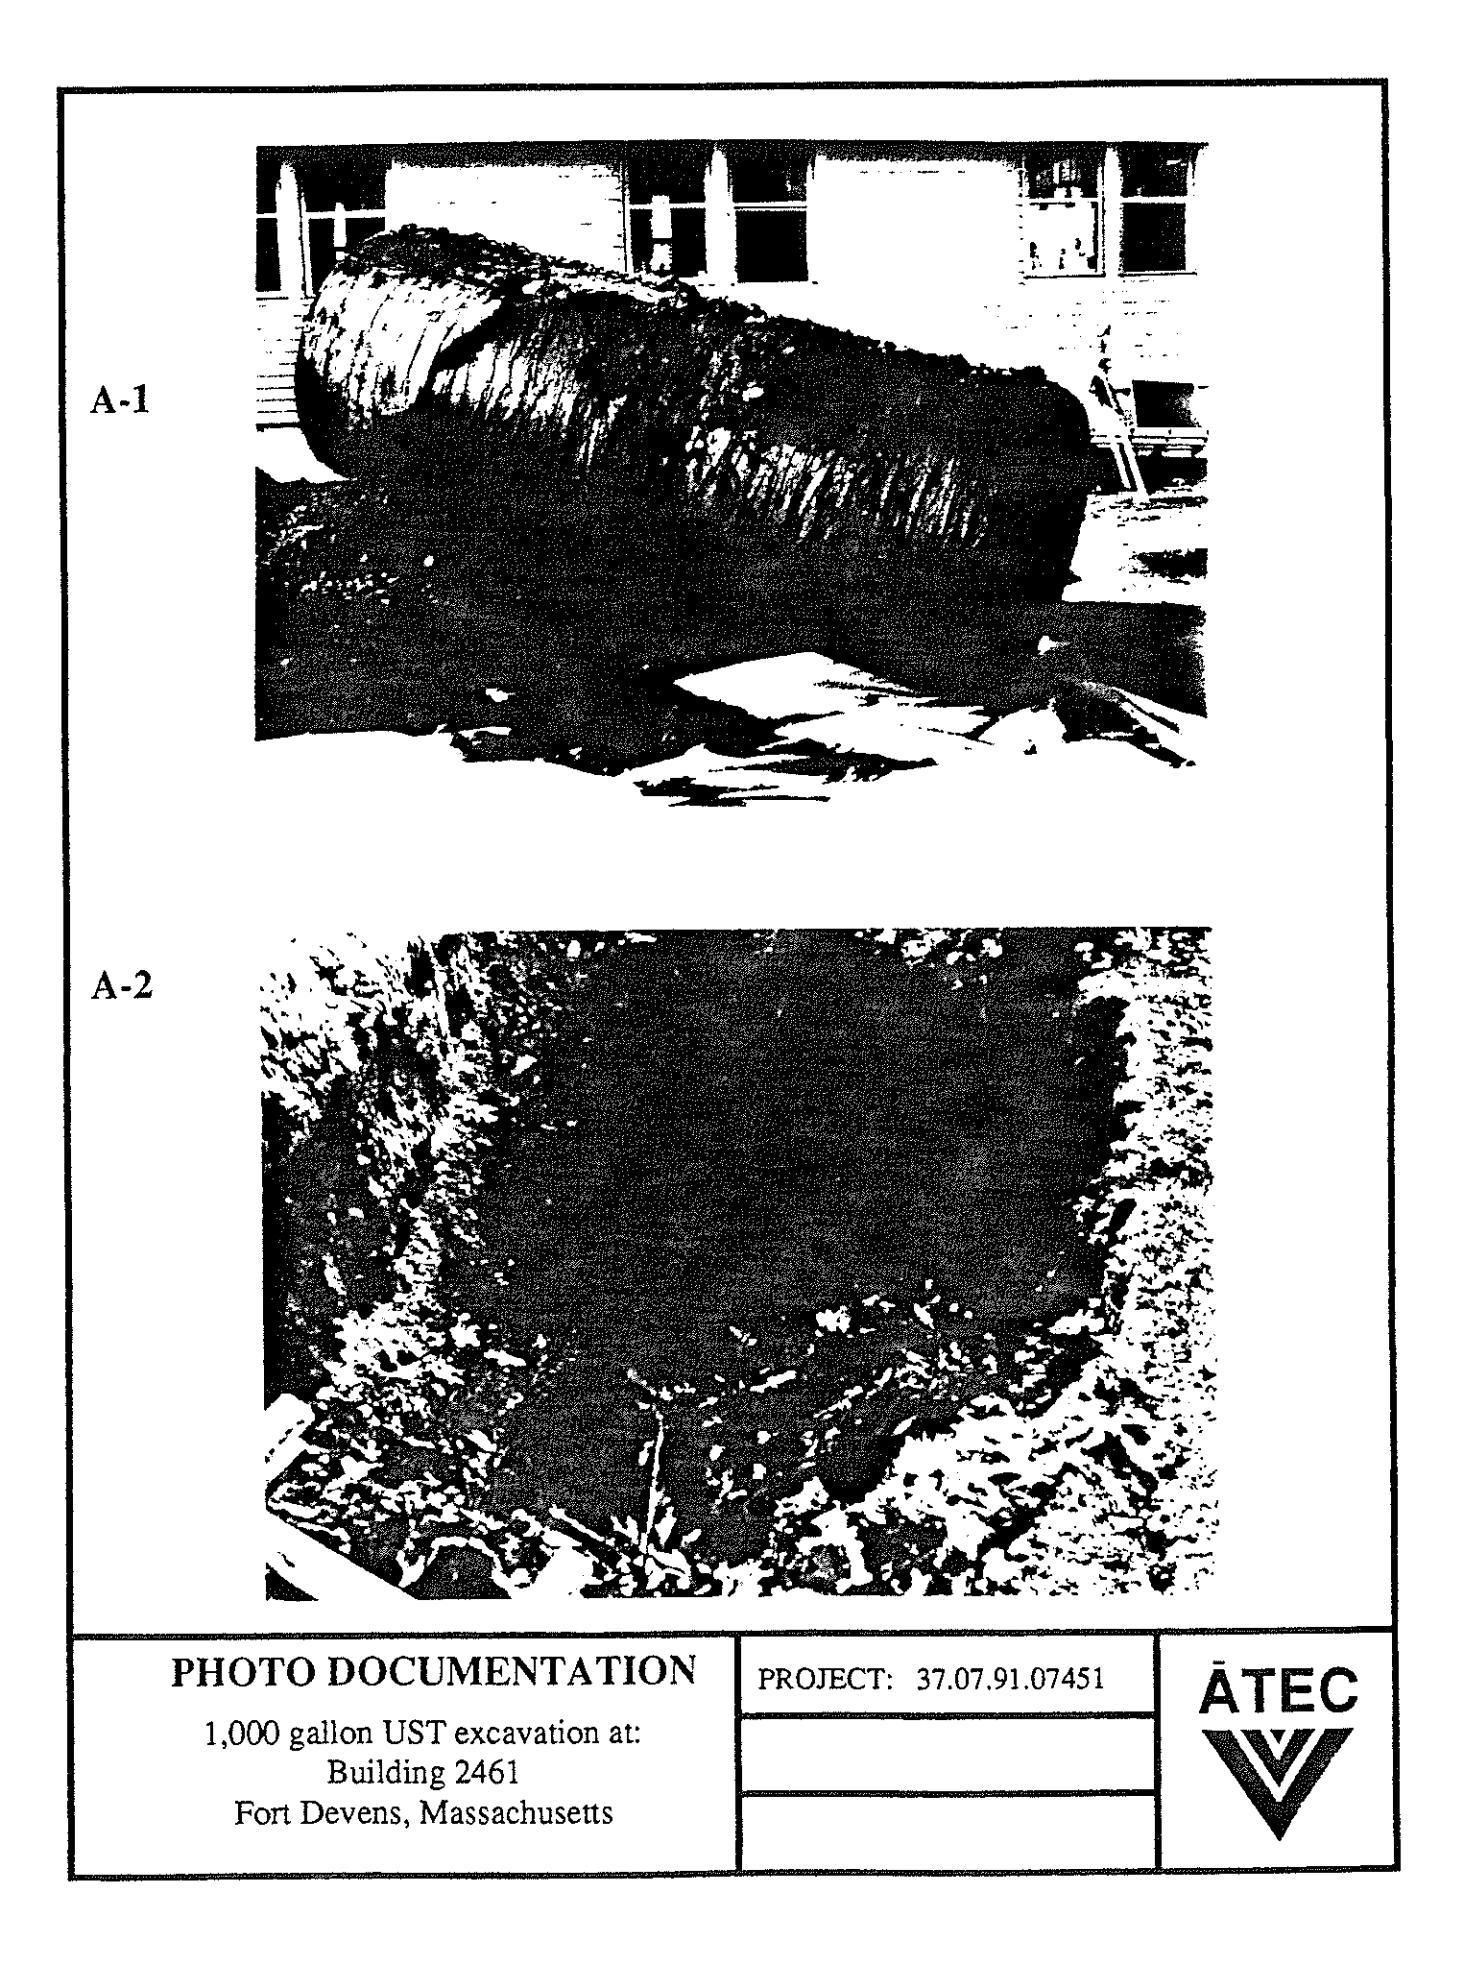
- A-2: Opposite side of removed tank.
- A-3: Excavation as viewed from north, facing south.
- A-4: Excavation as viewed from south, facing north.
- A-5: Post-Remedial excavation as viewed from north, facing south.
- A-6: Post-Remedial Excavation as viewed from south, facing north.
