Merrimack River Watershed Assessment Study

Summary of Information on Pollutant Sources

January 2004

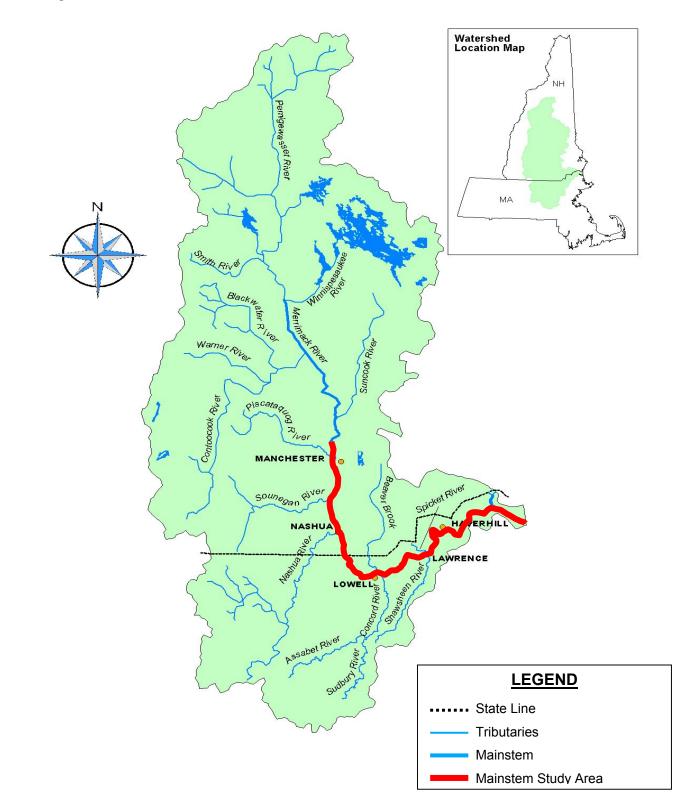
Figure 1-1: Merrimack River Watershed

A map of the overall watershed is provided in Figure 1-1, with the mainstem Study Area highlighted in red.

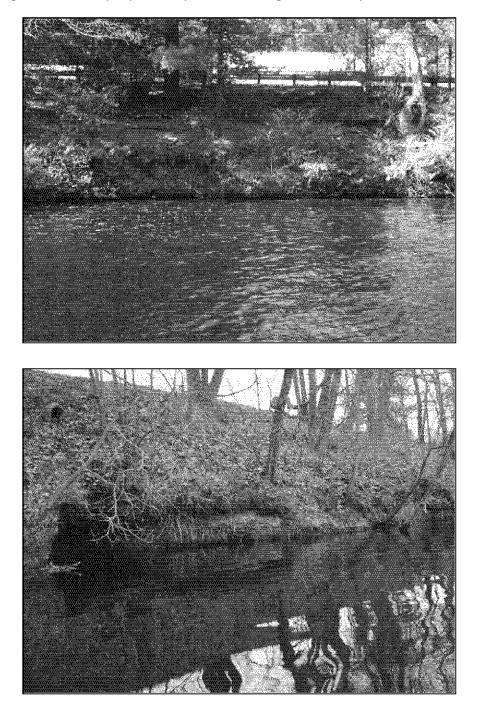
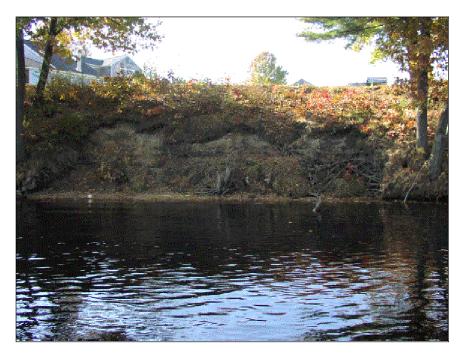
Figure 6-5: Example photos of erosion along the banks of the Merrimack River

Example photos are provided in Figure 6-5, depicting the range of erosion problems noted along the bank of the Merrimack River. CDM has a CD containing the complete set of digital photos taken during the field surveys. Field notes and coordinates defining the upstream and downstream extent of the erosion are provided in Appendix B.

No areas of erosion fitting the designated criteria were observed downstream of Haverhill, Massachusetts. This result is not unexpected due to the wider, estuarine nature of the Merrimack River in this area.
