EXECUTIVE SUMMARY

**NANTASKET BEACH DCR RESERVATION
HULL, MASSACHUSETTS**

Coastal Storm Damage Reduction Report

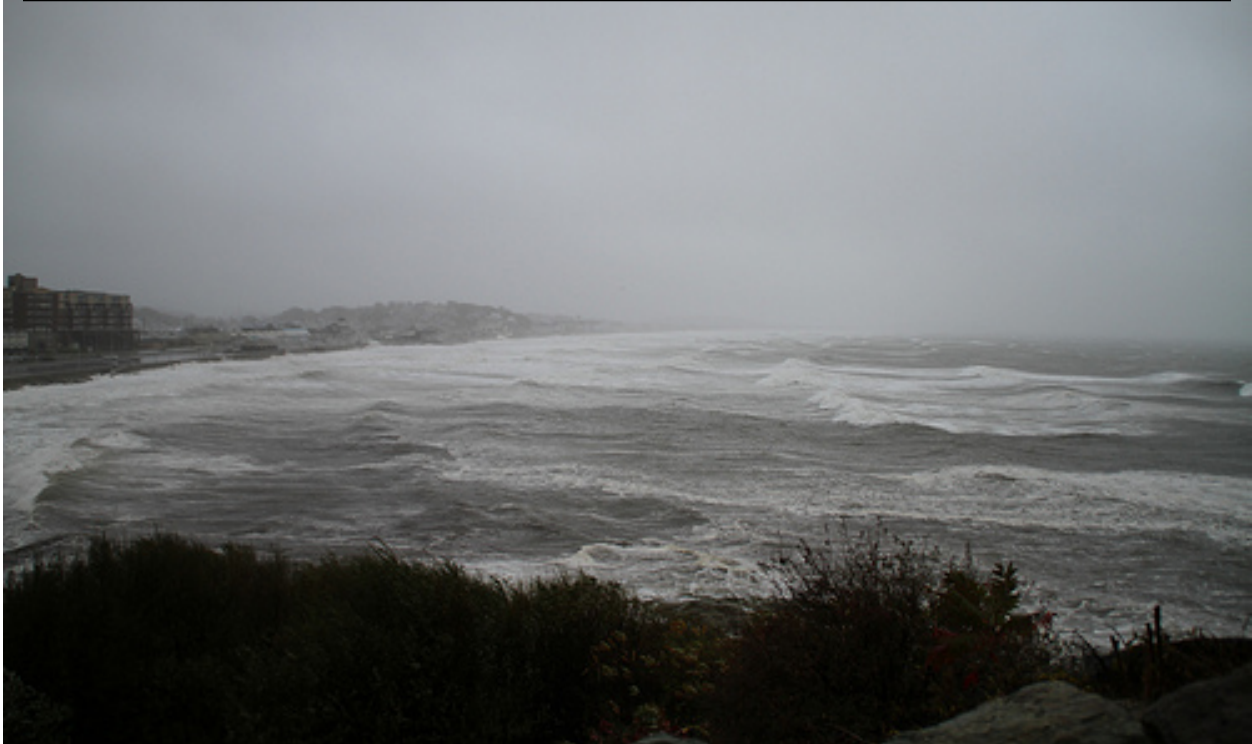
Storm waves attack Nantasket Beach on October 29, 2012

Coastal storms cause extensive damage to the publicly owned Nantasket Beach, its protective works and backshore public, commercial, and residential properties. Storm driven waves from the east are responsible for the removal of sand in front of the concrete sea wall and the consequent lowering of the beach. The sea wall footings have been exposed and undermined in some places. By December 1992, the conditions had deteriorated to such an extent that a coastal storm with an approximately 10-year recurrence interval caused the failure and weakening of about 650 feet of sea wall at its northern end. The lowering of the beach and the sea wall breach increased ocean overtopping during coastal storms and the flooding of the backshore.
