## Vermont

# Roaring Branch (Arlington) Local Protection Project

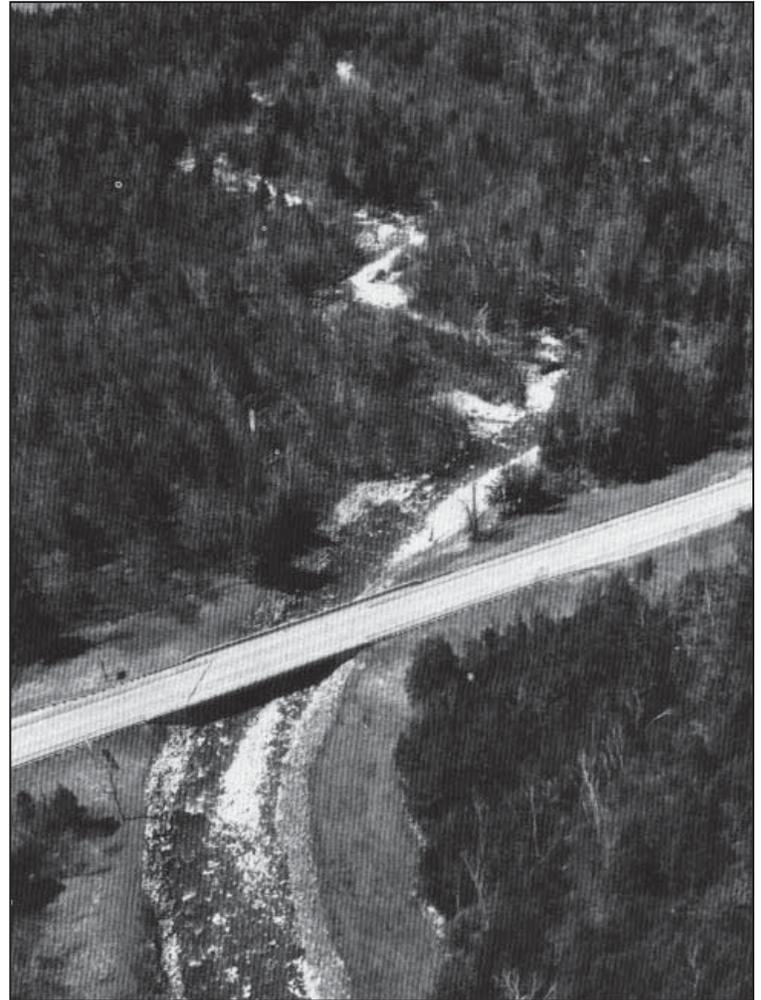
Aerial view of Roaring Branch Local Protection Project in Arlington, Vt. The Roaring Branch Local Protection Project in Arlington is located on Roaring Branch in the town's East Arlington section. This stream, a tributary of the Batten Kill, is one of two rivers in southern Vermont named Roaring Branch; the other is a tributary of the Walloomsac River and passes through Bennington. (Click photo for high-resolution version)

The work involved clearing accumulated gravel, boulders, and eroded material from about 1,000 feet of Roaring Branch channel. The excavated material was deposited along a 300-foot-long section of an earthen dike lying adjacent to Roaring Branch that had been washed out from Roaring Branch floodwaters in December 1948.
