Daily Report

Project: Date: December 13, 2019 **Durham Meadows Pipeline Installation** Day of Week: **Location:** Middletown and Durham, CT Friday Report No: 47 Project #: AECOM: 60445033 1 of 4 Page: **Contractor: Ludlow Construction**

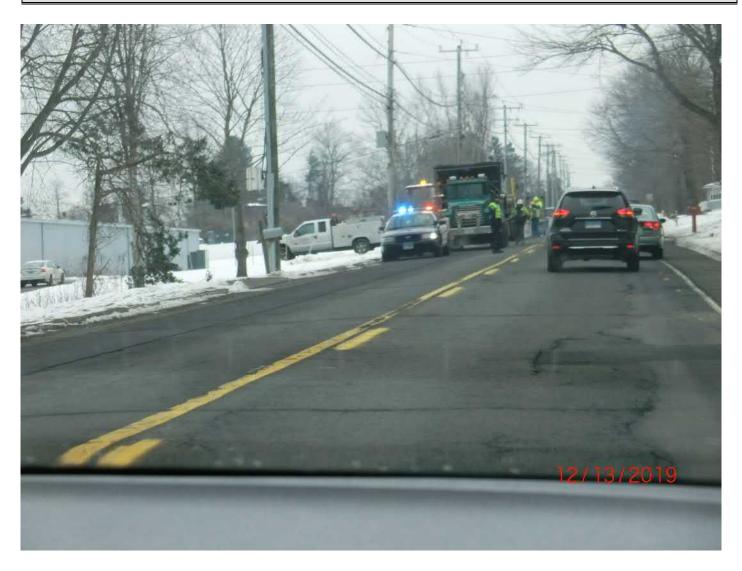
Figure 1 – Facing north from the passage seat. View of traffic set up along Main St. Route 17.

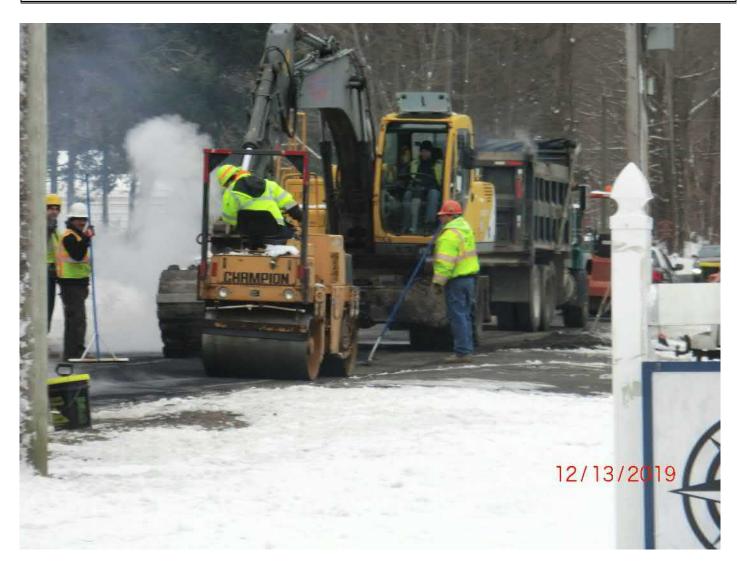
Figure 2 – View looking southeast at the repair work being conducted on Main Street. The excavator scraped off the initial layer place when piping was done and is now re-applying the asphalt to specification.

Shimming on Main St.: Ludlow was scraping of previous asphalt path and re-applying new asphalt to a stretch of Main St. Roughly 300-400 feet. Two town police officers were directing traffic and had one lane shut down for periods of time.
