Daily Report

| Project: | Durham Meadows Pipeline Installation | Date: | April 2, 2020 |
| Location: | Packinghouse Hill Road, Water tank, Durham & Middletown, CT | Day of Week: | Thursday |
| Project #: | AECOM: 6061487 | Report No: | 53 |

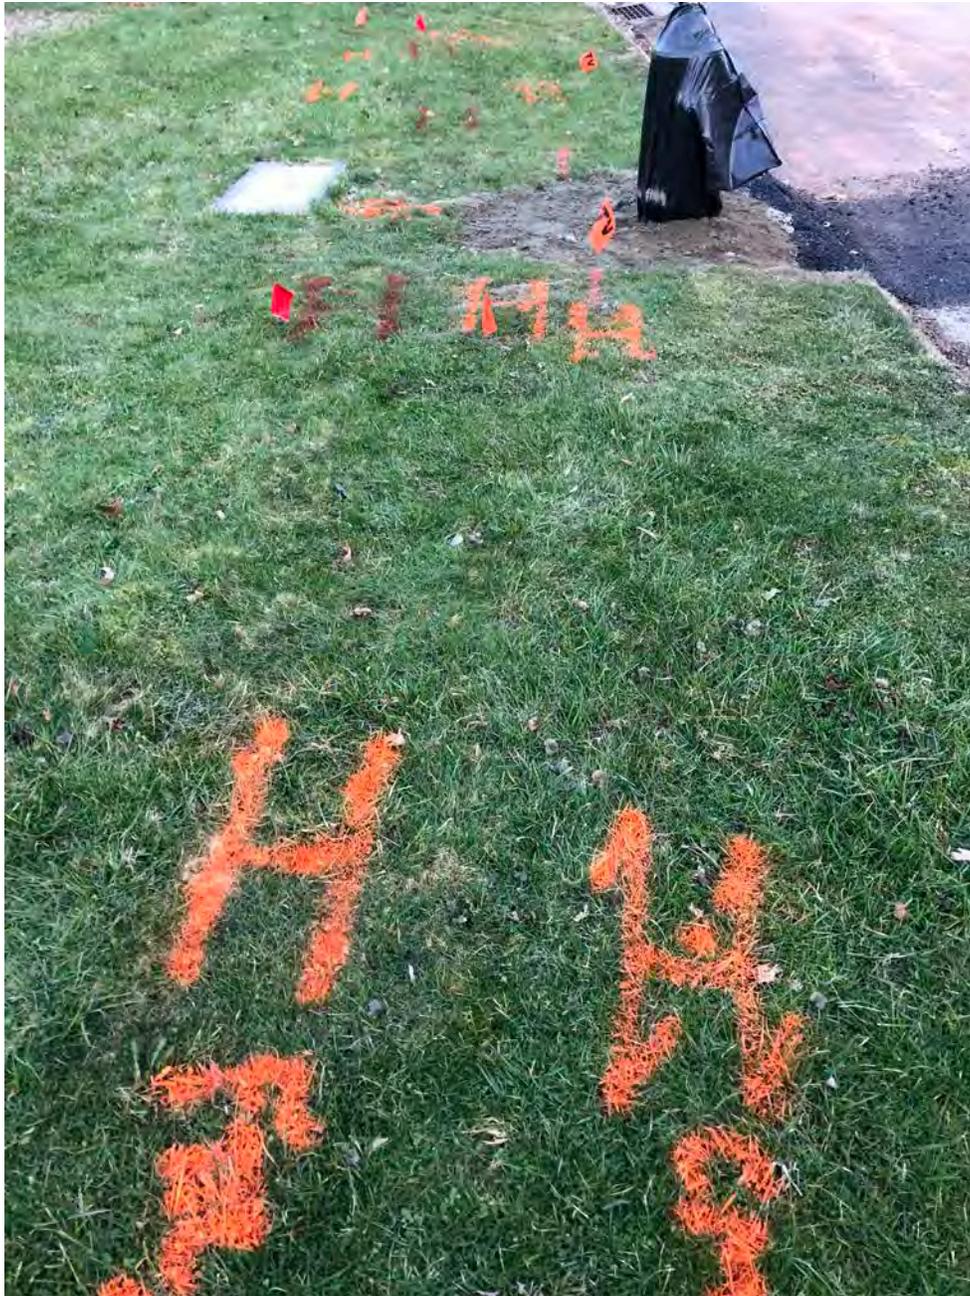
Picture 1: Call-before-you-dig markings, made after Comcast lines were severed during the installation of a fire hydrant assembly on Royal Oak Drive.

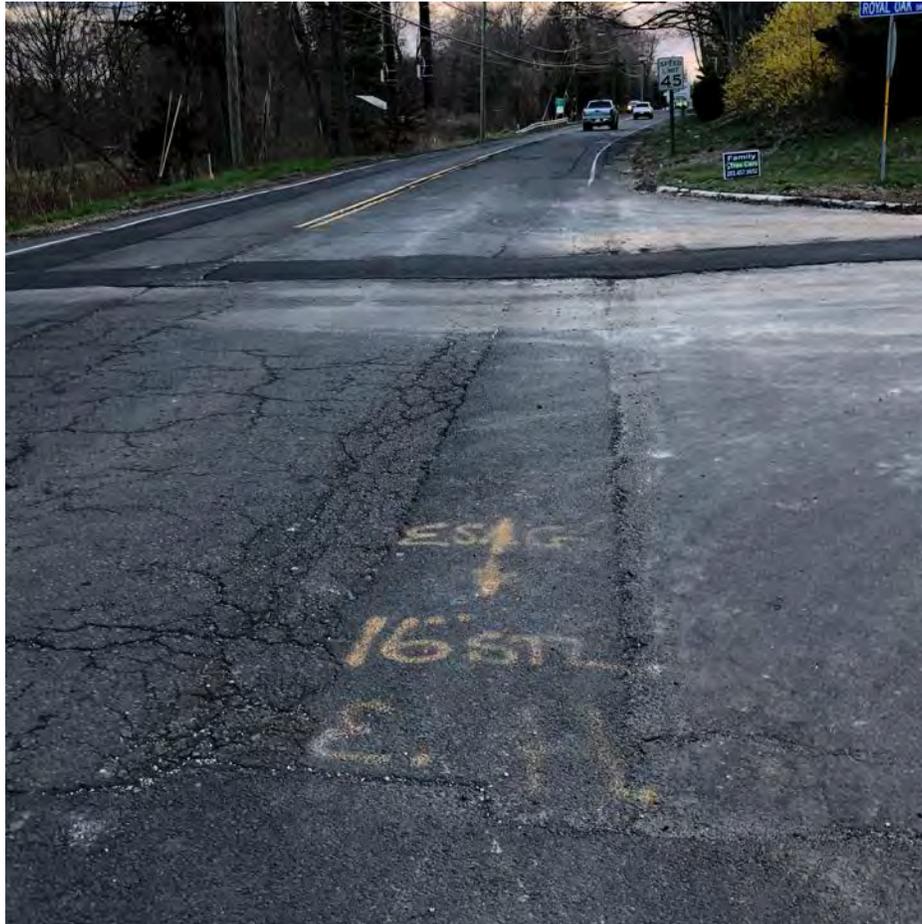
Picture 2: Paint identifying location of 16" gas line that runs under the northbound lane of Main Street (at the intersection of Main and Royal Oak Drive).

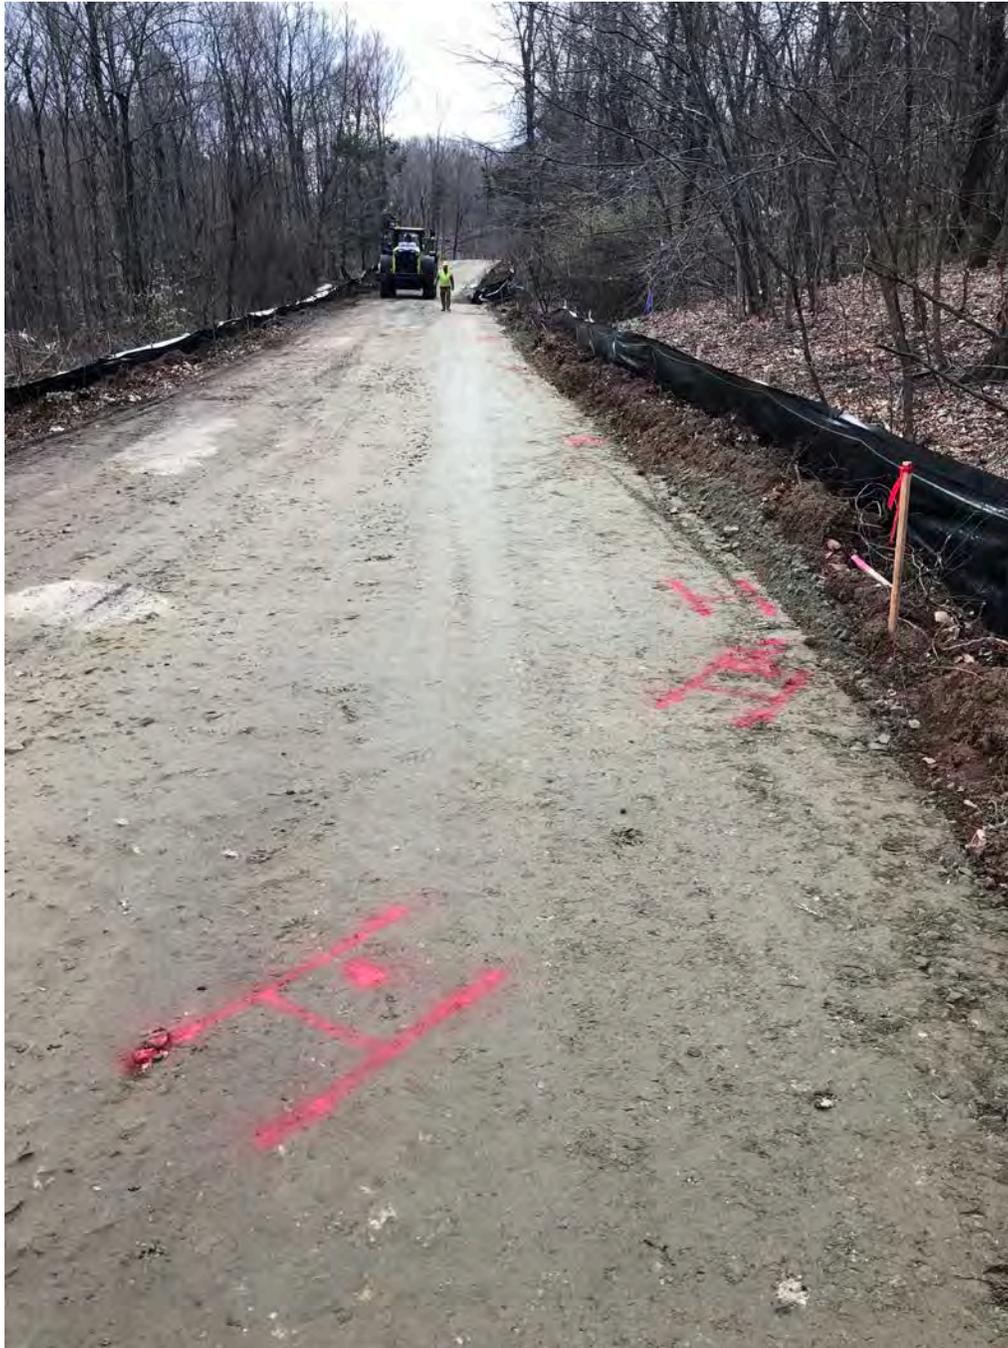
Picture 3: Call-before-you-dig mark out of utilities on the water tank access road. View to the southeast.

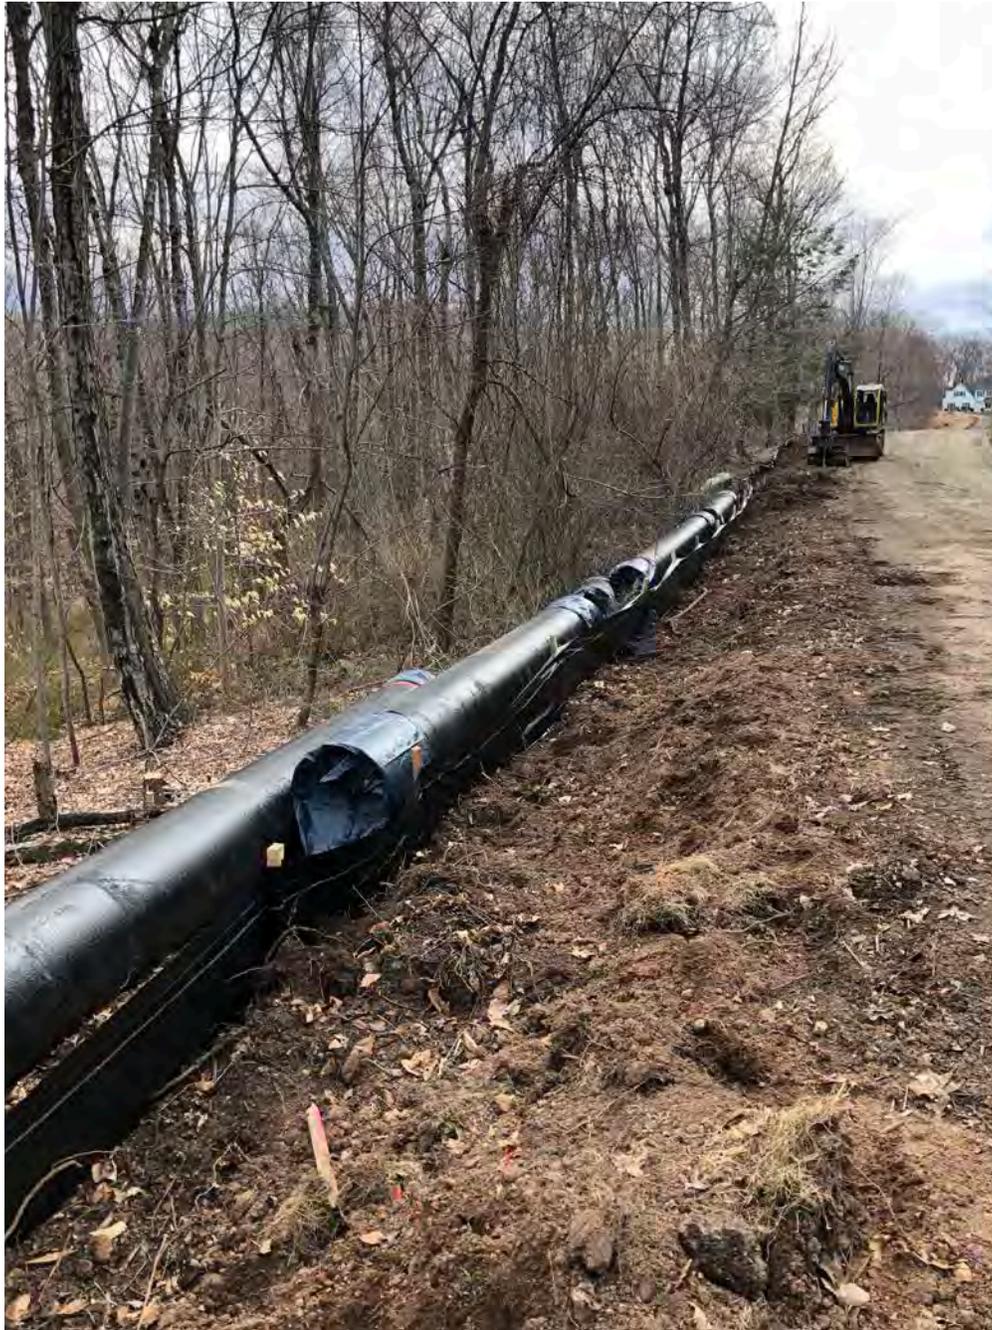
Picture 4: 20" DIP being staged next to silt fence along the water tank access road in preparation for upcoming installation.

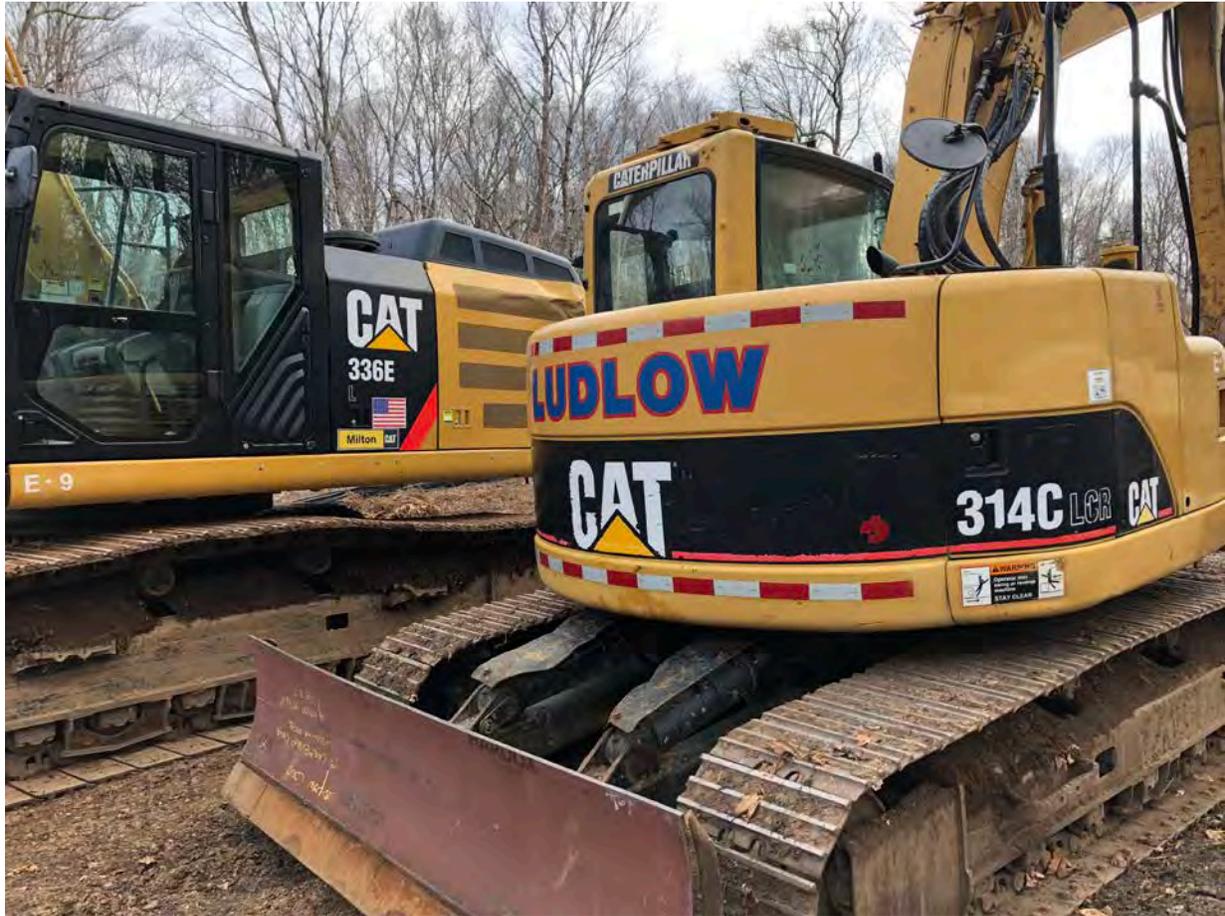
Picture 5: Ludlow excavators being used at the water tank pad area.

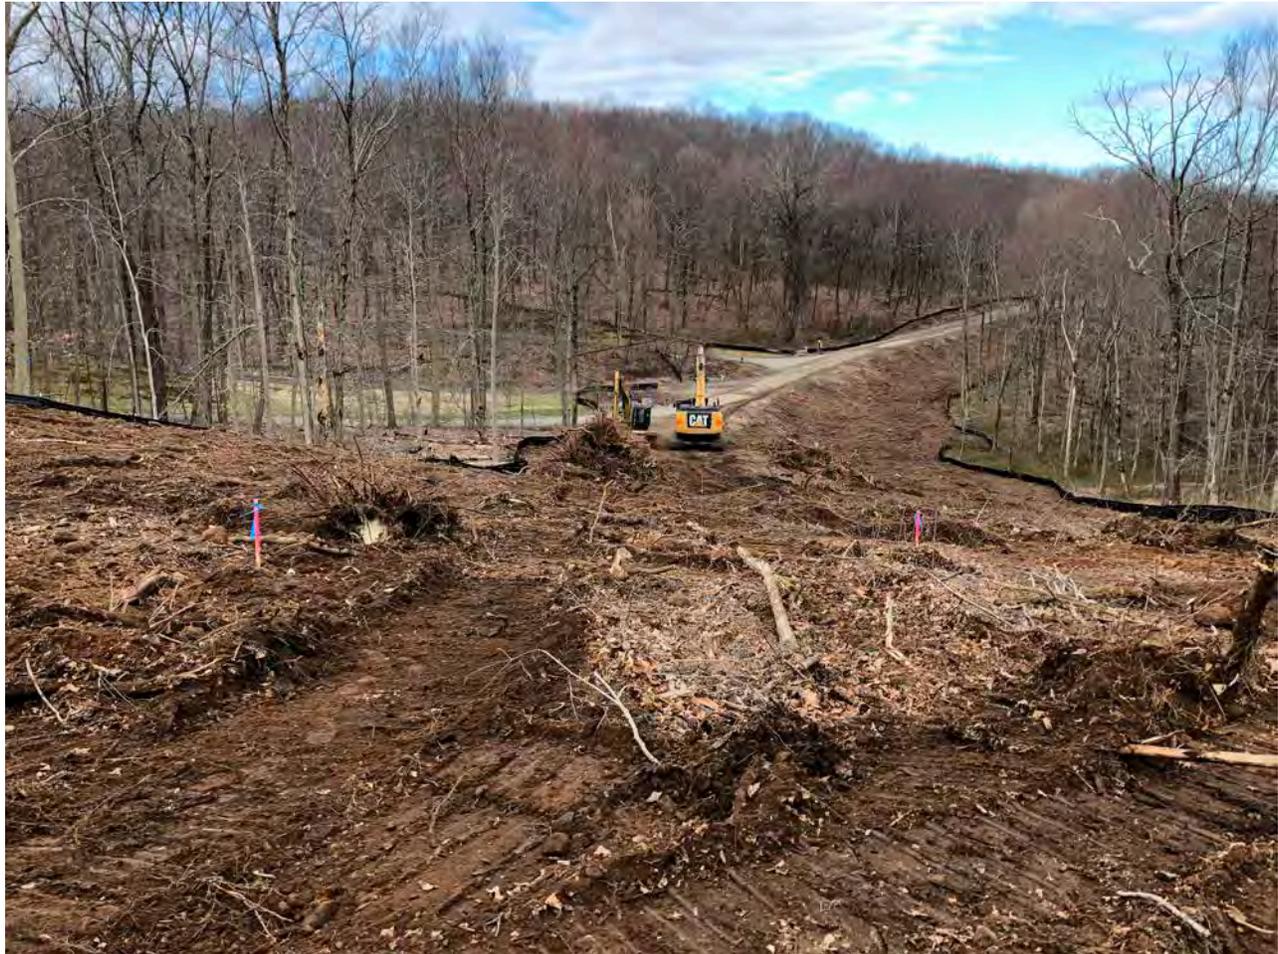
Picture 6: Overview of land clearing at the water tank pad and access road. View to the north/northwest.

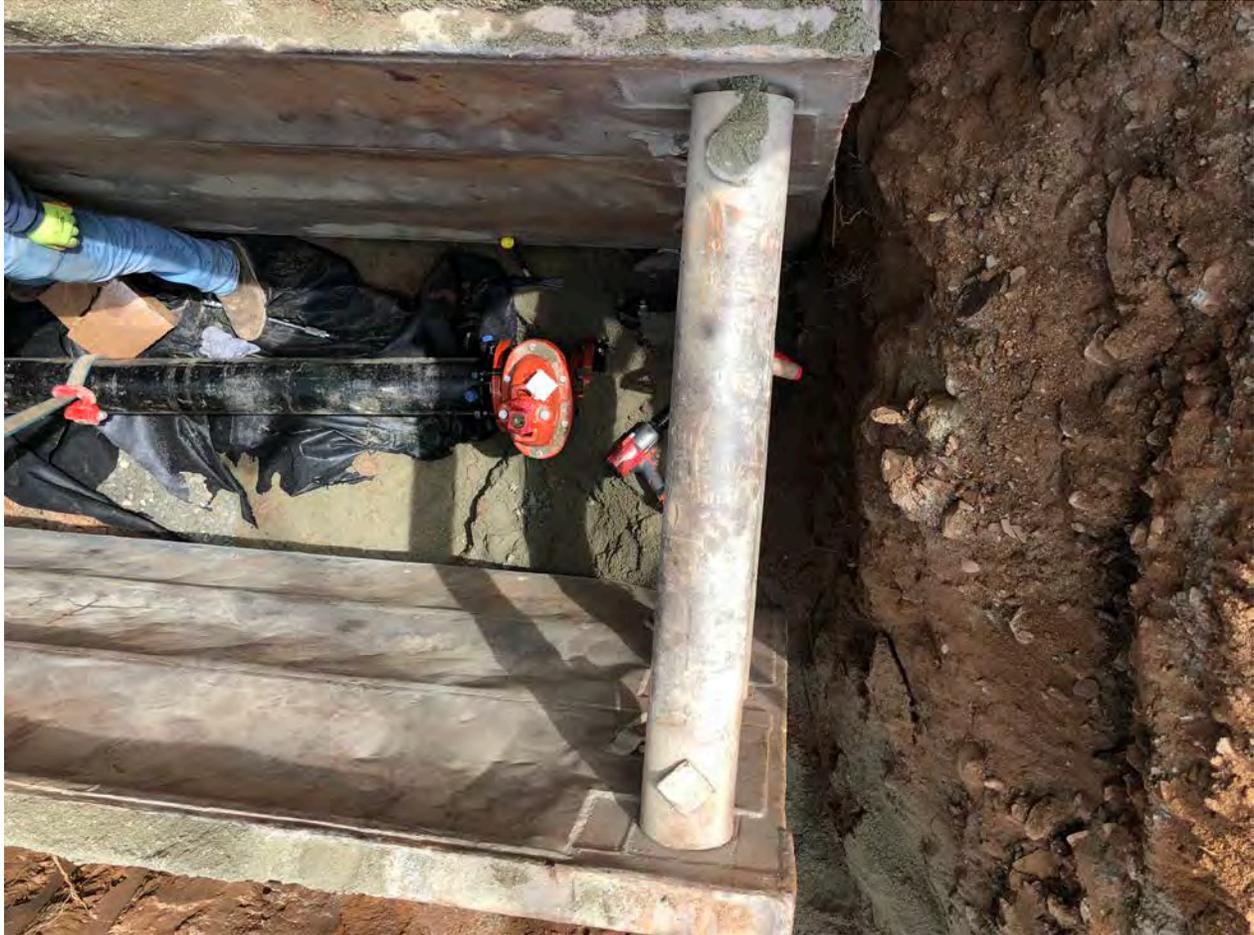
1230 Ludlow making the transition from 8" DIP to 6" DIP using a T-fitting and a valve assembly.

Picture 7: View of 6" DIP and valve assembly at the Packinghouse Hill Road fire hydrant assembly installation.

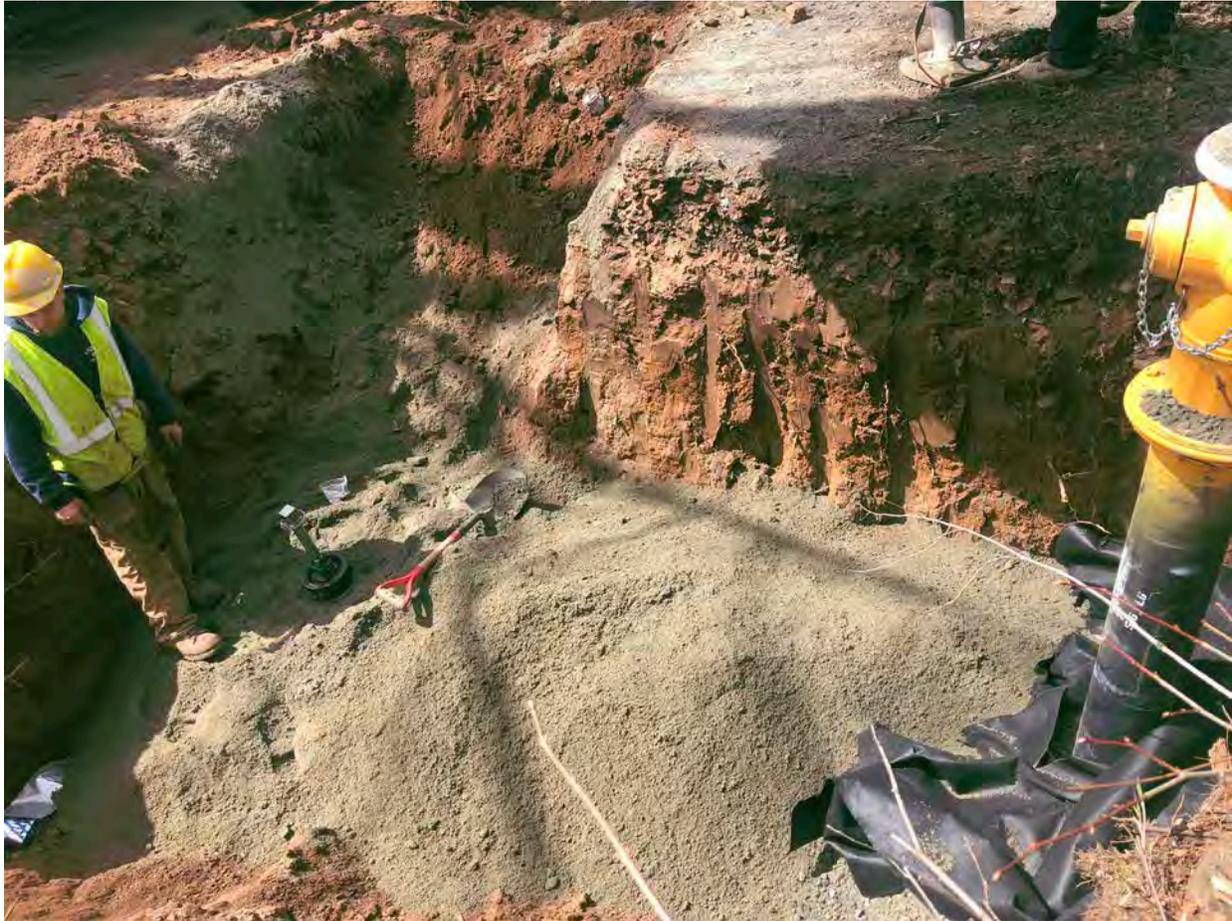
Picture 8: Valve stem extension and fire hydrant assembly installed.

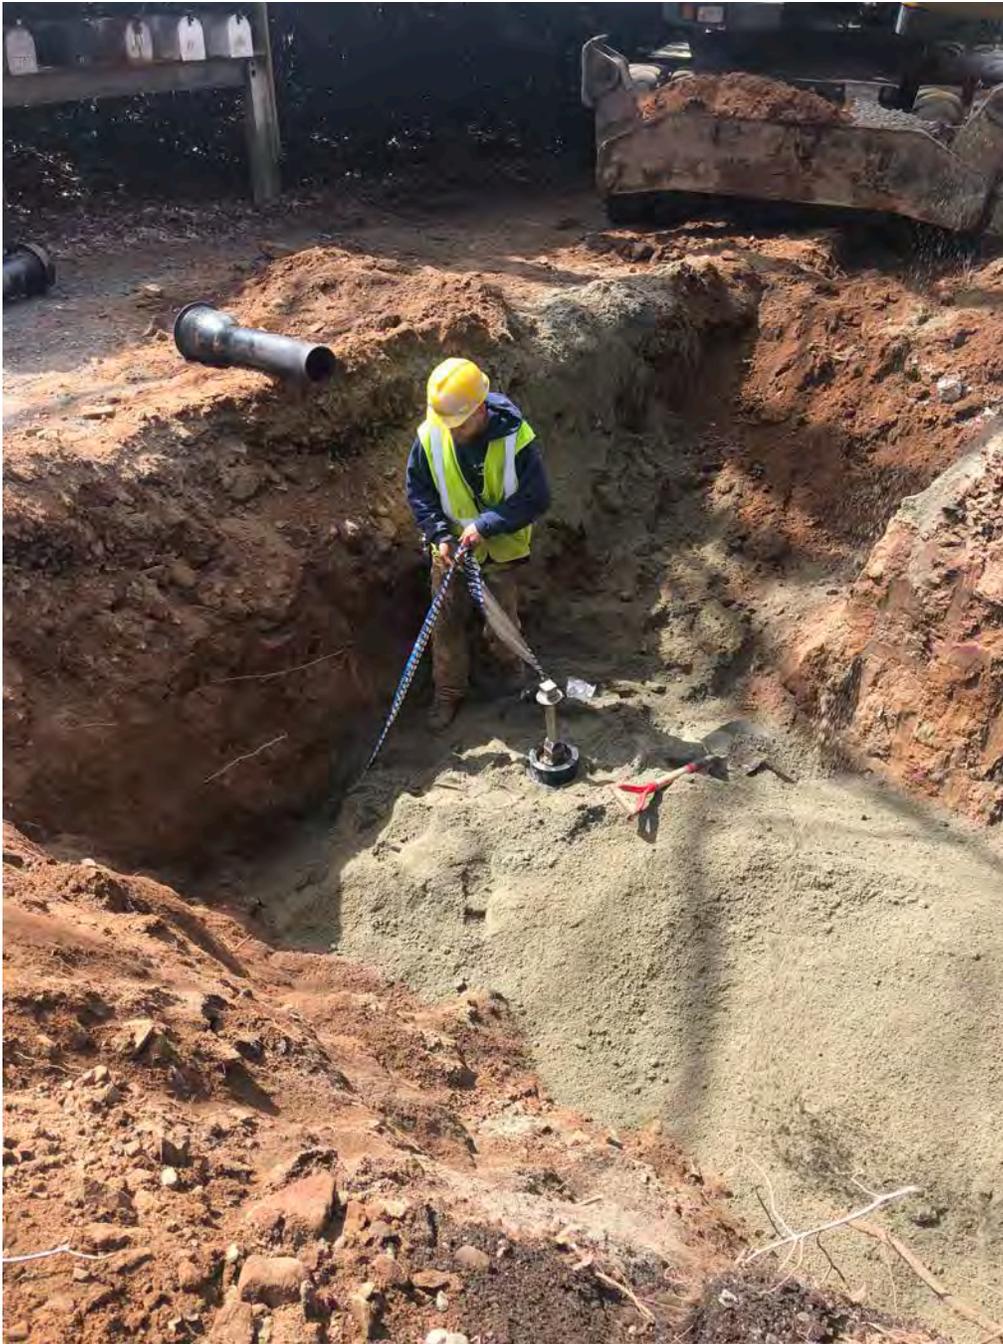
1315: Ludlow installing valve box over the valve stem.

Picture 9: Caution tape placed over installed pipe. Valve box about to be installed over valve stem.
