## Daily Report

<b>Project:</b>	Durham Meadows Pipeline Installation	<b>Date:</b>	April 6, 2020
<b>Location:</b>	Packinghouse Hill Road, Water tank, Durham & Middletown, CT	<b>Day of Week:</b>	Monday
<b>Project #:</b>	AECOM: 6061487	<b>Report No:</b>	54
<b>Contractor:</b>	Ludlow Construction	<b>Page:</b>	<b>1 of 10</b>

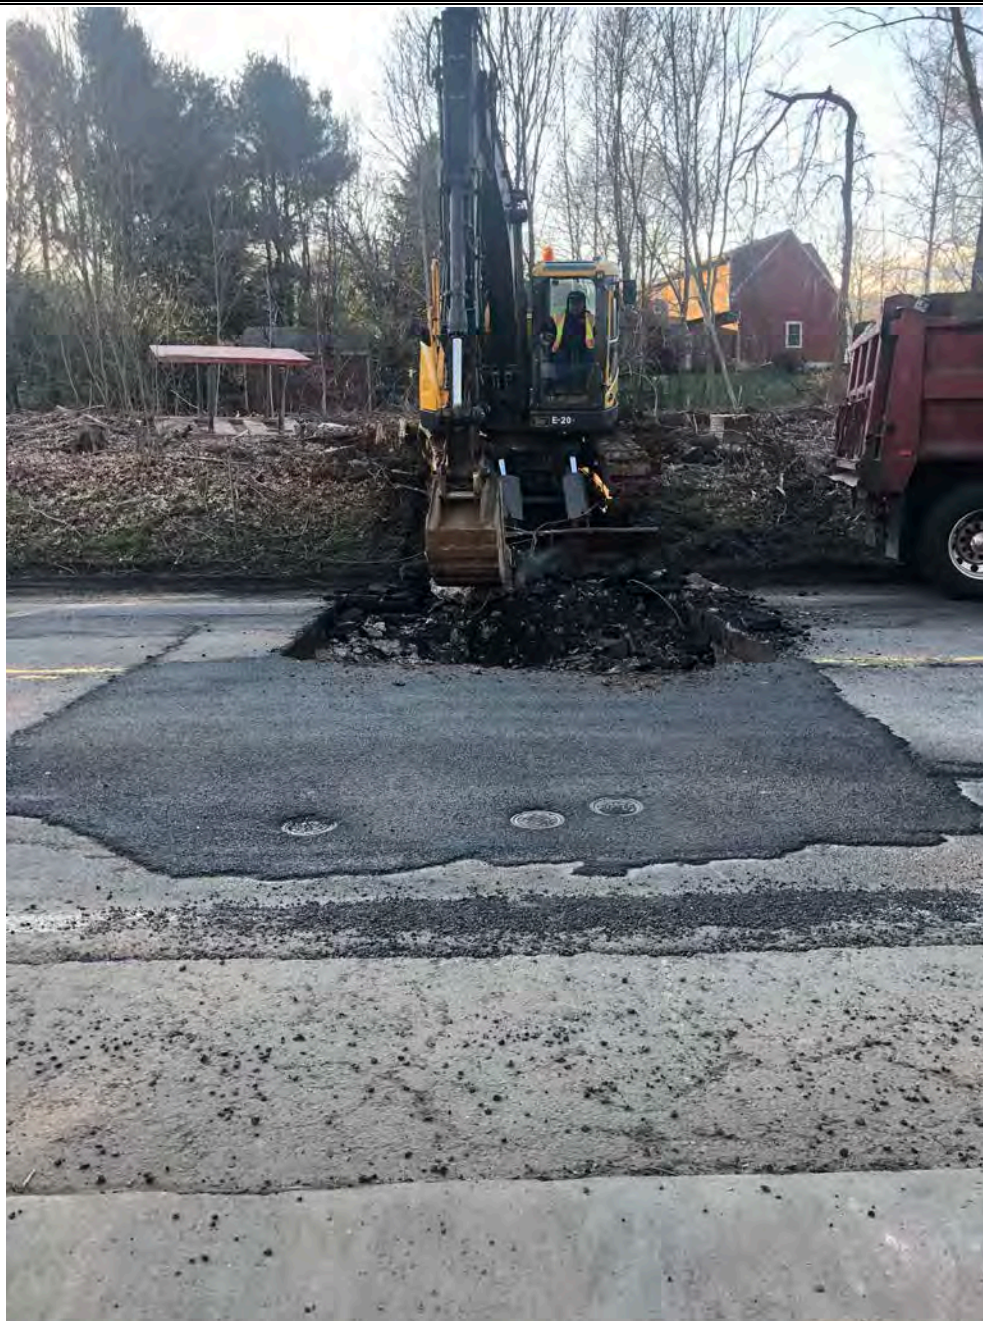
0720: Ludlow is set up at Station 124+65, close to where South Main Street and Acorn Dr. intersect and at the site for the water meter vault. Two Middletown police officers are on traffic detail. The northbound lane has been closed off to traffic. Ludlow begins by breaking pavement on northbound side of South Main Street. The asphalt is underlain with reinforced concrete, both of which have been pre-cut.

**Picture 1: Ludlow begins to excavate at Station 124+65. View to the east toward the water meter vault site.**

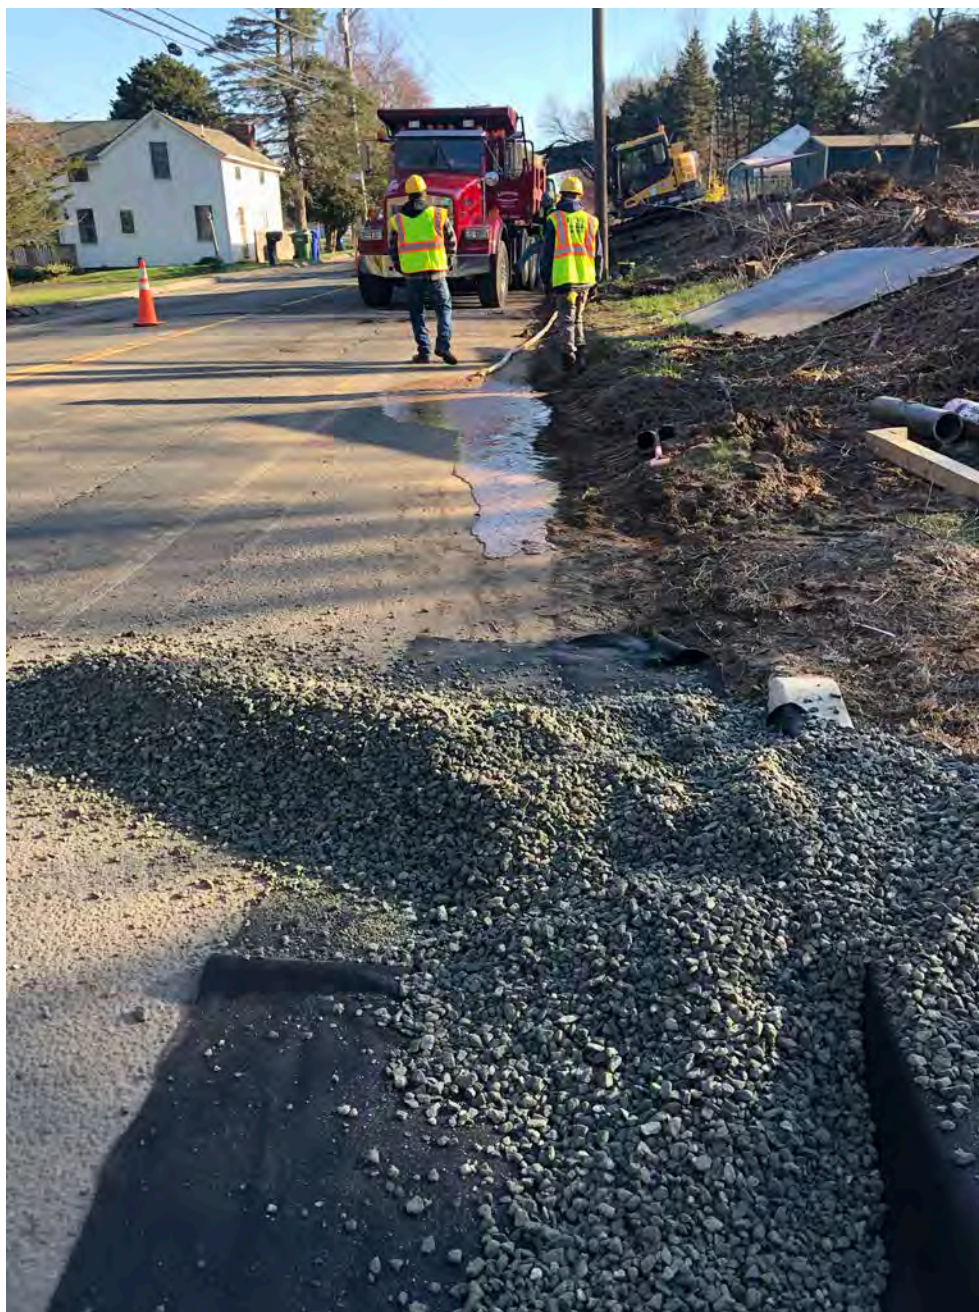
Street, as well as an existing T-fitting on the 16" water line that runs beneath South Main Street. Water is observed in the bottom of the excavation, 91" below surface grade. Ludlow sets up a pump and hose to redirect the water into a catch basin located next to the intersection of Acorn Drive and South Main Street. The water is filtered through filter fabric ( the same fabric that is being placed beneath the DIP during installation) and covered with ¾" stone. Ludlow foreman John Poi stated that Ludlow was dealing with the water in this manner as he said that Ludlow wasn't able to get the lid off the catch basin to install a silt trap.

Picture 2: Ludlow pumping water from trench to catch basin covered with filter fabric and  $\frac{3}{4}$ " stone. View to the north.

0920: At Station 124+65, Ludlow has solved the problem of slow filtration through filter fabric covering the catch basin by punching at least two quarter-sized holes in the filter fabric.

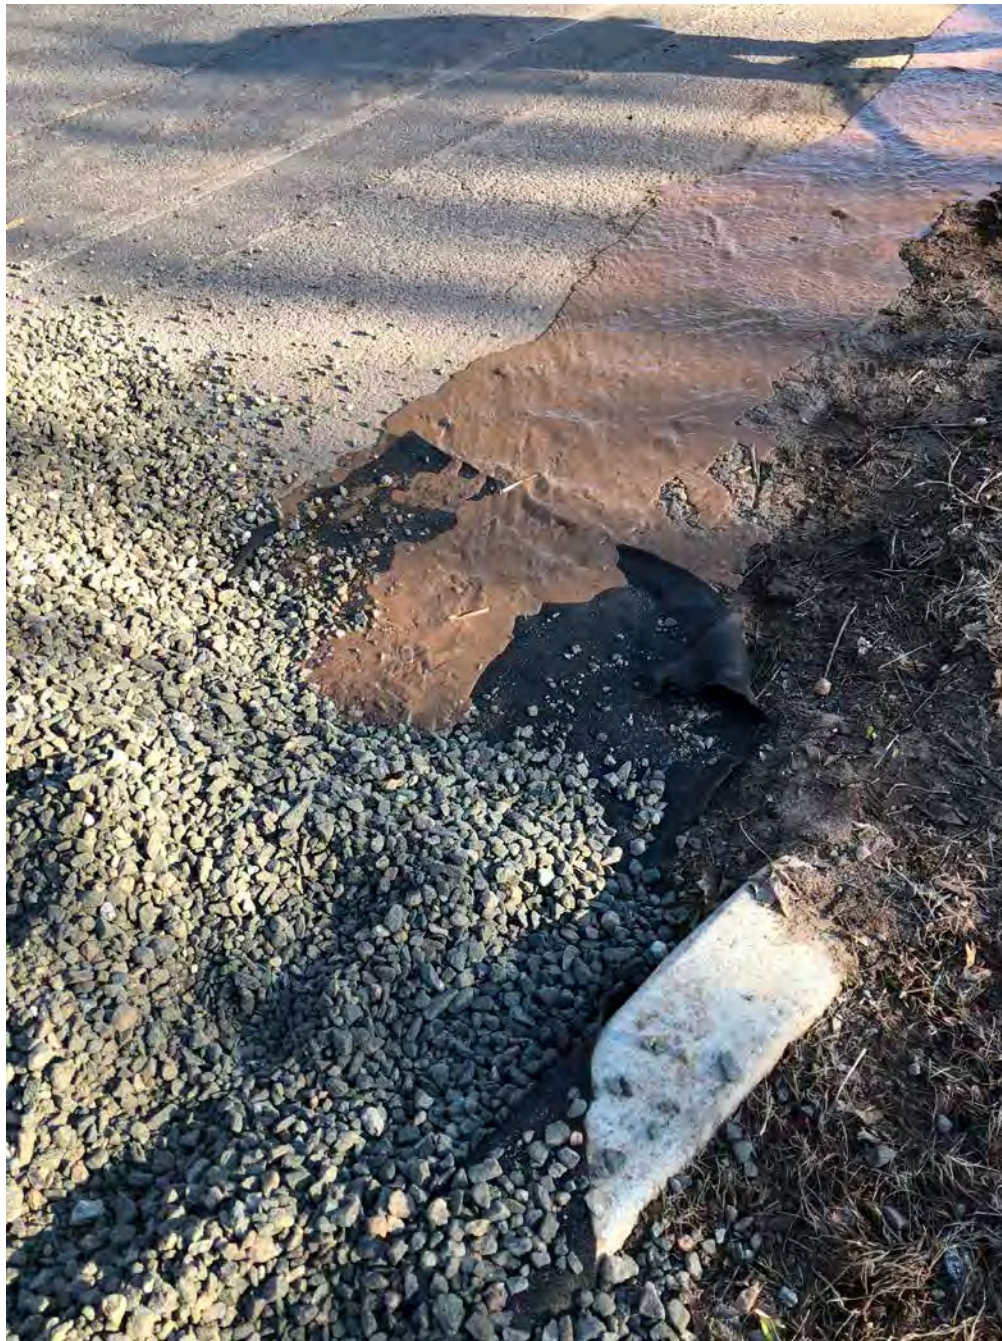
Picture 3: Close-up of catch basin covered with filter fabric and 3/4" stone, receiving water pumped from trench at Station 124+65.

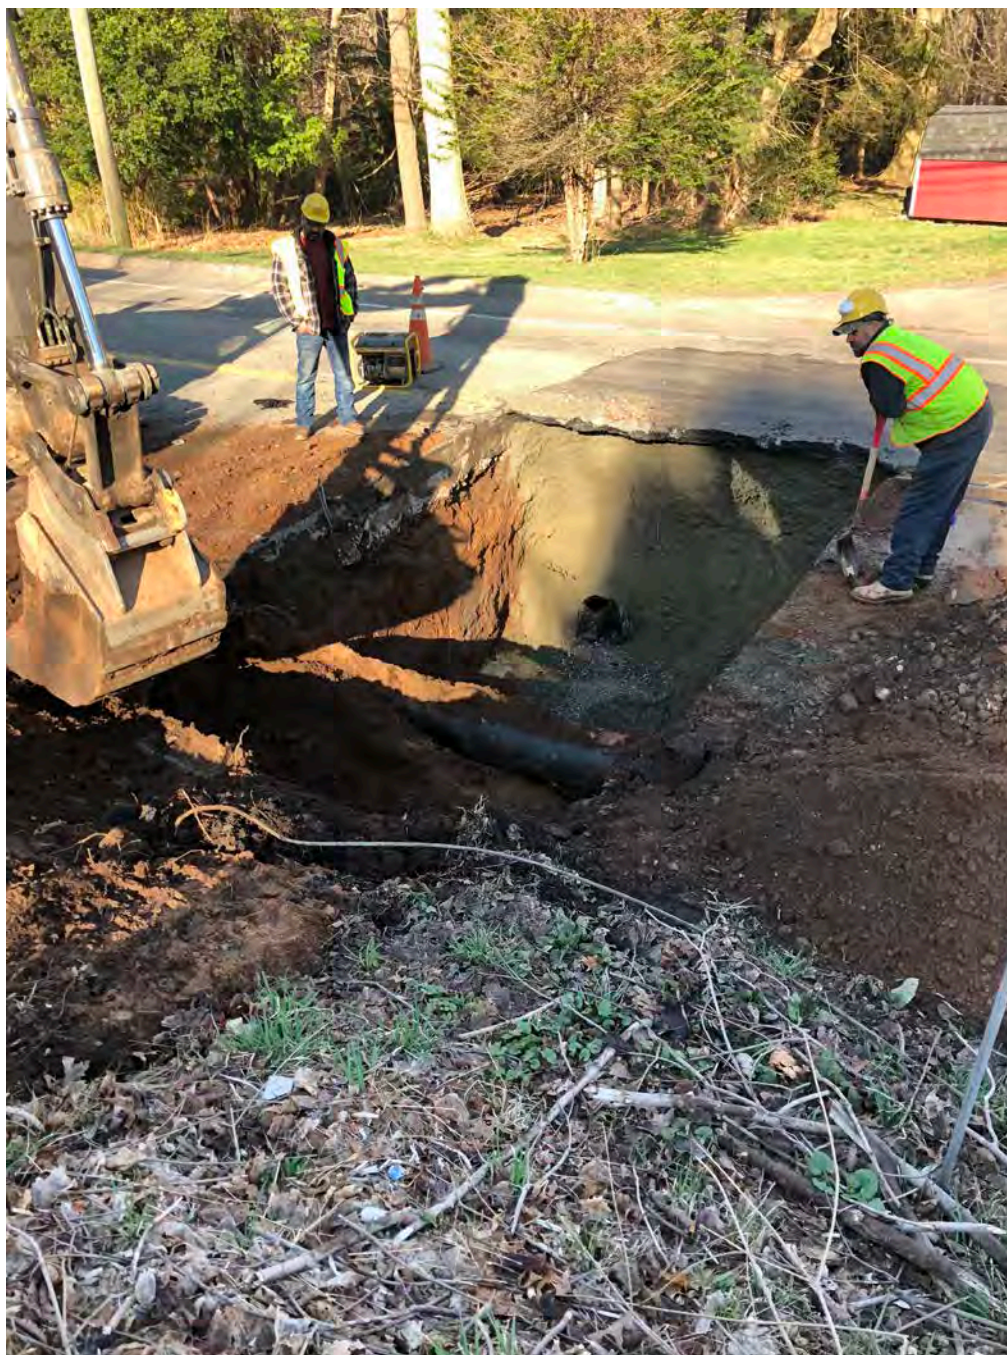
0813: At Station 124+65, Ludlow has daylighted the high-pressure gas line that runs beneath the north-bound lane of South Main

Picture 4: Excavation at Station 124+65, with high pressure gas line and existing 16" T-fitting visible

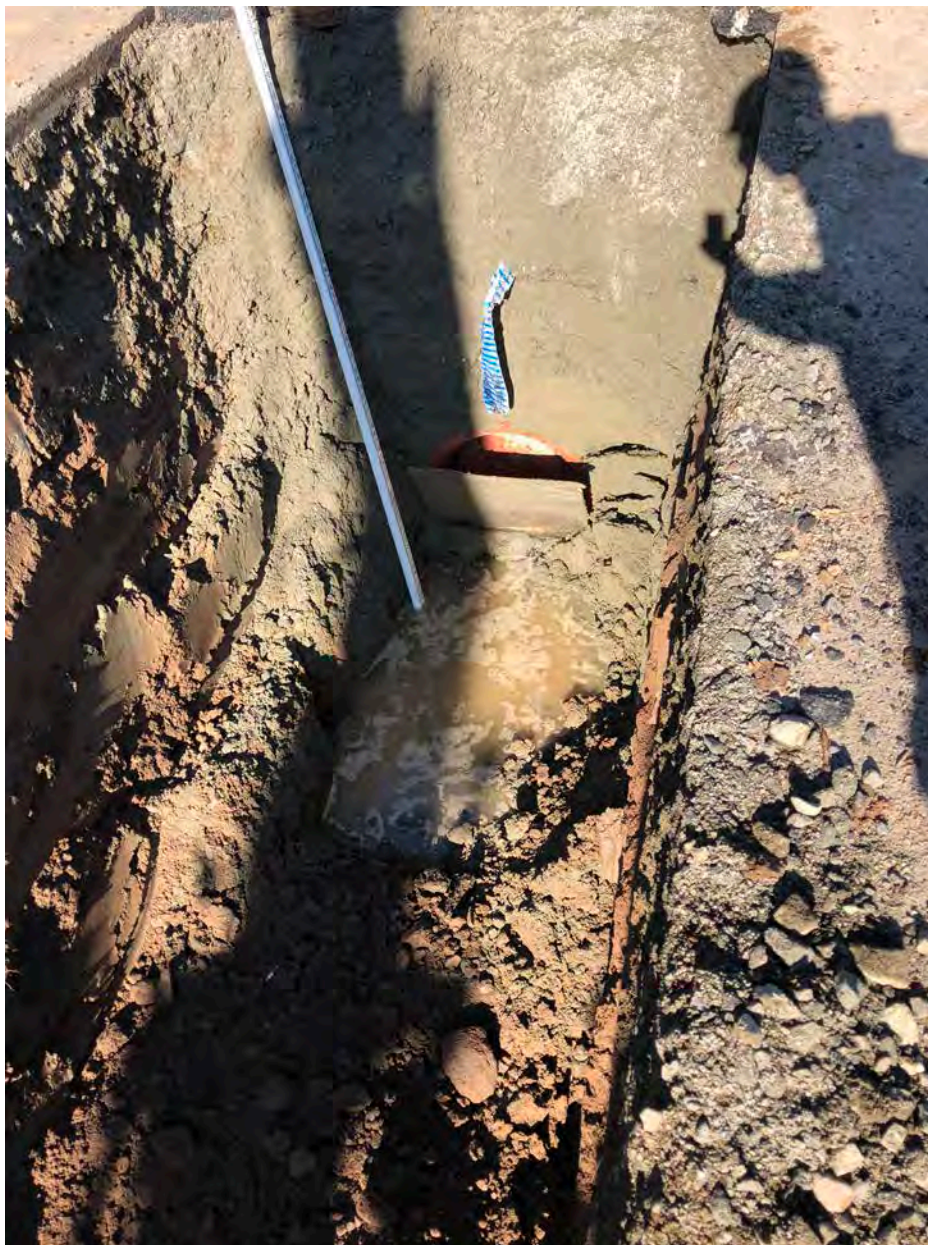
Picture 5: Water visible at 91" below surface grade at Station 124+65.

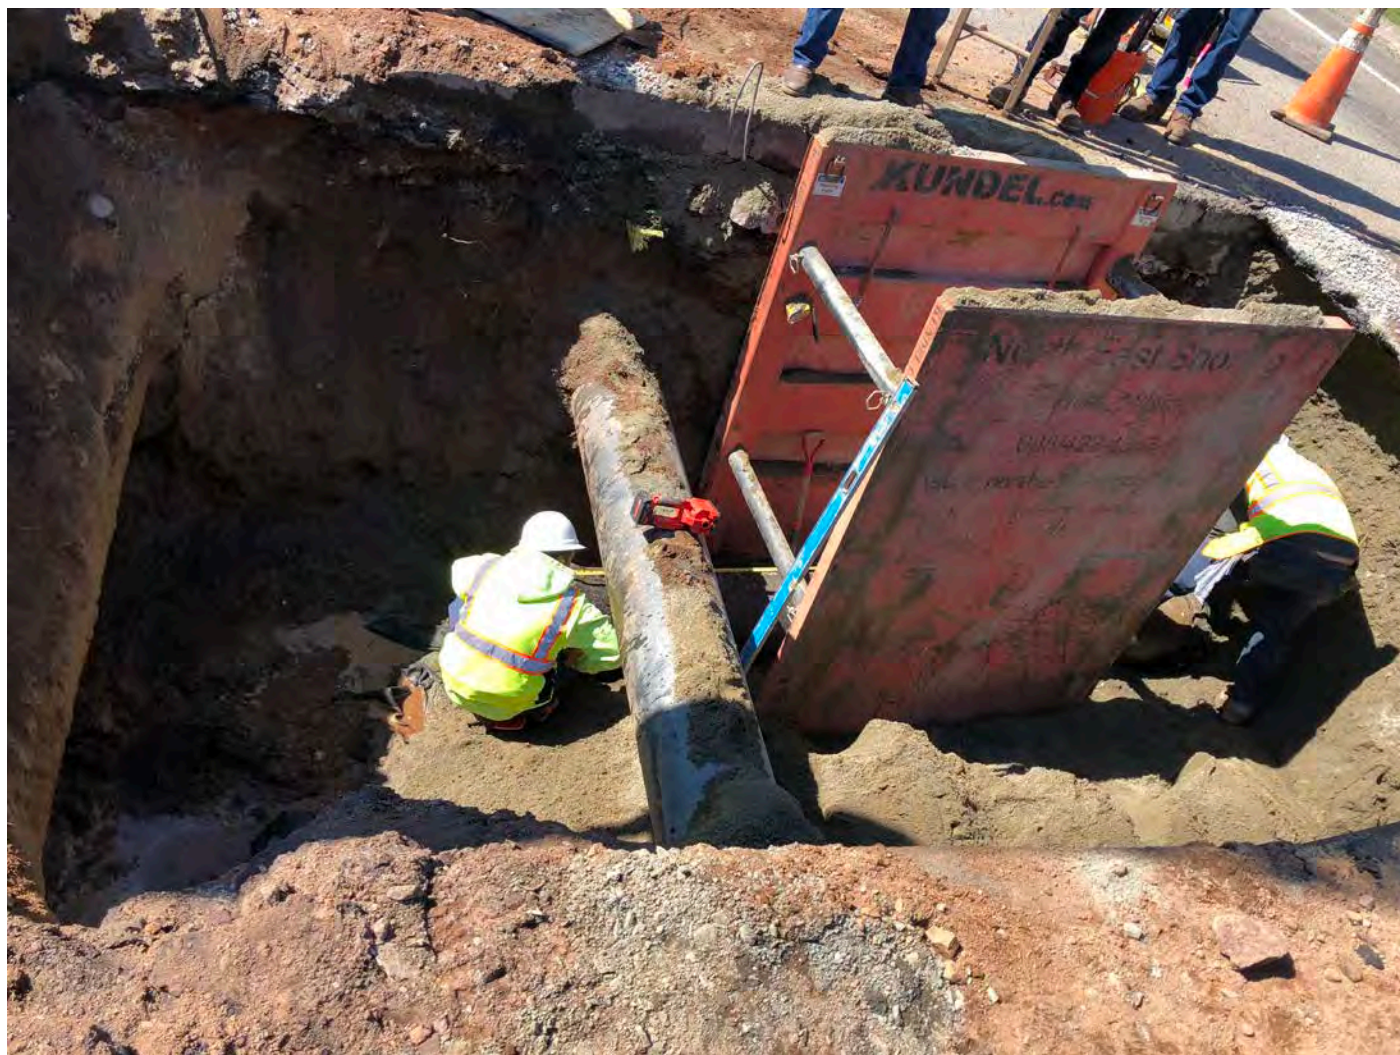
1100: Ludlow has connected the 12' section of 16" DIP to a previously installed T-fitting on the 16" waterline. In addition to the high-pressure gas line that runs beneath the northbound lane of South Main Street, Ludlow has daylighted the storm drain that runs along the eastern edge of South Main Street. Ludlow currently has five laborers, two excavator operators, and their health and safety guy present at Station 124+65.

Picture 6: Ludlow installing 12' section of 16" pipe at Station 124+65. High pressure gas line visible in the center of the photo; Storm drain line visible on the very left-hand side of the picture. View to the south.

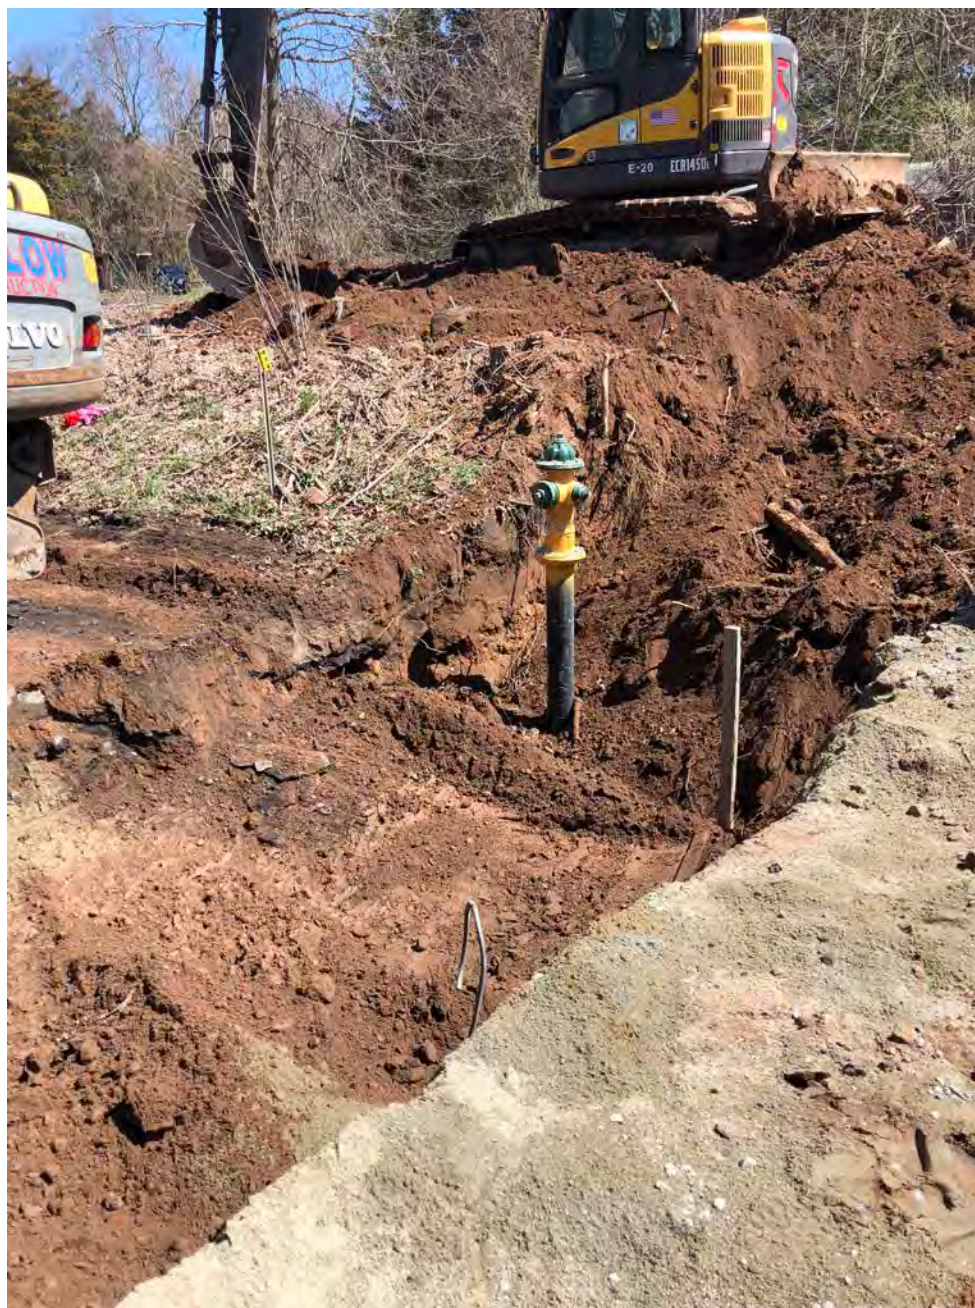
1315: Ludlow has installed fire hydrant assembly at Station 124+65.

Picture 7: Fire hydrant assembly installed at Station 124+65. View to the east.

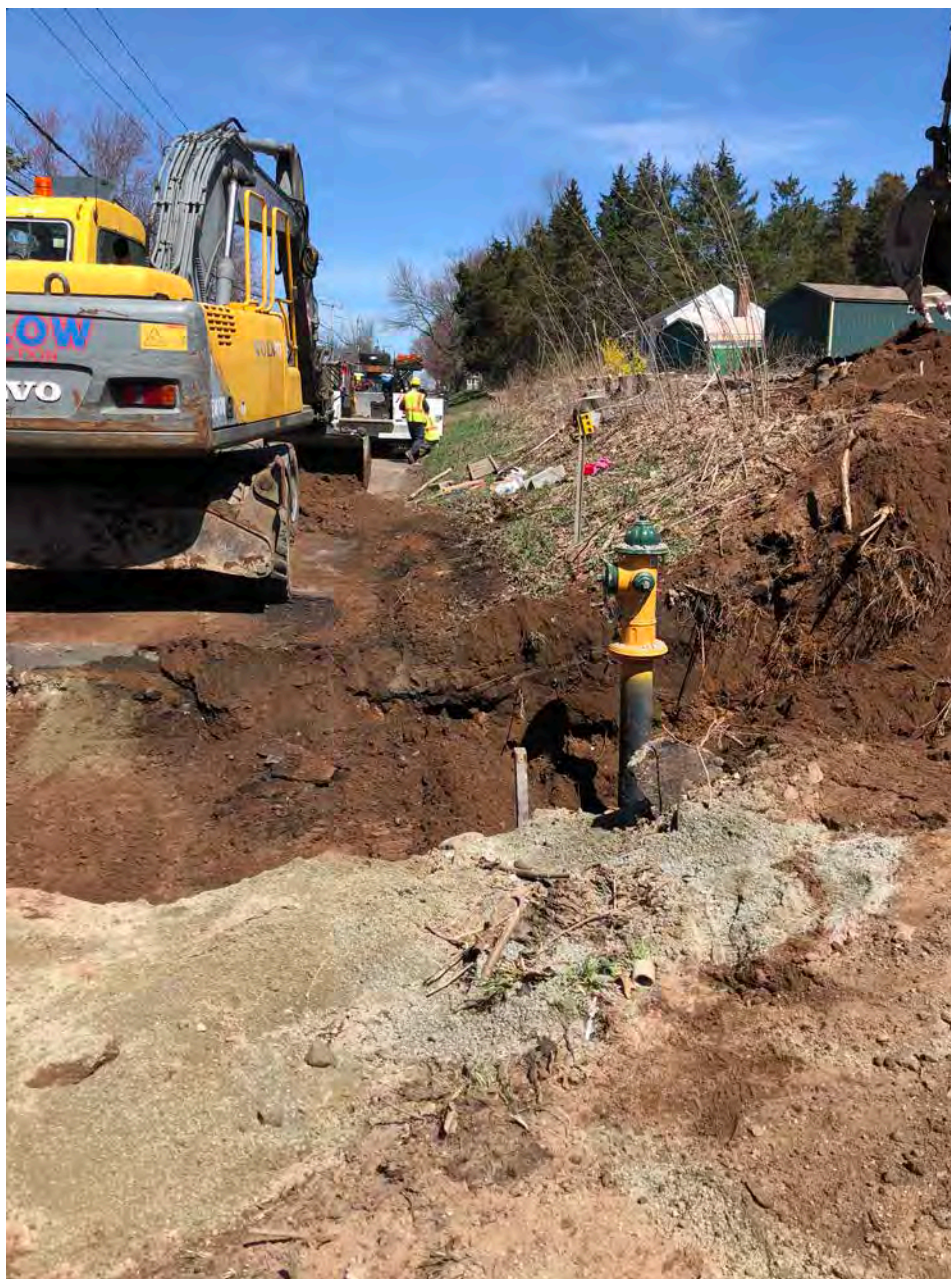
Picture 8: Fire hydrant assembly installed at Station 124+65. View to the north.
