## Daily Report

<b>Project:</b>	Durham Meadows Pipeline Installation	<b>Date:</b>	April 21, 2020
<b>Location:</b>	Main Street, Water tank access road, Durham & Middletown, CT	<b>Day of Week:</b>	Tuesday
<b>Project #:</b>	AECOM: 6061487	<b>Report No:</b>	62
<b>Contractor:</b>	Ludlow Construction	<b>Page:</b>	<b>1 of 10</b>

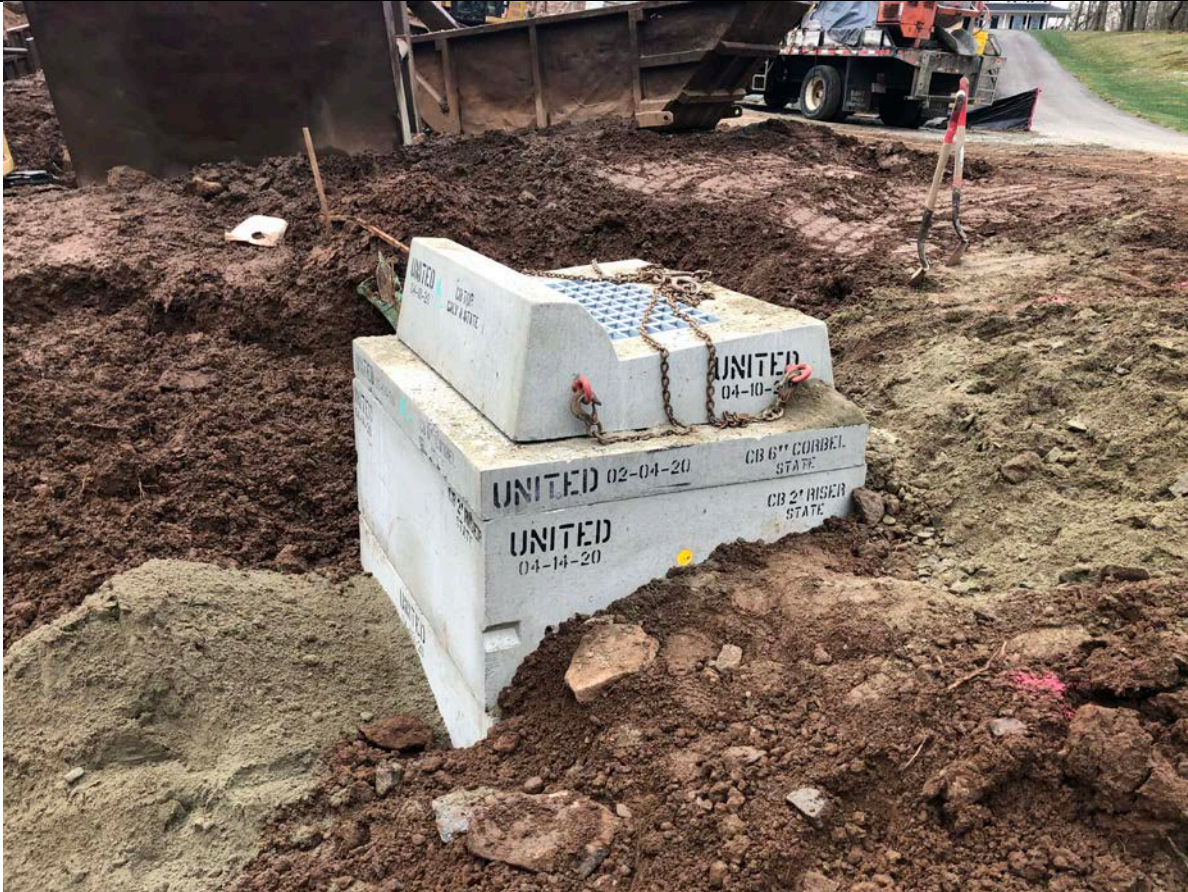
Picture 1: Type C catch basin that was installed at Station 14+40 on April 20, 2020. View to the southeast.

**Additional data:** Ludlow also installed a Type C catch basin at Station 14+40 on 4-20-20.

1044: Ludlow placing RCP across the tank access road from the west side of road diagonally across to the catch basin installed yesterday at Station 14+40. Excavation on the west side of the road starts at approximately Station 15+10.

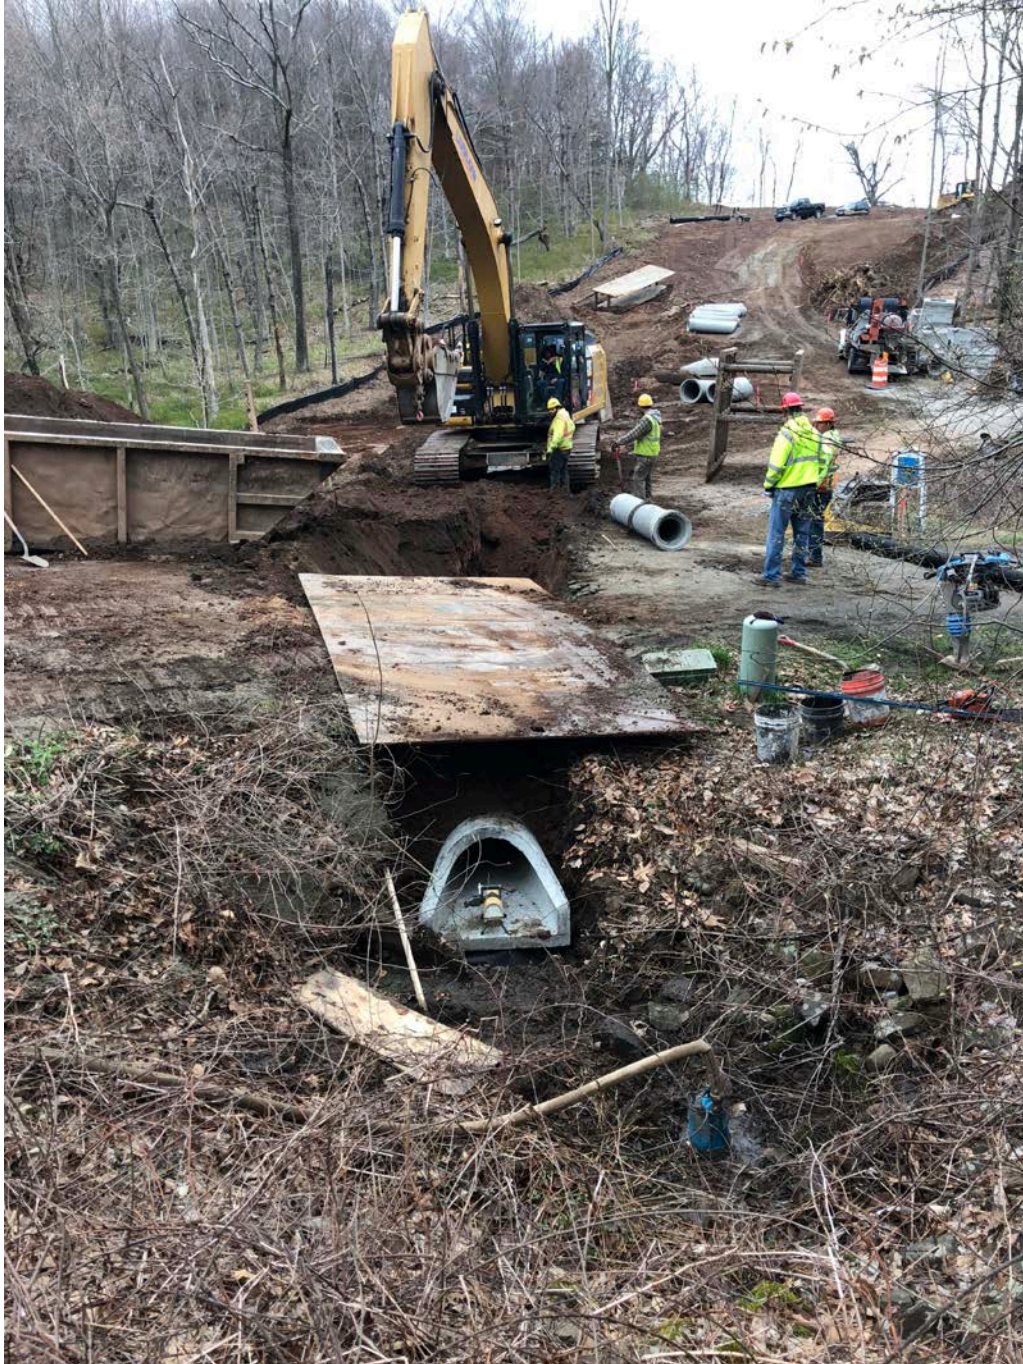
**Picture 2: Culvert placed on the south side of the tank access road between the driveways for 224 and 216 Talcott Ridge Drive at ~Station 15+10. View to the northeast.**

1255: Ludlow places in other section of reinforced concrete pipe across from 216 Talcott Ridge Drive driveway.

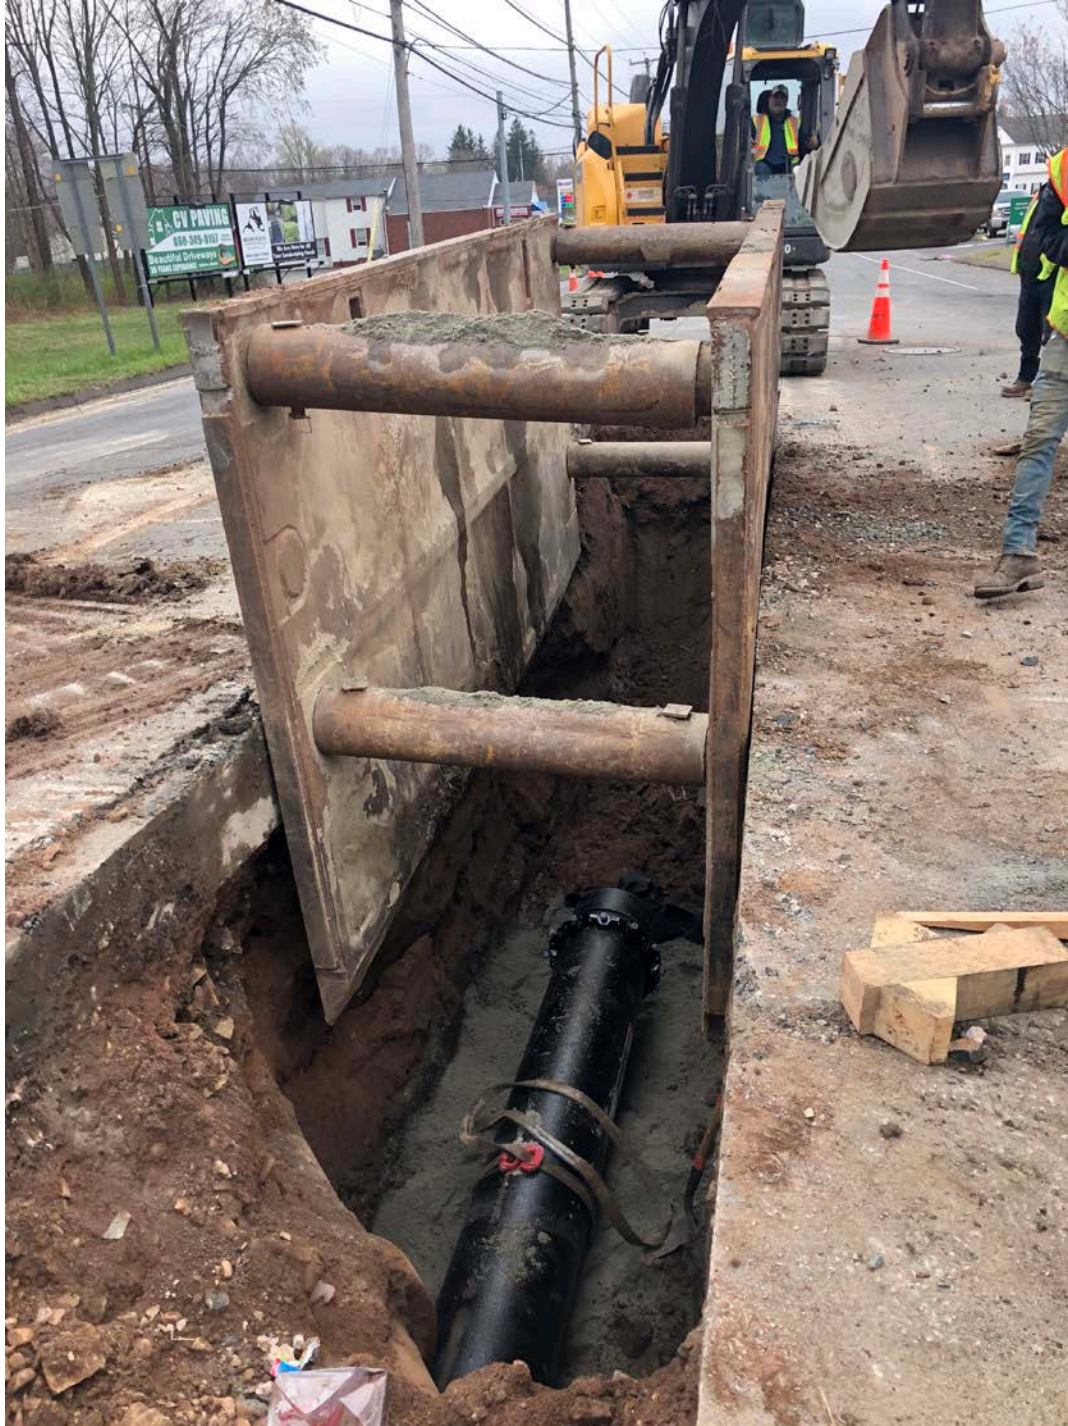
1116 USACE representatives just kicked Ludlow out of the trench on Main Street because the trench box was not set properly (it was sticking up quite a bit above grade as it was sitting on rock along the side walls of the trench)

**Picture 3: Position of trench box just after the USACE representatives directed Ludlow personnel out of the trench so the box could be placed deeper and provide more safety. View to the south.**

1127: Ludlow has the trench box positioned properly where the butterfly valve assembly will be placed.

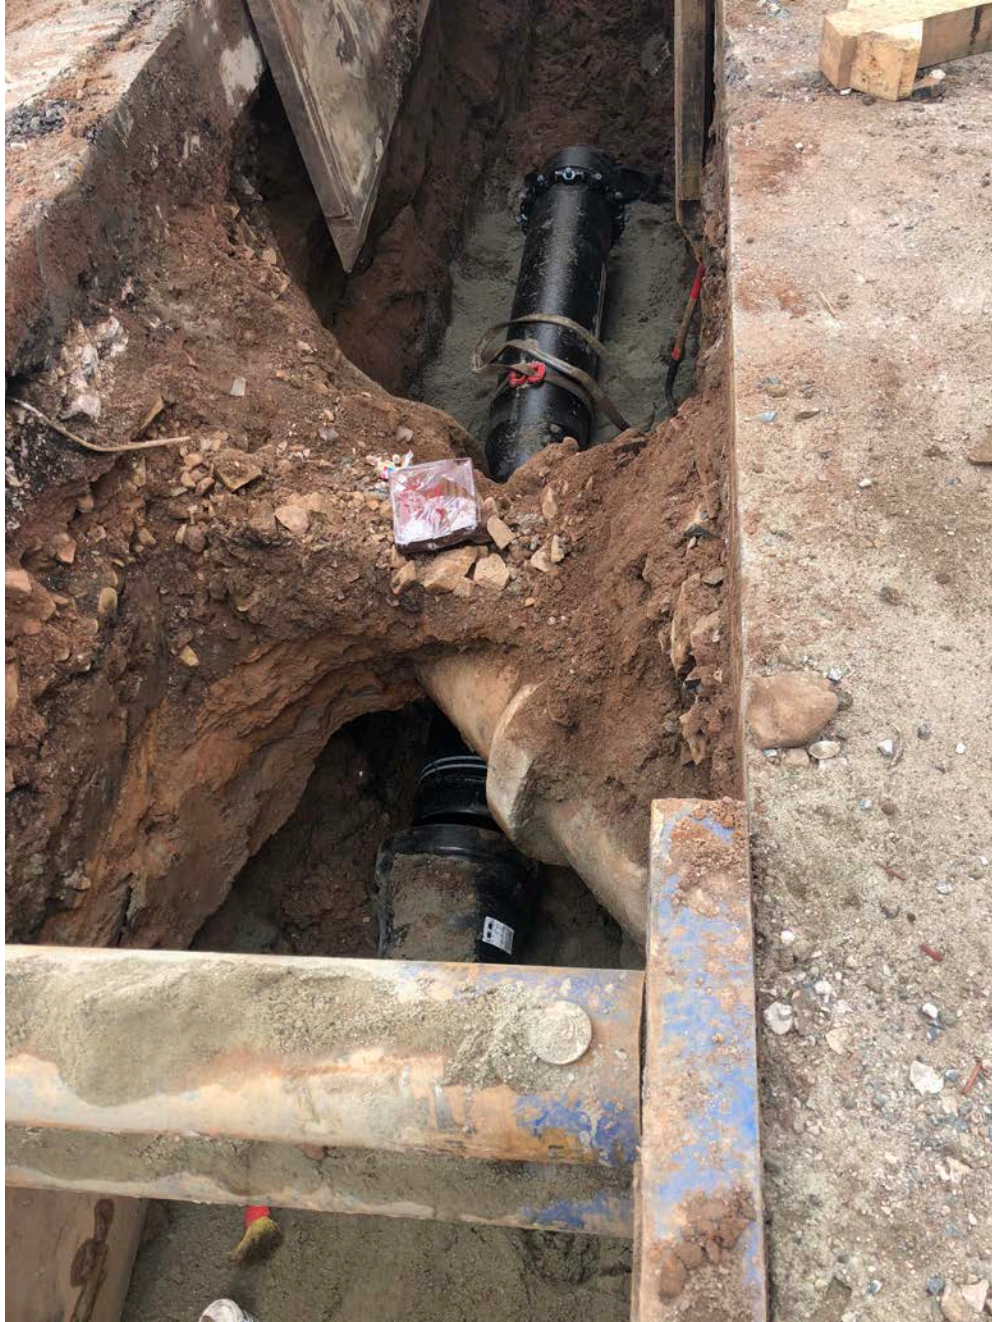
**Picture 4: 16" DIP placed beneath storm drain pipe at the intersection of Main Street and Route 147 West. View to the south.**

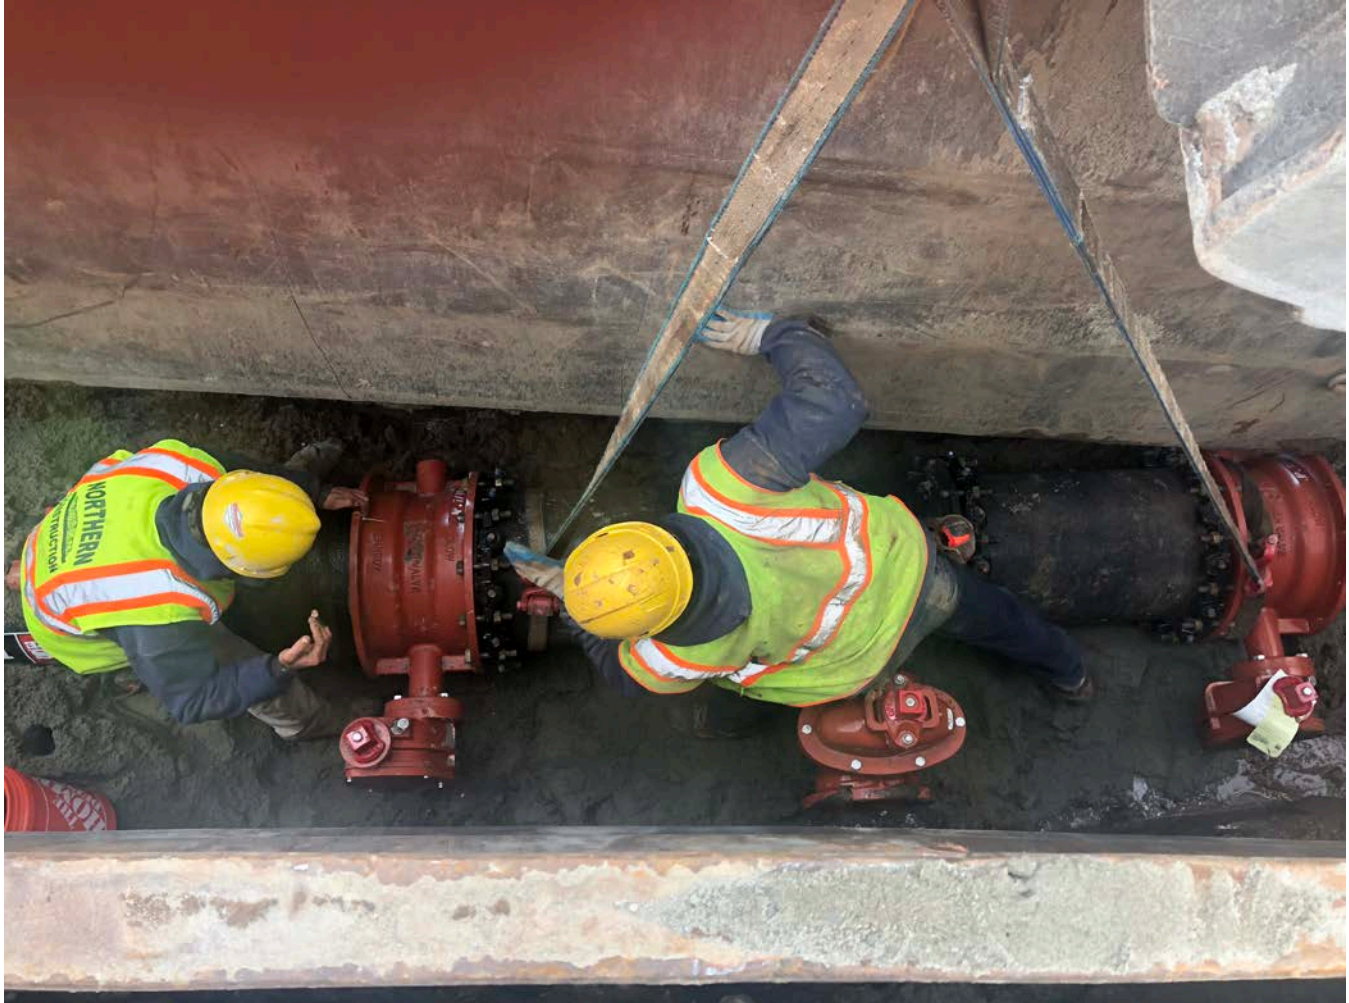
**Pipe Connections and Installations:** Ludlow placed restrained 16" DIP from Station 163+20 to Station 164+16. The last 9' is comprised of two sections of 16" DIP that connect two 16" M.J. butterfly valves and a 16"x16"x8" M.J. C.L.D.I. Ludlow also placed RCP from ~Station 15+10 to the Type C catch basin that was installed yesterday at Station 14+40. In addition, Ludlow installed a 1" service connection at ~Station 15+00 that will service 216 Talcott Ridge Drive.

Picture 5: Ludlow installing two sections of 16" DIP that connect two 16" M.J. butterfly valves and a 16"x16"x8" M.J. C.L.D.I.

1150: Ludlow placing 8.7' double butterfly valve/Tee assembly into trench. Wind has picked up and is gusting up to 20 mph.

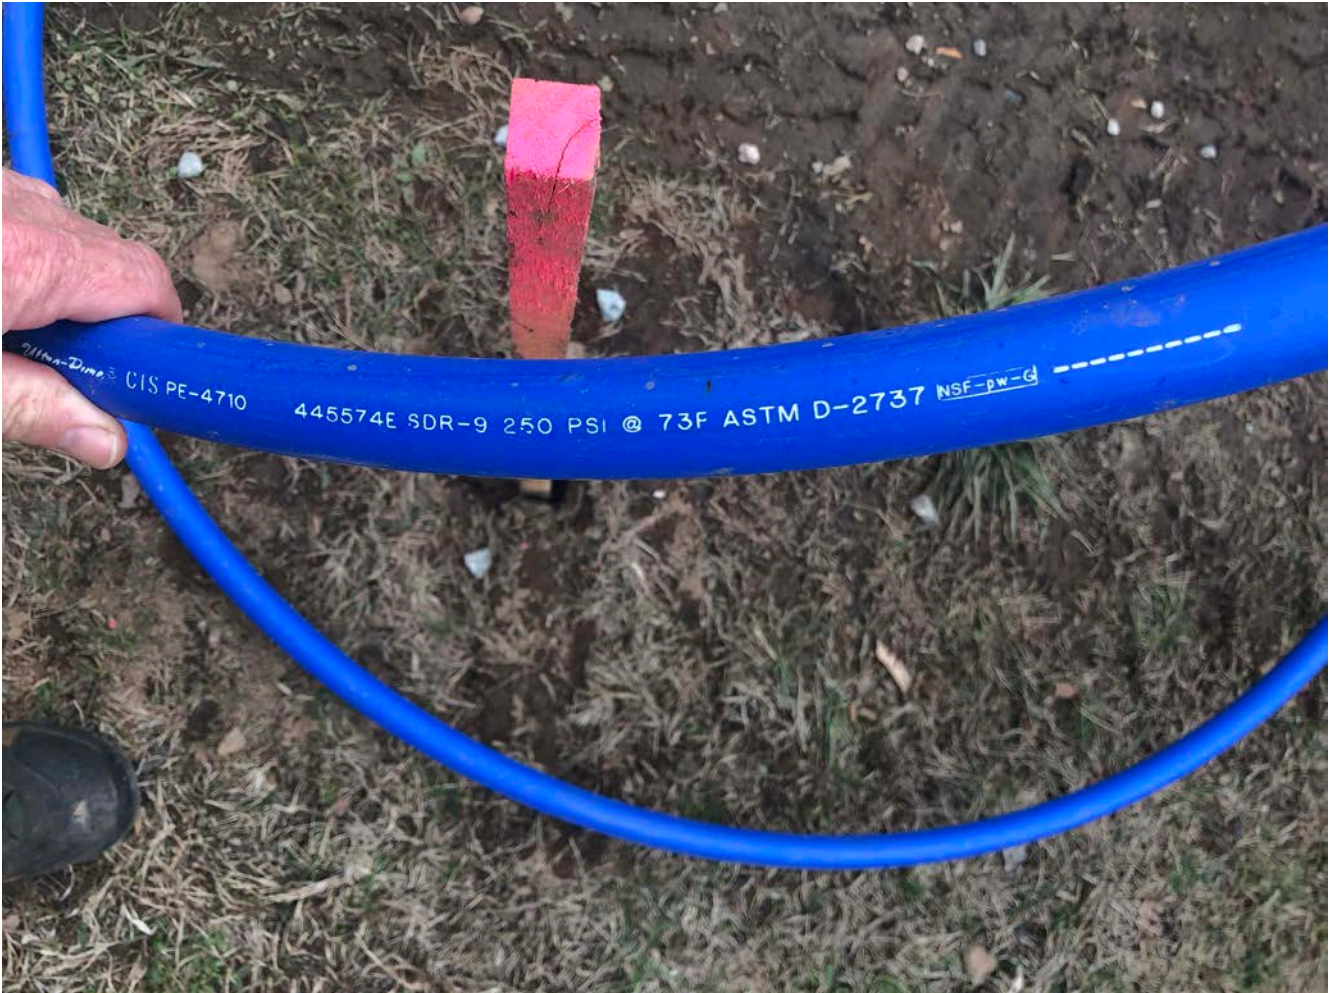
1235: Ludlow transitioning from 1" copper service line to 1" blue plastic line (ASTM D-2737). Ludlow attaches a stainless steel rod to a valve where at the copper/plastic junction that will be placed inside of a road box.

Picture 6: 1" plastic pipe used in conjunction with 1" copper pipe for service connection to 216 Talcott Ridge Drive.

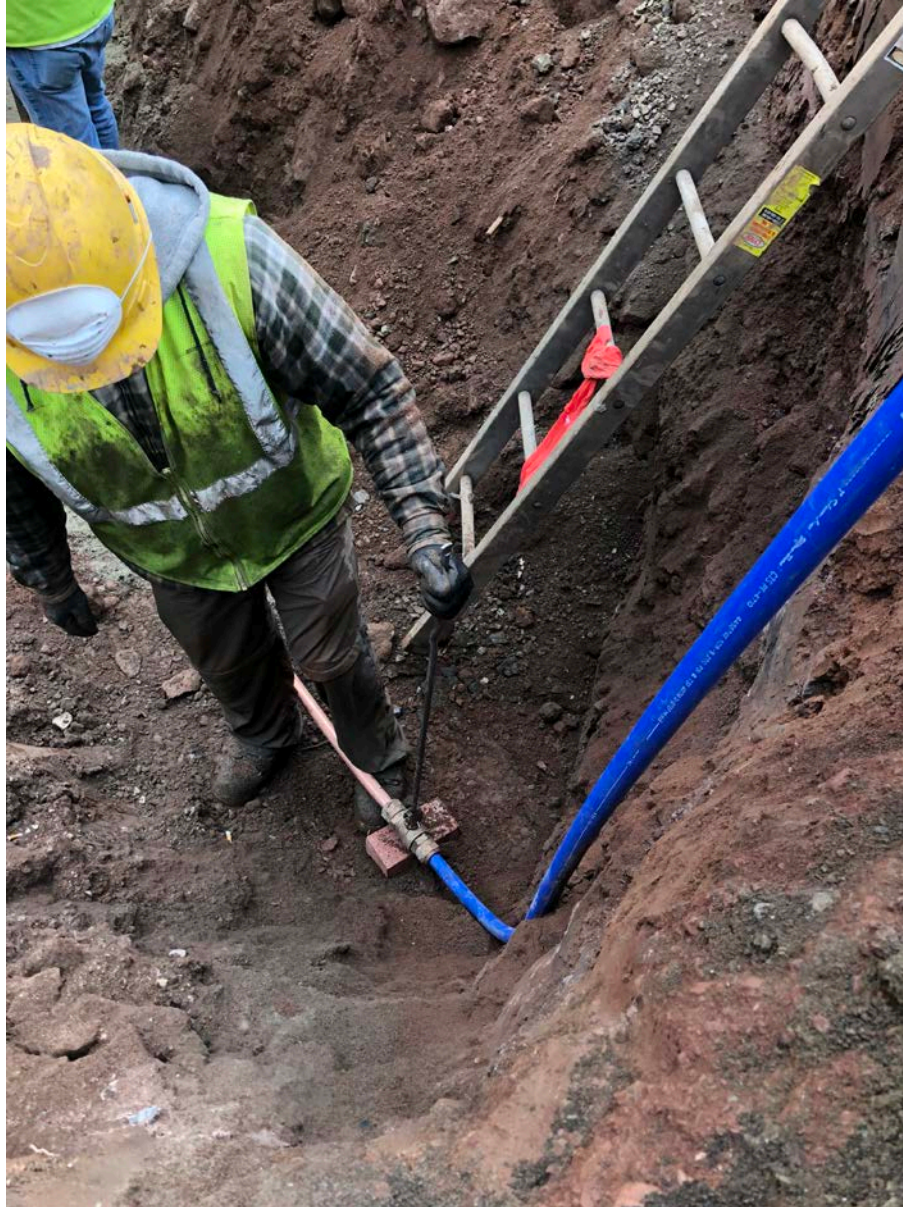
1222: Ludlow has installed a 1" copper service line that will service to 216 Talcott Ridge Drive.

Picture 7: 1" plastic pipe connected to 1" copper pipe for service connection to 216 Talcott Ridge Drive.

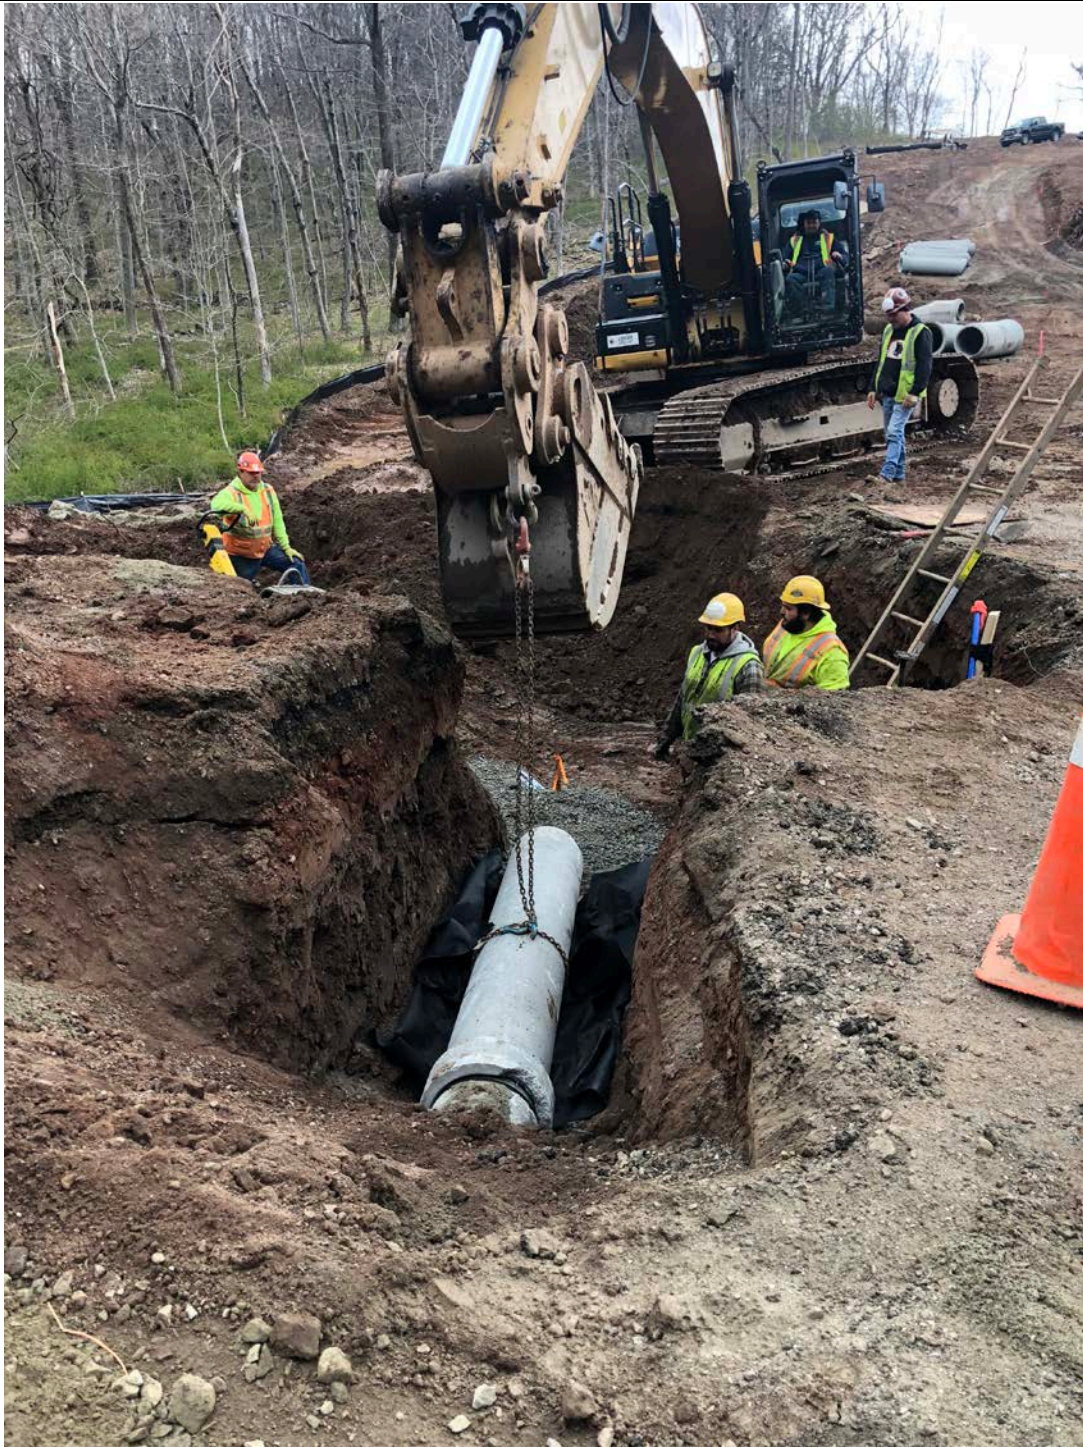
Picture 8: Placing RCP storm drain culvert at ~Station 15+00. View to the northeast.
