Daily Report

Project:	Durham Meadows Pipeline Installation	Date:	April 23, 2020
Location:	Main Street, Water tank access road, Durham & Middletown, CT	Day of Week:	Thursday
Project #:	AECOM: 6061487	Report No:	64
Contractor:	Ludlow Construction	Page:	1 of 11

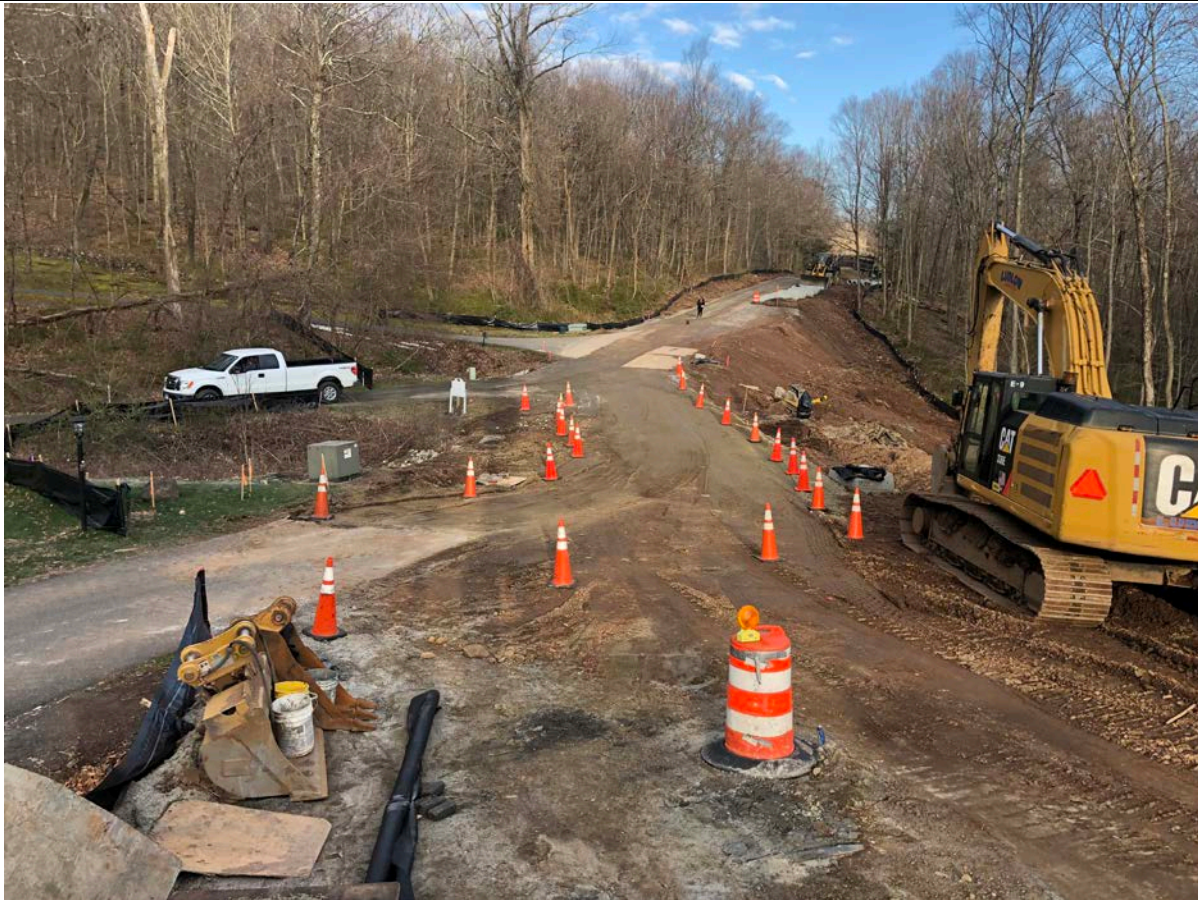
0720: No work currently being performed at Station 14+40. The shared access road and adjacent work areas were inspected for erosion issues – none were observed.

Picture 1: Overview of Station 14+40 work area after yesterday's construction activities. View to the west.

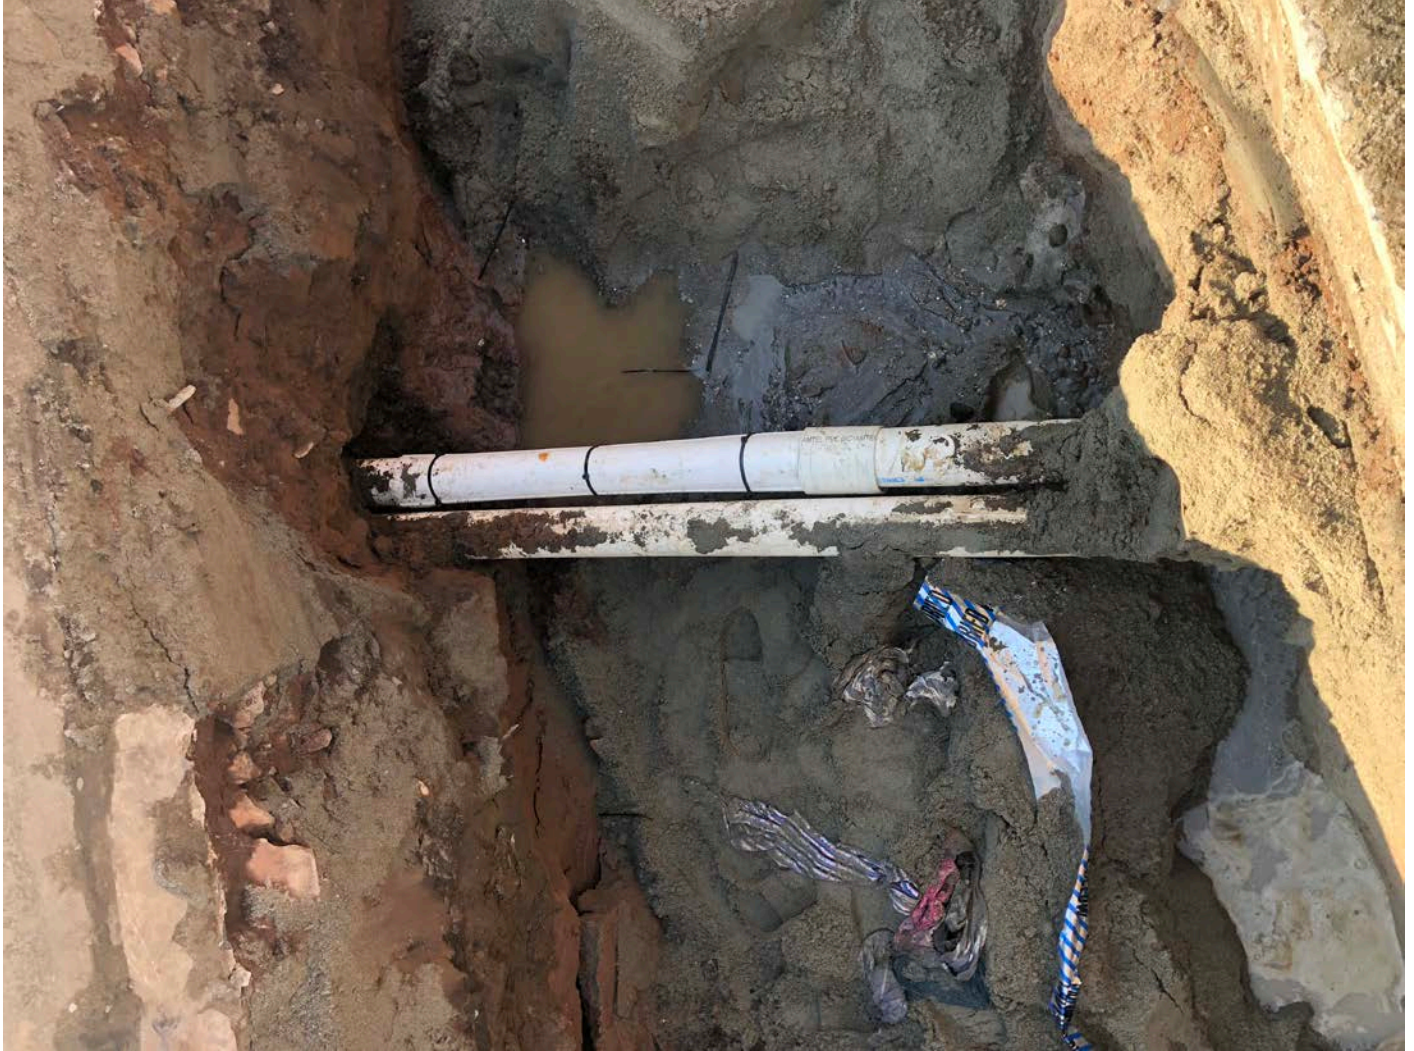
0705: One Ludlow crew is picking up at Station 165+70 where they stopped placing pipe after damaging the conduit of a communications cable yesterday located at Station 165+78.

Picture 2: Communications cable conduit repaired by Ludlow at Station 165+78.

0905: Ludlow placing a second piece of 16" DIP, bringing placed DIP to ~Station 166+10. The broken PVC conduit at station 165+78 has been repaired with PVC sleeves and a single PVC collar plus 3 zip ties.

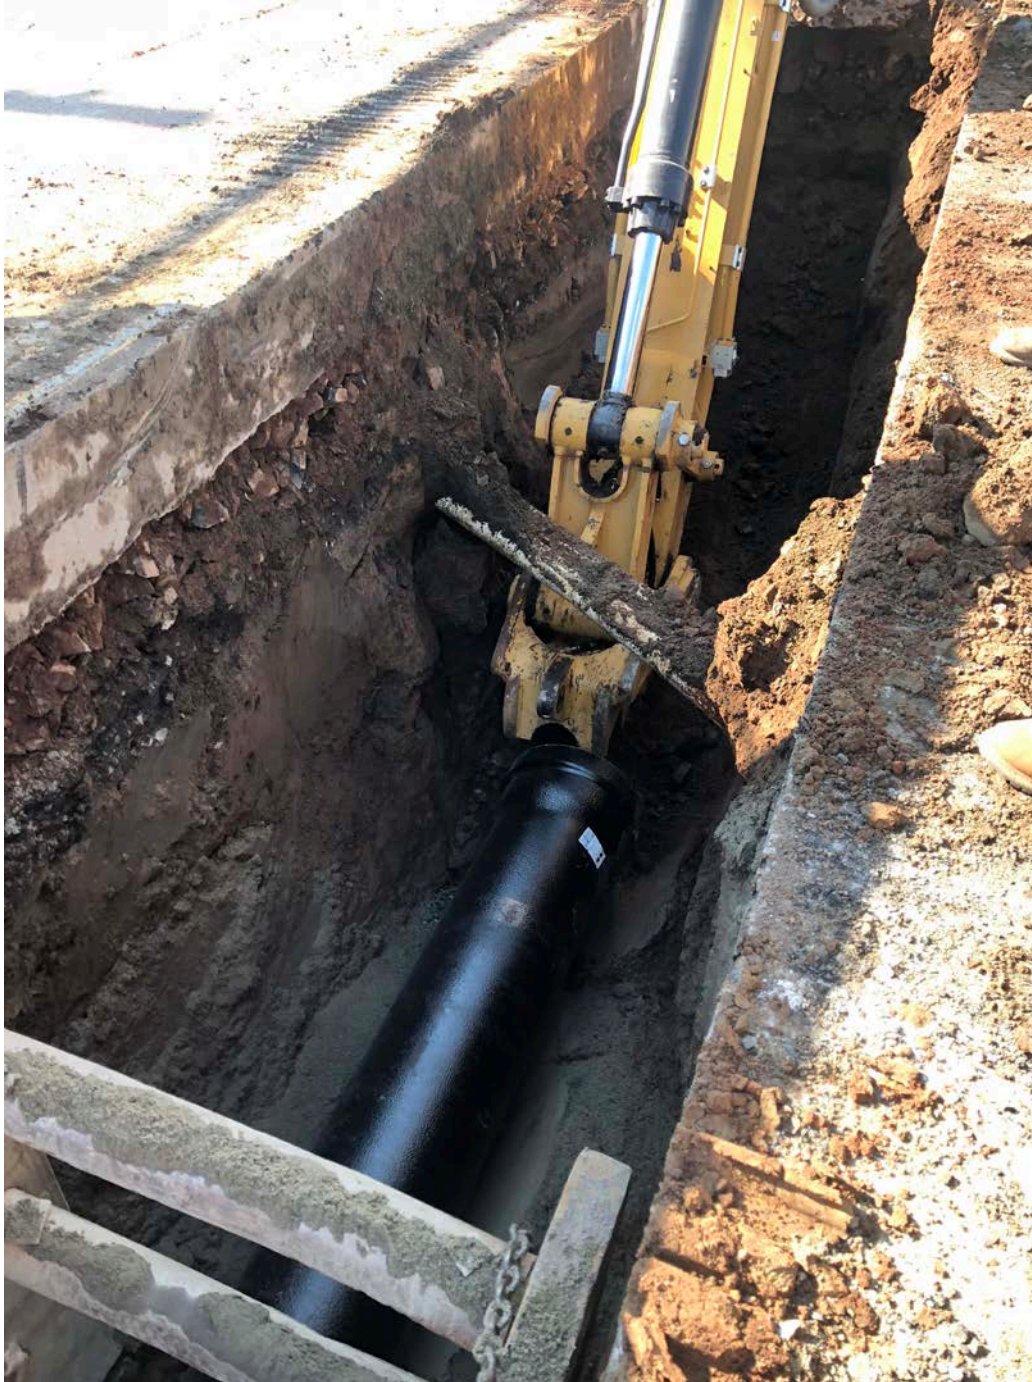
0738: Ludlow is daylighting a communication line that comes off the north side of Haddam Quarter Road, west towards The Whole Enchilada at approximately Station 166+05. A small amount of water is observed at approximately 7' below surface grade. Ludlow is not pumping water yet.

Picture 3: 16" DIP placed below communications cable located at ~Station 166+05. View to the south.

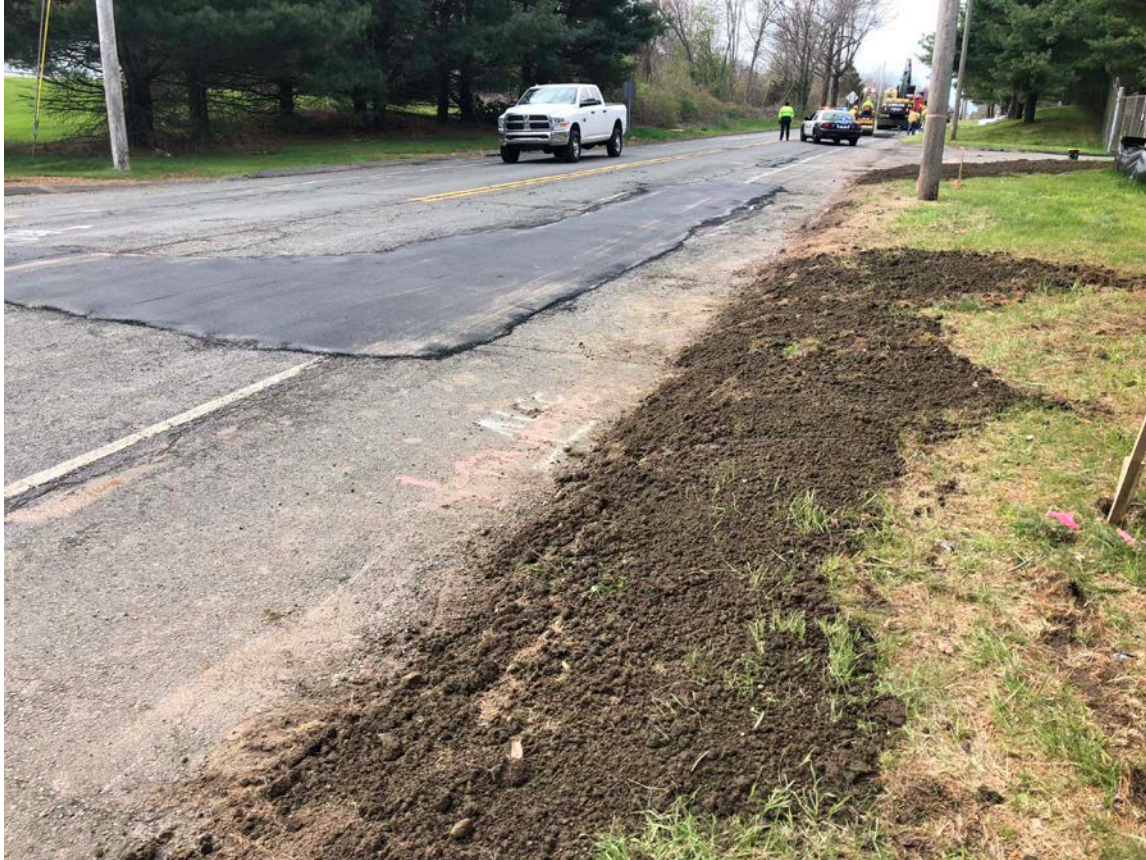
0715: A second Ludlow crew at the intersection of Talcott Ridge Drive and Main Street waiting to start shim coating asphalt along South Main Street. They are also spreading loam at selected areas that have been impacted by the operation and staging of construction equipment.

Picture 4: Newly placed loam and shim coating of asphalt on South Main Street, just south of the intersection with Talcott Ridge Drive. View to the south.

0930: One of the Ludlow crews is working just north of the intersection of Talcott Drive Ridge and South Main Street, shim coating asphalt and spreading loam on the south side of the road.

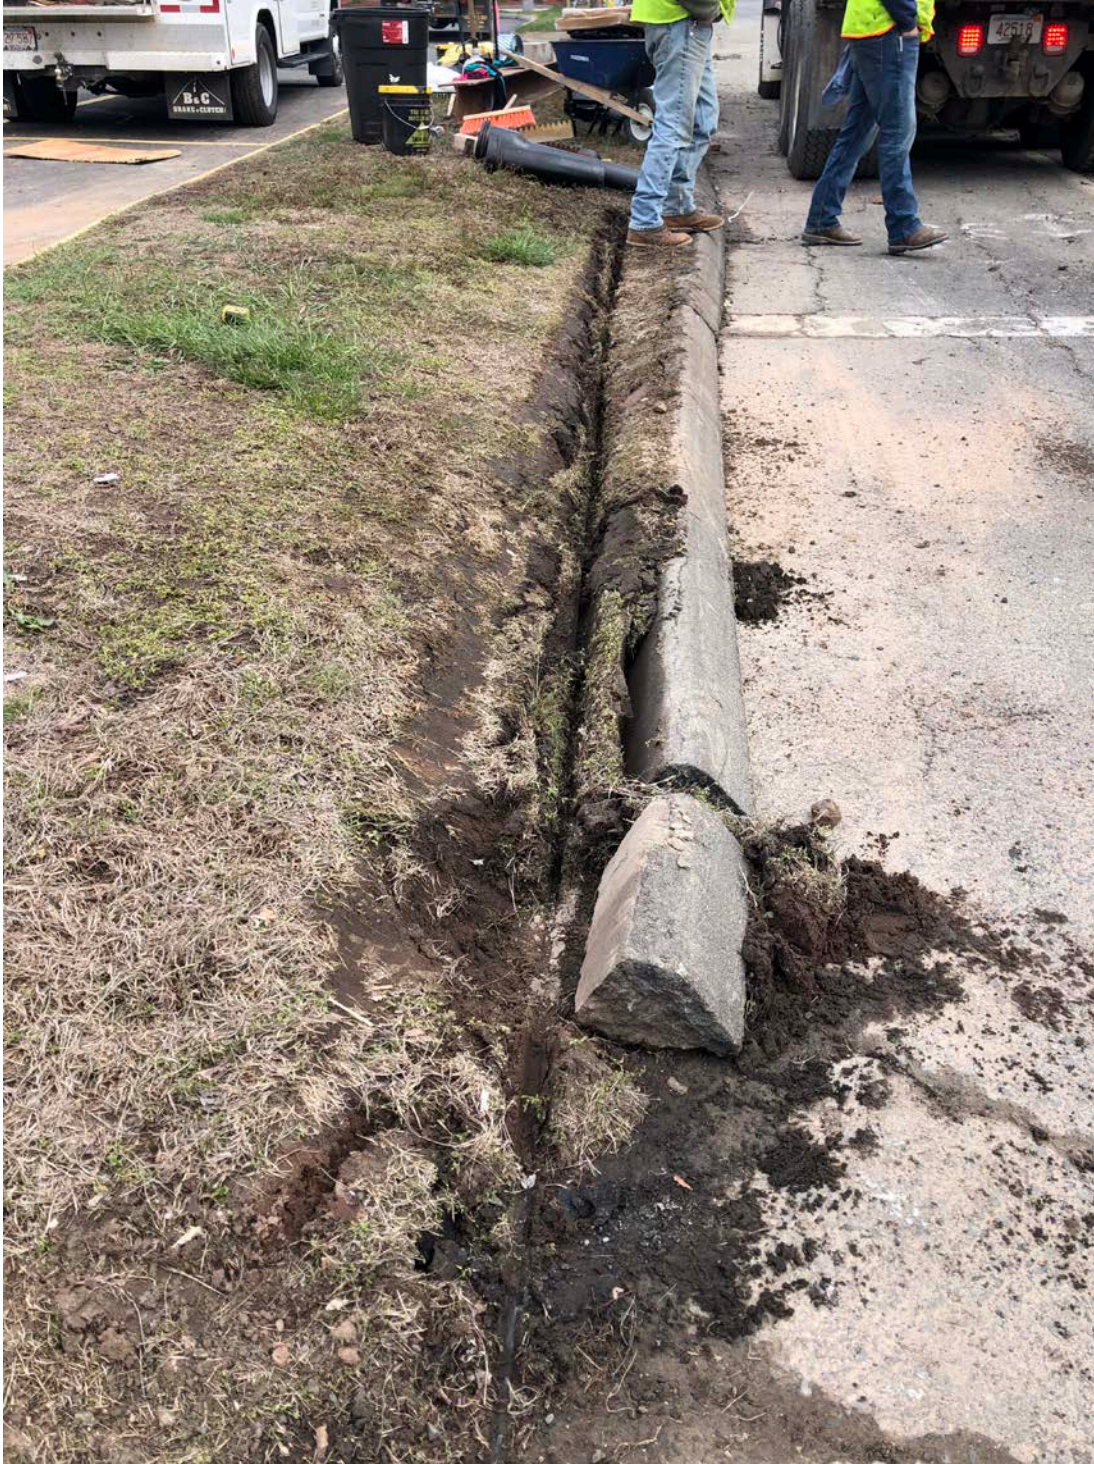
Picture 5: Damage to curbing at ~Stations 166+20 to 166+35. View to the north.

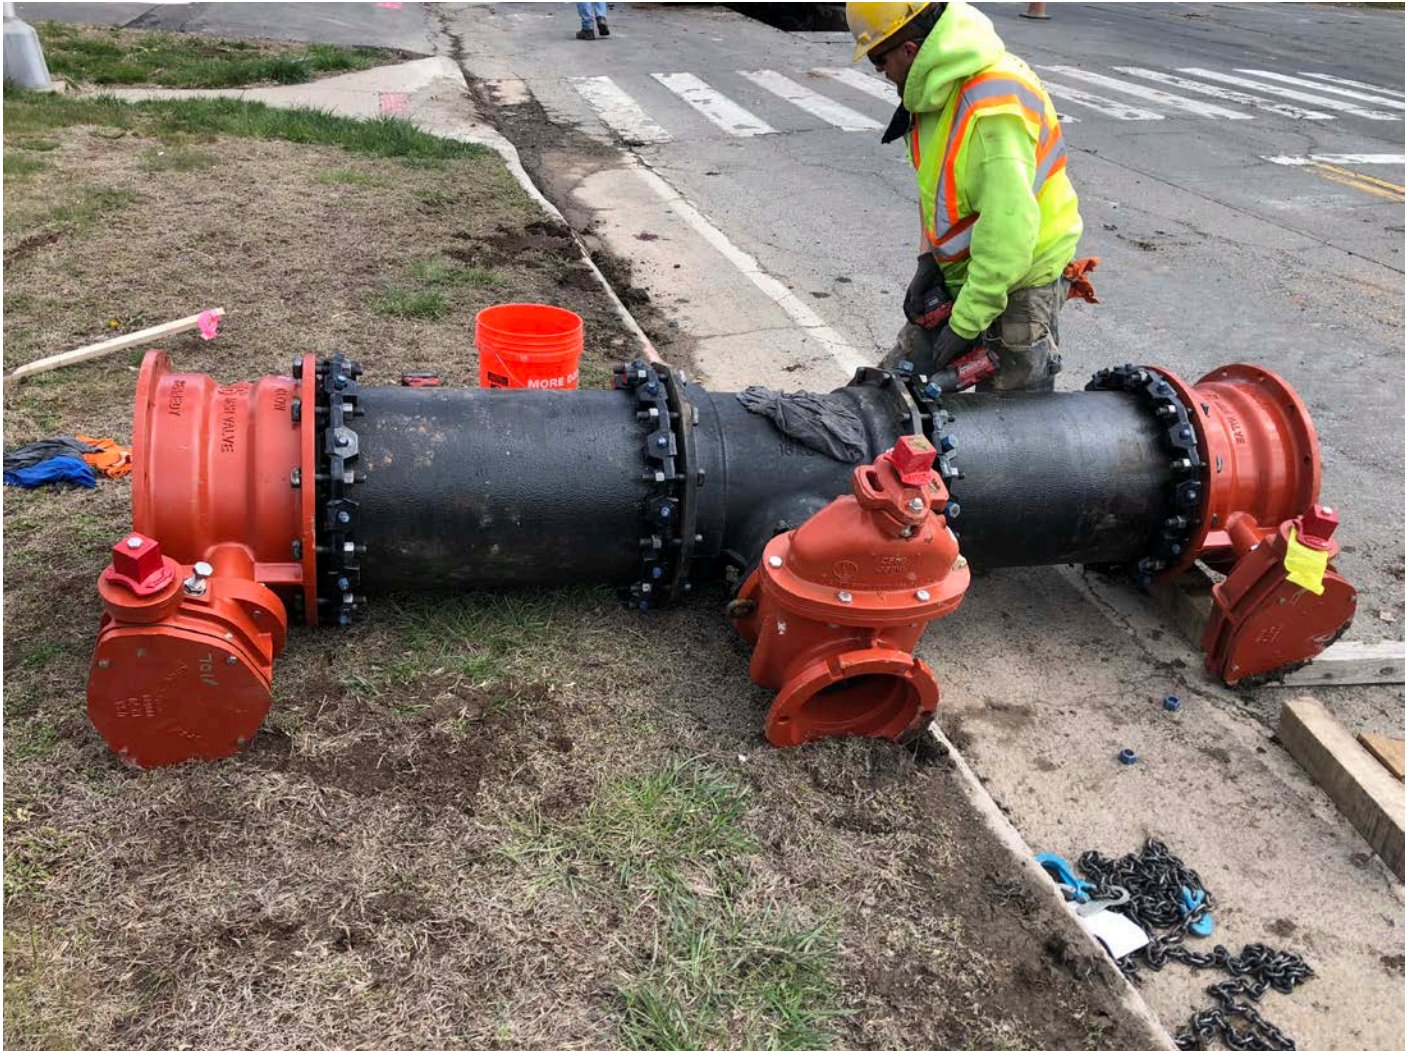
1045: Ludlow installs a 16"x16"x8" M.J. C.L.D.I. Tee with two 16" butterfly valves and one 8" gate valve and a valve box.

Picture 6: 16"x16"x8" M.J. C.L.D.I. Tee with two 16" butterfly valves and one 8" gate valve and a valve box that was placed at Station 166+32 (Haddam Quarter Road intersection).

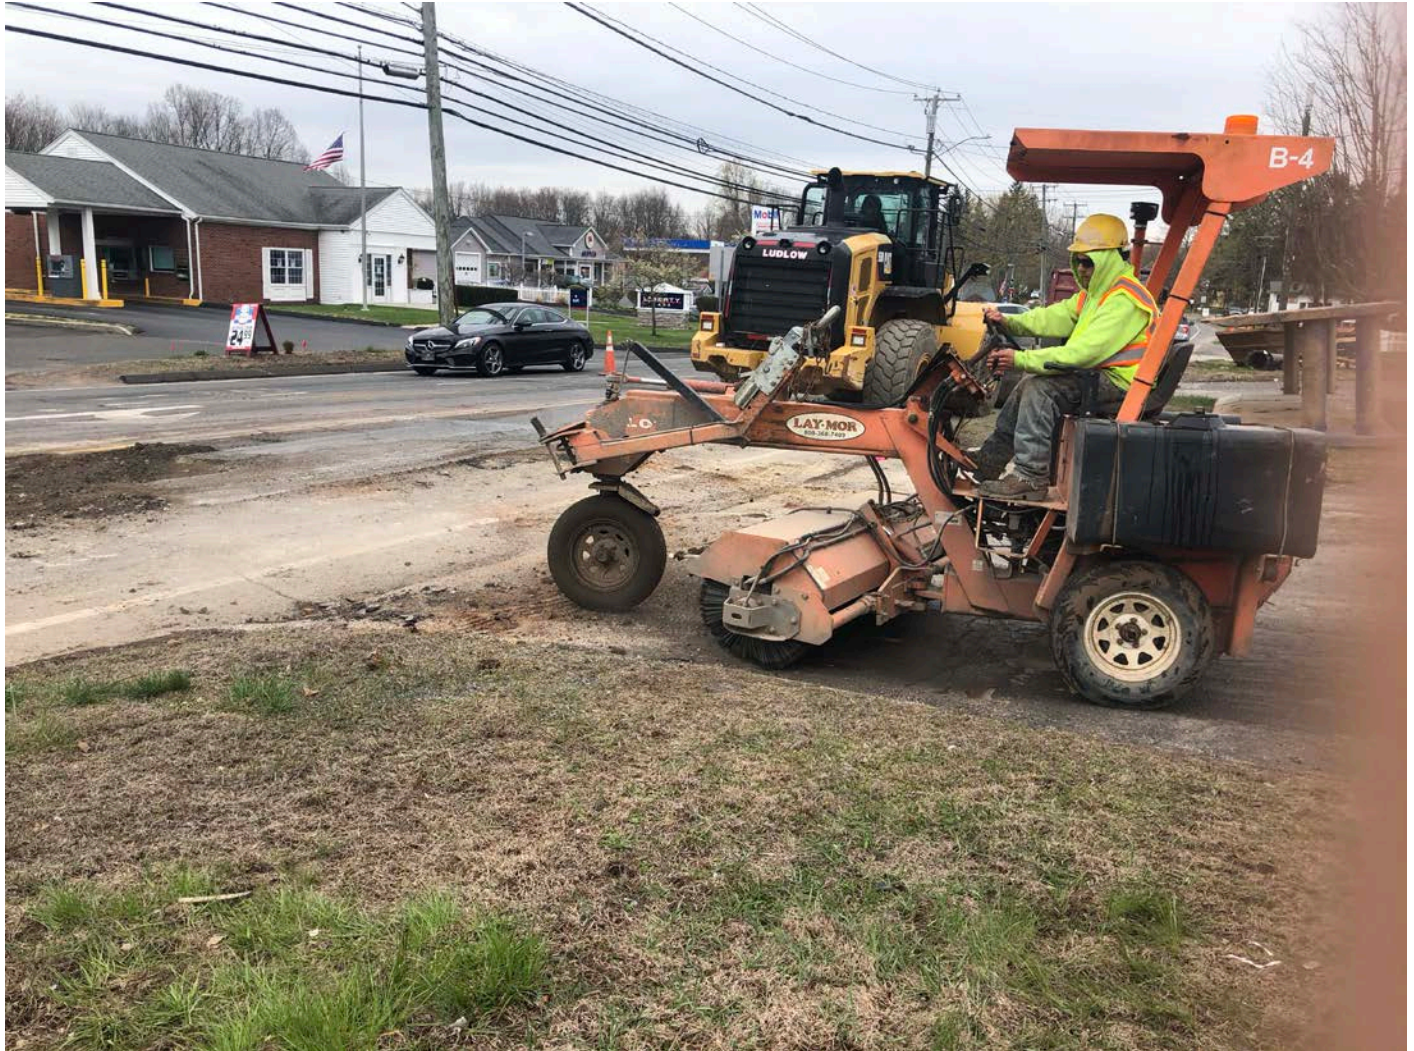
Picture 7: Ludlow sweeping up after construction activities has finished. View to the southeast.

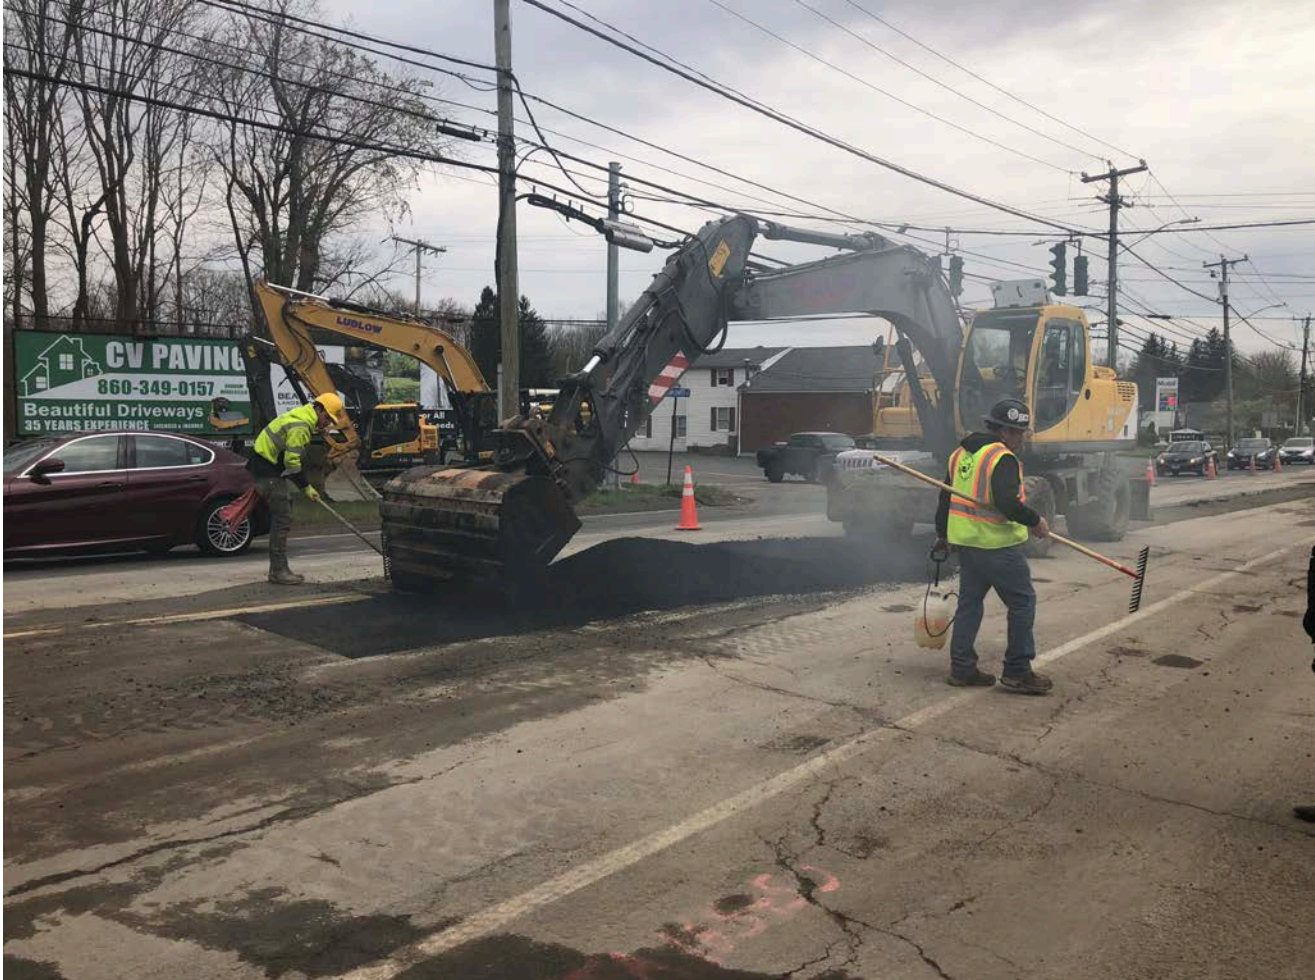
1445: Ludlow is currently capping the backfilled trench with hot patch.

Picture 8: Ludlow placing hot patch over compacted soil on Main Street. View to the southeast.
