Daily Report

Project:	Durham Meadows Pipeline Installation	Date:	April 28, 2020
Location:	Main Street and shared access road, Durham & Middletown, CT	Day of Week:	Tuesday
Project #:	AECOM: 6061487	Report No:	67
Contractor:	Ludlow Construction	Page:	1 of 11

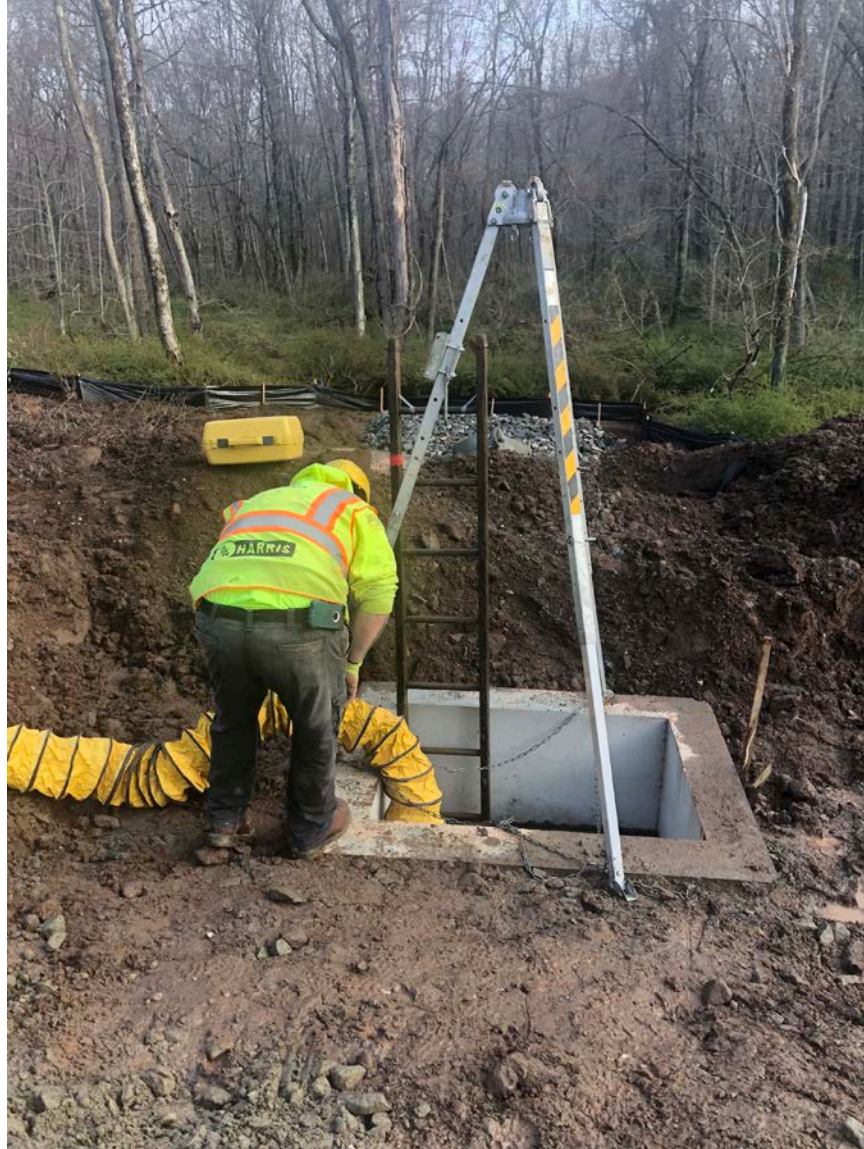
Picture 1: Ludlow preparing to make a confined space entry into the catch basin located on the north side of the shared access road at Station 14+40. View to the north. Middletown, CT.

0730: Ludlow set up for confined space entry inside the catch basin located at Station 14+40 on the north side of the shared access road. The purpose of the entry was to set up a laser inside of the catch basin to help align the 15" RCP they planned to place today from the catch basin up the slope eastwards, towards the tank pad.

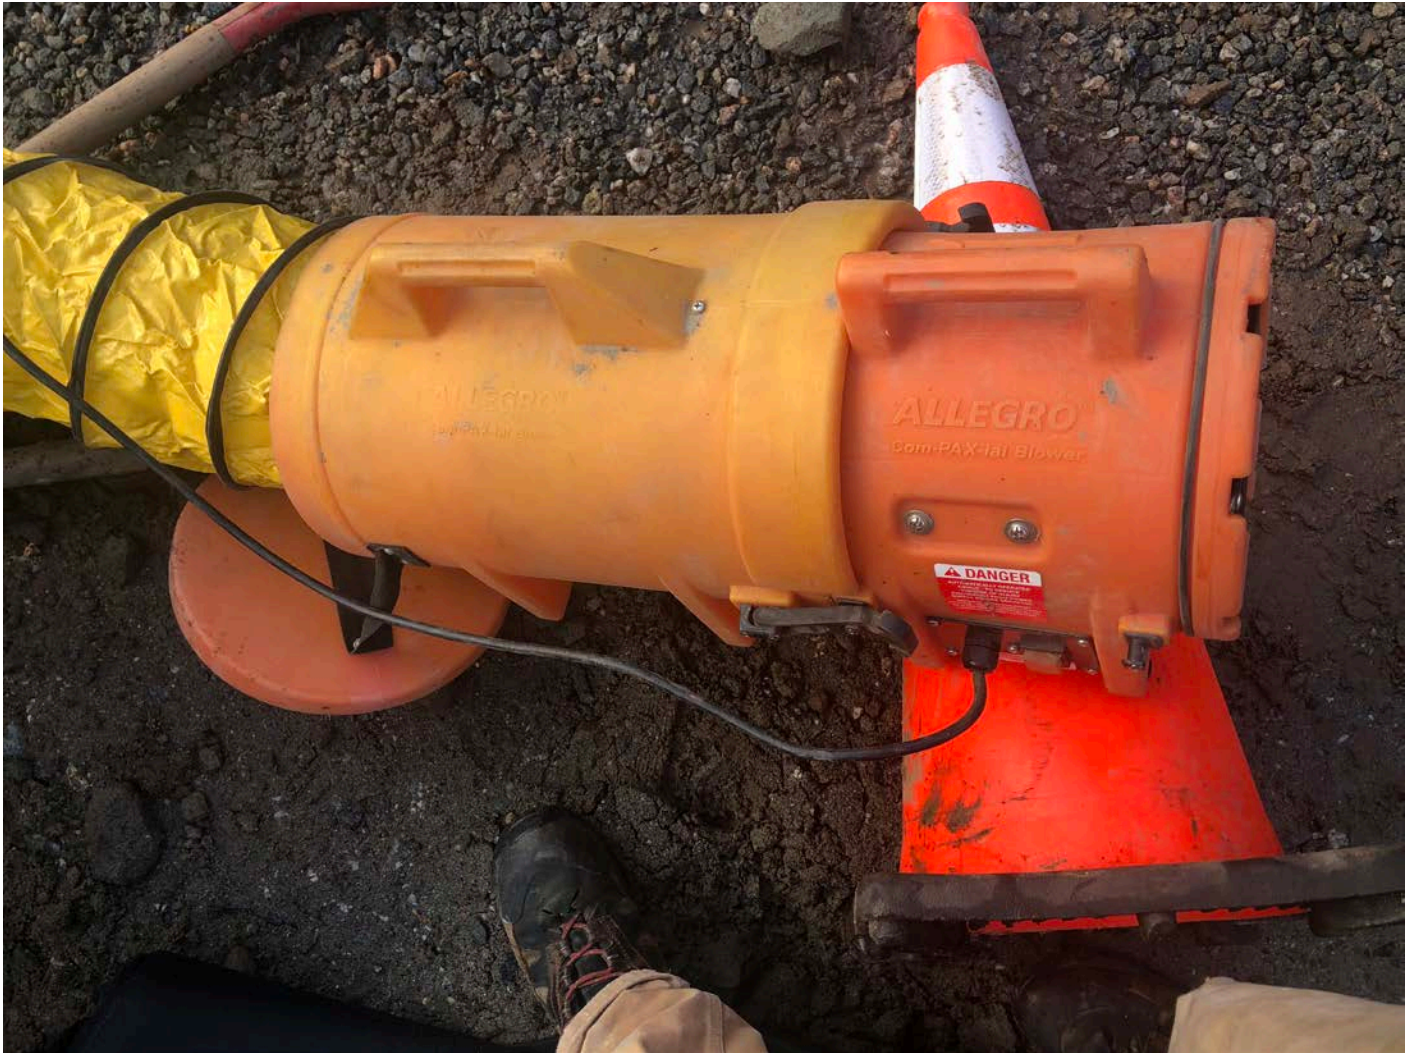
Picture 2: The blower Ludlow used to evacuate air from the catch basin while performing the confined space entry. North side of the shared access road at Station 14+40. Middletown, CT.

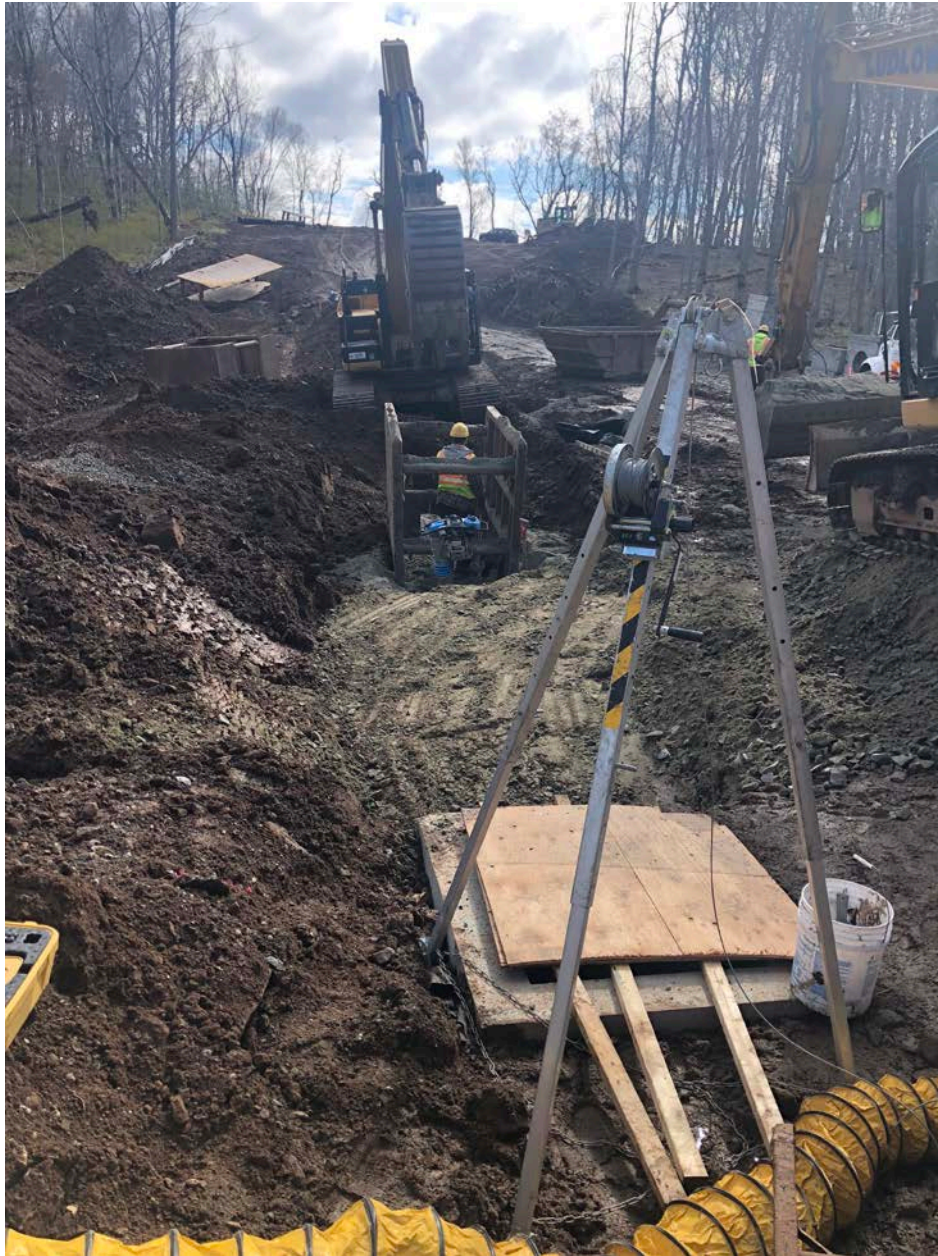
Picture 3: Ludlow placing 15" RCP east of the catch basin located on the north side of the shared access road at Station 14+40. View to the east. Middletown, CT.

0925: Starting from the catch basin located at Station 14+40, Ludlow is placing 15" RCP in an eastern direction, towards the tank pad.

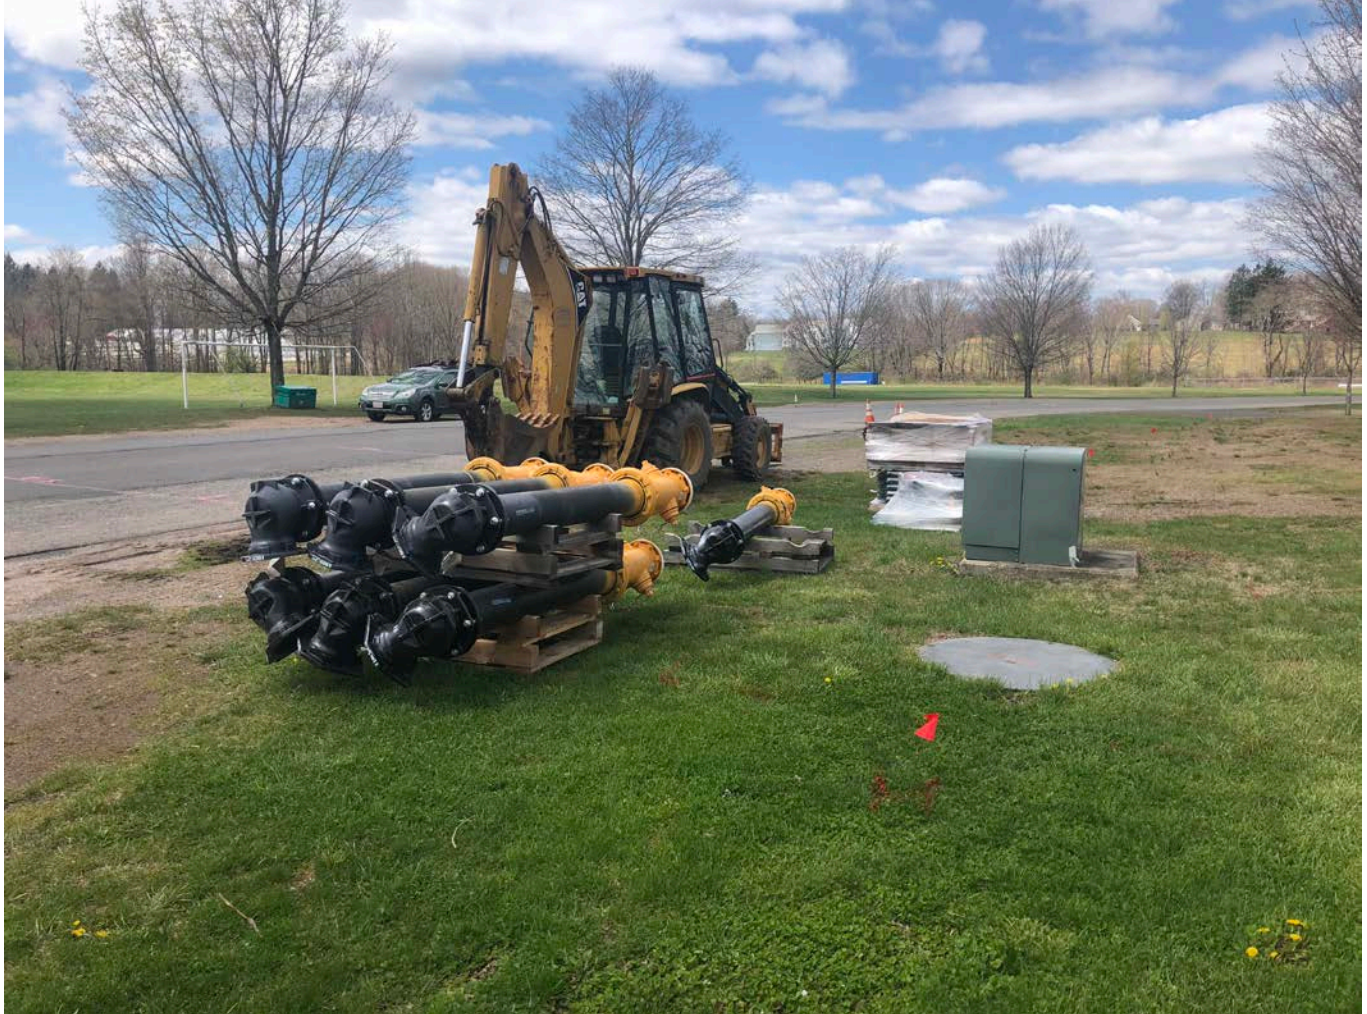
Picture 4: Equipment and materials Ludlow staged today at Station 518+00. View to the southwest. Pickett Lane, Durham, CT.

Ludlow began staging materials and equipment at Station 518+00 today.

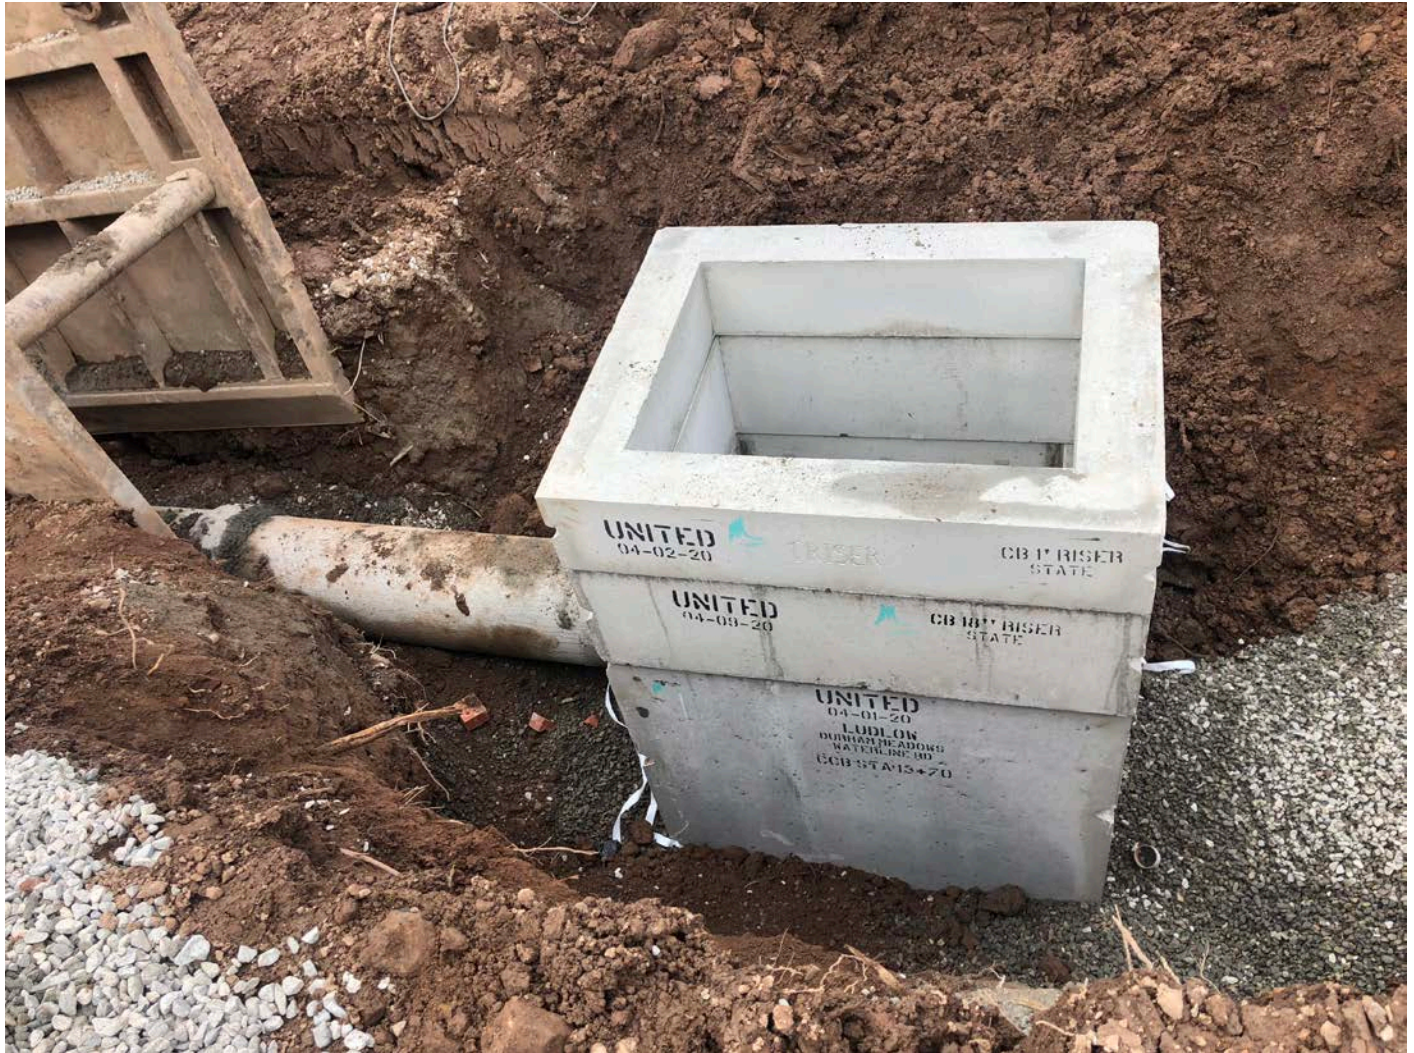
Picture 5: Type C catch basin Ludlow placed at Station 13+70. View to the north. Middletown, CT.

1205: Ludlow has placed a Type C catch basin at Station 13+70.

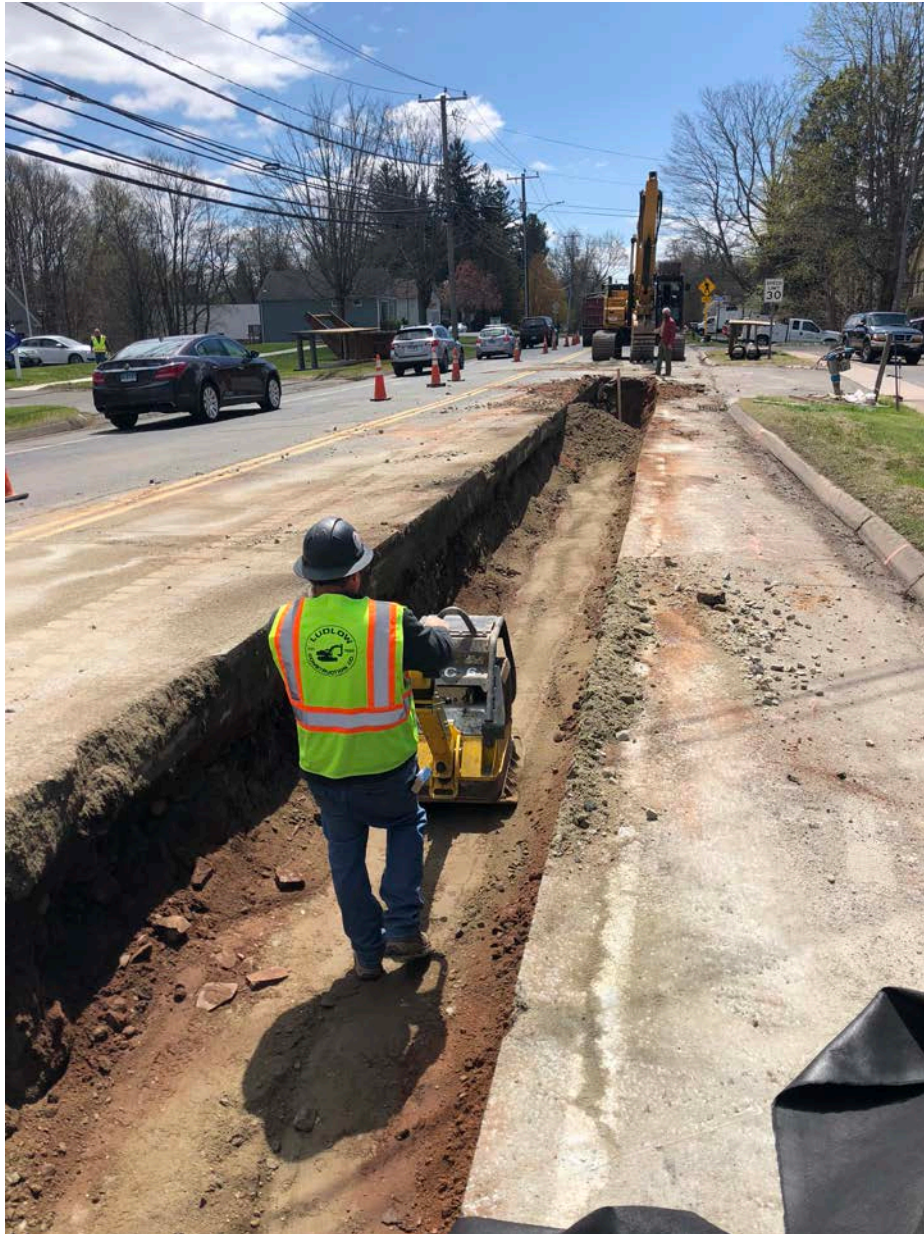
Picture 6: Ludlow compacting -3" gravel along the southbound lane of Main Street. View to the south. ~Station 171+50. Durham, CT.

1340: Ludlow is backfilling and compacting gravel.

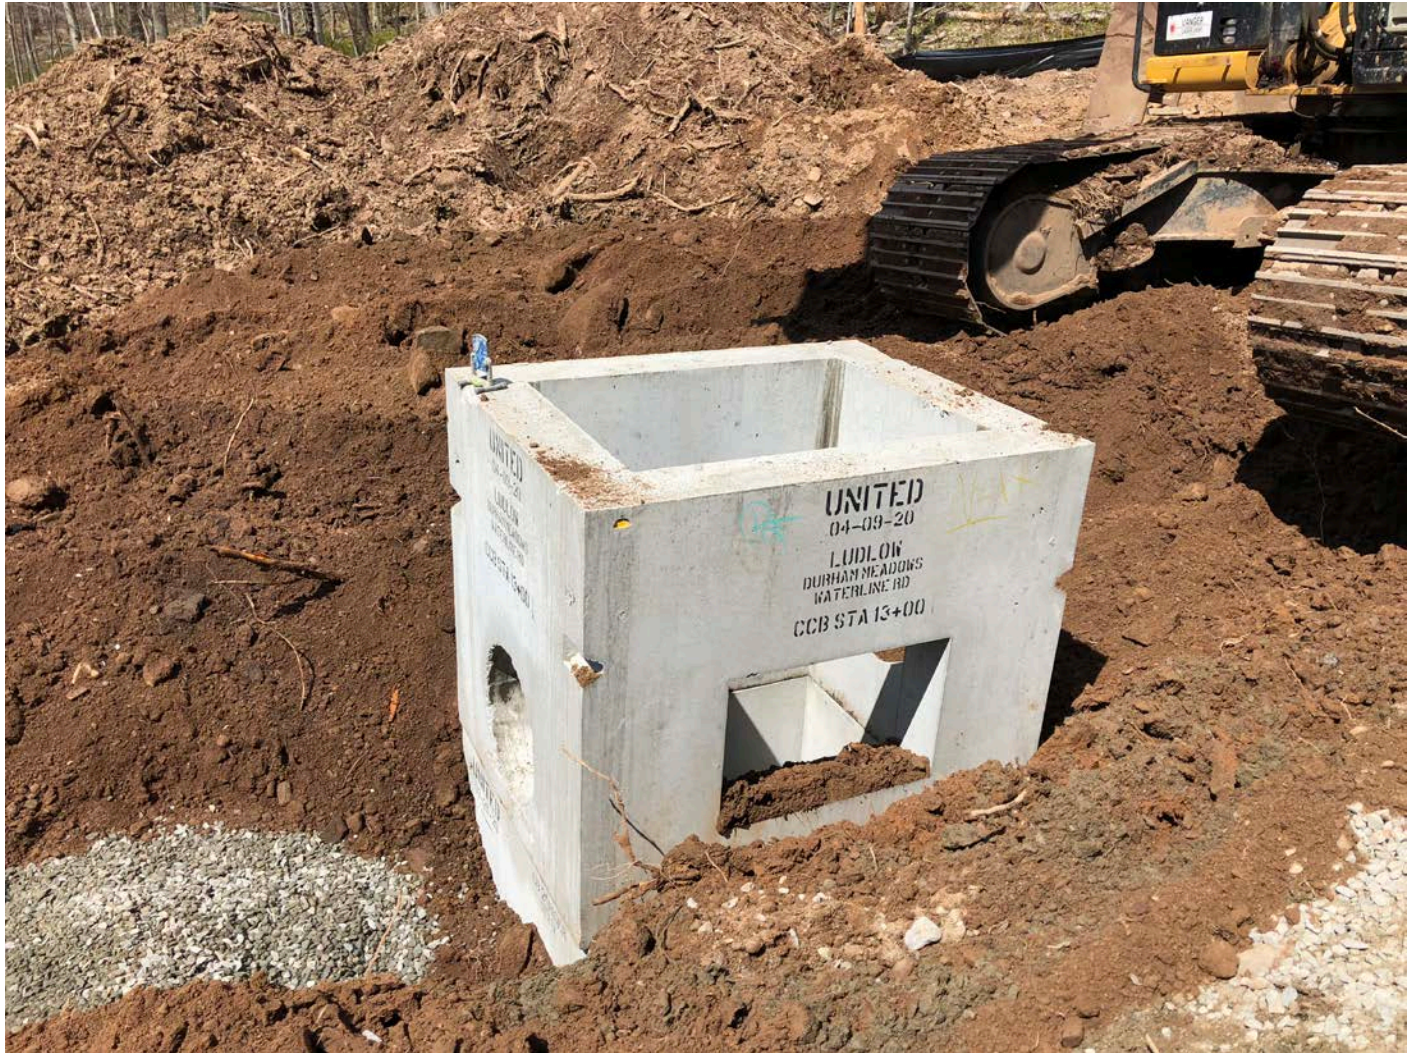
Picture 7: Type C catch basin Ludlow placed at Station 13+00. View to the north. Middletown, CT.

1445: Ludlow placing a Type C catch basin at Station 13+00.

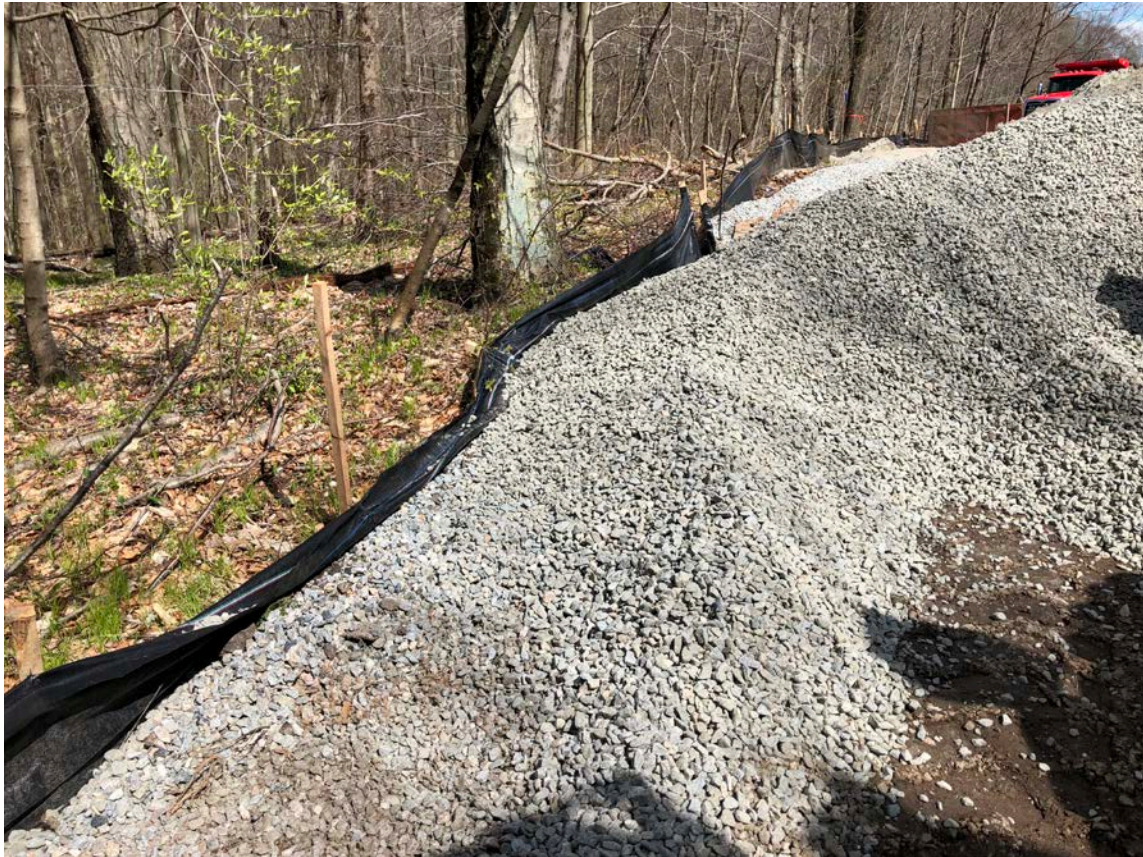
Picture 8: 3/4" stone crowding silt fence located on the north side of the shared access road. View to the northeast. Middletown, CT.
