Daily Report

Project:
 Durham Meadows Pipeline Installation
 Date:
 April 30, 2020

Location: Main Street and shared access road, Durham & Middletown,

69

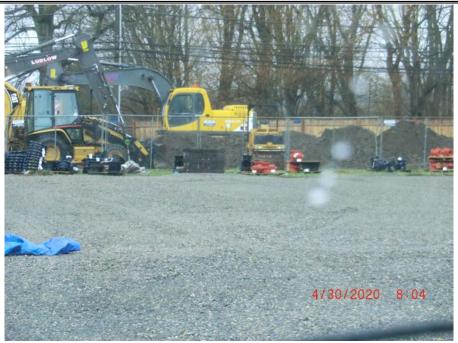
Picture 1: 281 Main Street, Durham, CT. New gravel parking area in front of USACE trailer.

Ludlow significantly expanded the gravel parking area at the trailer site, creating a large pad in front of the USACE trailer. The added gravel makes a significant improvement in the parking area.

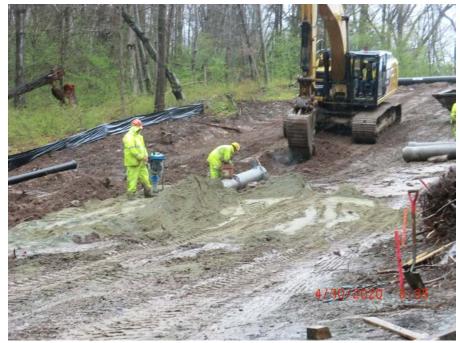
Picture 2: Facing east. Installation of 12" concrete drainpipe up the slope to the water tower. Middletown, CT.

Other than moving stockpiled materials (gravel) from a point along the shared access road, Ludlow did not perform any activities along the road. Work was being conducted on the slope up to the tank field area and at the top of the slope. The work included installing roughly 120-150 feet of 12" concrete drainpipe along the north side of the slope. After running out of pipe, they converted to adding gravel to the slope and the top of slope to stabilize the road so that trucks could be run up to the top.

0812: Drove up to the shared access road and water tank site. No activity currently on Main Street. On the shared access road, work was being done on the slope up to the water tank field. Ludlow was installing 12" drainpipe heading up the slope. Later found out that they ran out of pipe near the top of the slope.

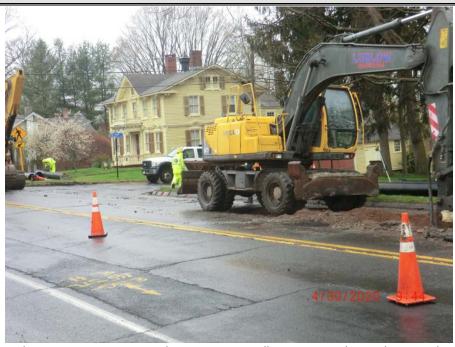
Picture 3: View facing southwest on Main Street, Durham, CT. DIP installation approaching Talcott Road, seen left of center in the picture (white pickup parked at intersection).

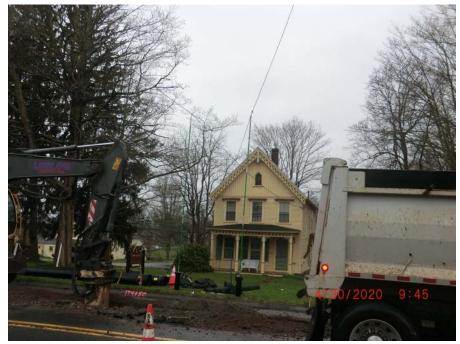
Picture 4: View facing west, across Main Street, Durham, CT. On going trenching. Note Station 174+50 on curb in orange and two fiberglass poles holding up power and phone lines to the house in the background.

Ludlow began trenching on Main Street in Durham, just north of Talcott Road. When I first arrived, they were hammering bedrock at Station 174+50. Once cleared they installed a road box and one 20-foot stick of 16" DIP. This was observed from my vehicle during the start of the Thursday meeting. After installation of the pipe, Ludlow began close-up and clean-up activities and shut down operations due to the rain. Traffic detail was provided by CT State Police. Traffic on Main Street was restricted to one lane in the construction zone.

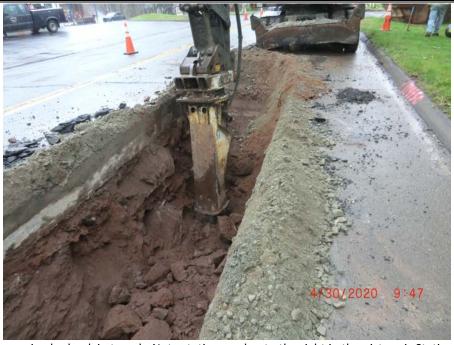
Picture 5: Ludlow hammering bedrock in trench. Note station marker to the right in the picture is Station 174+50. View facing south. Durham, CT.

0945: Ludlow is underway on Main Street. Starting at 174+23, they had already excavated approximately 30 feet of trench and are currently hammering bedrock which appeared to run approximately 4-5 feet below grade and from approximately 174+35 to 174+50.

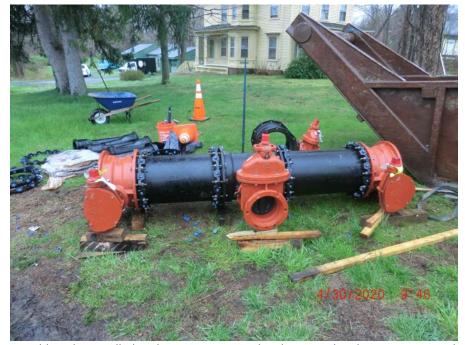
Figure 6: Three valve assembly to be installed at the intersection with Talcott Road and Main Street, Durham. Two 16" butterfly valves either side and an 8" gate valve facing the camera.

Ludlow placed on 20-foot stick of unrestrained 16" DIP from Station 174+23 to Station 174+43. There were no corporation stops due to the short distance and lack of houses between the current position and the intersection with Talcott Road, Durham Meadows, CT. There is roughly another 40-60 feet to go to reach the intersection where a 16"x16"x8" valve assembly will be installed. The assembly has 2 16" butterfly valves and one 8" gate valve. The structure is 6 feet in length.

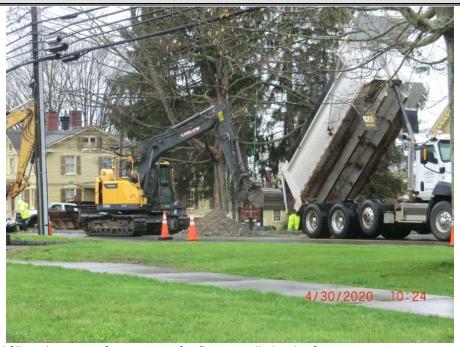
Figure 7: Backfilling the one 20-foot section of 16" DIP installed today from Station 174+23 to Station 174+43.

Compaction testing was performed today at essentially one location along the 20-foot of pipe installed. Due to the sloped access to trench for drum compactor, the testing agent ran the first two test such that they covered the first 3 lifts. The last two test were for the last two lifts.

Compaction Data for 4-30-20				
Percent Percent				
Station	Compaction	Moisture Content		
	98.5	3.8		
173+58 to 174+32	97.3	3.5		
	97.8	3.9		
	99.4	3.8		
	_	_

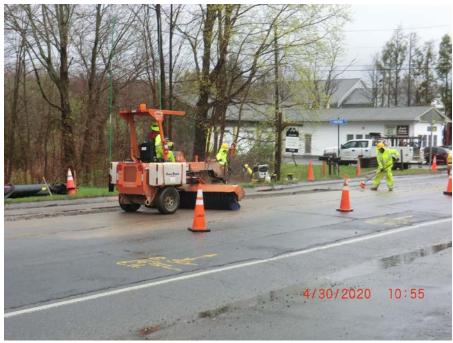
Figure 8: Clean-up operations along Main Street Durham.

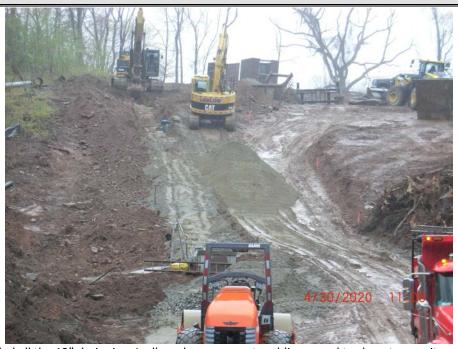
Figure 9: Having installed all the 12" drainpipe, Ludlow changes over to adding gravel to slope to sure it up and allow truck access up the slope.

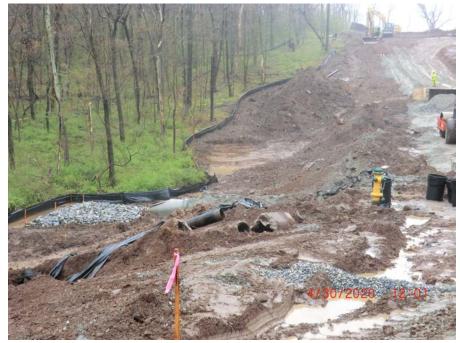
Figure 10: Facing east, silt fencing in good shape along the north (lower) side of the slope.
