Daily Report

Project:	Durham Meadows Pipeline Installation	Date:	May 8, 2020
Location:	Main Street, Durham and shared access road, Middletown, CT	Day of Week:	Friday
Project #:	AECOM: 6061487	Report No:	74
Contractor:	Ludlow Construction	Page:	2 of 10

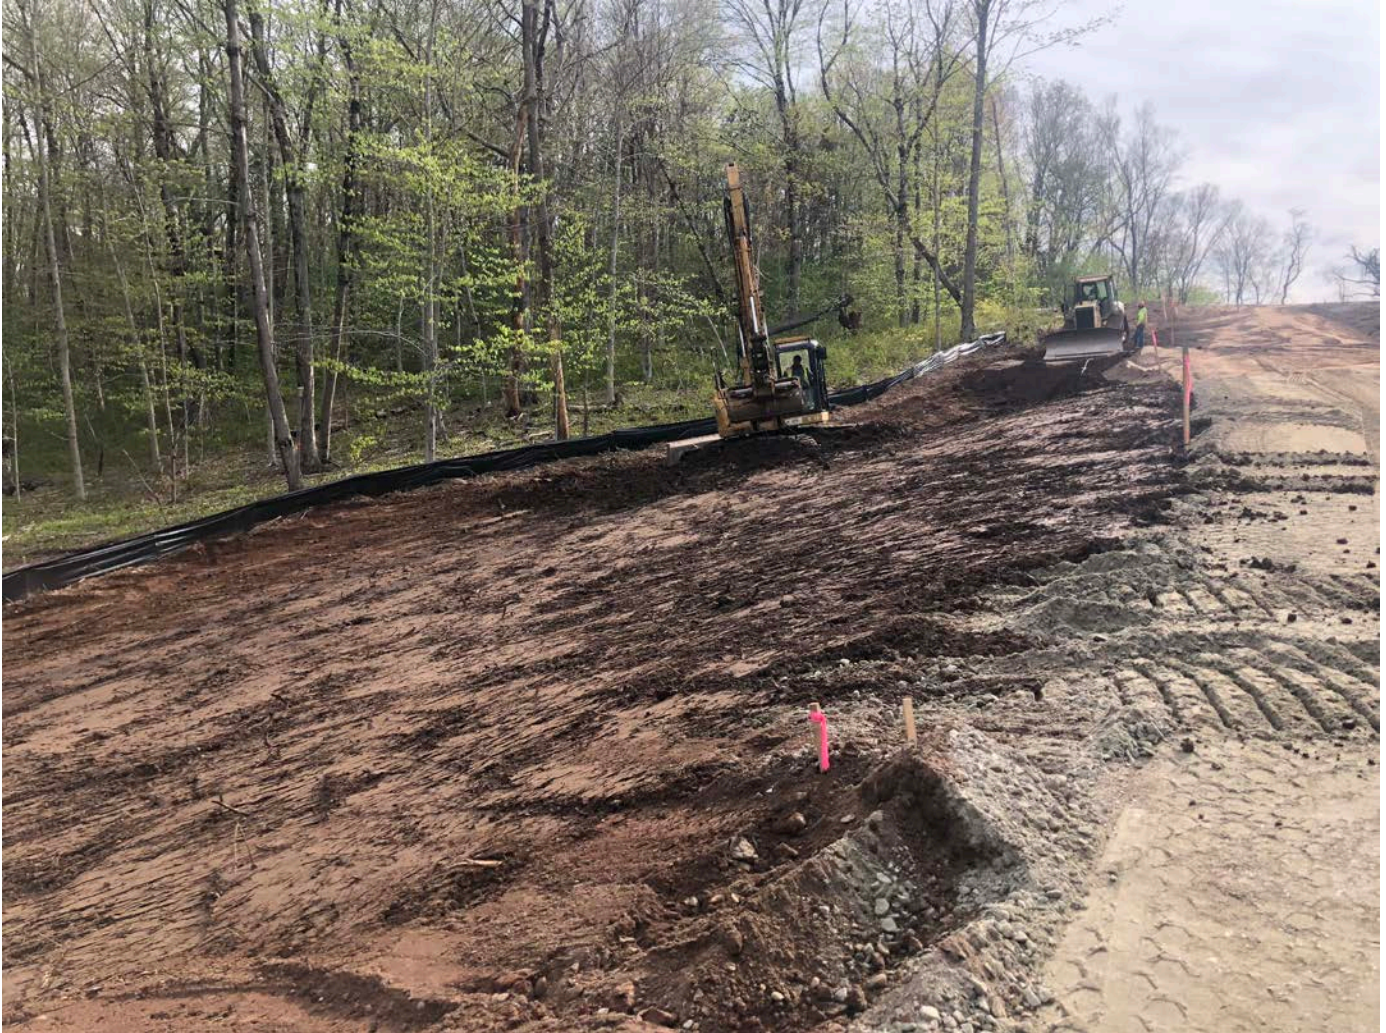
Picture 1: Ludlow filling and grading along the north side of the shared access road. View to the east. Middletown, CT.

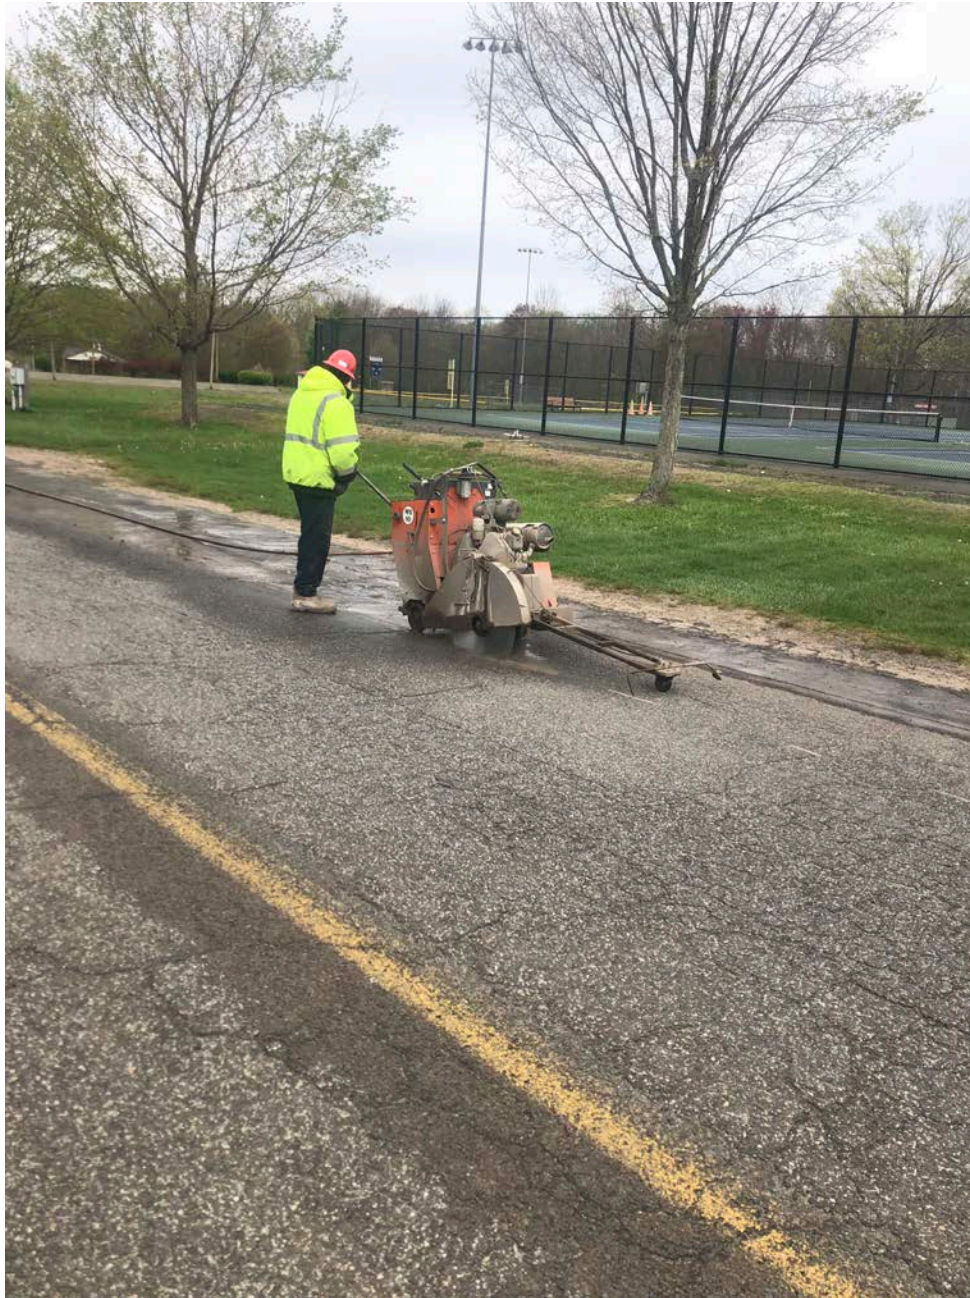
Picture 2: Ludlow saw cutting pavement at Station 521. View to the northwest. Pickett Lane, Durham, CT.

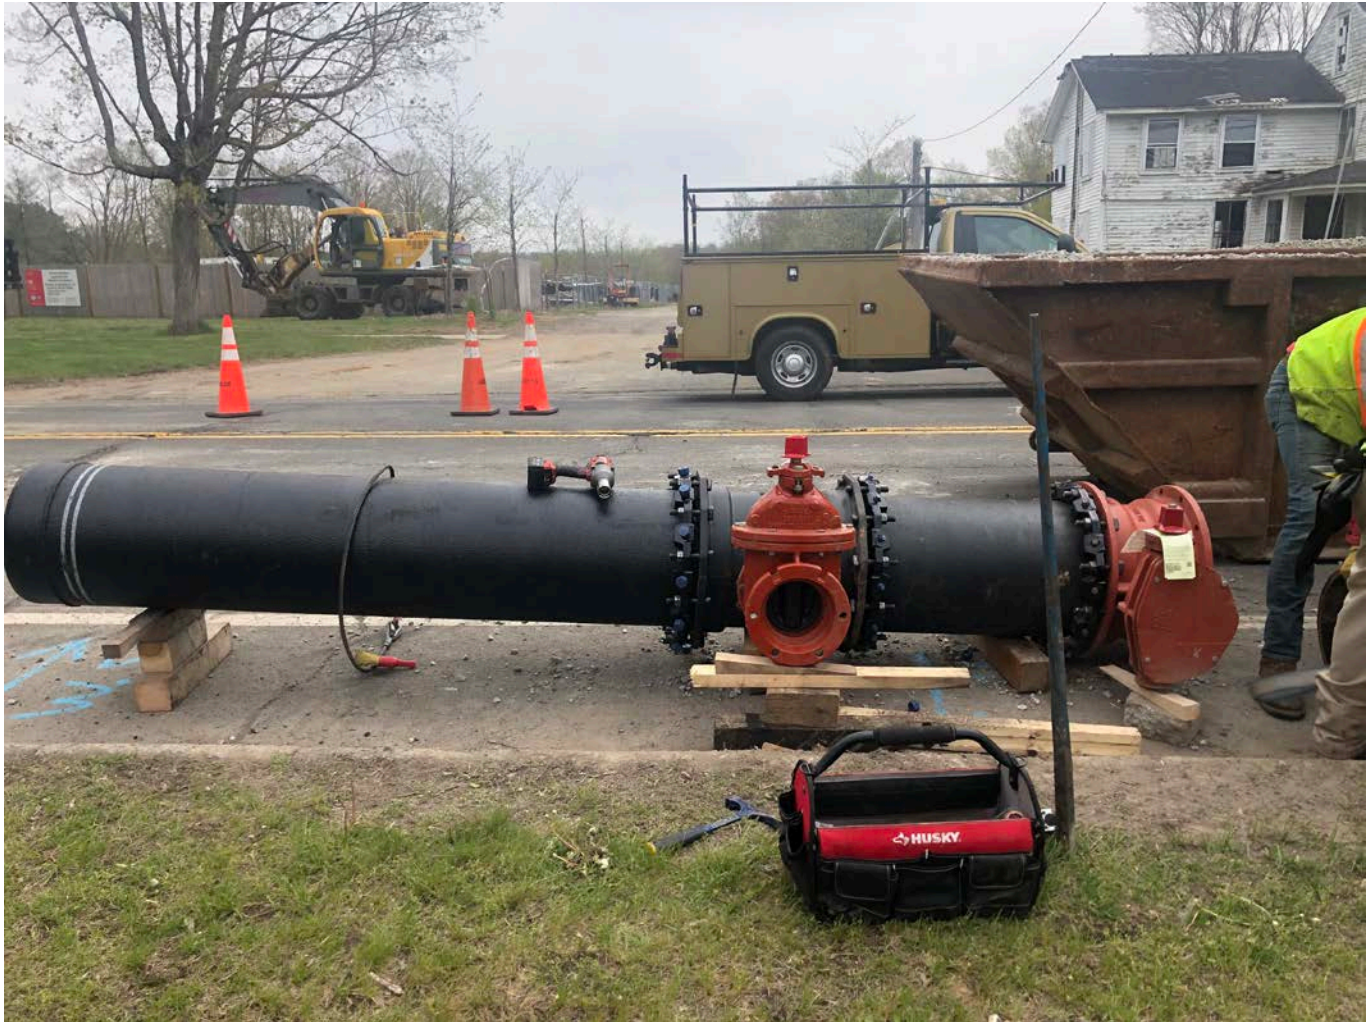
Picture 3: 16" x 6" M.J. C.D.L.I. hydrant Tee with a 6" gate valve and valve box and a 16" M.J butterfly valve and valve box being assembled to place at Stations 183+57.5 and 183+61, respectively. Main Street, Durham, CT.

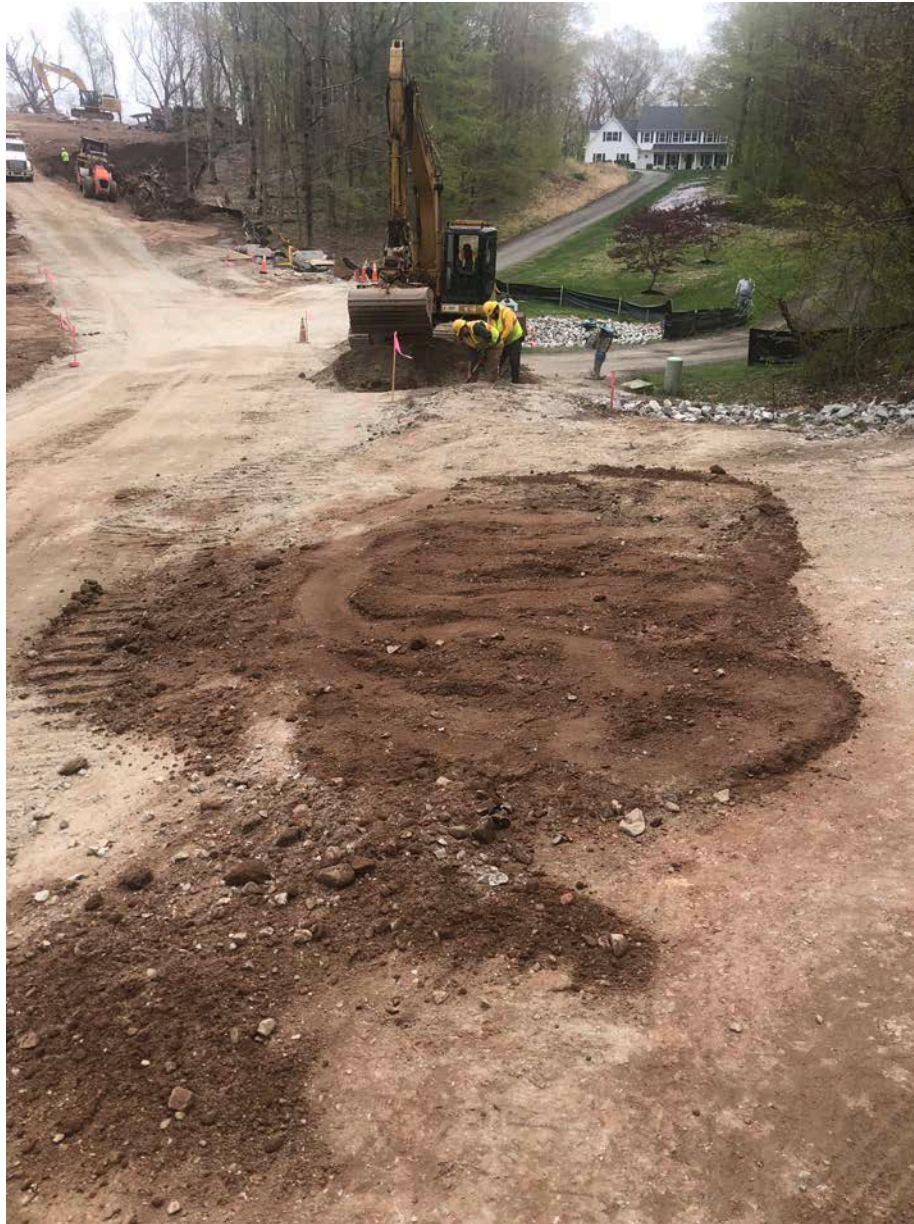
Picture 4: Ludlow digging test pits in front of the driveways for 216 and 224 Talcott Ridge Drive to locate utilities. View to the east. Middletown, CT.

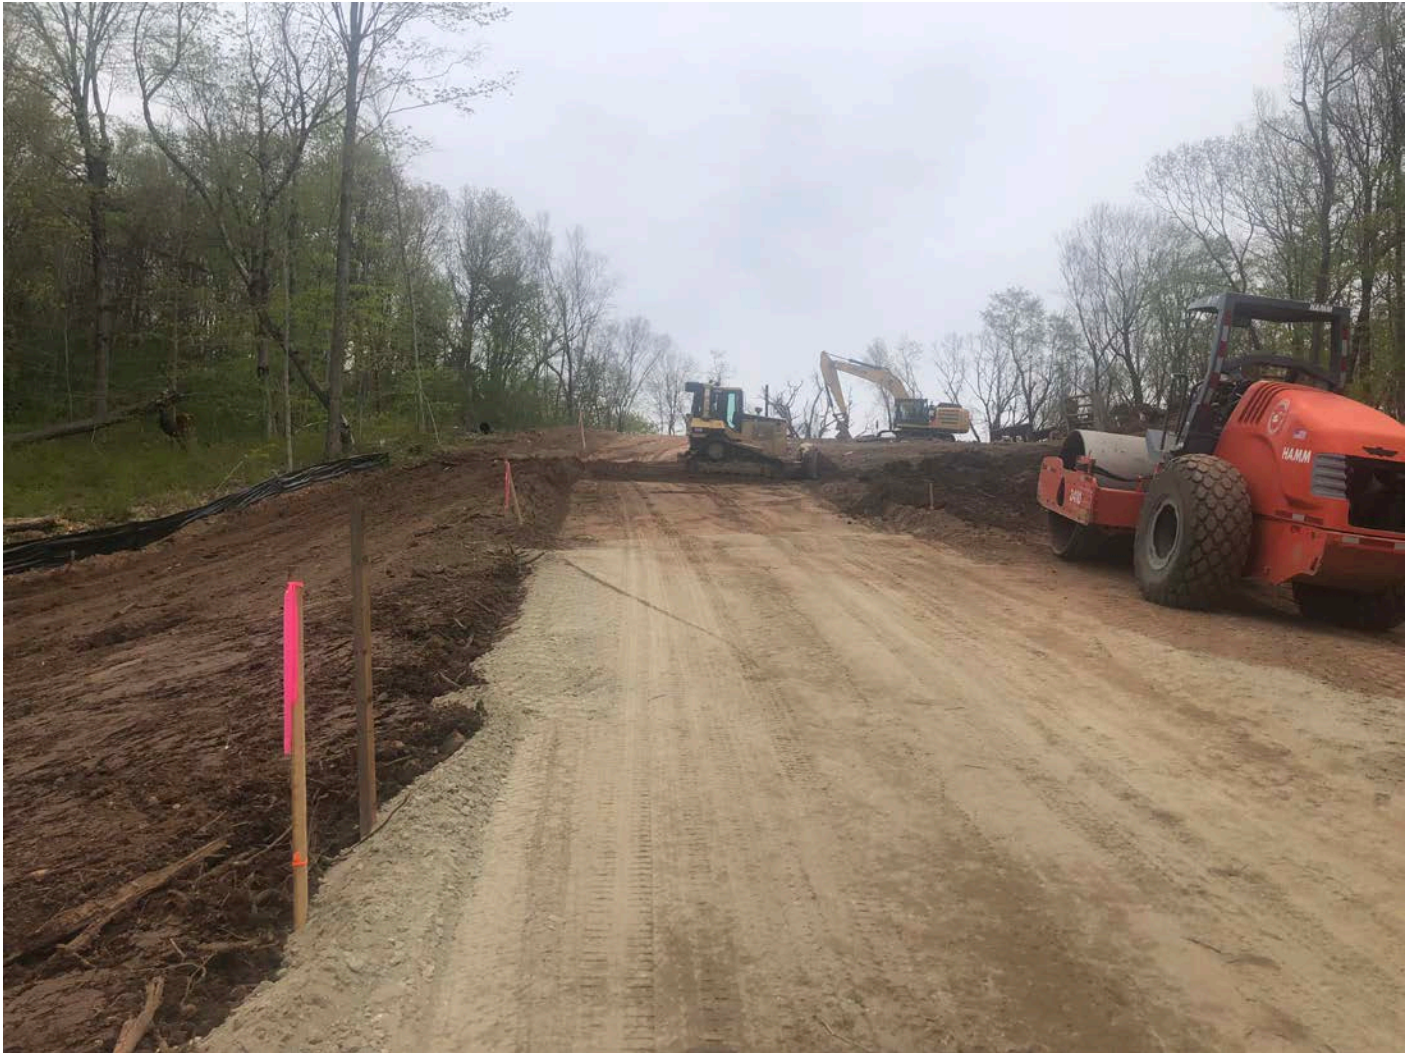
Picture 5: Ludlow working on the shared access road and the adjacent area to the north. ~Station 11+70. View to the east. Middletown, CT.

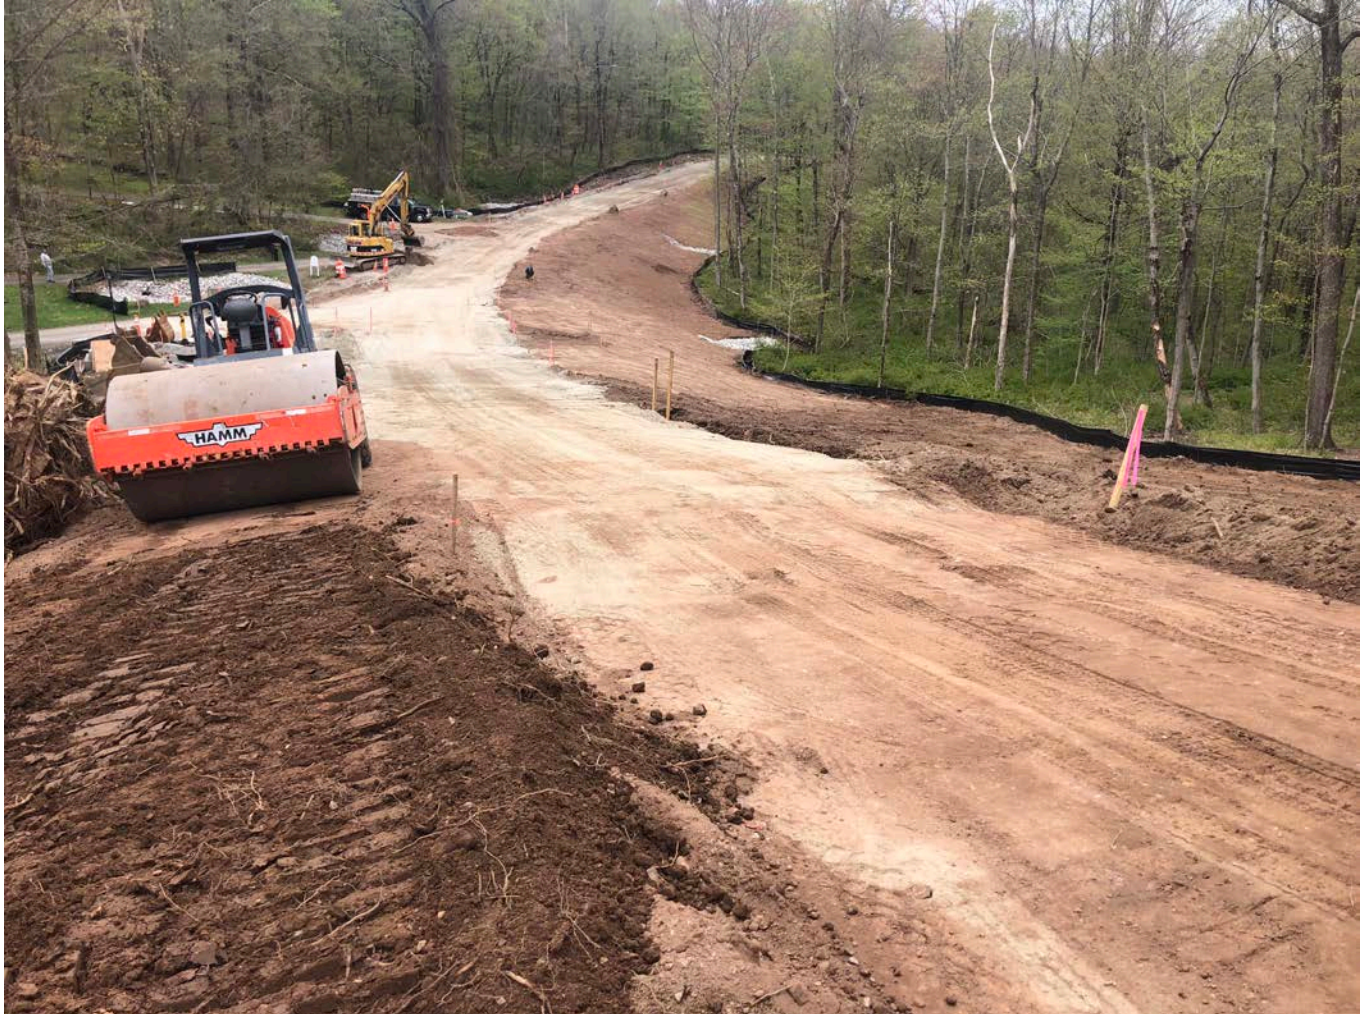
Picture 6: Overview of progress on the shared access road. View to the west. Middletown, CT.

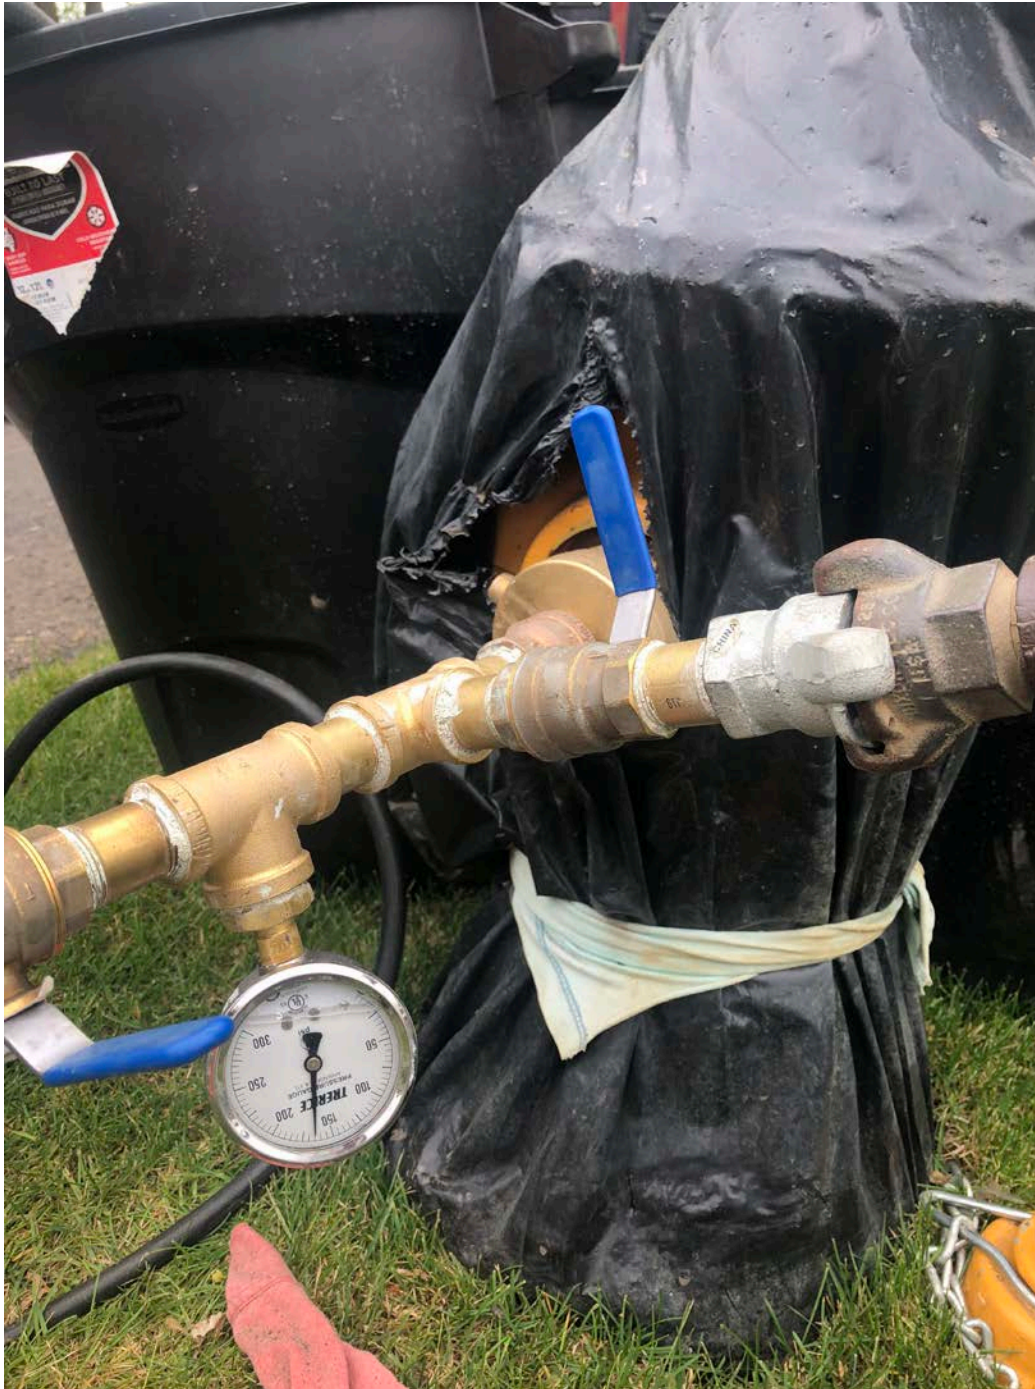
Picture 7: Final pressure reading for the line running from Parsons Lane and Winsome Road (Winsome Road hydrant). Durham, CT.
