Daily Report

| Project: | Durham Meadows Pipeline Installation | Date: | May 12, 2020 |
| Project #: | AECOM: 6061487 | Report No: | 76 |
| Contractor: | Ludlow Construction | Page: | 1 of 10 |

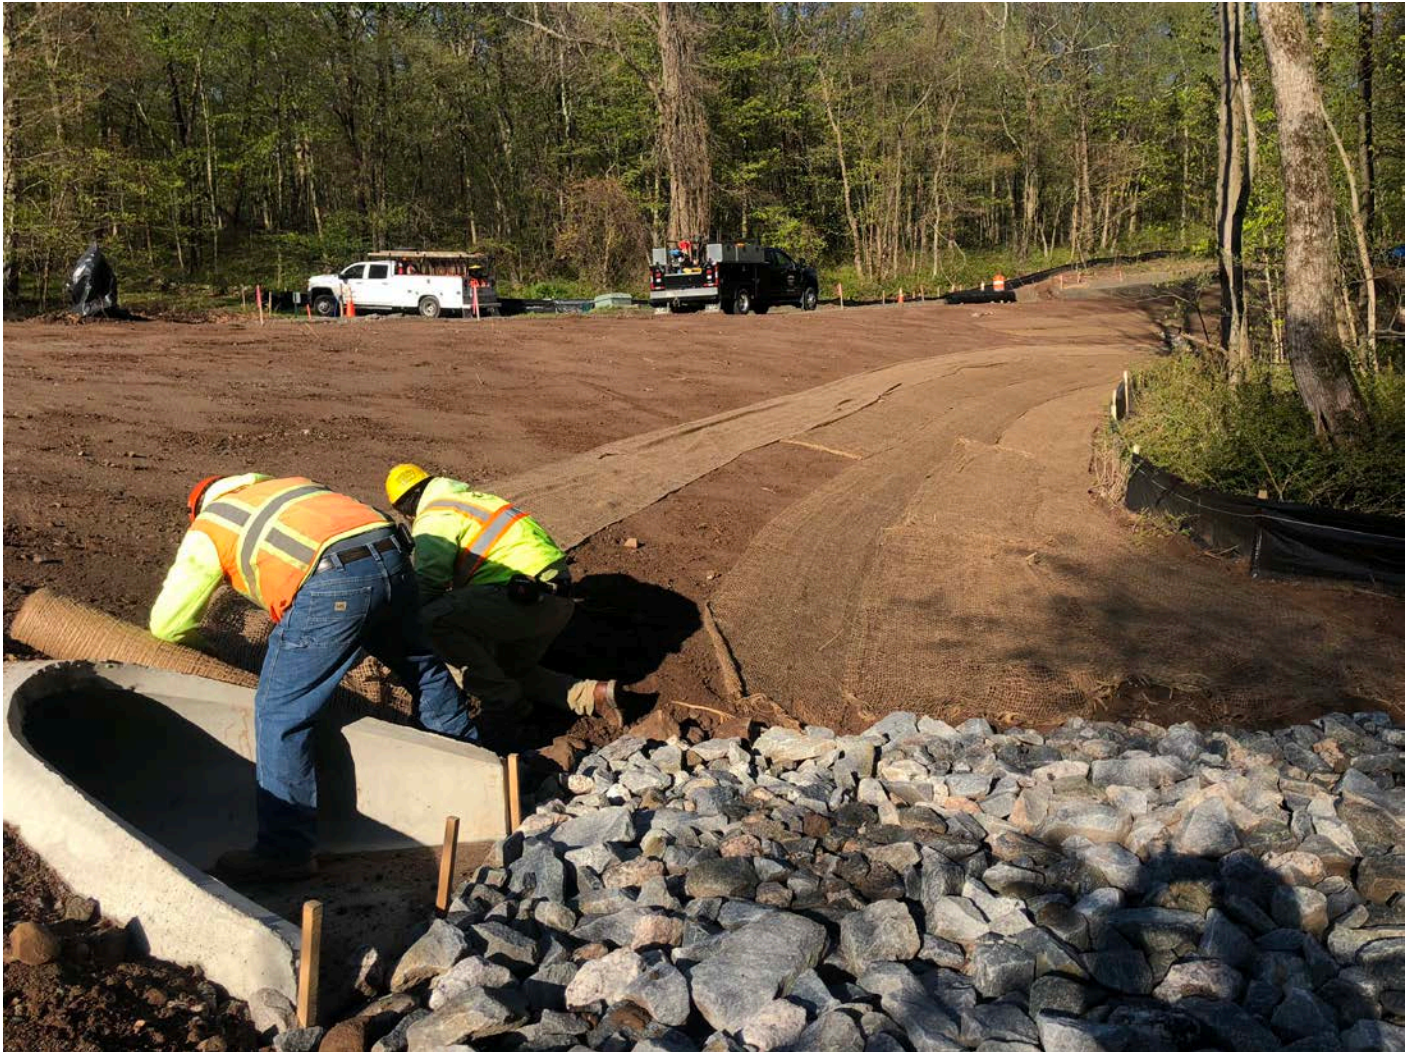
Picture 1: Ludlow placing jute erosion control cloth on the north side of the shared access road at ~Station 14+40. View to the west. Middletown, CT.

0735: Ludlow placing jute erosion control cloth on the northern side of the shared access driveway.

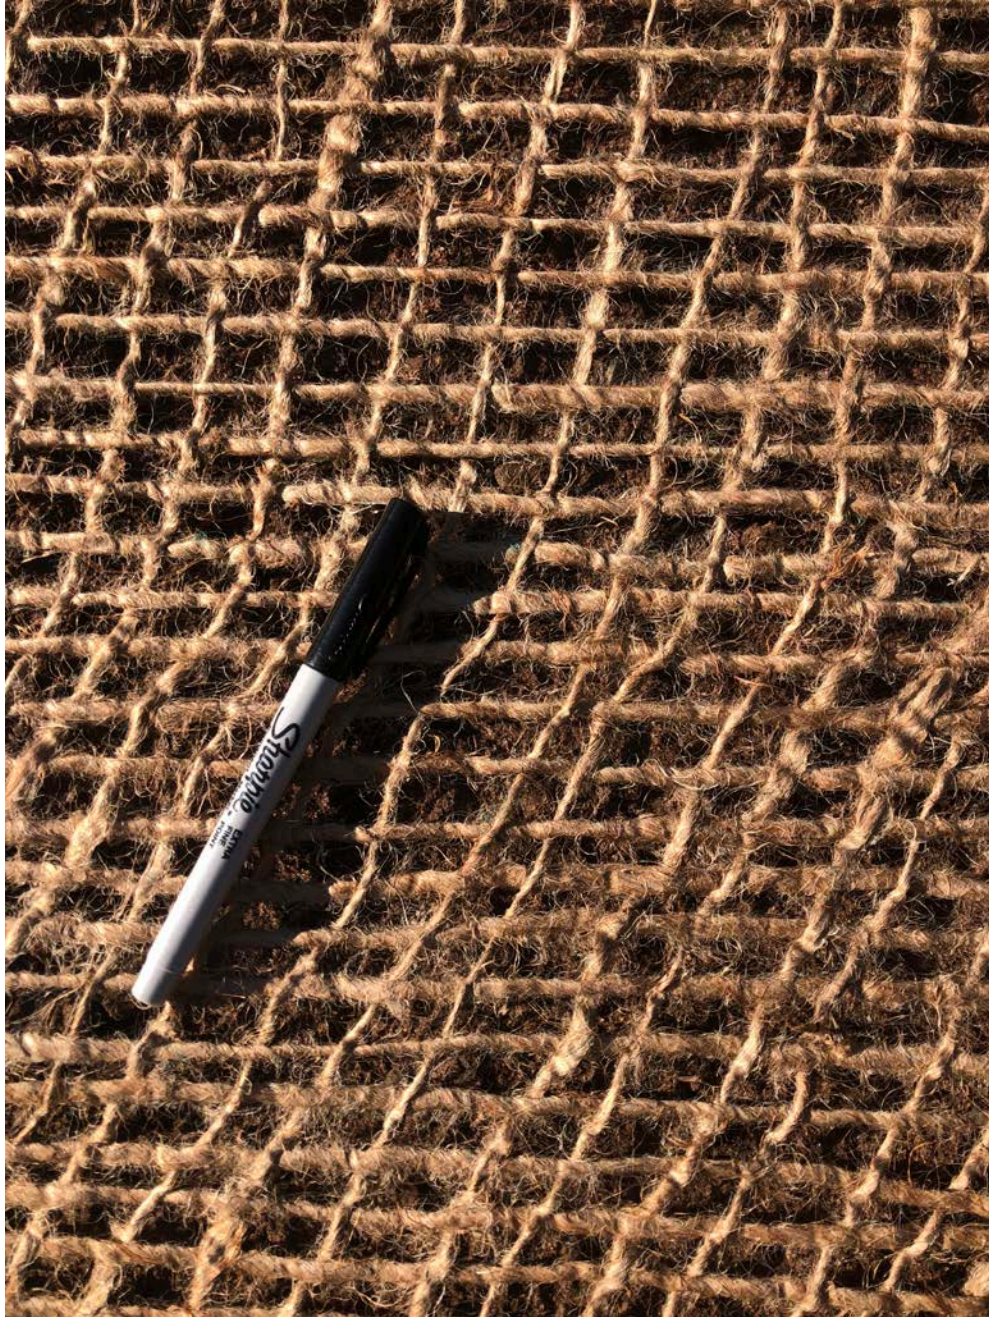
Picture 2: Close-up of jute erosion control cloth that Ludlow is placing north of the shared access road. Middletown, CT.

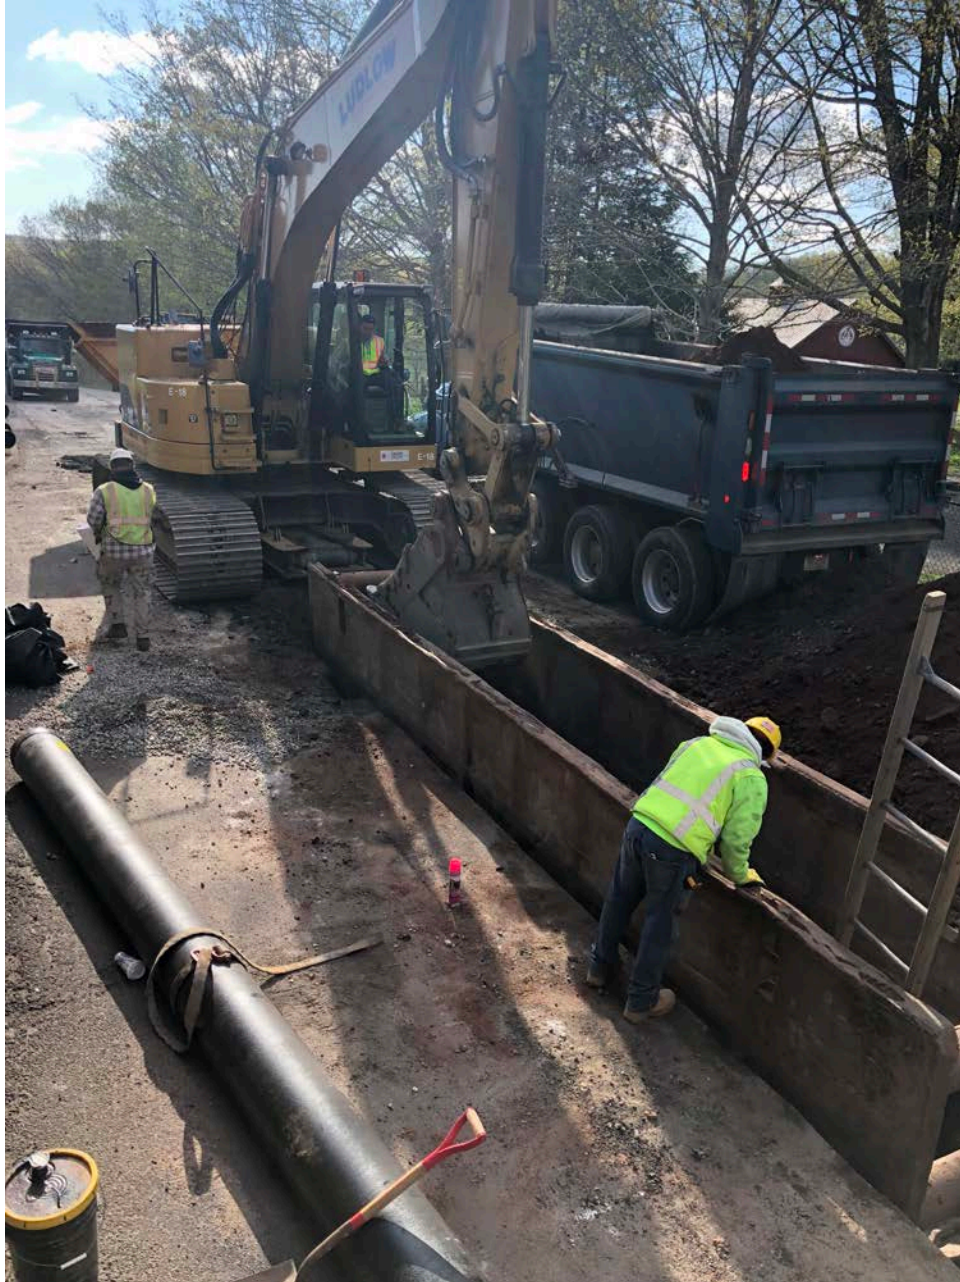
Picture 3: Ludlow placing 12" DIP. View to the southeast. Pickett Lane, Durham, CT.

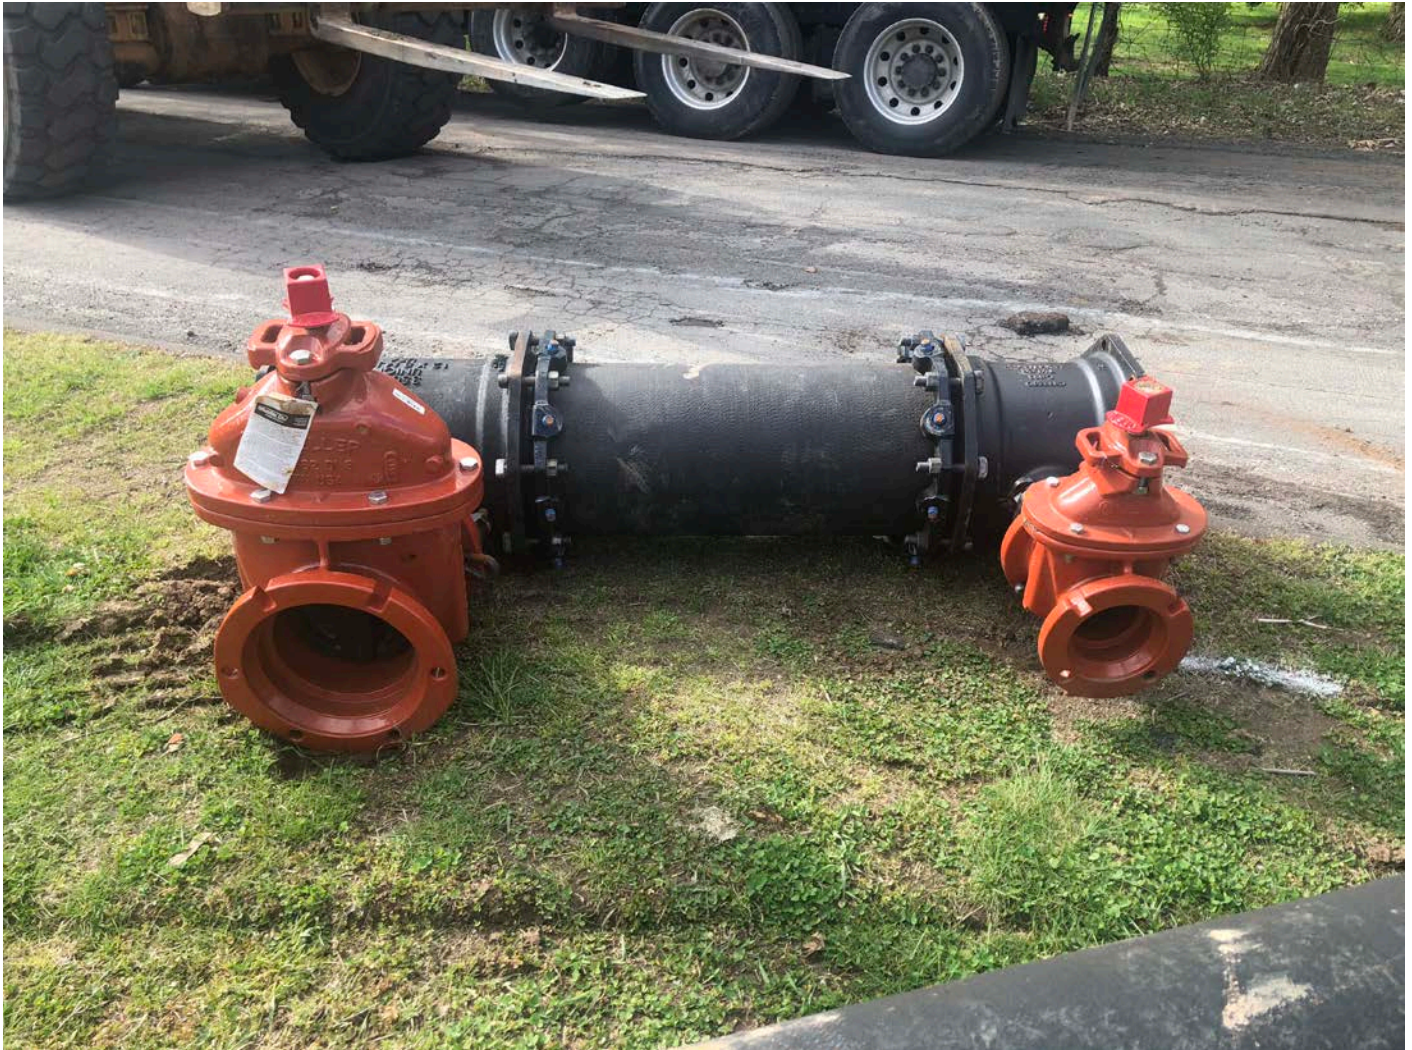
Picture 4: 12"x12"x4" M.J. TEE with 4" M.J. R.S. gate valve and gate box that Ludlow installed at Station 503+70 and a 12"x12"x8" TEE with 8" M.J. R.S. gate valve and gate box that Ludlow installed at Station 503+77. Pickett Lane, Durham, CT.

1150: Ludlow placing a 12"x12"x4" M.J. TEE 12"x12"x4" M.J. TEE with a 4" M.J. R.S. gate valve and gate box at Station 503+70. Ludlow also placing a 12"x12"x8" TEE With 8" M.J. R.S. gate valve and gate box at Station 503+77.

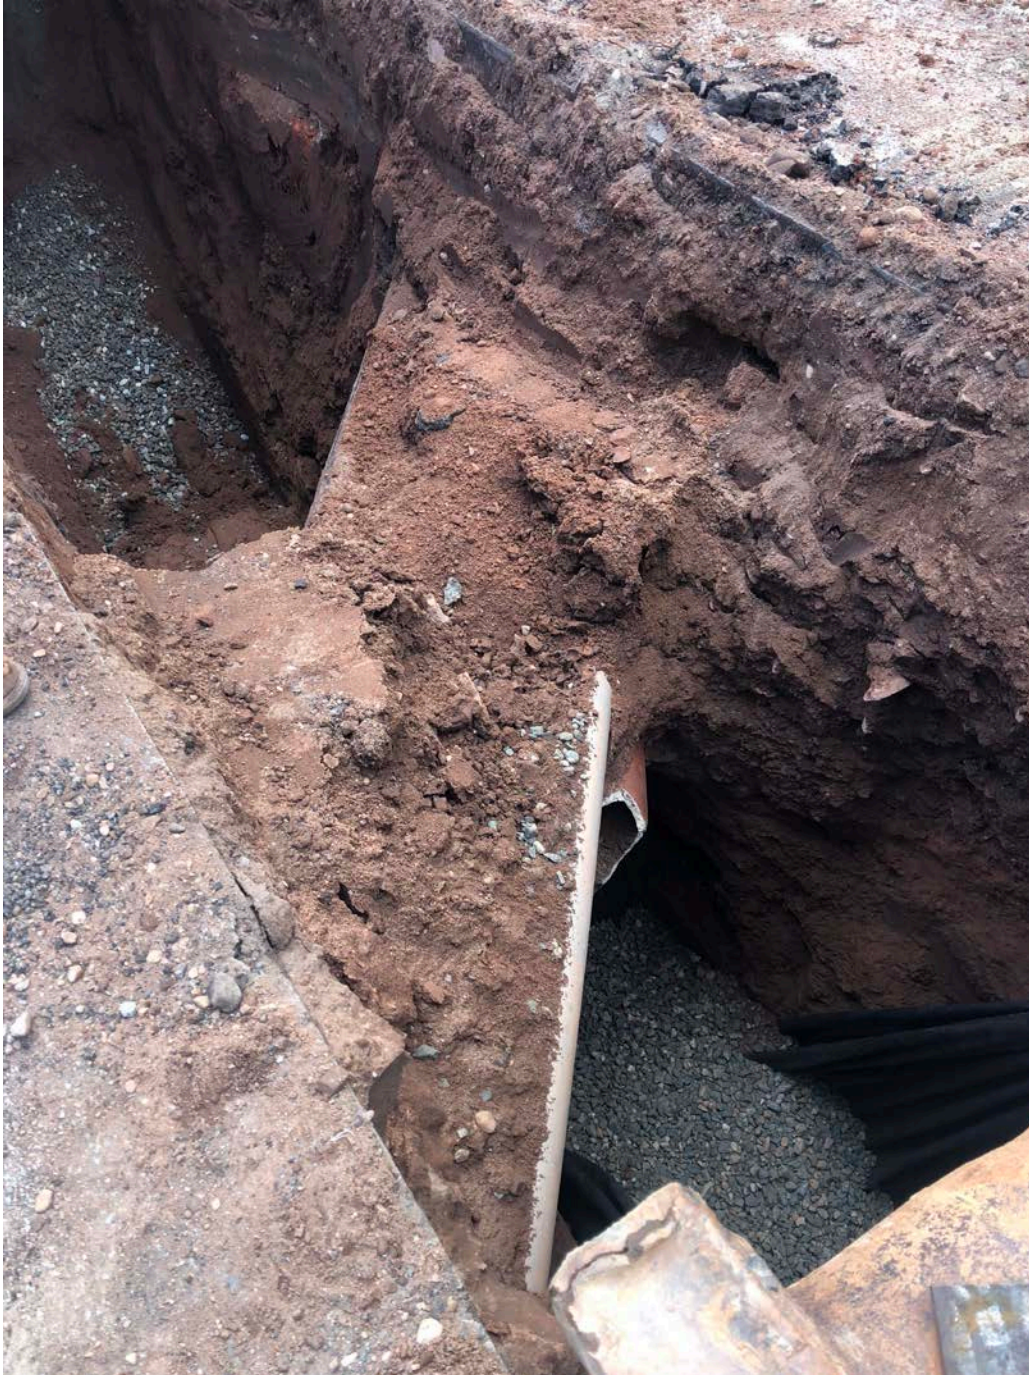
Picture 5: Utilities daylighted at Station 503+50: two conduits of 4" PVC and an 8" clay pipe beneath the PVC that was damaged during excavation. Durham, CT.

0938: Ludlow has utilities daylighted at Station 503+50. There are two conduits of 4" PVC and an 8" clay pipe that runs beneath the PVC conduits. The clay pipe was broken in the process of excavation. Ludlow prepares to fix the broken pipe with a section of schedule 80 PVC and two Fernco boots.

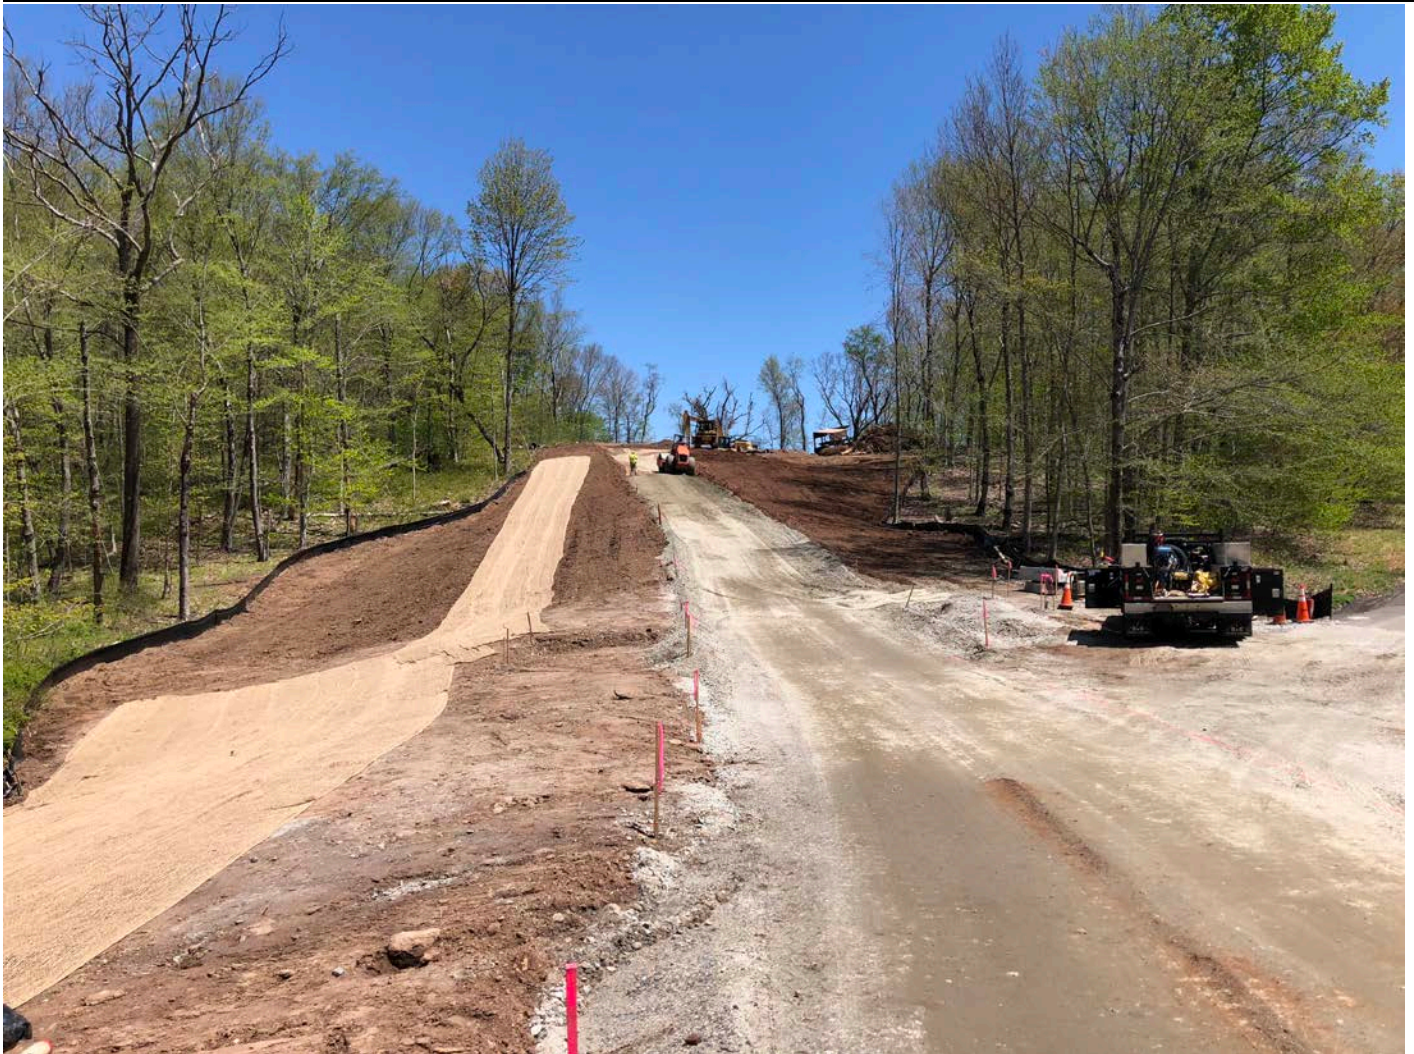
Picture 6: Overview of progress at the shared access driveway. View to the east from ~Station 15+00. Durham, CT.

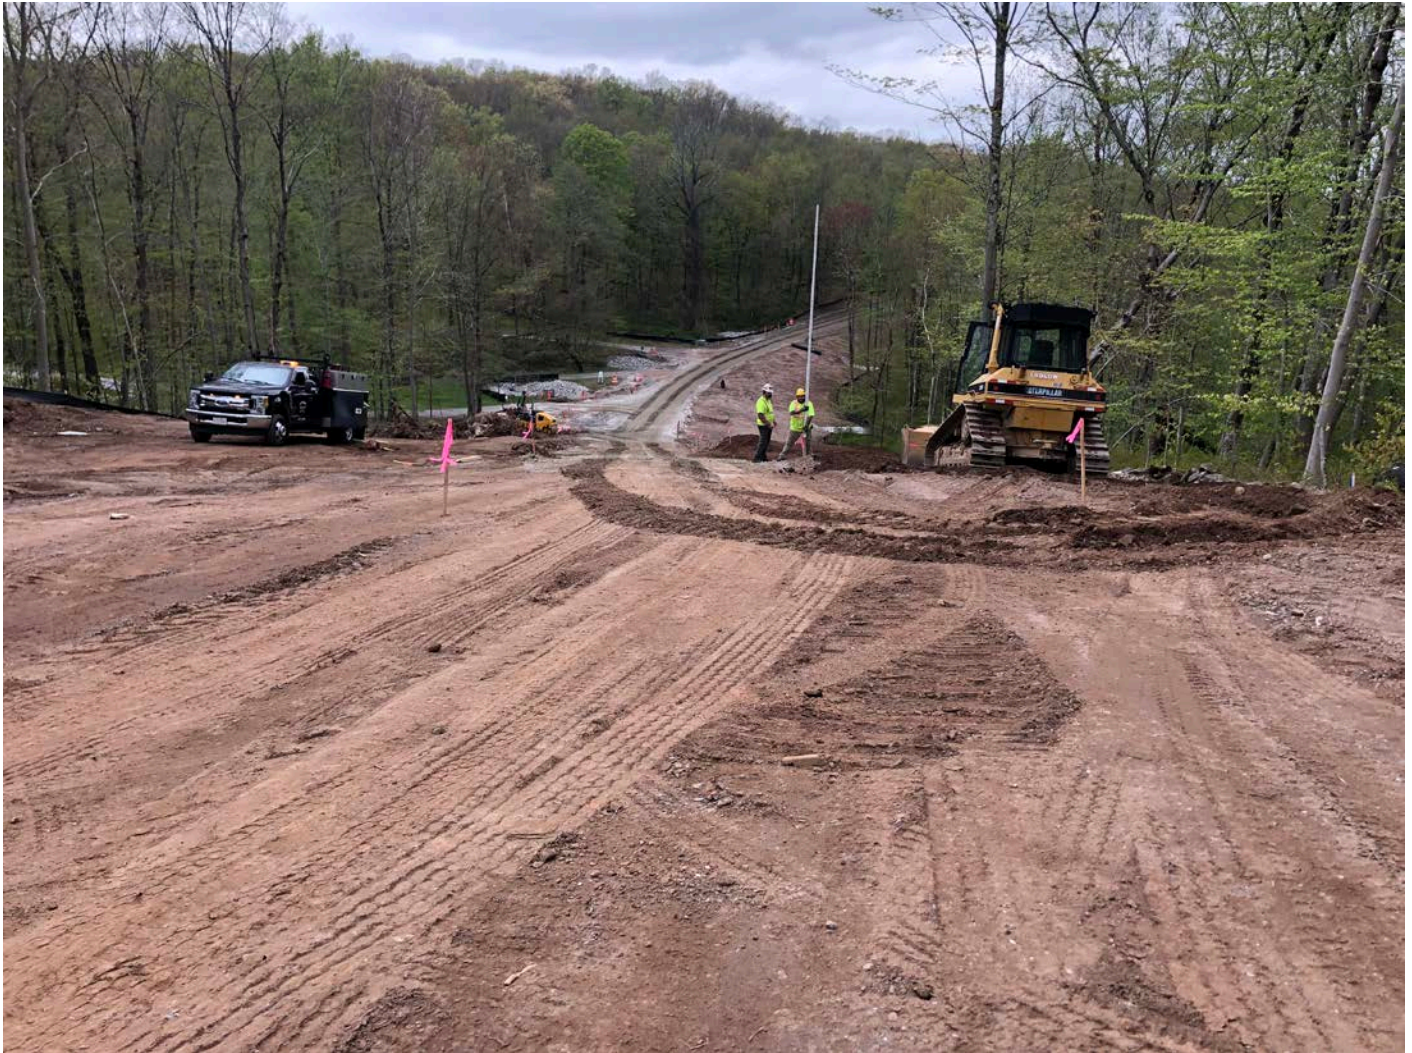
Picture 7: Overview of progress on the shared access driveway from ~10+00. View to the west. Middletown, CT.
