Daily Report

Project:	Durham Meadows Pipeline Installation	Date:	May 19, 2020
Location:	Pickett Lane, Durham; Main Street, Durham; and shared access road, Middletown, CT	Day of Week:	Tuesday
Project #:	AECOM: 6061487	Report No:	80
Contractor:	Ludlow Construction	Page:	1 of 11

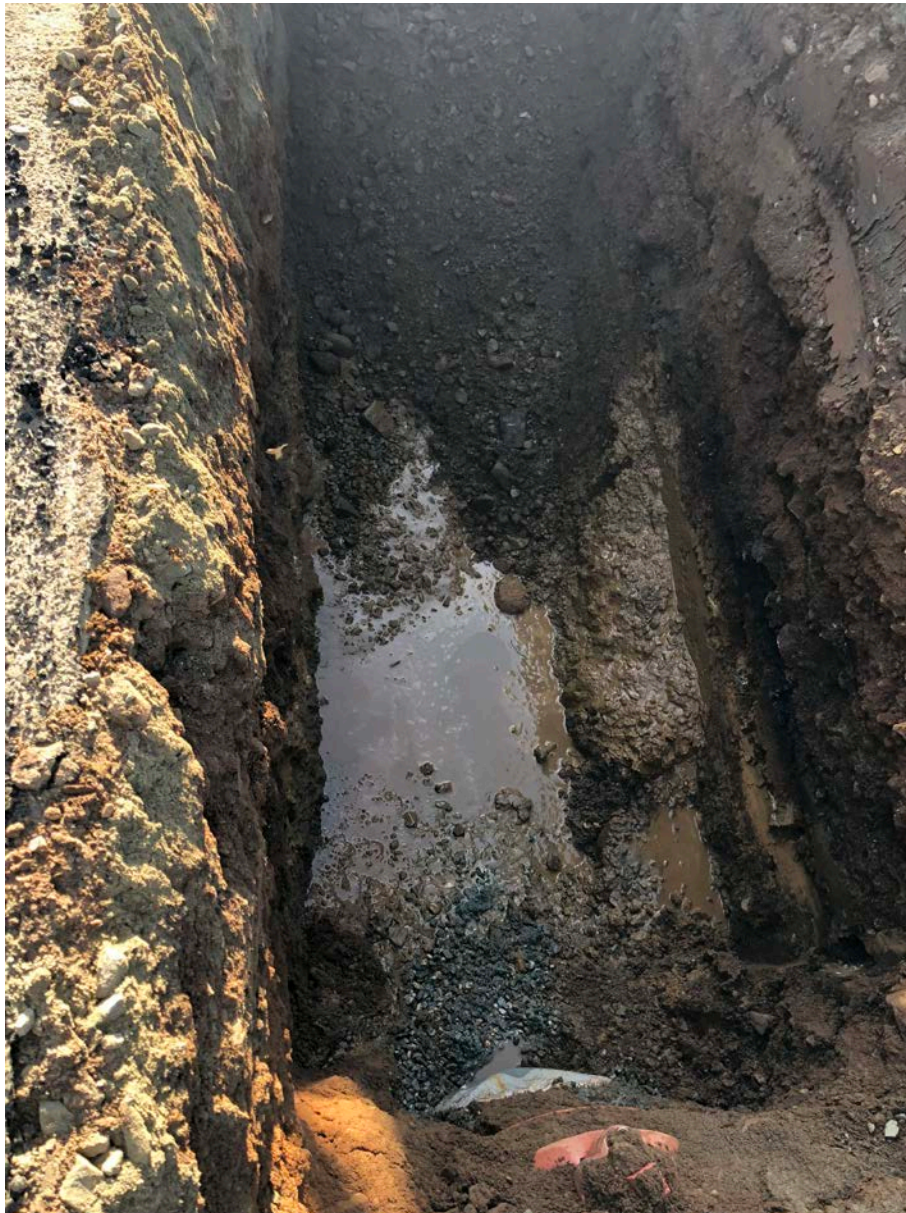
0717: Ludlow daylighting the end of pipe at Station 518+38, where they will resume the placement of 12" DIP. Water is encountered at bottom of trench but not enough to pump out. Ludlow reports having seen a similar amount of water in portions of the trench yesterday.

Picture 1: Water observed in bottom of trench on Pickett Lane at ~ Station 518+38. View to the southeast. Middletown, CT).

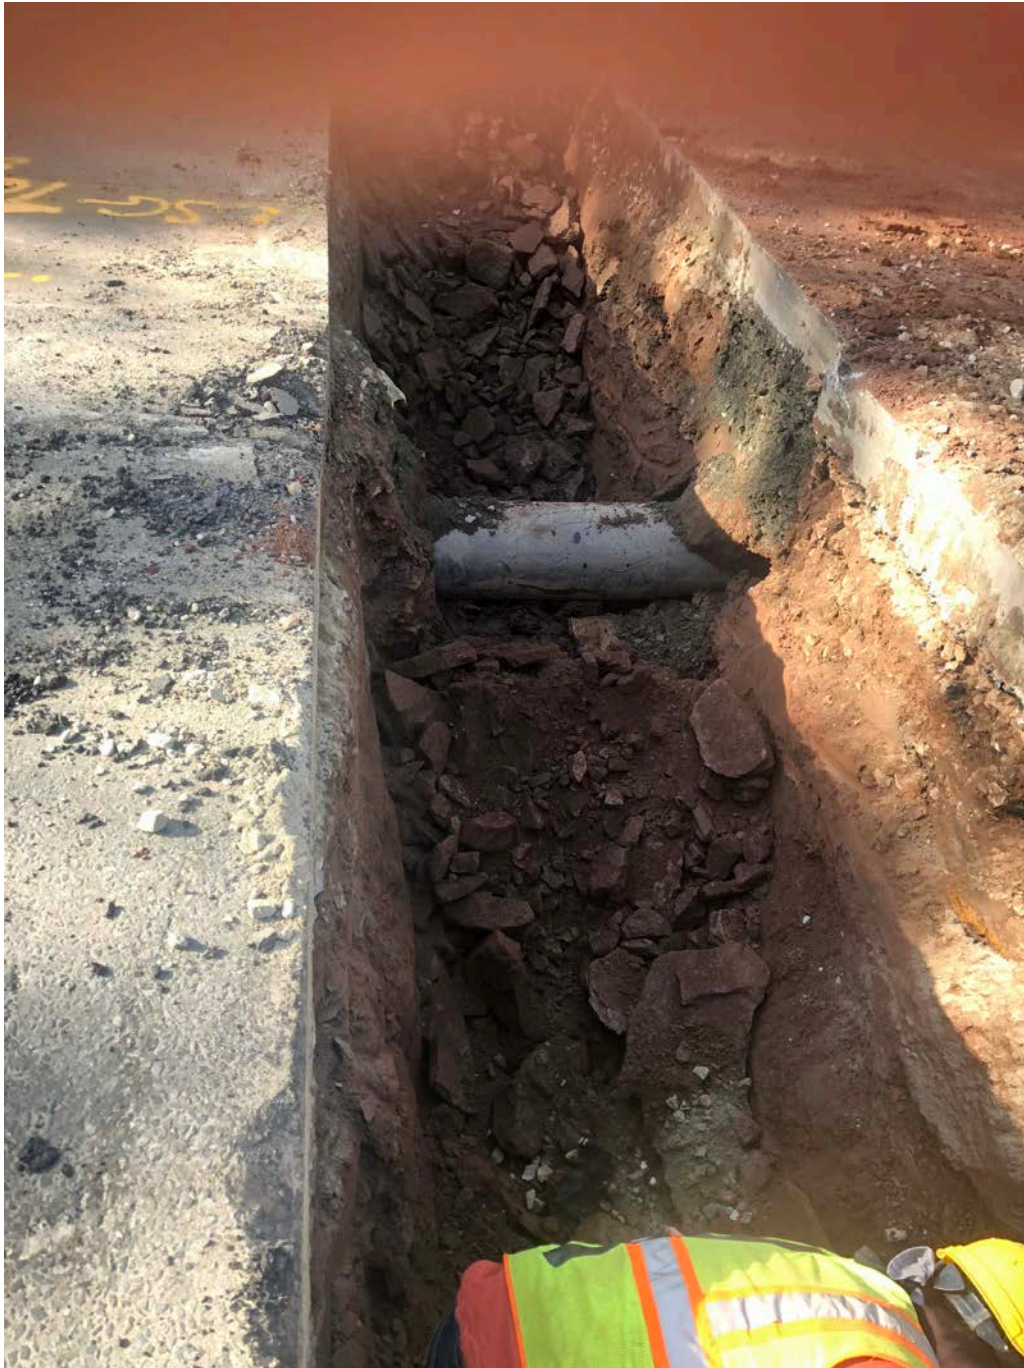
0825: Ludlow has about 20' of trench open at the intersection of Main Street and Route 68. They have daylighted a 16" gas line coming into Main Street from Route 68. Ludlow has had to hammer rock for all portions of the trench so far today. JTC is on site to perform compaction tests.

1000: Ludlow hammering rock in the trench at Station 195+65 (intersection of Route 68 and Main Street). Ludlow has placed a 20' section of 16" DIP underneath the 16" gas line.

Picture 2: High-pressure gas line at the intersection of Route 68 and Main Street. Ludlow had to hammer rock around the pipe. View to the south. Durham, CT.

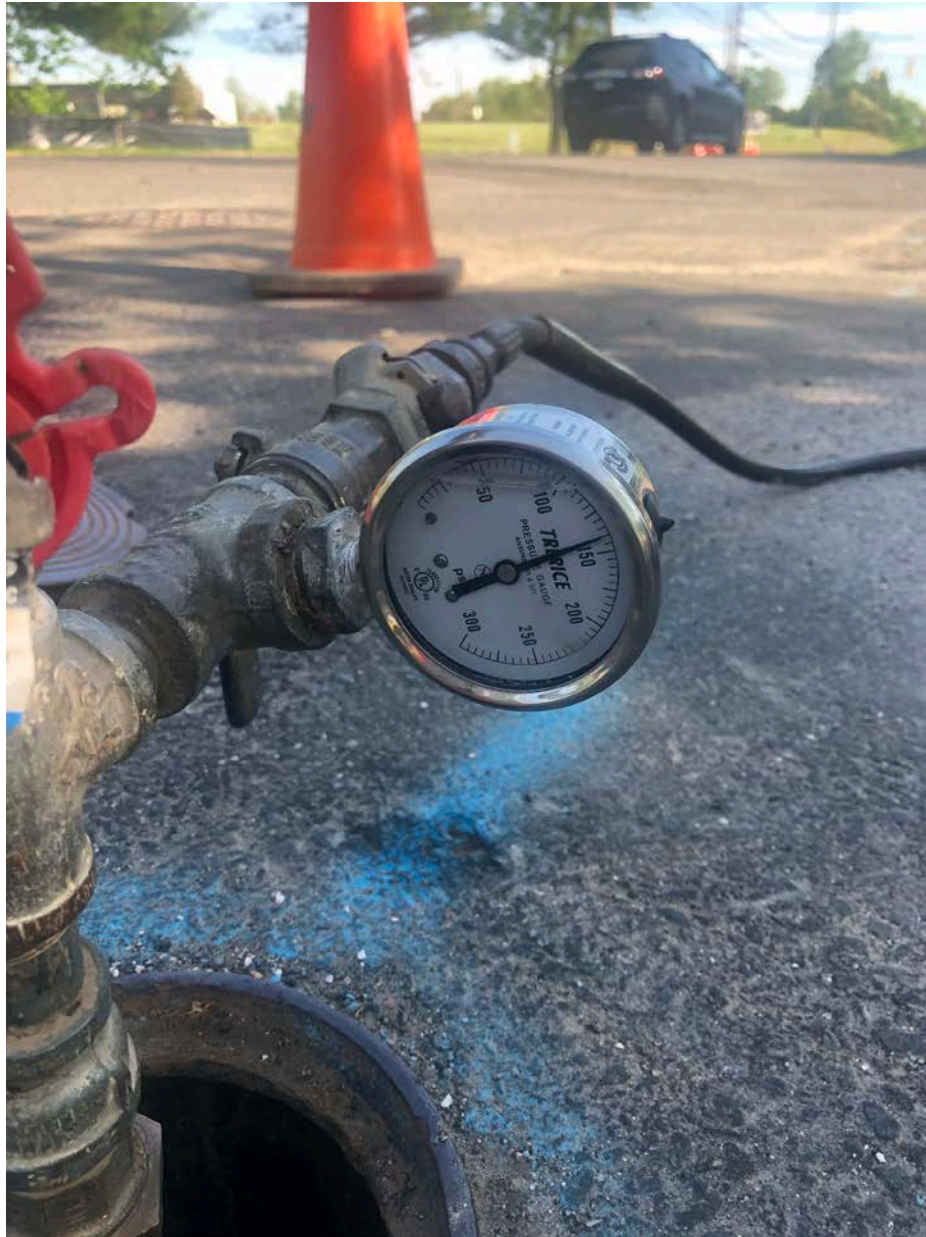
0900: On the pressure test at the intersection of South Main Street and Talcott Ridge Drive, an initial pressure of 150 psi has dropped to 140 psi. John Ewanowski said that the pressure test is engaging a 30 year old gate valve that might be losing water. He said it will be the City's discretion whether to allow this test to pass or fail.

1255: John Ewanoski from the City of Middletown Water and Sewer Department indicates that the final pressure for the 20' section pipe they tested today dropped to 135 PSI.

Picture 3: Pressure gauge for the pressure test performed on the water line located at the intersection of Talcott Ridge Drive and South Main Street. Middletown, CT. View to the north.

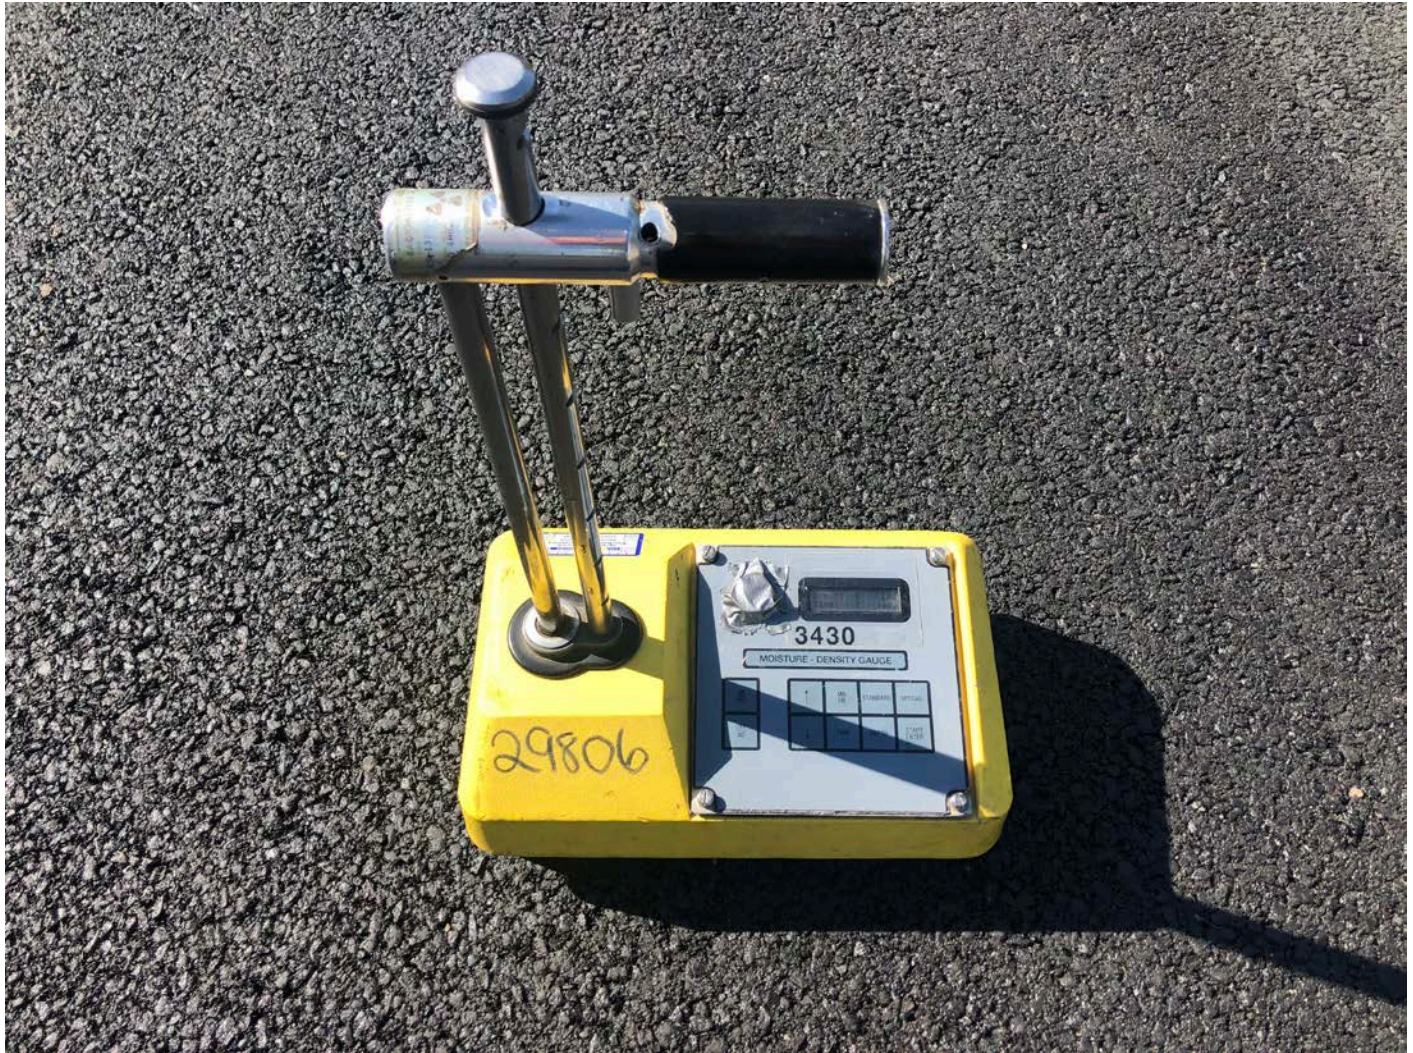
0907: JTC is performing compaction tests on the asphalt patching that was placed on May 18, 2020 on Talcott Ridge Drive.

Picture 4: JTC collecting compaction test data on the asphalt placed on May 18, 2020 on Talcott Ridge Drive.

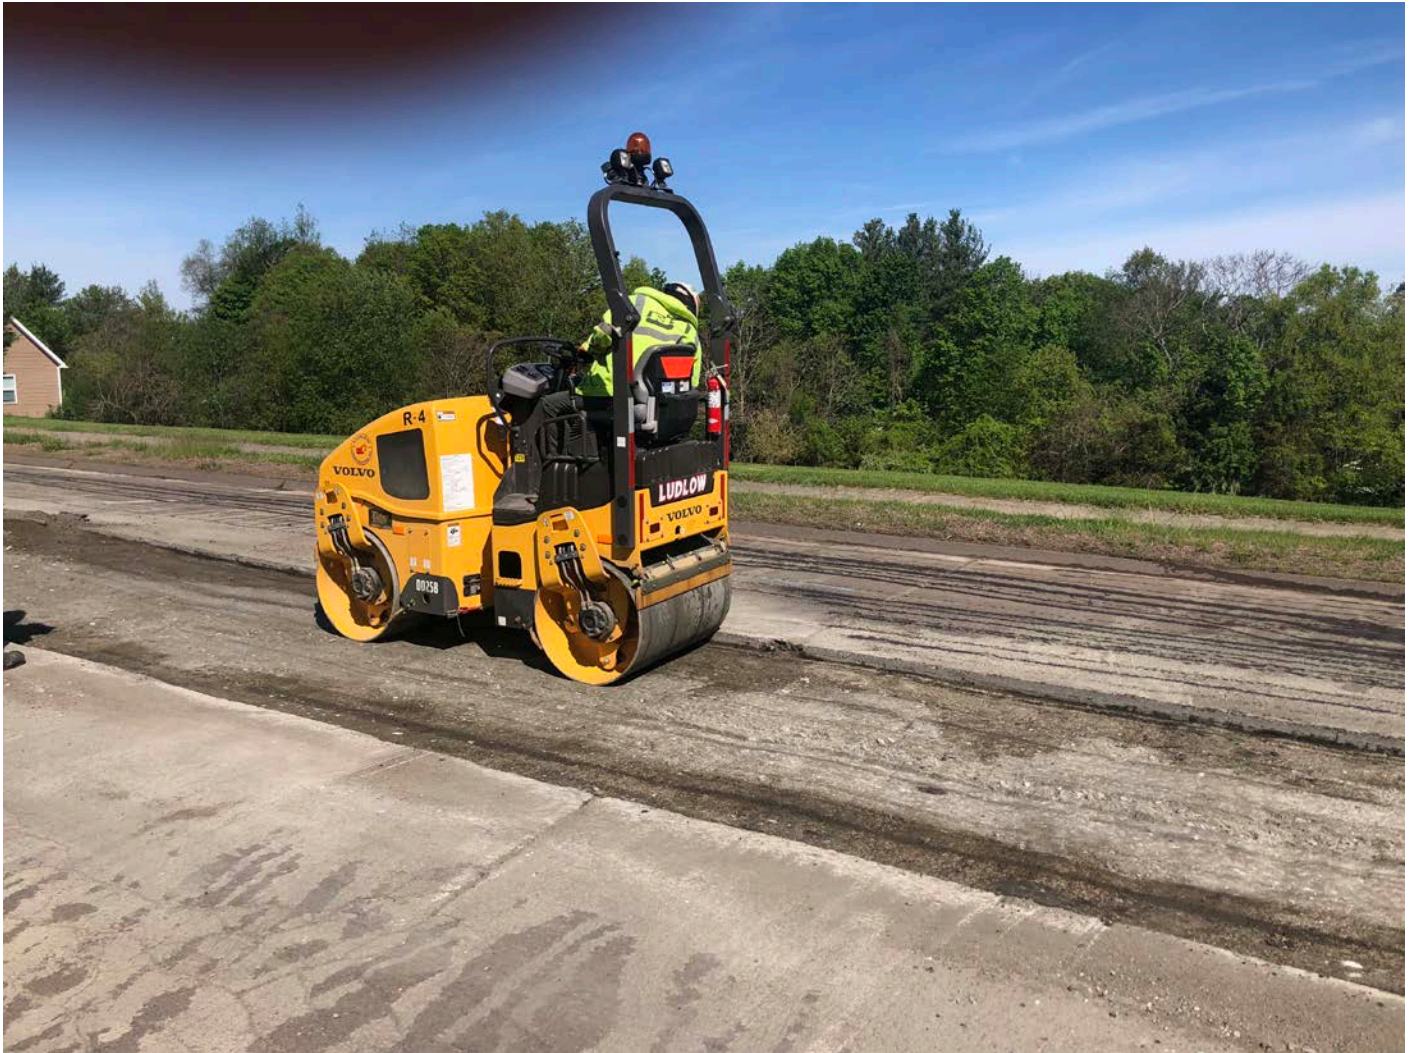
Picture 5: Ludlow compacting road base after having removed asphalt patch. Talcott Ridge Drive, Middletown, CT.

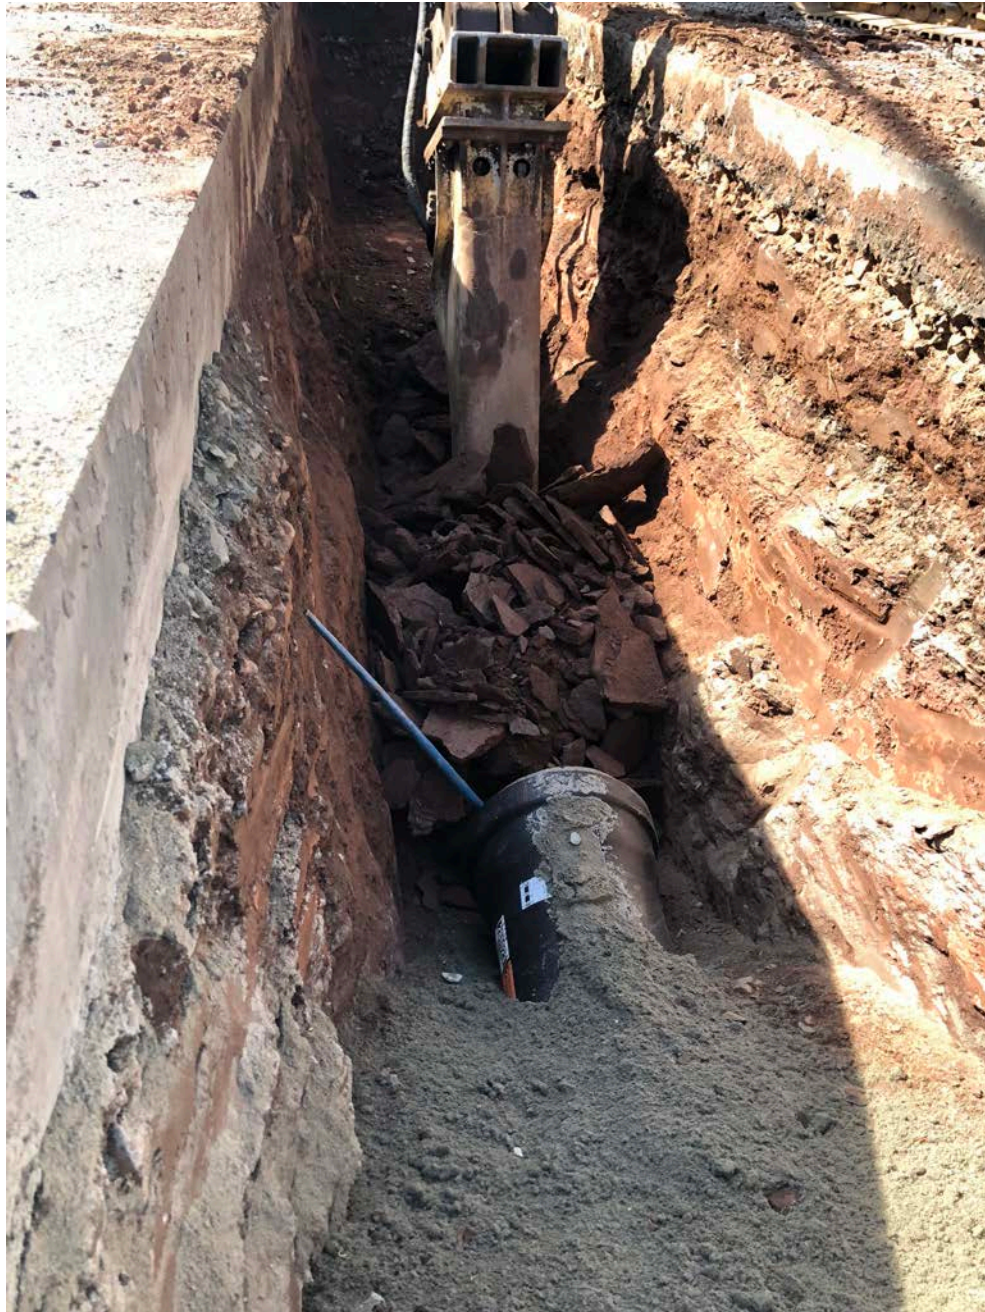
Picture 6: Ludlow hammering rock in the trench at Station 195+65 (intersection of Route 68 and Main Street). View to the south. Main Street, Durham, CT.

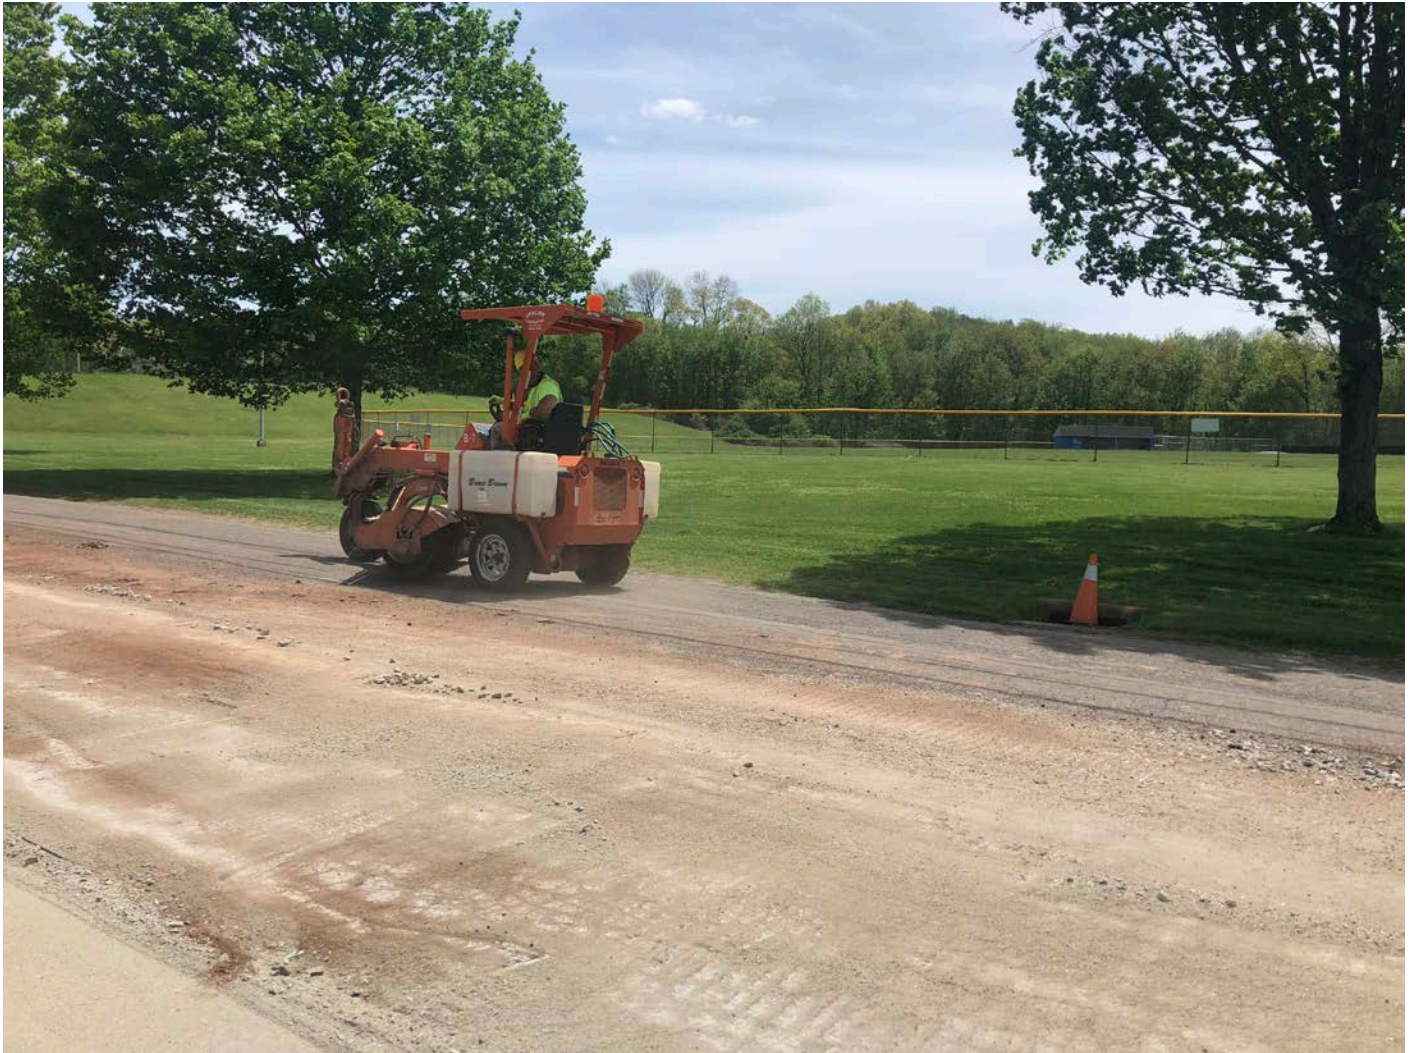
Picture 7: Ludlow cleaning up Pickett Lane with the Bocce Broom. Durham, CT.

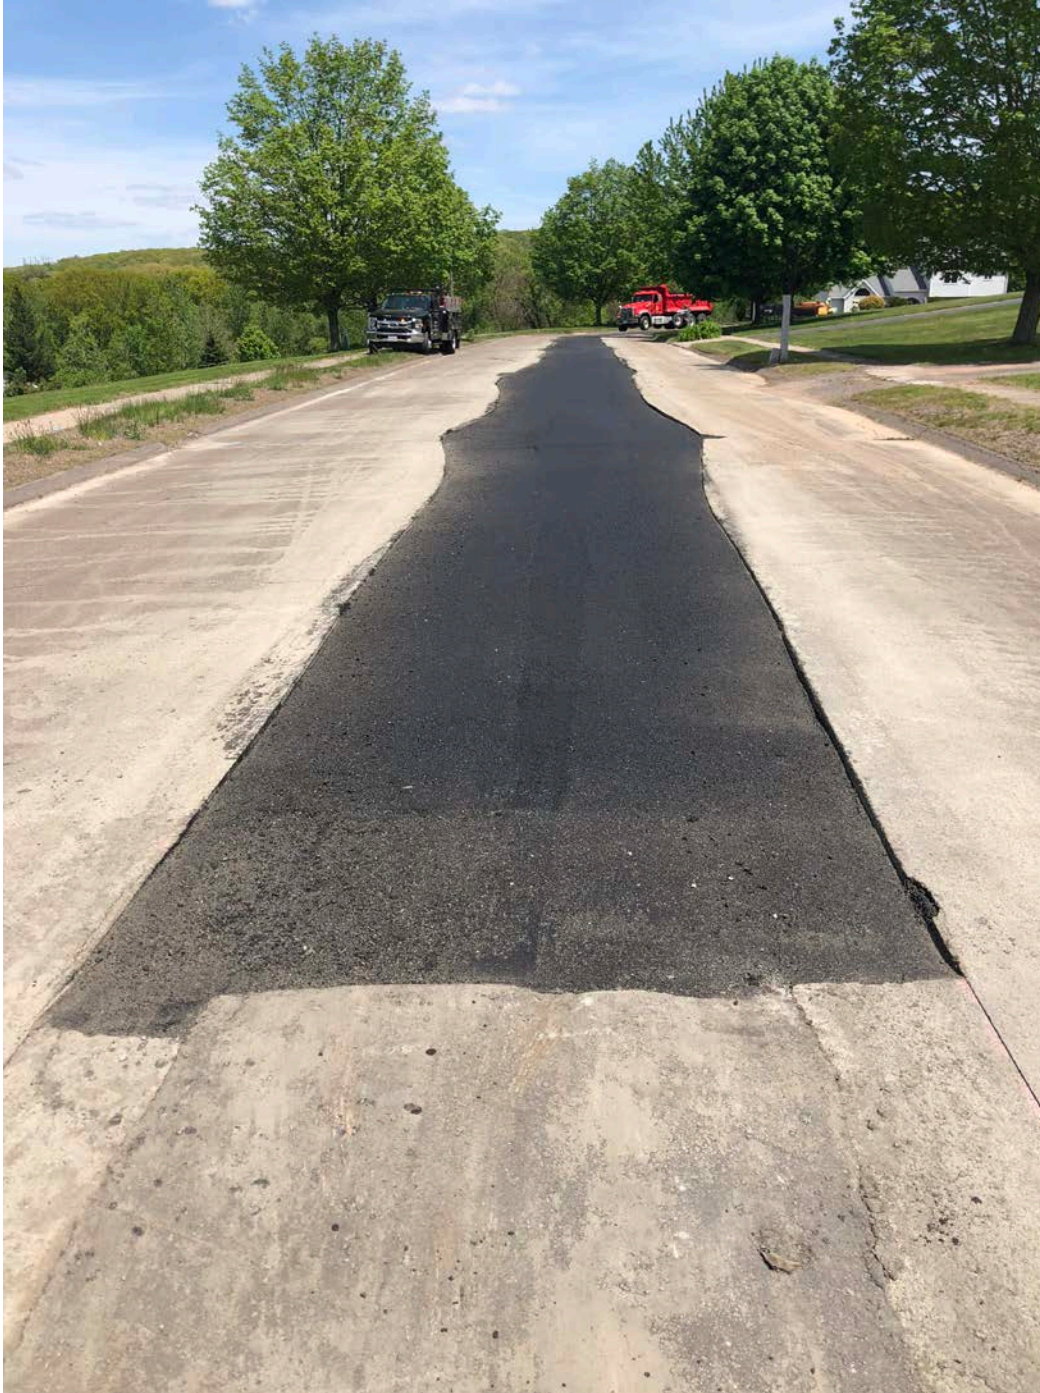
1315: Ludlow has placed a first lift of asphalt on Talcott Ridge Drive as far as Station 42+50

Picture 8: The first of two lifts of asphalt placed and compacted on 12" cut backs from edge of patch on Talcott Ridge Drive, Middletown, CT. Station 42+50 in the foreground.
