Daily Report

Project:	Durham Meadows Pipeline Installation	Date:	May 22, 2020
Location:	Pickett Lane, Durham; Main Street, Durham; Shared Access Driveway, Middletown; and Watch Hill Drive, Middletown, CT	Day of Week:	Friday
Project #:	AECOM: 6061487	Report No:	83
Contractor:	Ludlow Construction	Page:	1 of 11

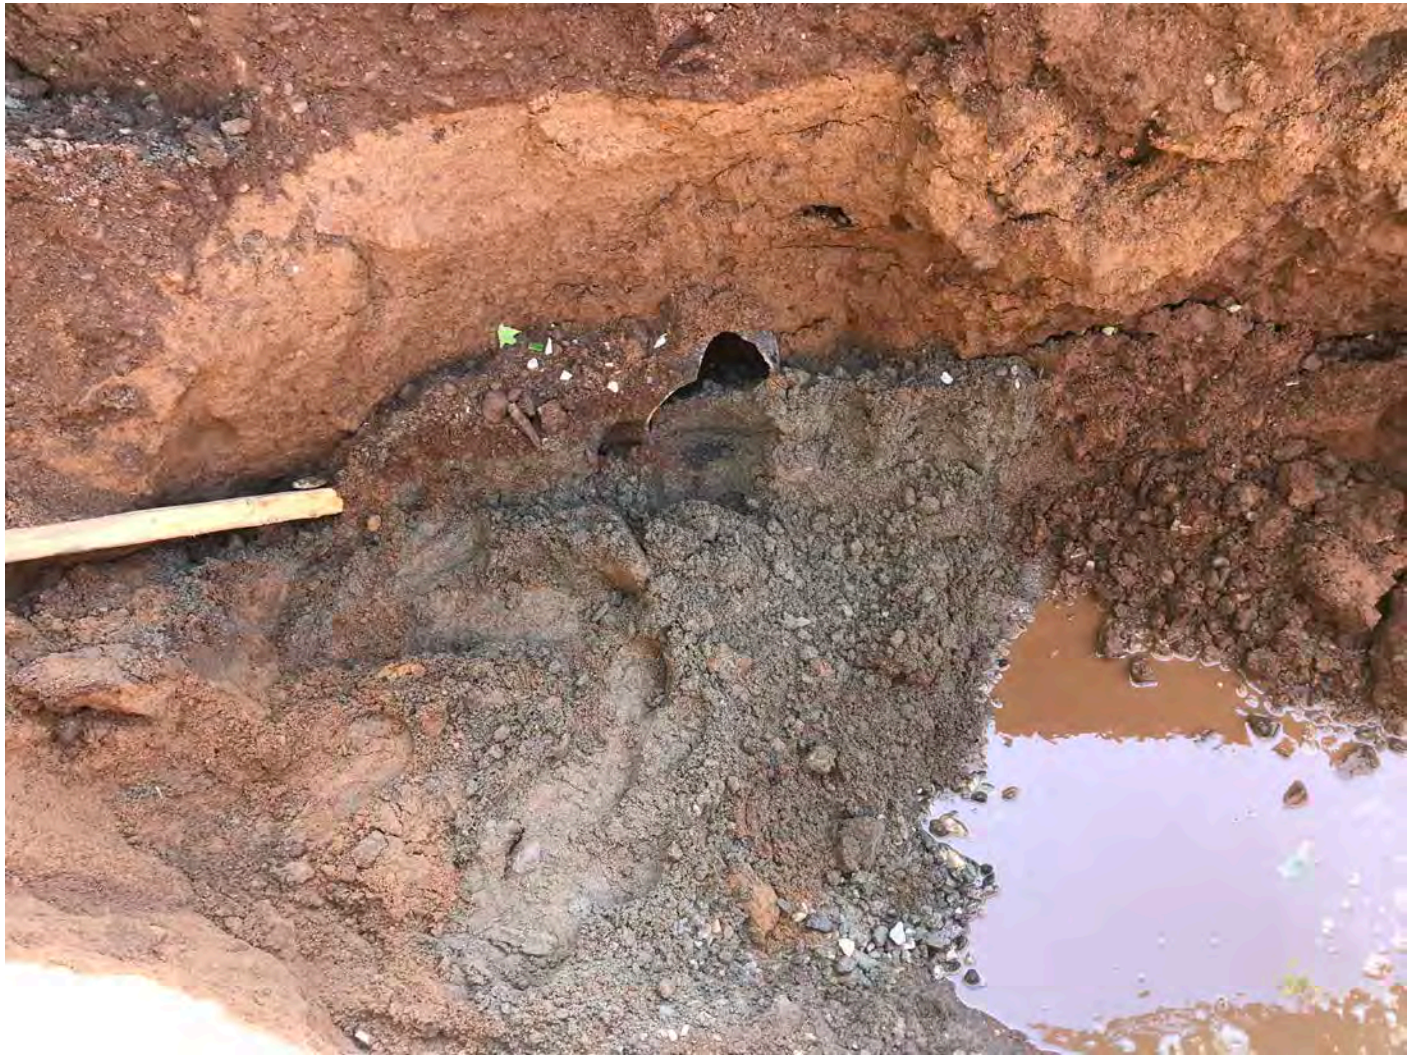
0920: Ludlow continuing to place 12" DIP on Pickett Lane. Currently they have pipe placed up to Station 527+75. Some water observed in the bottom of the trench: Ludlow hit an unmarked sewer line (8" PVC) at Station 275+86.

Picture 1: 8" PVC sewer pipe that Ludlow encountered at Station 275+86. Pickett Lane, Durham, CT.

1028: Ludlow repaired sewer pipe with 8" PVC and two Fernco fittings. Ludlow currently placing another stick of 12" DIP. This will bring placed pipe up to ~Station 528+30.

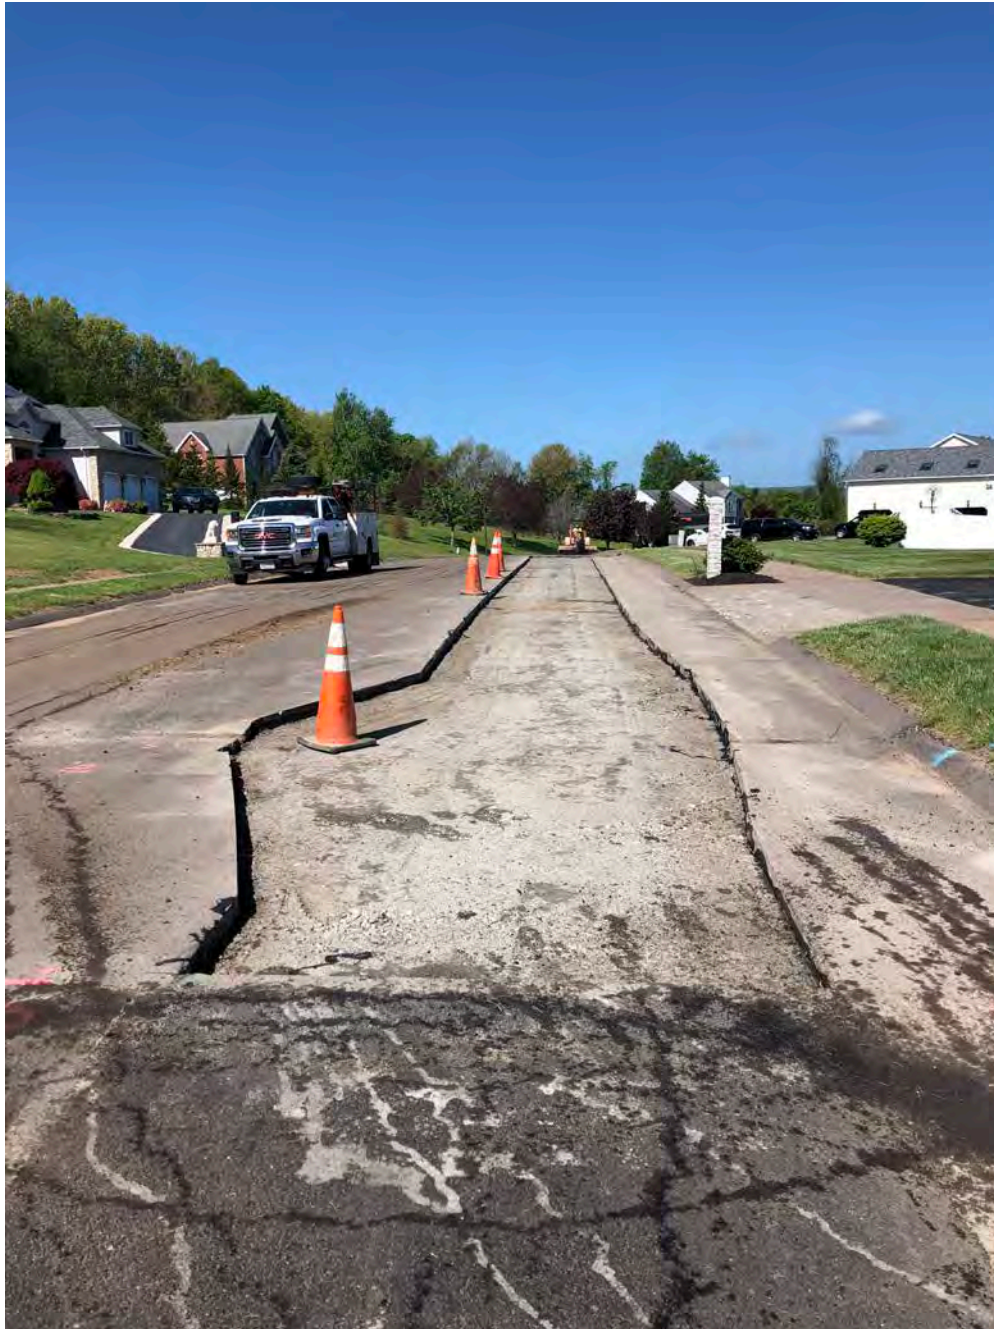
0938: Ludlow peeling asphalt back on Watch Hill Drive. They have removed asphalt from the 12" cut back from Stations 603+06 to 604+44.

Picture 2: Asphalt removed from 12" cutbacks on Watch Hill Drive from Stations 603+06 to 604+44. Middletown, CT.

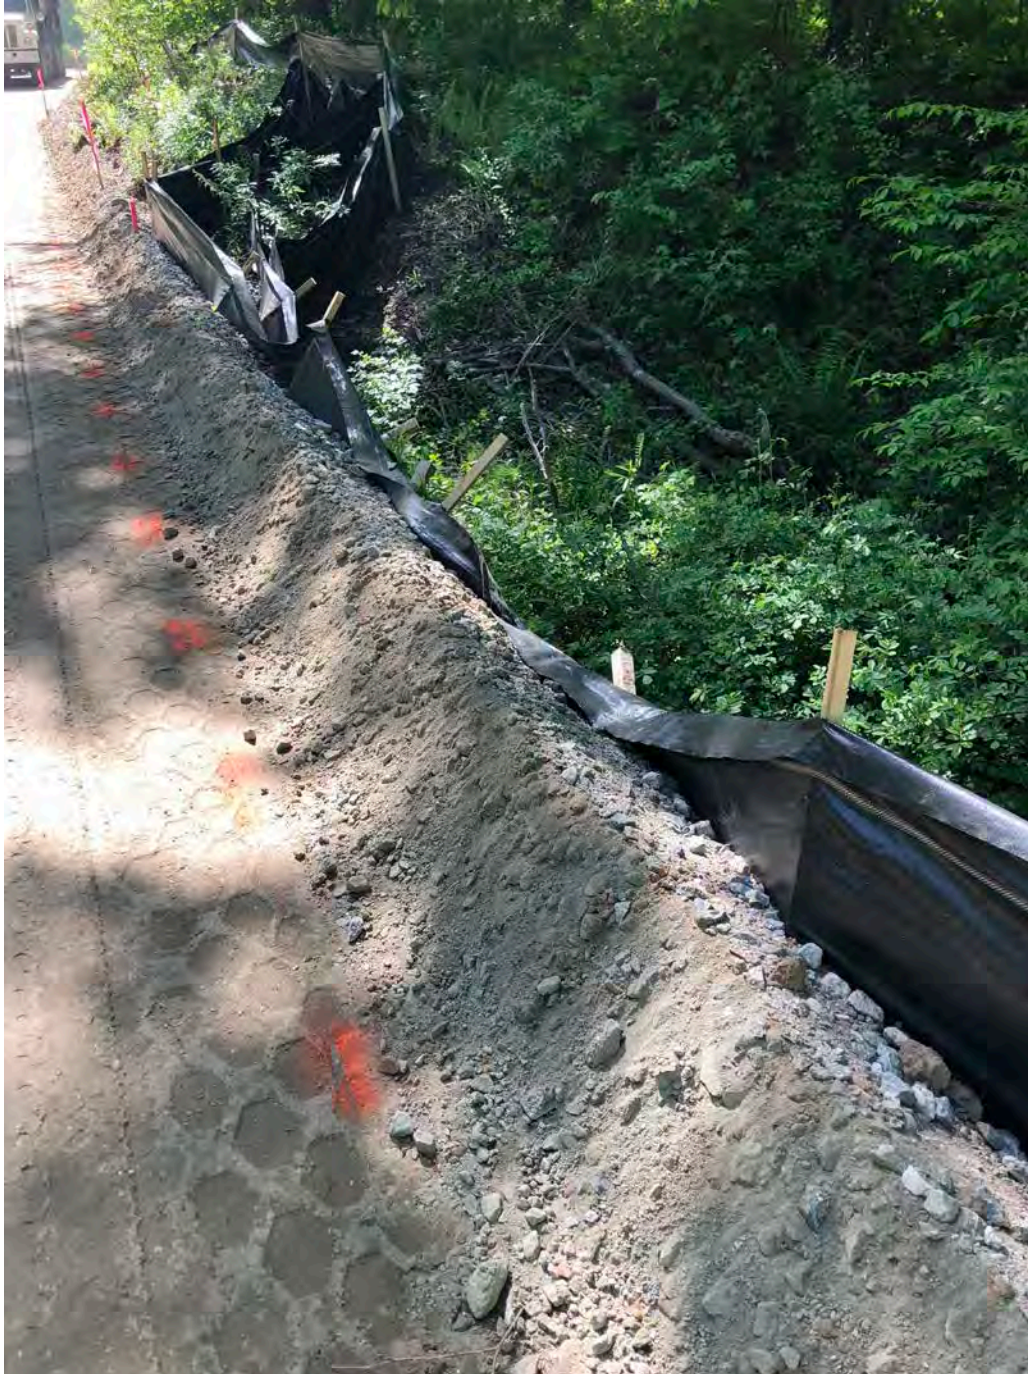
0945: Observed the following on the Shared Access Driveway: silt fence on the south side of the road at Station 19+85 showing encroachment from fill (see Photograph 3).

Picture 3: Silt fence on the south side of the Shared Access Driveway at Station 19+85 showing encroachment from fill. View to the east. Middletown, CT.

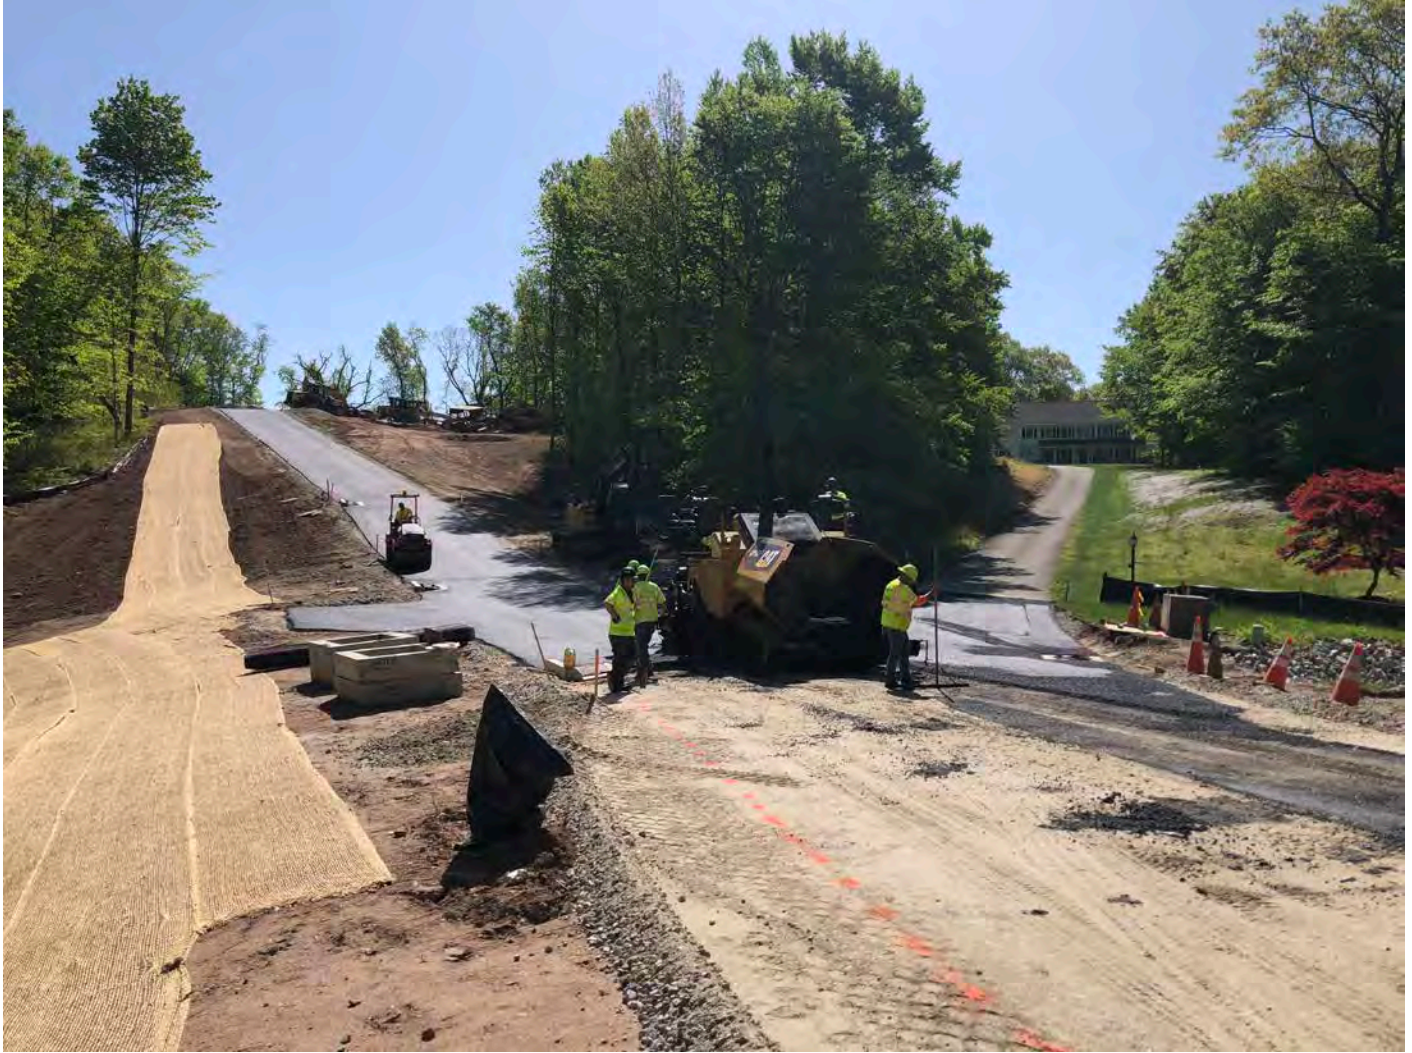
Picture 4: Overview of paving in progress on the Shared Access Driveway. View to the east. Middletown, CT

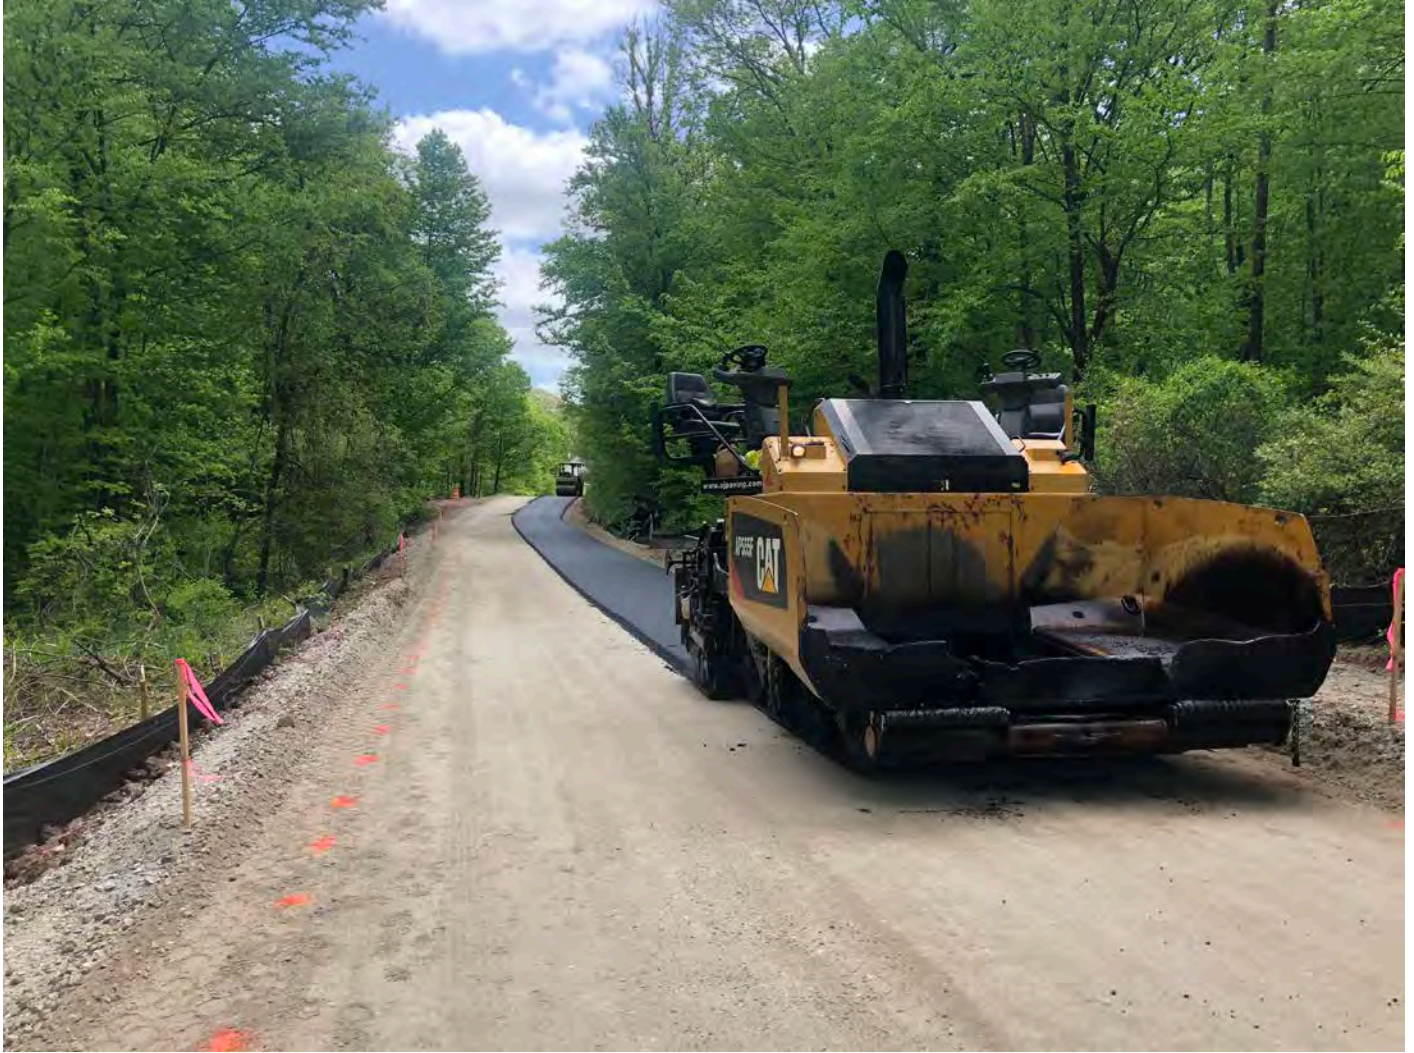
Picture 5: Overview of paving in progress on the Shared Access Driveway. View to the east. Middletown, CT

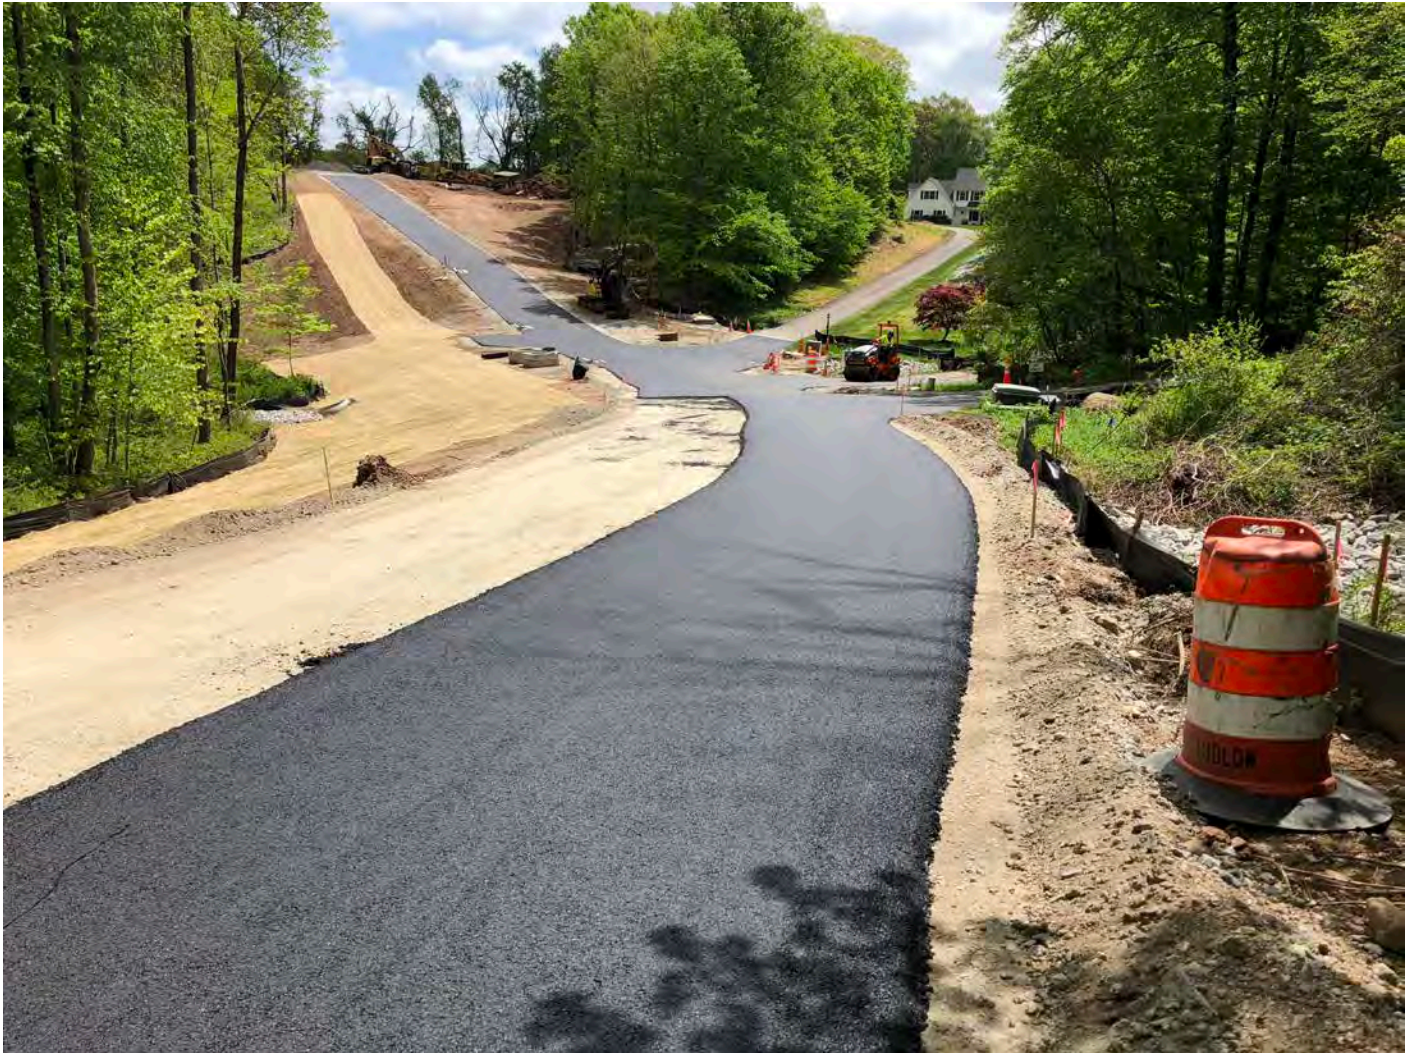
Picture 6: Overview of paving in progress on the Shared Access Driveway. View to the east. Middletown, CT

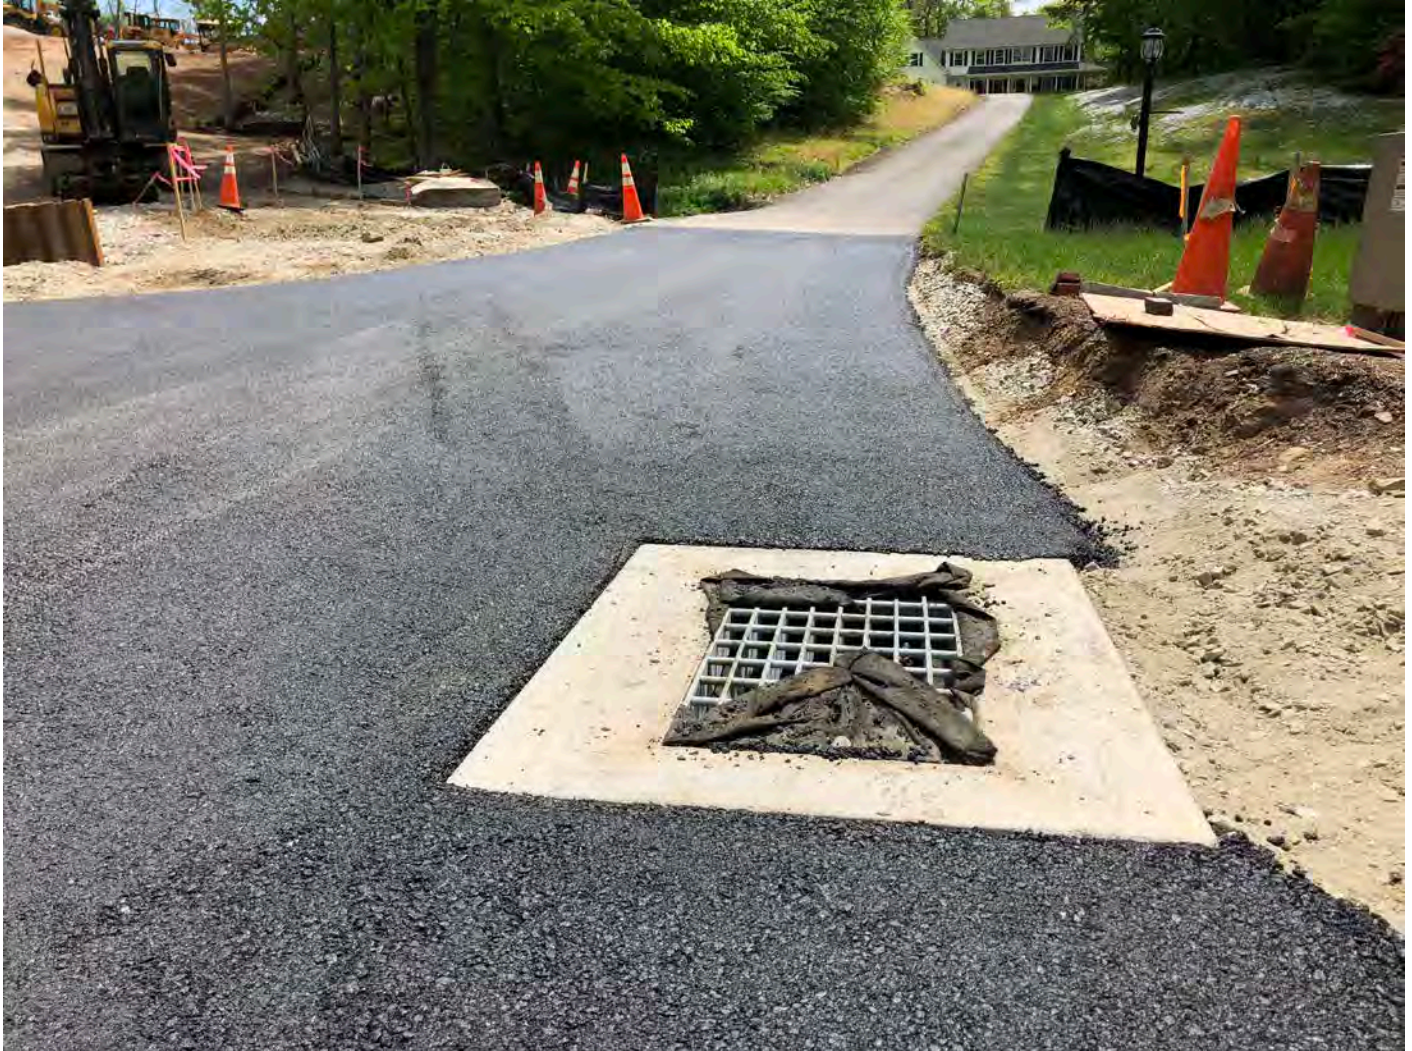
Picture 7: Base coat of pavement surrounding catch basin next to the driveway entrance for 214 Talcott Ridge Drive.. View to the southeast. Middletown, CT

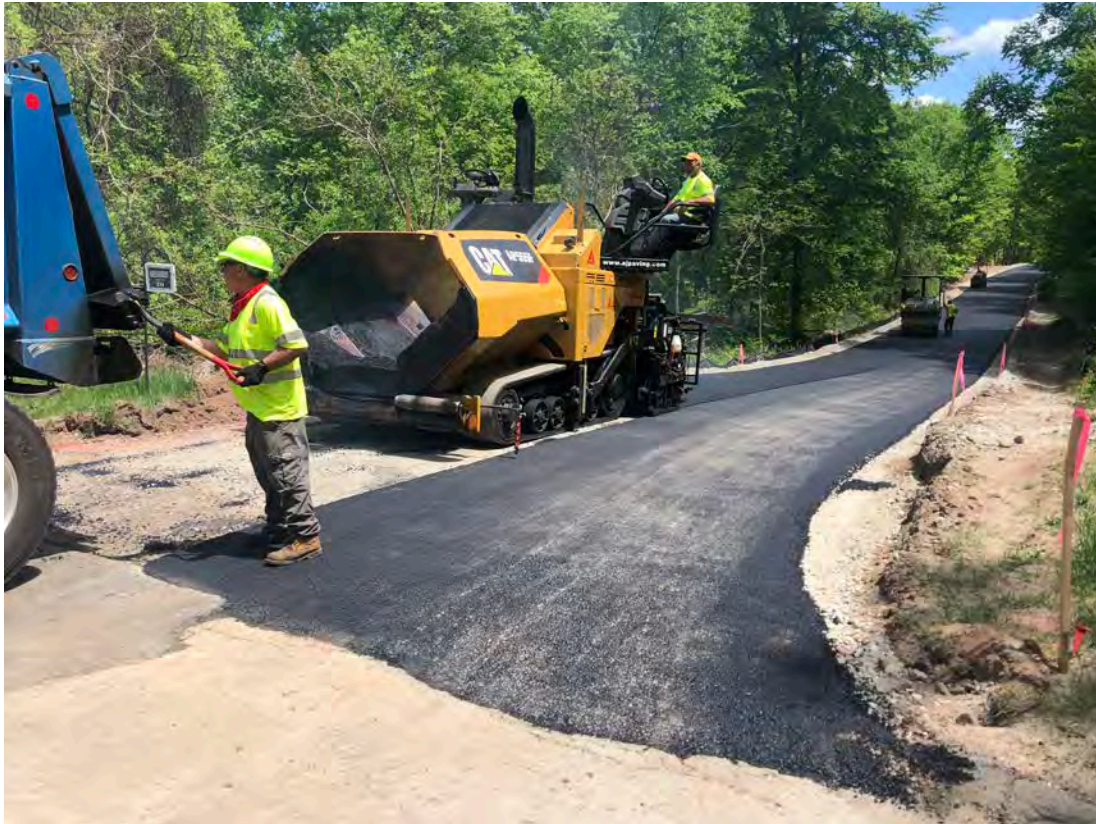
1325: A&J has just finished laying asphalt on Shared Access Driveway. They are currently compacting the asphalt.

Picture 8: A&J Construction finishing the paving of the Shared Access Driveway. View to the east. Middletown, CT
