Daily Report

Project:	Durham Meadows Pipeline Installation	Date:	June 1, 2020
Location:	Pickett Lane, Durham; Main Street, Durham; and Shared Access Driveway, Middletown;	Day of Week:	Monday
Project #:	AECOM: 6061487	Report No:	88
Contractor:	Ludlow Construction	Page:	1 of 12

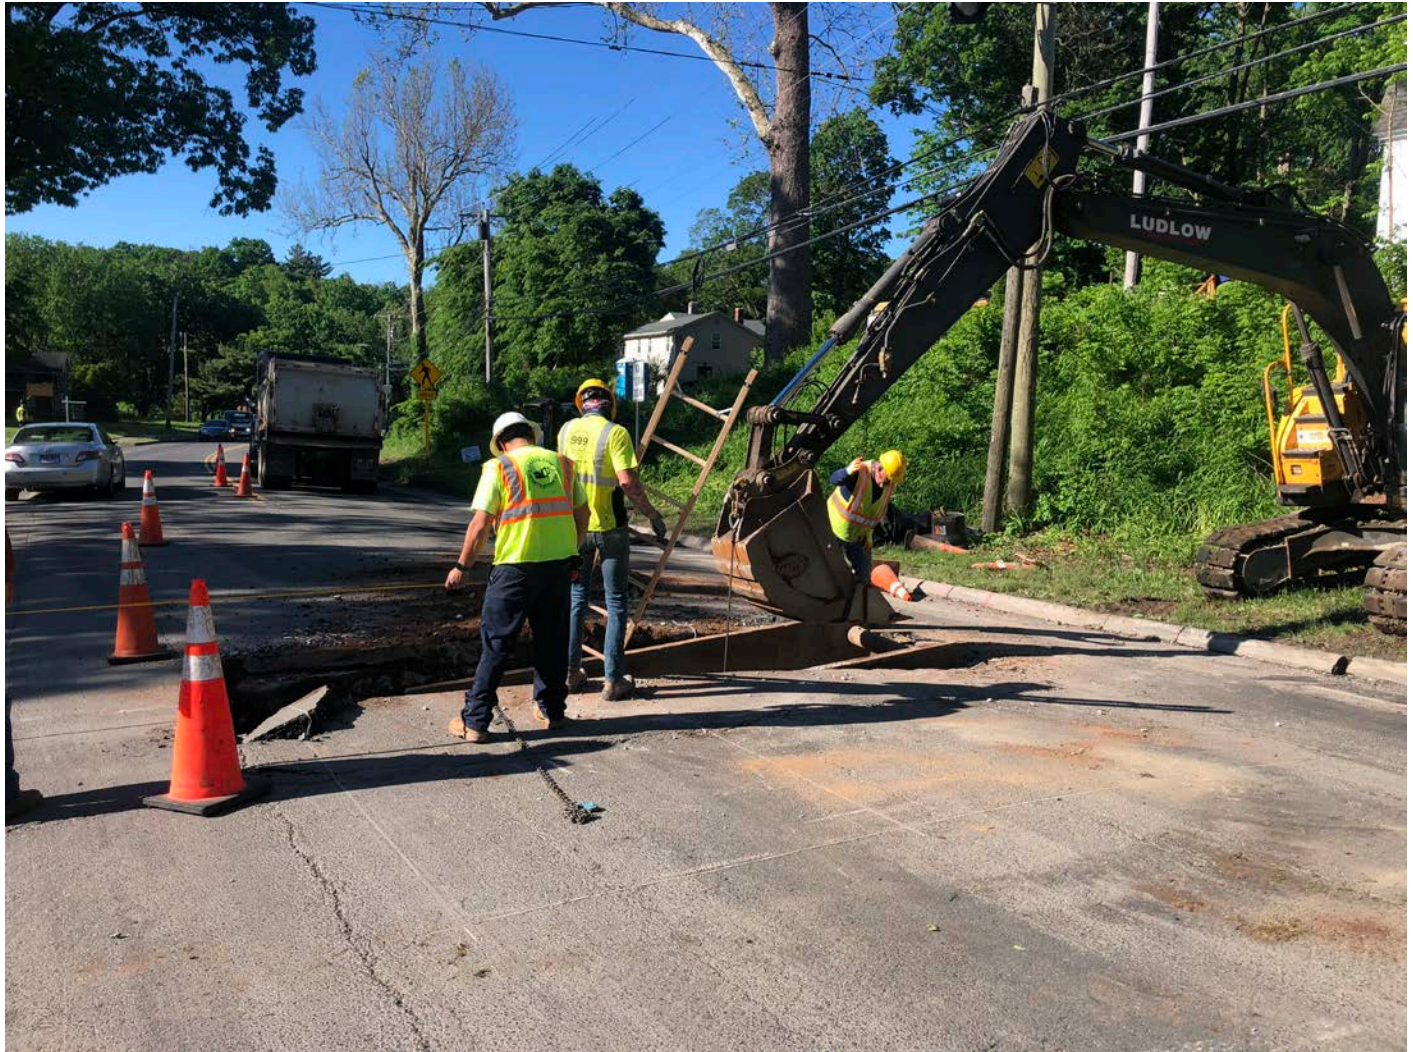
Picture 1: Ludlow begins excavation for placement of 12" DIP at intersection of Pickett Lane and Main Street. Station 500+03, Main Street, Durham. View to the southwest.

0822: Ludlow placing a piece of 12" DIP across the north and south lane of Main Street starting at Station 500+03, across from where it intersects with Pickett Lane. A 1" corporation stop has been placed at ~Station 500+04 as a dechlorination point. Two state troopers are currently providing traffic detail.

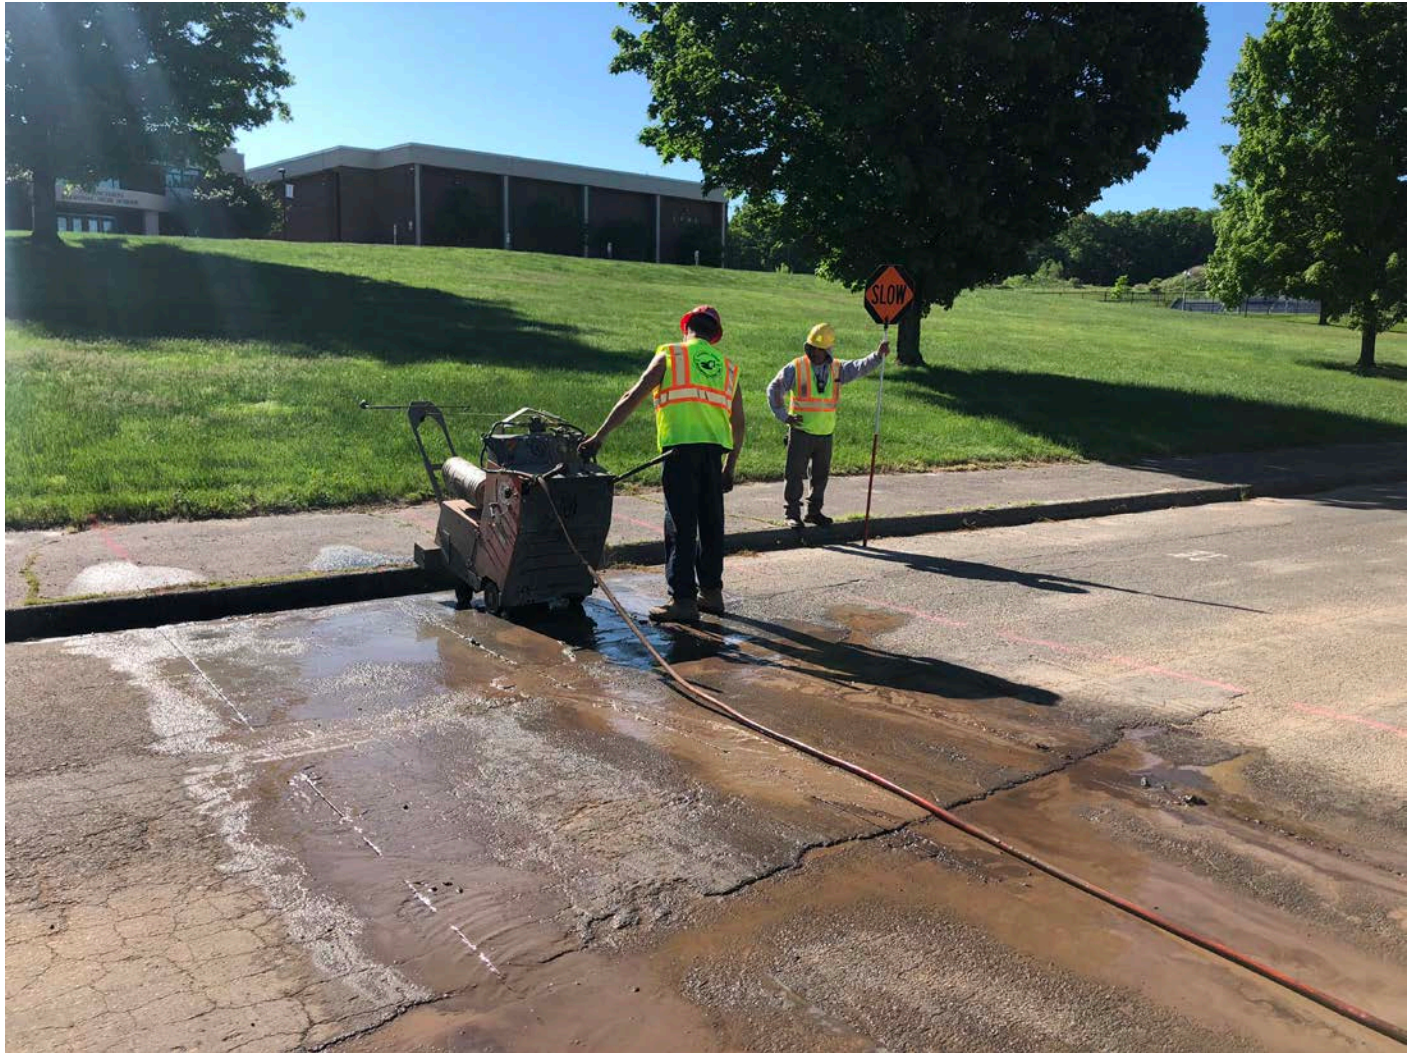
Picture 2: Ludlow saw cutting on Pickett Lane, Durham. View to the southeast.

0840: Ludlow is currently saw cutting pavement on Pickett Lane at Station 529+64, after having just finished saw cutting at Station 529+90.

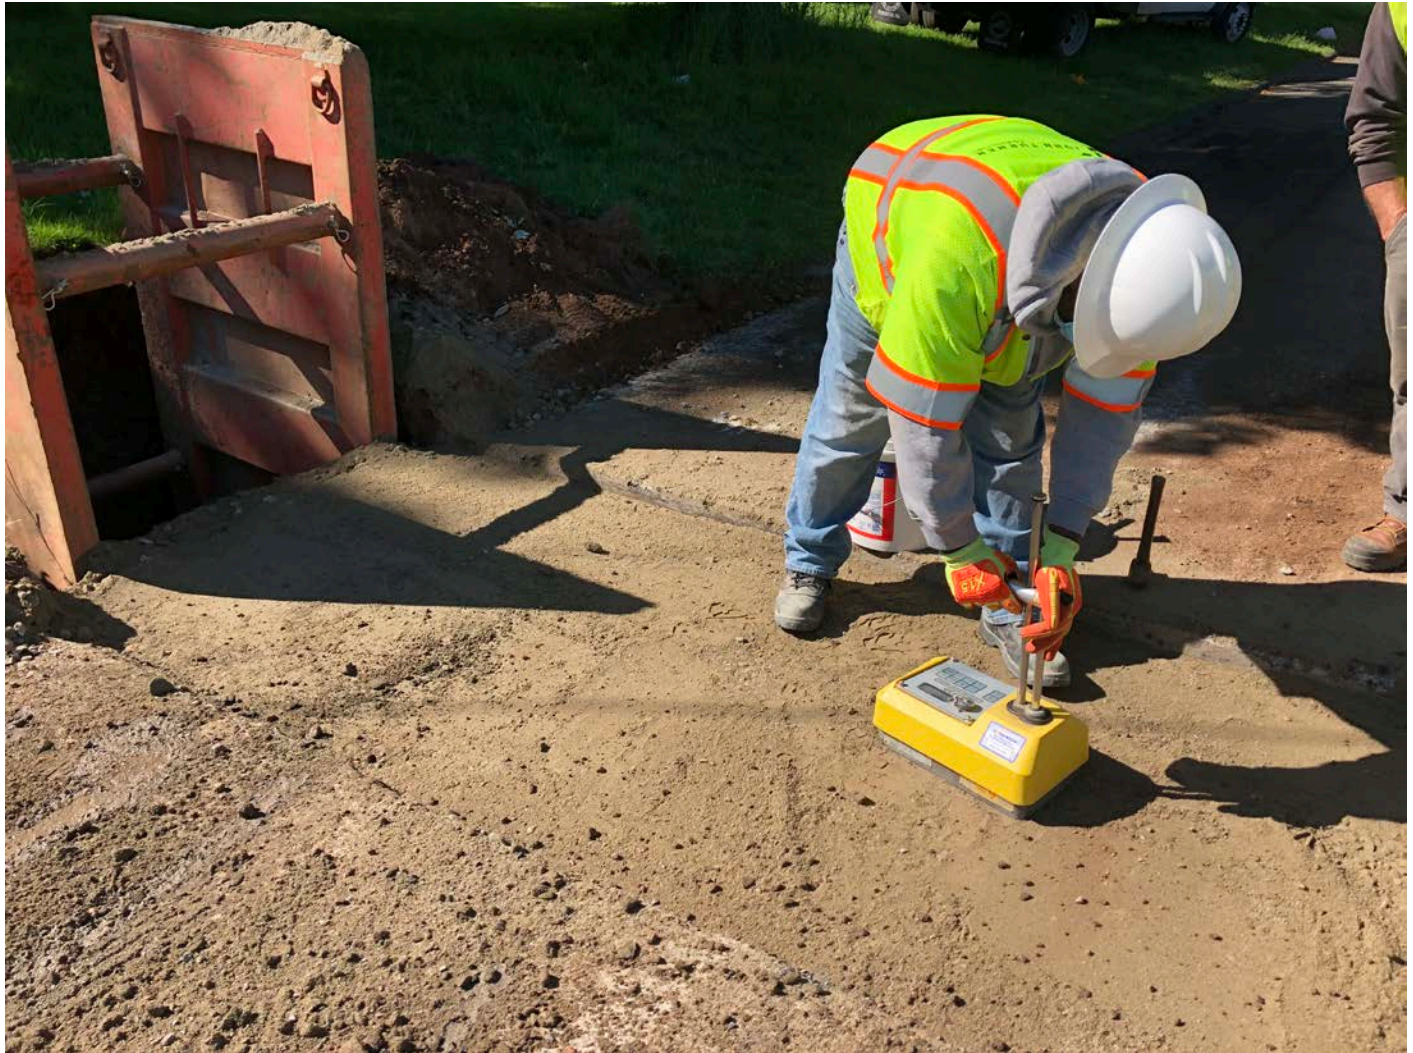
Picture 3: JTC performing soil compaction testing at Station 117+64. South Main Street, Middletown. View to the southeast.

0904: JTC is present at Station 117+64 to perform soil compaction testing.

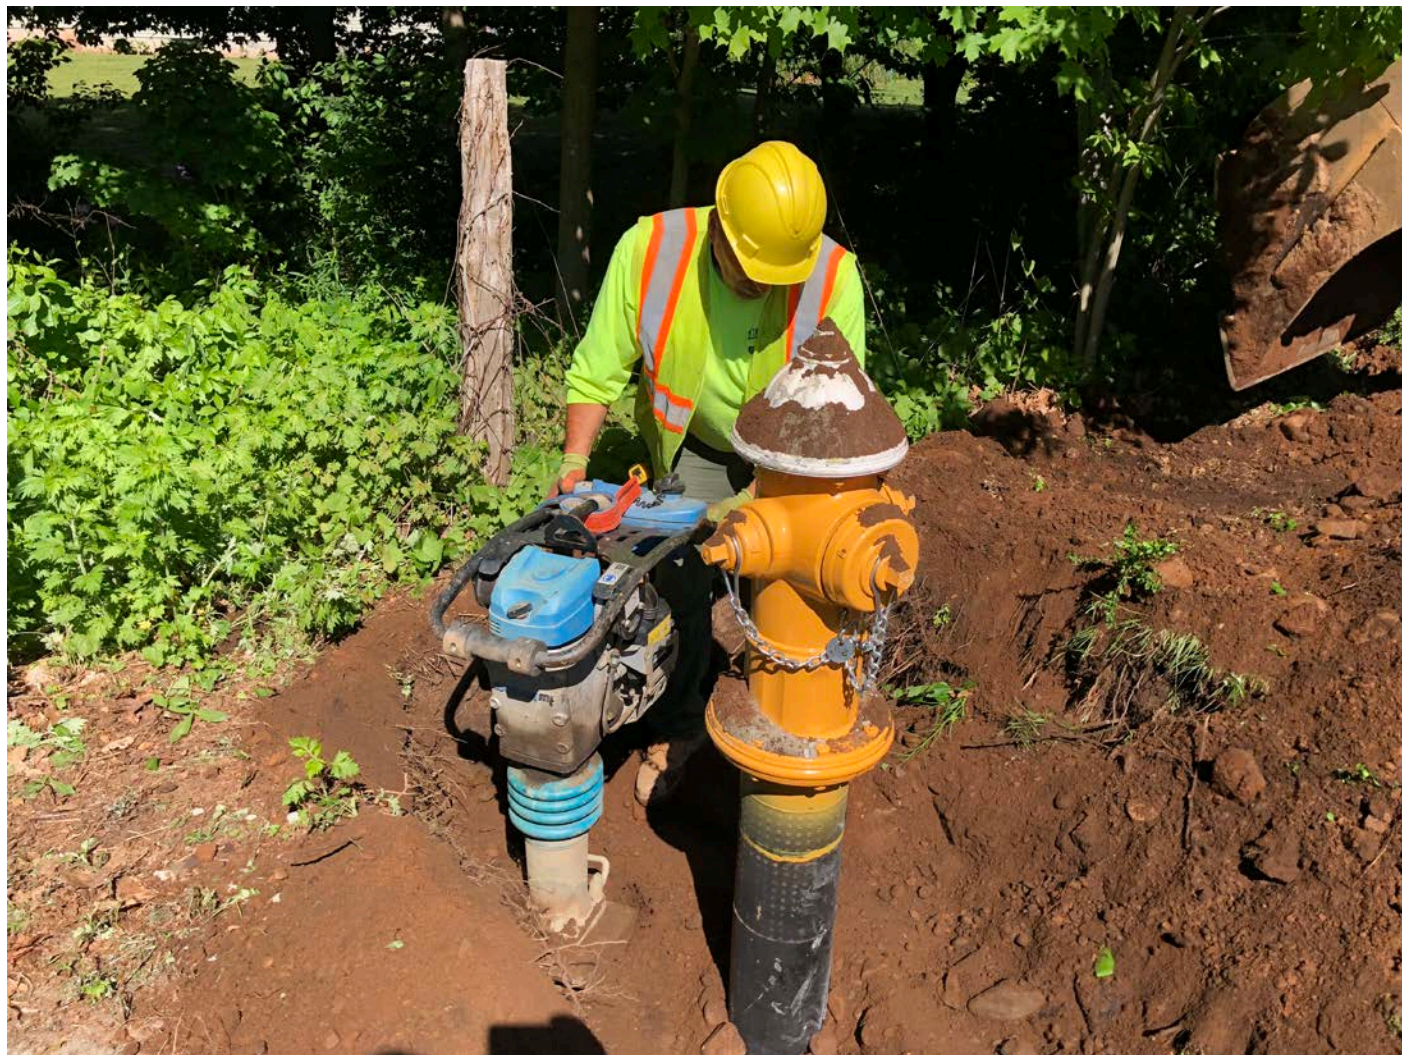
Picture 4: Ludlow compacting backfill around hydrant installed at Station 534+30. Pickett Lane, Durham. View to the northwest.

0942: Ludlow is finishing up with hydrant installation at Station 534+30, and is currently compacting soil around the hydrant and placing valve stem and curb box over the valve box.

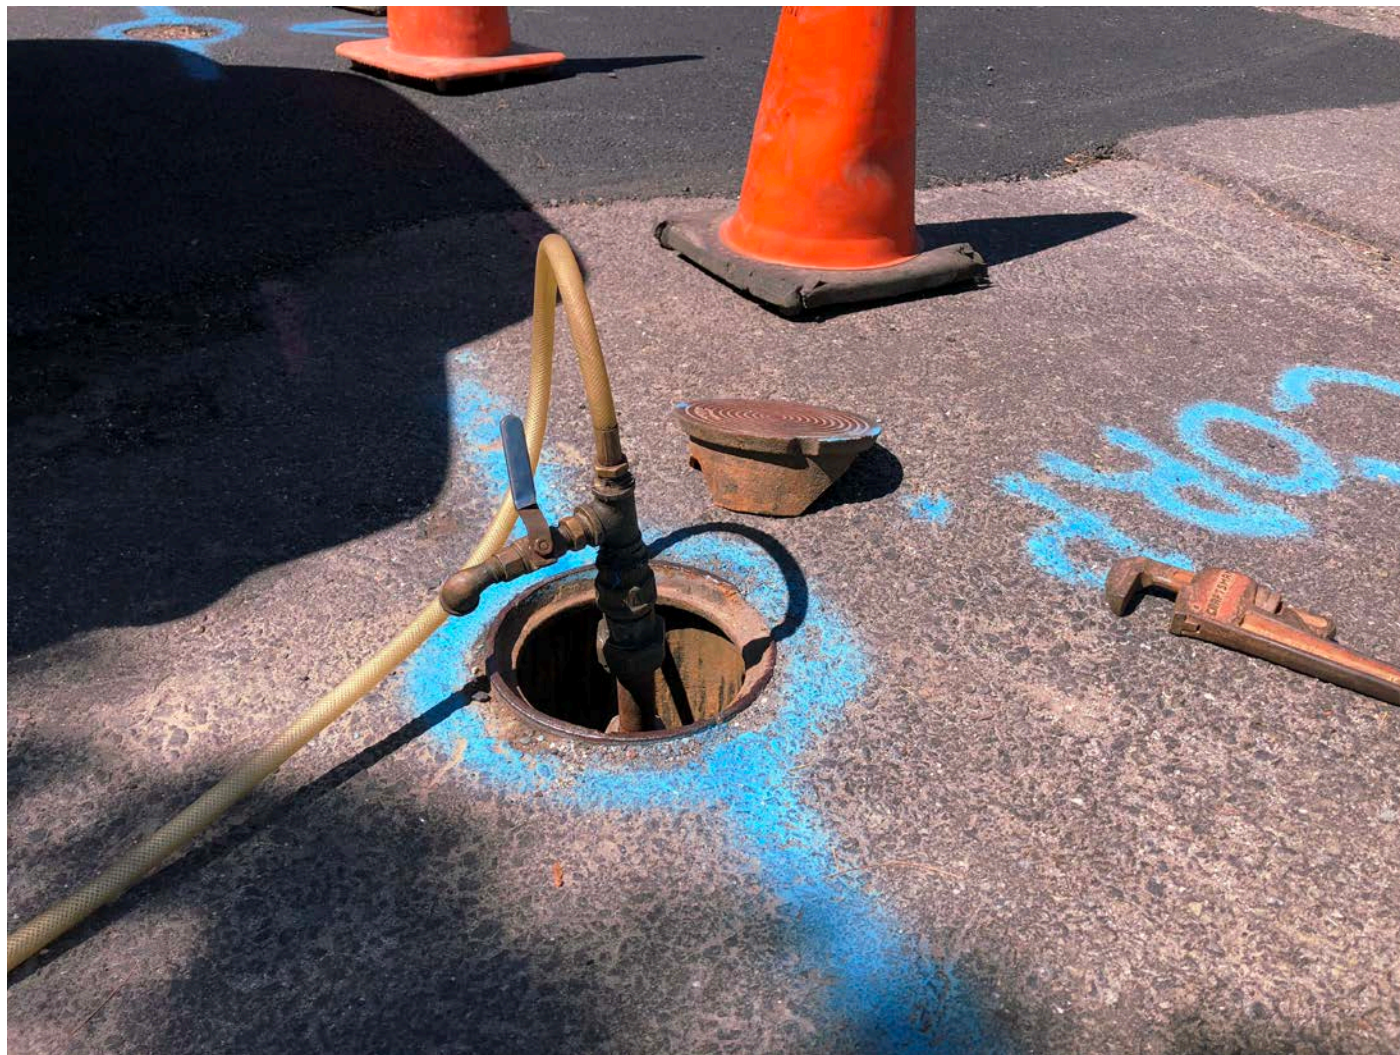
Picture 5: JWS Connections injecting sodium hypochlorite into water line at intersection of Talcott Ridge Drive and Main Street. View to the southwest.

0735: AECOM spoke with John Ewanowski (Middletown Water and Sewer Department) who is staged at the Talcott Ridge Drive cul-de-sac hydrant. He said his department was assisting Ludlow today as they chlorinated water lines running from the (future) water tank to the cul-de-sac hydrant; water lines on Watch Hill Drive; and several water lines in Durham. John stated that dechlorination would be performed on Wednesday.

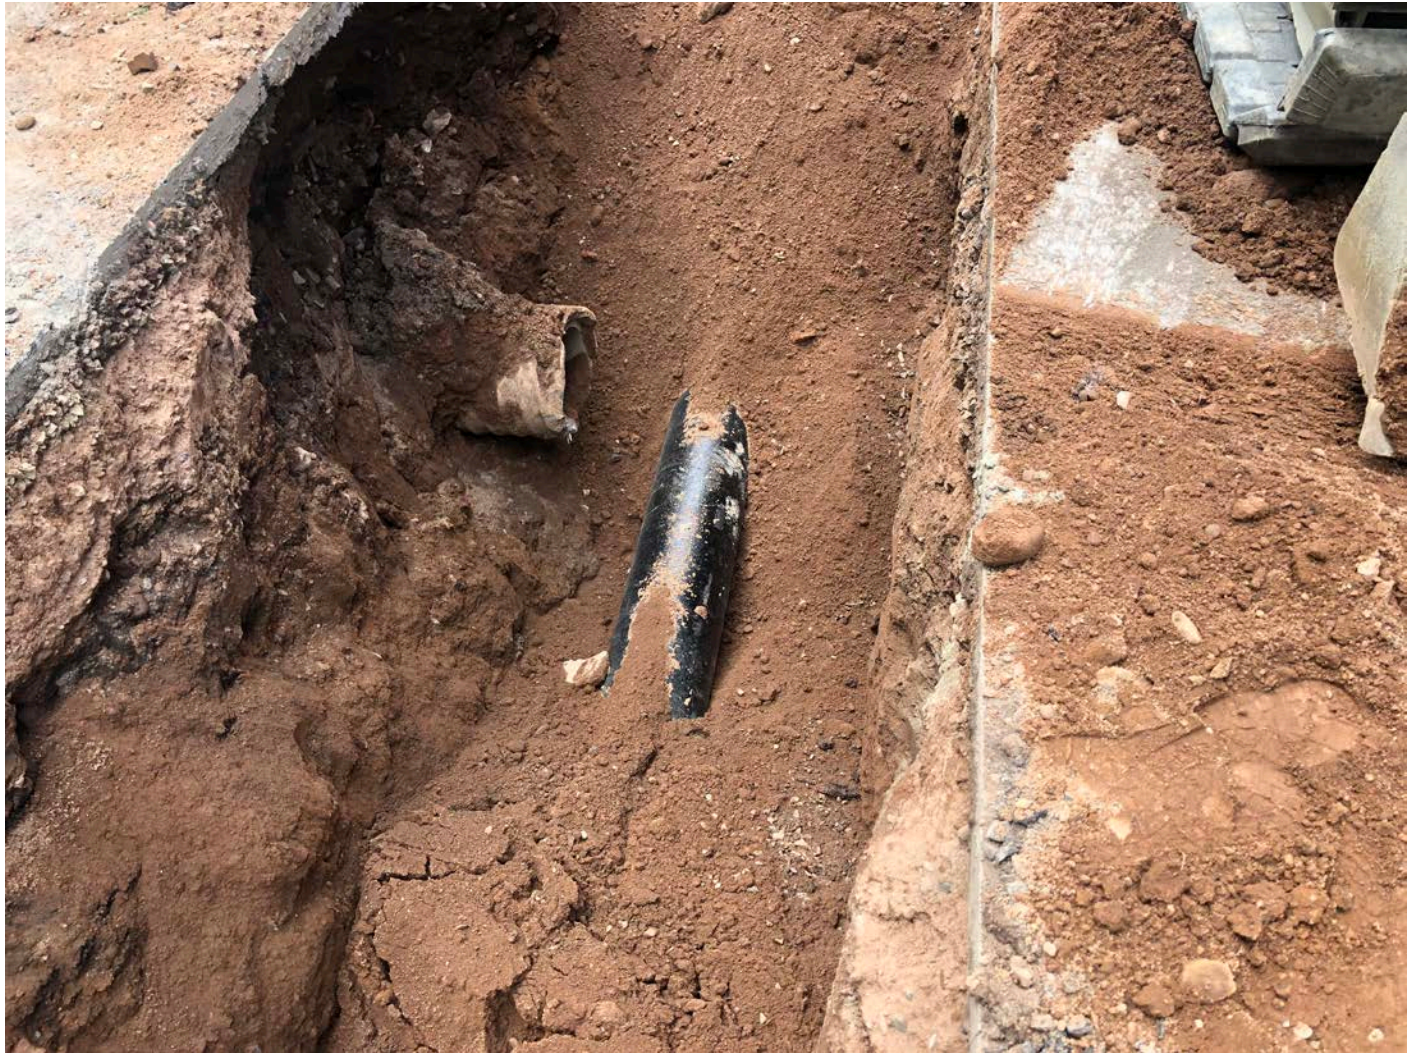
1224: Ludlow is working on Pickett Lane near the intersection of Main Street, placing 12" DIP. They have sawn through an 18" storm drain at ~Station 500+55 to place the 12" DIP, and are going to repair it with a section of 12" PVC and Fernco boots.

Picture 6: Storm drain pipe that was cut during the installation of 12" DIP on Pickett Lane at ~Station 500+55. View to the west.

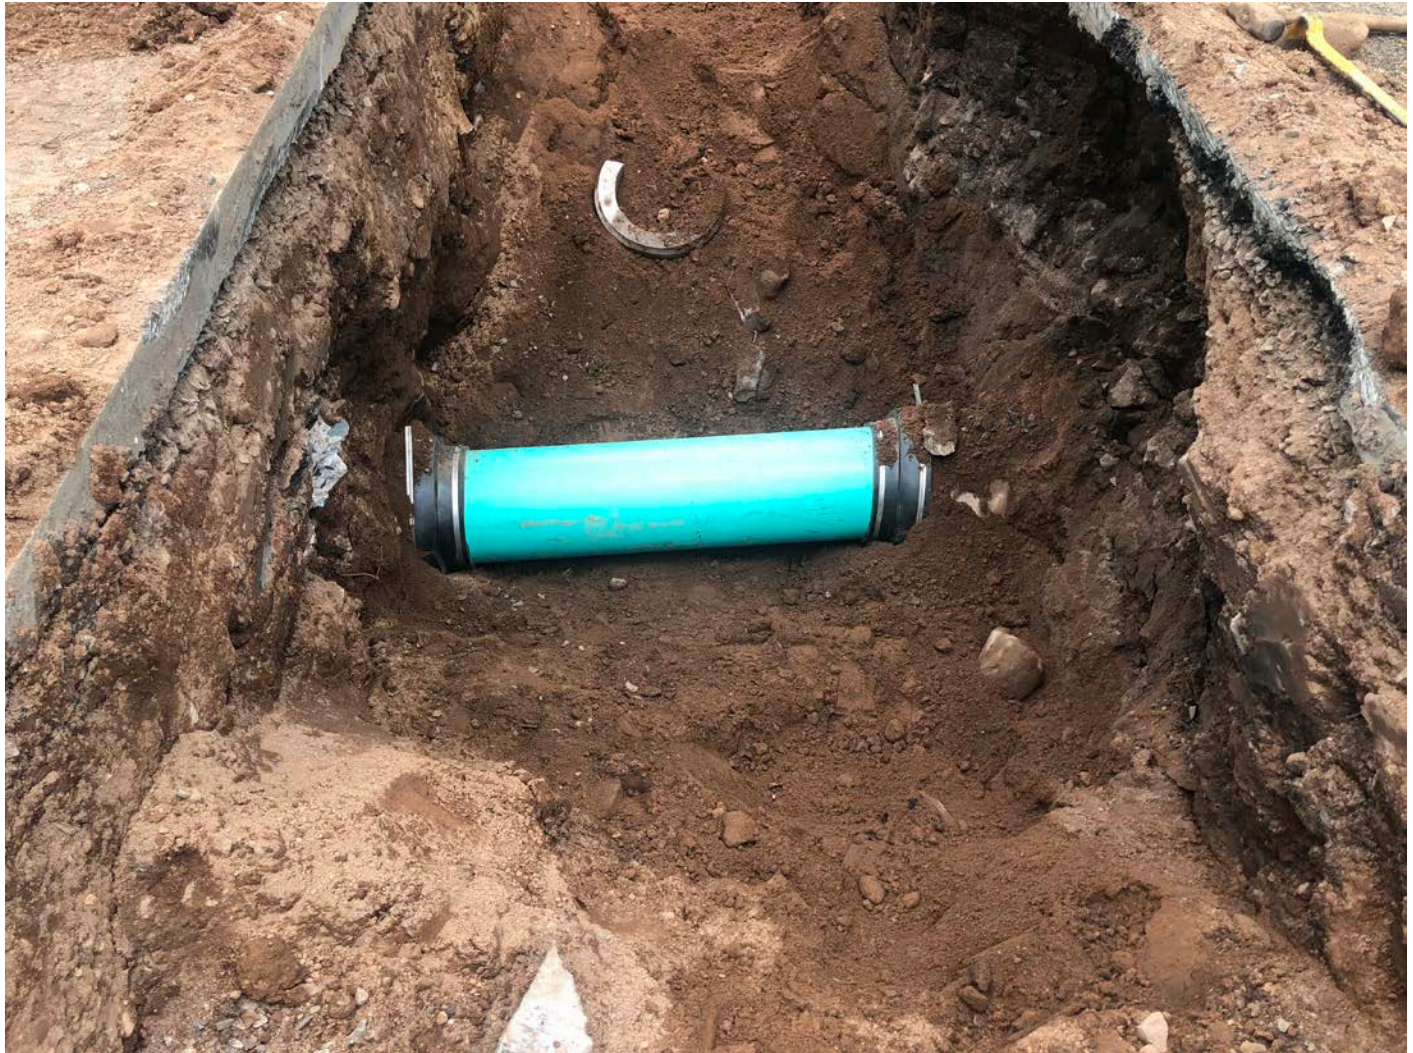
Picture 7: Repair of corrugated steel storm drain pipe that was cut during the installation of 12" DIP on Pickett Lane at ~Station 500+55. View to the west.

1320: Ludlow has the storm drain at ~Station 500+55 repaired with 12" PVC. Ludlow has 12" DIP connected from what was already installed on Pickett Lane up to Station 501+00, across the intersection of Main Street to a Tee at Station 500+03. At Station 500+65, Ludlow daylighted a 4" PVC conduit and a 4" black cast-iron conduit located about 3' below ground surface. The iron pipe was broken, which Ludlow is working to address.

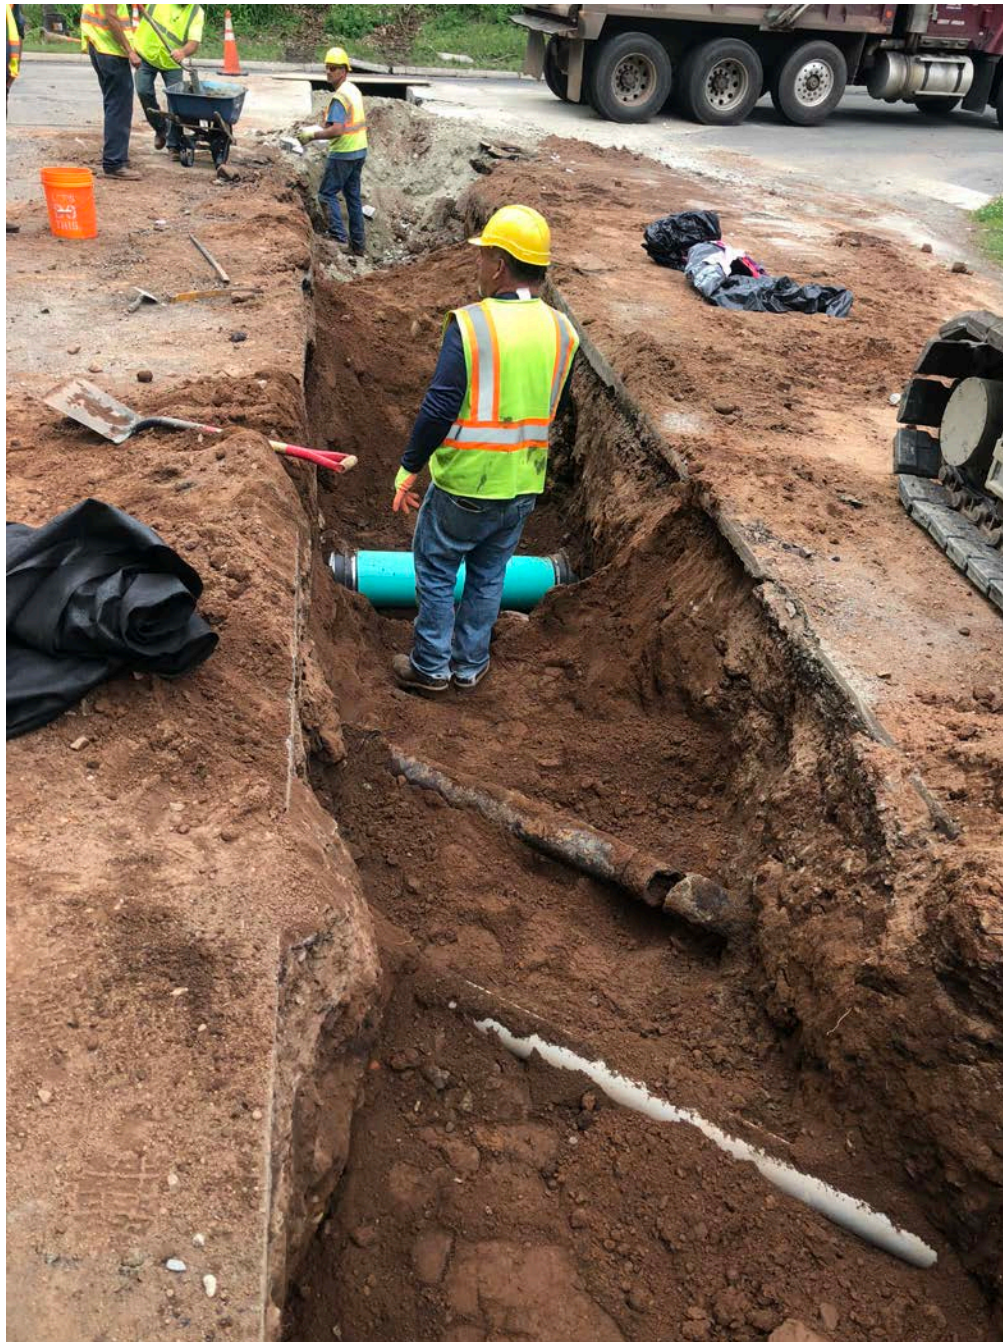
Picture 8: PVC conduit and broken cast iron conduit daylighted at ~Station 500+65 during the installation of 12" DIP on Pickett Lane, Durham. View to the west.
