Daily Report

Project:	Durham Meadows Pipeline Installation	Date:	June 8, 2020
Location:	Pickett Lane, Durham; Main Street, Durham; and Shared Access Driveway, Middletown;	Day of Week:	Monday
Project #:	AECOM: 6061487	Report No:	93
Contractor:	Ludlow Construction	Page:	2 of 8

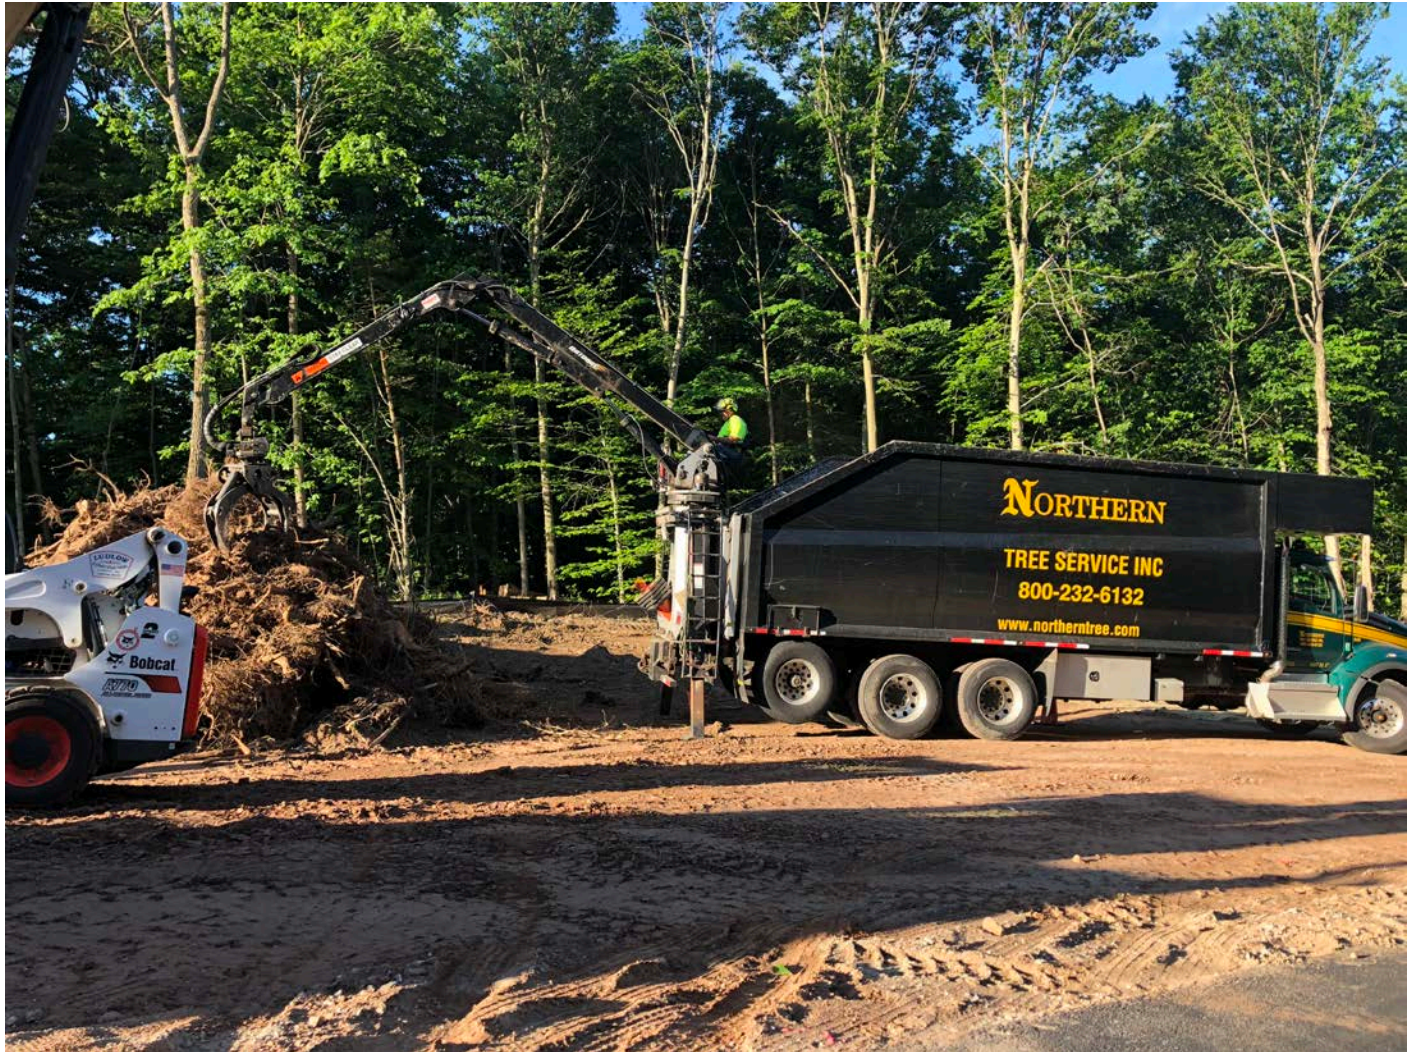
Picture 1: Norther Tree Service removing some tree stumps from south of the shared access driveway. View to the south, Middletown, CT.

0722: Northern Tree Service is loading stumps for removal that are staged on the south side of the shared access driveway at ~Station 12+00.

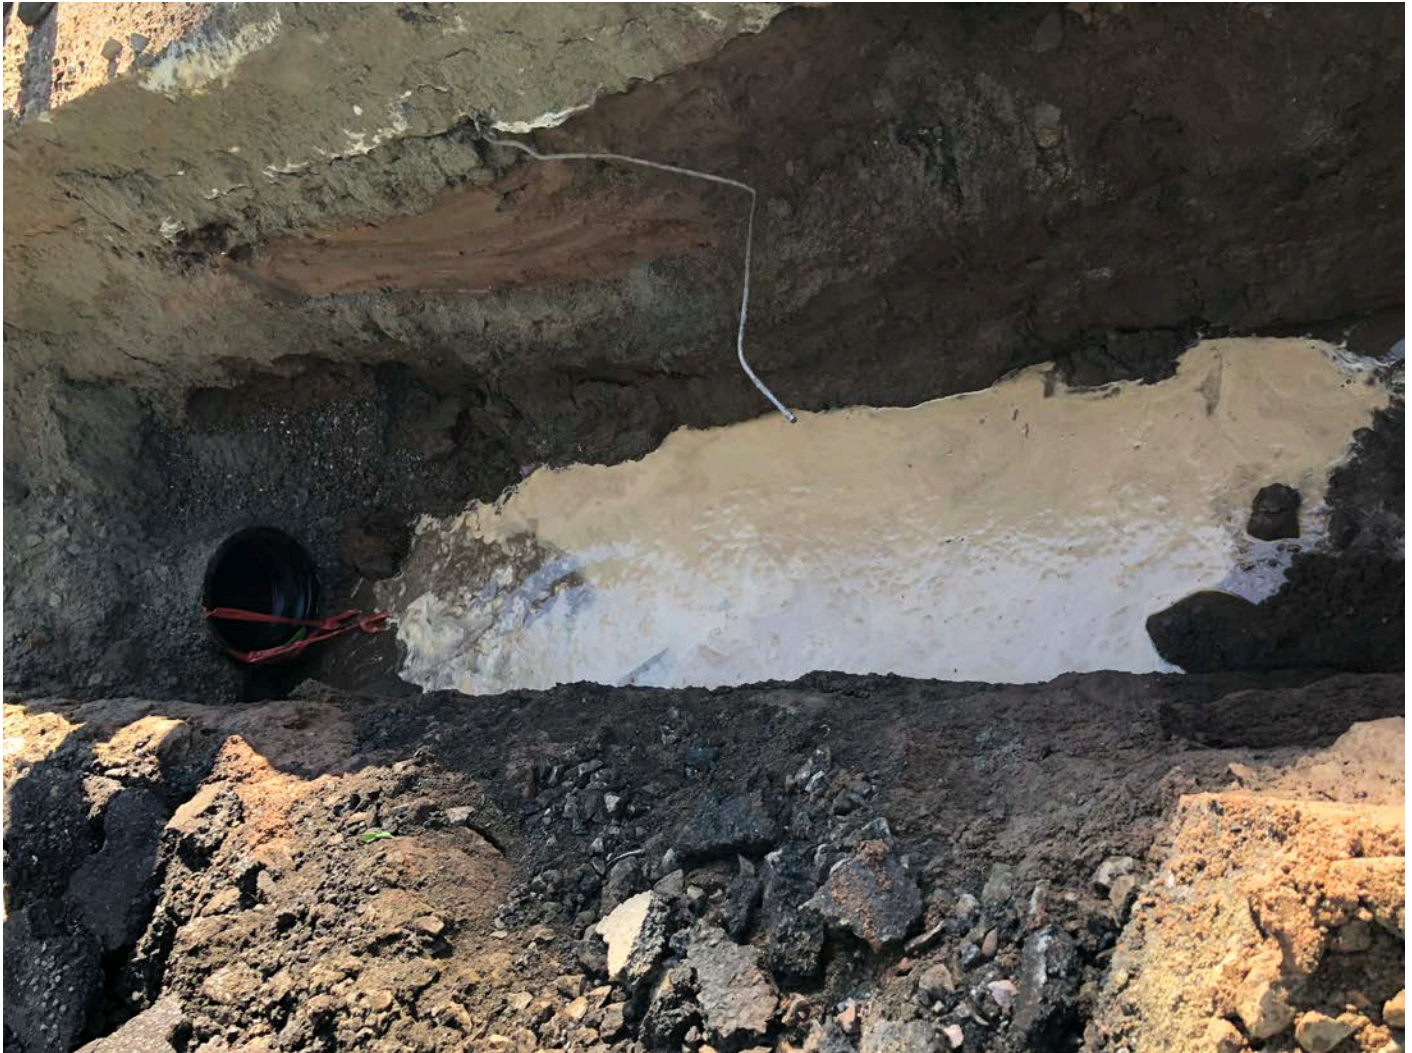
Picture 2: Water observed in the excavation at Station 207+87. Main Street, Durham, CT.

0745: Ludlow is resuming work placing DIP on Main Street in Durham, starting where they left off at Station 207+87 (near where Main Street intersects with Old Cemetery Road). Ludlow is pumping water from the bottom of the trench and discharging it to a catch basin located at the intersection of Main Street and Old Cemetery Road. The catch basin is outfitted with a silt sock. The water in the trench appears to be entering from under the previously installed 16" DIP at Station 207+87.

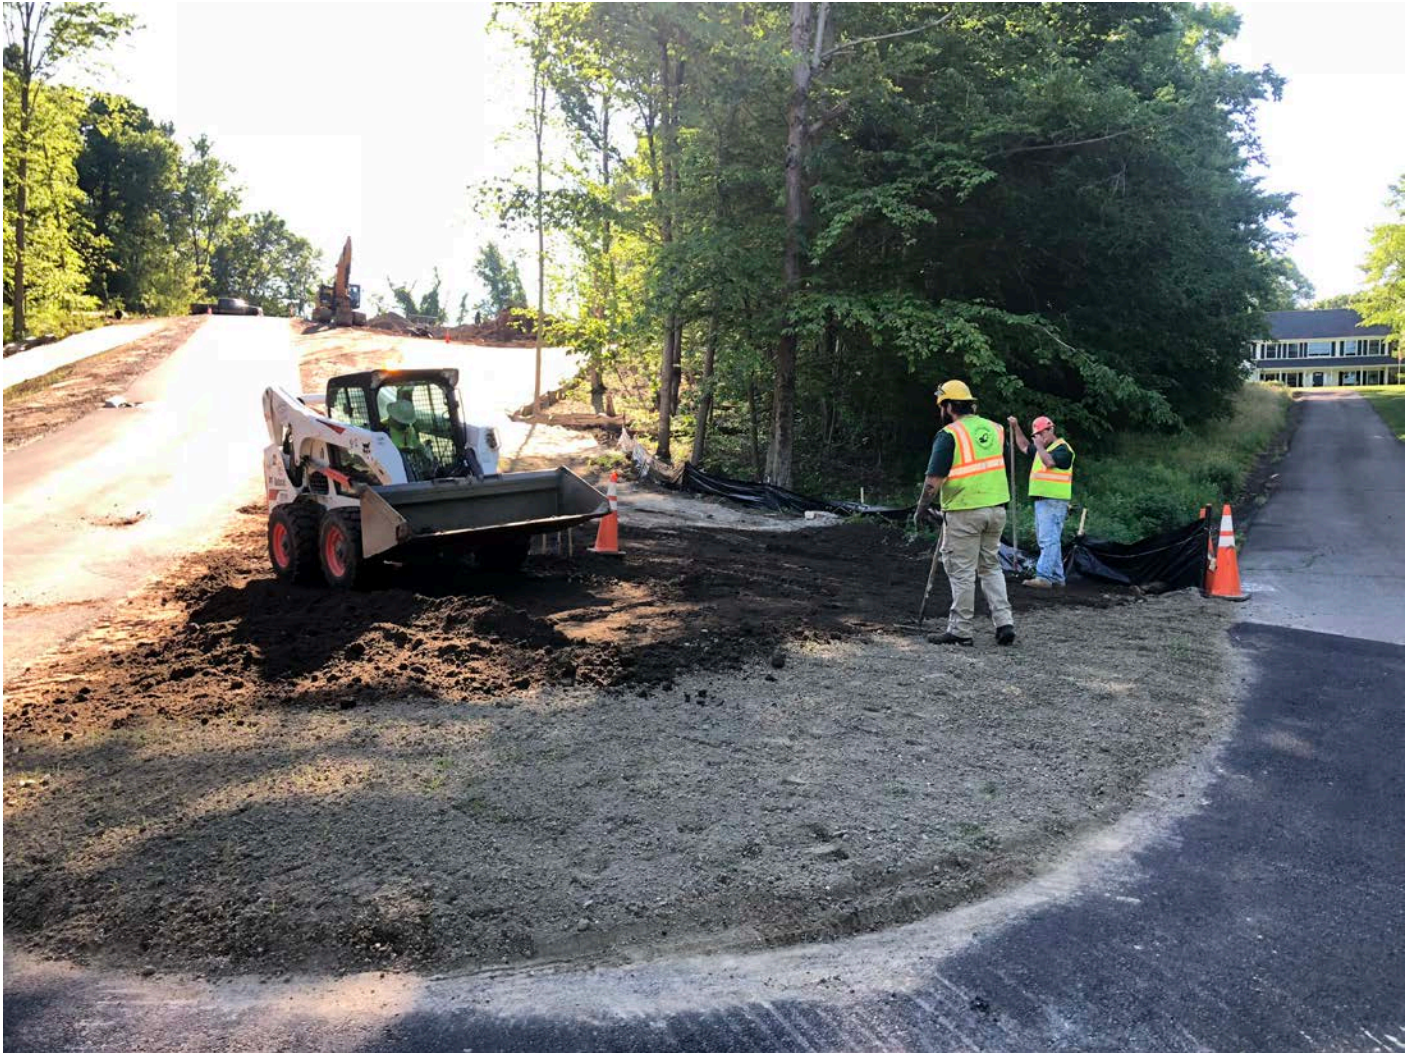
Picture 3: Ludlow placing loam and grass seed at the intersection the shared access driveway and the driveway for 214 Talcott Ridge Drive. View to the southeast. Middletown, CT.

0821: Ludlow is currently placing loam and seed on the south side of the shared access driveway next to where it intersects with the driveway for 214 Talcott Ridge Drive. Ludlow is also filling and compacting the area east of the tank pad footprint.

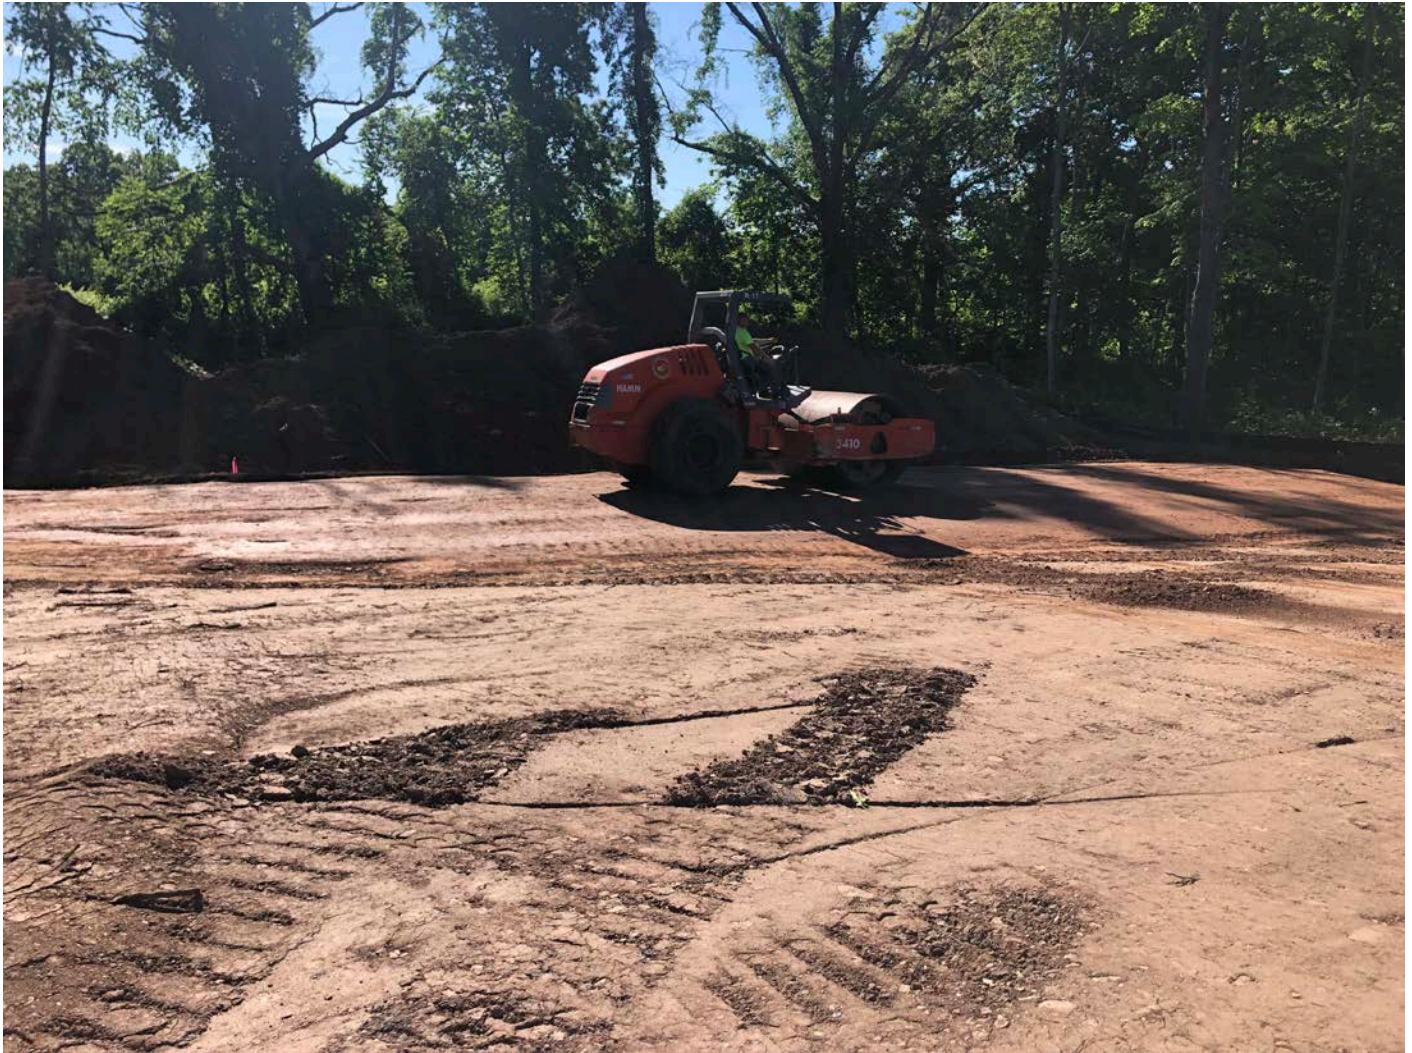
Picture 4: Ludlow compacting fill to east of the water tank pad footprint. View to the southeast. Middletown, CT.

1310: Ludlow continues to place loam and seed on north side of shared access driveway, between ~Stations 17+00 and 21+00. Ludlow is also continuing to place and compact fill to the west of the tank pad foot print.

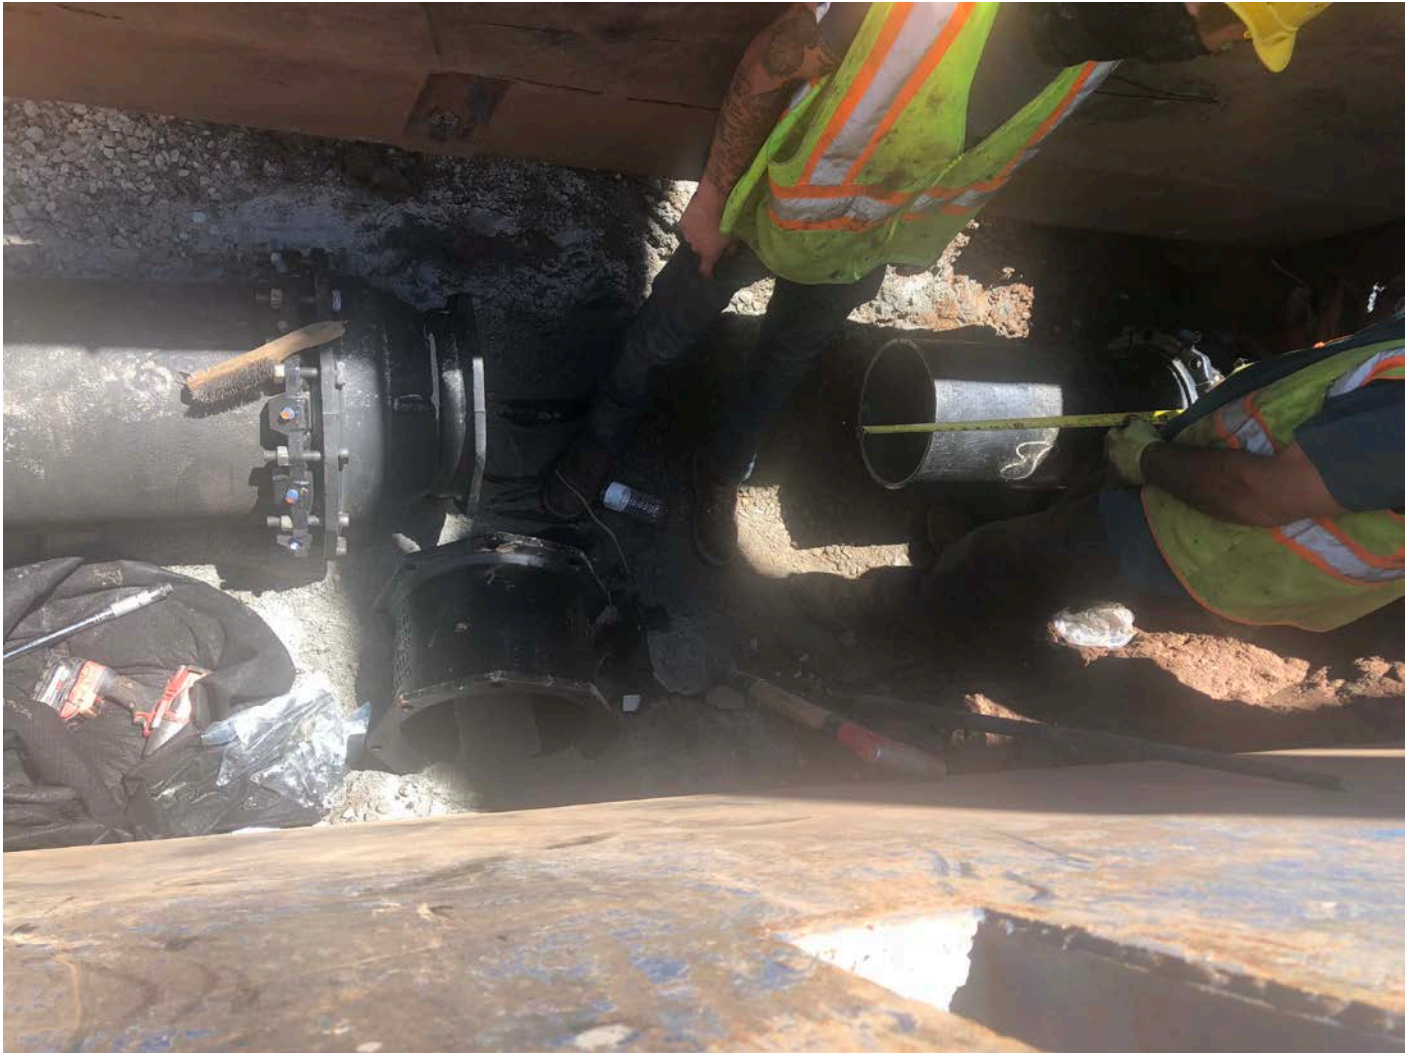
Picture 5: Ludlow preparing to connect 16" DIP to existing 12" water main. 16"x12" reducer visible along with 12" MJ solid sleeve. Main Street, southbound lane, Station 209+19. Durham, CT.

1206: Ludlow has placed a 16"x16"x12" M.J. C.L.D.I. TEE with a 16" M.J. butterfly valve and a 12" M.J. R.S. gate valve and gate box and a 12" M.J. R.S. gate valve and valve box at Station 209+15. In addition, they have placed a 16"x12" M.J. C.L.D.I. reducer at Station 209+19. A 2" air bleed valve was also placed at Station 209+19.

1231: Ludlow is currently placing two short sections of 12" DIP (totaling 7' in length) to connect the 12" reducer to the existing water main. A 12" MJ solid sleeve with restrained glands will connect the two pieces of 12" DIP together.
