Daily Report

Project:	Durham Meadows Pipeline Installation	Date:	July 7, 2020
Location:	Maiden Lane, Pickett Lane, Main Street	Day of Week:	Tuesday
Project #:	AECOM: 6061487	Report No:	114
Contractor:	Ludlow Construction	Page:	1 of 11

Daily Activities –Saw cutting of Pavement, Main Street, Durham

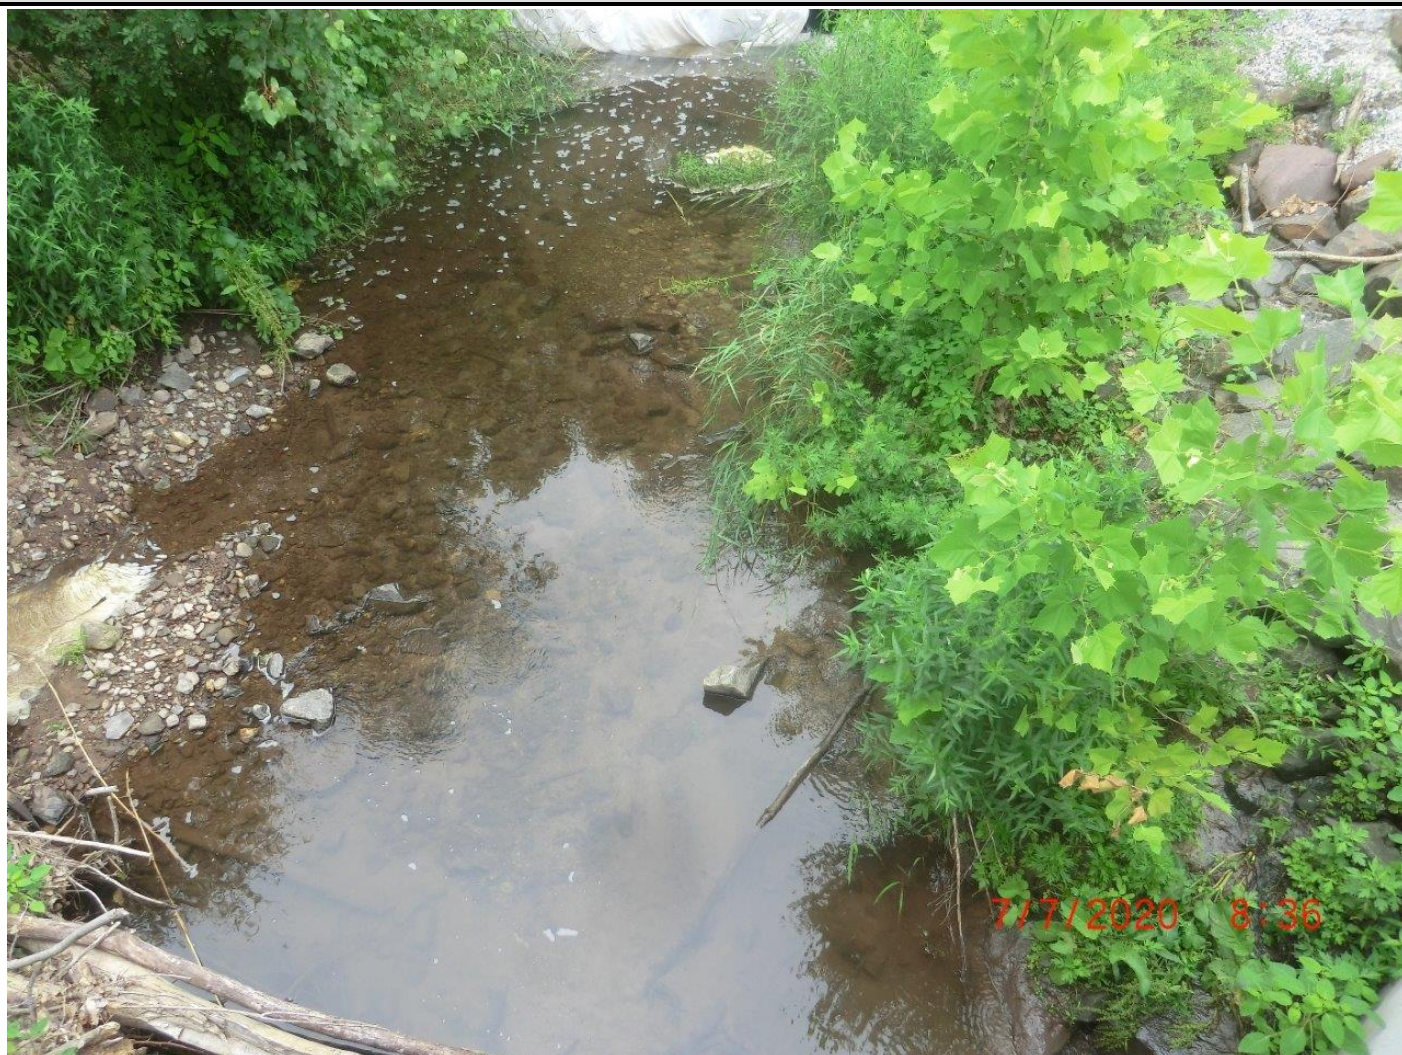
Picture 1: Condition of Allyn Brook prior to earth work being performed at the stream crossing at Station ~511+00 today. Pickett Lane, Durham. View to the north.

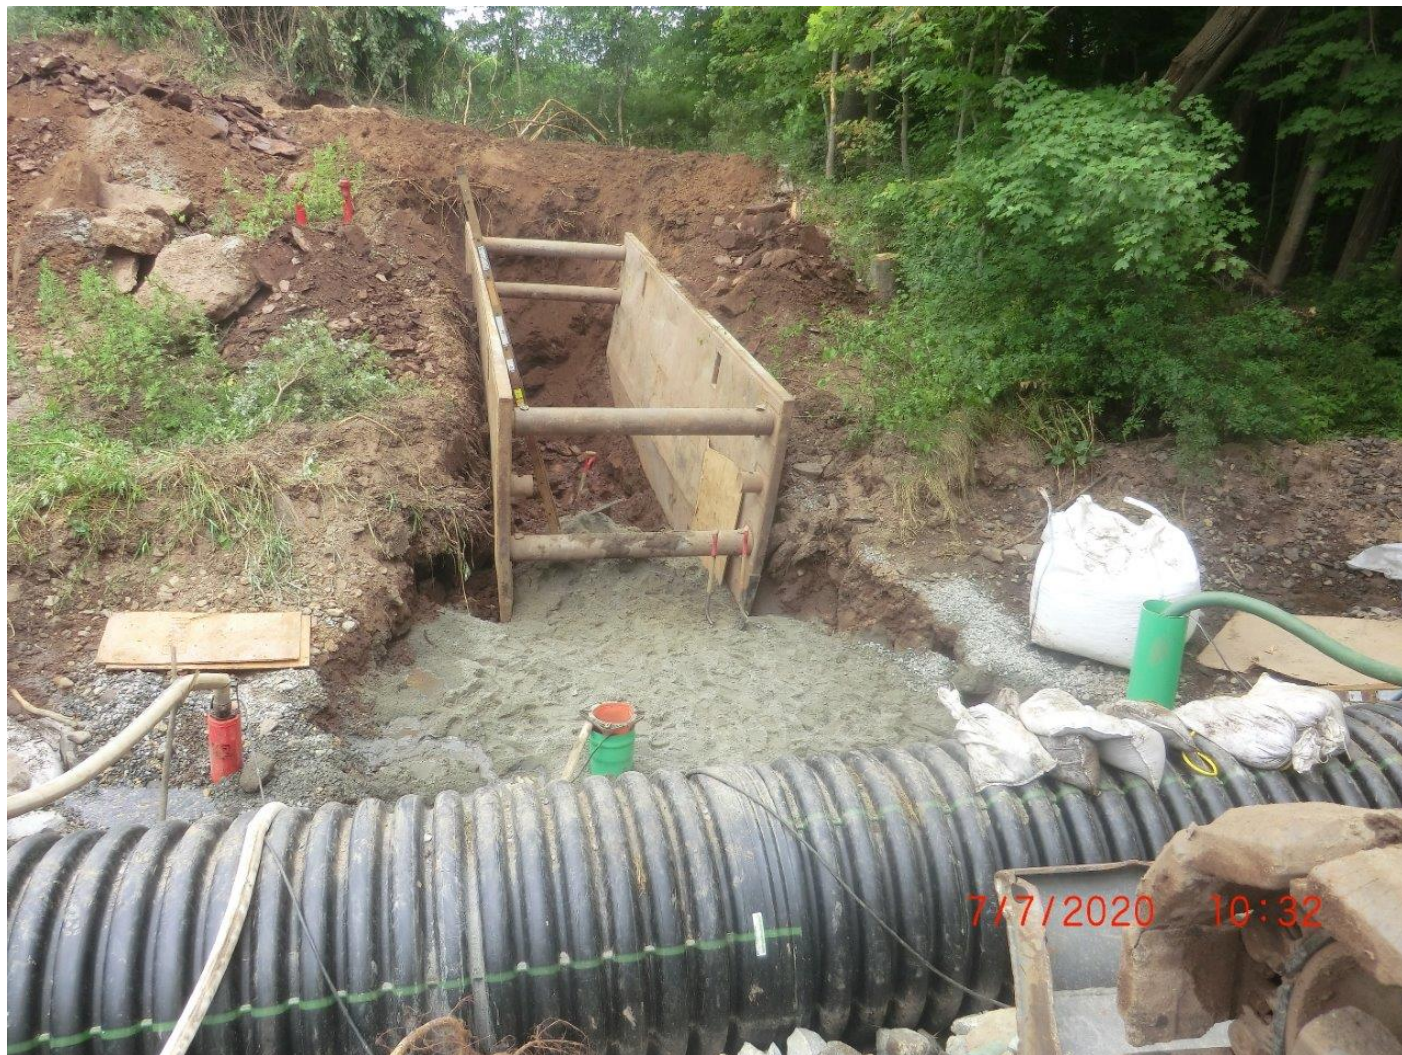
Picture 2: Trench box on the west bank of Allyn Brook during pipe installation activities. The 36" conduit has been backfilled with sand. Station ~511+00, Pickett Lane, Durham. View to the west.

1105: Ludlow has set up the trench box on the west bank of Allyn Brook to continue excavation activities. A pump has been set in gravel at the bottom of the trench to depress the water level.

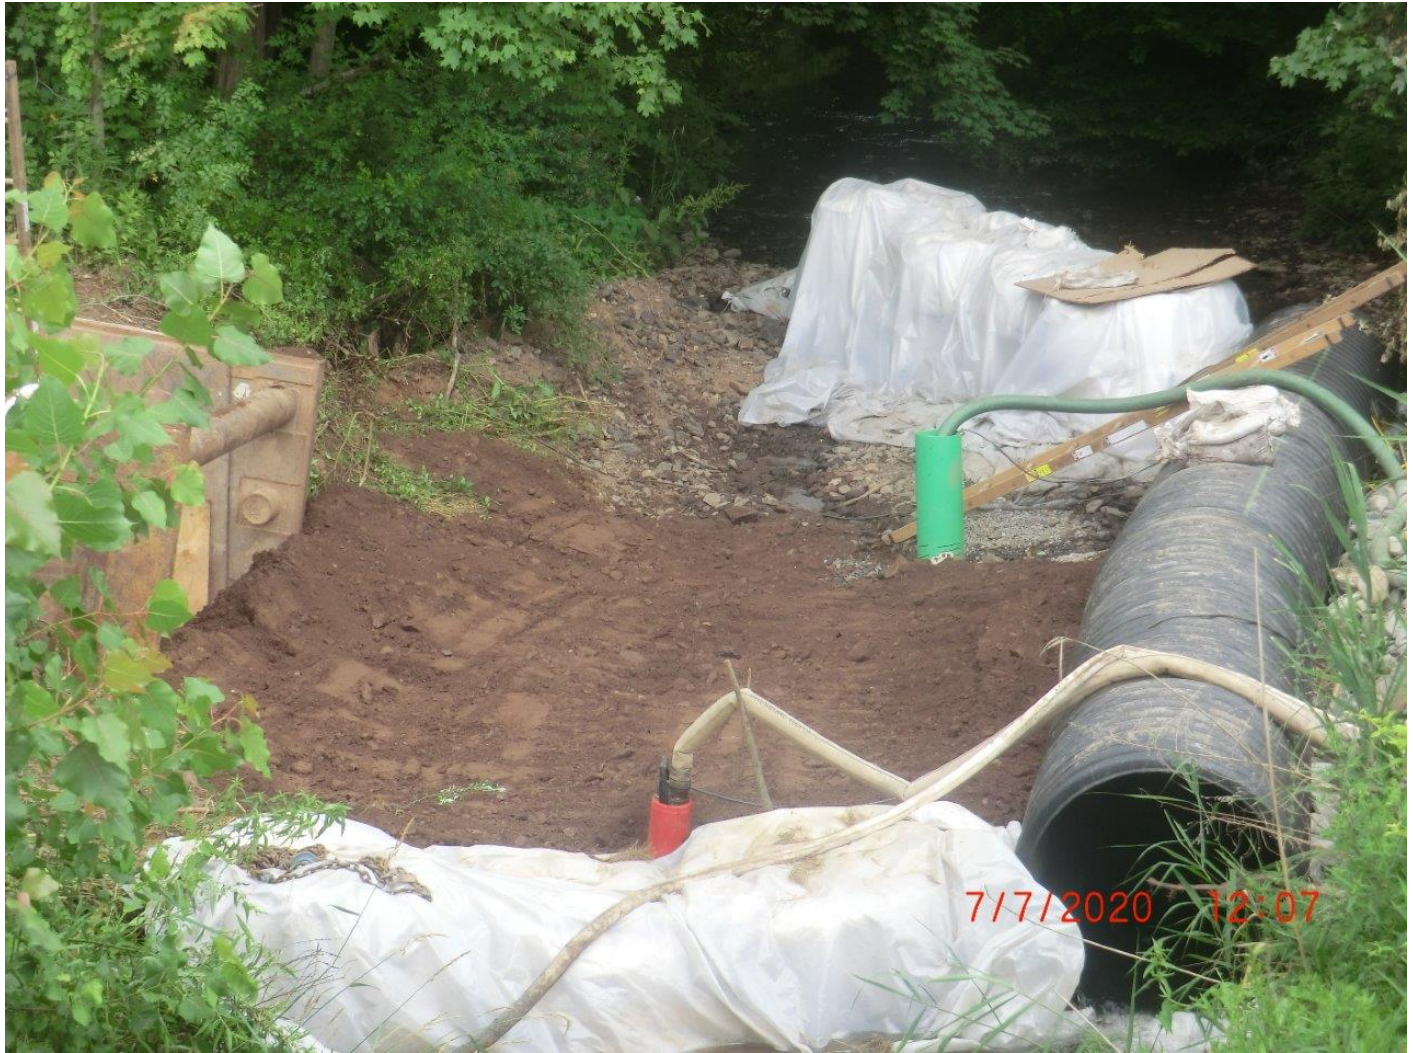
Picture 3: Allyn Brook after the 36" conduit was backfilled with sand. Station ~511+00, Pickett Lane, Durham. View to the north.

1125: Ludlow has backfilled over the 36" conduit in the brook channel with riprap stone roughly 5"-6" in size. Ludlow then placed some native stream bed material on top of the riprap. Ludlow continues to use pumps in the work zone to keep the water level in the work zone depressed.

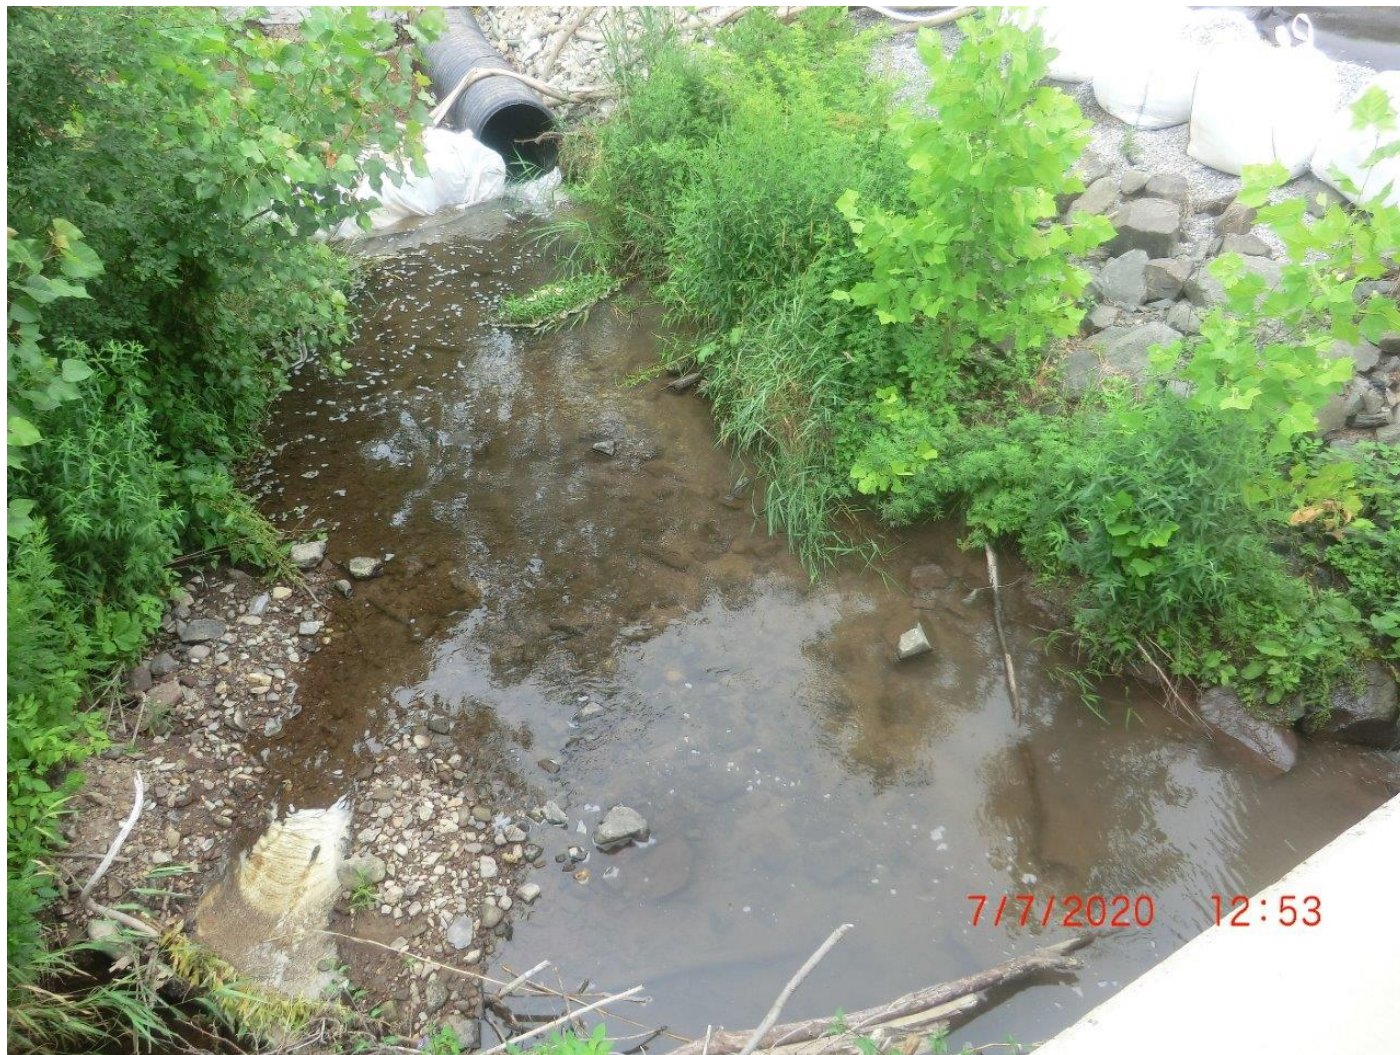
Picture 4: Minor turbidity observed downstream of ongoing stream crossing activities. Station ~511+00, Pickett Lane, Durham. View to the north.

0730: Ludlow continues to weld conduit together. Ludlow is performing minor excavation on the west side of Allyn Brook. Ludlow continues to pump water from work zone into the frac tank and the filter bed staged on the east side of the brook. Water in the frac tank settled some overnight, which has resulted in less turbid water overflowing into the filter bed and then into the brook. No obvious release of silt to the brook is currently being observed.

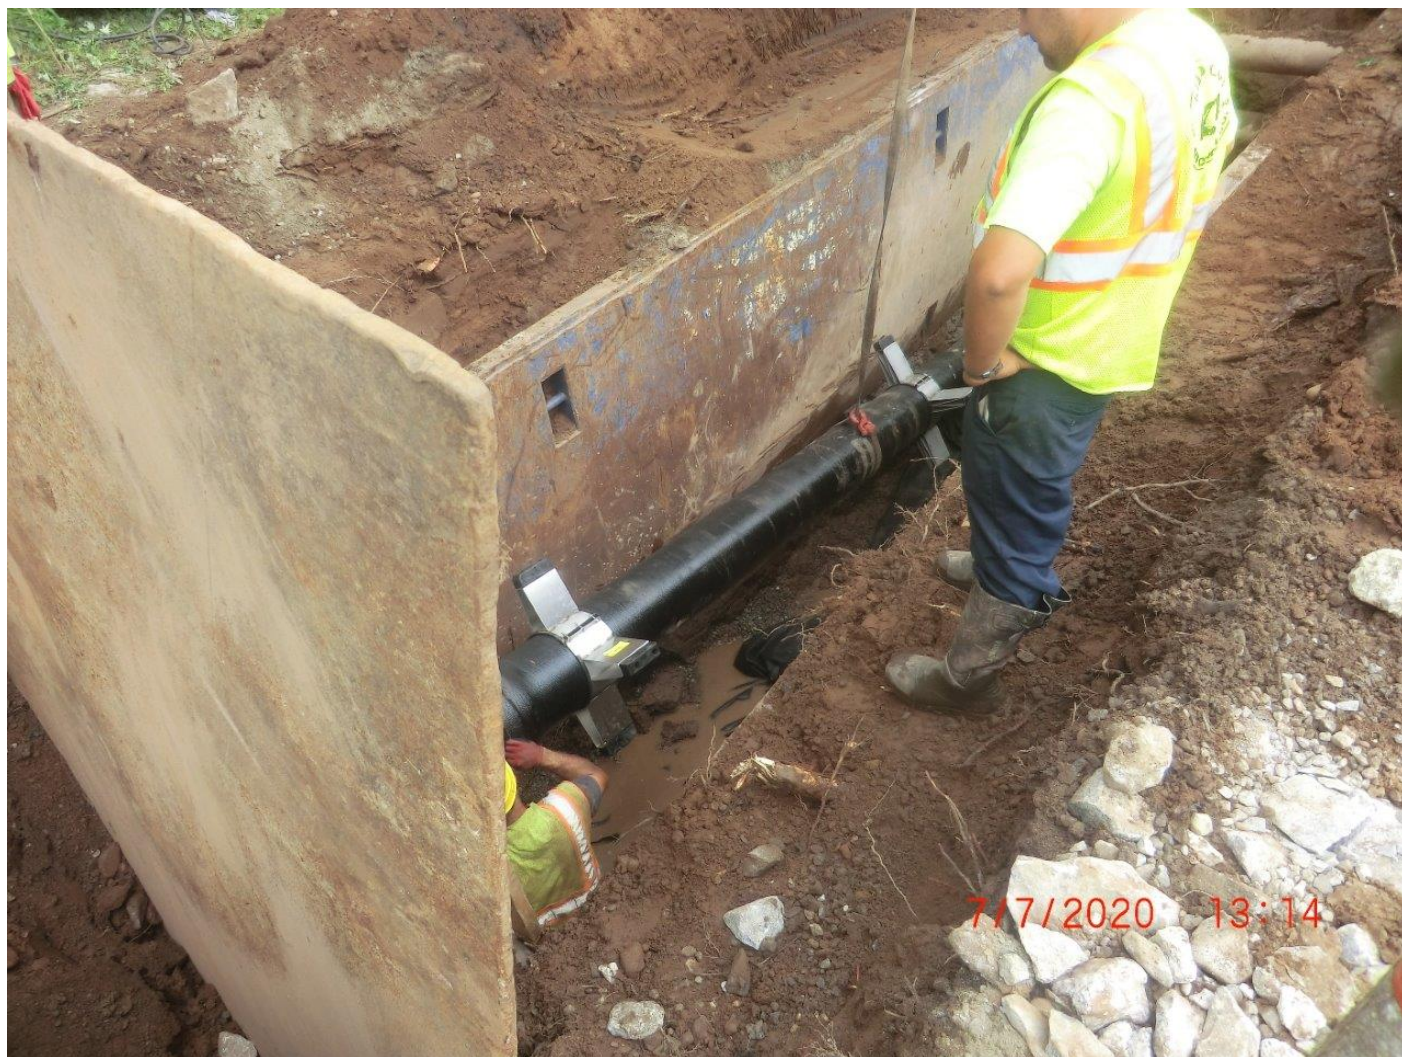
Picture 5: Ludlow preparing to insert 12" DIP with casing spacers into the 36" conduit. Station ~511+00, Pickett Lane, Durham. View to the northeast.

1130: Ludlow is prepping 12" DIP to insert into 36" conduit. Two 20' sections of 12" DIP have been outfitted with casing spacers.

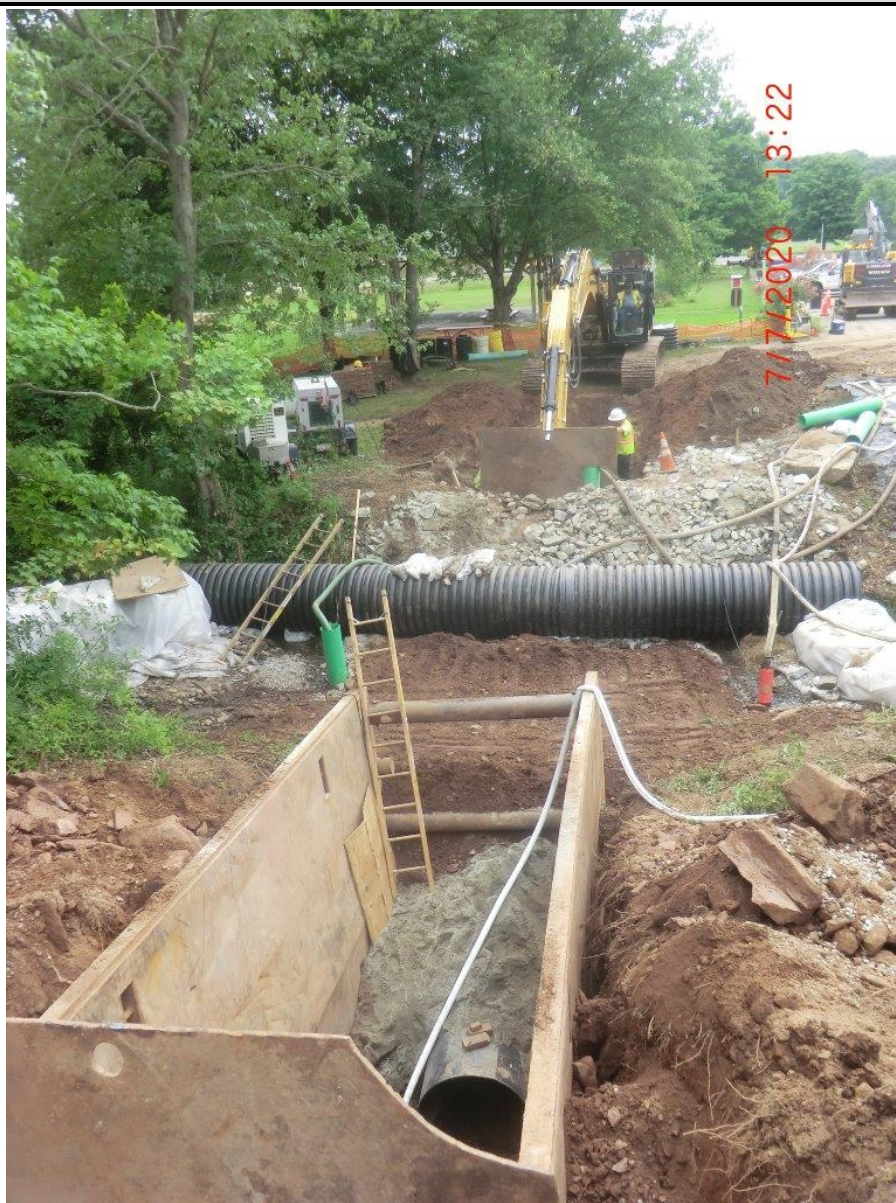
Picture 6: Overview of stream crossing work zone; view to east. 36" conduit is visible in the foreground within the trench box. Station ~511+00, Pickett Lane, Durham. View to the east.

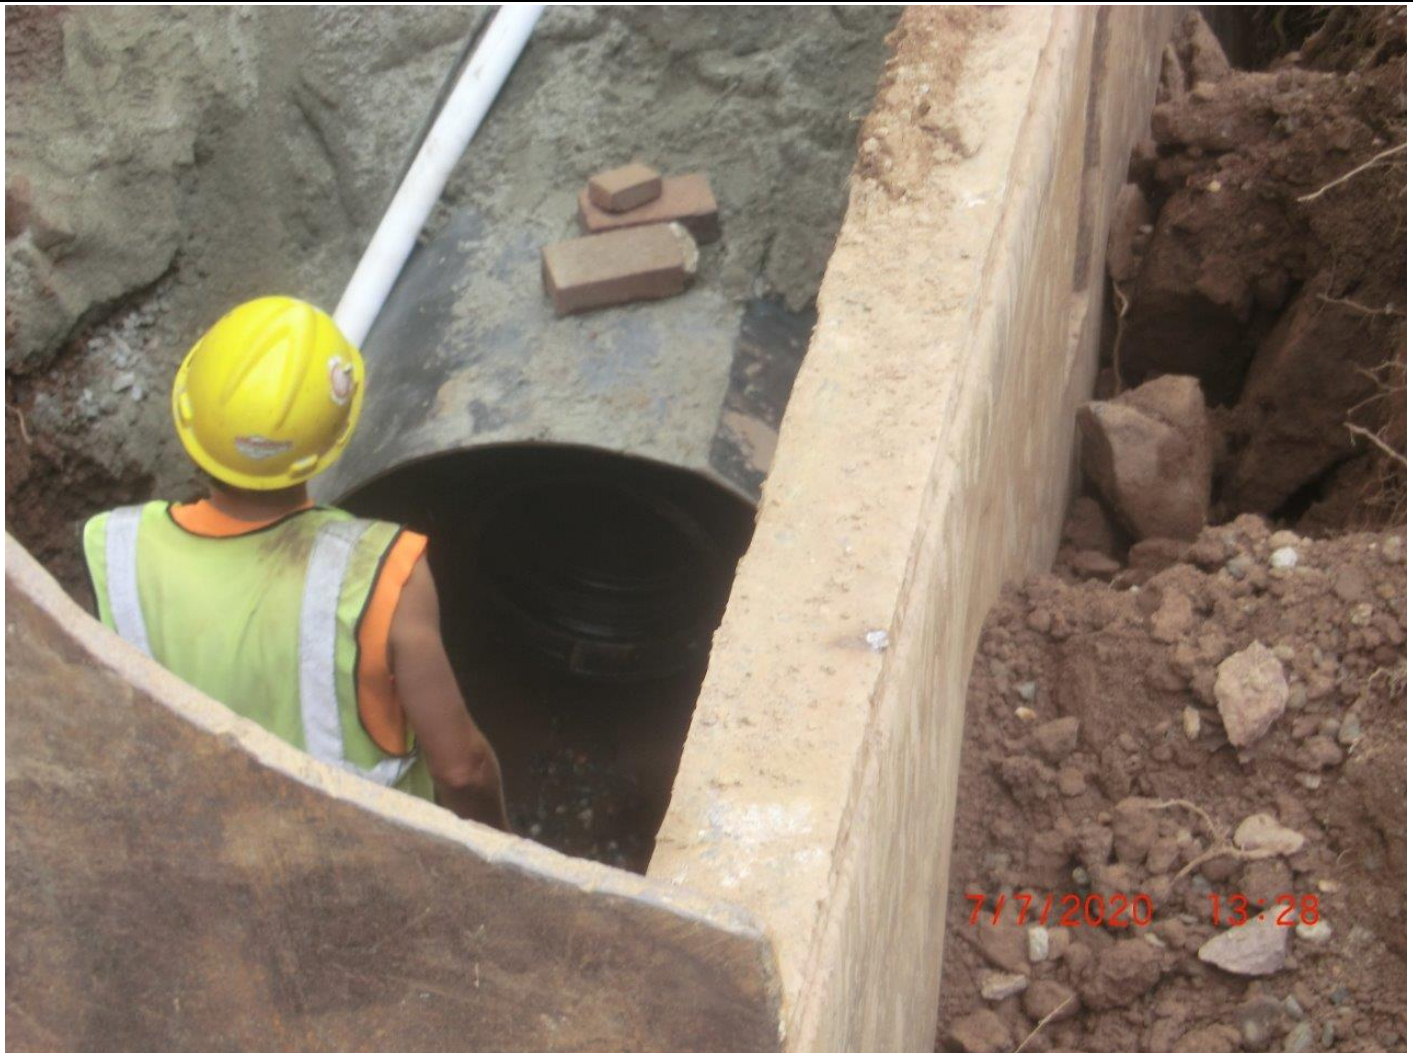
Picture 7: 36" conduit with 12" DIP placed inside of it. Station ~511+00, Pickett Lane, Durham. View to the east.

1330: Ludlow has finished installing two 20' sections of 12" DIP into the 36" conduit. The spacer tolerance (35.25" diameter) was too tight for the 36" conduit. Ludlow removed 1 of the 4 rubber bumpers from each spacer to get the 12" DIP inserted into the 36" conduit. The bumpers removed were the ones at the top of the DIP.

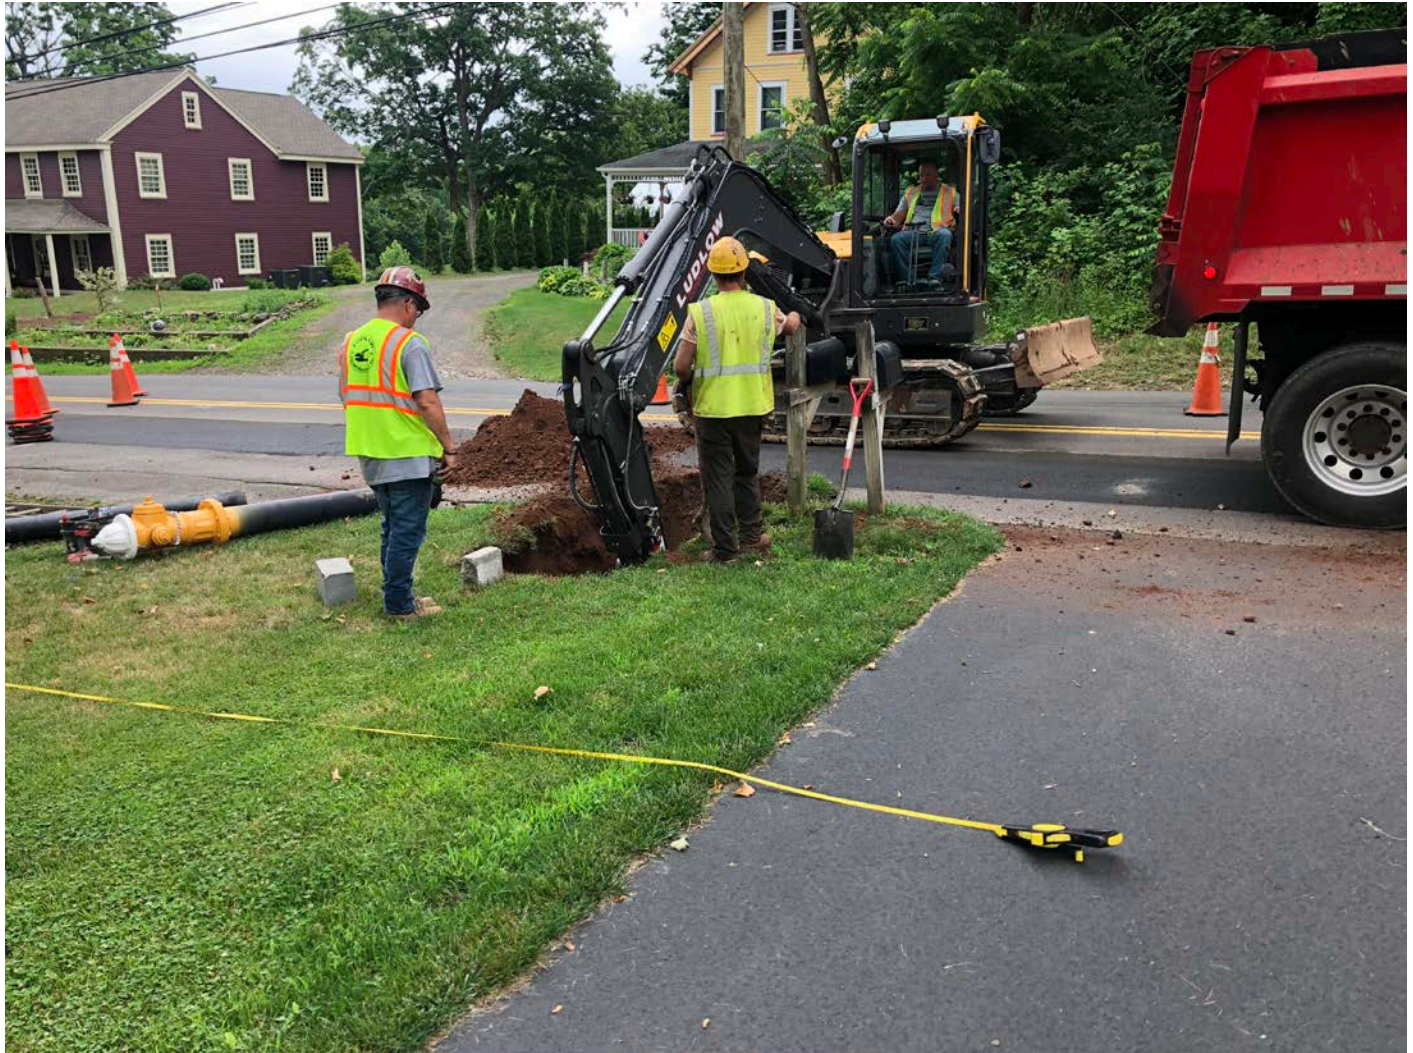
Picture 8: Ludlow installing hydrant at Station 405+40. The tape measure is located at Station 405+31, where the hydrant was originally located on Sheet C-37. View to the southeast from the driveway of 24 Maiden Lane, Durham.

1305: Ludlow moves to Station 405+40 to install another hydrant on the north side of Maiden Lane. Sheet C-37 has the hydrant placed at Station 405+31; however, this would have resulted in the hydrant being placed in the driveway of 24 Maiden Lane.
