## Daily Report

<b>Project:</b>	Durham Meadows Pipeline Installation	<b>Date:</b>	July 9, 2020
<b>Location:</b>	Pickett Lane, Maiden Lane, and Main Street, Durham	<b>Day of Week:</b>	Thursday
<b>Project #:</b>	AECOM: 6061487	<b>Report No:</b>	116
<b>Contractor:</b>	Ludlow Construction	<b>Page:</b>	1 of 9

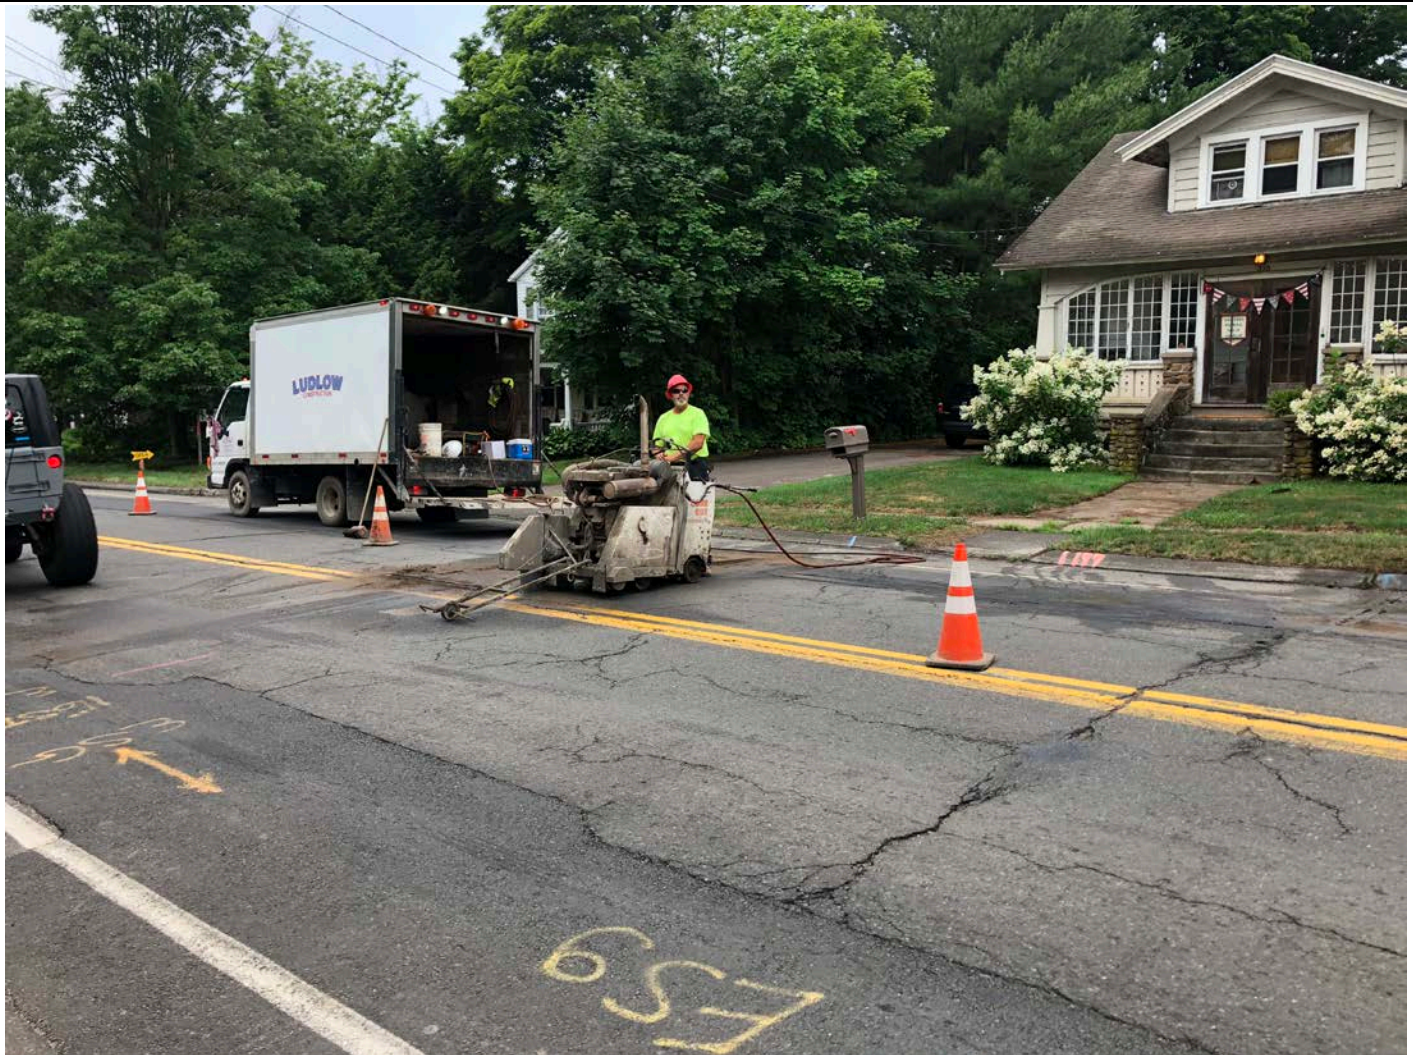
Picture 1: Ludlow saw cutting pavement on the southbound lane of Main Street, Durham. View to the southwest.

0730: Ludlow is saw cutting pavement on the southbound lane of Main Street at Station 177+05.

1219: Ludlow is saw cutting pavement on the southbound lane of Main Street just north of the intersection of Route 147.

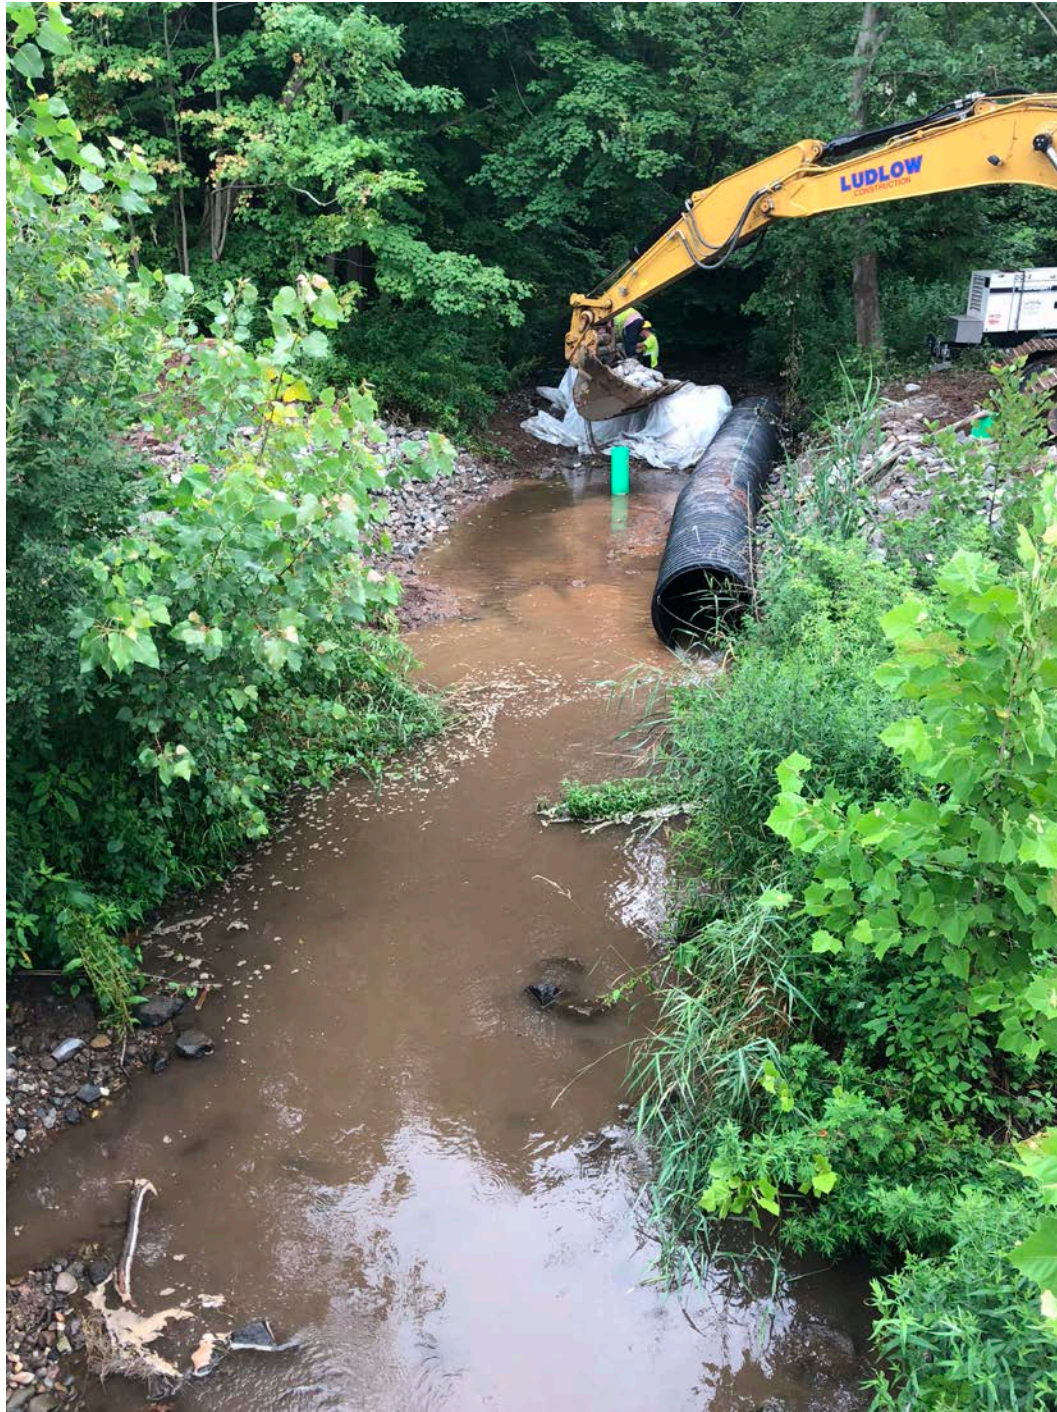
Picture 2: Ludlow removing upstream coffer dam of sandbags. Allyn Brook looking north. Pickett Lane, Durham.

0757: Ludlow is removing the sandbags from upstream and downstream of the work zone in the brook. Elevated turbidity is observed in the brook as water flows over the top layer of fill that was played over the 36" conduit.

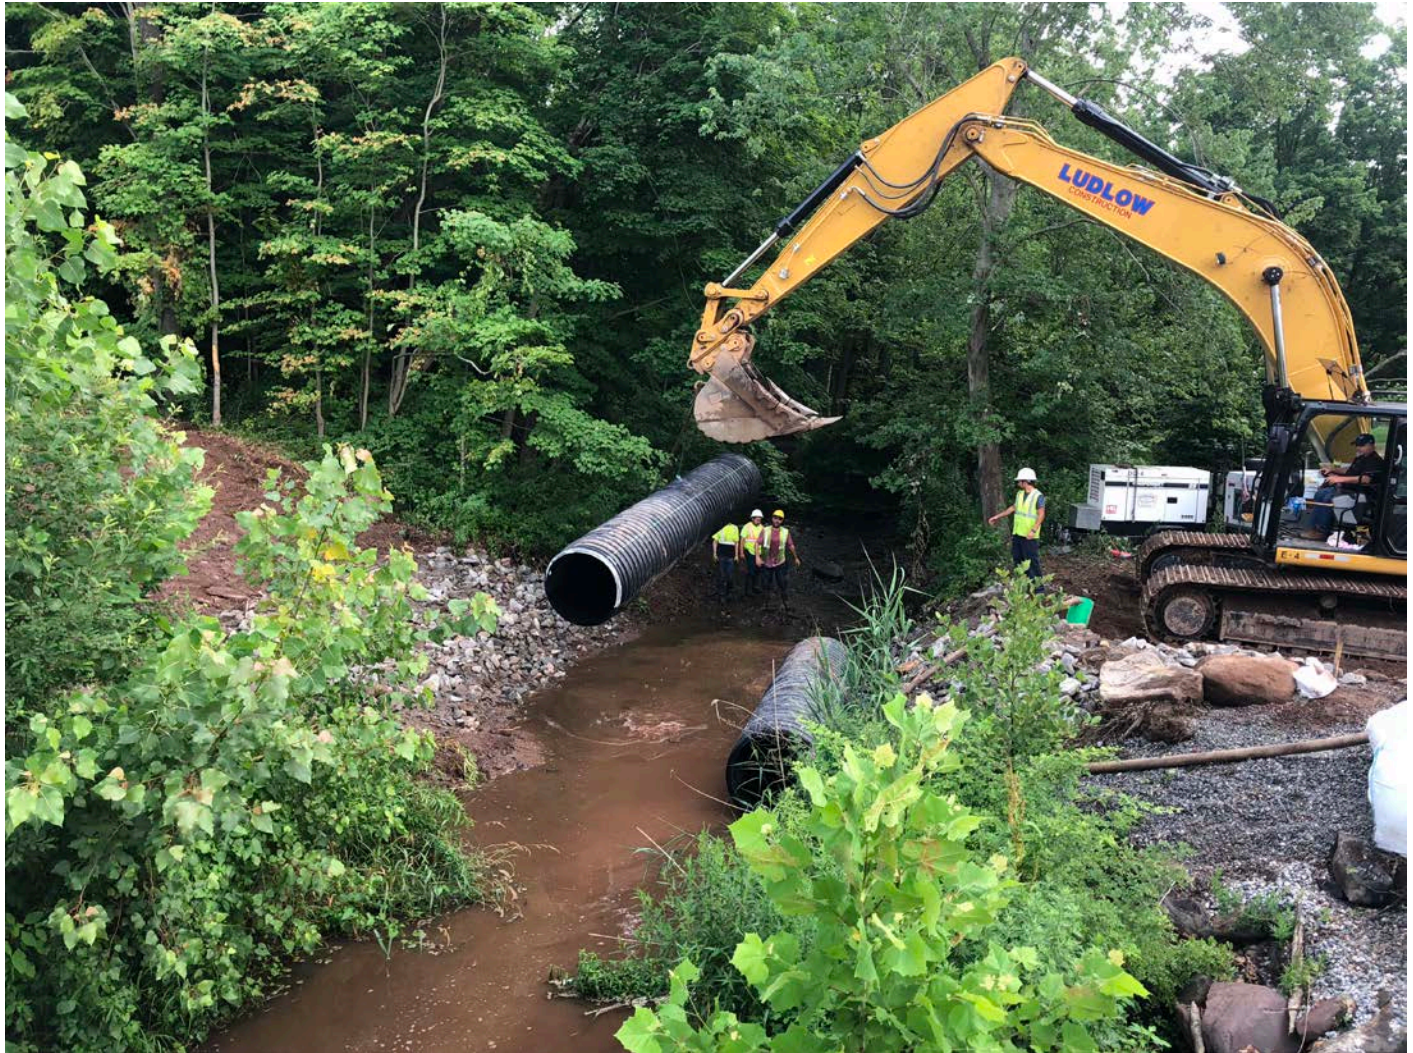
Picture 3: Ludlow removing stream bypass conduit. Allyn Brook, looking north. Station ~511+00, Pickett Lane, Durham.

0829: Ludlow has removed the 40" corrugated plastic stream flow bypass culvert from the brook.

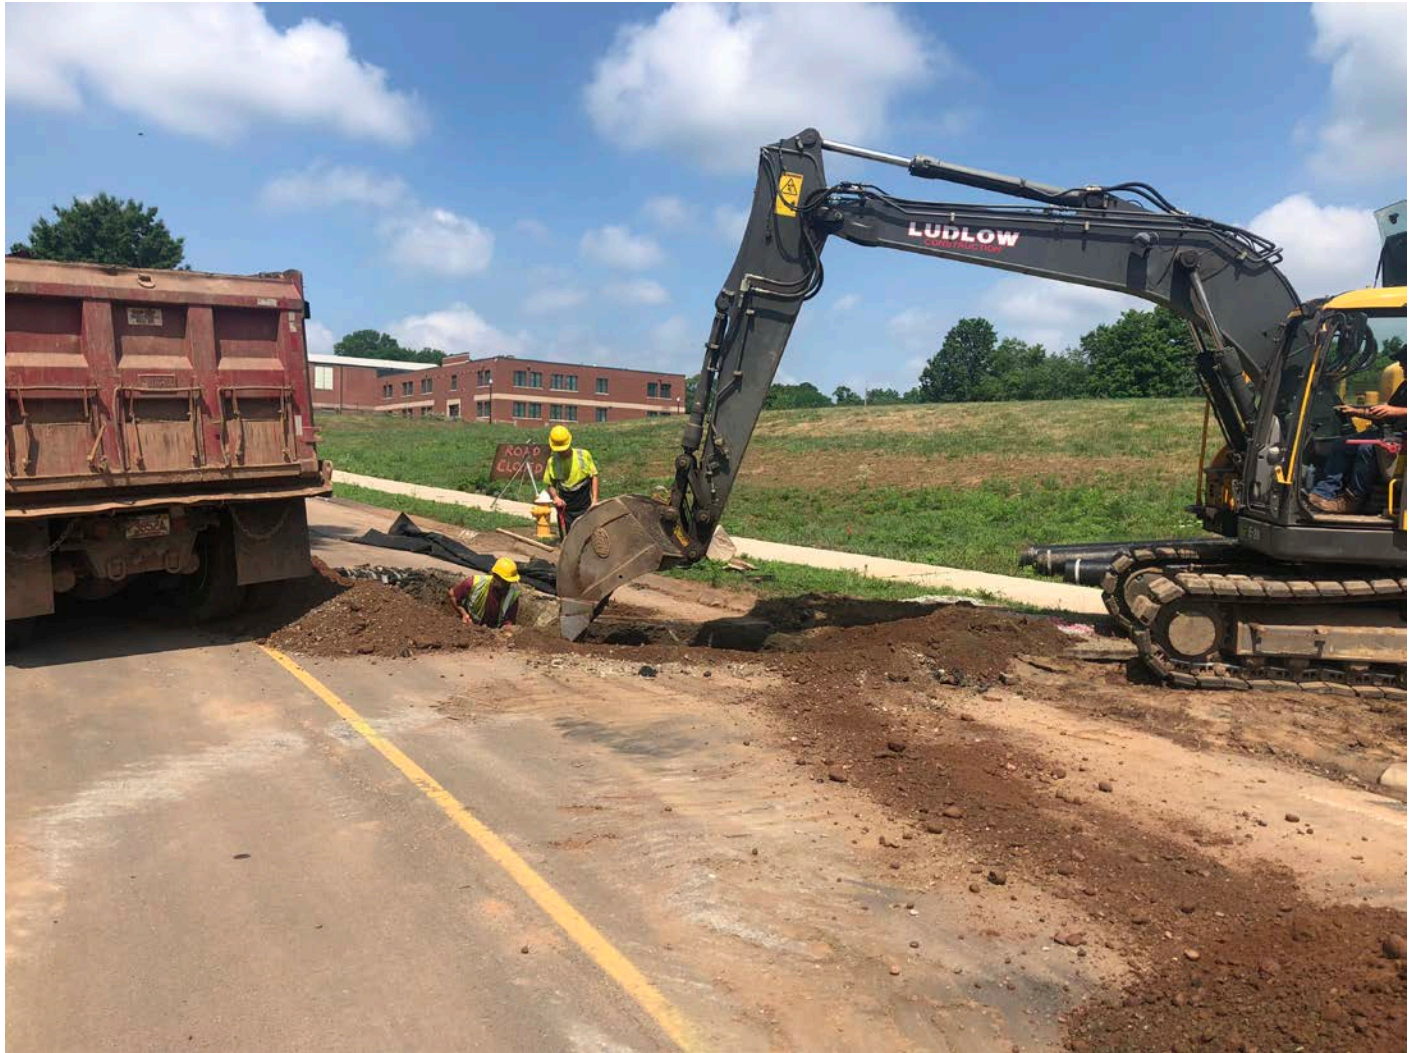
Picture 4: Ludlow excavating on Pickett Lane at Station ~509+10. View to the northwest.

1034: Ludlow excavating on Pickett Lane at Station ~509+25 (west of Allyn Brook).

1120: Ludlow continues to excavate on Pickett Lane at Station ~509+20.

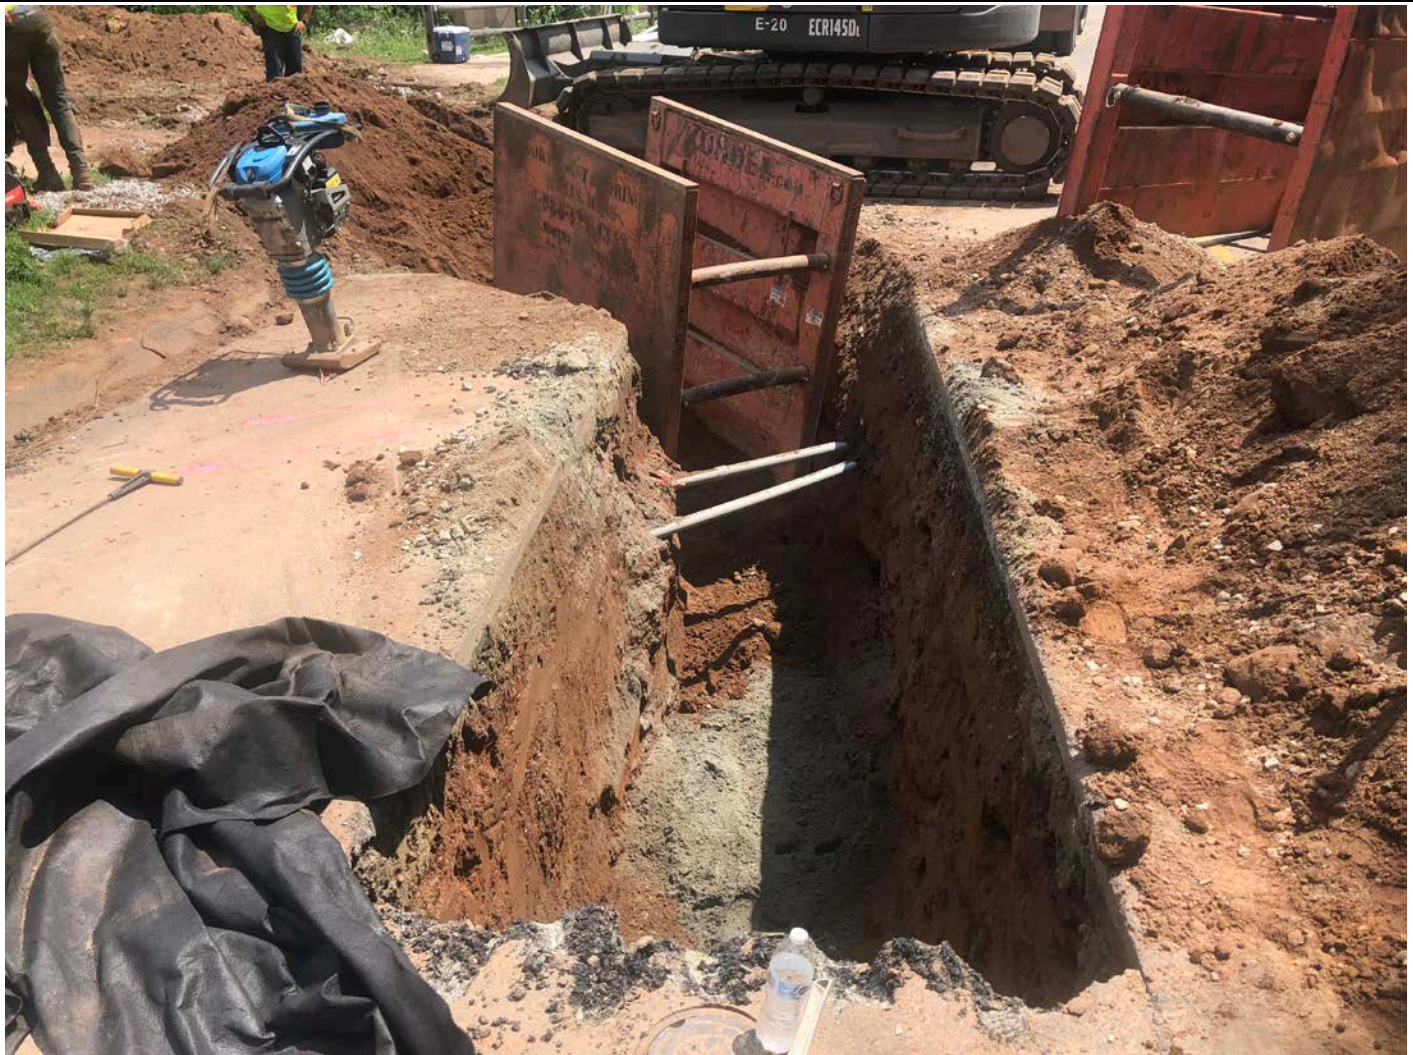
Picture 5: Ludlow about to place 12" DIP and a 45° bend at Station ~509+15. View to the northeast. Pickett Lane, Durham.

1141: Ludlow is placing a 15' section of 12" DIP at Station ~509+10 that includes a 12" M.J. C.L.D.I. 45° bend.

1239: Ludlow places a 5' section of 12" DIP after the 45° bend at Station ~509+15.

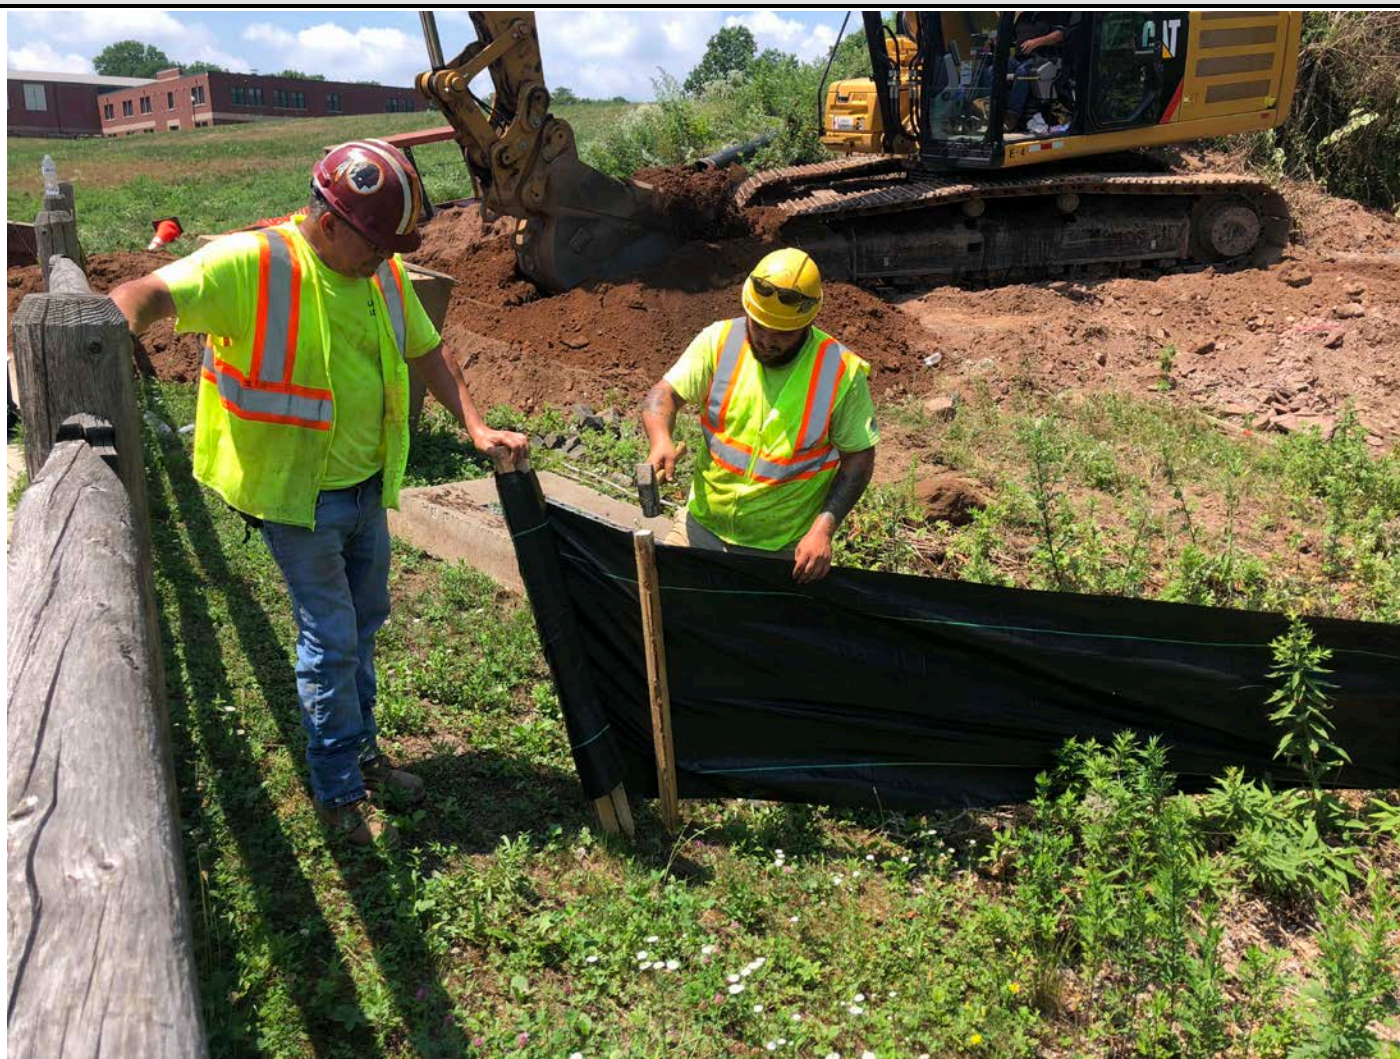
Picture 6: Ludlow installing silt fence on the west side of Allyn Brook. View to the west. Station ~509+50, Pickett Lane, Durham.

1310: Ludlow is erecting silt fence on the west bank of Allyn Brook.
