Daily Report

Project: Date: August 10, 2020 **Durham Meadows Pipeline Installation** Day of Week: Monday Location: Maple Avenue and Main Street, Durham AECOM: 6061487 **Report No:** 134 Project #: **Contractor: Ludlow Construction** Page: 1 of 11

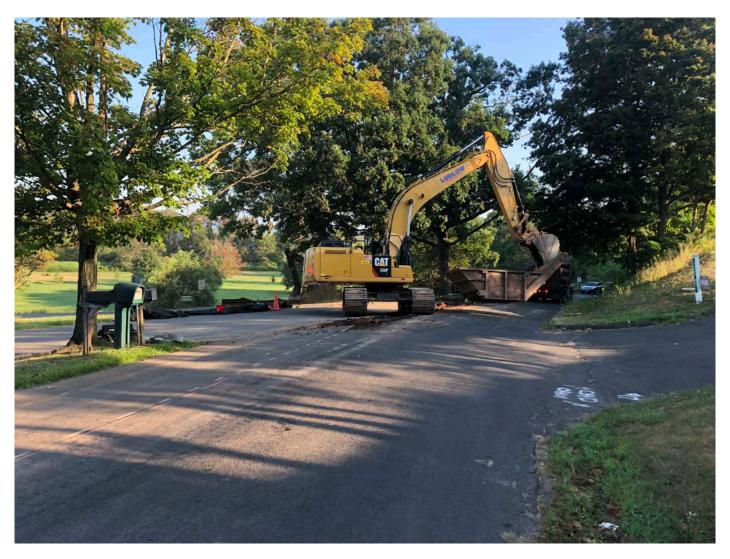
Picture 1: Ludlow excavating on Maple Avenue, Durham, at Station 901+50 for the installation of 12" DIP. View to the north.

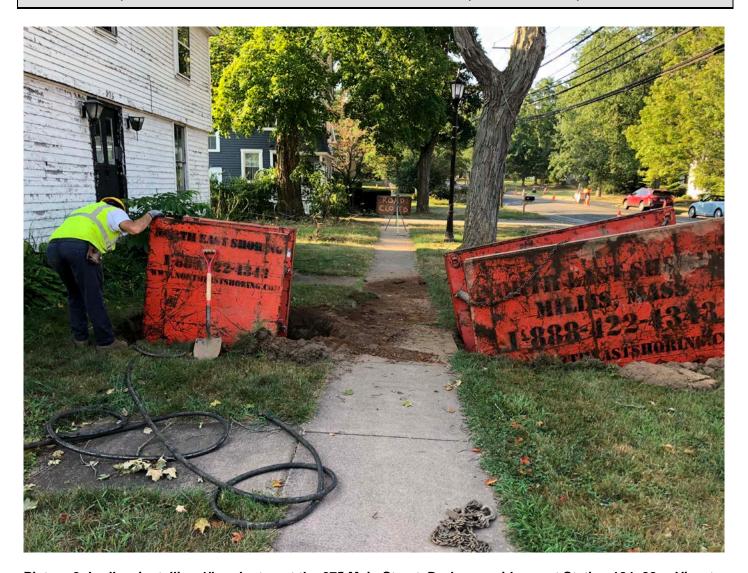
Picture 2: Ludlow installing 1" curb stop at the 275 Main Street, Durham residence at Station 184+88. View to the south.

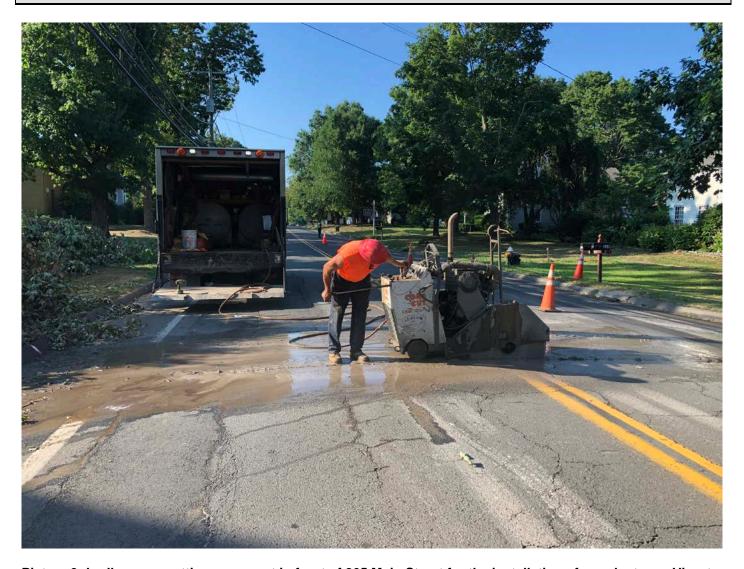
Picture 3: Ludlow saw cutting pavement in front of 265 Main Street for the installation of a curb stop. View to the south.

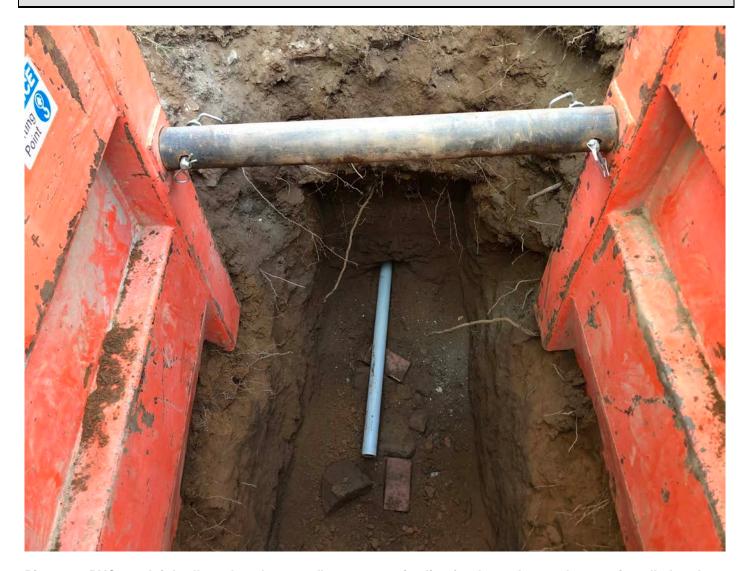
Picture 4: PVC conduit Ludlow placed to run 1" copper service line for the curb stop that was installed under the sidewalk in front of the 275 Main Street residence. Station 184+88. View to the west.

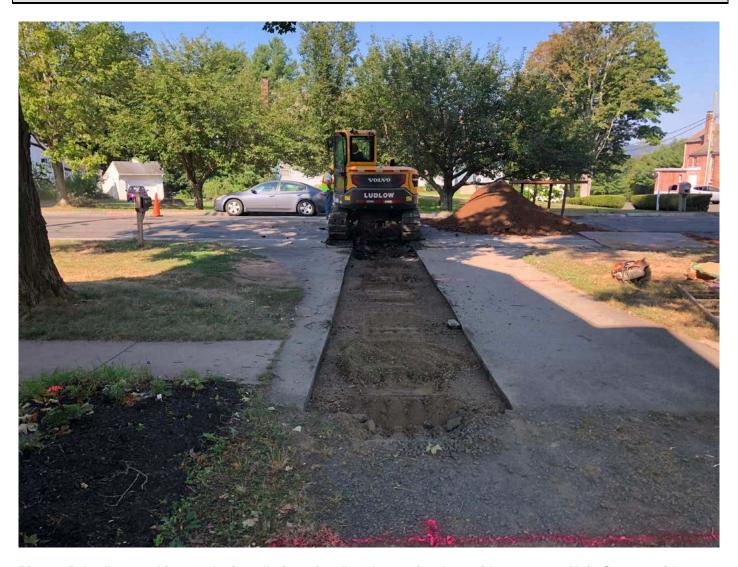
Picture 5: Ludlow working on the installation of a 1" curb stop for the residence at 271 Main Street residence. Station 185+72. View to the west.

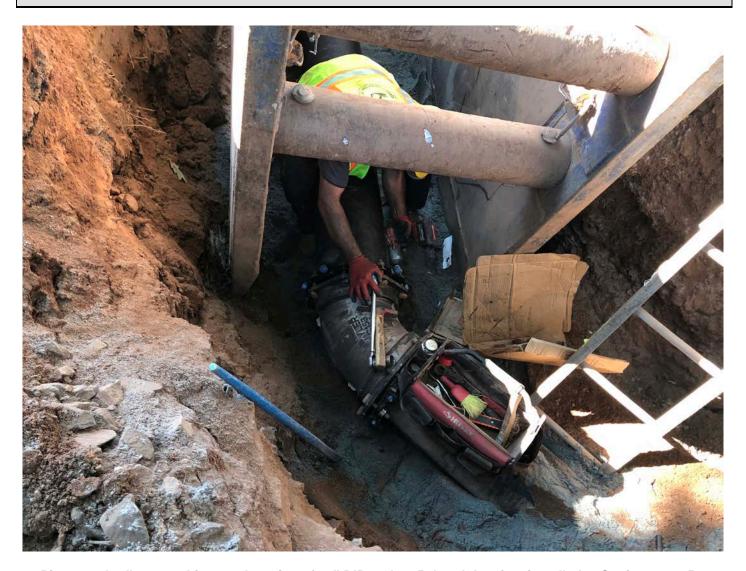
0942: Ludlow has just installed a 45° bend at Station 901+69 on Maple Avenue. Ludlow is currently attaching a 14' section of 12" DIP to the 45° bend.

Picture 6: Ludlow attaching a 14' section of 12" DIP to the 45° bend they just installed at Station 901+65. Maple Avenue, Durham. View to the south.

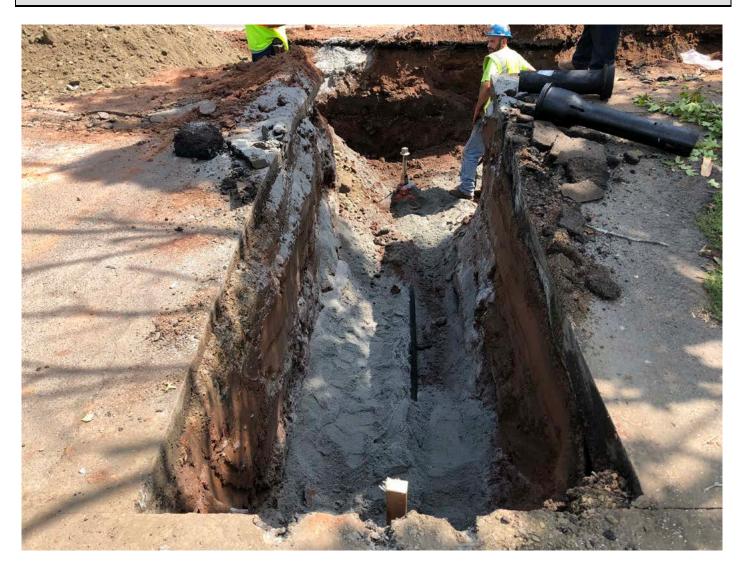
1206: Ludlow is installing a 14.5' section of 8" DIP at the paved entrance to the Durham Fair property (this is the location that was selected by the owner of the fairgrounds). The 8" DIP was placed with a DIP end cap on its west side; it was connected to an 8" gate valve that was installed earlier today at Station 900+79 on the 12" waterline (the 8" valve was connected to a 12"x12"x8" TEE that was also installed today at Station 900+79).

Picture 7: Ludlow installing a 14.5' section of 8" DIP at Station 900+90, placed west of Maple Avenue into the Durham fairgrounds entrance. View to the east.

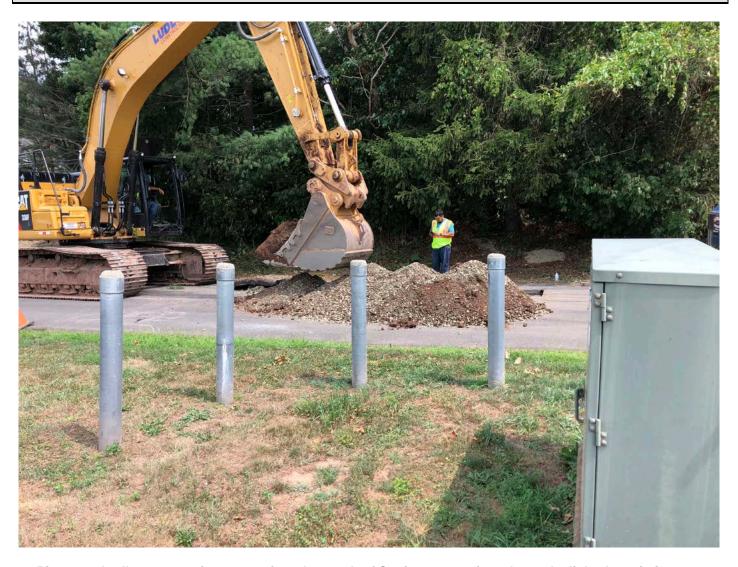
1320: Ludlow is excavating a test pit on Maple Avenue south of Station 900+00 (and adjacent to transformer number 1180 which is located on the west side of the road). Ludlow is daylighting the existing water line to see if it was installed using restrained piping. It was not.

Picture 8: Ludlow excavating a test pit to the south of Station 900+00 in order to daylight the existing water line. Maple Avenue, Durham. View to the east.
