Daily Report

Project:	Durham Meadows Pipeline Installation	Date:	August 19, 2020
Location:	Maple Avenue and Main Street, Durham; Shared Access Driveway, Middletown	Day of Week:	Wednesday
Project #:	AECOM: 6061487	Report No:	141
Contractor:	Ludlow Construction	Page:	2 of 13

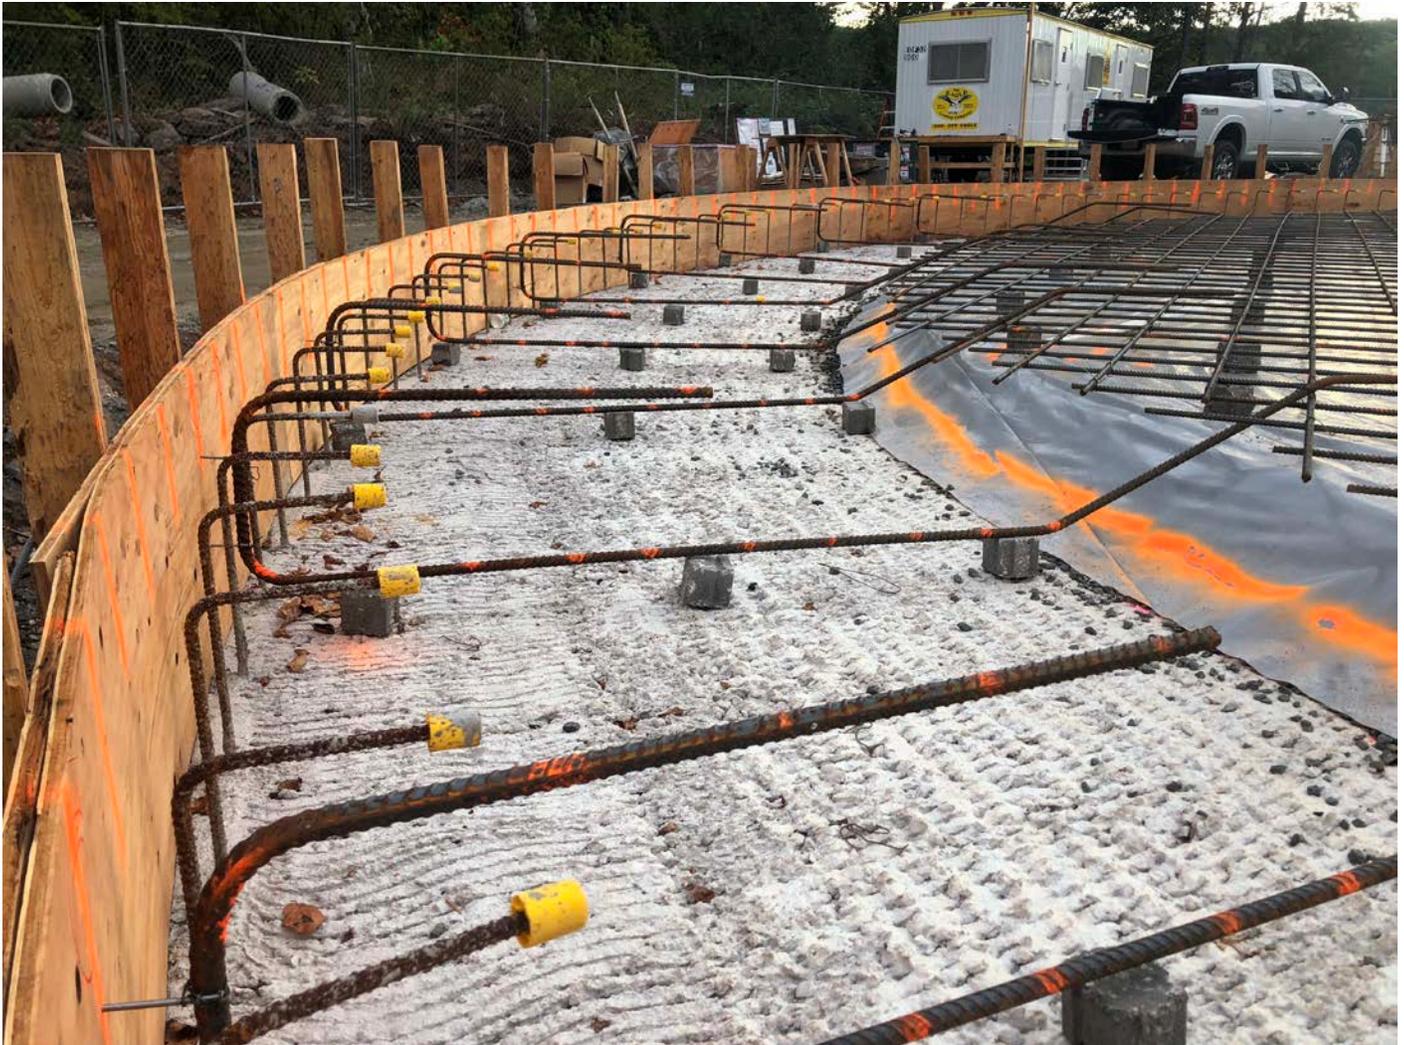
Picture 1: Rebar placed on frost wall of the water tank footprint by Northeastern Steel. Water tank work zone, east of the Shared Access Driveway, Middletown. View to the west.

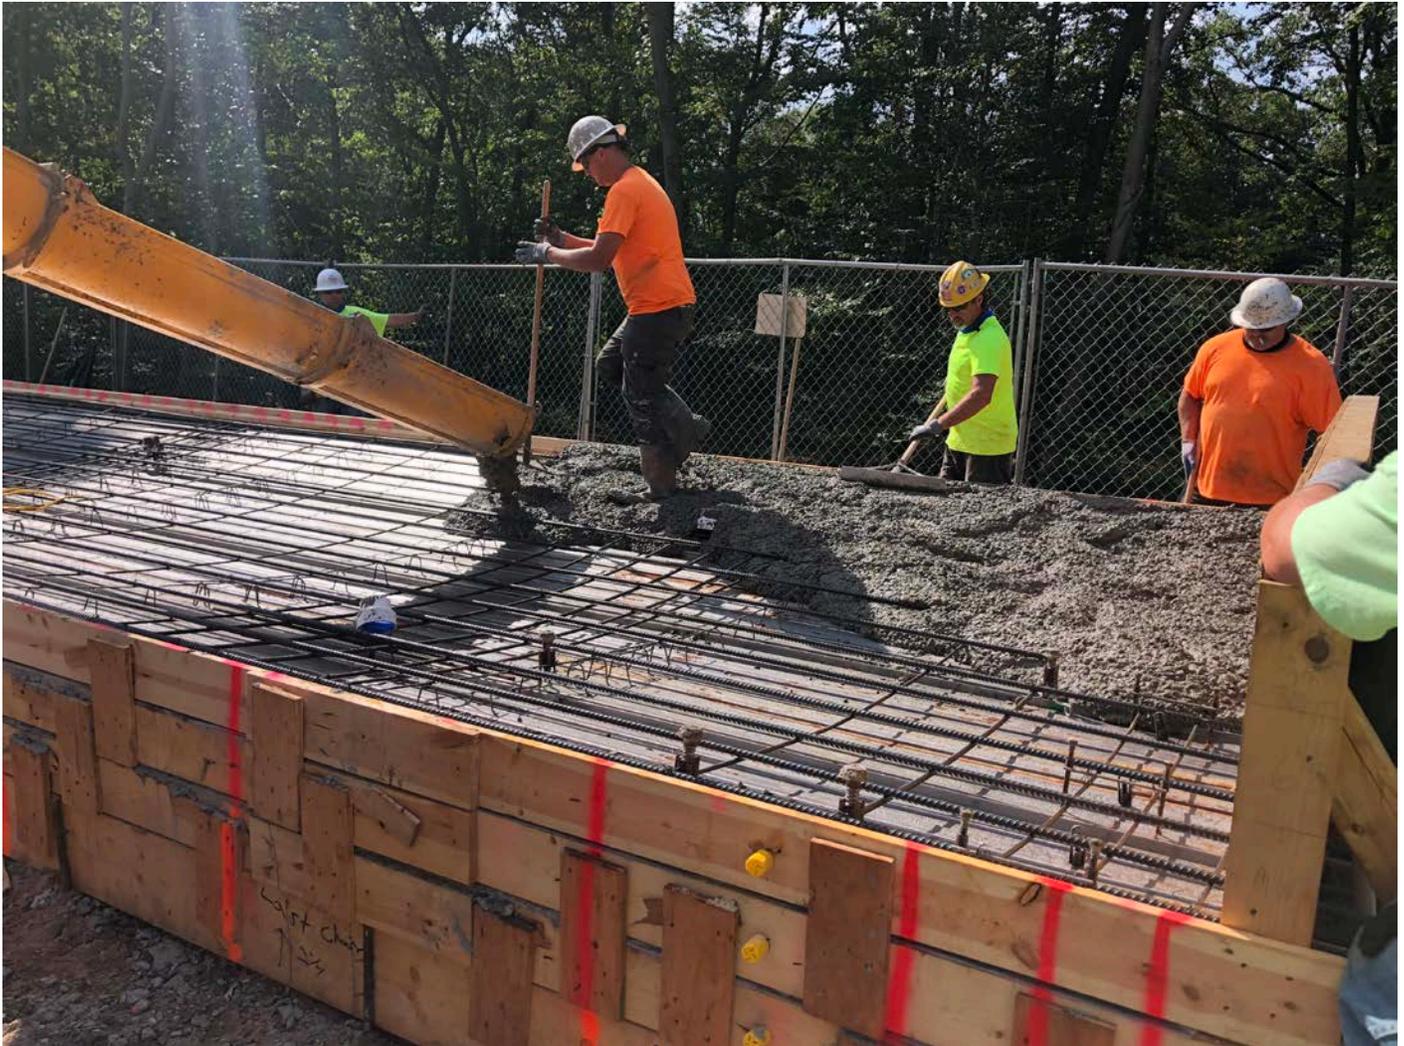
Picture 2: DN Tanks placing 4000 PSI concrete on the first of two concrete forms for the side panels of the water tank. East of the Shared Access Driveway, Middletown. View to the south.

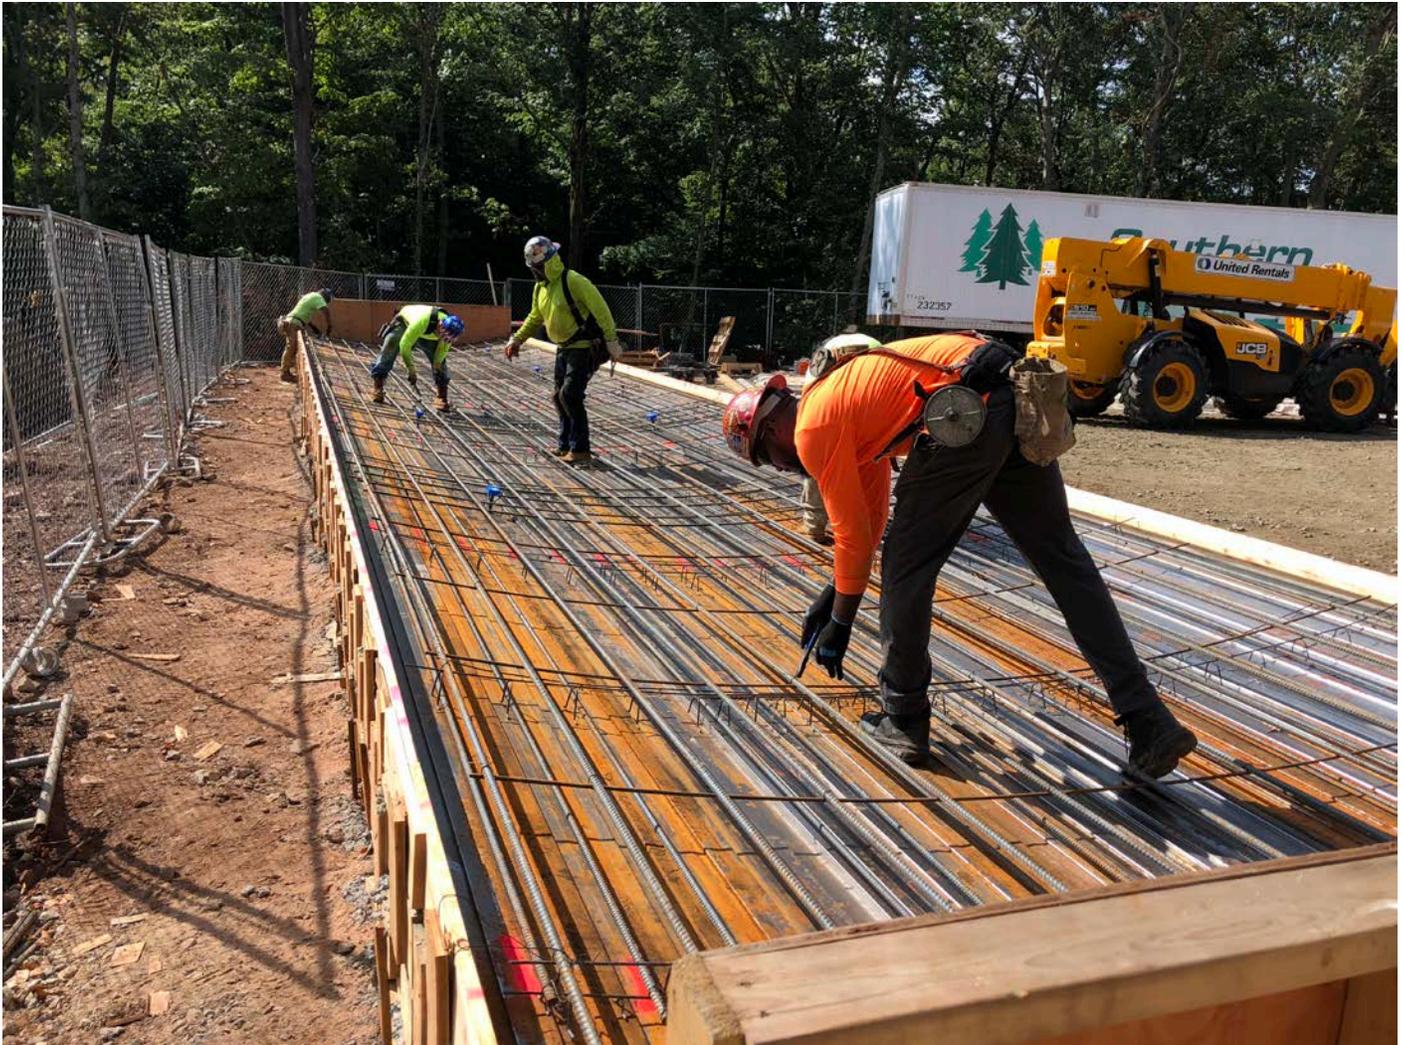
Picture 3: Northeastern Steel fastening rebar with wire ties on top of chairs on one of the two water tank side panel concrete forms. Water tank work zone, east of the Shared Access Driveway, Middletown.

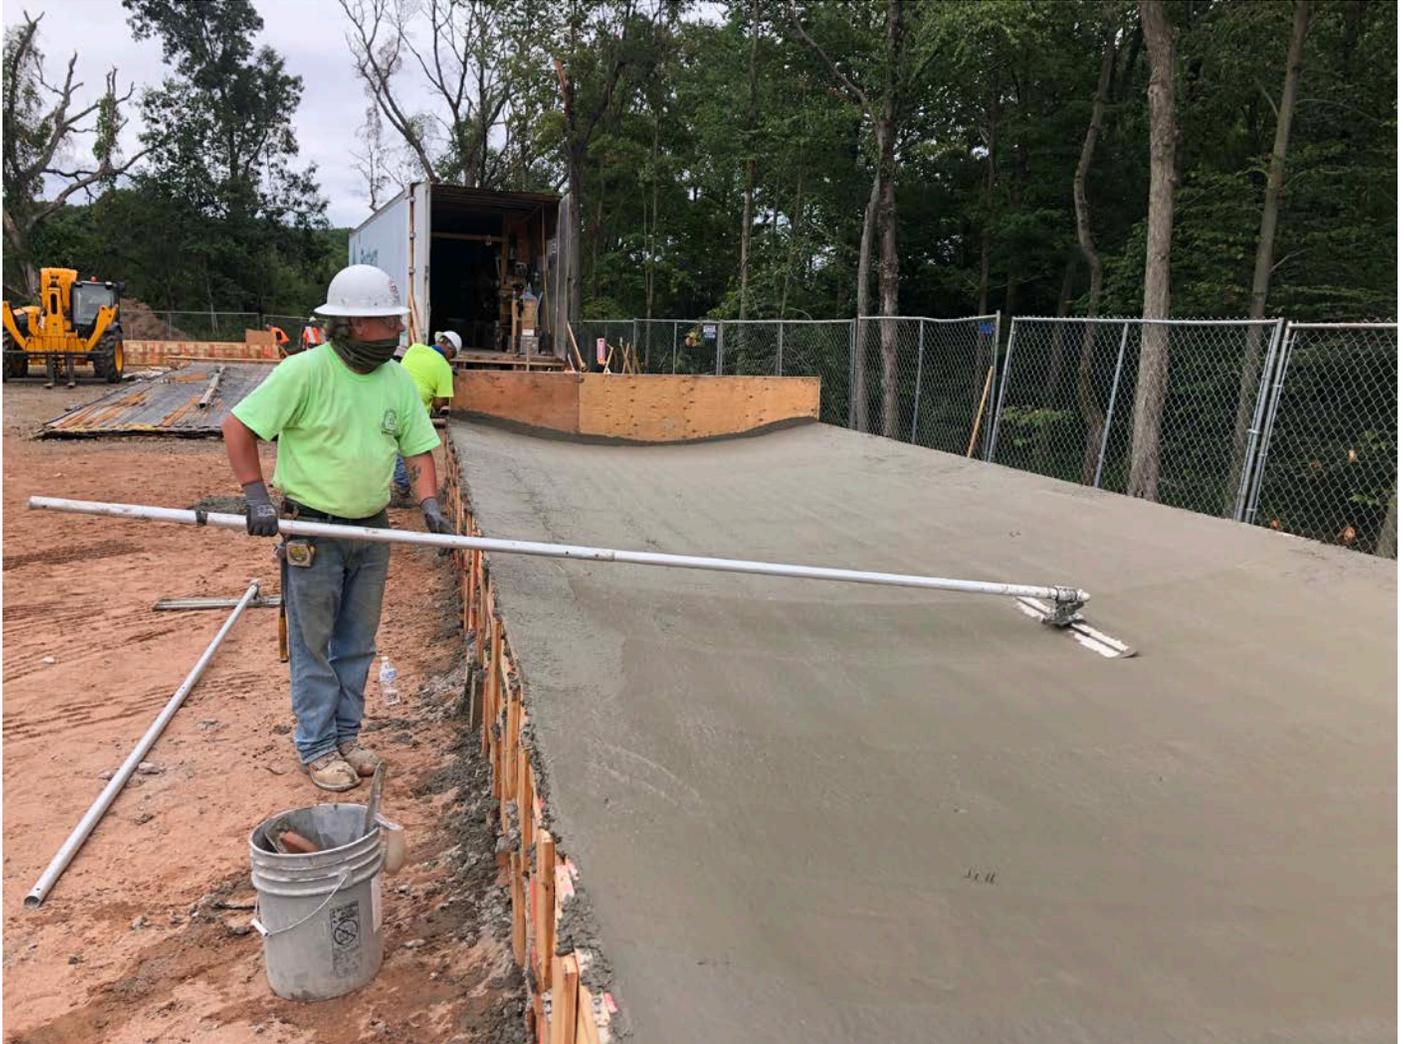
Picture 4: DN Tanks finishing the surface of concrete placed on one of the two water tank side panel concrete forms. Water tank work zone, east of the Shared Access Driveway, Middletown. View to the east.

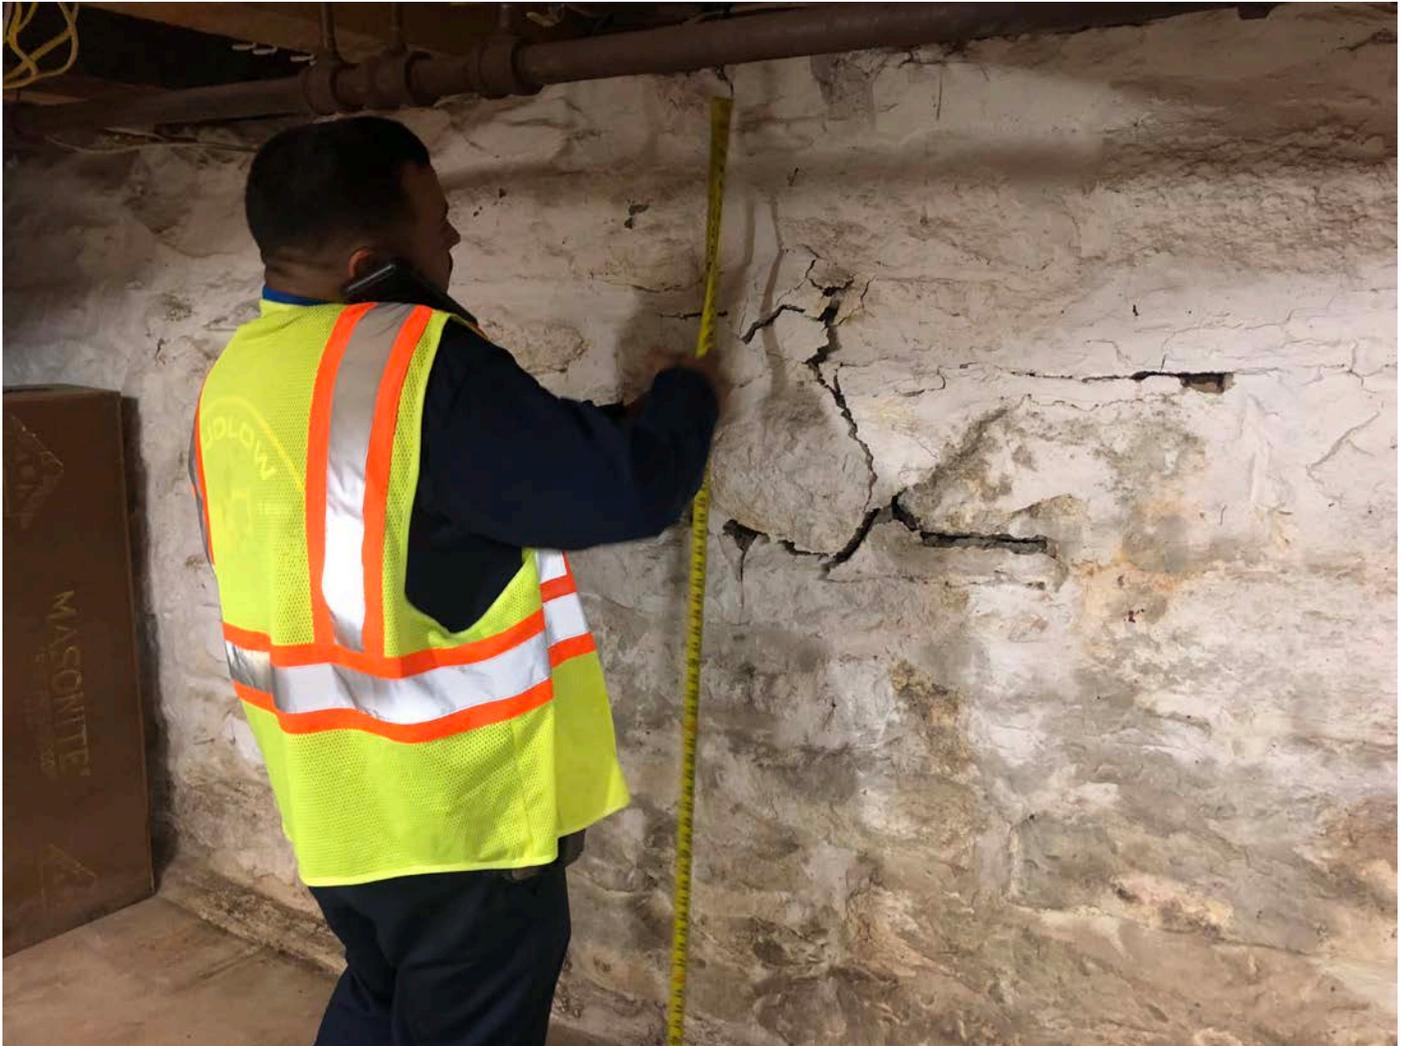
Picture 5: Ludlow preparing to penetrate the basement wall of the residence at 13 Maple Avenue, Durham in order to bring a 1" copper service line into the house.

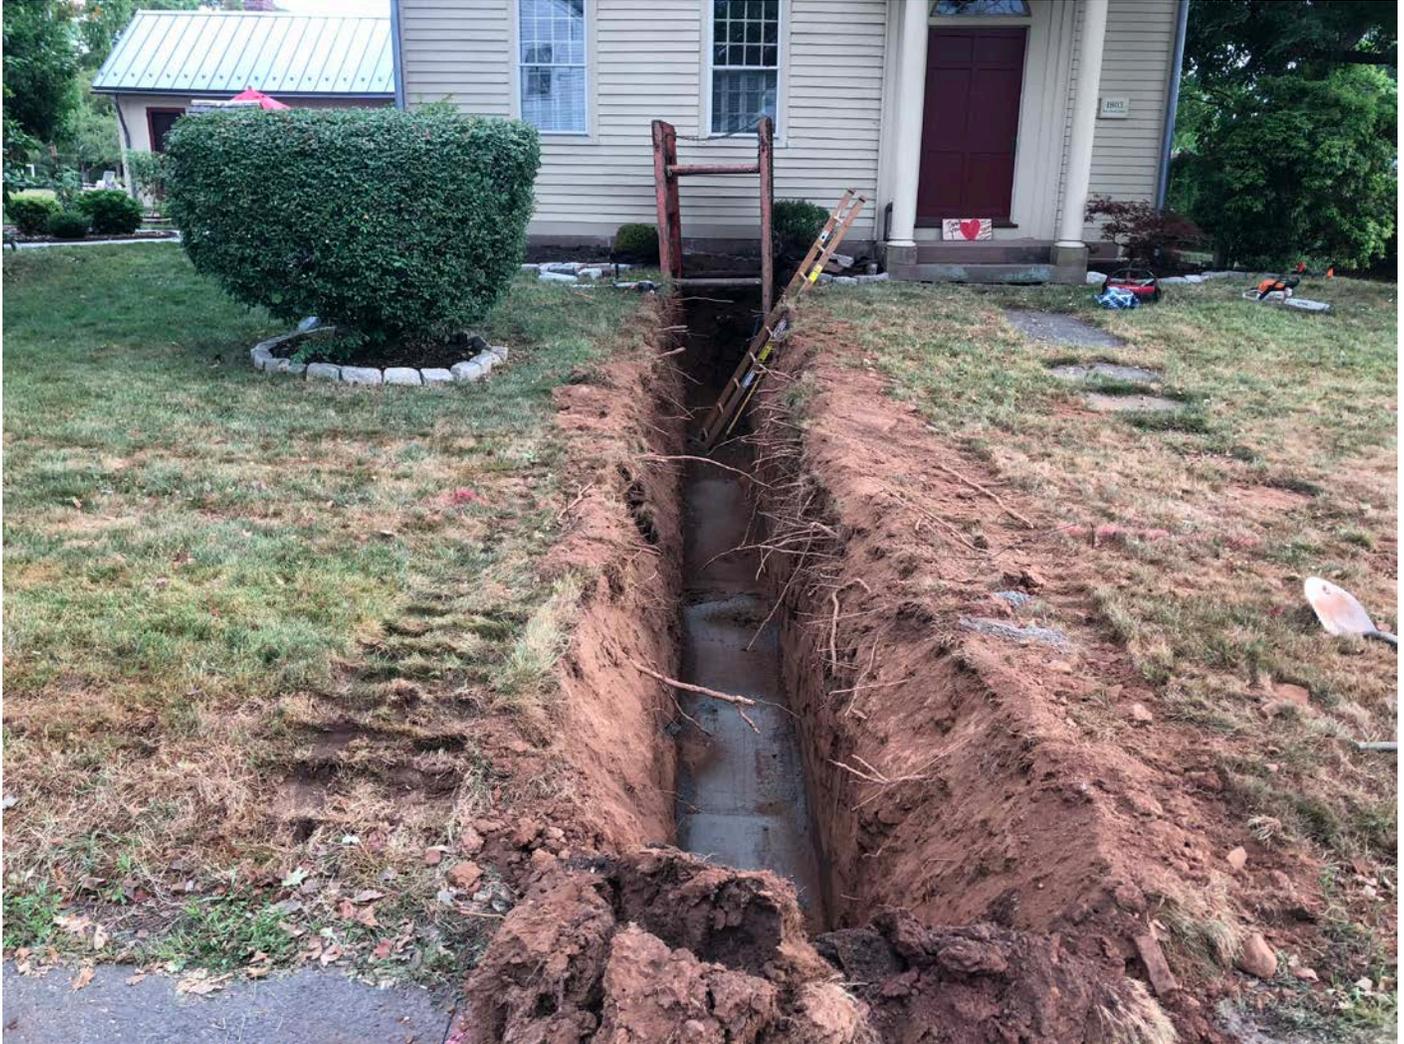
Picture 6: Trench that Ludlow has excavated for the installation of a curb stop and 1" copper service line at the residence at 13 Maple Avenue, Durham. View to the north.

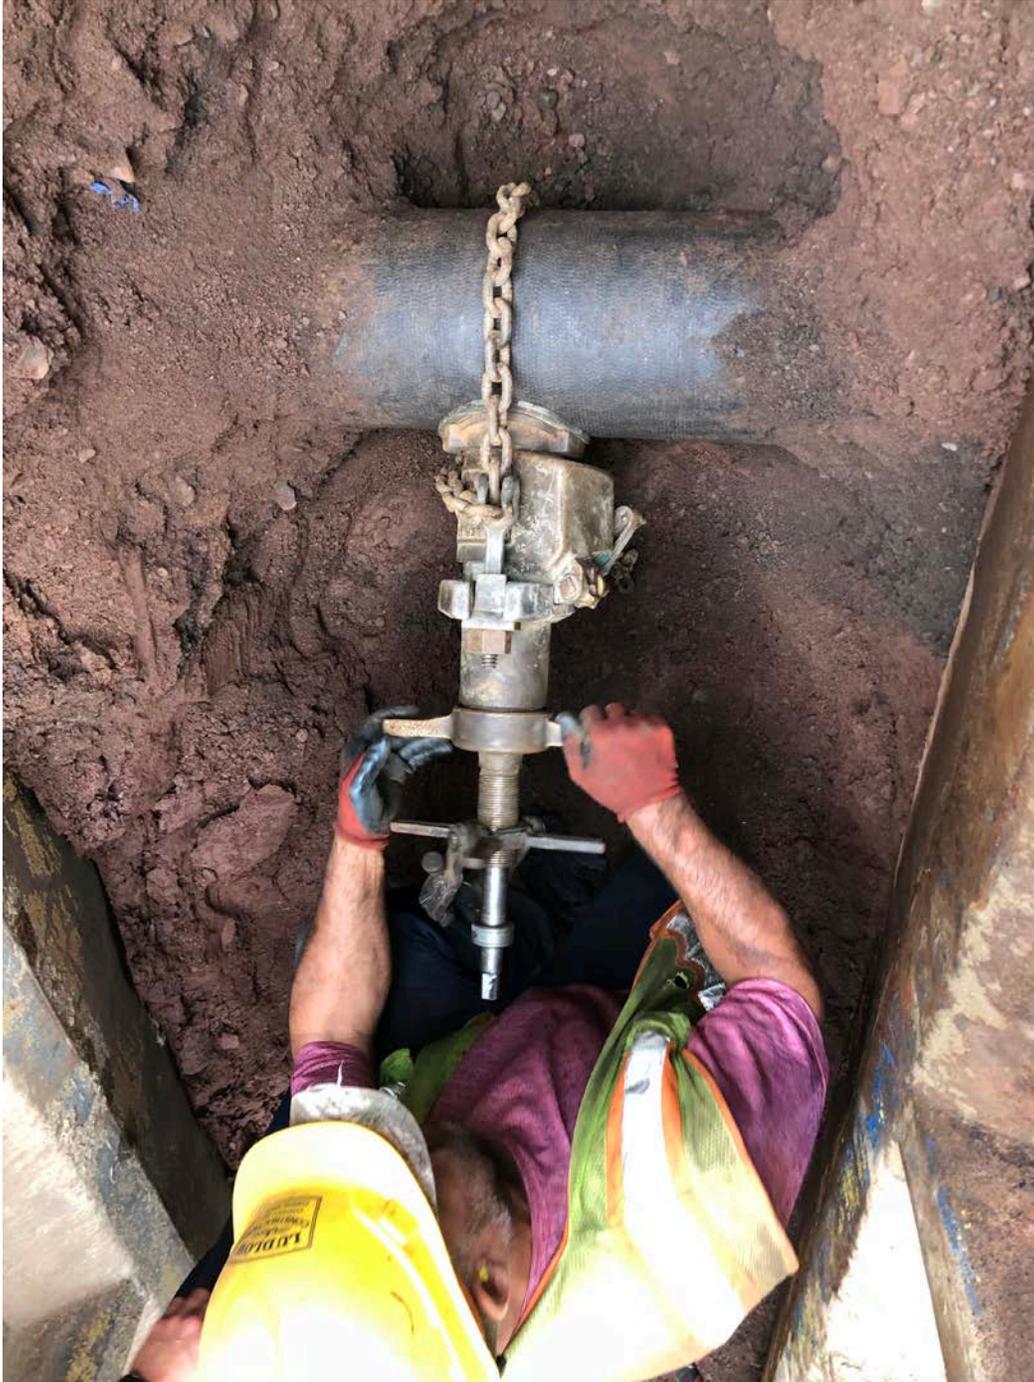
Picture 7: Ludlow tapping existing 8" water line at 13 Maple Avenue, Durham in order to install a corporation stop.

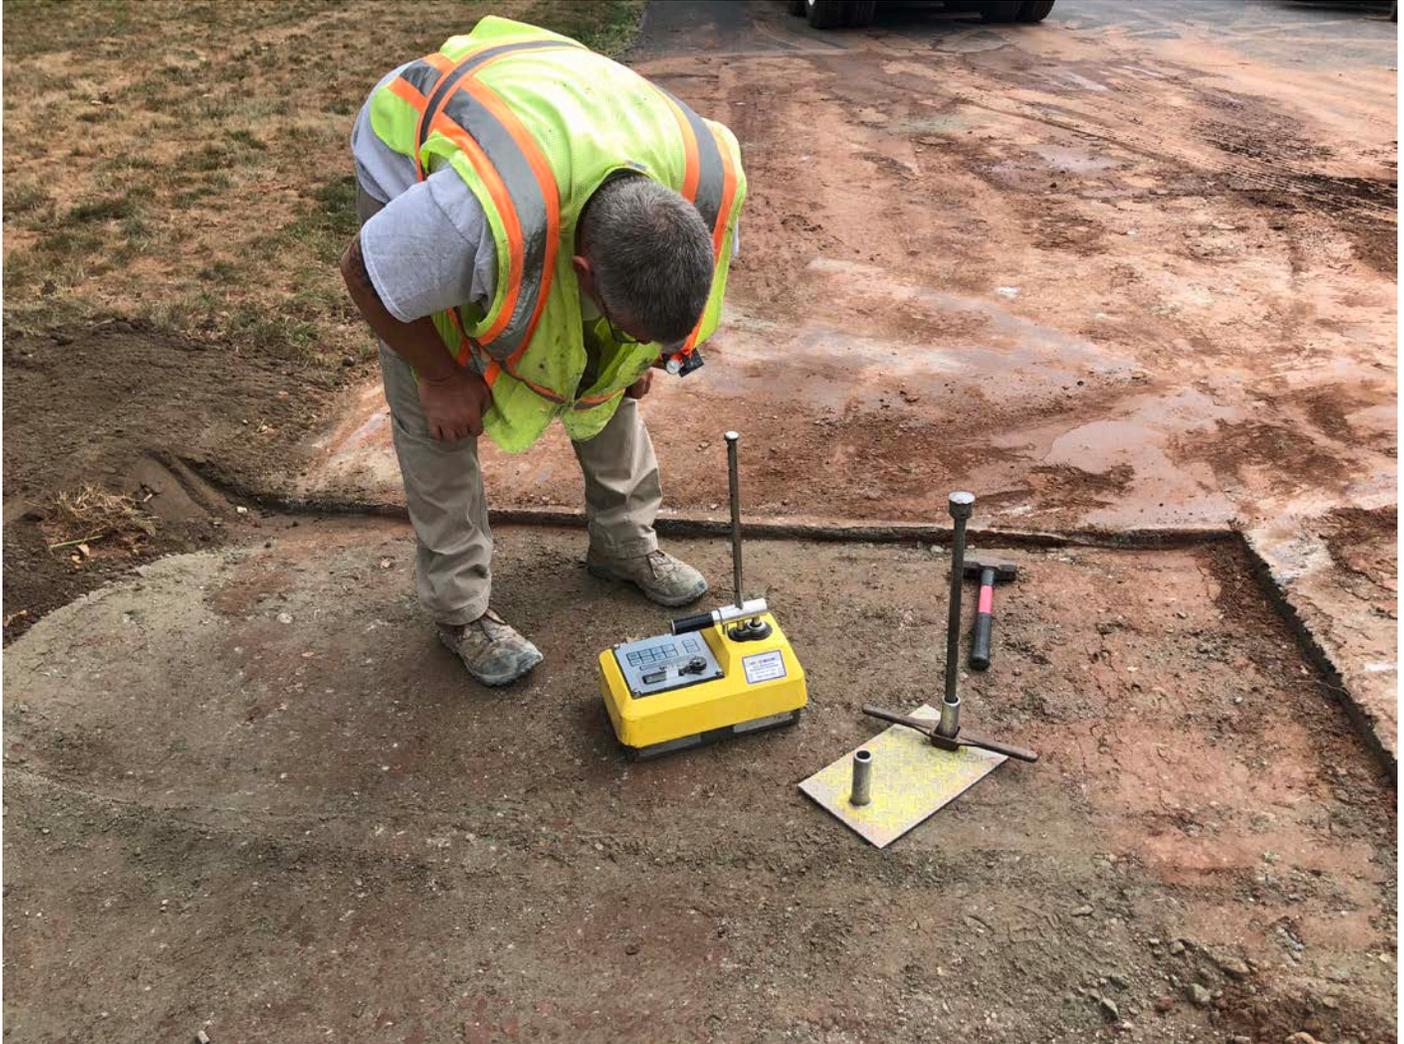
Picture 8: JTC collecting soil compaction data at the water service installation at 13 Maple Avenue, Durham. View to the north.

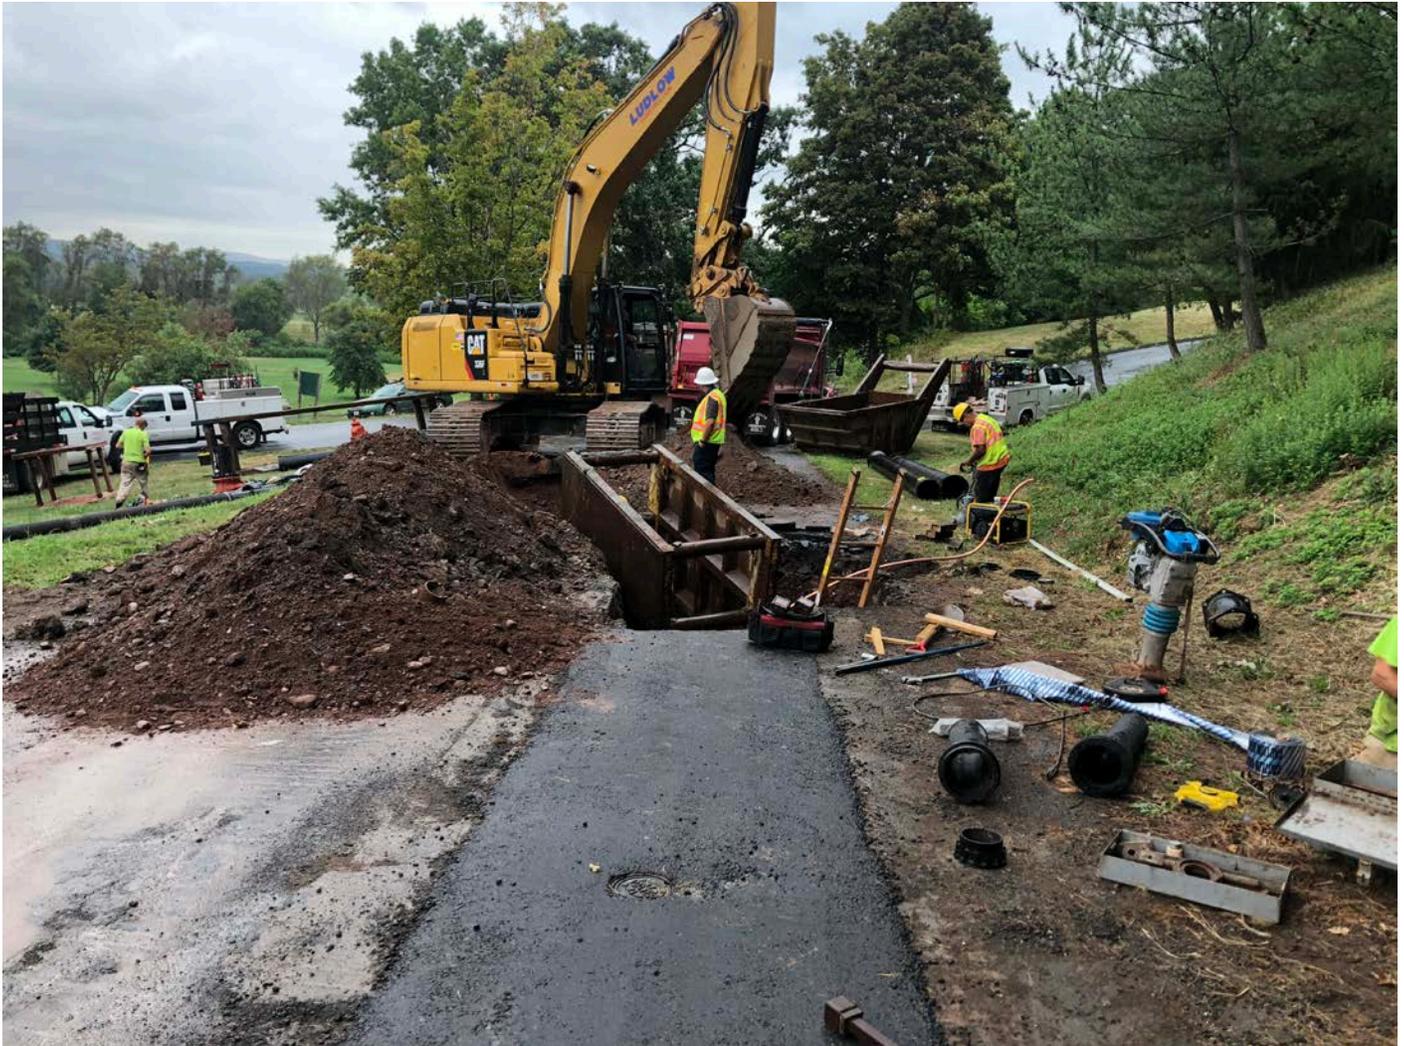
Picture 9: Ludlow connecting to the existing 8" DIP water line to the 12" DIP that they previously installed south of the Maple Avenue stream crossing. View to the north.

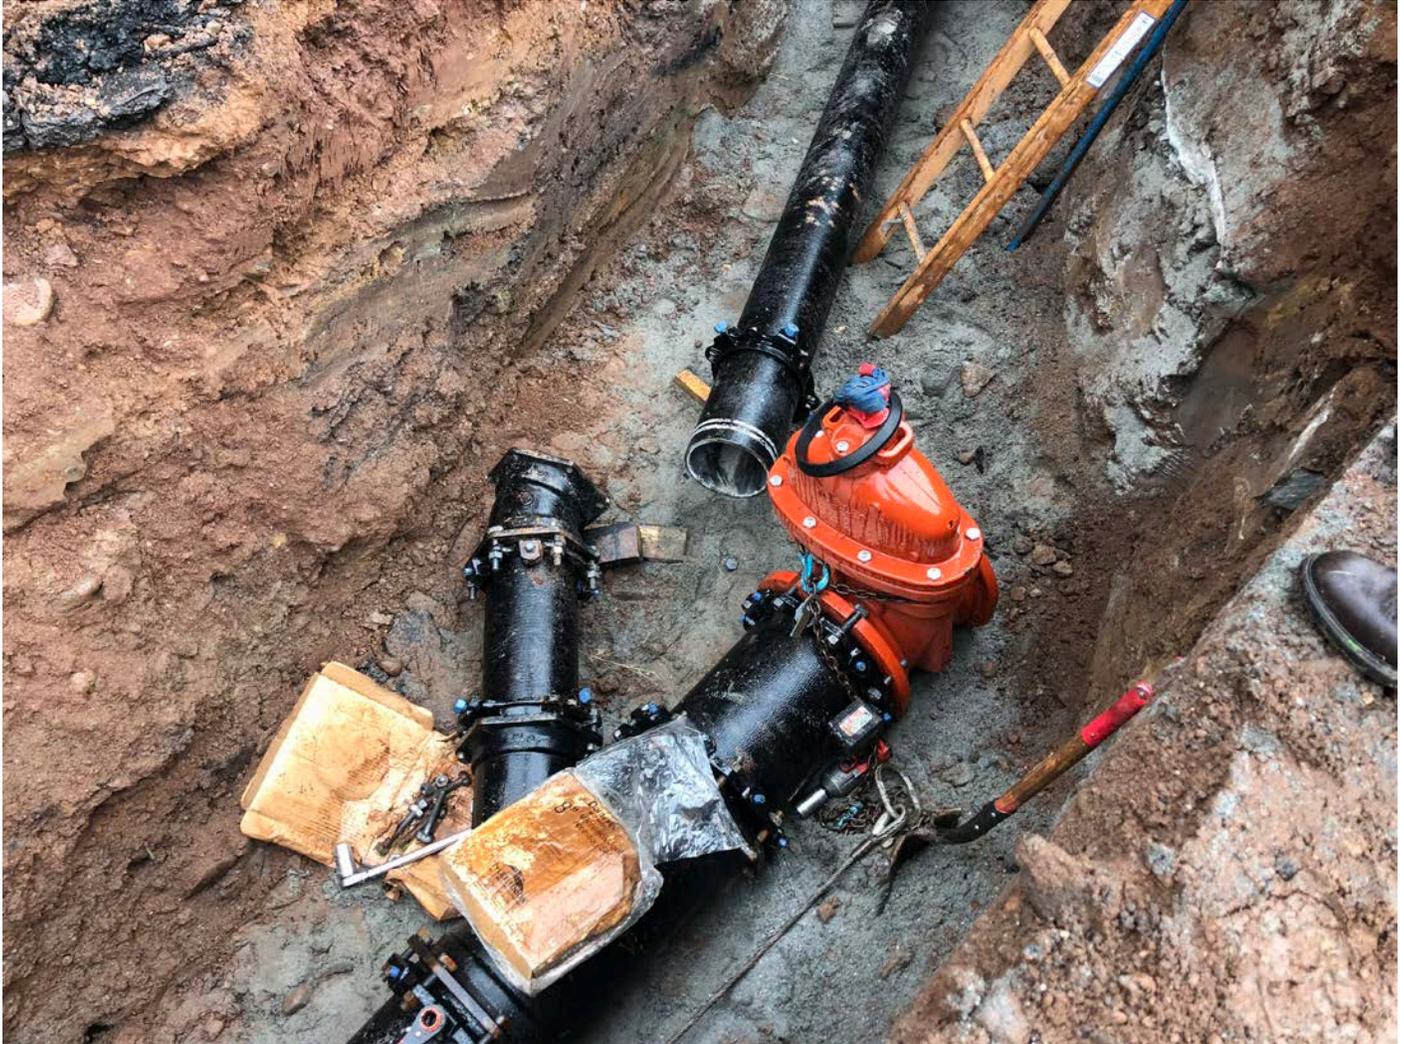
Picture 10: Ludlow preparing to connect 8" DIP to WYE fitting coming off of the 12" DIP on Maple Avenue, Durham.
