Daily Report

Project:	Durham Meadows Pipeline Installation	Date:	August 27, 2020
Location:	Maple Avenue and Main Street, Durham; Shared Access Driveway, Middletown	Day of Week:	Thursday
Project #:	AECOM: 6061487	Report No:	147
Contractor:	Ludlow Construction	Page:	1 of 13

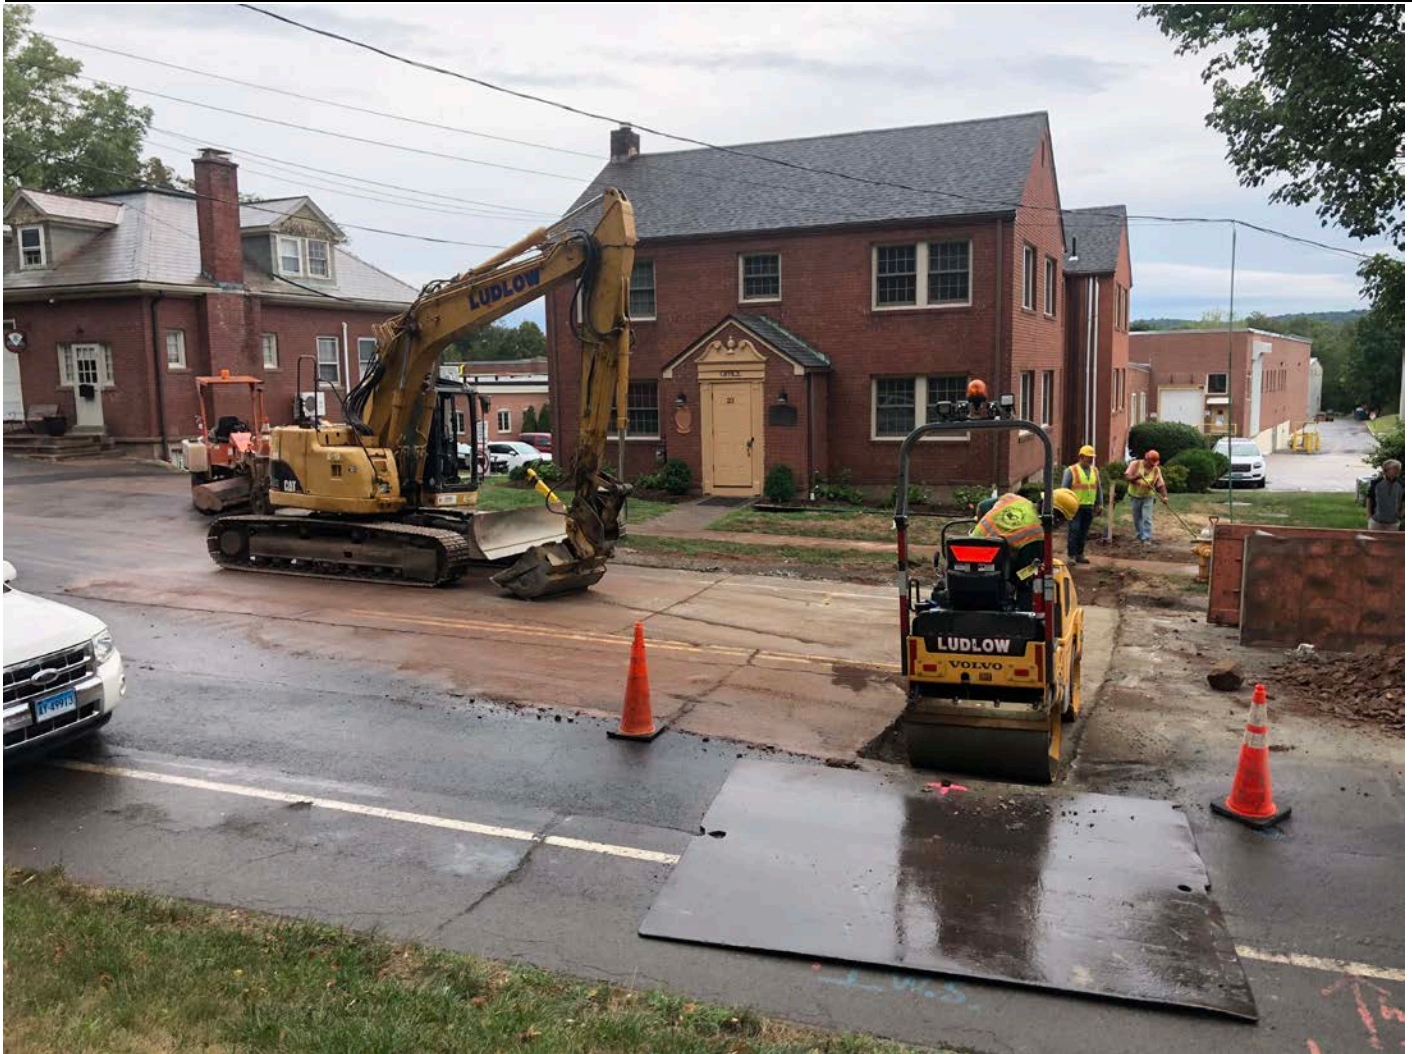
Picture 1: Ludlow installing a curb stop at Station 199+93.5 (201 Main Street, Durham). View to the east.

0714: Ludlow has set up at Station 199+93.5 (201 Main Street, Durham) to install a curb stop.

0732: Ludlow is using the pneumatic mole to get a 1" copper service line beneath the sidewalk at Station 199+93.5.

0851: Ludlow is backfilling the trench for the curb stop at 201 Main Street. Ludlow is in the process of excavating a trench for the installation of a curb stop at 199 Main Street. Traffic management is being provided by two State Troopers. The curb stop at 201 Main Street has been installed 17' from the edge of pavement.

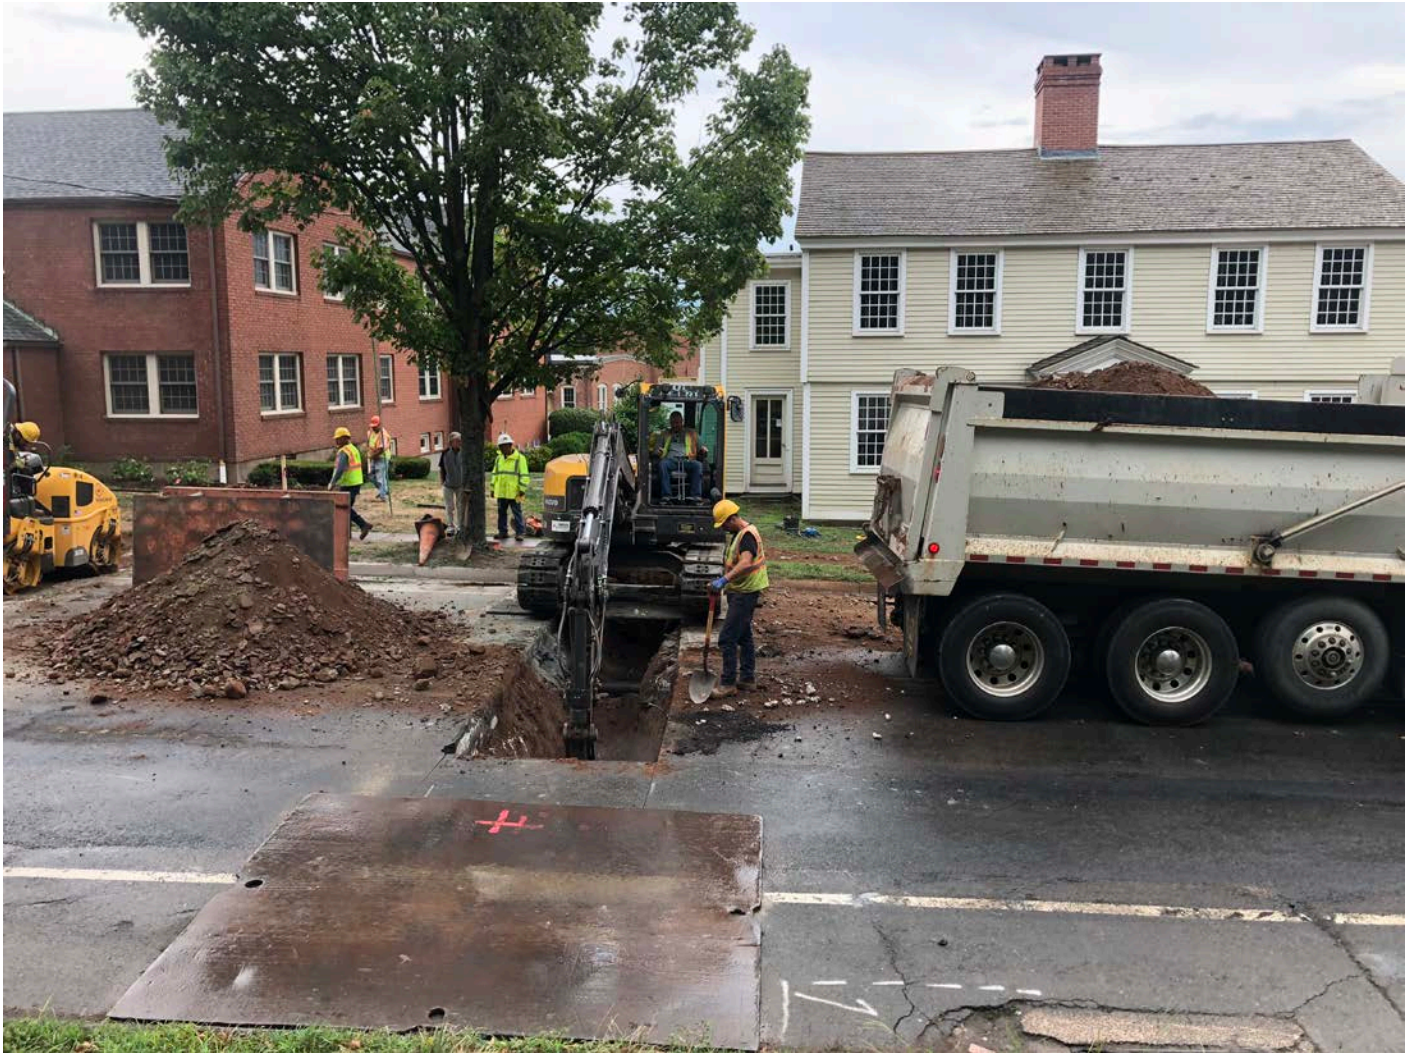
Picture 2: Ludlow installing a curb stop at Station 200+22 (199 Main Street, Durham). View to the east.

1049: Ludlow has finished installing curb stops at 201 and 199 Main Street. The curb stop at 199 Main Street is 17' from the edge of pavement.

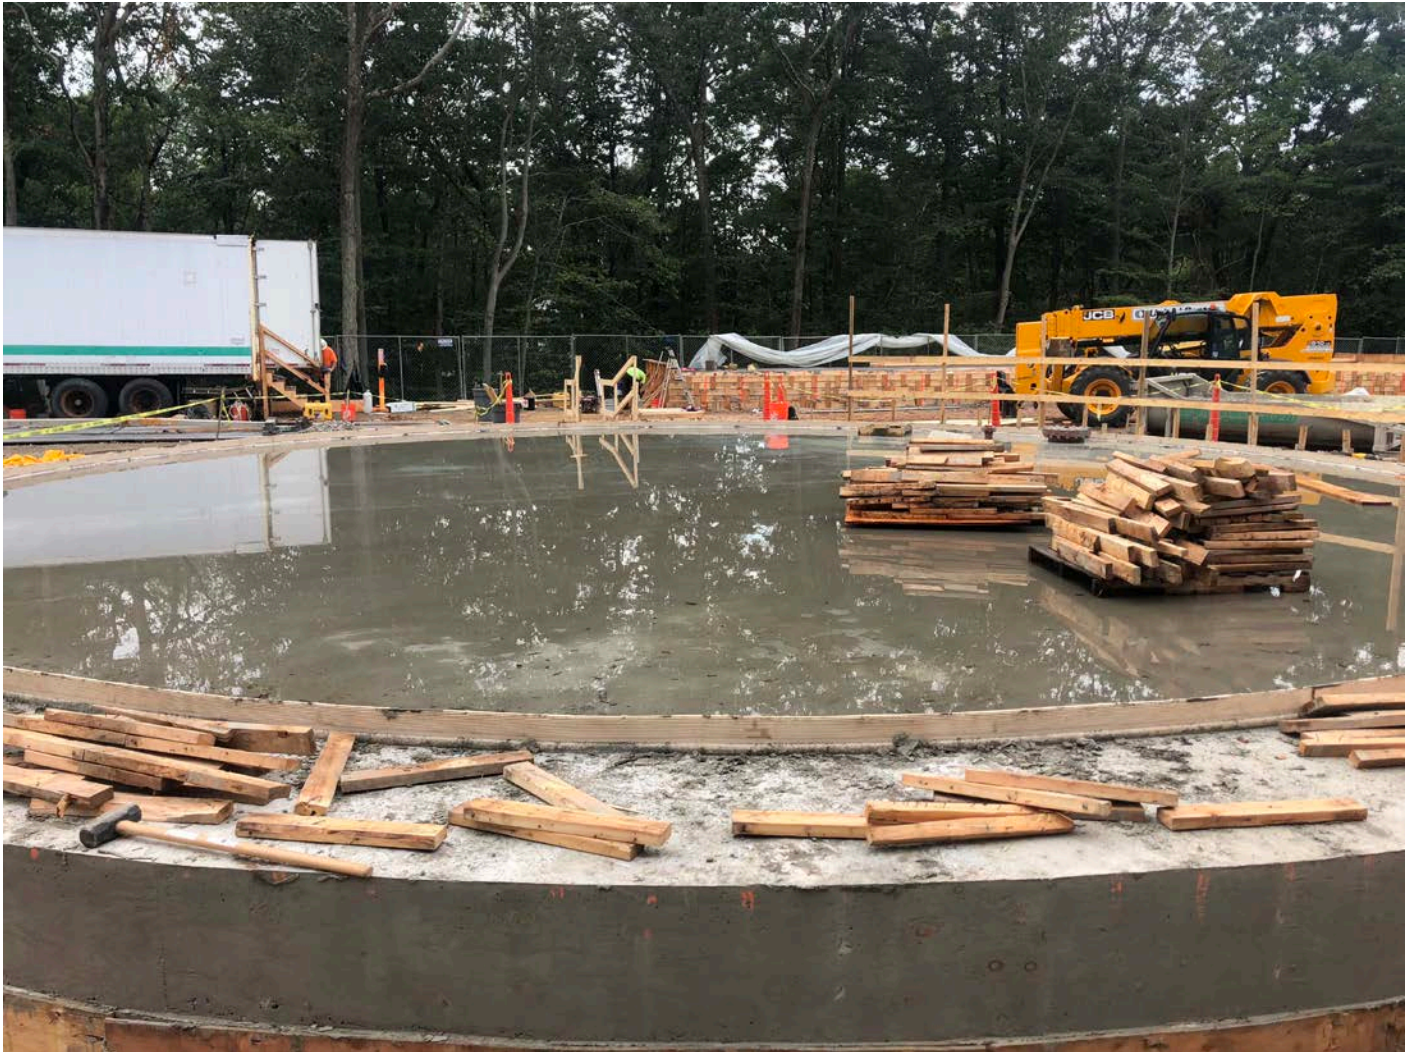
Picture 3: The top of the water tank base with a layer of water on top of it to slow the cure of the concrete. Water tank work zone, east of the Shared Access Driveway, Middletown. View to the south.

0700: DN Tanks and Northeastern Steel are present at the water tank work zone. Two laborers from Northeastern Steel are placing rebar on one of forms for the water tank dome panels. The top of the water tank base still has a layer of water on it to help slow its curing.

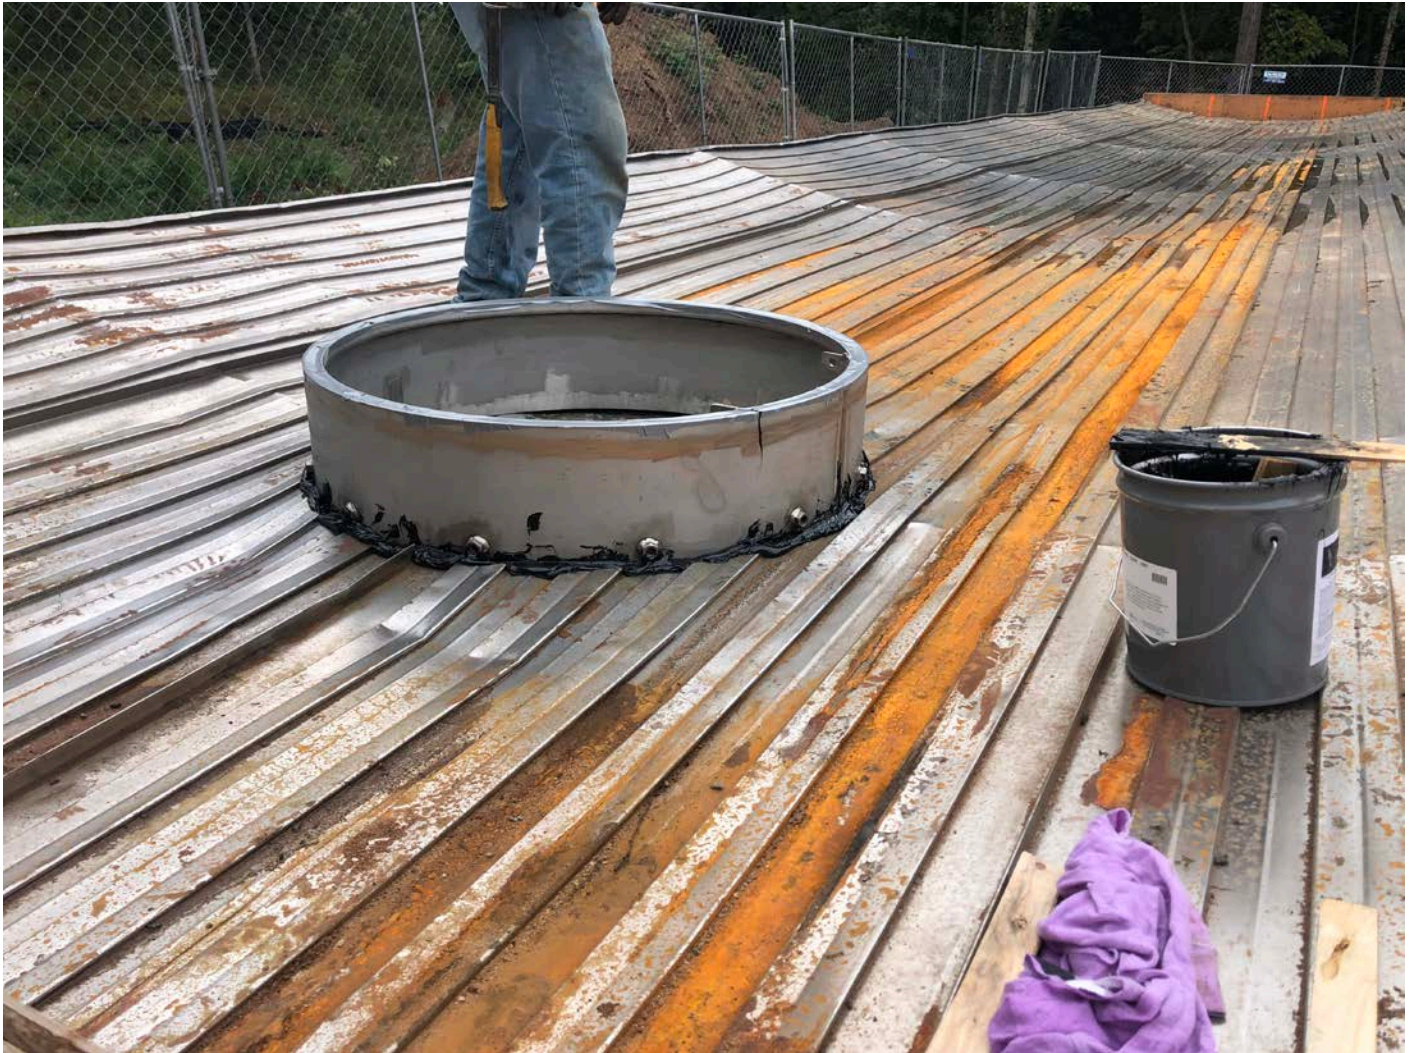
Picture 4: DN Tanks placing a manway on the wide side panel concrete form. Water tank work zone, east of the Shared Access Driveway, Middletown.

0955: Northeastern Steel has 2 laborers working on both dome panel concrete forms. DN Tanks has removed the form from the water tank base. DN Tanks is placing a manway on the wide side panel form and is working on the narrow side panel form. USA Hauling and Recycling is on site to change out the roll off dumpsters.

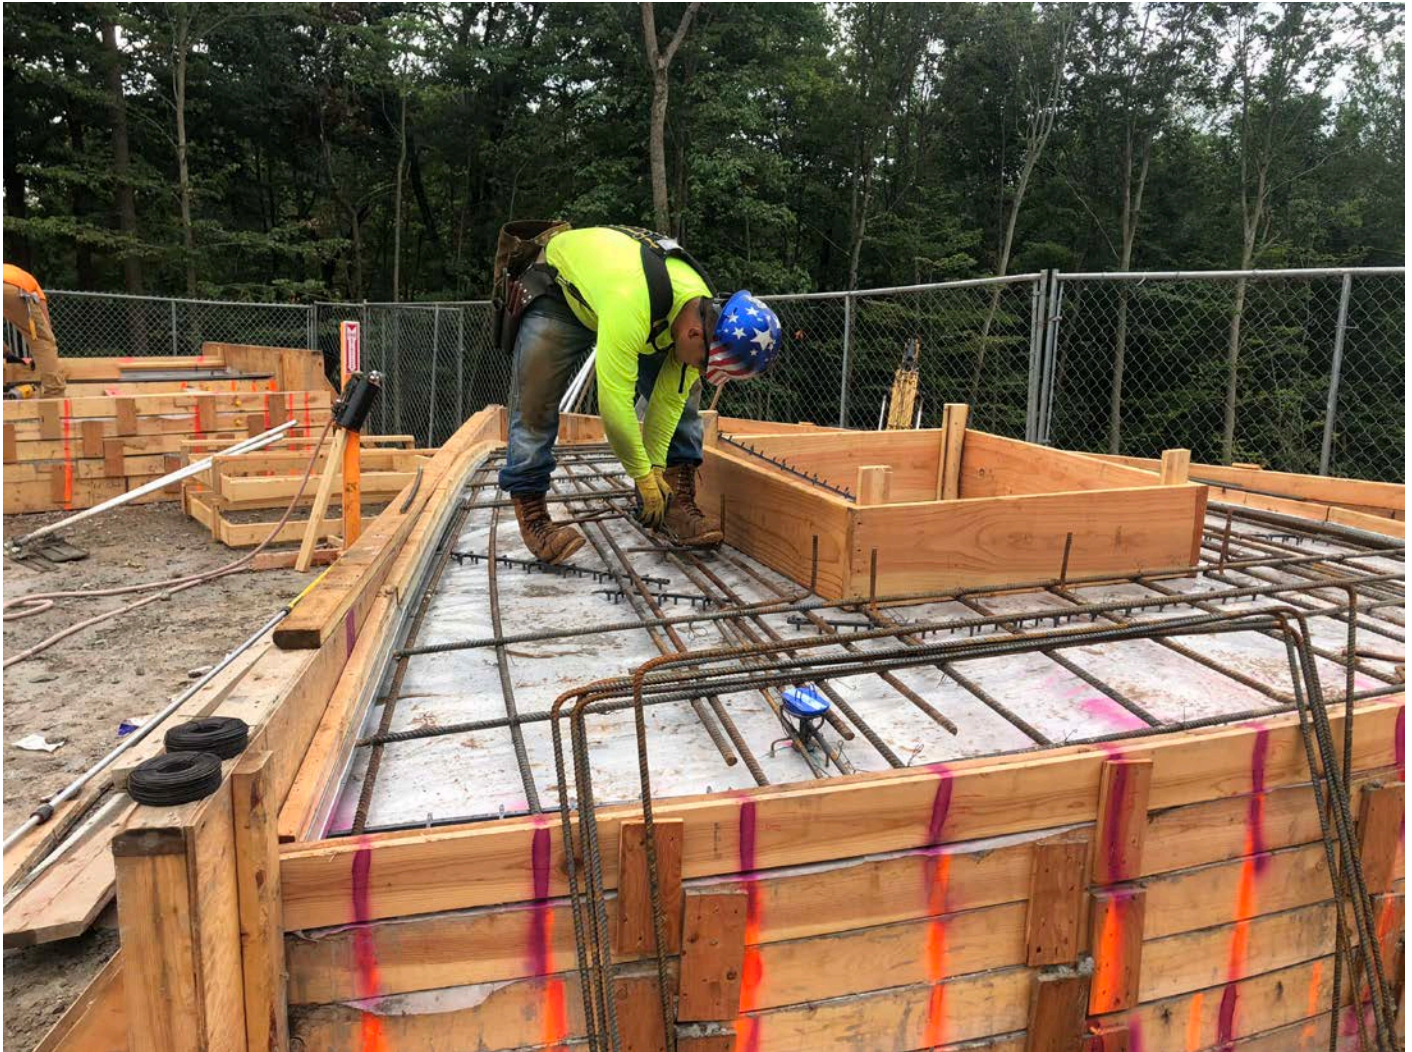
Picture 5: Northeastern Steel placing and fastening rebar on one of the water tank dome forms. Water tank work zone, east of the Shared Access Driveway, Middletown. View to the south.

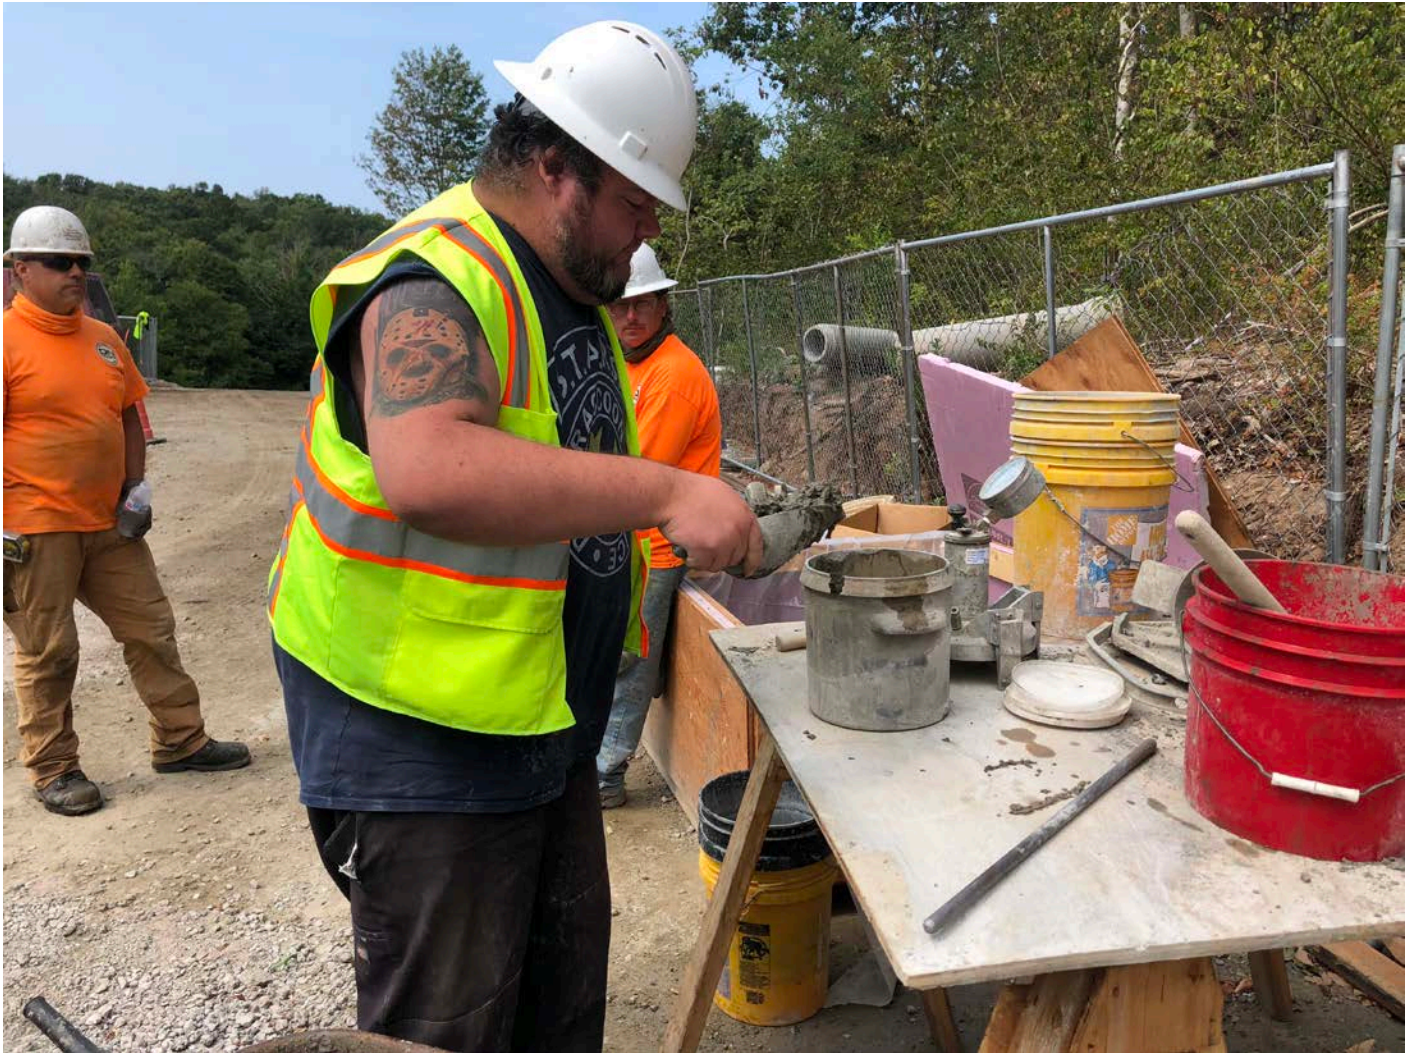
Picture 6: JTC collecting an air sample from the one truck of concrete brought to the water tank work zone today for placement on the water tank dome panels. Water tank work zone, east of the Shared Access Driveway, Middletown. View to the west.

1141: A truck of concrete arrives on site from Connecticut Ready Mix. JTC's field testing indicates 4.5% air.

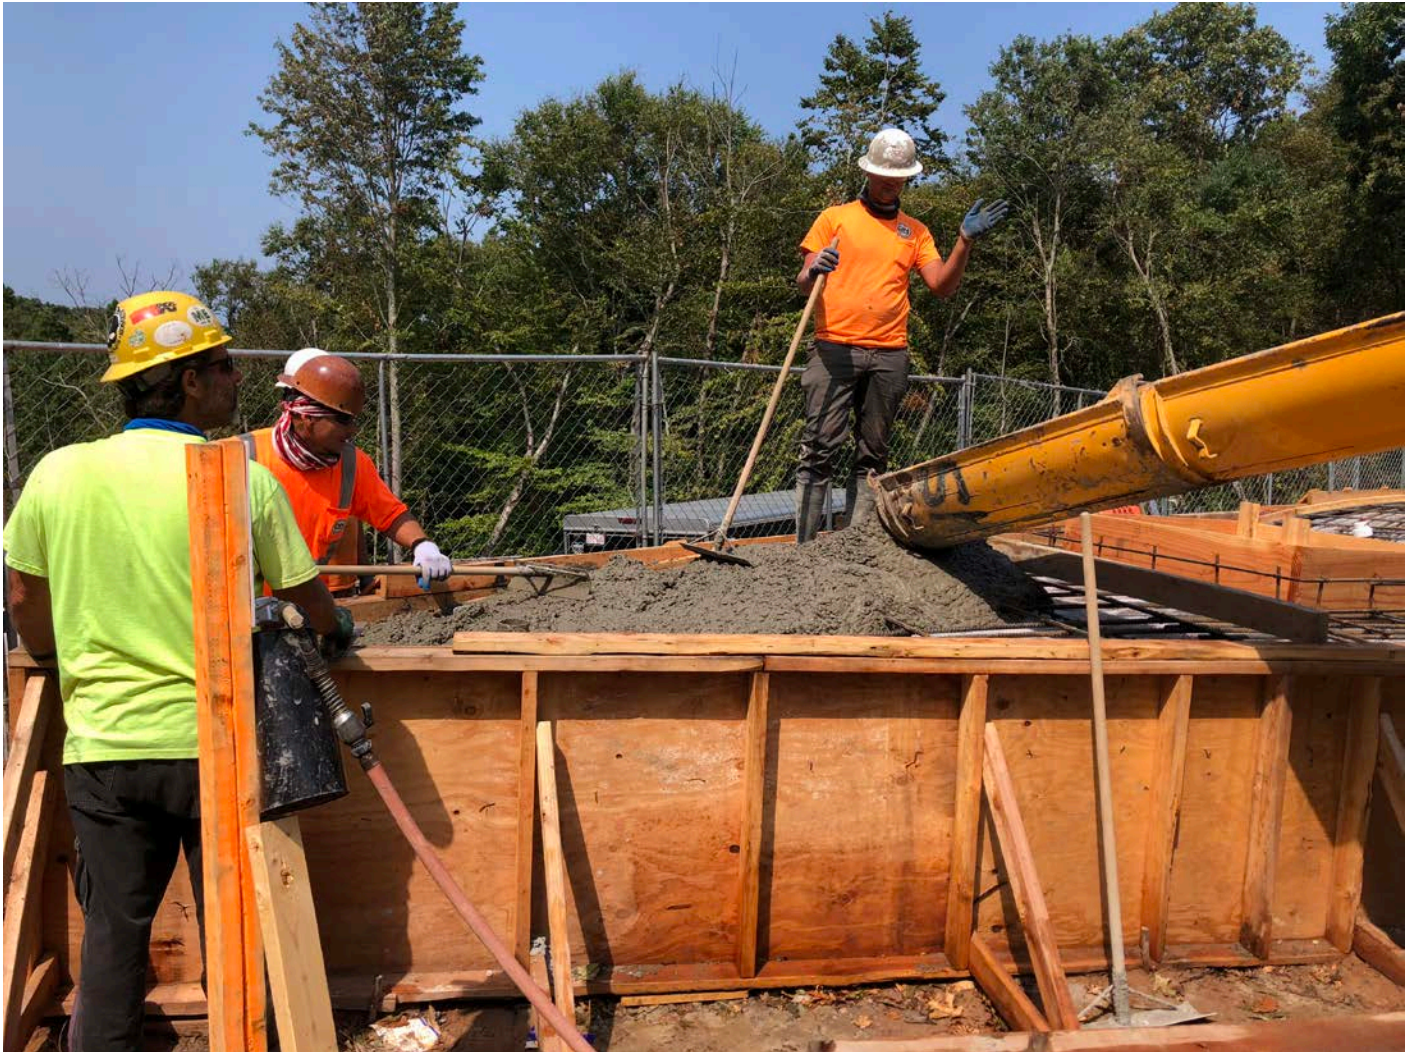
Picture 7: DN Tanks placing concrete on one of the water tank dome panel forms. Water tank work zone, east of the Shared Access Driveway, Middletown.

1153: DN Tanks begins to pour concrete on one of the two dome forms.

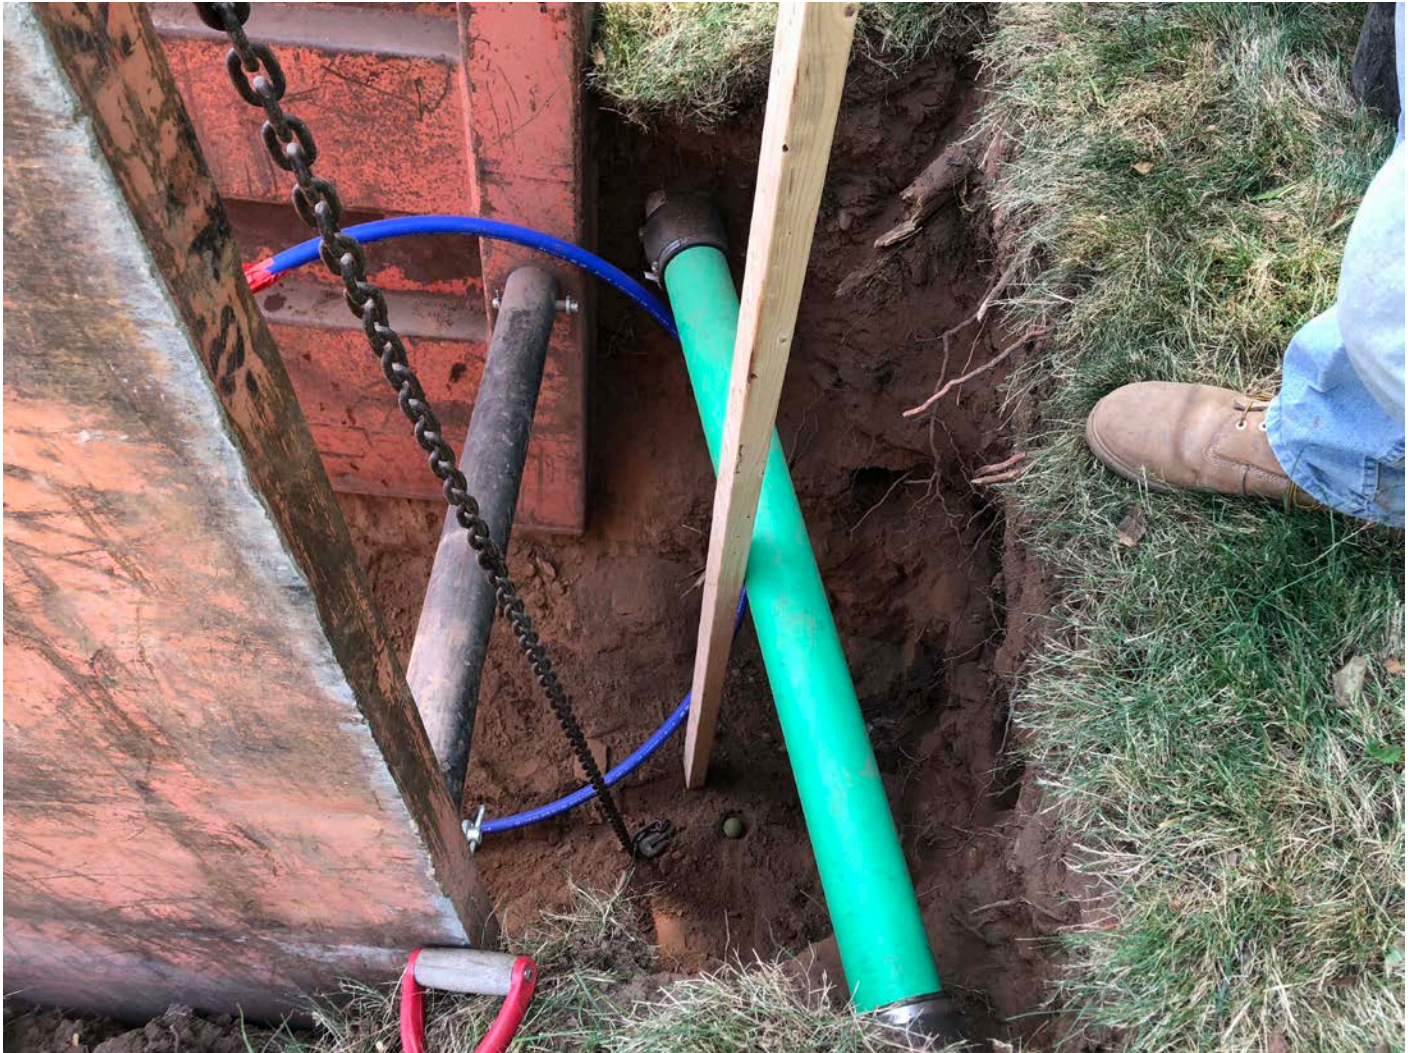
Picture 8: PVC drainpipe that was damaged and repaired by Ludlow at 202 Main Street, Durham during the installation of a curb stop.

1209: Ludlow is backfilling the trench at 202 Main Street where they have installed a curb stop. Ludlow has just repaired a 4" PVC drainpipe that was broken during excavation with 4" PVC and 2 Fernco boots. The curb stop is located 34.5 feet from edge of pavement.

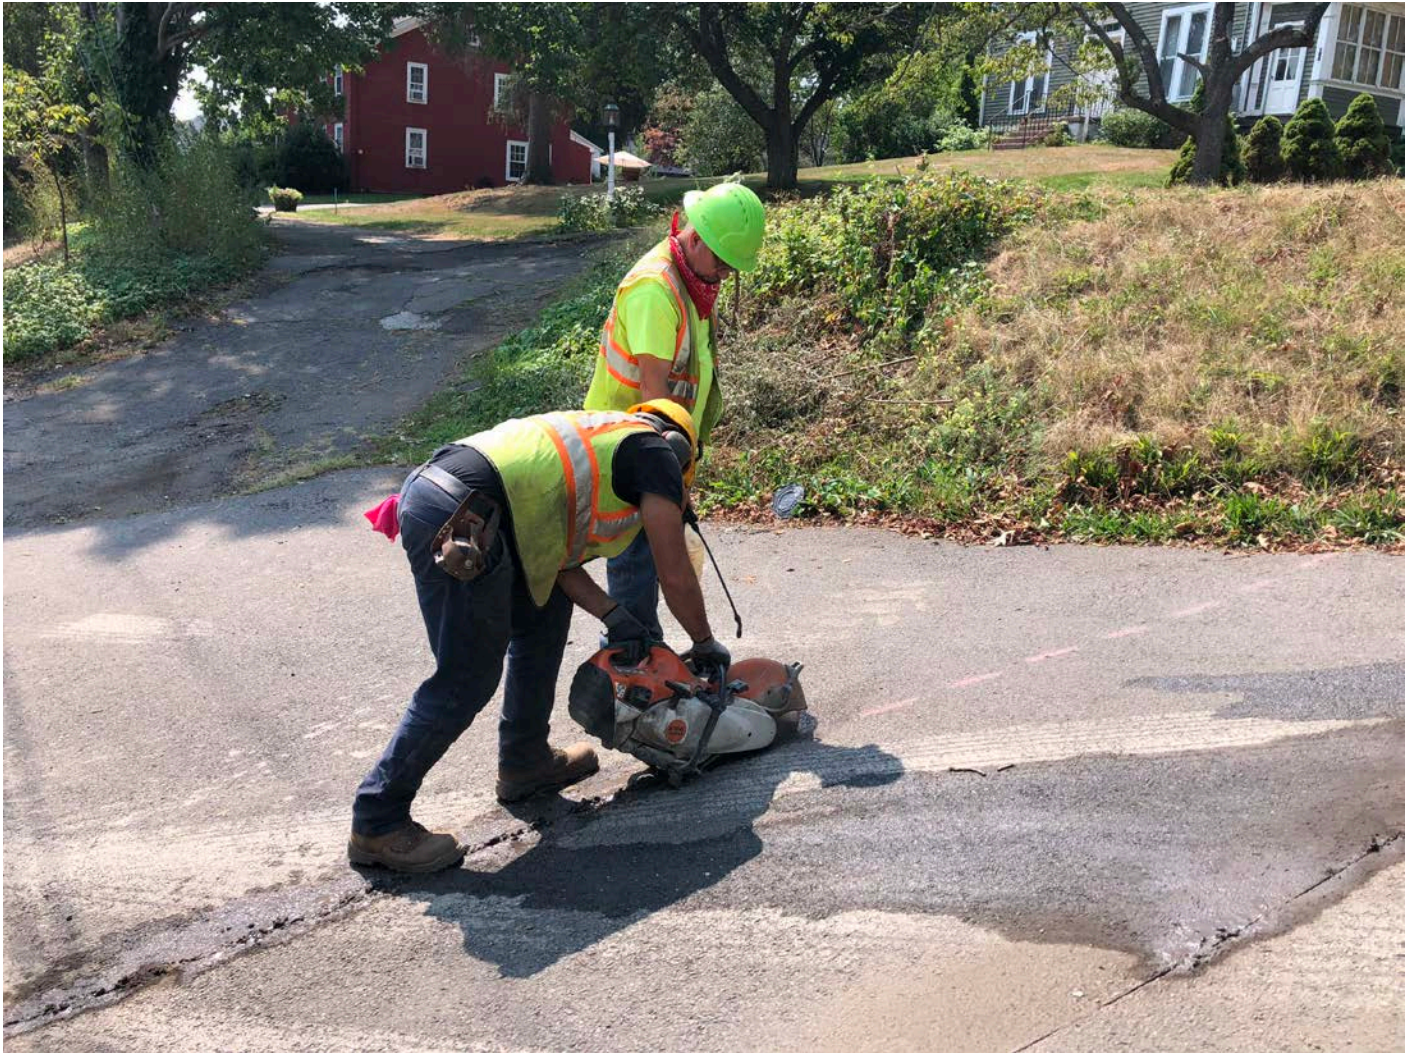
Picture 9: Ludlow saw cutting pavement at 196 Main Street, Durham (Station 201+36) for the installation of a curb stop. View to the southeast.

1218: Ludlow is saw cutting pavement on the driveway to the Church of the Epiphany driveway at Station 201+36 for the installation of a 2" curb stop.

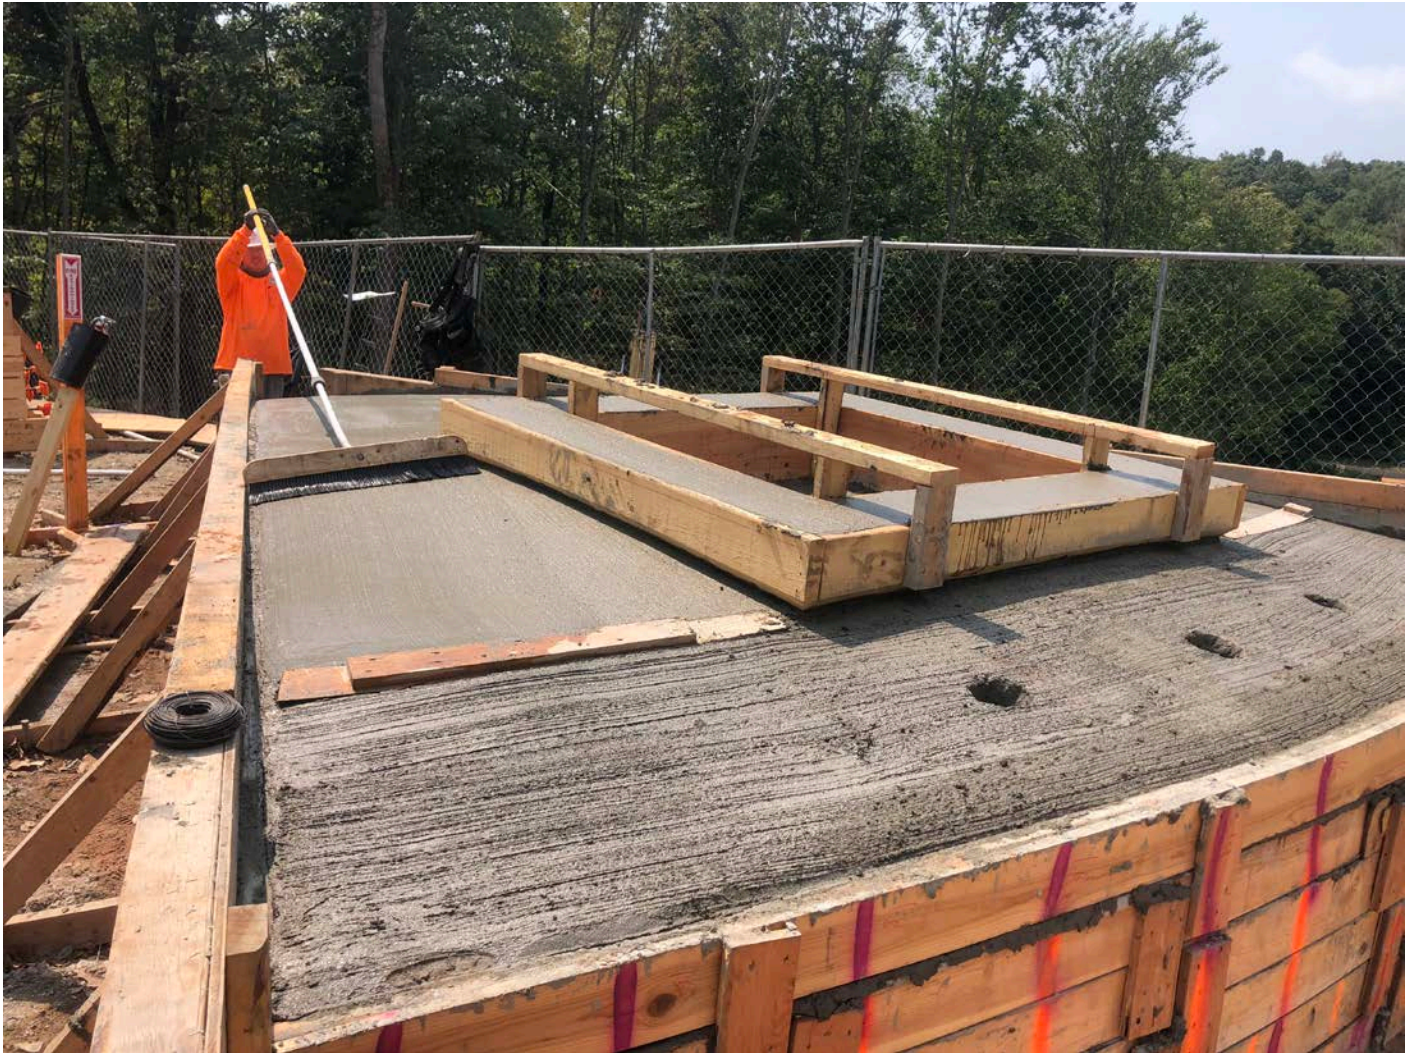
Picture 10: DN Tanks finishing the surface of freshly-placed concrete on one of the water tank dome panel forms. Water tank work zone, east of the Shared Access Driveway, Middletown. View to the south.
