Daily Report

Project:	Durham Meadows Pipeline Installation	Date:	September 14, 2020
		Day of Week:	Monday
Location:	Maple Avenue and Main Street, Durham; S. Main Street and the Shared Access Driveway, Middletown		
Project #:	AECOM: 6061487	Report No:	158
Contractor:	Ludlow Construction	Page:	1 of 14

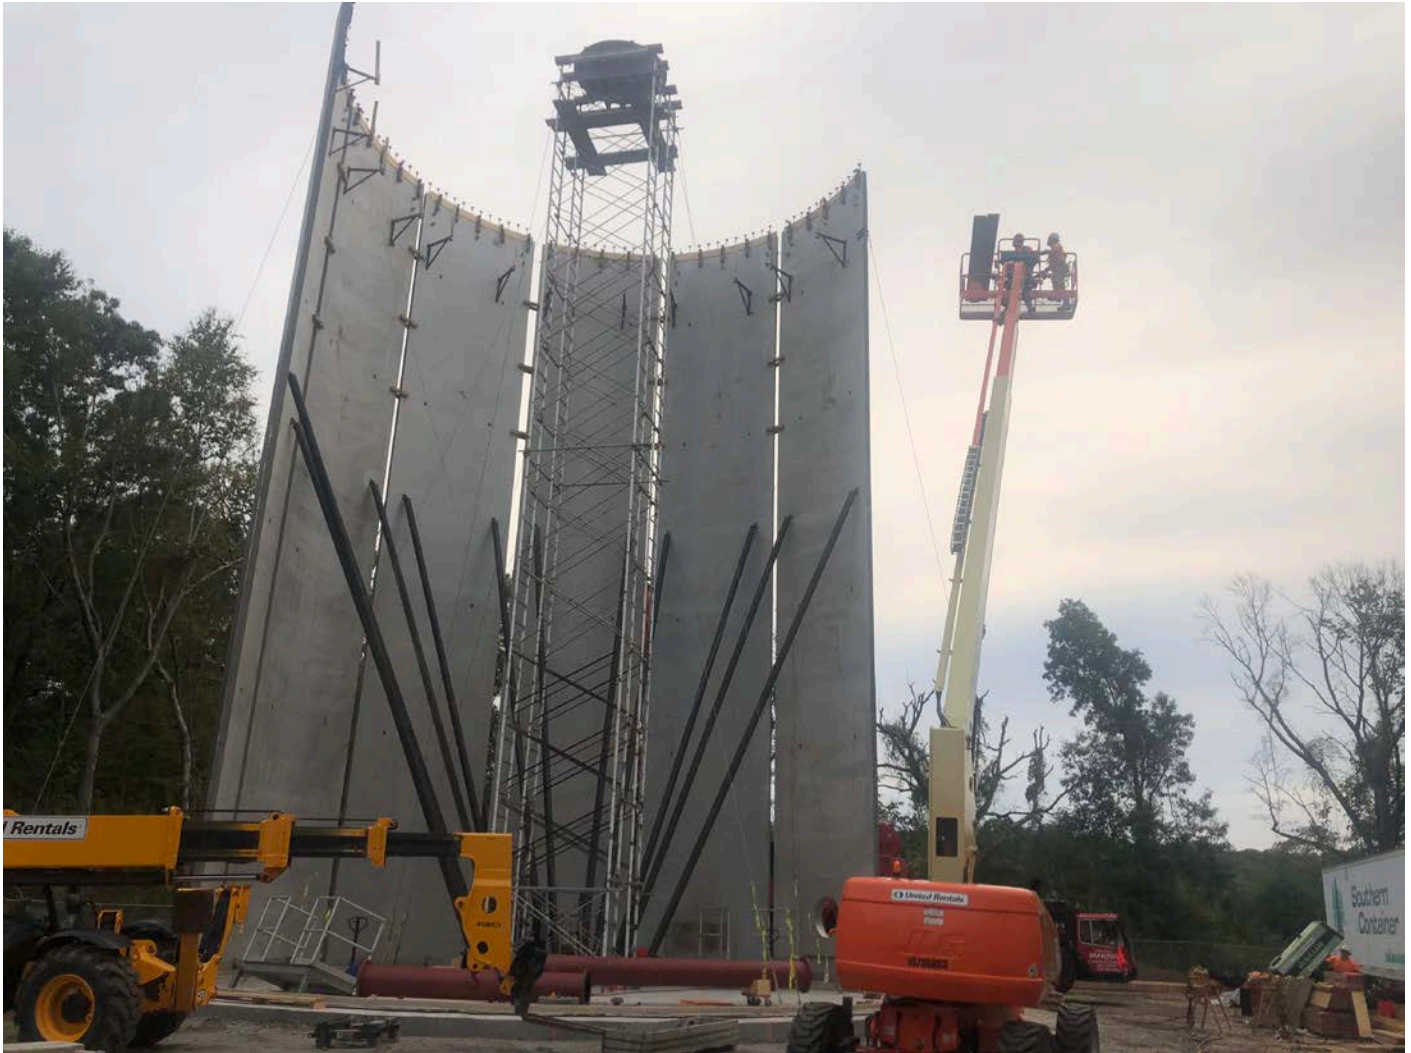
Picture 1: DN Tanks using lift boom to bring materials to the top of the center tower. Water tank work zone, east of the Shared Access Driveway, Middletown. View to the east.

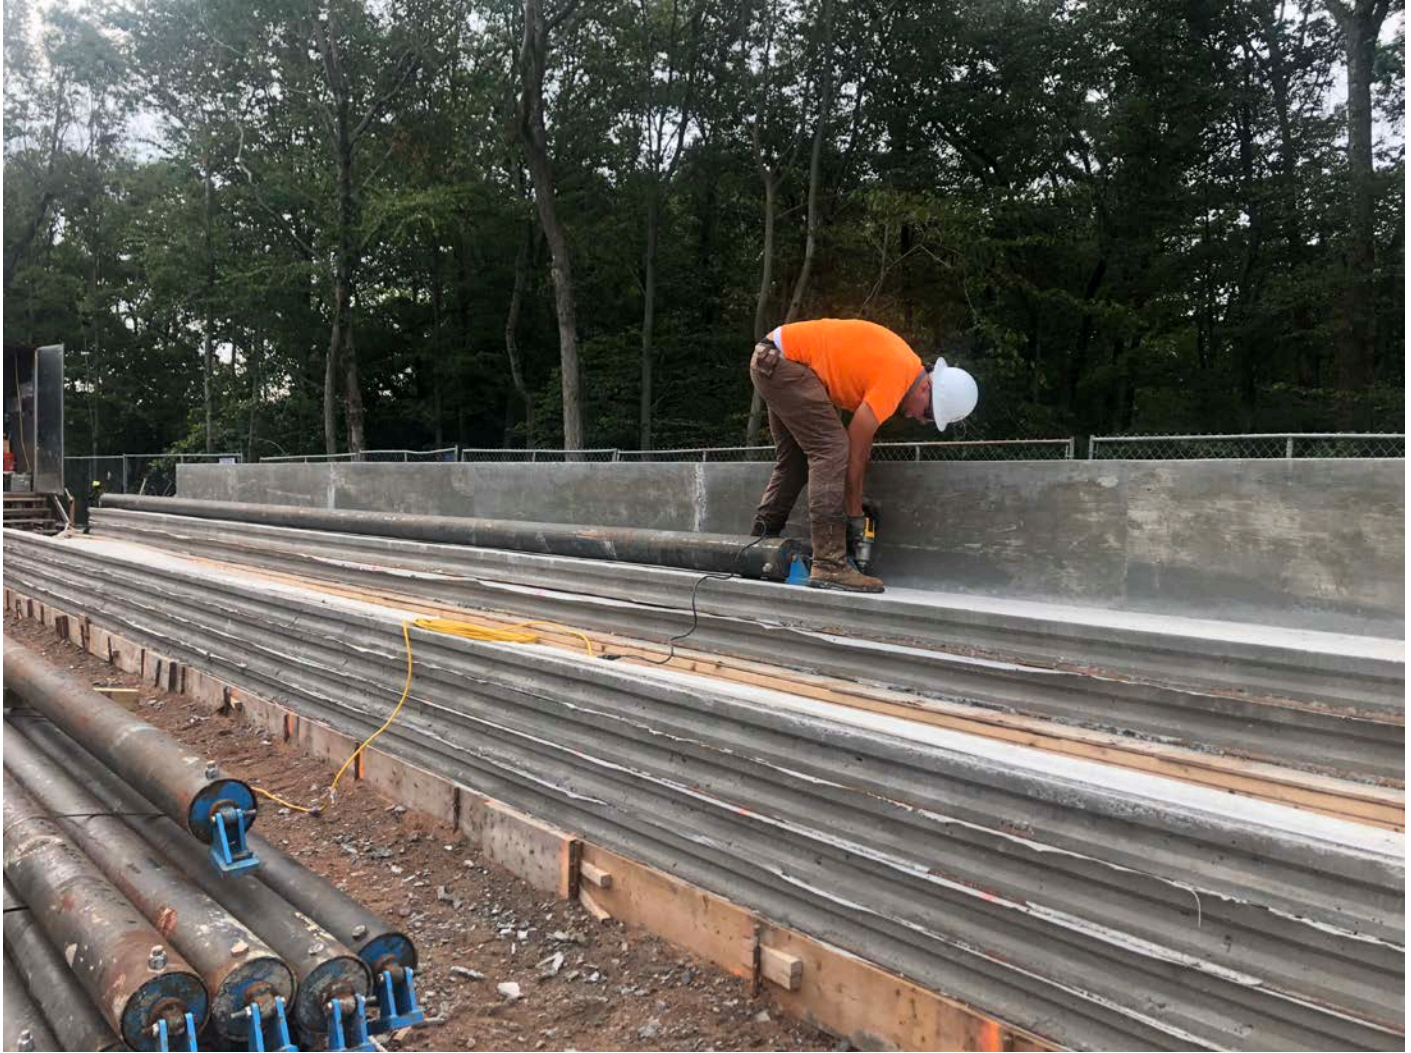
Picture 2: DN Tanks securing knee brace to narrow water tank side panel. Water tank work zone, east of the Shared Access Driveway, Middletown. View to the southeast.

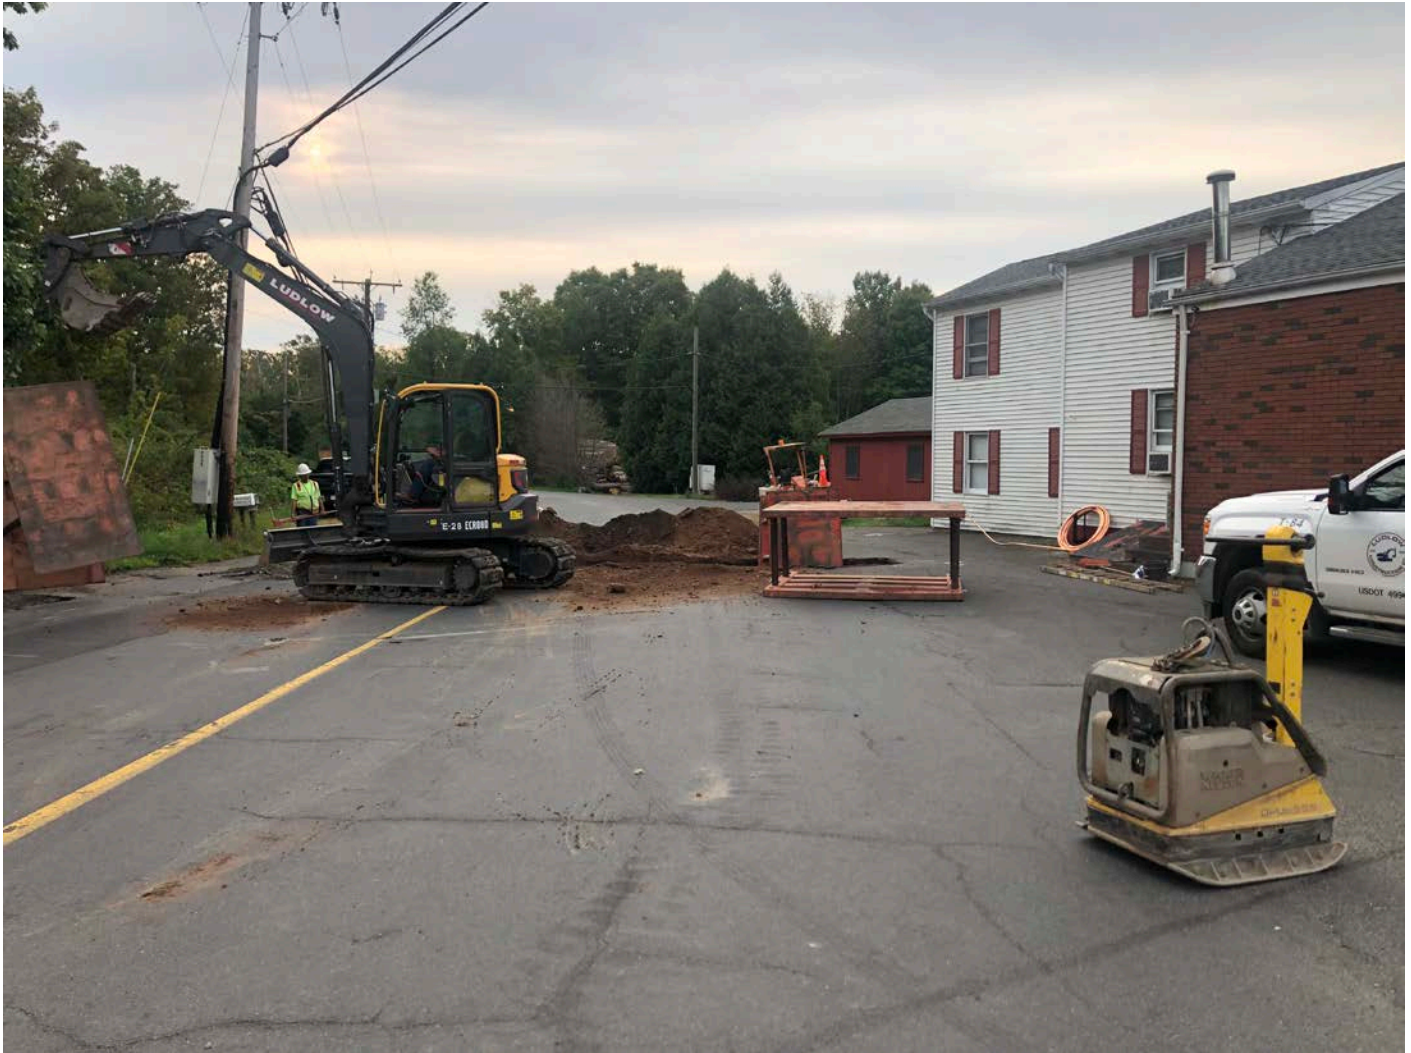
Picture 3: Ludlow excavating for the installation of a curb stop on Haddam Quarter Road, servicing 363 Main Street, Durham. View to the east.

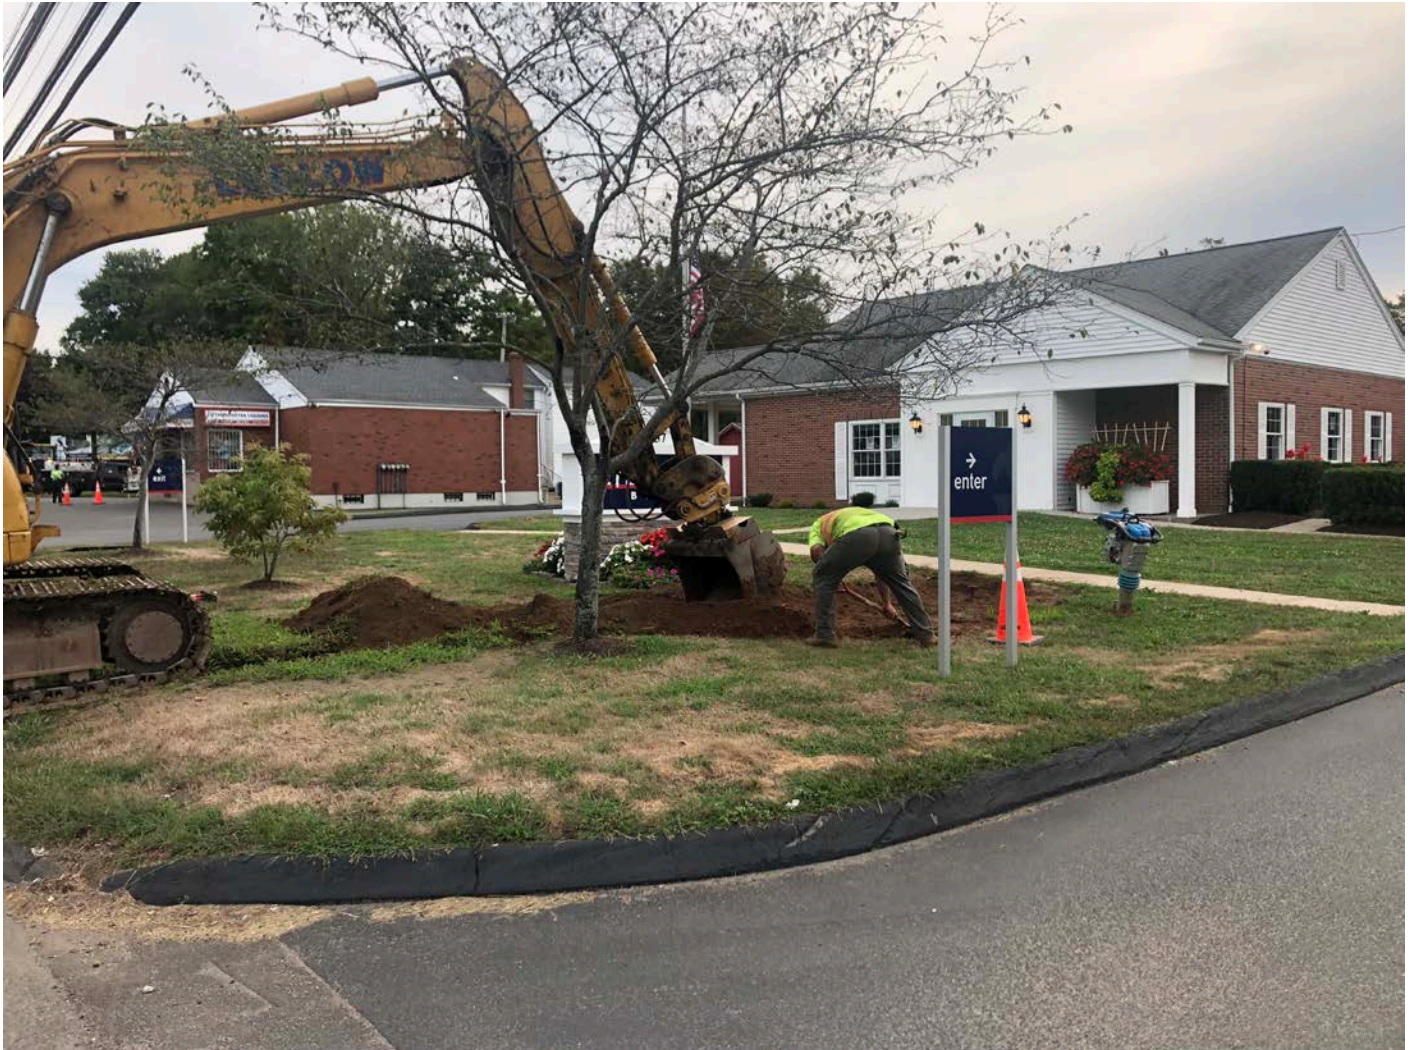
Picture 4: Ludlow excavating for the installation of a curb stop at Station 168+79 that will bring service to 357 Main Street, Durham. View to the southeast.

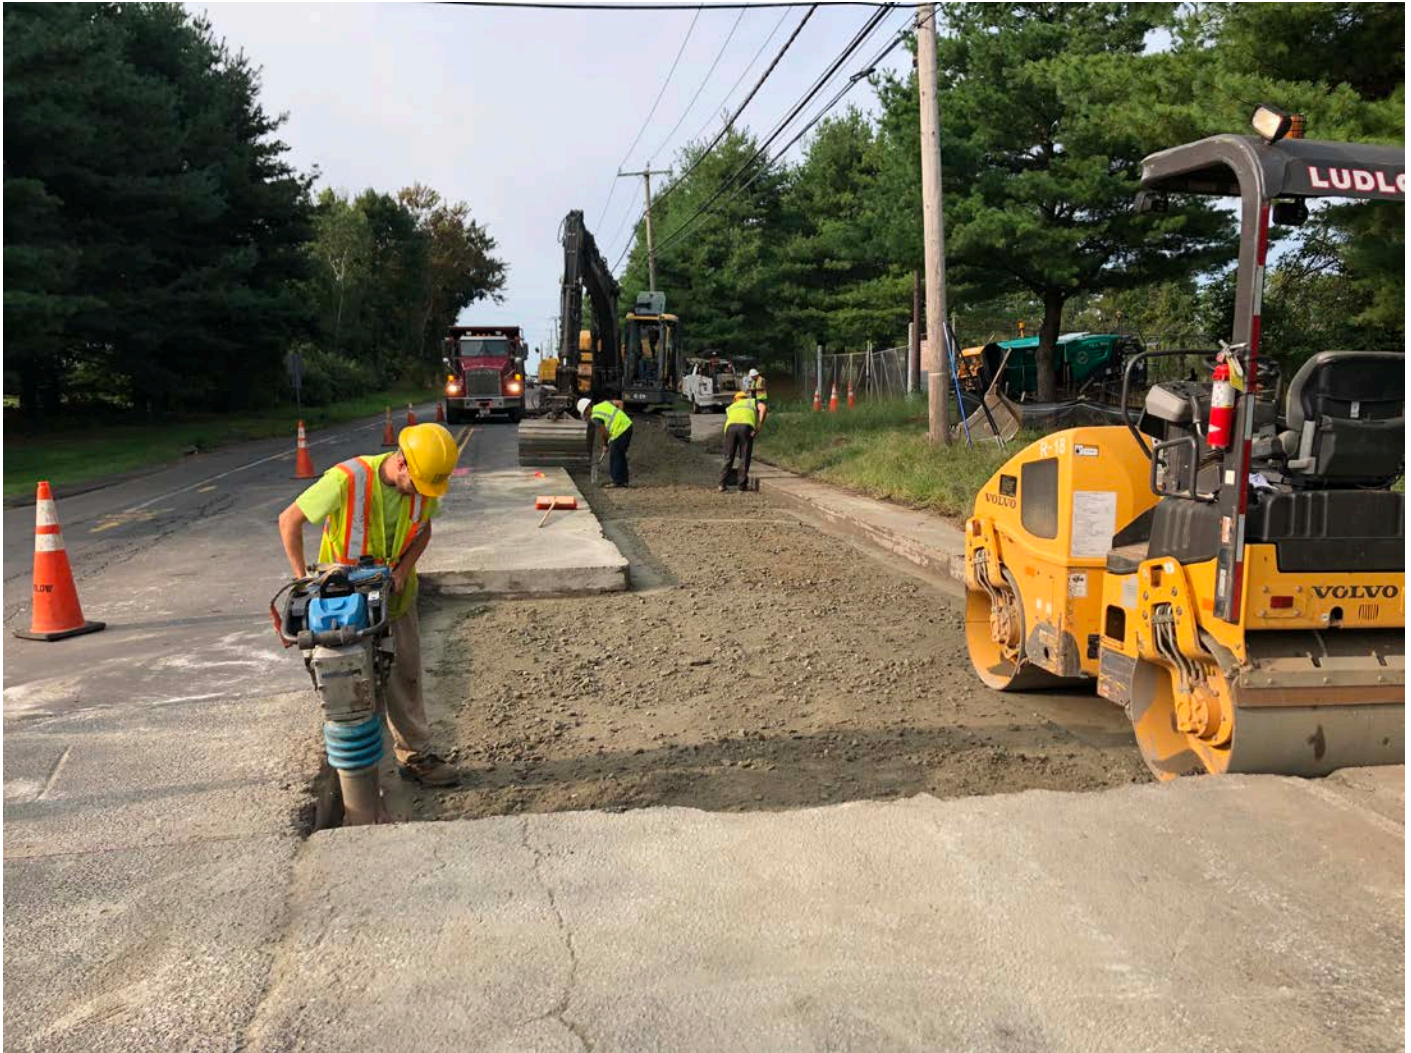
Picture 5: Ludlow compacting 1.5" processed gravel as they prepare to repave trench cutbacks on S. Main Street, Middletown. Station 100+00. View to the south.

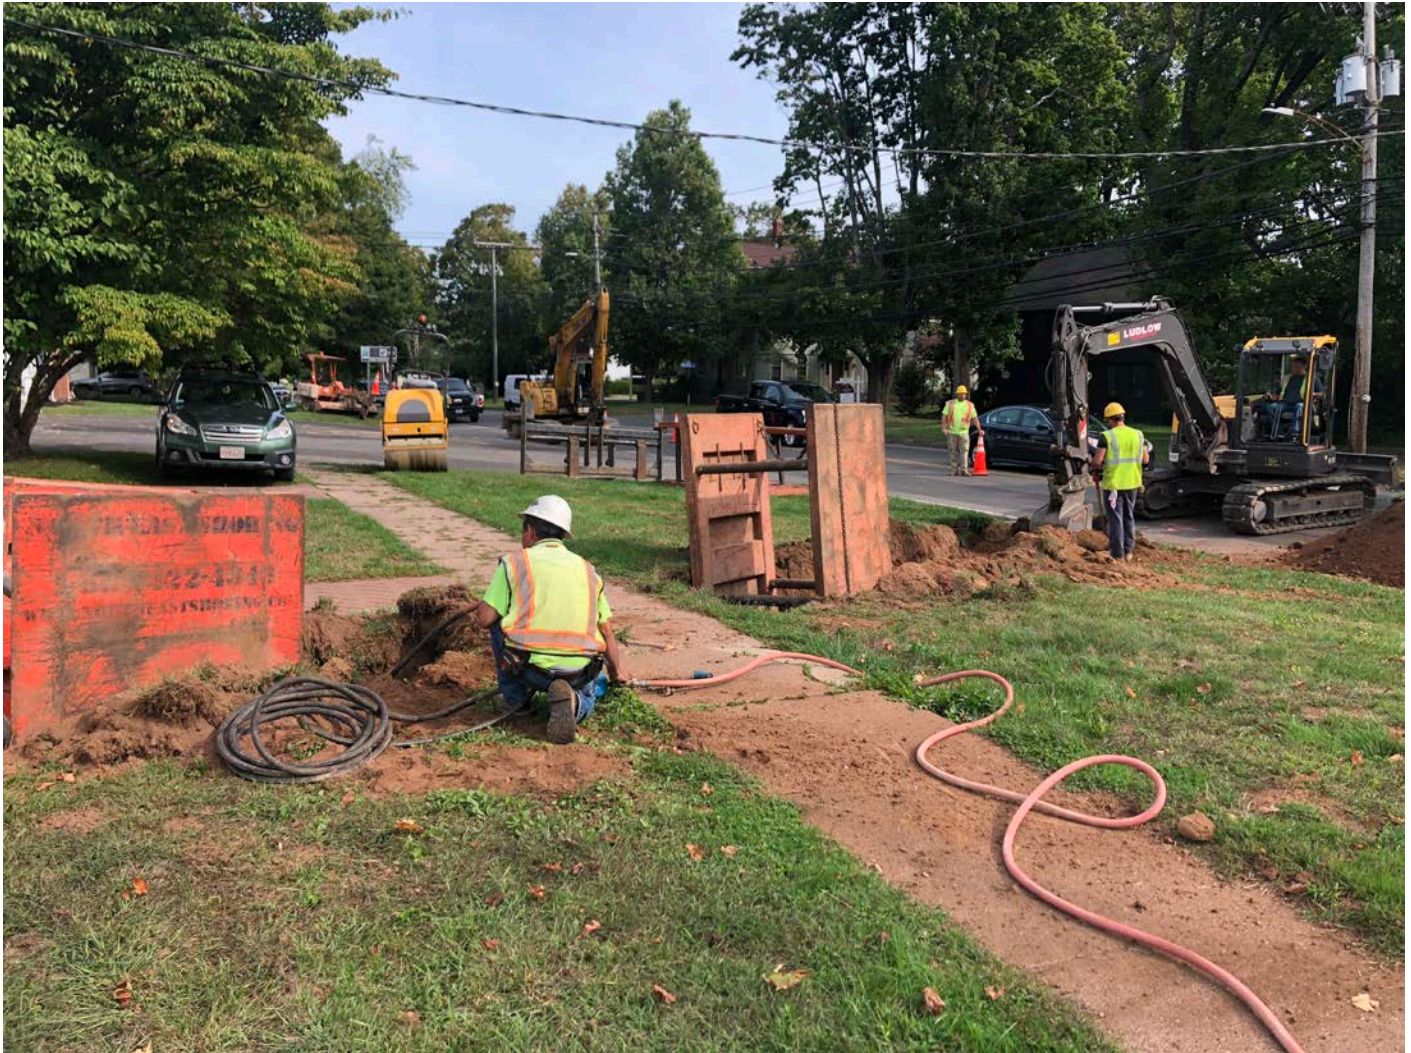
Picture 6: Ludlow installing a curb stop at Station 193+18 to provide service to 236 Main Street. Ludlow is using a pneumatic mole to advance a hole beneath the Town sidewalk for the placement of a 1" copper service line. View to the northeast.

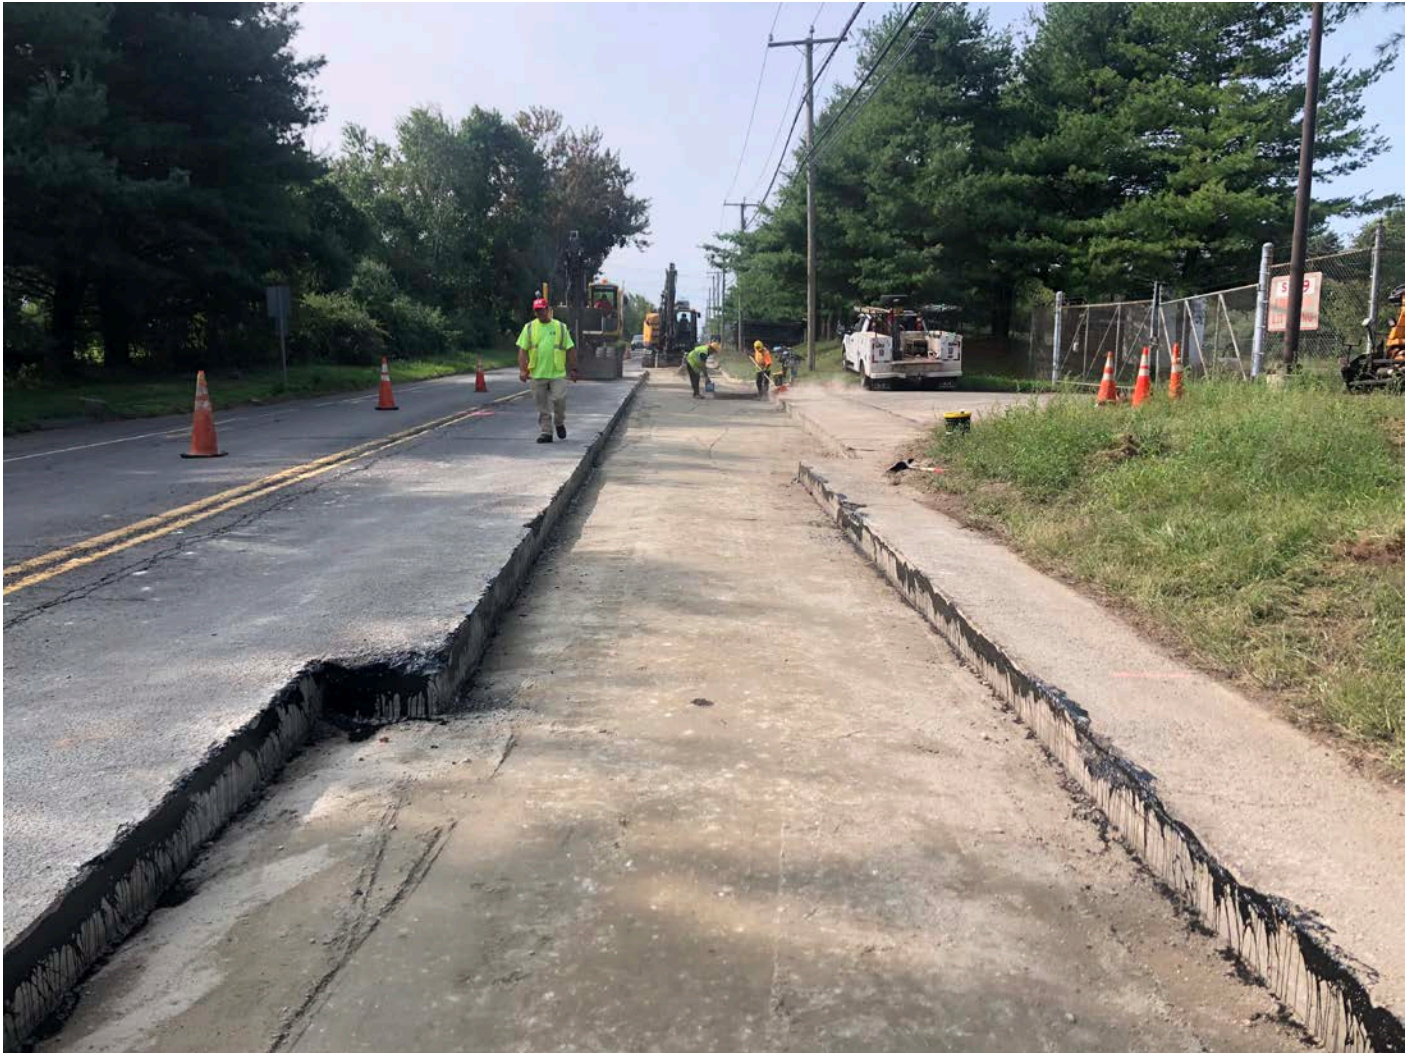
Picture 7: Ludlow applying tack coat to the edges of saw cut pavement as they prepare to repave trench cutbacks on S. Main Street, Middletown. View to the south.

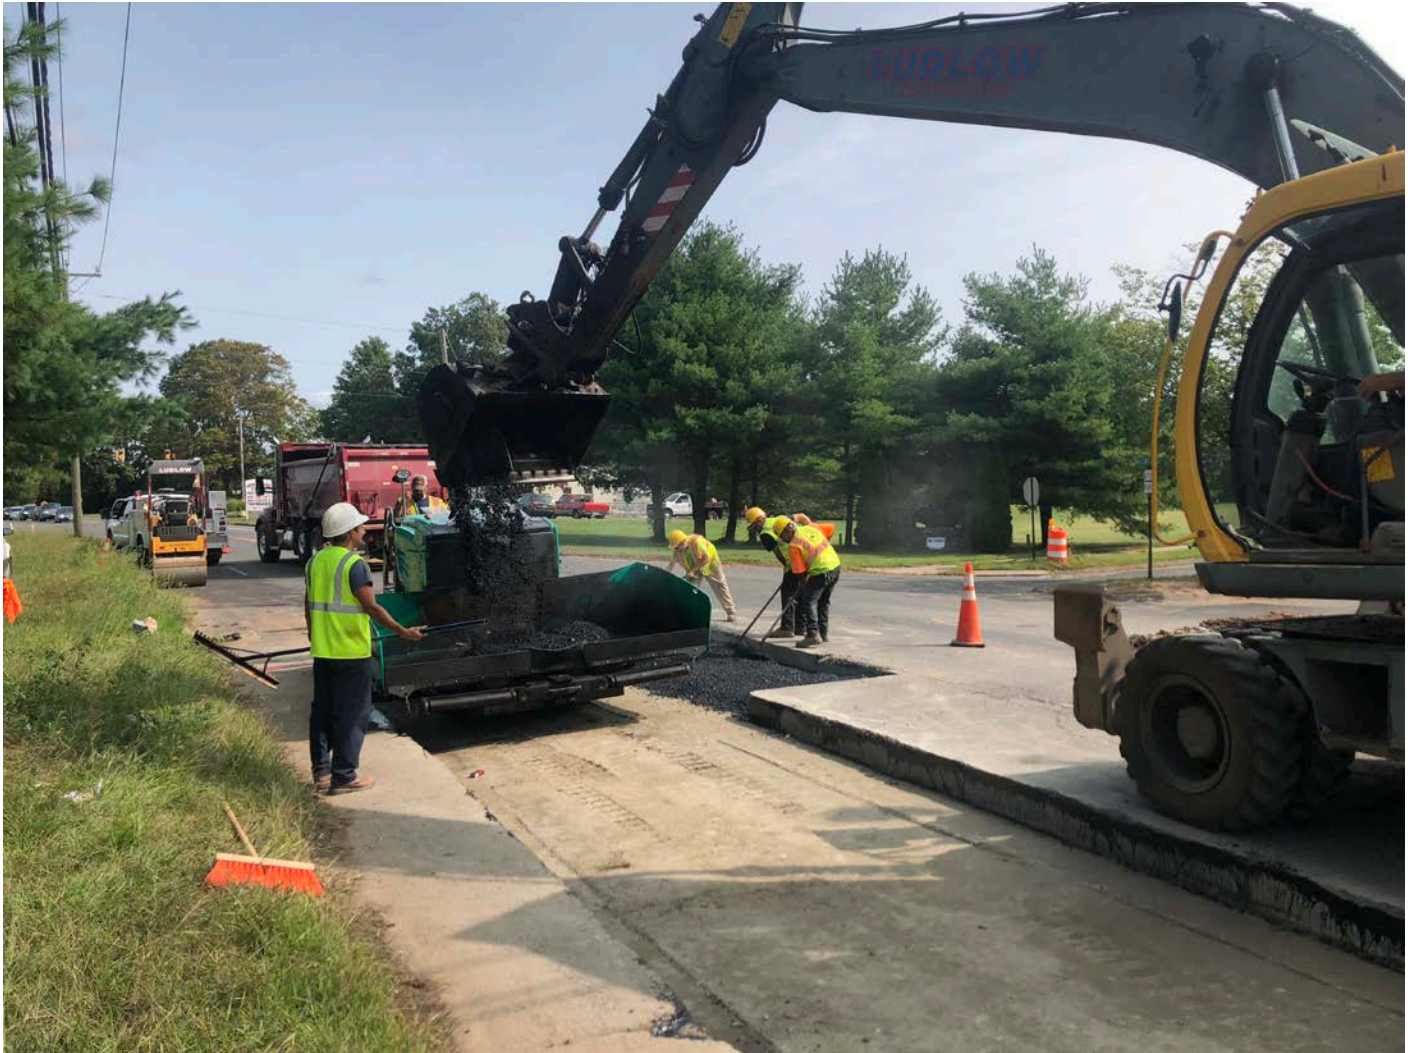
Picture 8: Ludlow placing the first of three 3" lifts of asphalt as they repave trench cutbacks on S. Main Street, Middletown. Station 100+00. View to the northeast.

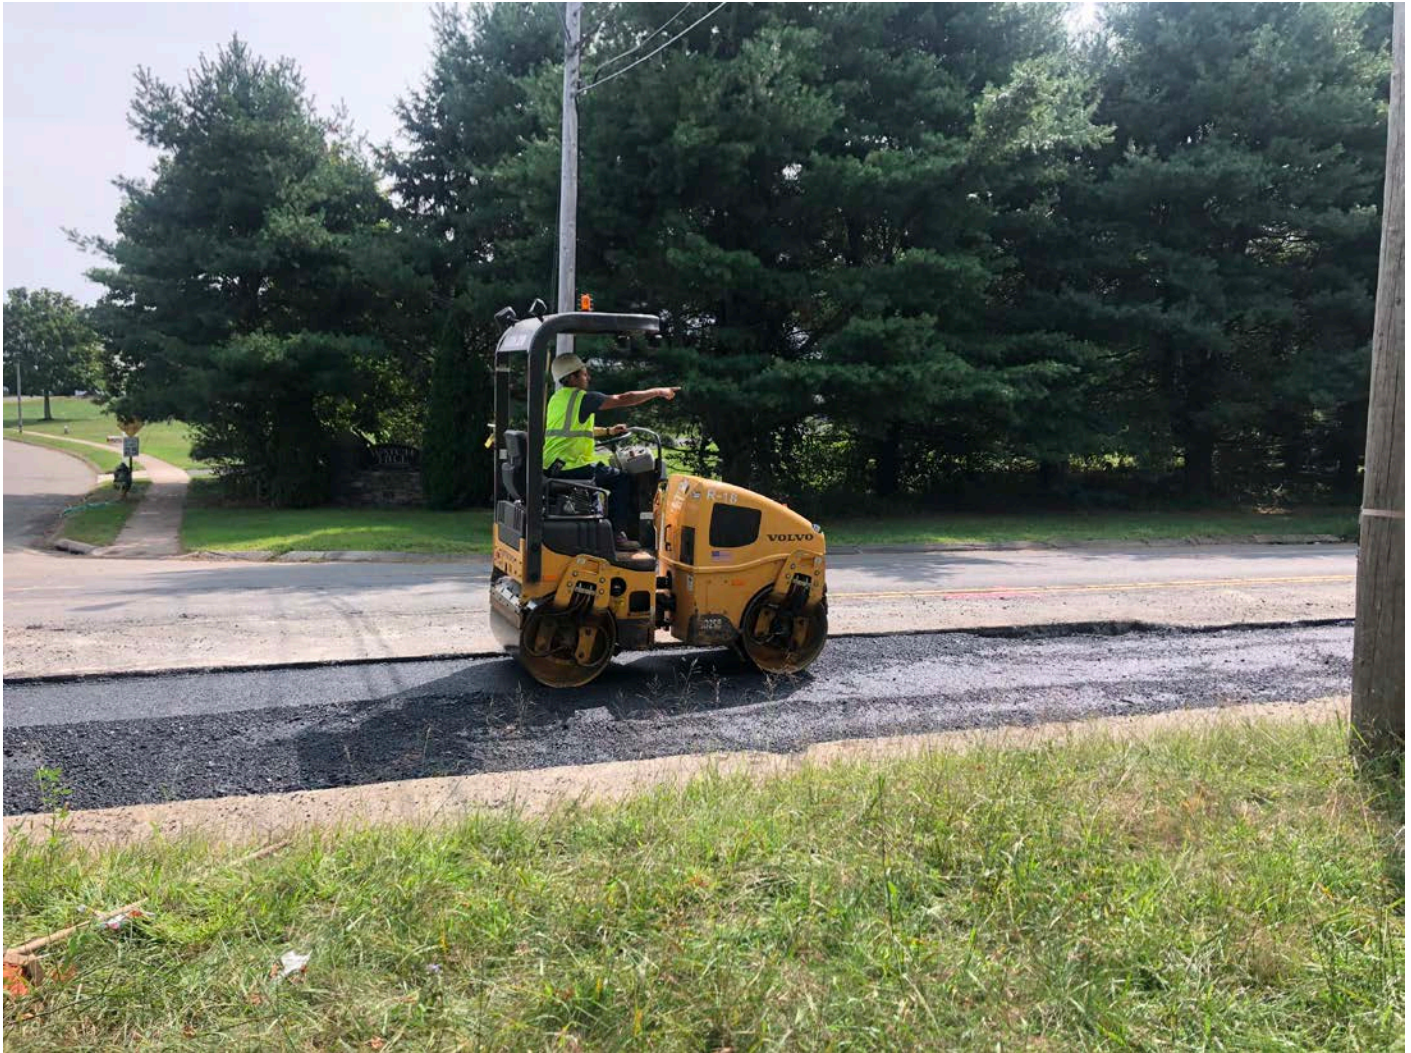
Picture 9: Ludlow compacting second of three 3" lifts of asphalt as they repave trench cutbacks on S. Main Street, Middletown. Station 100+00. View to the east.

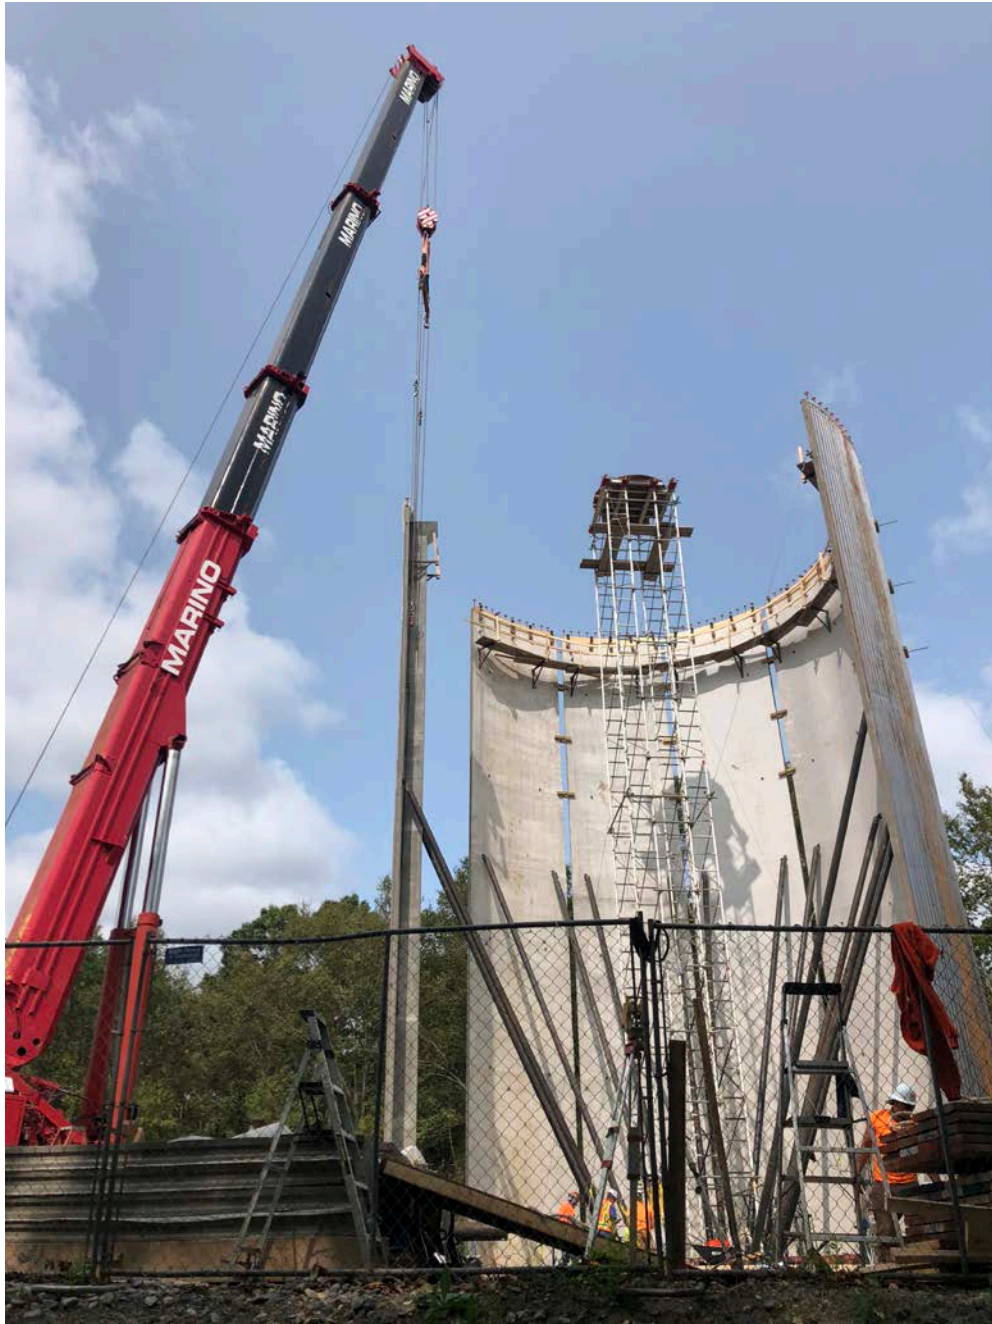
Picture 10: Marino lifting narrow water tank side panel into place for DN Tanks to secure it to the water tank base. Water tank work zone, east of the Shared Access Driveway, Middletown. View to the north.
