Daily Report

Project:	Durham Meadows Pipeline Installation	Date:	September 15, 2020
Location:	Maple Avenue, Talcott Lane, and Main Street, Durham; S. Main Street and the Shared Access Driveway, Middletown	Day of Week:	Tuesday
Project #:	AECOM: 6061487	Report No:	159
Contractor:	Ludlow Construction	Page:	1 of 16

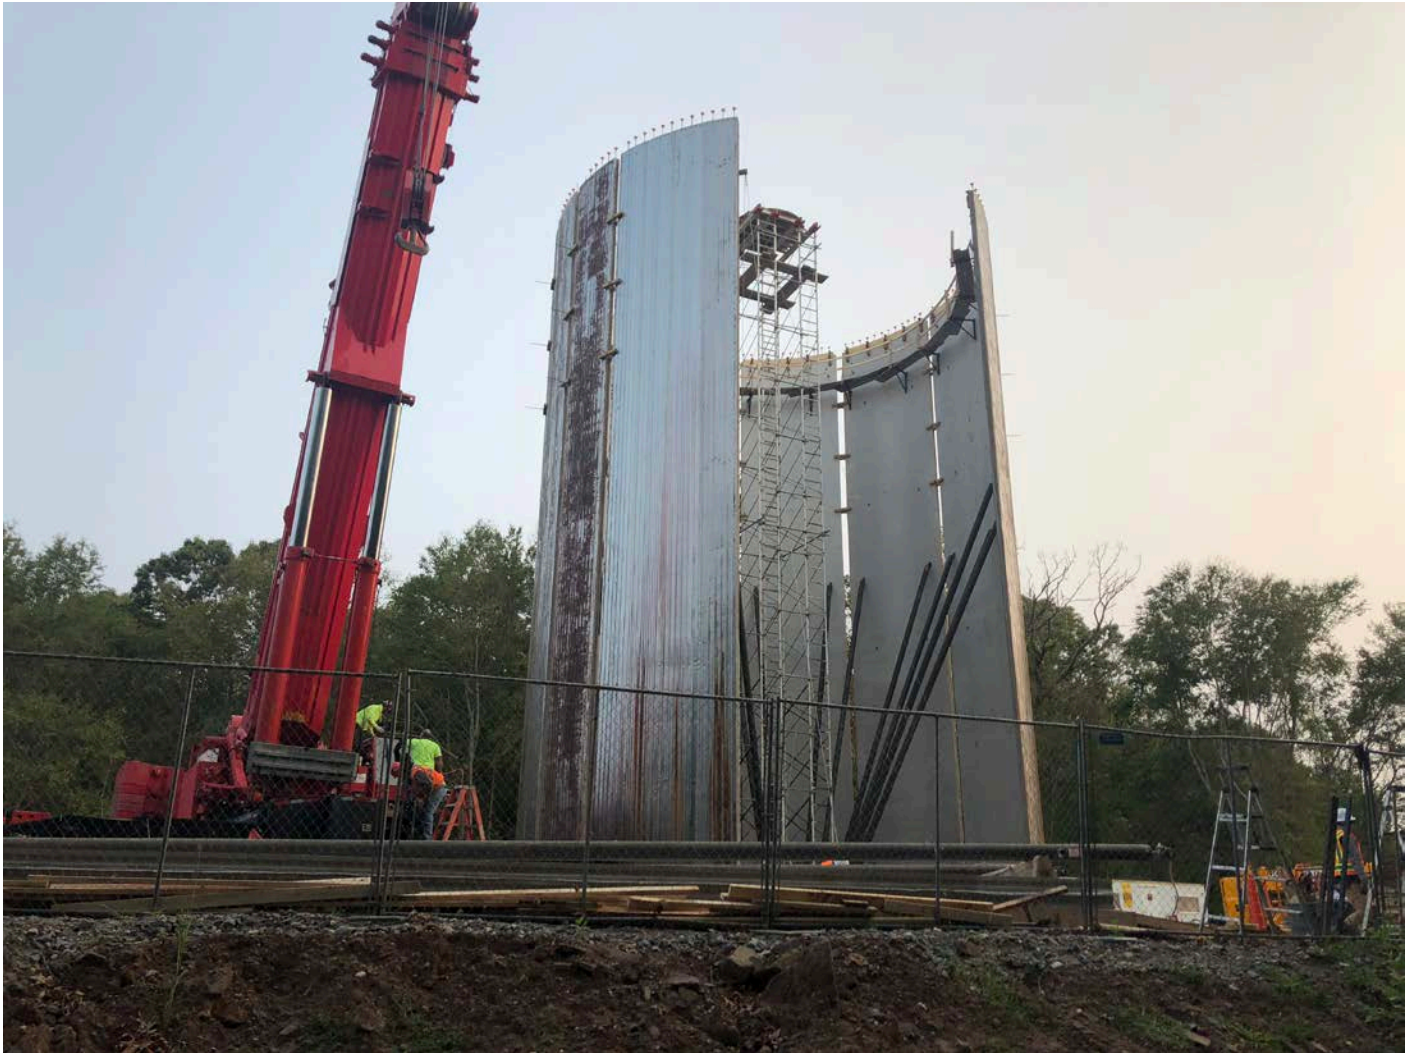
Picture 1: View of water tank construction progress at the start of the day. Water tank work zone, east of the Shared Access Road, Middletown. View to the northeast.

0716: Eight wide side panels and two narrow side panels have been erected on the water tank base so far. DN Tanks is preparing to erect the remaining side panels to the tank.

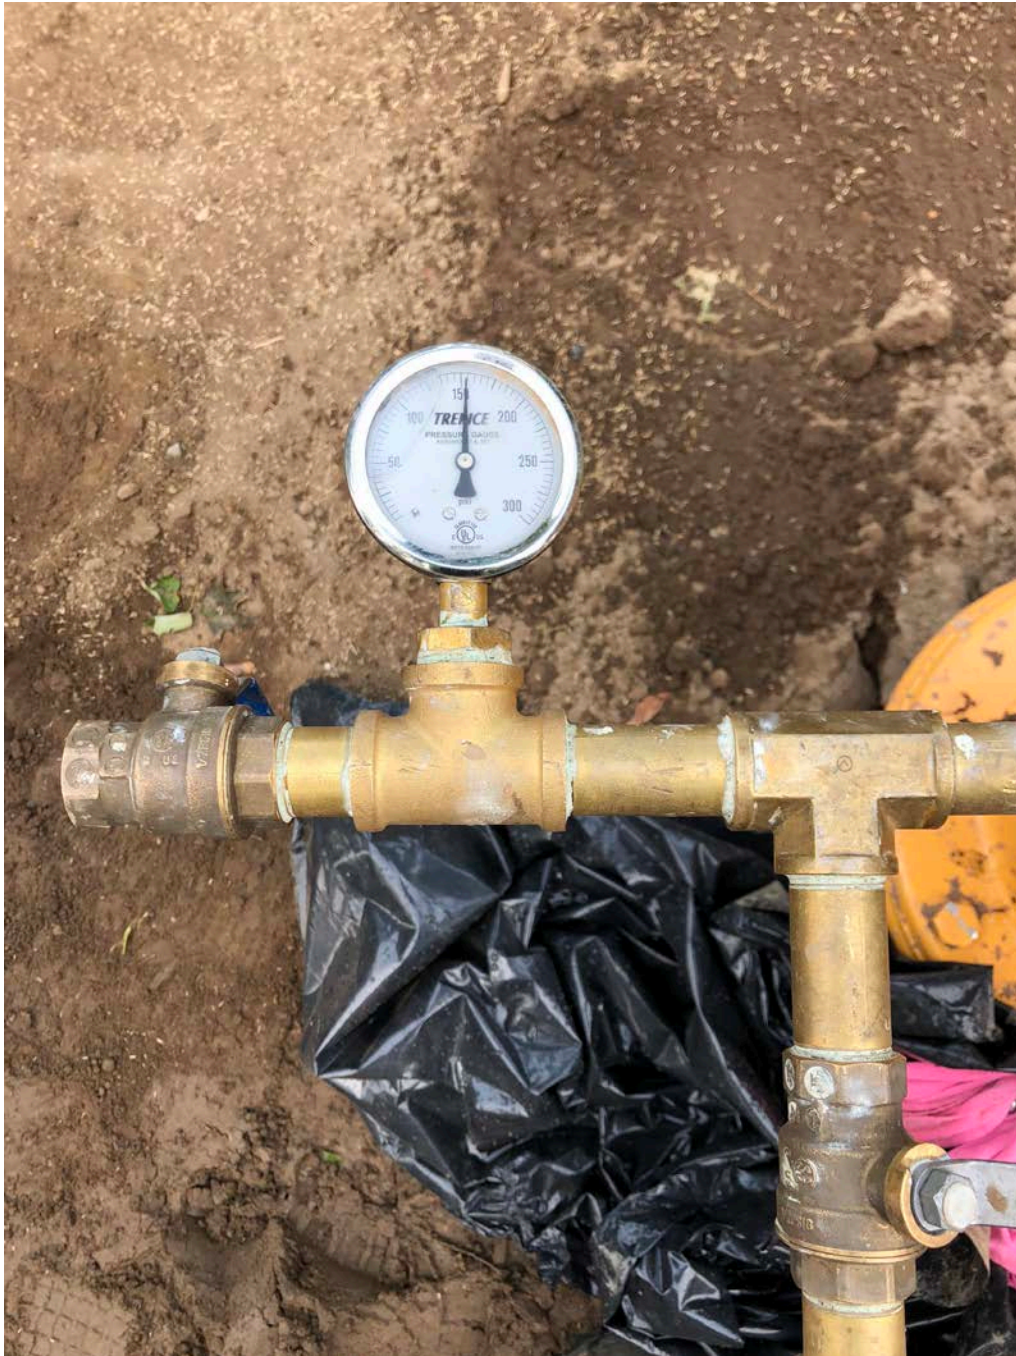
Picture 2: Beginning pressure at the start of the pressure test conducted today on Maple Avenue, Durham.

0811: Ludlow has just started a pressure test of the section of water line on Maple Avenue that runs from Station~930+40 to the intersection of Maple Avenue and Talcott Lane. The pressure gauge is on the fire hydrant located at Station 935+49. The starting pressure is 154 PSI.

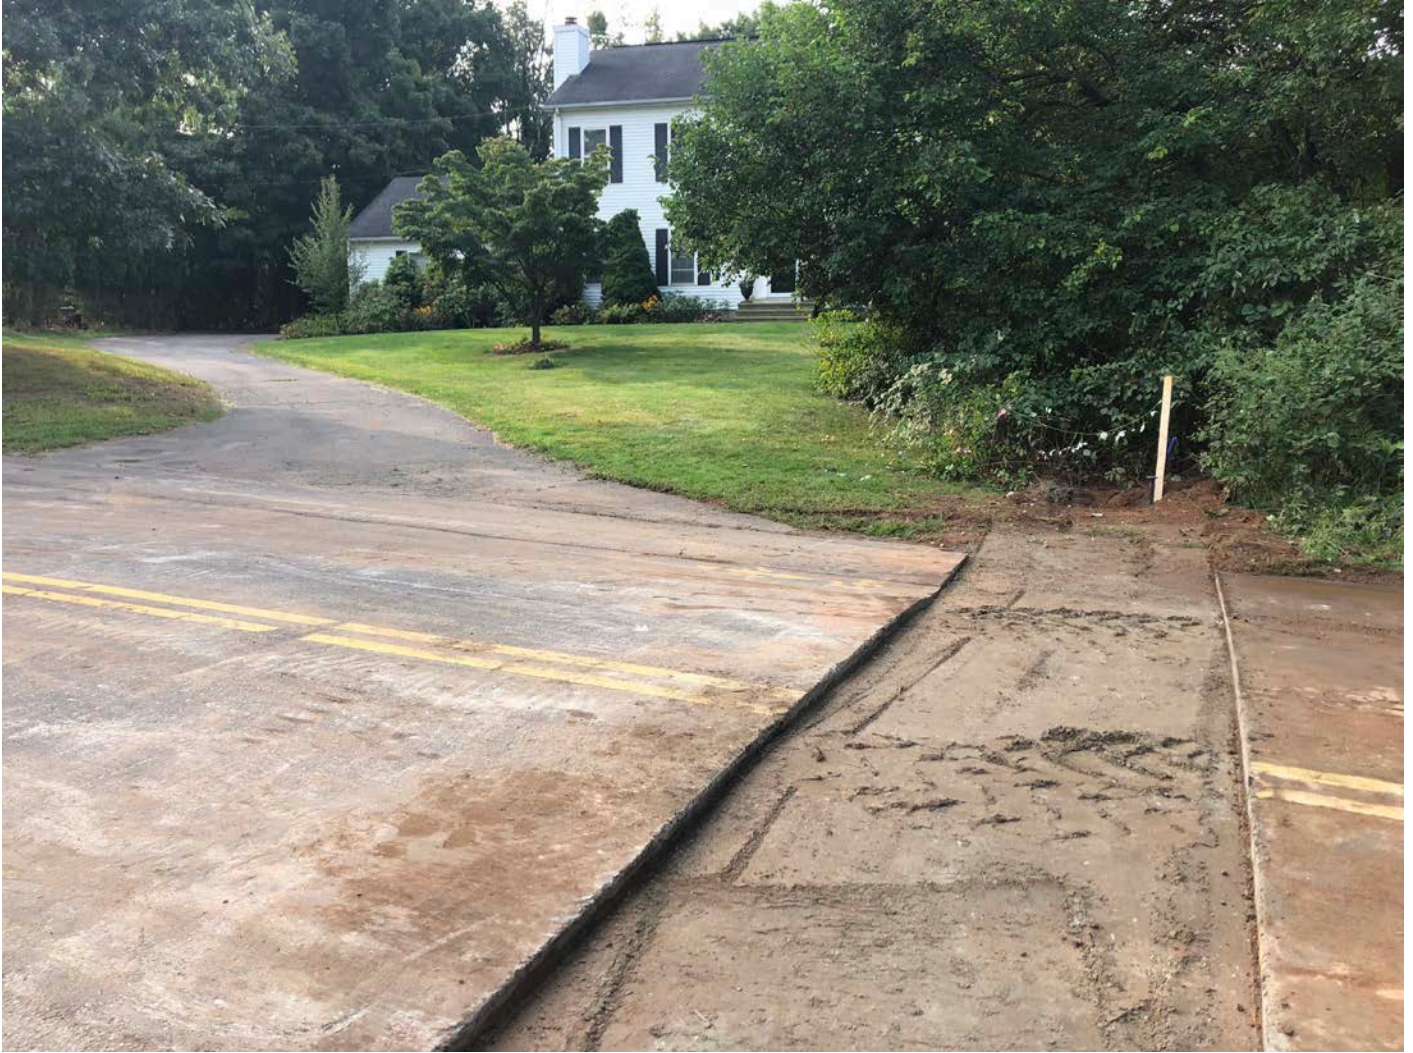
Picture 3: Curb stop installed at Station 422+52 that will service 105 Maiden Lane, Durham. View to the south.

0852: Ludlow has finished installing a curb stop at Station 422+52. The curb stop is located 10.5' from the edge of pavement.

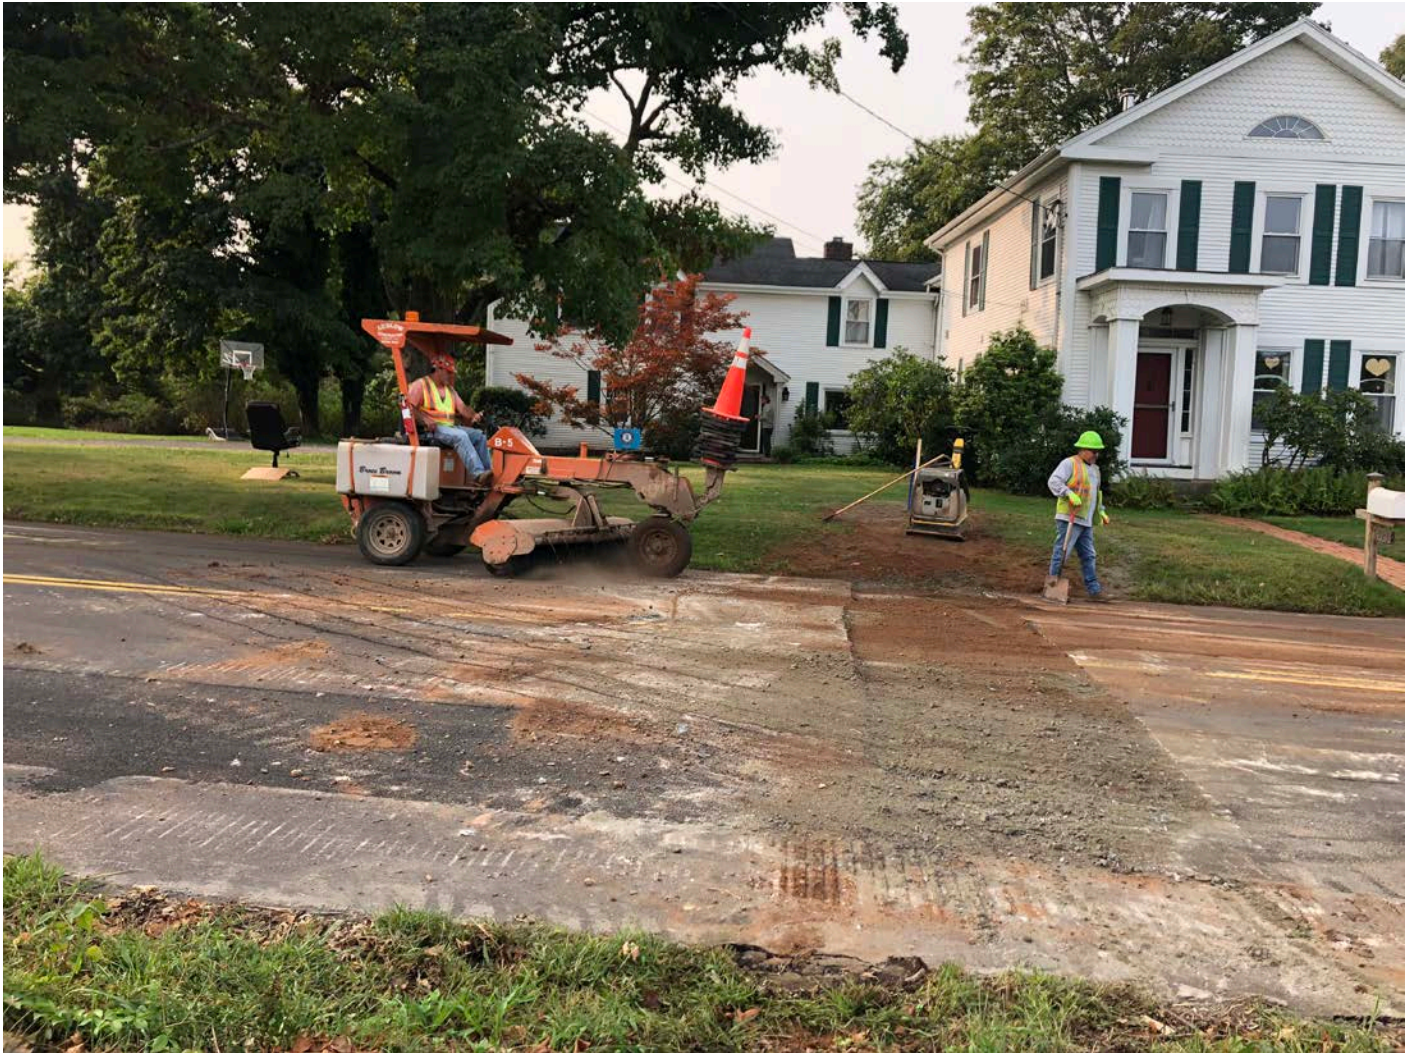
Picture 4: Curb stop installed at Station 424+67 that will service 123 Maiden Lane, Durham. View to the south.

0855: Ludlow is finishing with the installation of a curb stop at Station 424+67 for service to 123 Maiden Lane. The curb stop is 10' from the edge of pavement.

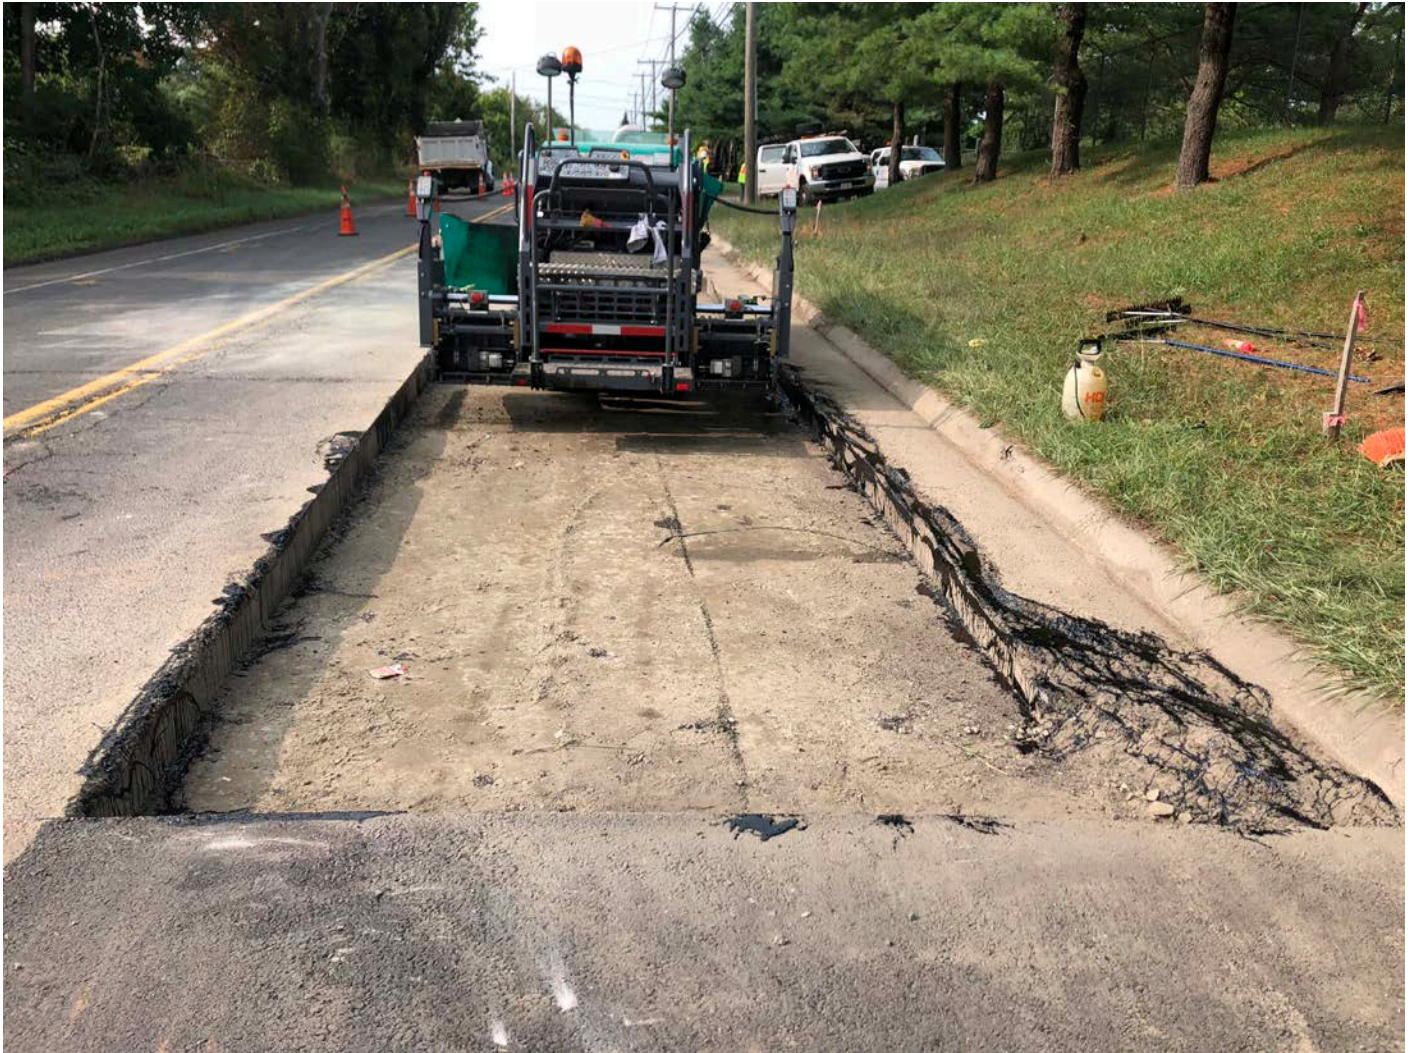
Picture 5: Tack coating applied to the cut edges of asphalt at the trench cutbacks that Ludlow repaved today from Stations 102+00 to 104+50 on S. Main Street, Middletown. View to the south.

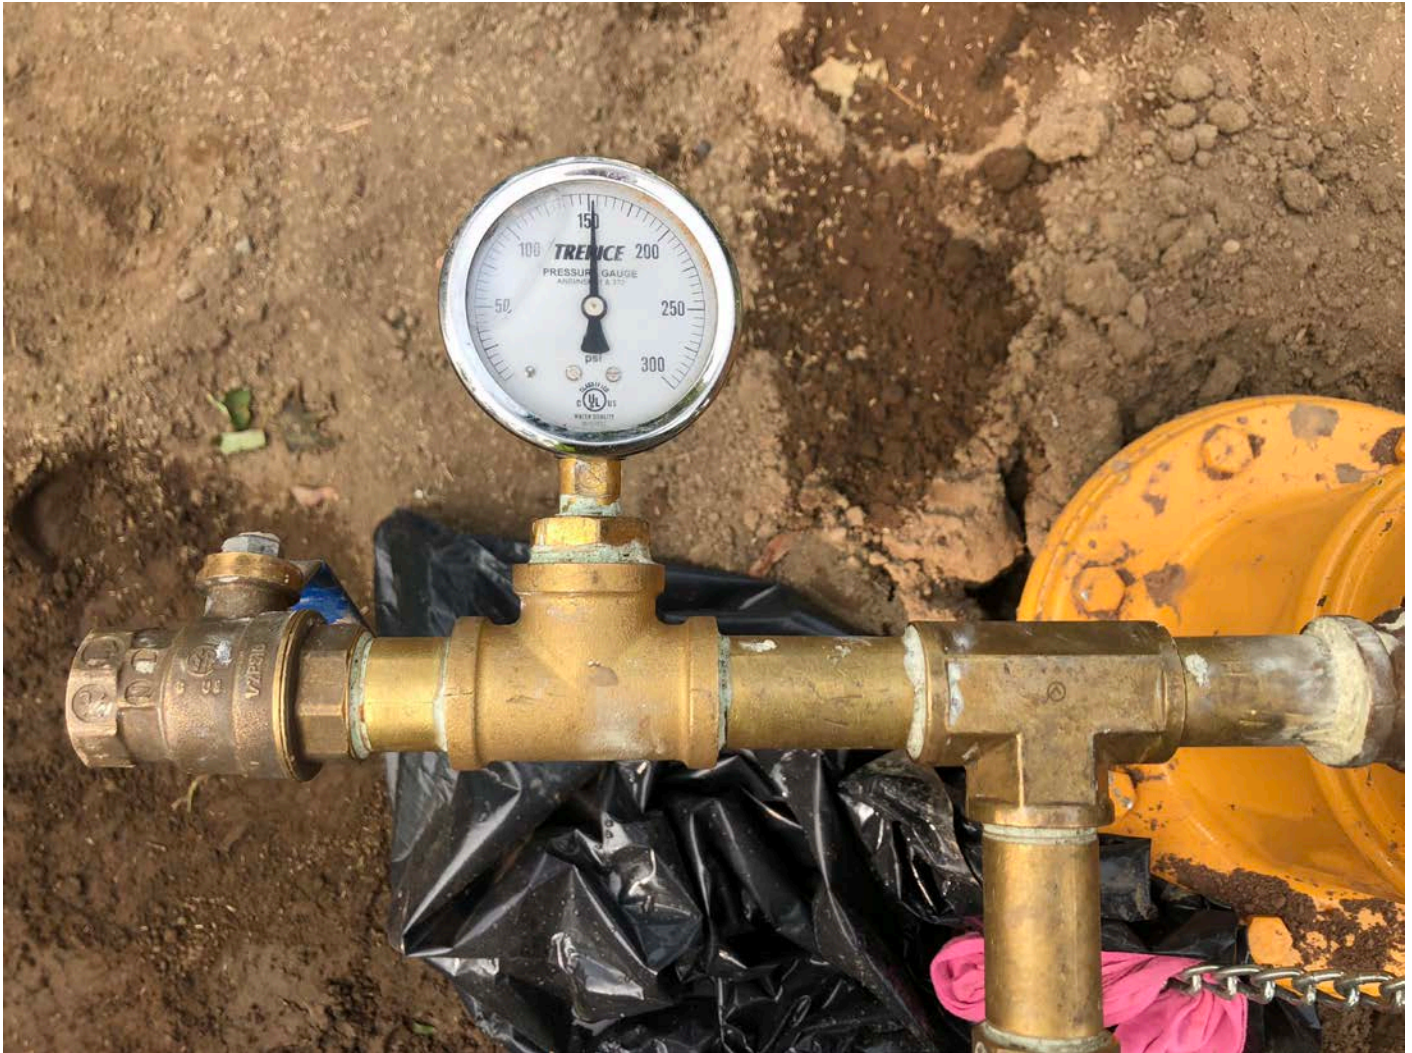
Picture 6: End pressure for the pressure test conducted today on Maple Avenue, Durham.

1011: The pressure test that Ludlow was conducting on Maple Avenue has finished. The final pressure is 152 PSI.

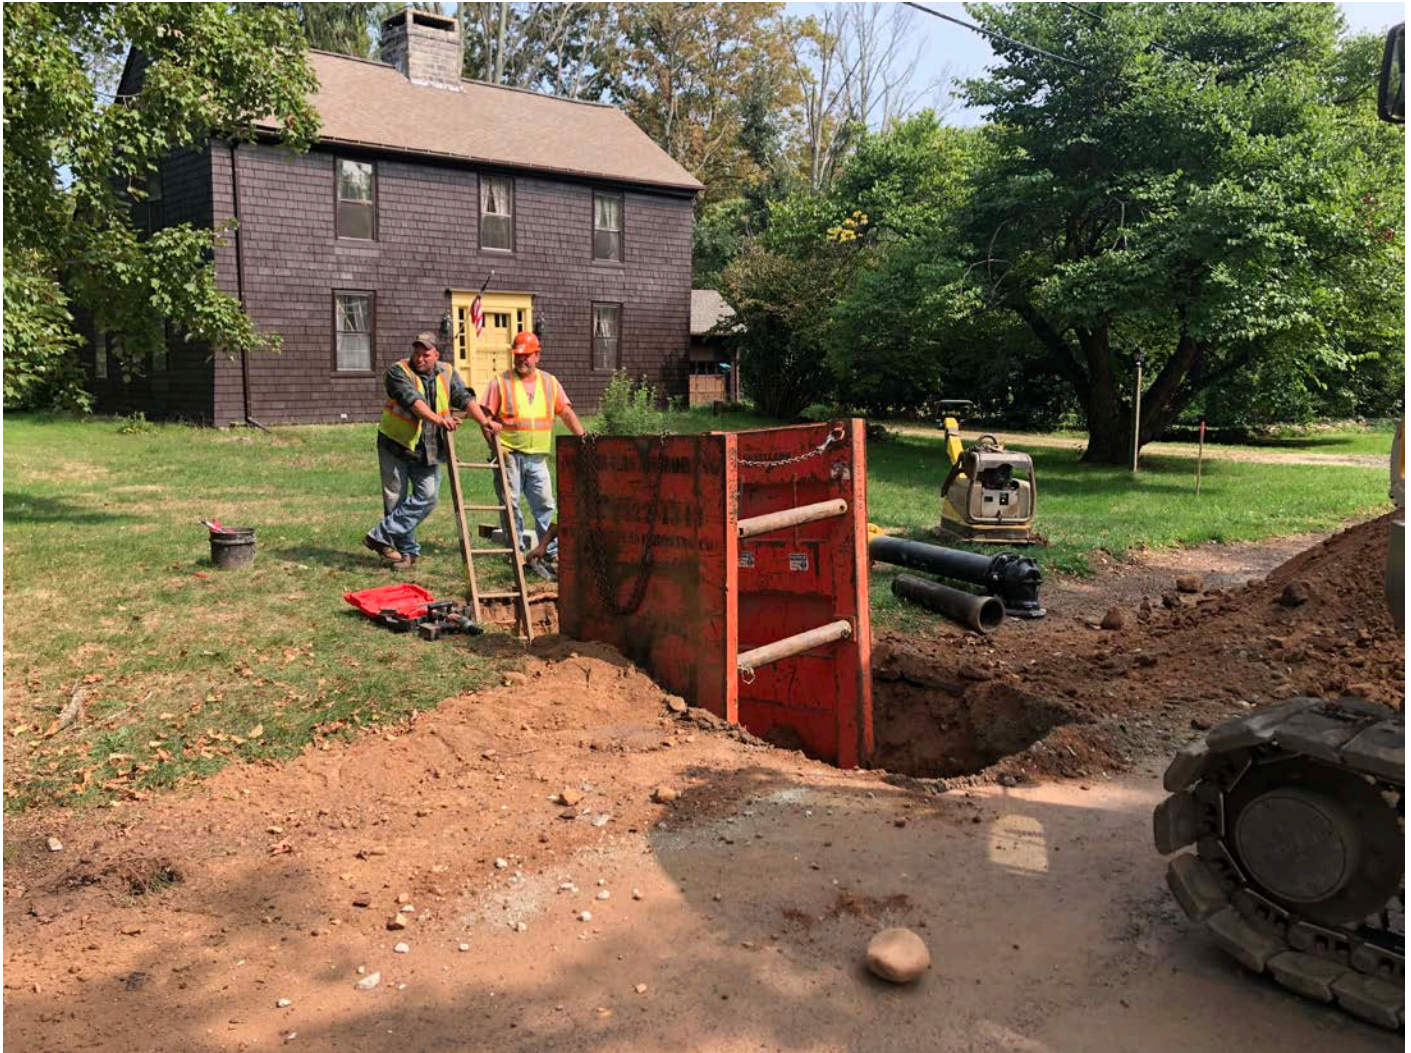
Picture 7: Ludlow installing a curb stop at Station 305+06 that will service 25 Talcott Lane, Durham. View to the northeast.

1135: Ludlow is currently installing a curb stop at Station 305+06 to provide service for 25 Talcott Lane, Durham.

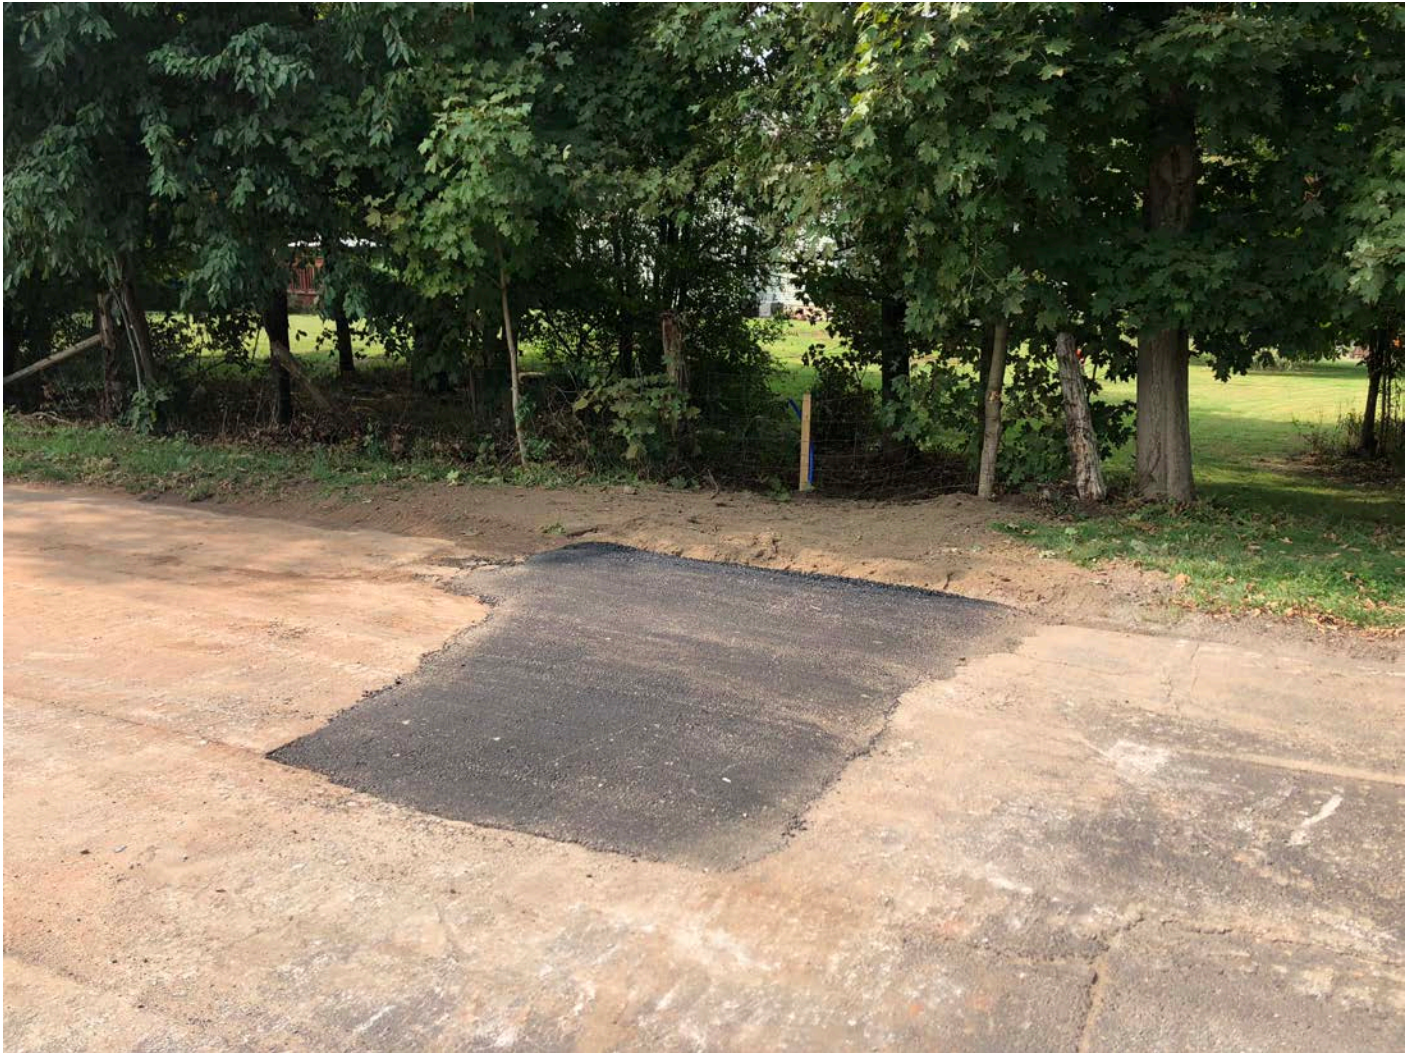
Picture 8: Installed curb stop at Station 535+20 on Picket Lane. View to the west.

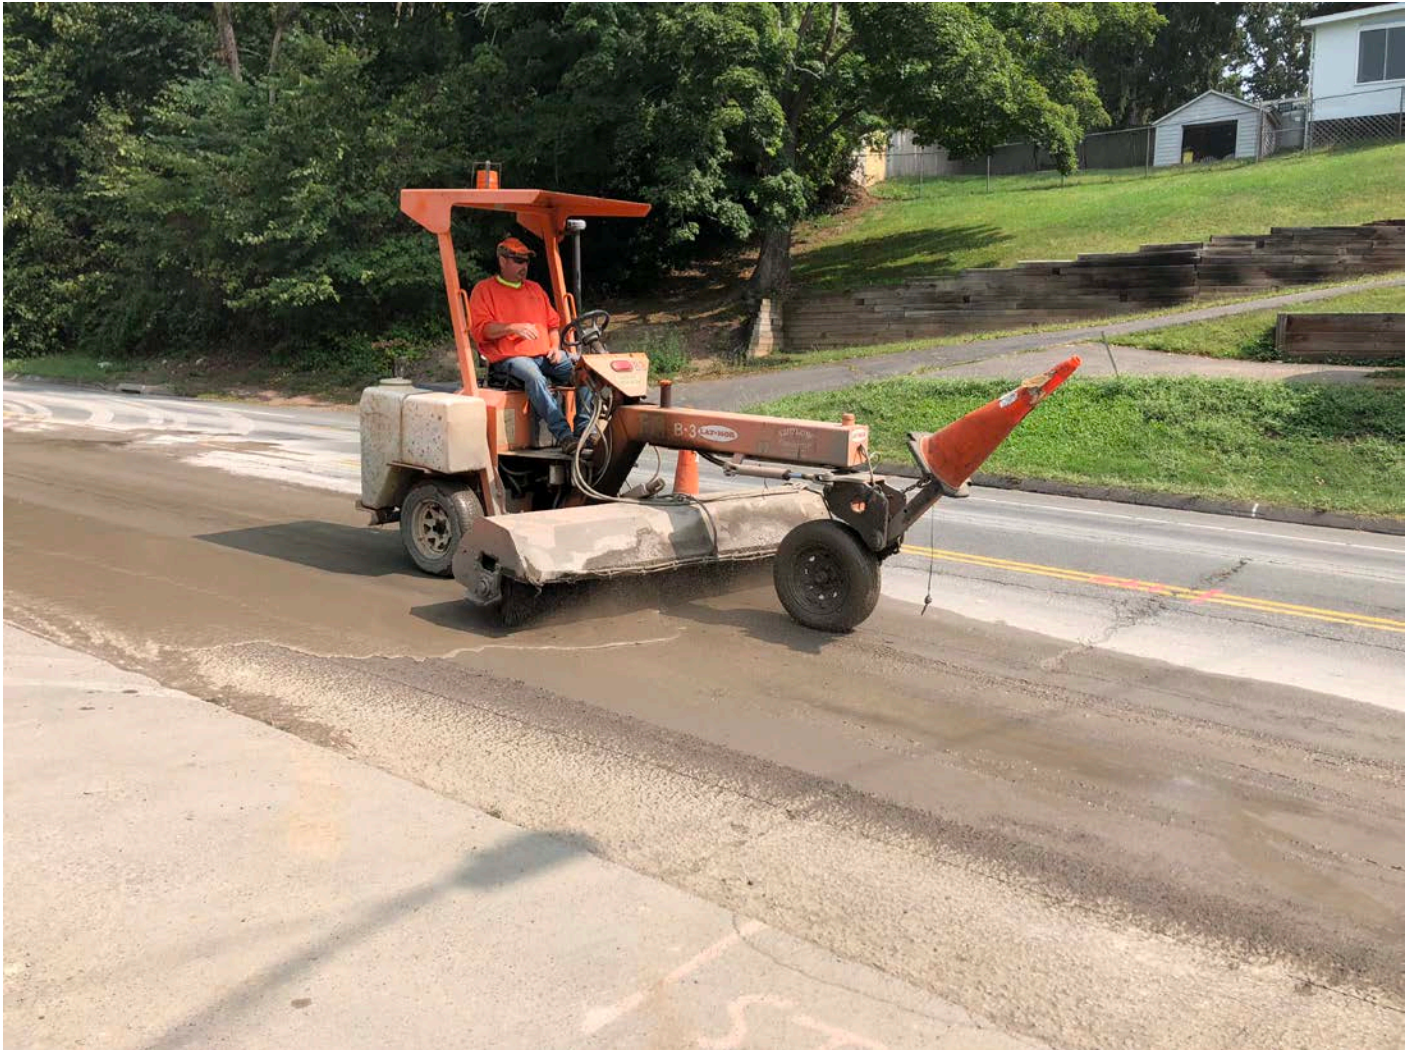
Picture 9: Ludlow using the Broce Broom to clean up after pavement saw cutting activities on the southbound lane of Main Street, Durham. Station 146+00. View to the northeast.

1207: Veilleux continues to saw cut pavement on the southbound side of Main Street, Durham. They are currently working at Station 145+20. Ludlow is cleaning up the work area with the Broce Broom.

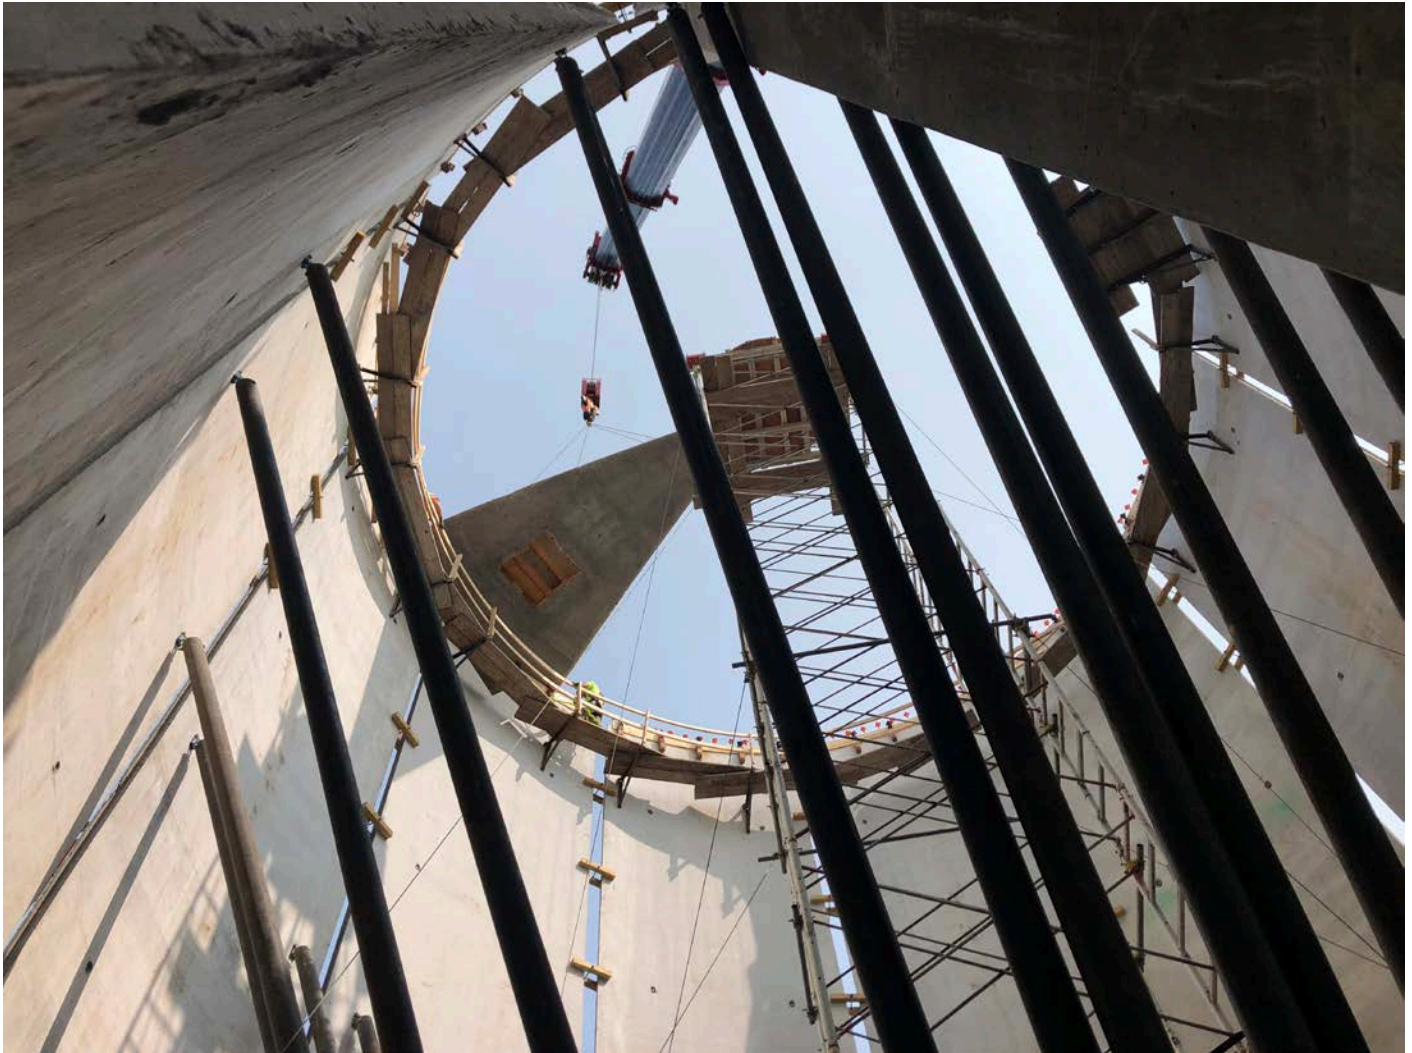
Picture 10: Marino holding the first dome panel in place for installation by DN Tanks. Water tank work zone, east of the Shared Access Driveway, Middletown.

1235: DN Tanks is in the process of placing the first dome panel to the top of the water tank.

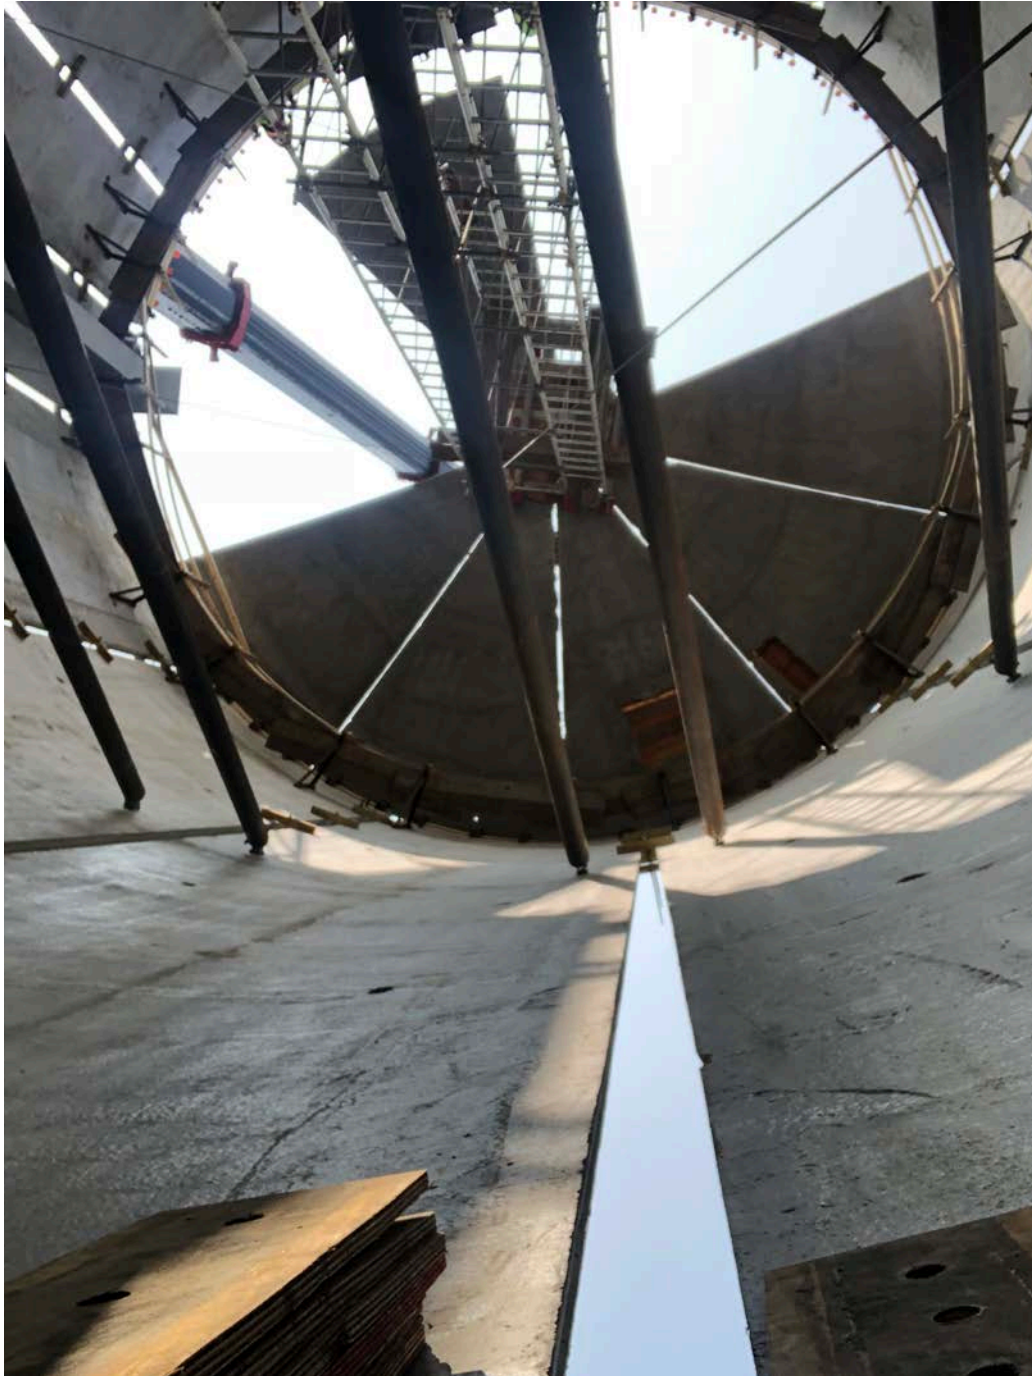
Picture 11: Marino holding the sixth dome panel in place for installation by DN Tanks. Water tank work zone, east of the Shared Access Driveway, Middletown.

1412: DN Tanks and Marino are placing the sixth dome panel on the water tank.

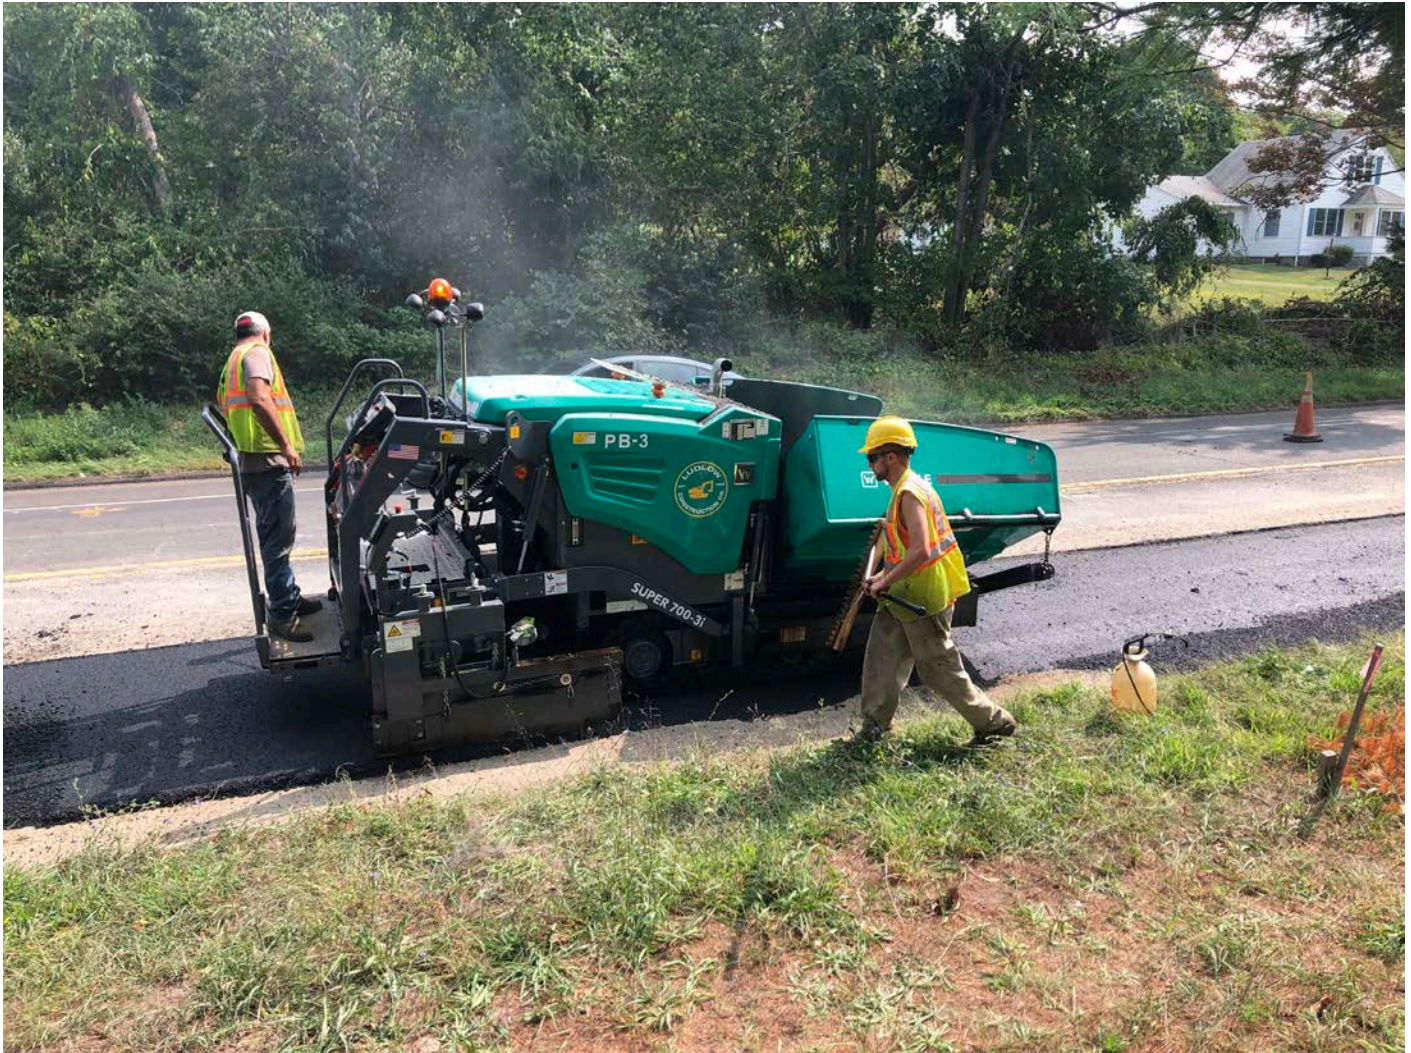
Picture 12: Ludlow placing third 3" lift of asphalt for the trench cutback repaving on S. Main Street, Middletown. View to the southeast.

1255: Ludlow is applying and compacting the third 3" lift of asphalt between Stations 102+00 and 104+50.
