Daily Report

Project:	Durham Meadows Pipeline Installation	Date:	September 23, 2020
Location:	Main Street, Durham; S. Main Street and the Shared Access Driveway, Middletown	Day of Week:	Wednesday
Project #:	AECOM: 6061487	Report No:	165
Contractor:	Ludlow Construction	Page:	1 of 8

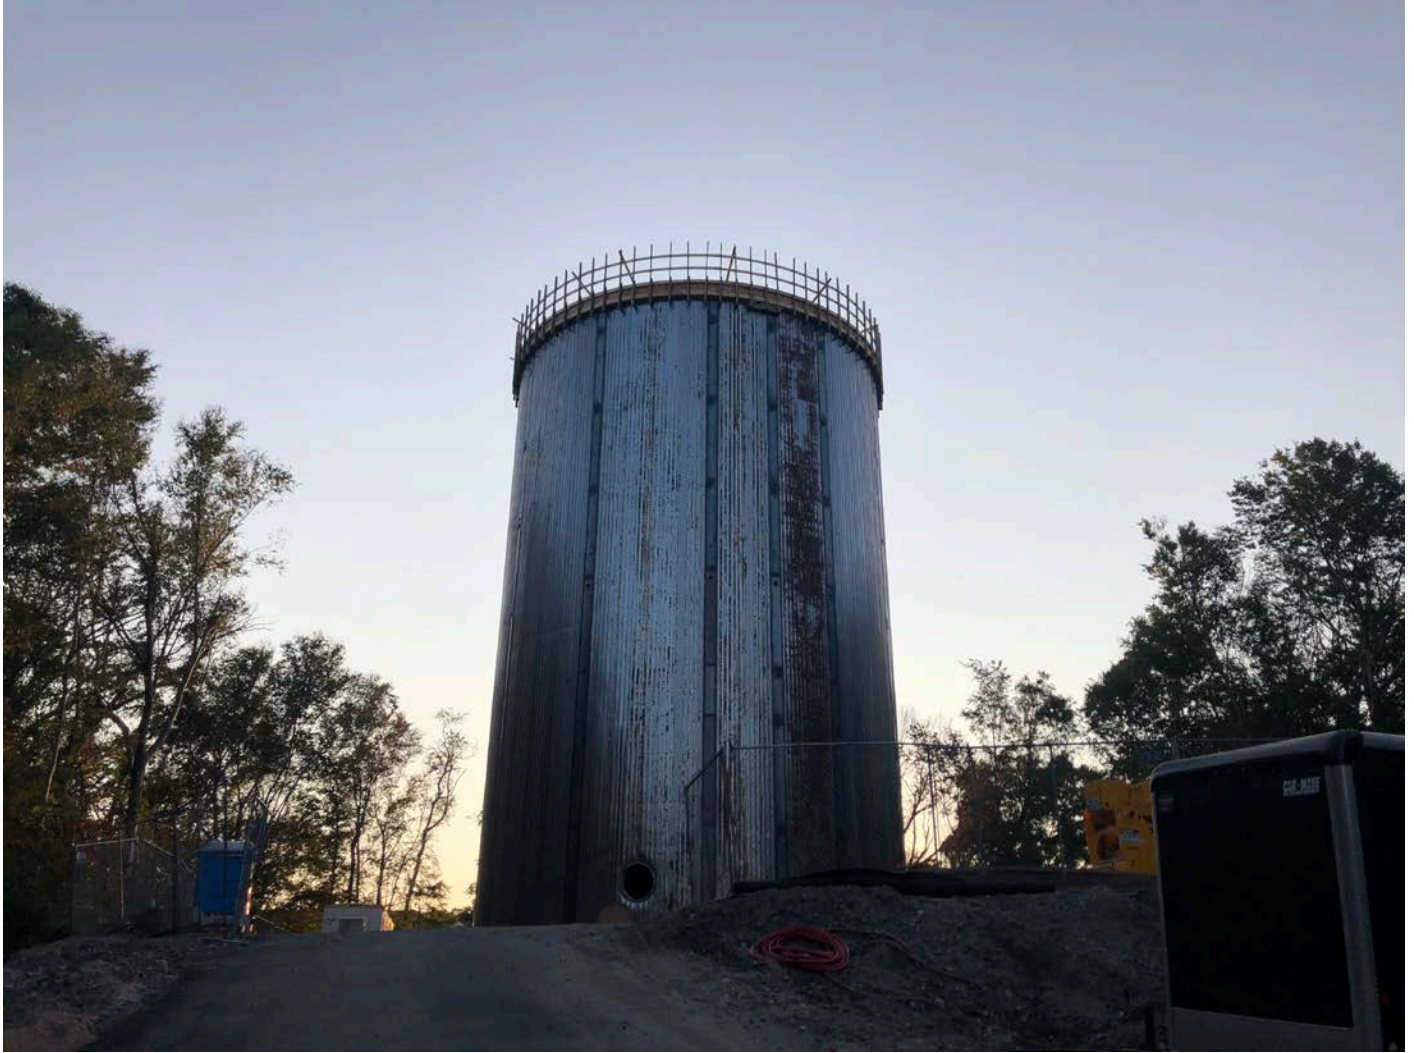
Picture 1: Guardrails and toe boards installed along the perimeter of the top of the water tank by DN Tanks. Water tank work zone, east of the Shared Access Driveway, Middletown. View to the east.

0714: DN Tanks has finished installing a guard rail and toe boards at the top of the water tank at the east of the Shared Access Driveway, Middletown.

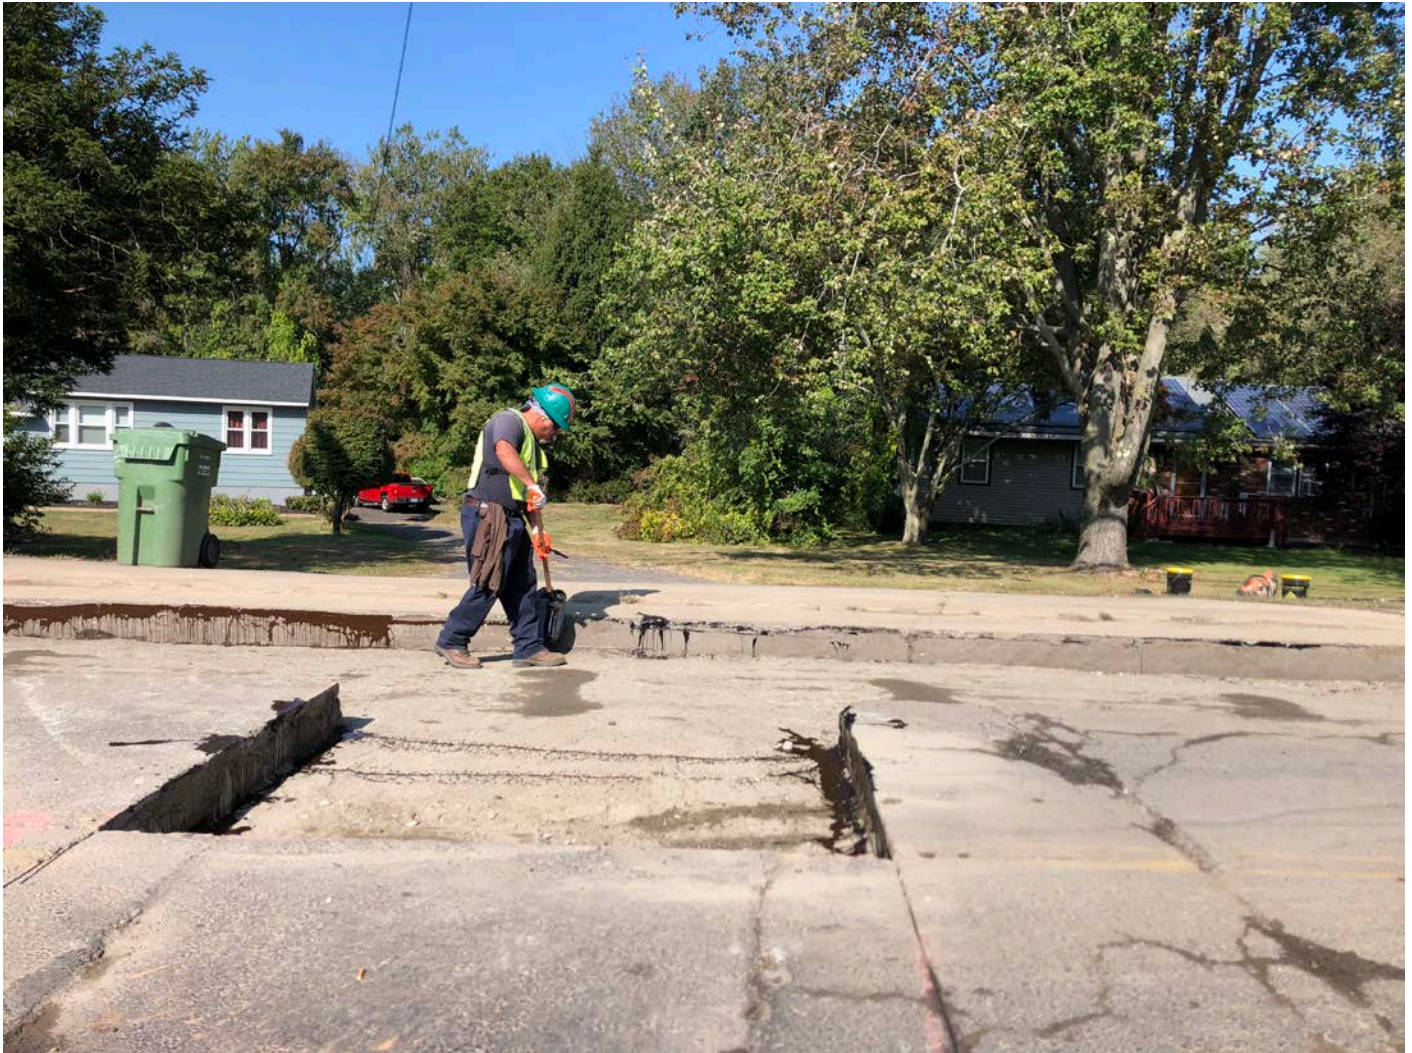
Picture 2: Ludlow applying tack coat to the cut edges of pavement as part of trench cutback paving activities on the southbound lane of S. Main Street, Middletown. View to the west.

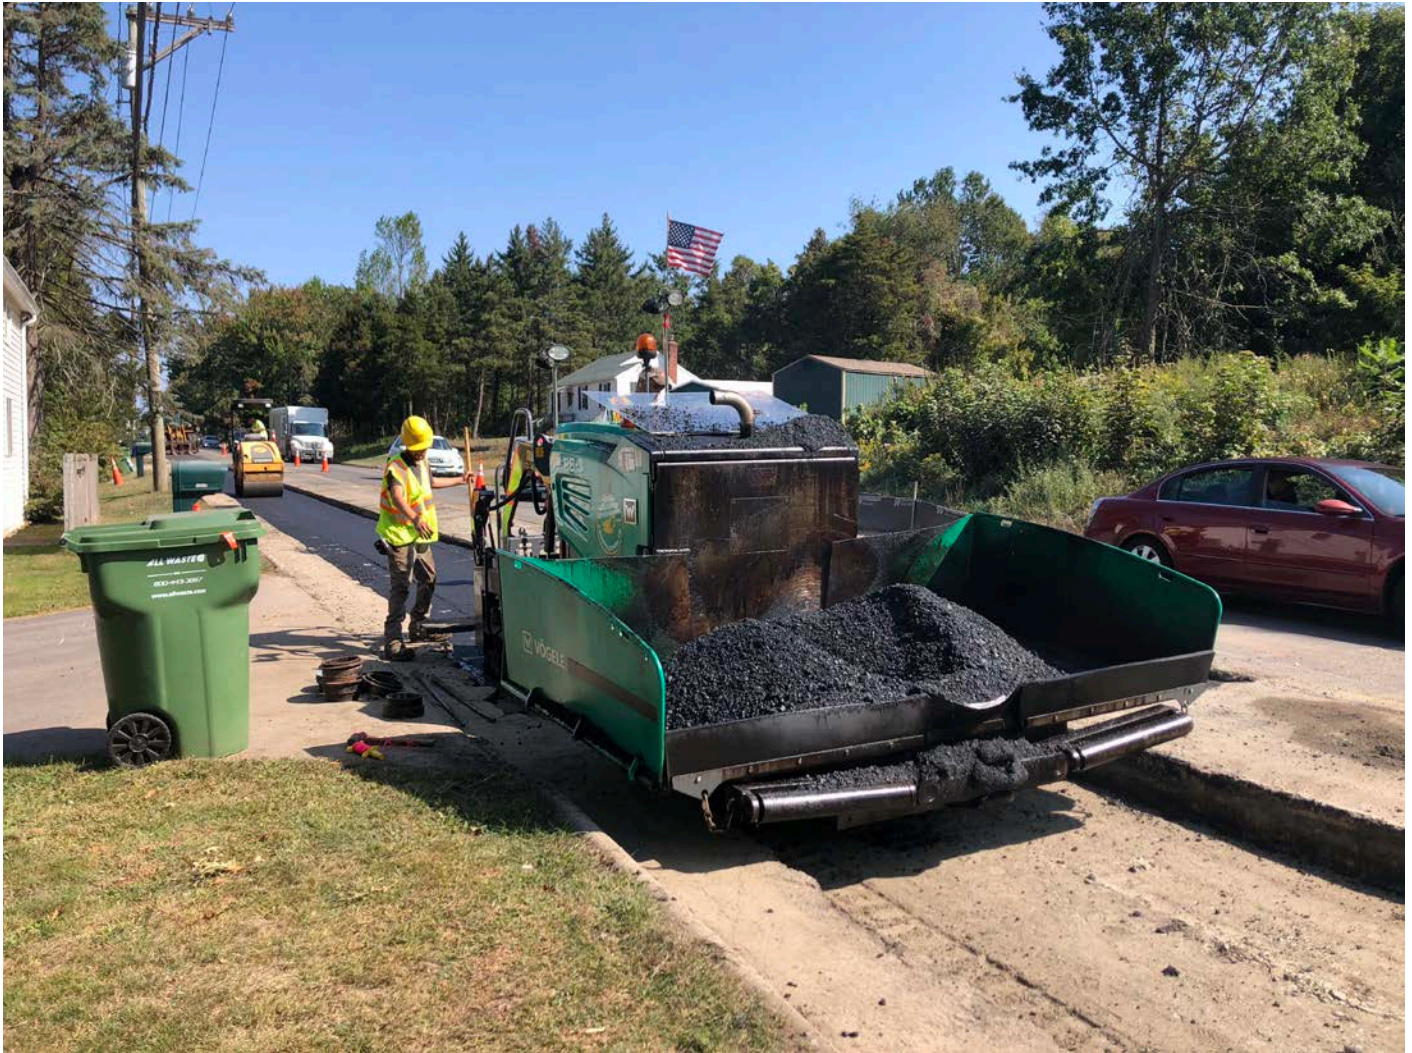
Picture 3: Ludlow placing the first of three 3” lifts of asphalt between Stations 122+75 and 126+00 as part of trench cutback paving activities on the southbound lane of S. Main Street, Middletown. View to the north.

1138: Ludlow is placing first of three 3" lifts of asphalt on the trench cutback on S. Main Street, Middletown. JTC is on site to collect compaction data from the placed and compacted asphalt.

1217: Ludlow has just finished placing and compacting the first of three 3" lifts of asphalt on the trench cutback on S. Main Street, Middletown.

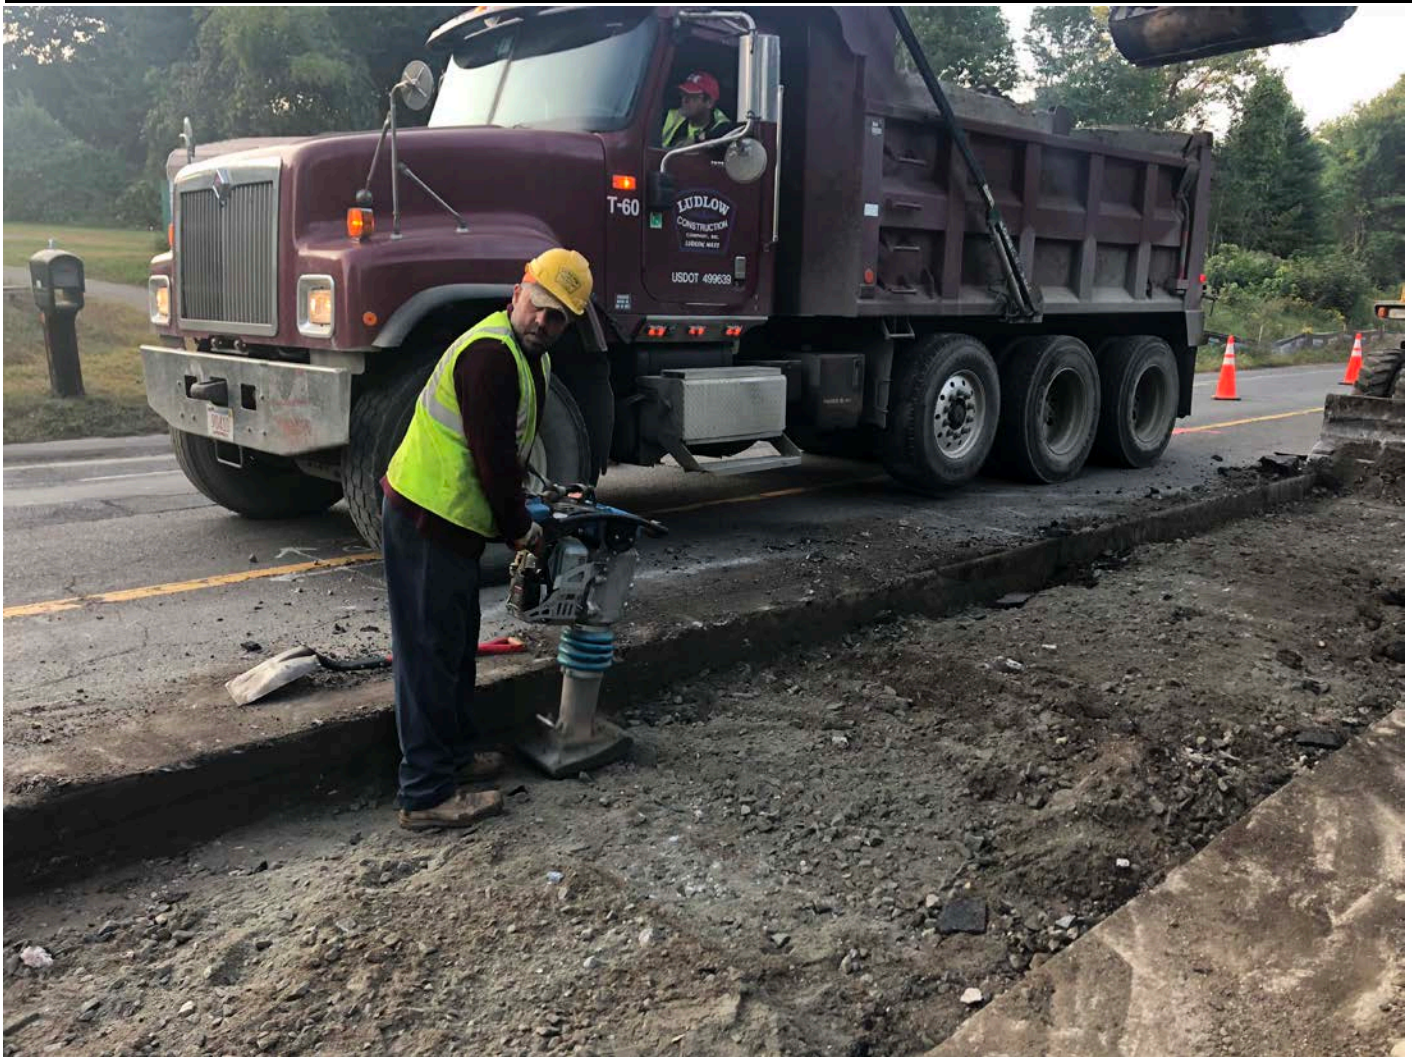
Picture 4: Ludlow using a jumping jack to compact 1.5” processed gravel along the edge of cut pavement as part of trench cutback paving activities on the southbound lane of S. Main Street, Middletown. View to the north.

1034: Ludlow has stripped pavement from Stations 122+75 to 126+00. They are currently compacting the 1.5" processed gravel subbase as they prepare to place the first of three 3" lifts of asphalt.

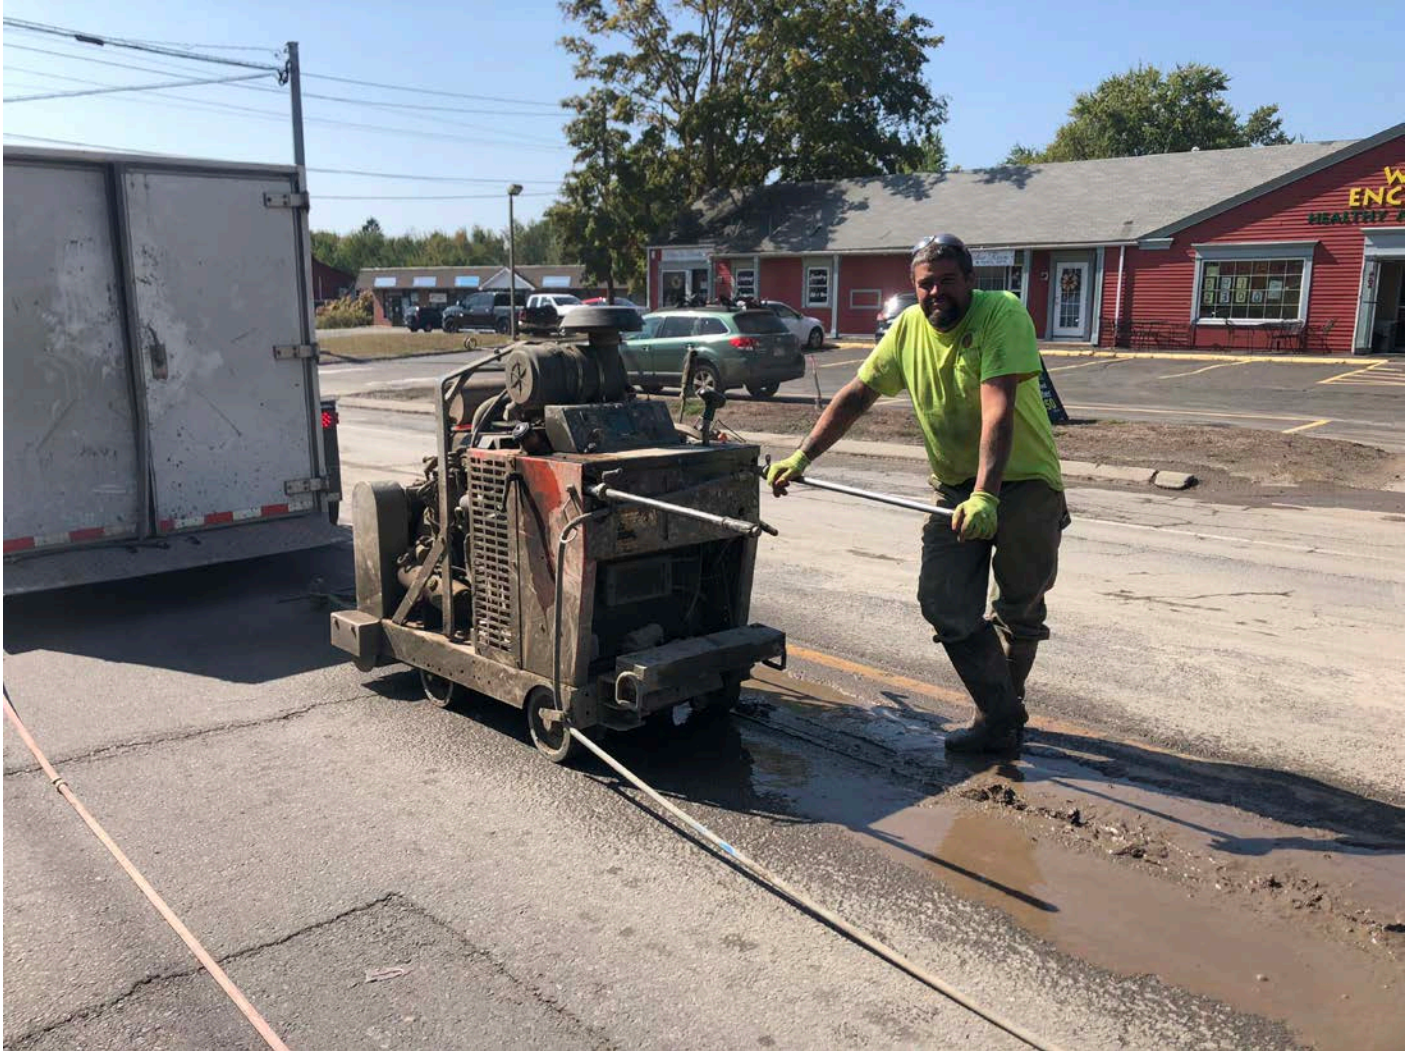
Picture 5: Veilleux saw cutting on the northbound lane of Main Street, Durham at Station 165+50. View to the southwest.

1210: Veilleux continues to saw cut pavement on Main Street, Durham. Veilleux is currently working on the northbound lane between the intersection of Route 147 and Haddam Quarter Road at Station 165+80.

1248: Veilleux continues to saw cut pavement on the northbound lane of Main Street, Durham.
