Daily Report

Project:	Durham Meadows Pipeline Installation	Date:	October 2, 2020
Location:	Main Street, Durham; Shared Access Driveway, Middletown	Day of Week:	Friday
Project #:	AECOM: 6061487	Report No:	171
Contractor:	Ludlow Construction	Page:	1 of 8

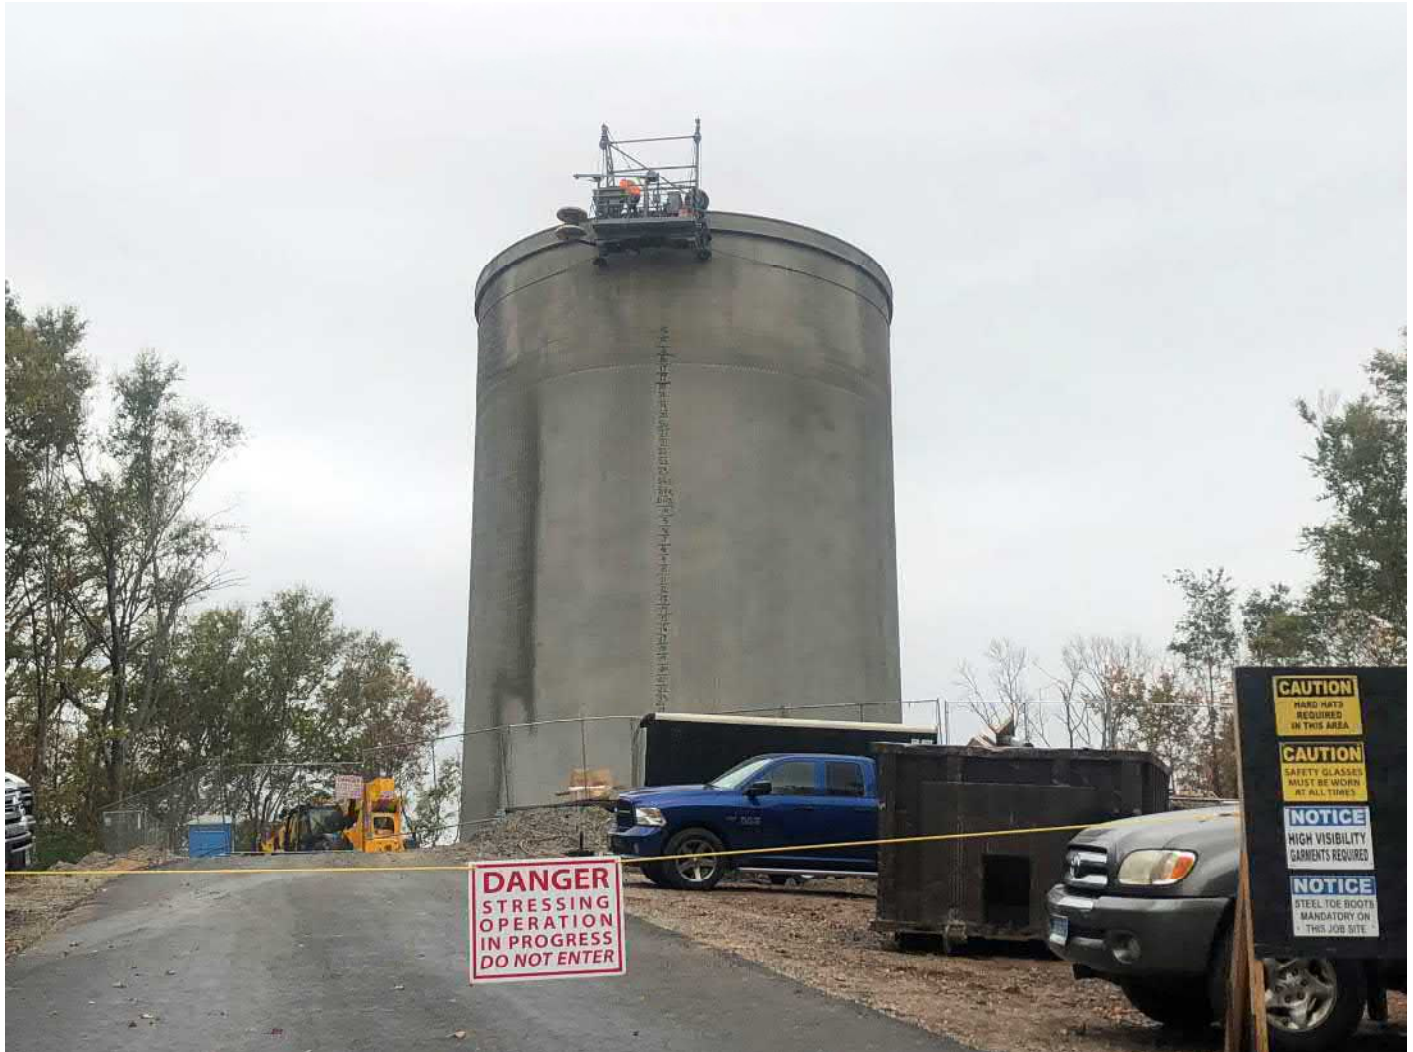
Picture 1: DN Tanks placing a second layer of prestressed wire around the dome rim of the water tank. Water tank work zone, east of the Shared Access Driveway, Middletown. View to the northeast.

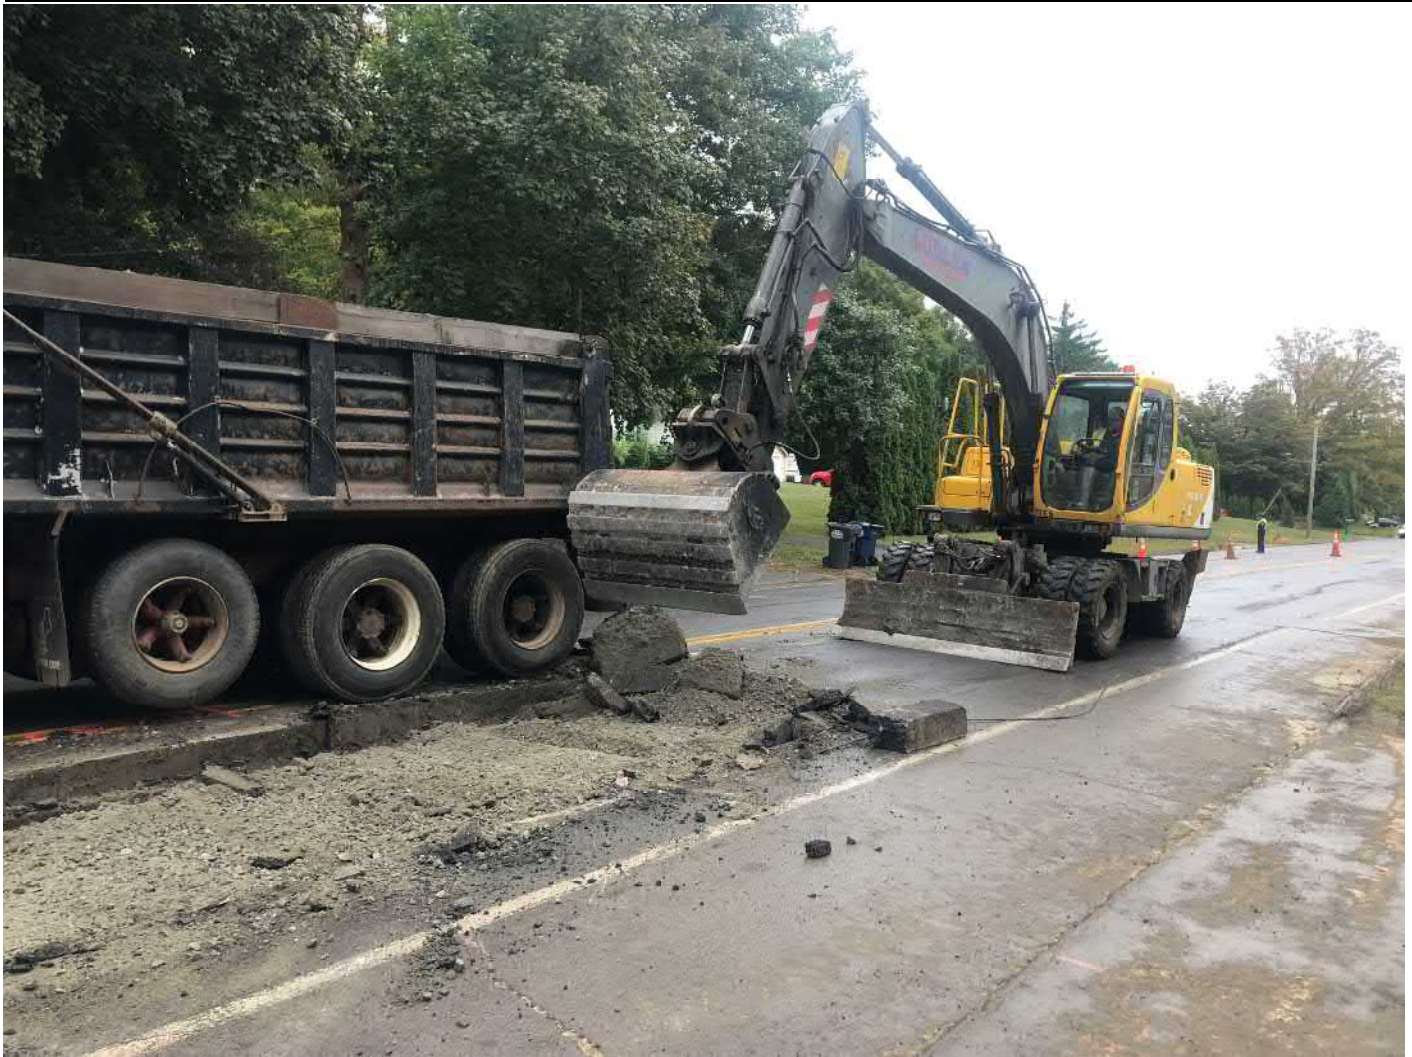
Picture 2: Ludlow stripping back asphalt as they prepare to place permanent paving on the southbound lane of Main Street, Durham from Stations 146+30 to 148+65. View to the southeast.

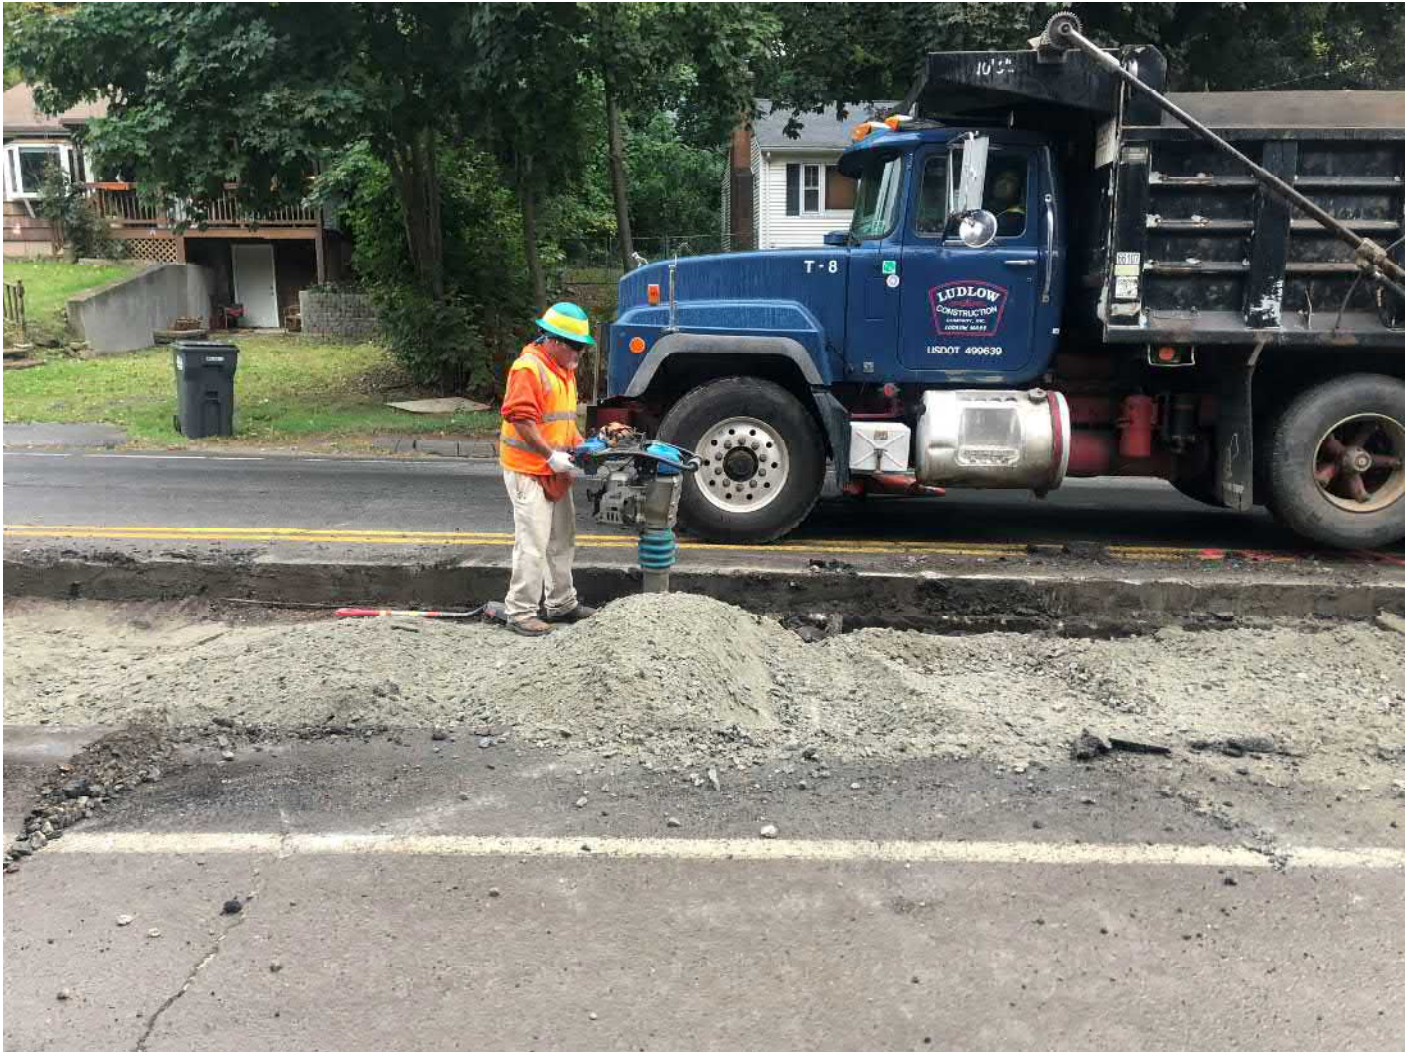
Picture 3: Ludlow compacting 1.5" processed gravel as part of permanent paving on the trench cutbacks on the southbound lane of Main Street, Durham from Stations 146+30 to 148+65. View to the east.

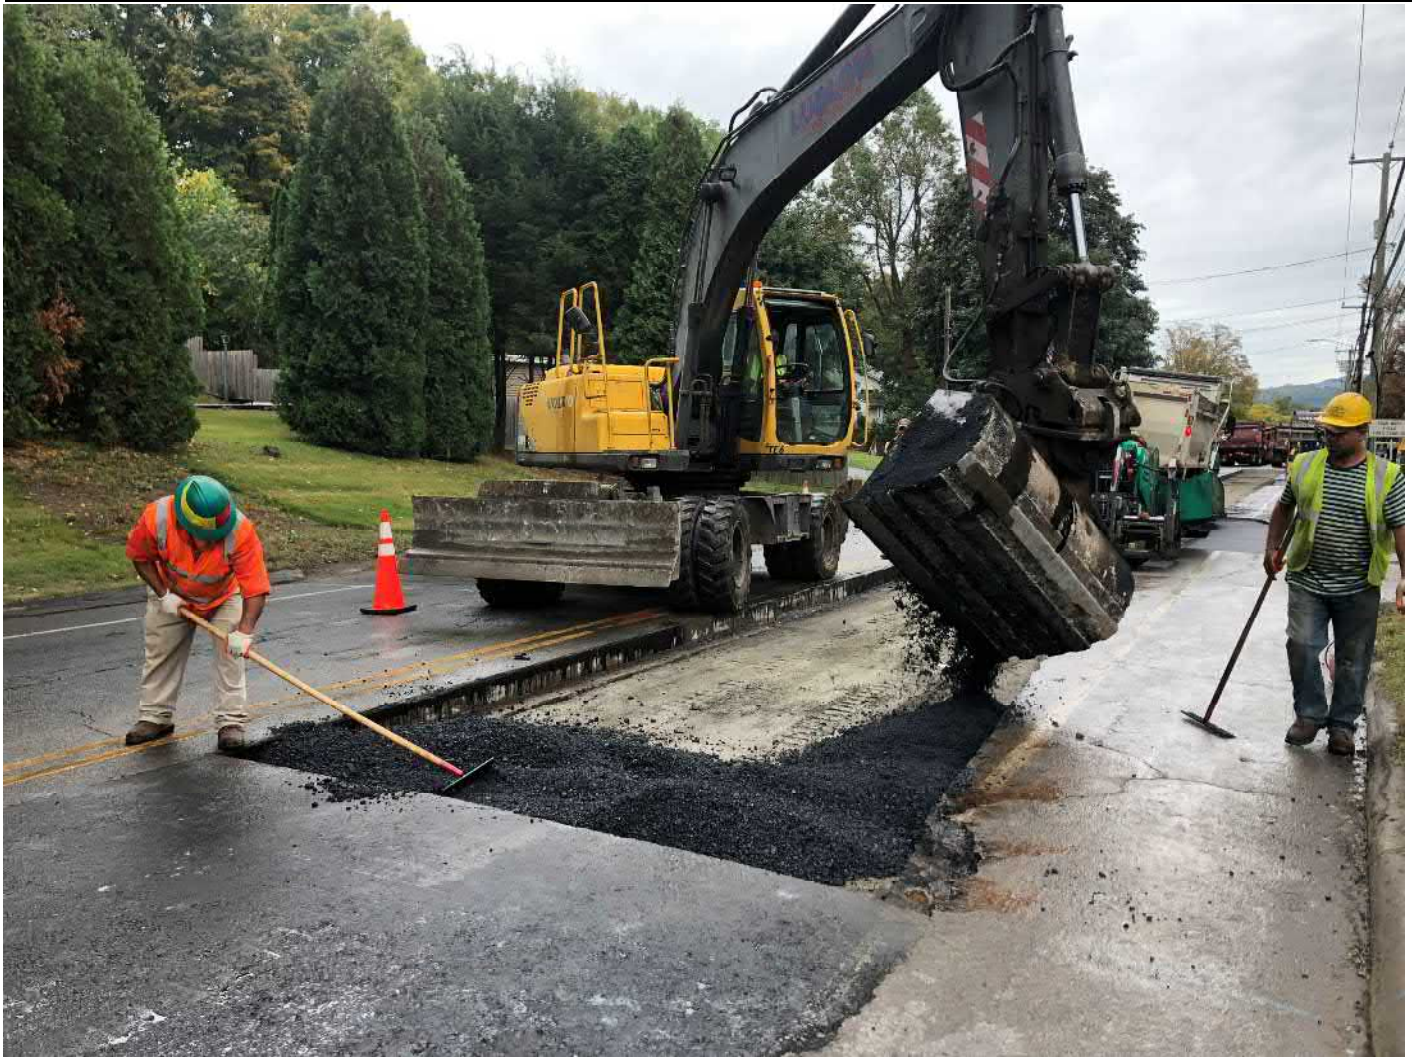
Picture 4: Ludlow placing first of three 3” lifts of asphalt on the southbound lane of Main Street, Durham from Stations 143+00 to 146+30. View to the southeast.

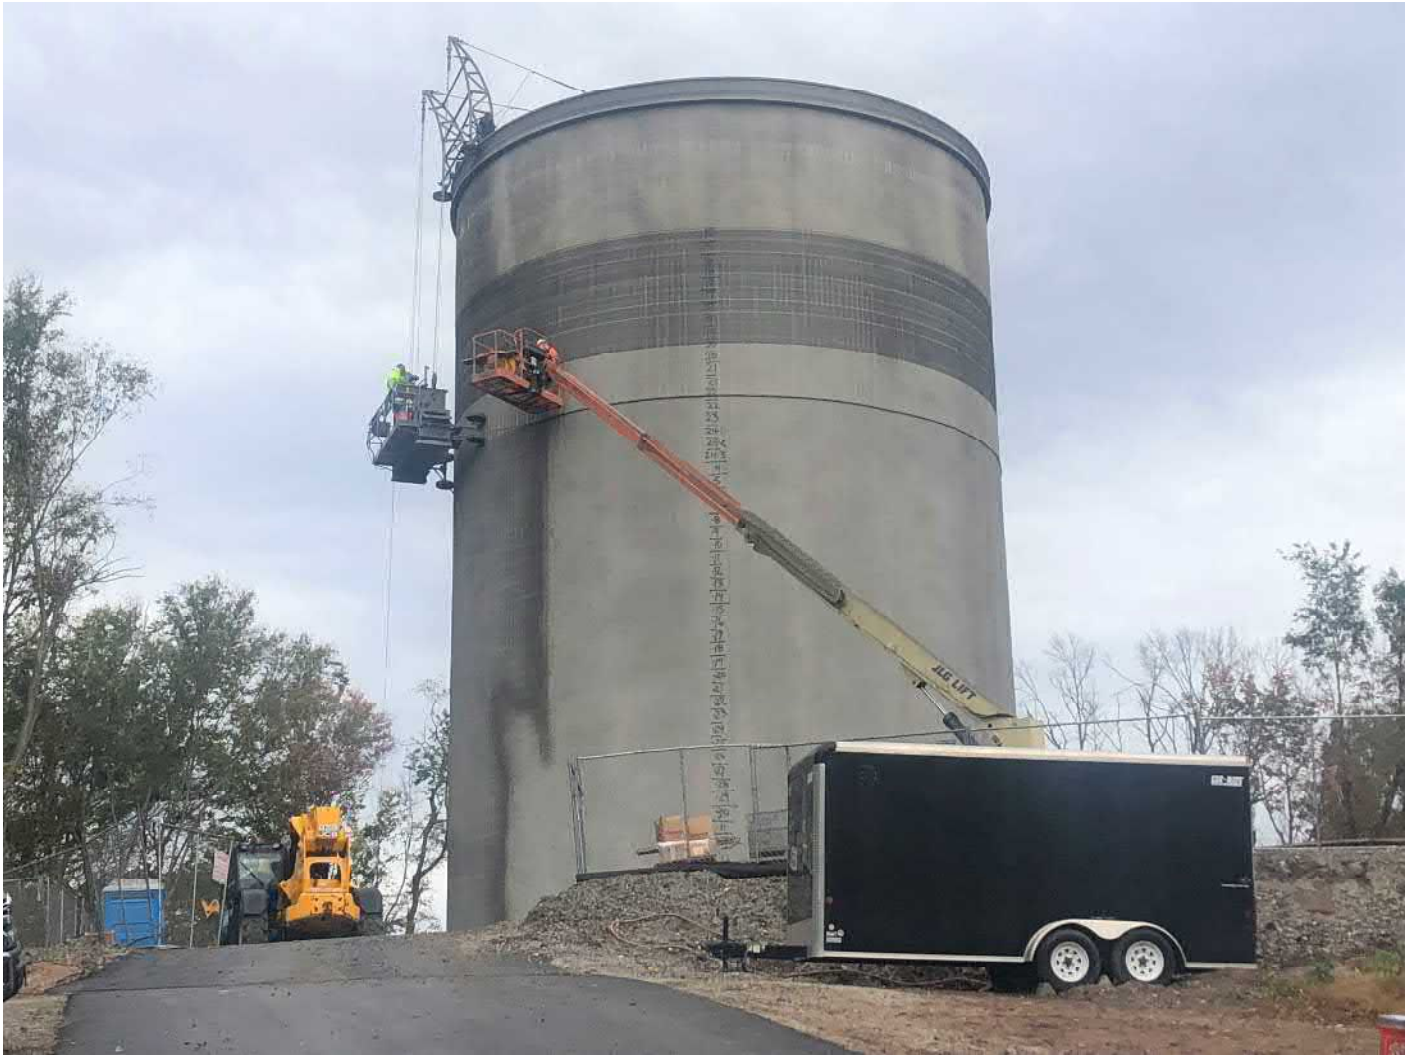
Picture 5: DN Tanks wrapping prestressed wire around the sides of the water tank from 47.5' to 58'. Water tank work zone, east of the Shared Access Driveway, Middletown. View to the northeast.
