Daily Report

Project:	Durham Meadows Pipeline Installation	Date:	October 13, 2020
Location:	Maple Avenue, Durham; Shared Access Driveway, Middletown	Day of Week:	Tuesday
Project #:	AECOM: 6061487	Report No:	178
Contractor:	Ludlow Construction	Page:	1 of 12

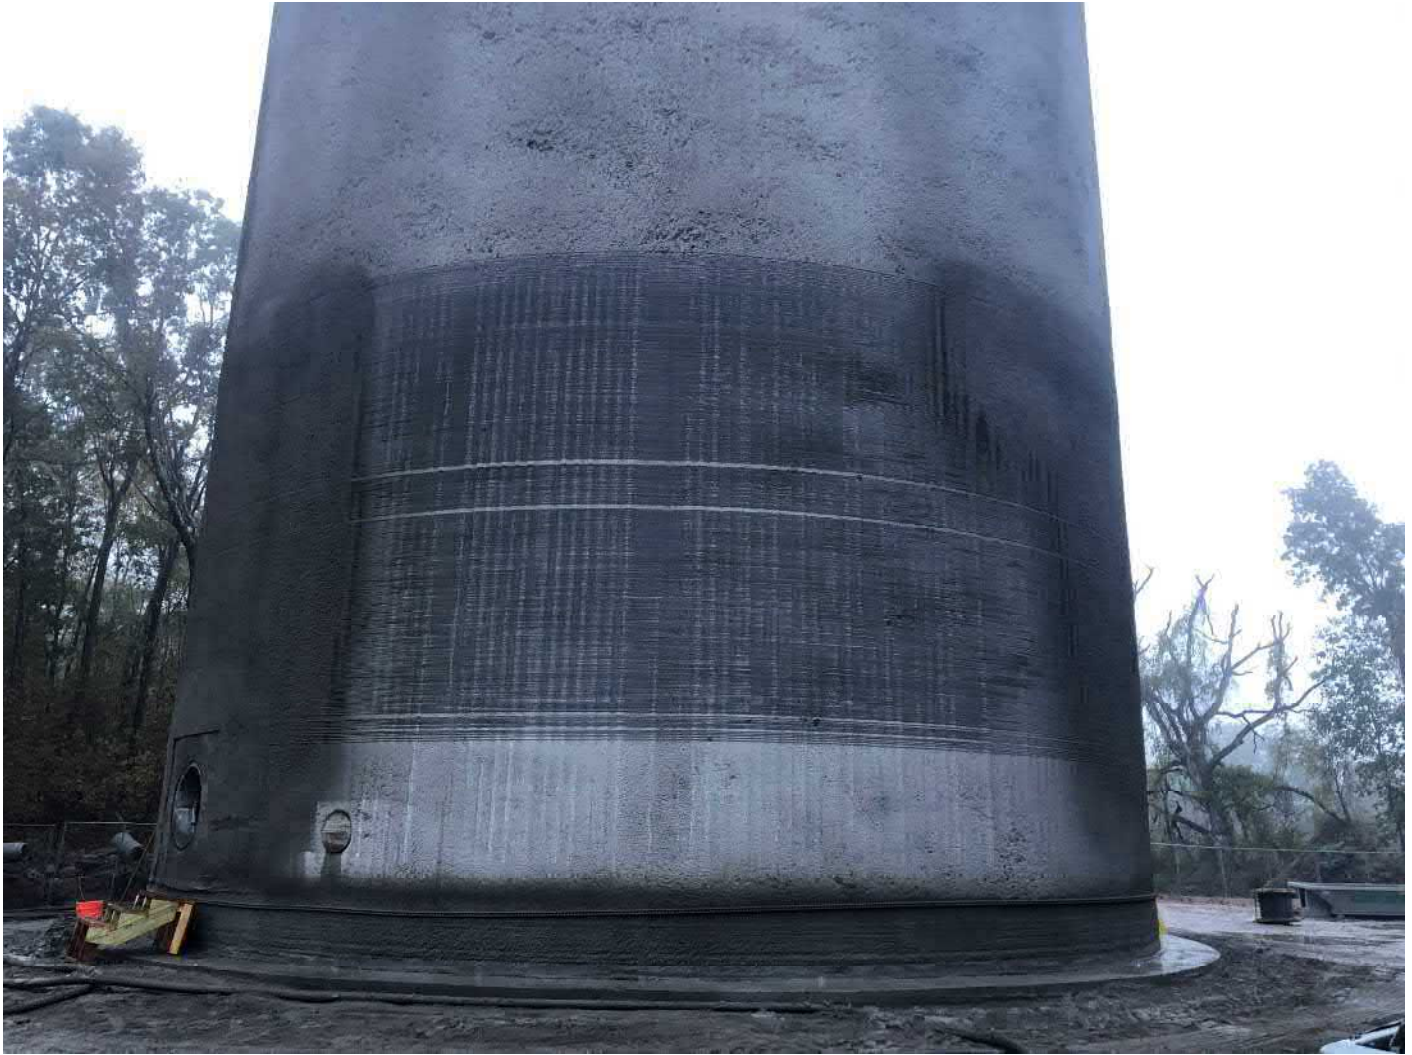
Picture 1: Prestressed wire on the southwest side of the tank was left exposed because DN Tanks ran out of shotcrete yesterday while it was being applied. Water tank work zone located to the east of the Shared Access Driveway, Middletown. View to the east.

0723: DN Tanks applied shotcrete to the exterior of the water tank yesterday. A large patch of exposed prestressed wire on the southwest side of the tank was left exposed because DN Tanks ran out of shotcrete yesterday while it was being applied. Concrete was poured into the C.I.P. cove form yesterday evening as well.

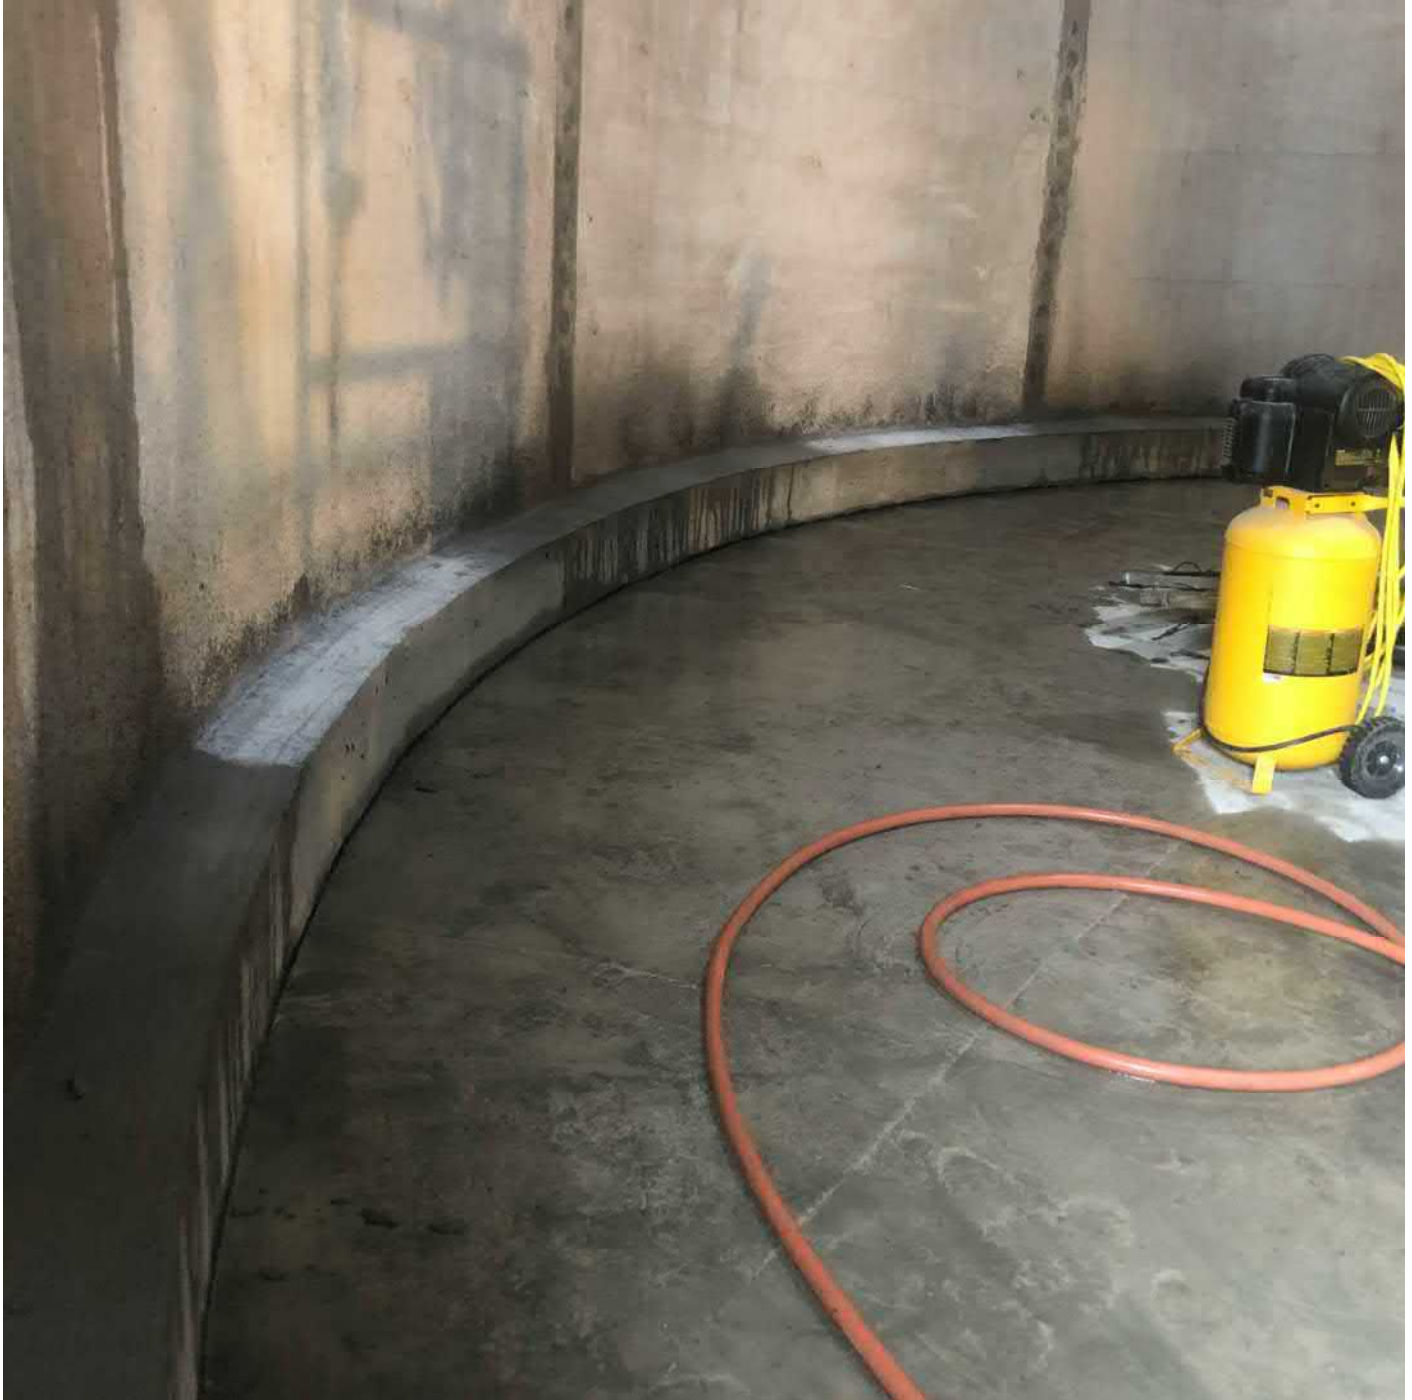
Picture 2: C.I.P cove with the concrete forms removed on the interior of the water tank. Water tank work zone located to the east of the Shared Access Driveway, Middletown.

1055: DN tanks continues to plug holes in the water tank floor and perform general housekeeping inside the tank. They have also removed the concrete form from the C.I.P. cove.

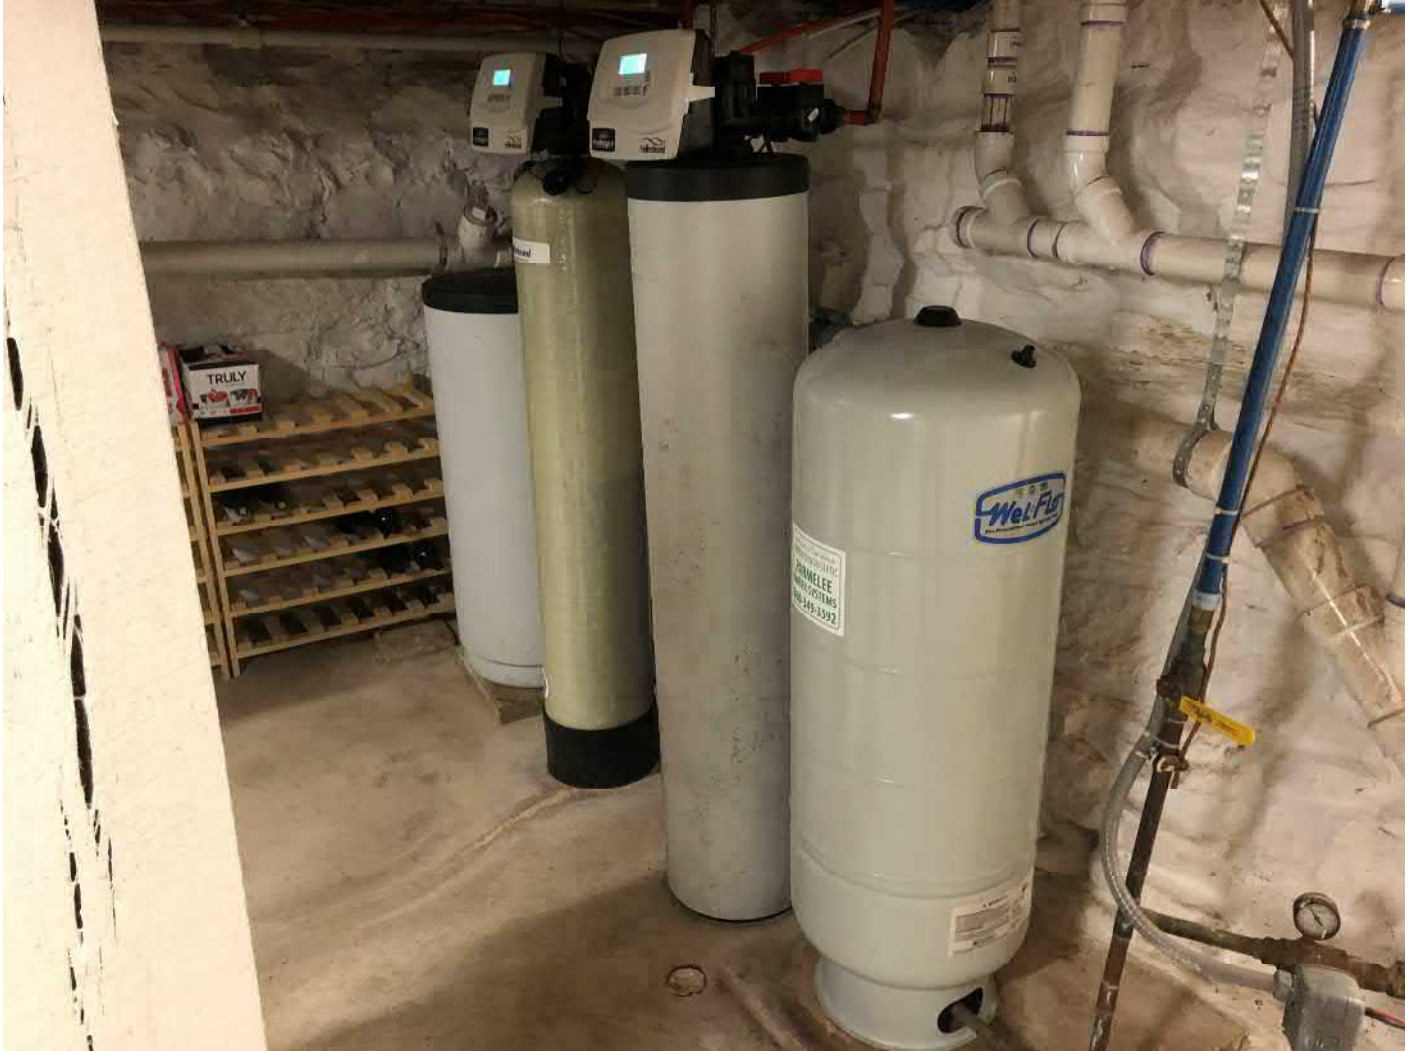
Picture 3: Water treatment system owned by the residents of 13 Maple Avenue, Durham. The water service brought into the house today by the Ludlow plumbing contractor was connected to this system at the request of the residents.

0825: The AECOM and USACE representatives and Fazzino meet with one of the homeowners at 13 Maple Avenue, Durham. At the request of the homeowner, the incoming water service will be directed into the existing water treatment system that was recently purchased by the homeowners. The irrigation feed will not be routed through the filtration system that Fazzino will be installing.

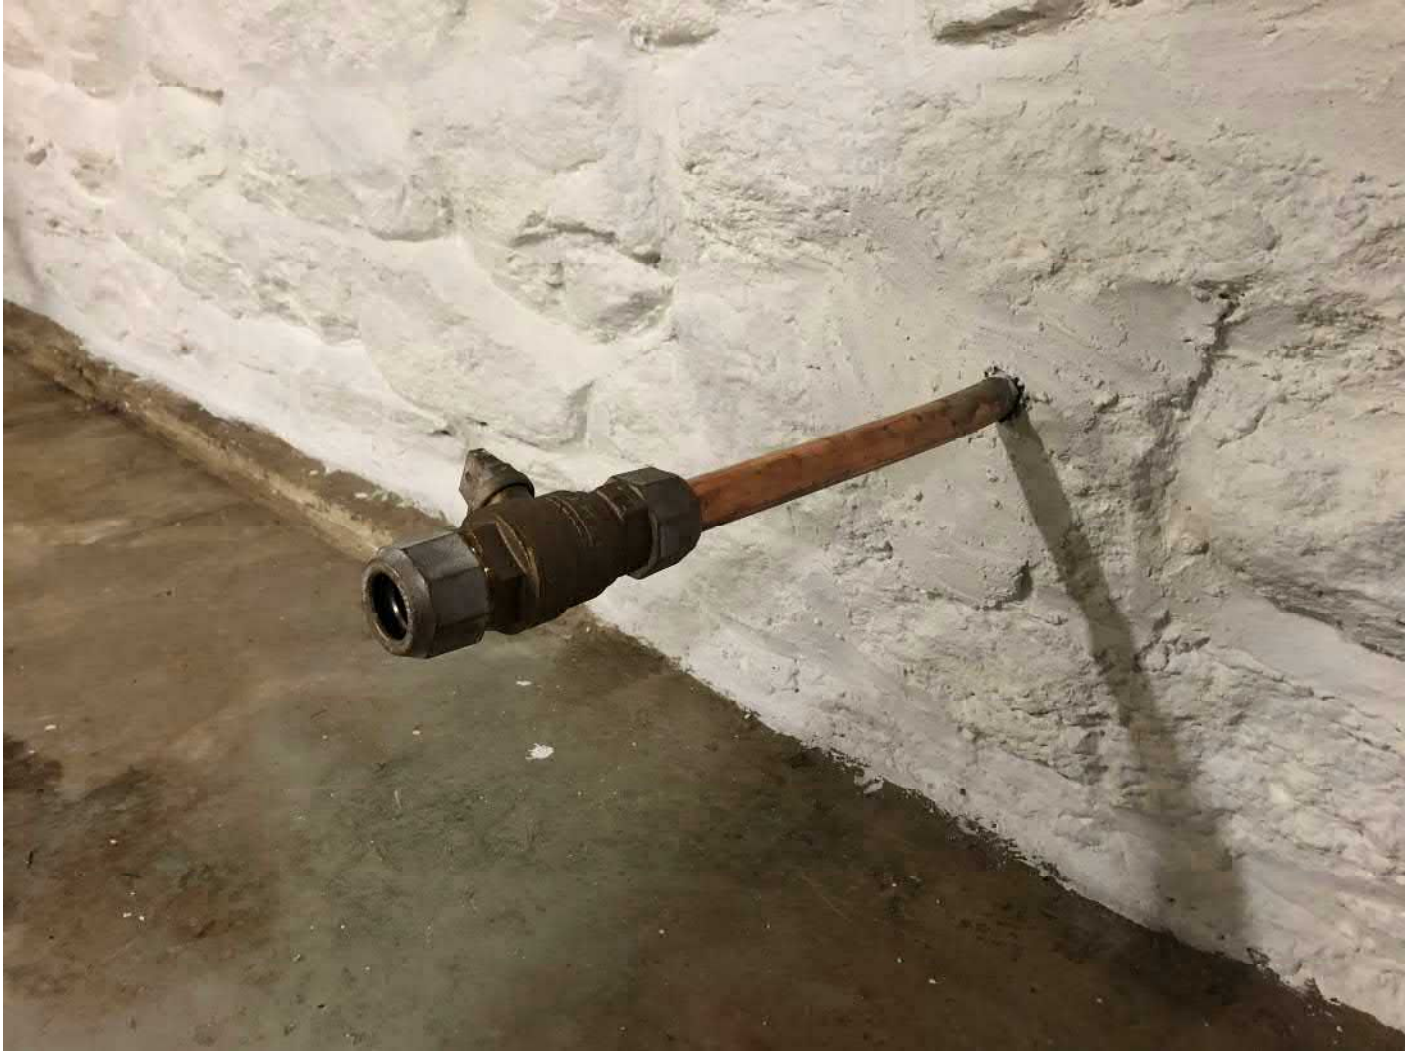
Picture 4: Water service line previously brought into the basement of the residence located at 13 Maple Avenue, Durham. View to the southeast.

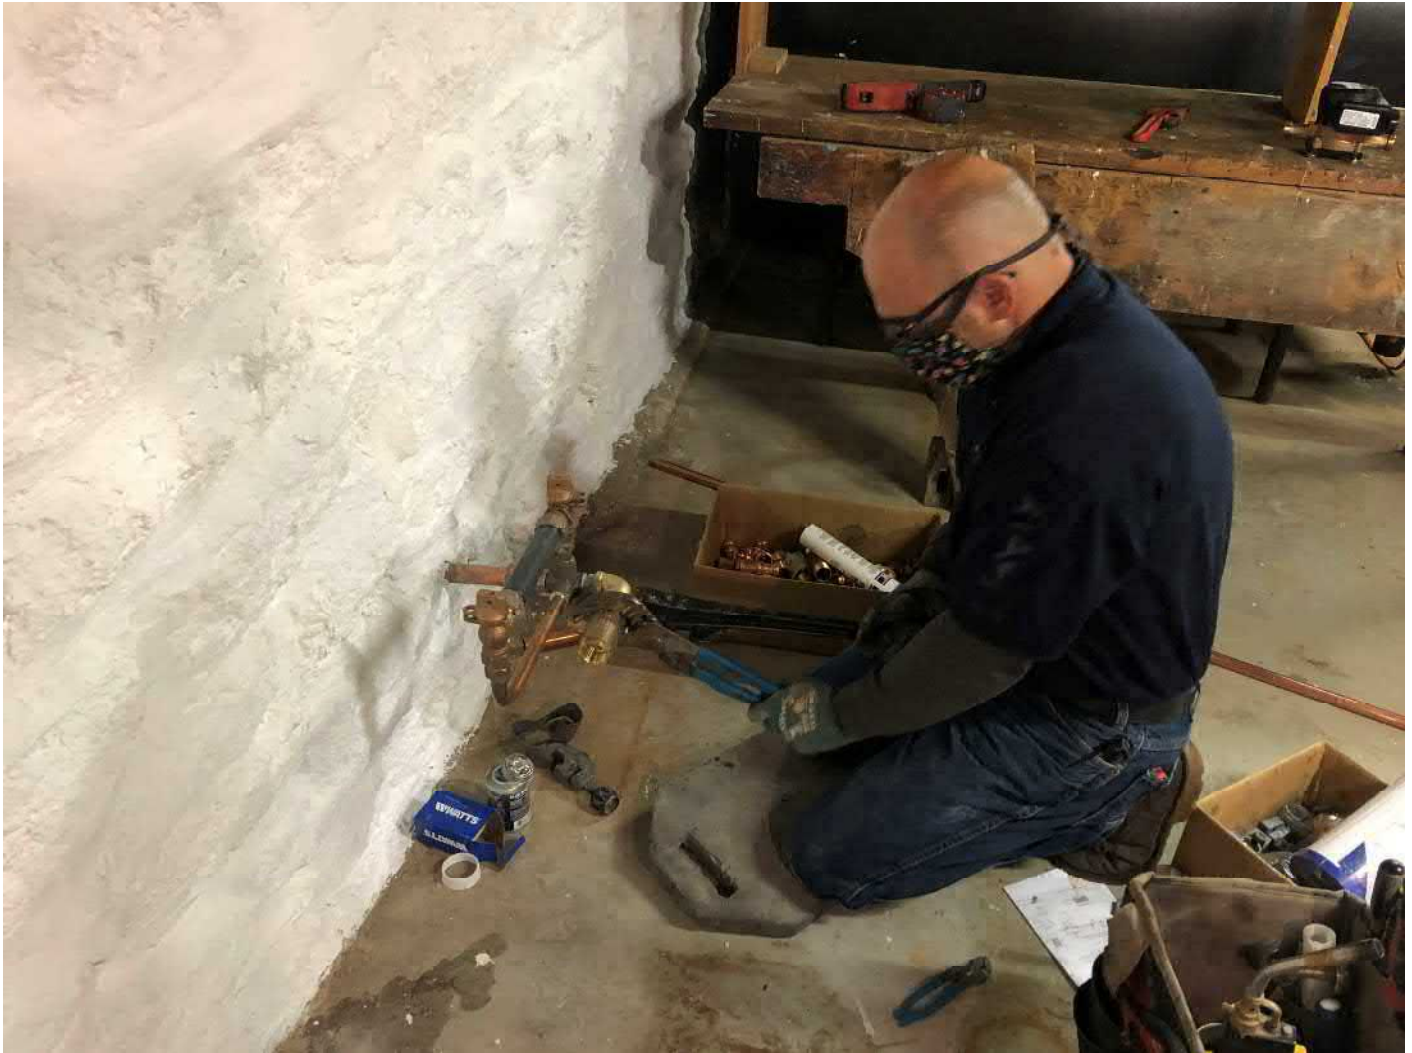
Picture 5: Fazzino working on connecting the residence at 13 Maple Avenue to the public water supply. View to the southwest.

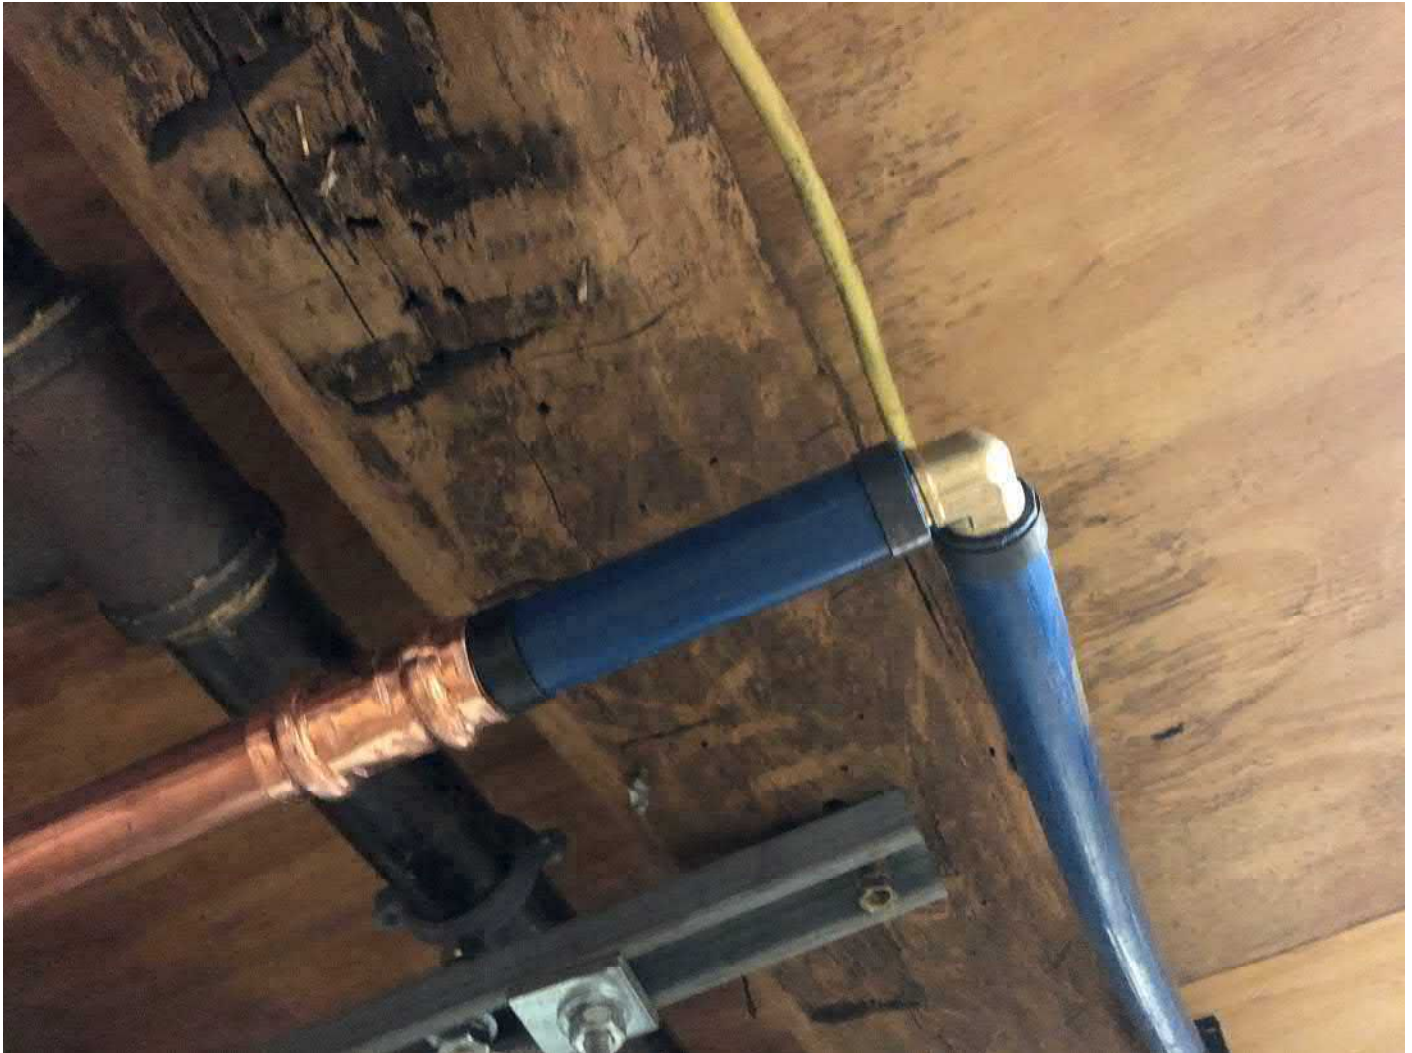
Picture 6: Copper pipe and PEX tubing used in connecting the residence at 13 Maple Avenue, Durham to the public water supply.

1146: Fazzino continues with the installation of water service in the basement of 13 Maple Avenue, Durham, using a combination of copper pipe and PEX tubing.

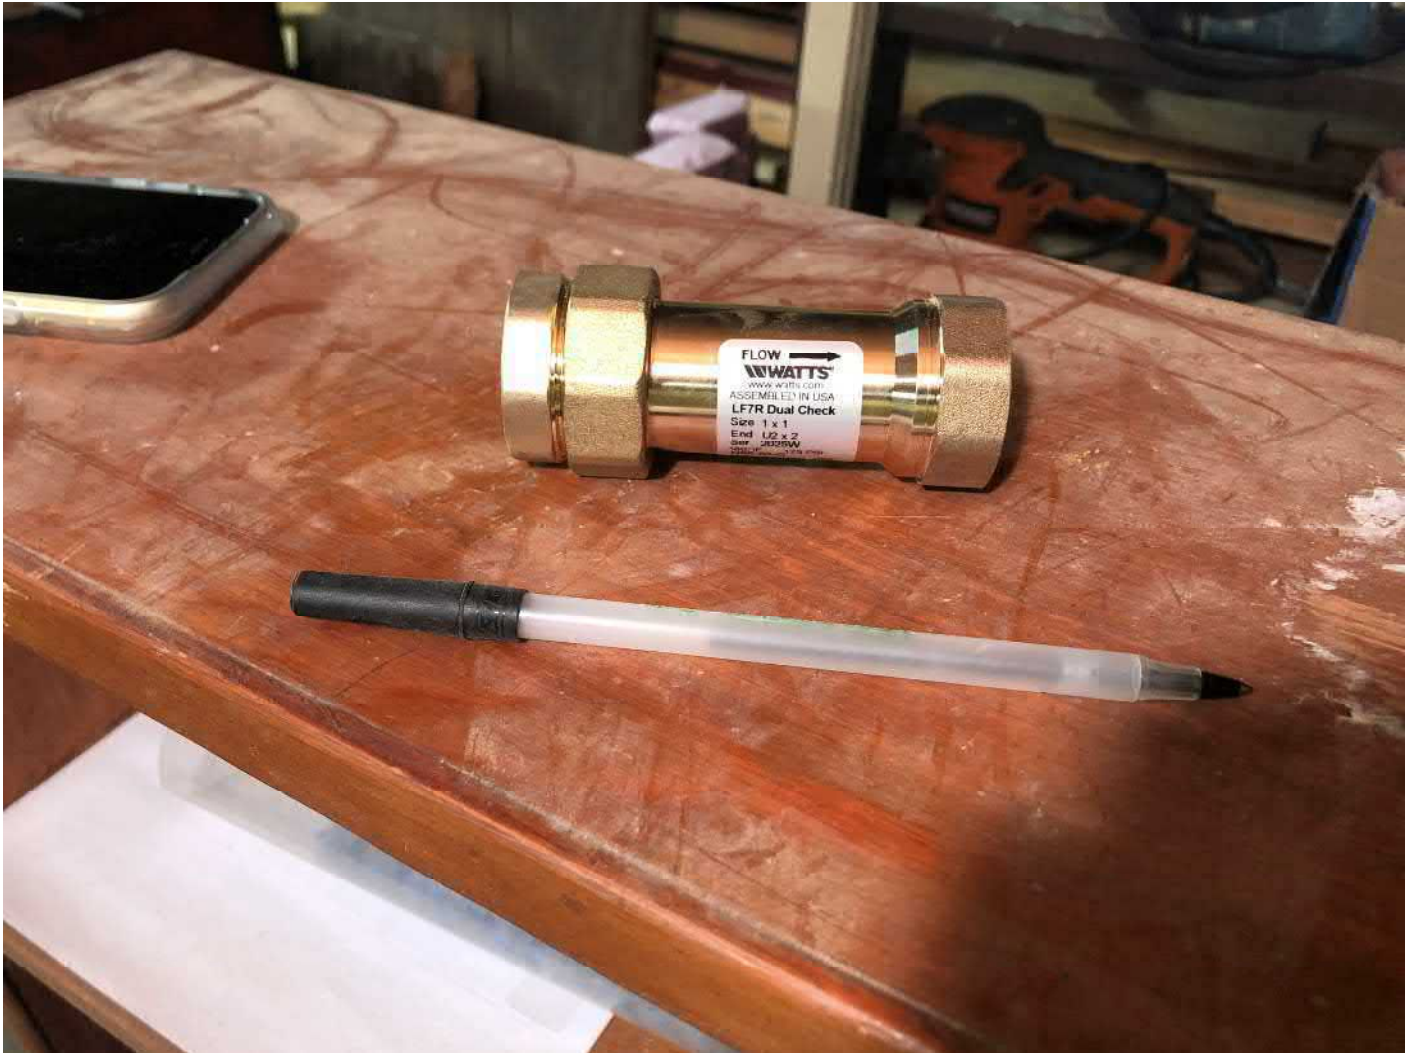
Picture 7: Watts Series LF7R backflow preventer that was used by Fazzino as they connected the residence at 13 Maple Avenue, Durham, to the public water supply.

0805: The USACE and Ludlow hold a prework meeting with Fazzino. Fazzino will install a Watts Series LF7R backflow preventer, which is different than what is called for in the specifications. The AECOM and USACE representatives confirmed with Rich Berlandy of AECOM that this change of backflow preventors is acceptable.

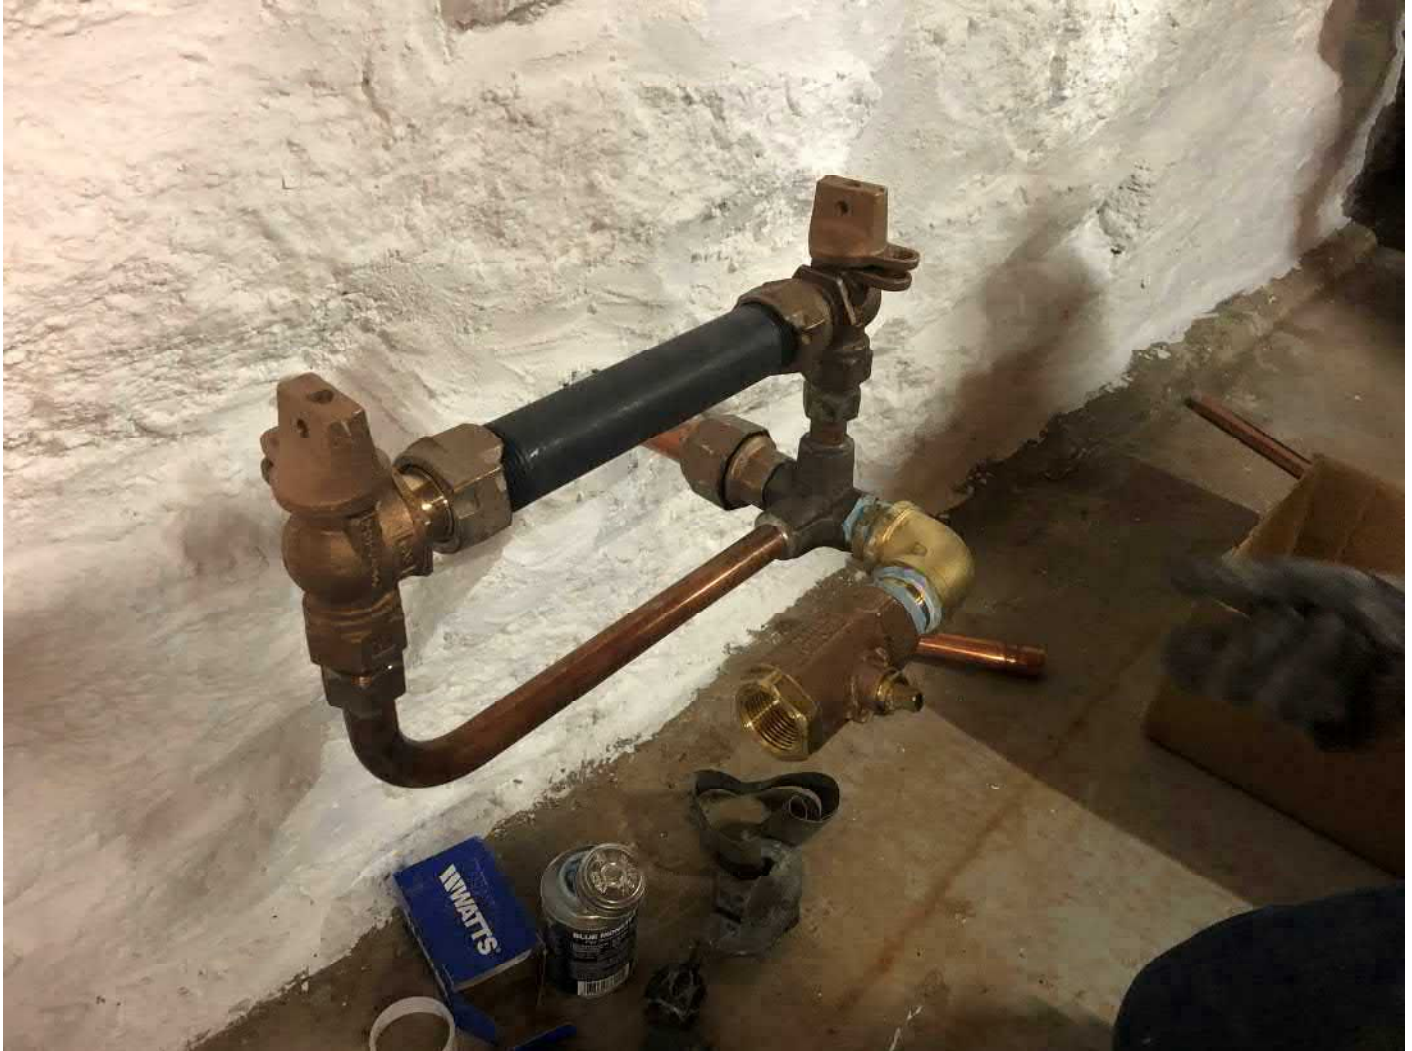
Picture 8: Plumbing associated with the connection of 13 Maple Avenue, Durham, to the public water supply. View to the southwest.

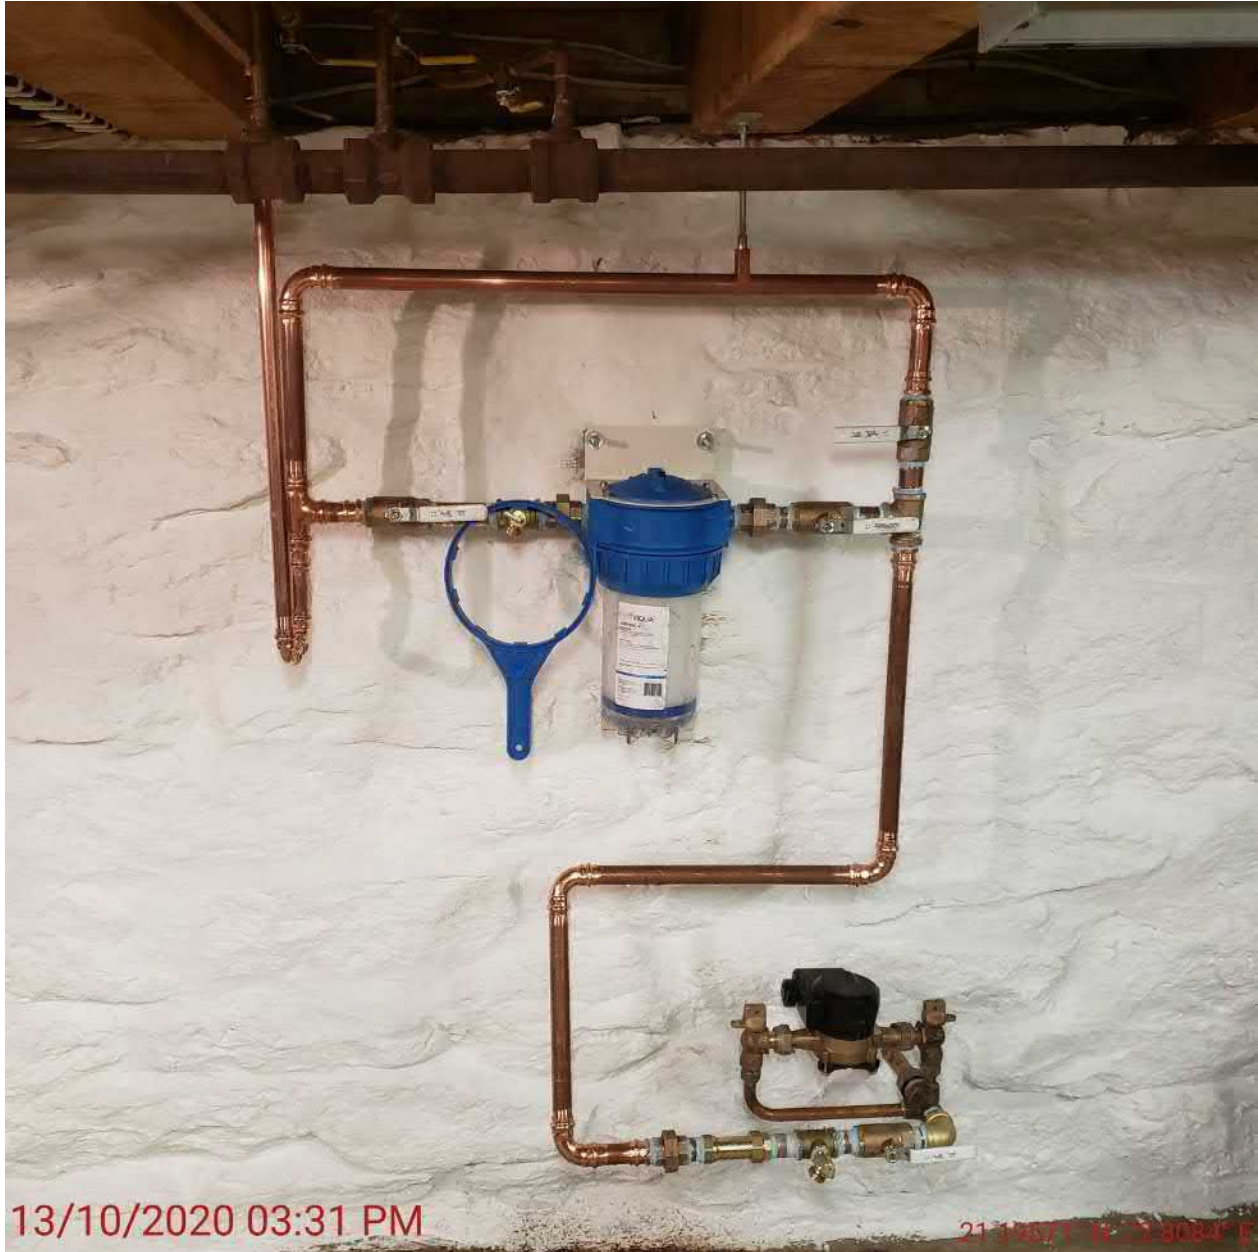
Picture 9: Water meter, backflow preventer and filter installed at 13 Maple Avenue, Durham.

Ludlow installed a water meter, water filter, and backflow device as part of connecting the residence at 13 Maple Avenue, Durham to the public water supply.
