Daily Report

Project:	Durham Meadows Pipeline Installation	Date:	November 12, 2020
Location:	Main Street and Route 68, Durham; Shared Access Driveway, Middletown	Day of Week:	Thursday
Project #:	AECOM: 6061487	Report No:	199
Contractor:	Ludlow Construction	Page:	1 of 11

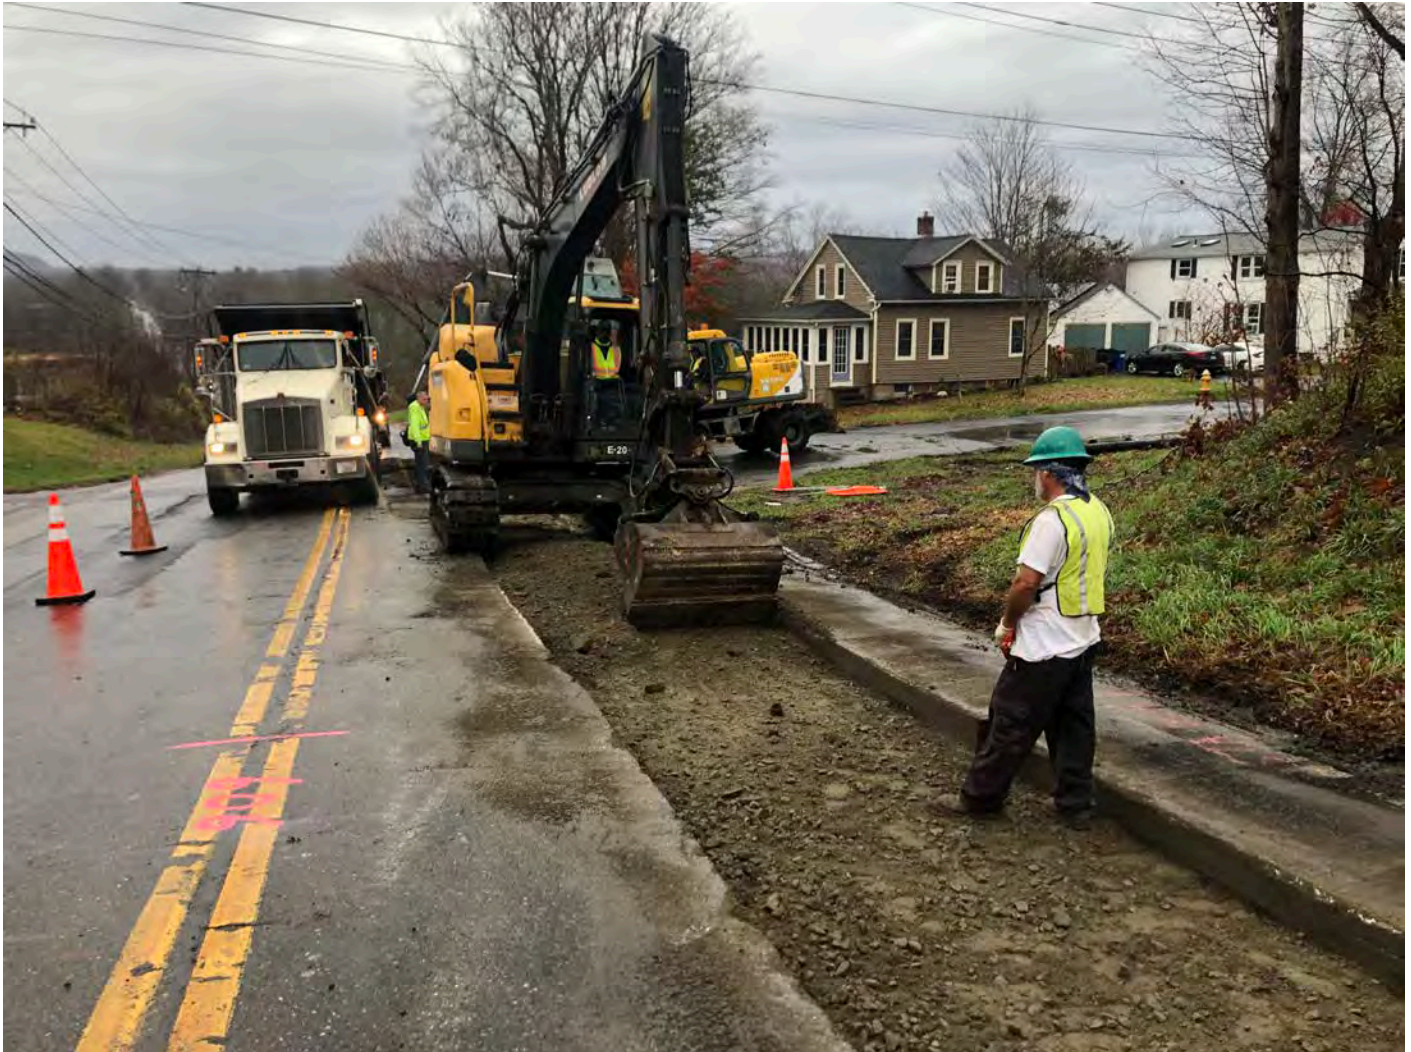
Picture 1: Ludlow grading 1.5" gravel between Stations 604+75 to 607+50 on the westbound lane of Route 68, Durham as part of permanent paving activities. View to the west.

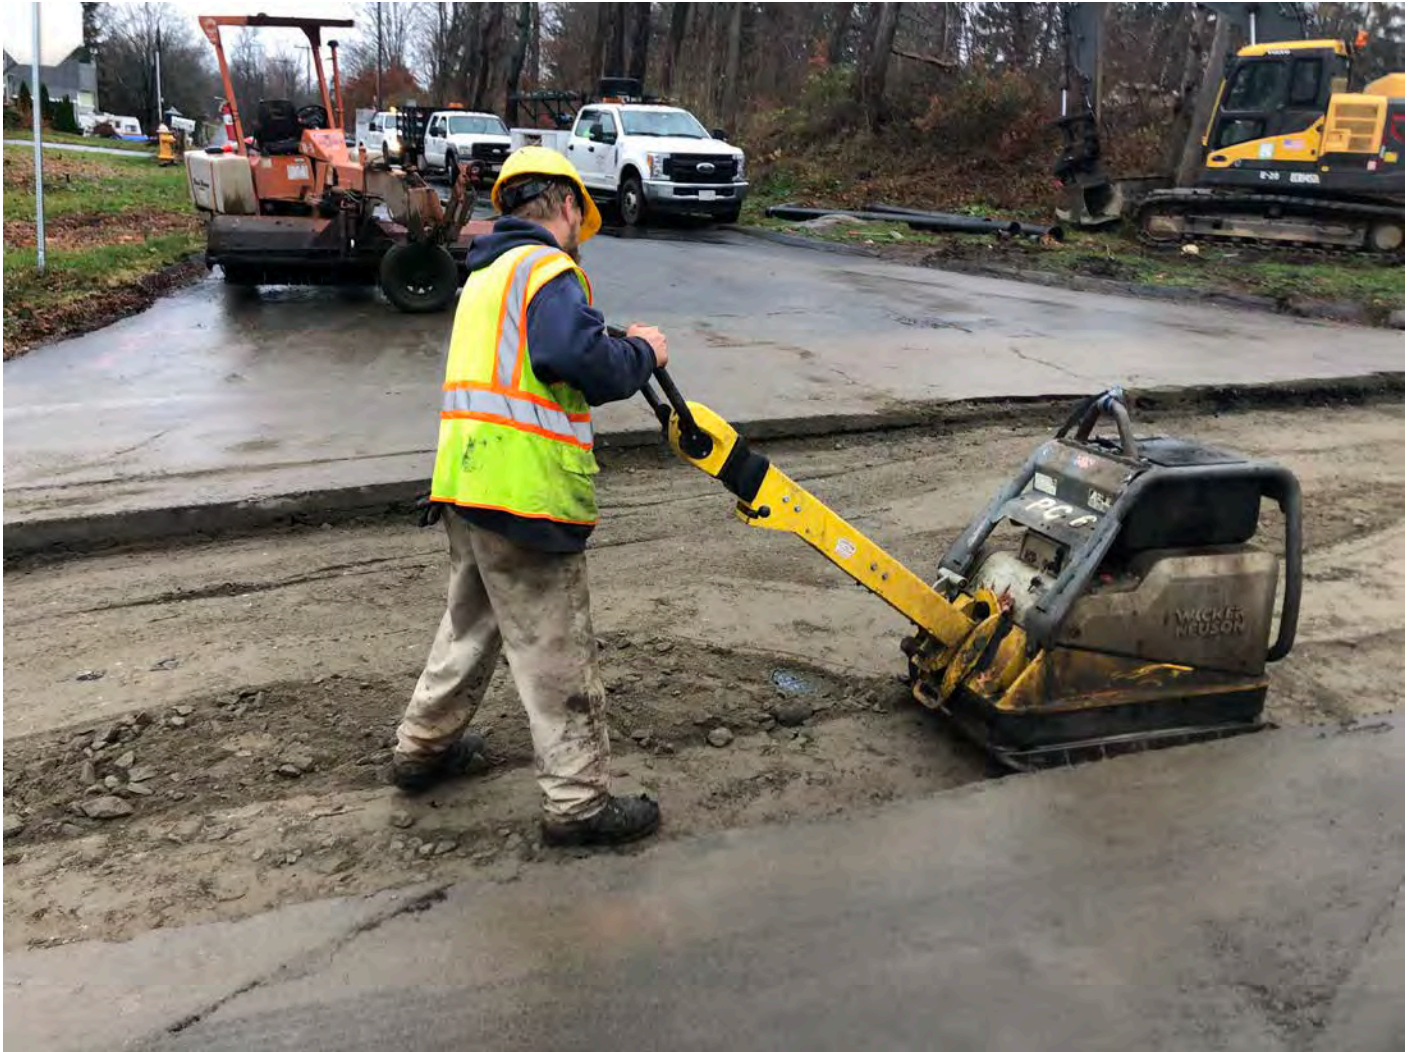
Picture 2: Ludlow compacting 1.5" gravel between Stations 604+75 to 607+50 on the westbound lane of Route 68, Durham as part of permanent paving activities. View to the north.

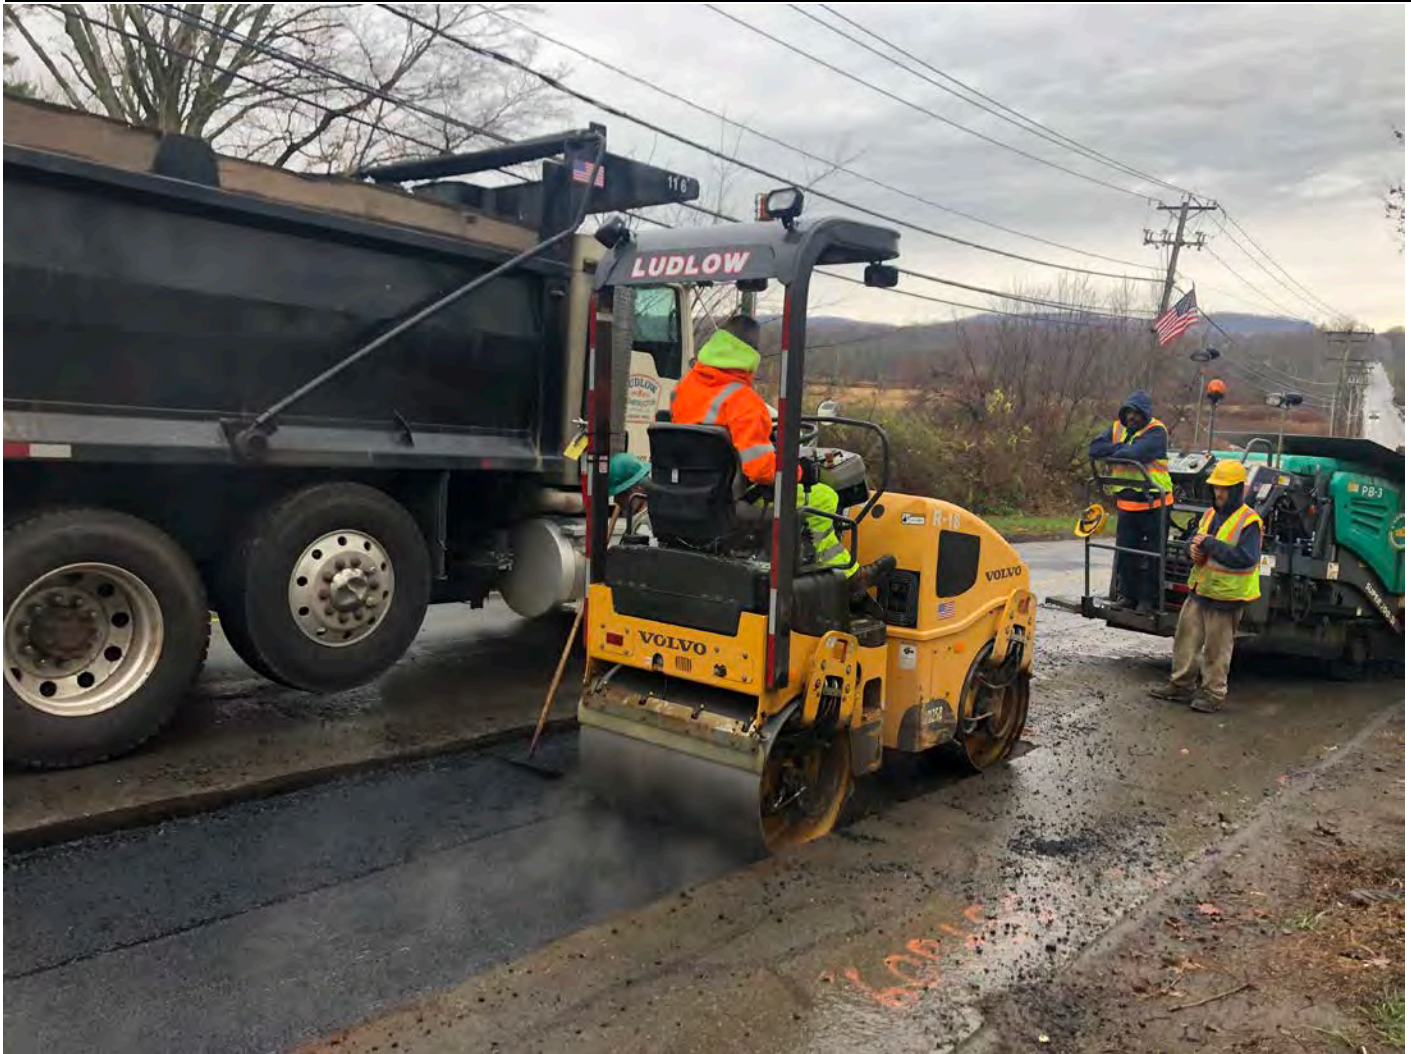
Picture 3: Ludlow compacting asphalt between Stations 604+75 to 607+50 on the westbound lane of Route 68, Durham as part of permanent paving activities. View to the southwest.

1102: Ludlow has almost finished placing the first of three 3" lifts of asphalt between Stations 604+75 and 607+50 on the westbound lane of Route 68, Durham. JTC is present to collection compaction data from those areas of the asphalt that have cooled sufficiently.

1223: JTC is collecting compaction data from the second lift of asphalt that Ludlow placed and compacted on Route 68 between Stations 604+75 and 607+50.

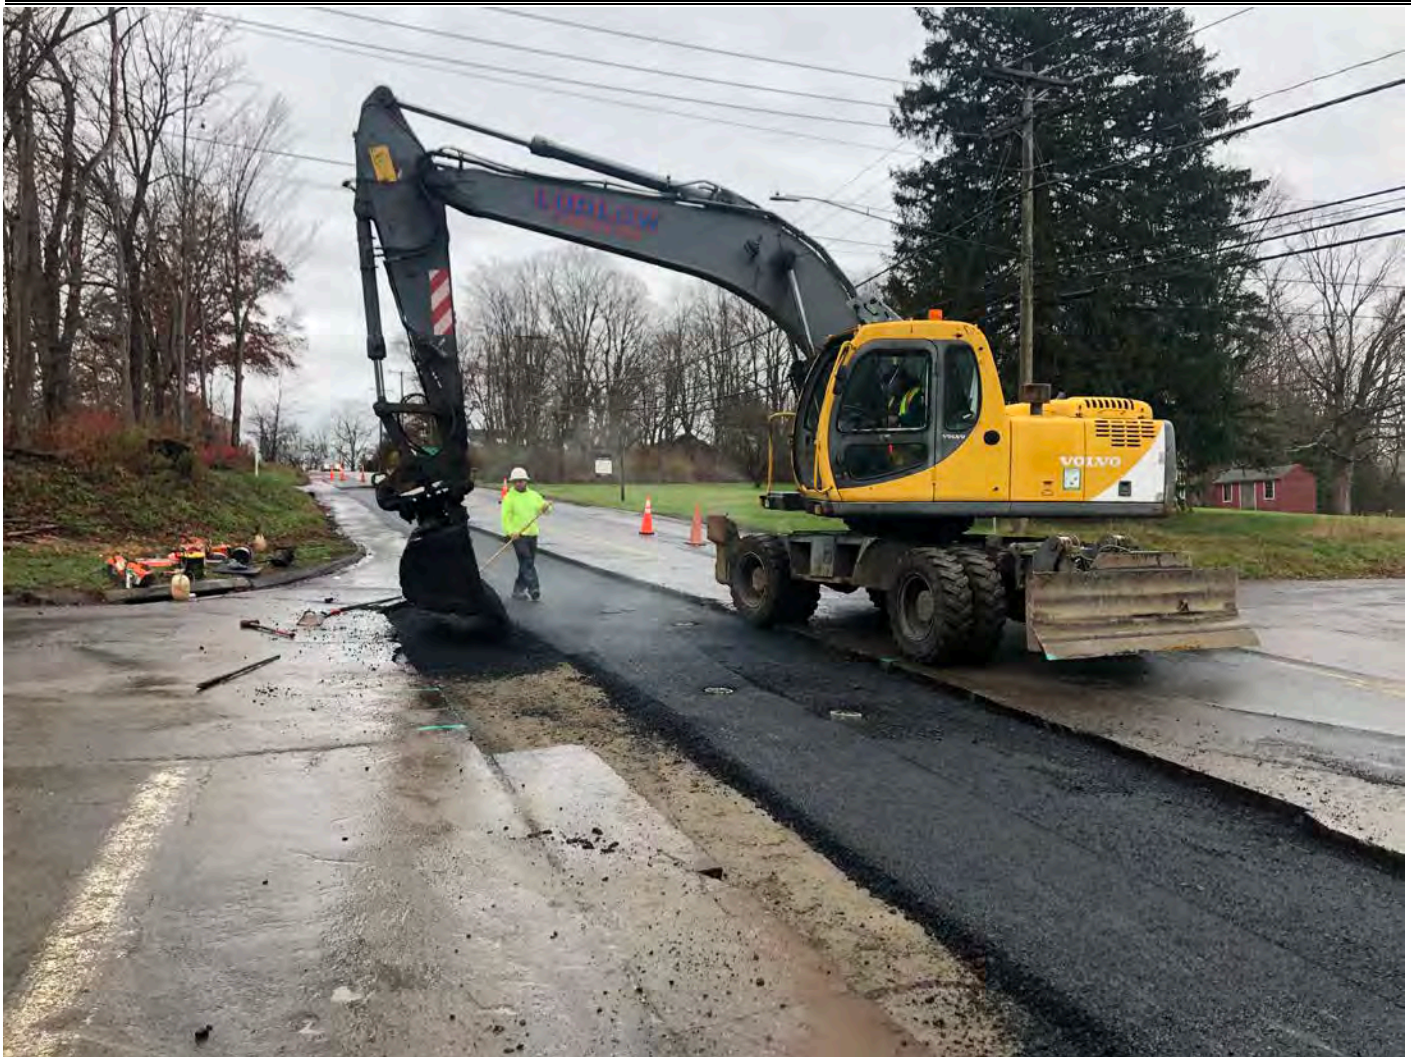
Picture 4: Ludlow placing asphalt in sliver slab cutout on the westbound lane of Route 68, Durham as part of permanent paving activities. View to the east.

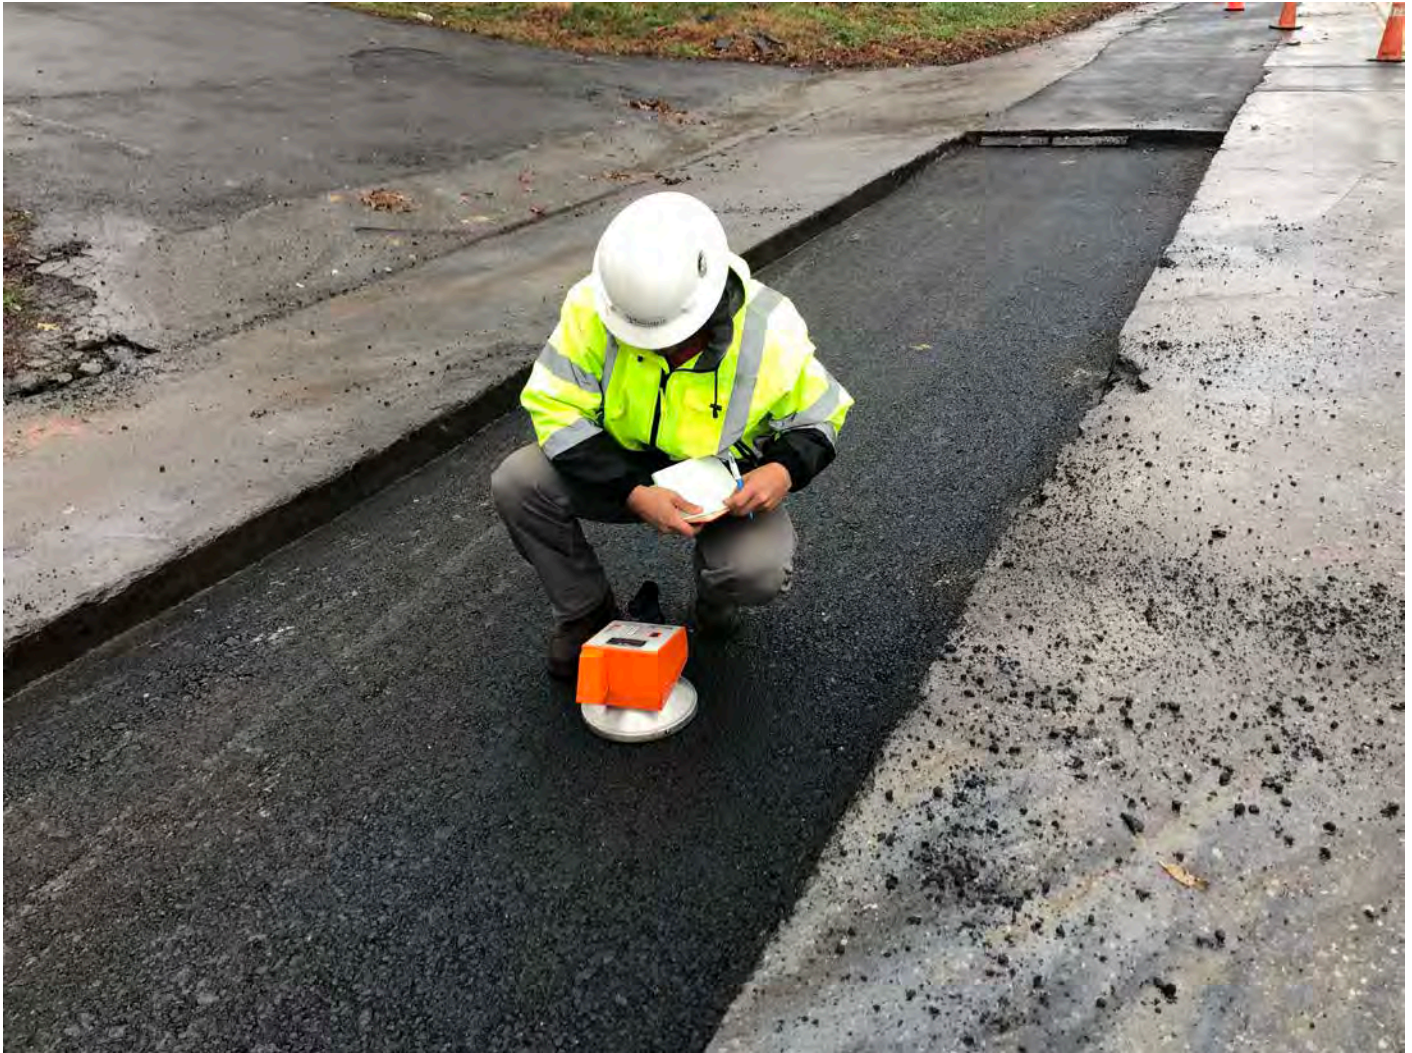
Picture 5: JTC collecting compaction data from asphalt placed and compacted between Stations 604+75 to 607+50 on the westbound lane of Route 68, Durham as part of permanent paving activities. View to the southwest.

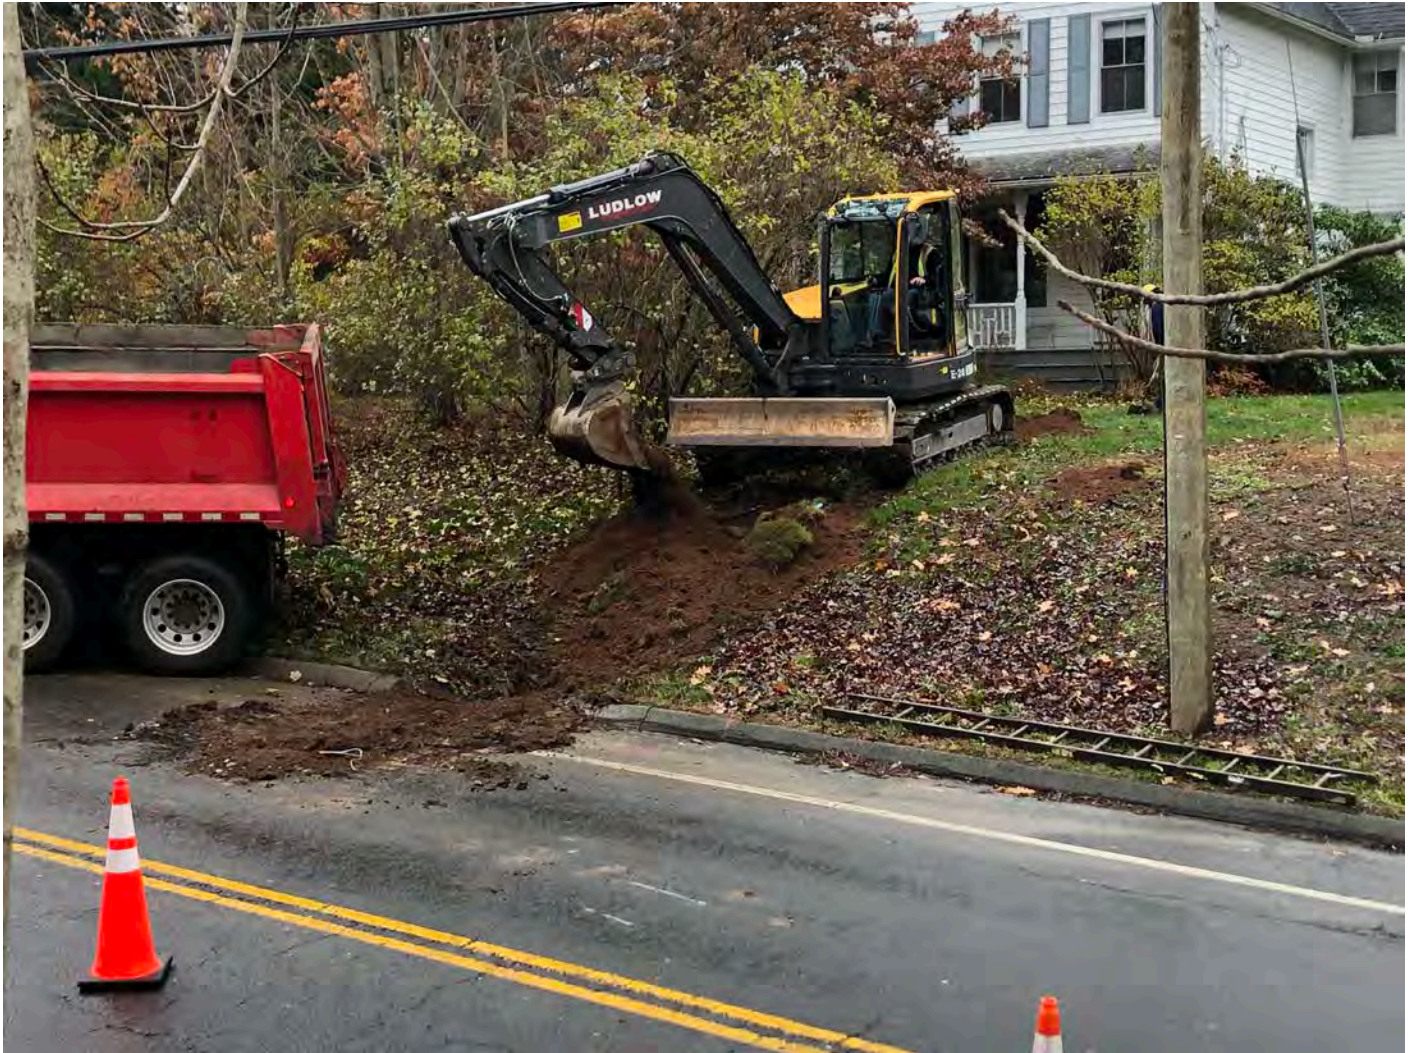
Picture 6: Ludlow excavating for the installation of a curb stop and corporation stop at 120 Main Street, Durham. View to the southwest.

1121: Ludlow is excavating pavement on the southbound lane of Main Street for the installation of a curb stop that will service 120 Main Street, Durham.

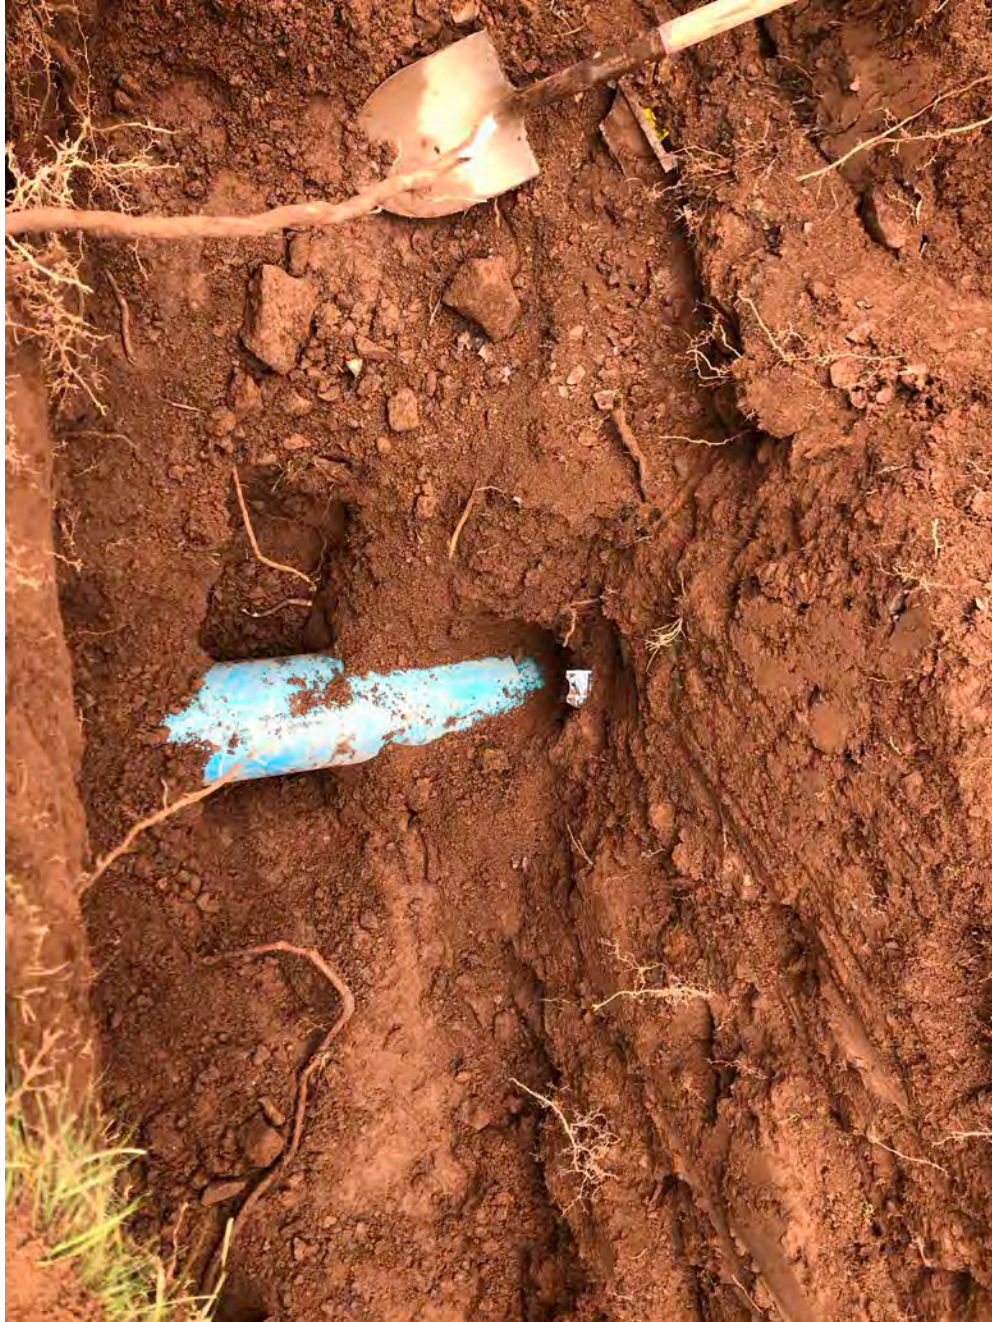
1145: Ludlow has daylighted an 8" blue plastic line during the installation of a curb stop at 120 Main Street that may be a Town waterline. The pipe is located 29.5' from the western edge of pavement. (Later confirmed to be the town's 8" PVC water main.)

Picture 7: Ludlow daylighted an 8" blue PVC line (believed to be a Town water main) located 29.5' west of the edge of Main Street while excavating for the installation of a curb stop at 120 Main Street, Durham. View to the east.

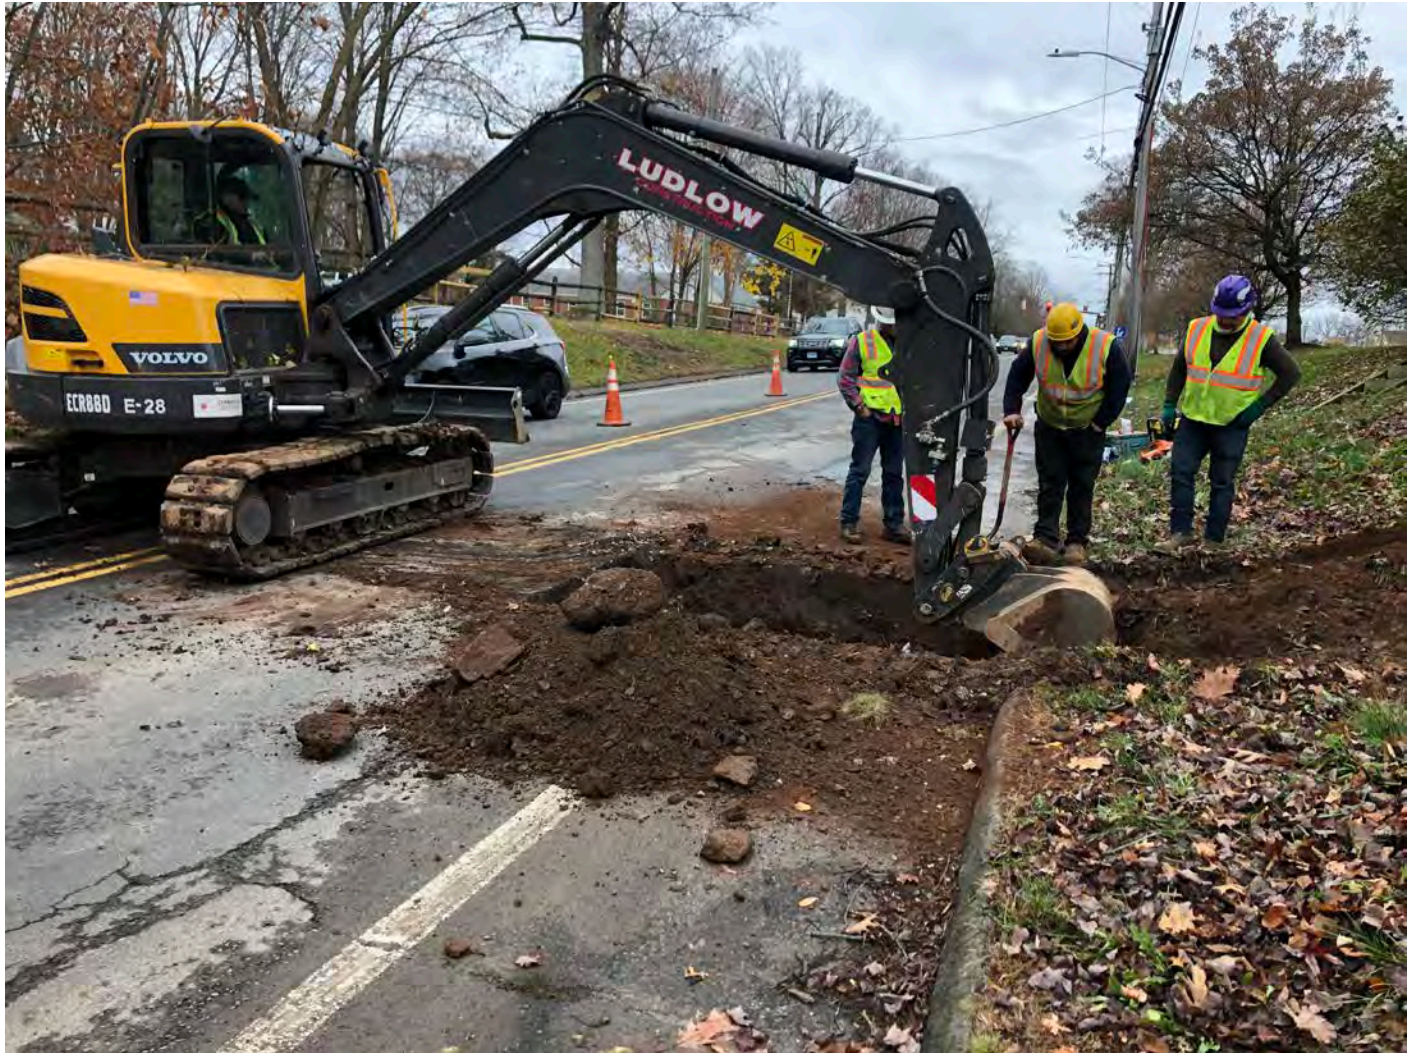
1245: Ludlow is excavating a test pit in front of 120 Main Street to further investigate the location of the Town water line that services Main Street, Durham. Ludlow did not install the curb stop for 120 Main Street as they didn't have all the materials to complete the installation.

Picture 8: Ludlow excavating a test pit in front of 120 Main Street to further investigate the location of the Town water line that services Main Street, Durham. View to the south.
