Daily I	Report		
Project:	Durham Meado	ows Pipeline Installation		Date:	April 7, 2021
Location:	Main Street and	d Manla Avanua, Durham		Day of Week:	Wednesday
Location:	Main Street and	d Maple Avenue, Durham			
Project #:	AECOM: 60614	87		Report No:	216
Contractor:	Ludlow Constru	uction		Page:	1 of 8

Pipe Connections, Installations, and Other Work

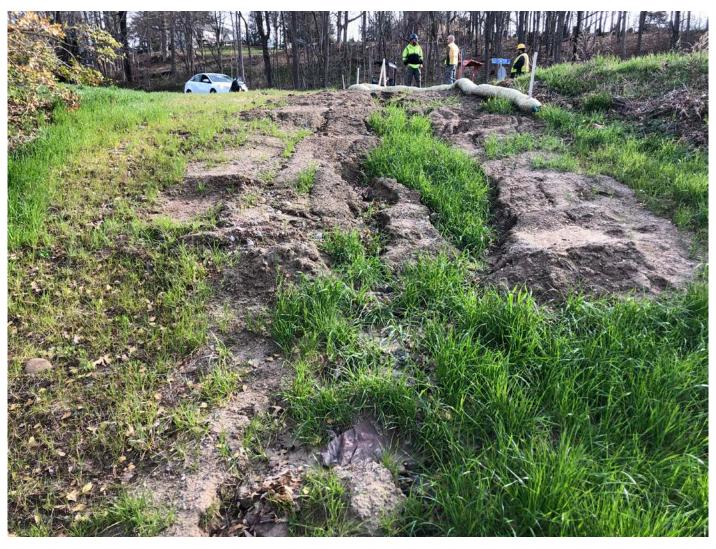
0844: Several 4"-8" rills were observed on the slope north of, and adjacent to, the bridge that crosses Allyn Brook on the west side of Maple Avenue. The erosion appears to have happened last fall, prior to when Ludlow placed straw wattles at the top of slope.

Picture 3: Several deep rills were observed on the slope north of, and adjacent to, the bridge that crosses Allyn Brook on the west side of Maple Avenue. View to the northeast.

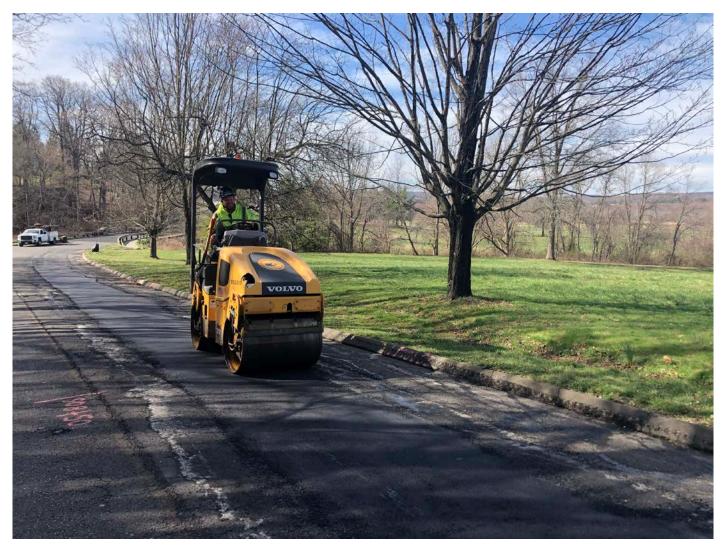
Ludlow shim coated the west side of Maple Avenue between Old Cemetery Road and Route 68 to address some minor settling of the trench where the water line was installed last year.

Picture 4: Ludlow rolling freshly-placed asphalt as they shim coat sections of Maple Avenue between Old Cemetery Road and Route 68. View to the south.

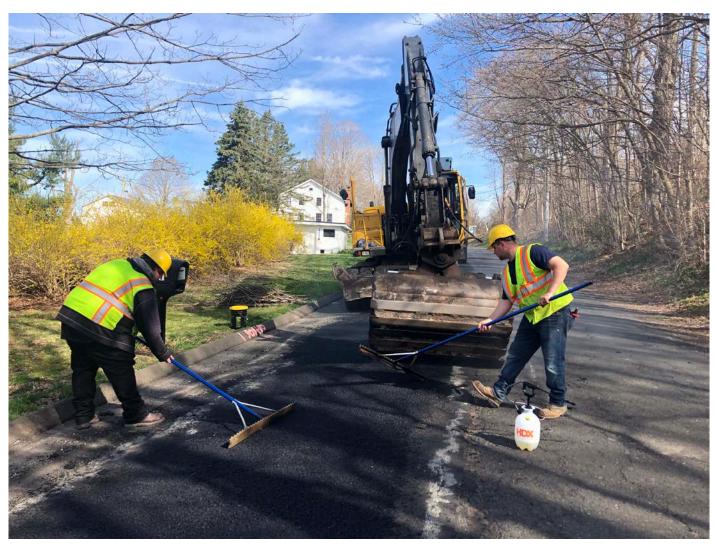
Picture 5: Ludlow grading freshly-placed asphalt as they shim coat on the west side of Maple Avenue between Old Cemetery Road and Route 68. View to the north.

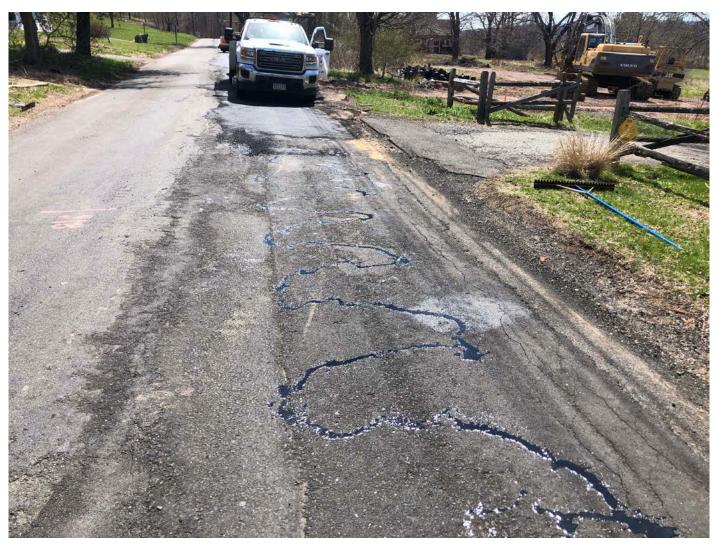
Picture 6: Tack coat that Ludlow applied to the west side of Maple Avenue as they shim coat sections of Maple Avenue between Old Cemetery Road and Route 68. View to the south.
