Daily Report

Project:	Durham Meadows Pipeline Installation	Date:	April 12, 2021
Location:	Main Street, Durham; S. Main Street and the Shared Access Driveway, Middletown	Day of Week:	Monday
Project #:	AECOM: 6061487	Report No:	219
Contractor:	Ludlow Construction	Page:	1 of 9

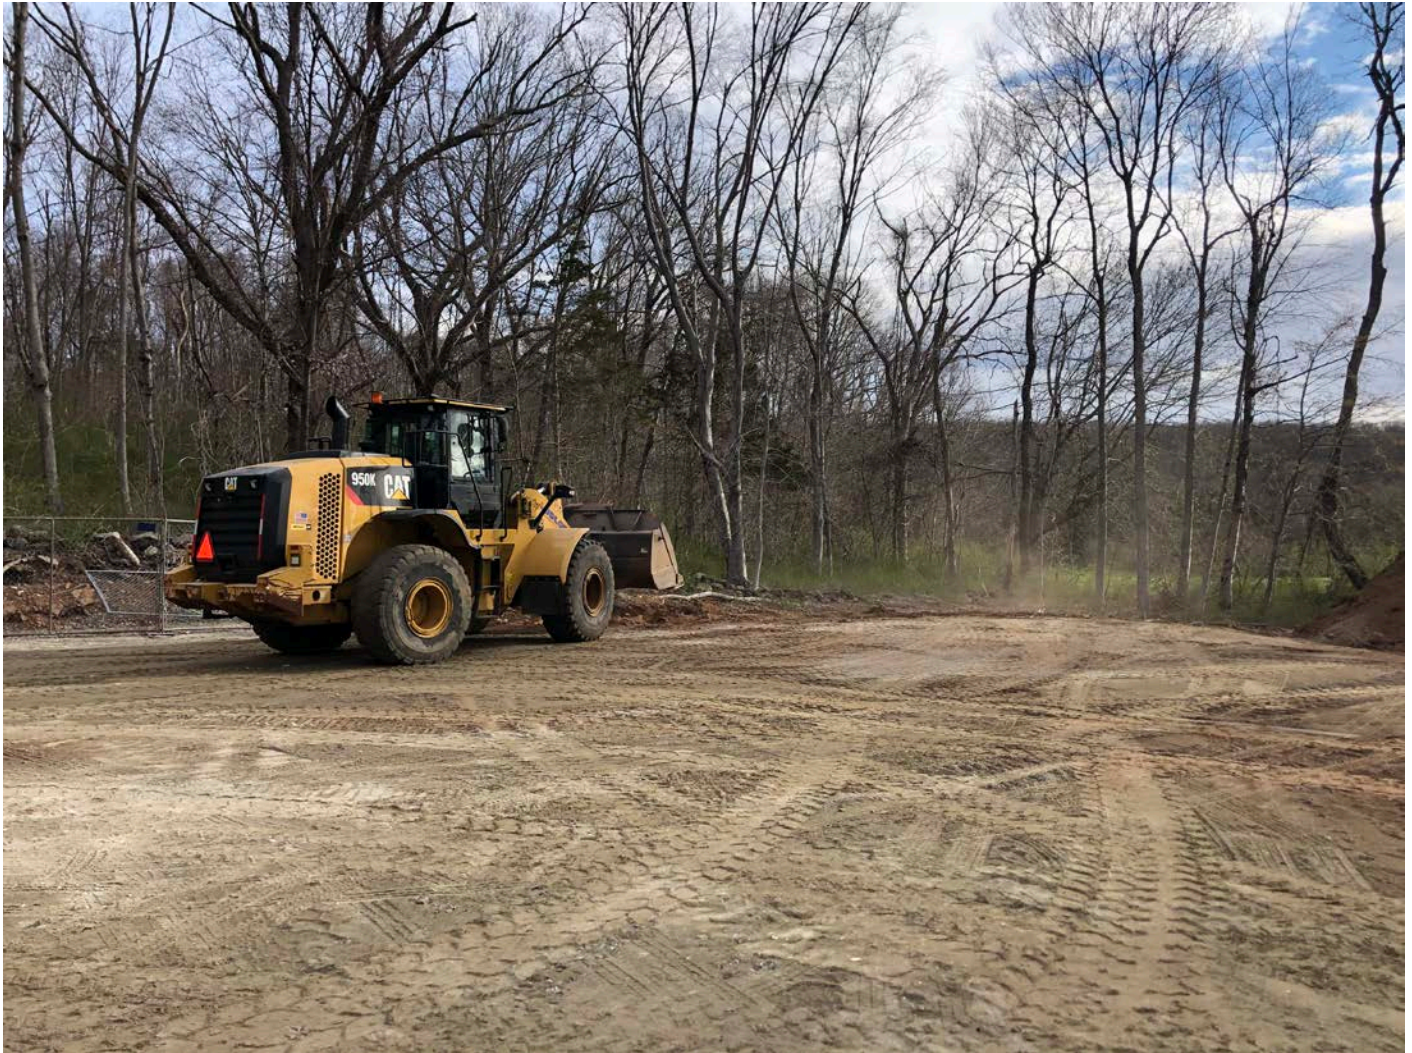
Picture 1: Ludlow grading fill at the northeast corner of the water tank work zone east of the shared access driveway in Middletown. View to the northeast.

0745: Ludlow is currently grading fill at the east corner of the water tank work zone, east of the shared access driveway in Middletown.

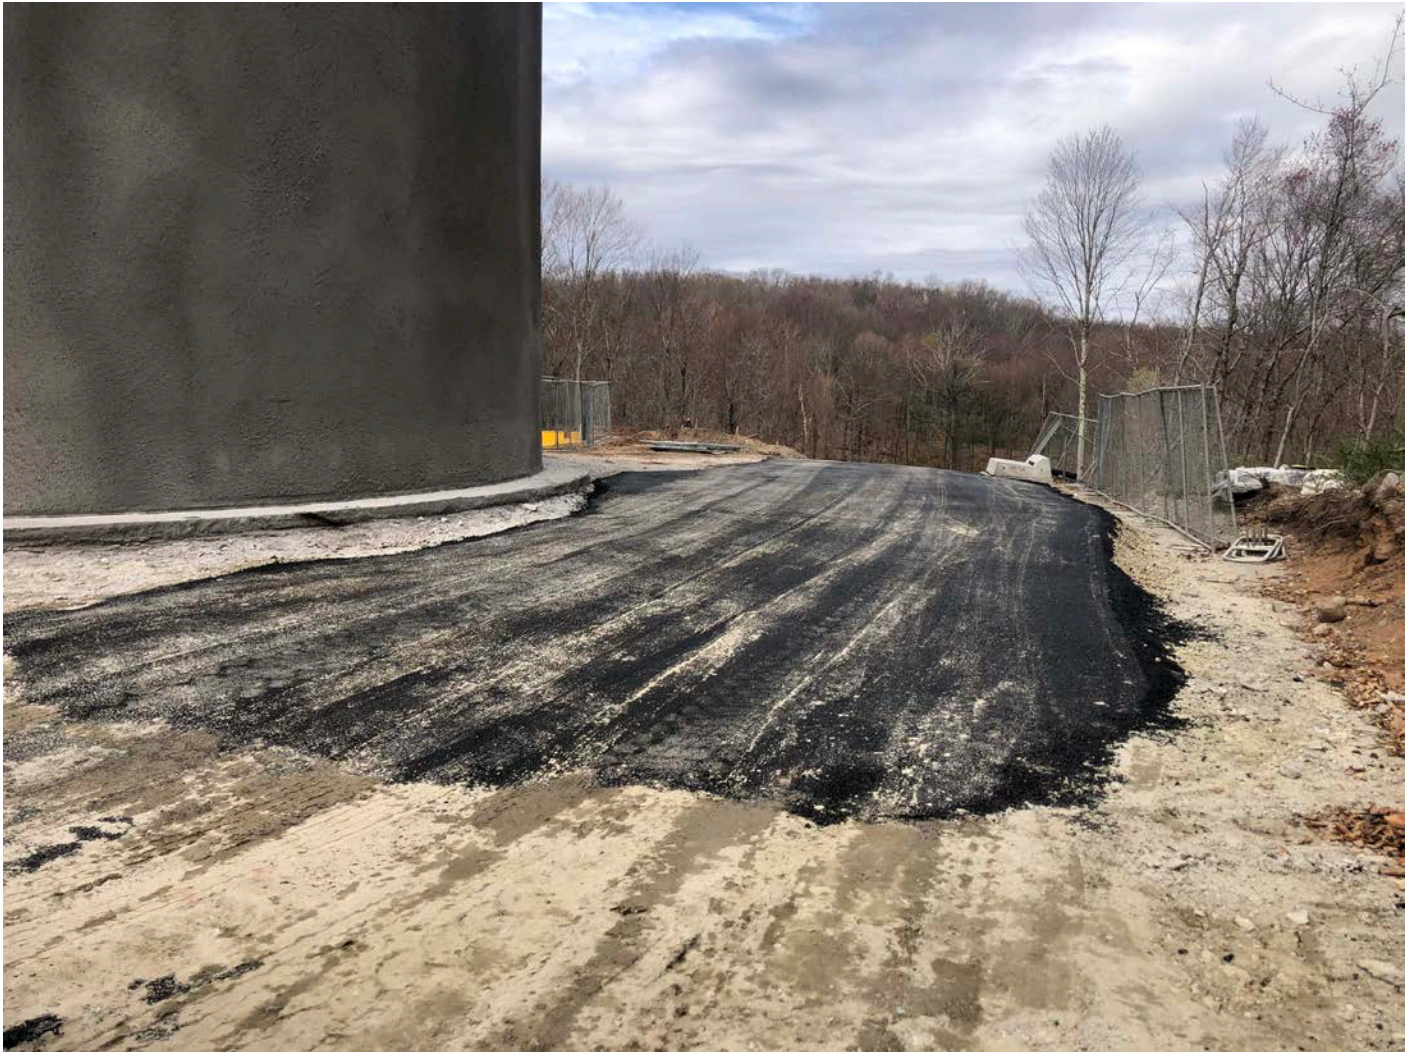
Picture 2: Ludlow has placed asphalt at the northwest corner of the water tank work zone located east of the shared access driveway in preparation for the heavy vehicles that will be at the site tomorrow for the installation of the altitude vault. View to the west.

0812: Ludlow is preparing the ground surface at the northwest corner of the water tank work zone as they prepare to place blacktop.

0922: Ludlow has finished placing blacktop on the north side of the water tank work zone.

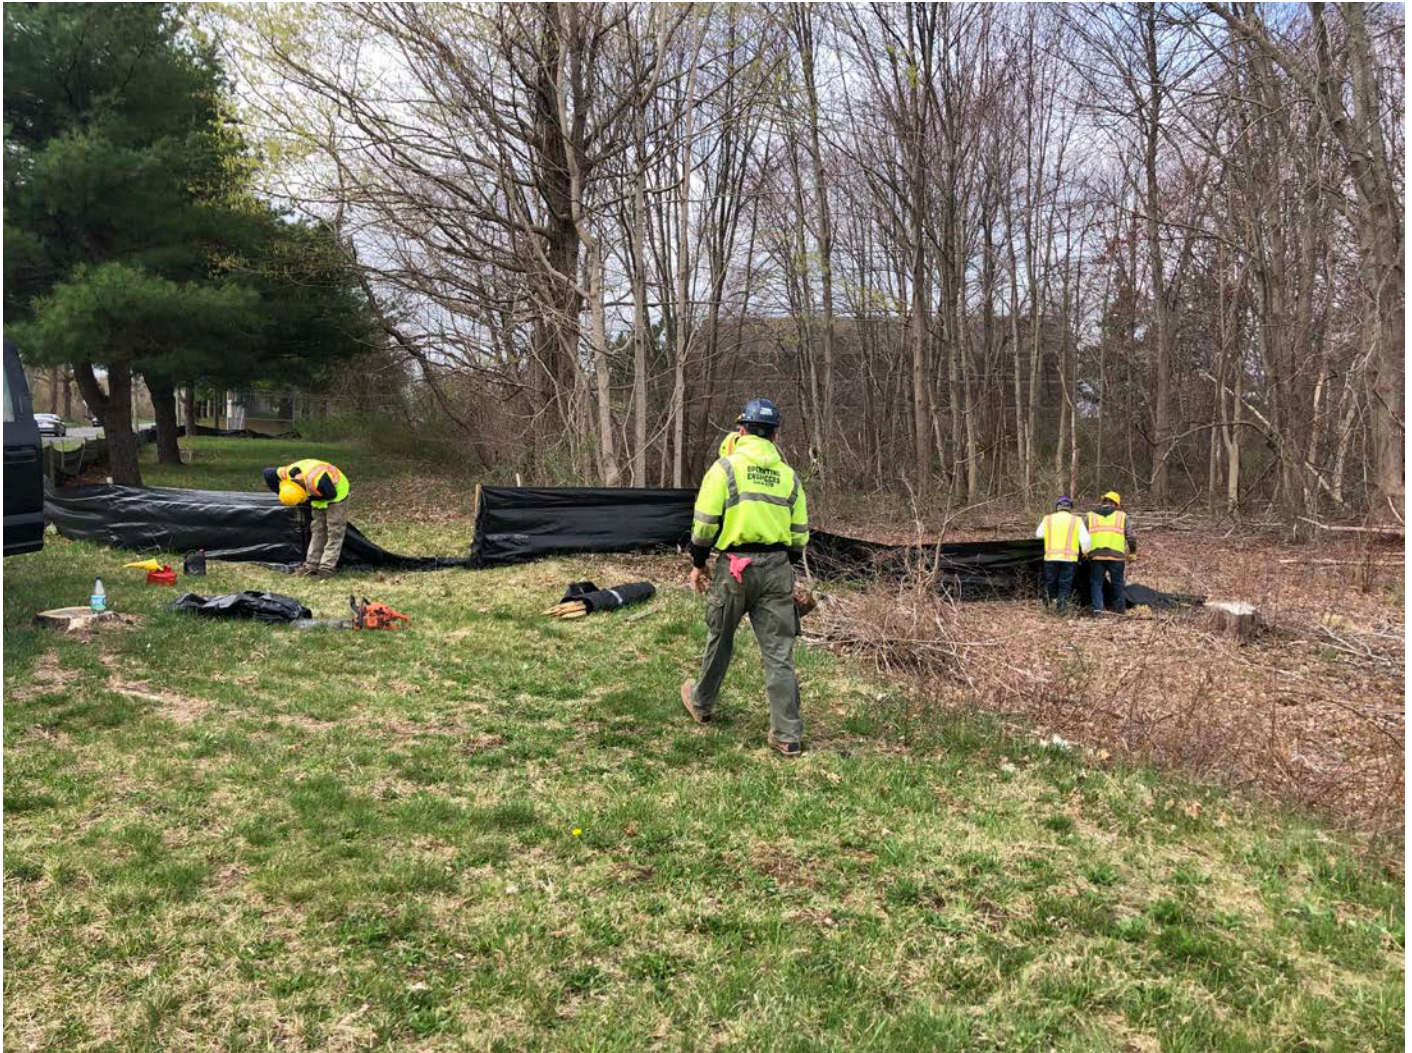
Picture 3: Ludlow placing and fixing silt fence south, and proximal to, the booster station at Station 750+63. View to the south.

0952: Ludlow is staged west of the intersection of S. Main and Talcott Lane (approximately Station 750+63) to perform site preparation and to excavate for the placement of the footings for the booster station. Ludlow is currently placing and fixing silt fence adjacent to the footprint of the booster station.

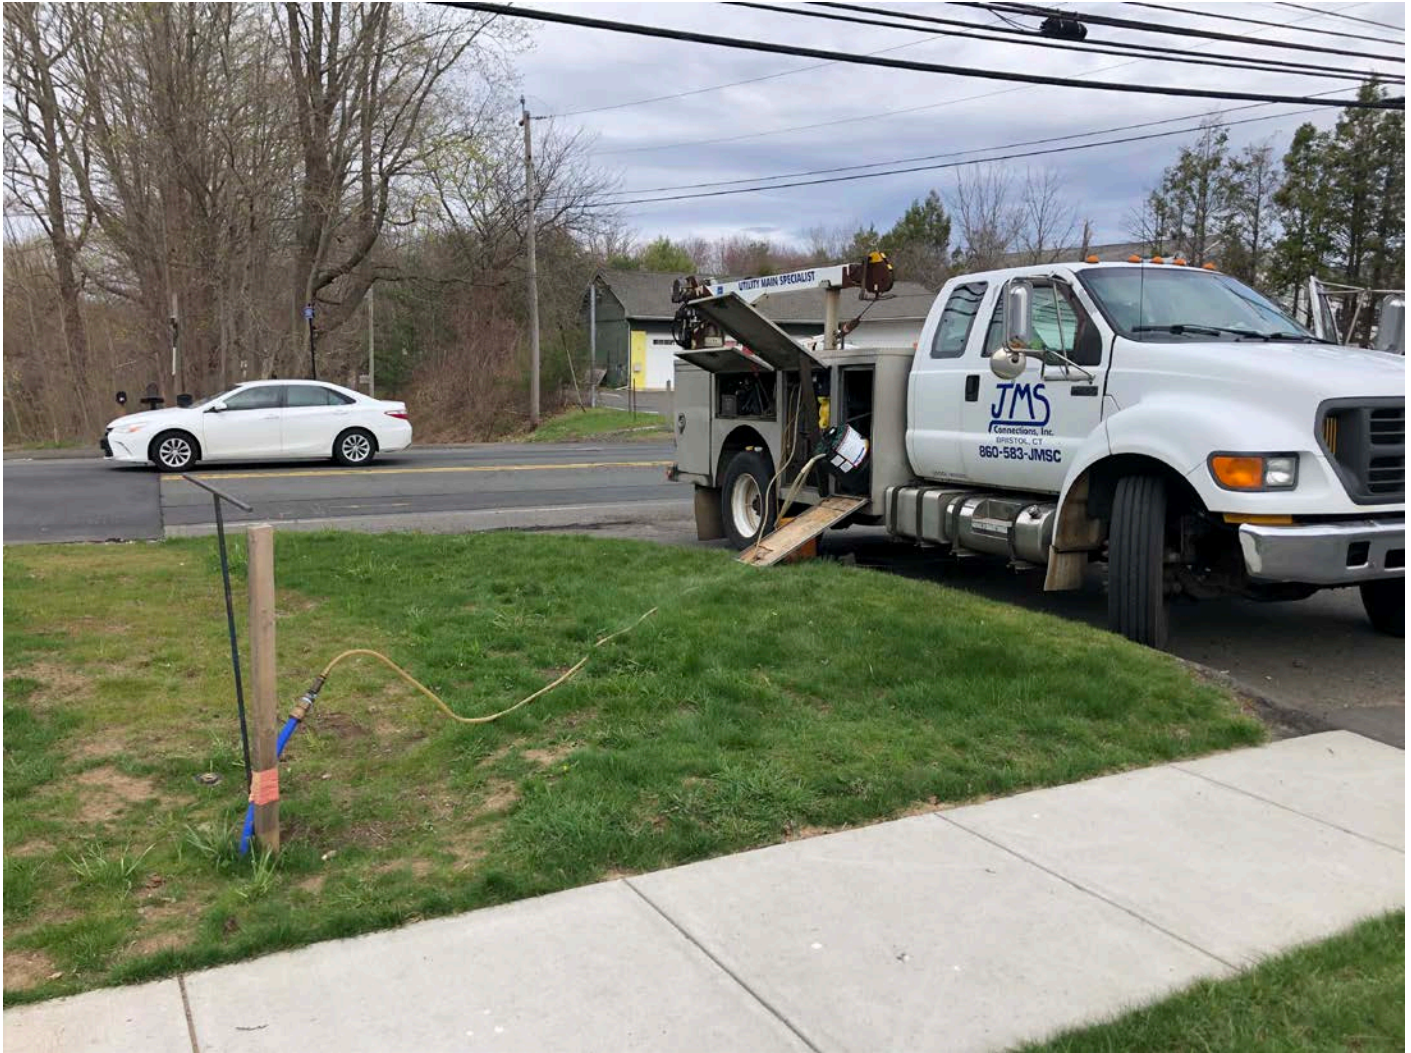
Picture 4: JMS Connections in the process of introducing sodium hypochlorite into the 16" water main at 327 Main Street, Durham. View to the west.

0935: Ludlow subcontractor JMS Connections is introducing sodium hypochlorite into the 16" DIP water main at 327 Main Street Durham.

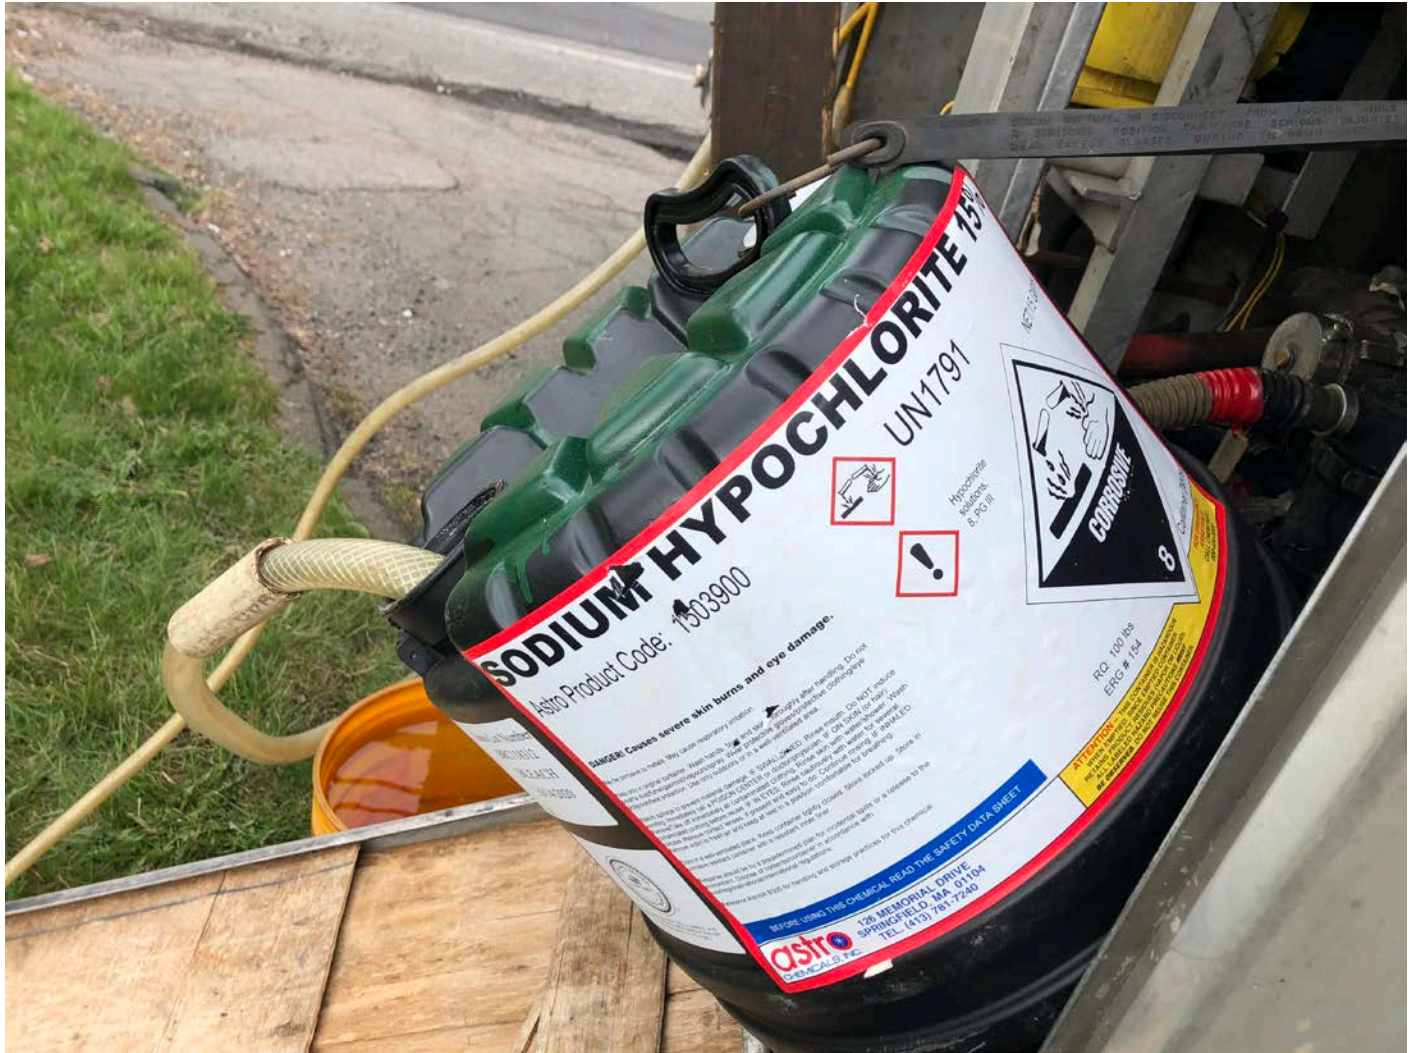
Picture 5: The sodium hypochlorite that JMS Connections in the process of introducing into the 16" water main at 327 Main Street, Durham.

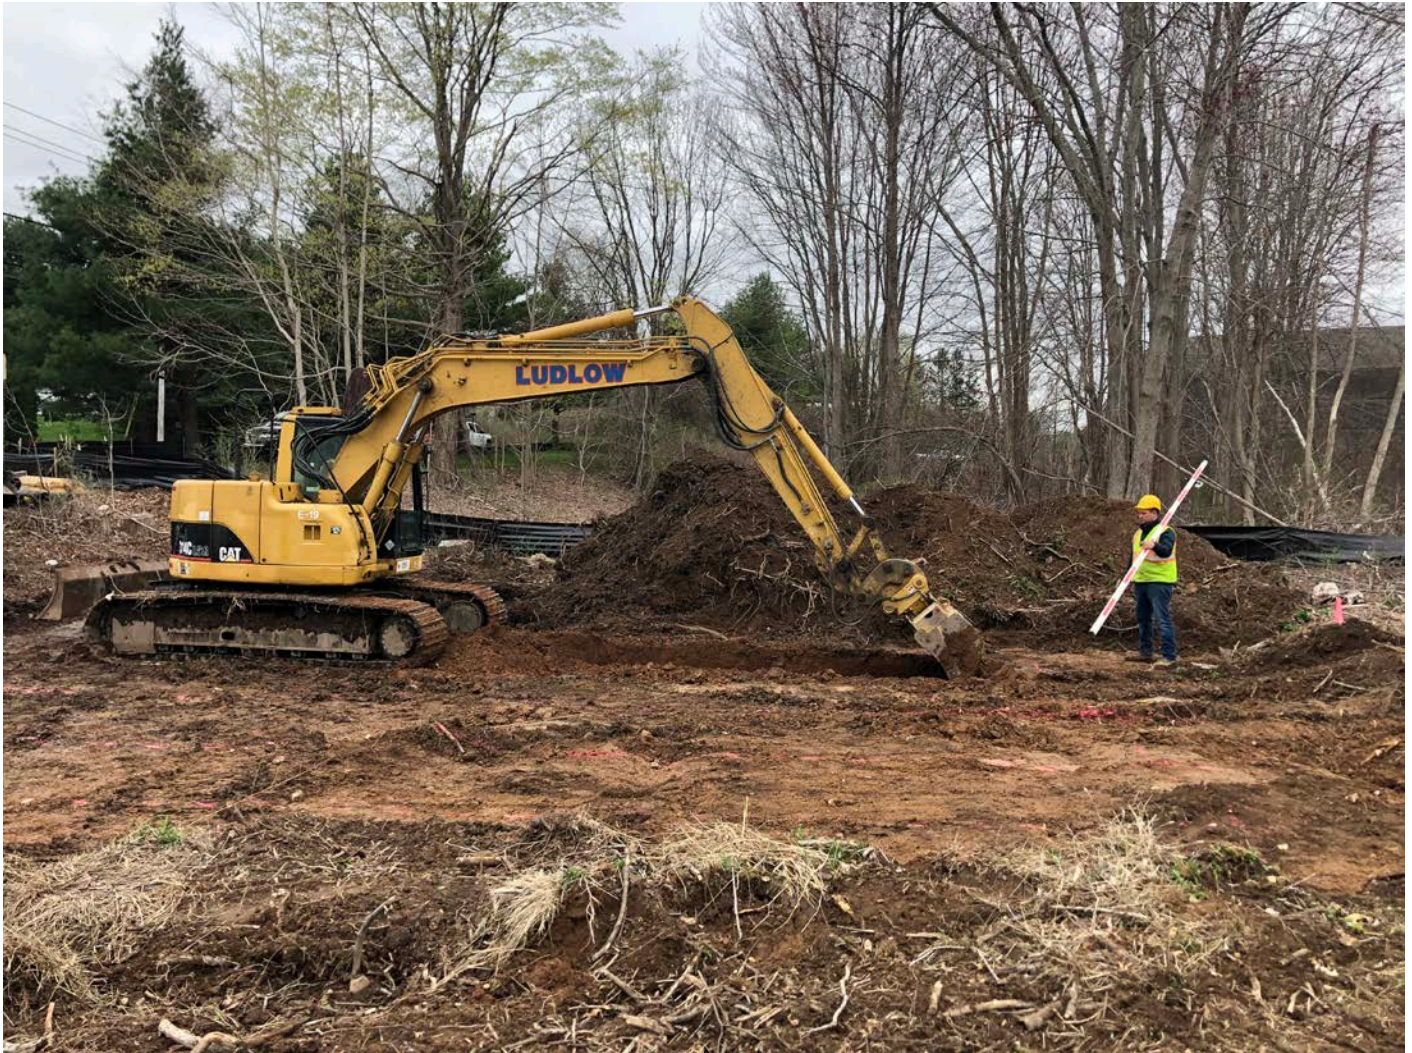
Picture 6: Ludlow clearing the footprint for the booster station that will be installed at Station 750+63 in Middletown. View to the south.

1112: Ludlow is clearing land at Station 750+63 (S. Main, Middletown) as they prepare for the installation of the booster station.

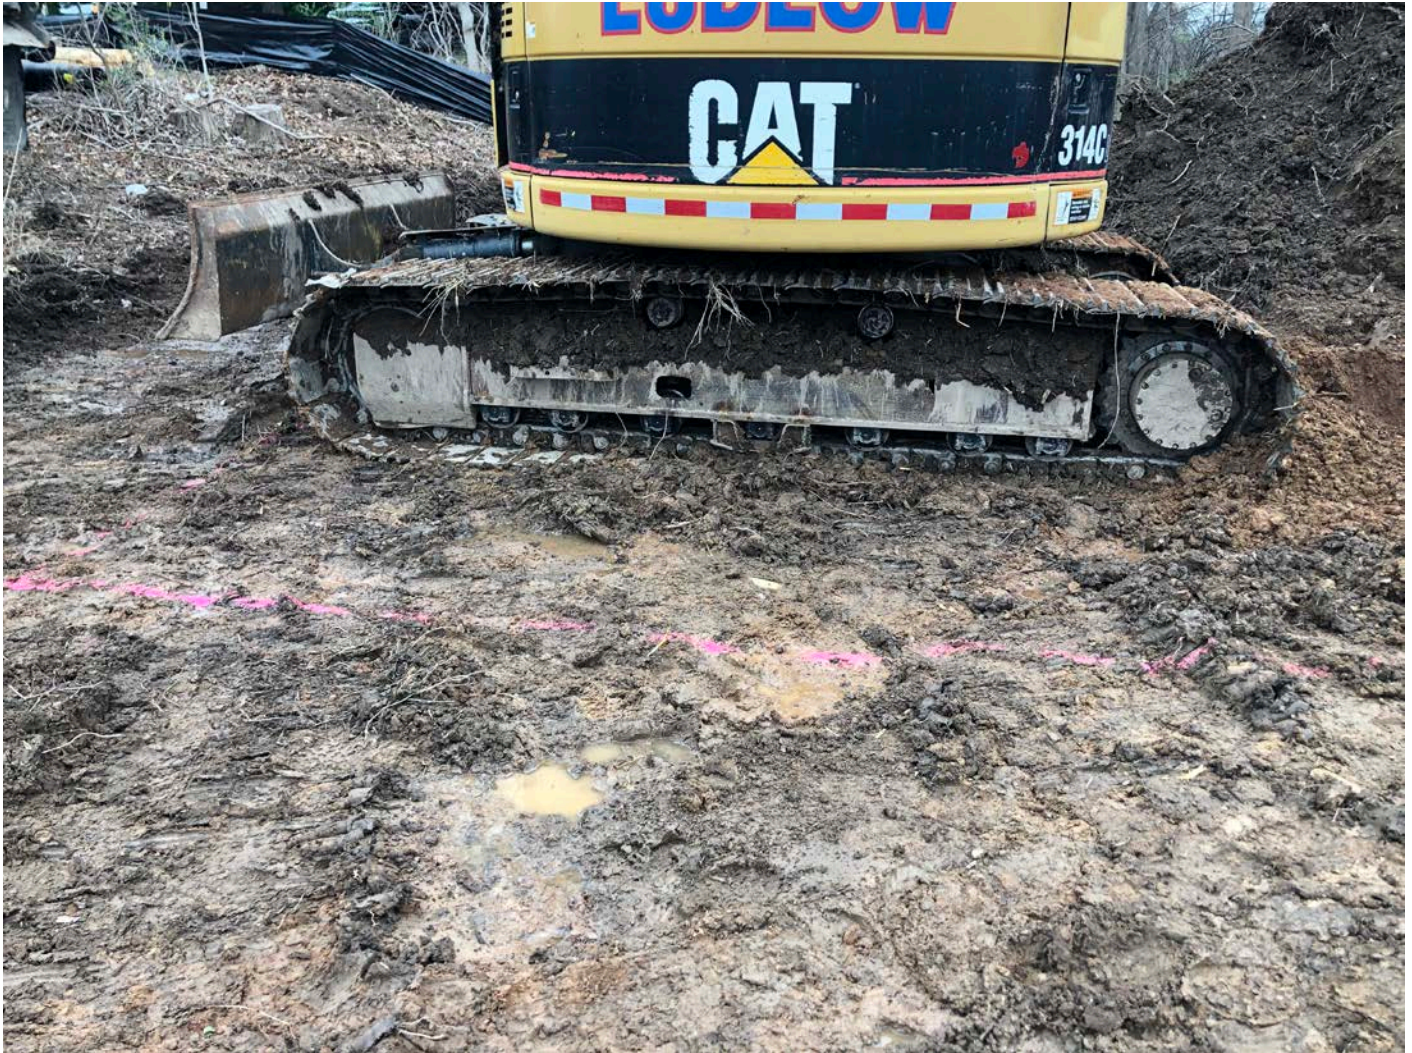
Picture 7: Standing water observed when Ludlow was clearing the footprint for the booster station that will be installed at Station 750+63. View to the south.
