Daily Report

Project:	Durham Meadows Pipeline Installation	Date:	April 15, 2021
Location:	S. Main Street, Middletown and Main Street, Durham	Day of Week:	Thursday
Project #:	AECOM: 6061487	Report No:	222
Contractor:	Ludlow Construction	Page:	1 of 8

Daily Activities - Booster station work zone, Station 750+63, Middletown

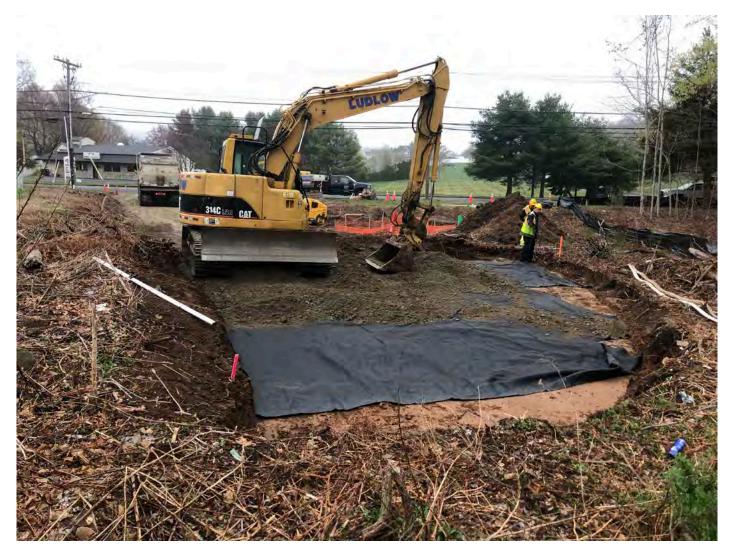
Picture 1: Ludlow placing 1.25" gravel on top of geofabric as they construct the bituminous concrete driveway at the booster station located at Station 750+63 in Middletown. View to the southeast.

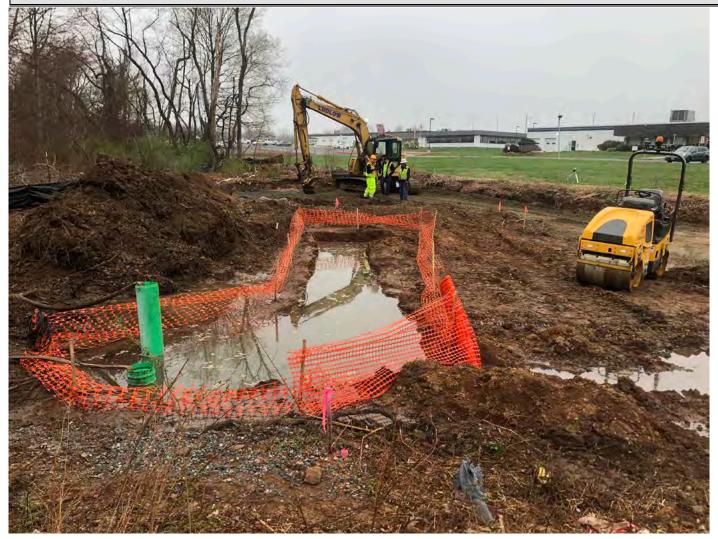
Picture 2: View of the booster station work zone located at Station 750+63 in Middletown. View to the west.

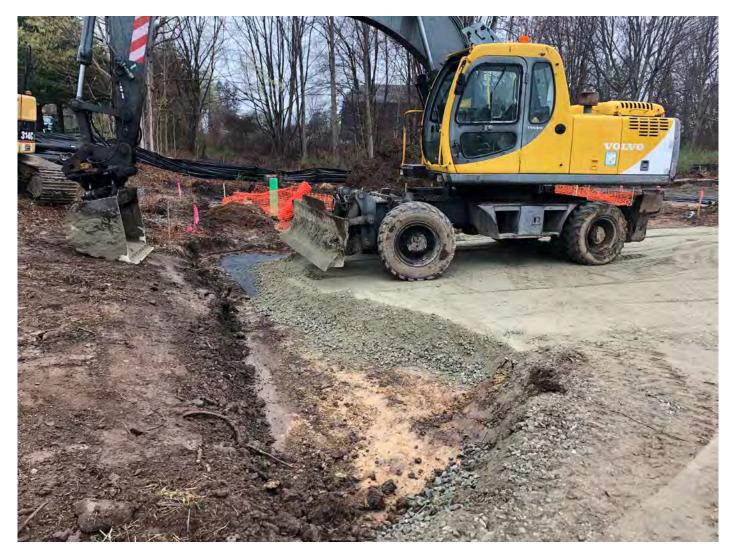
Picture 3: Ludlow placing 1.25" gravel on top of geofabric as they construct the bituminous concrete driveway at the booster station located at Station 750+63 in Middletown. View to the south.

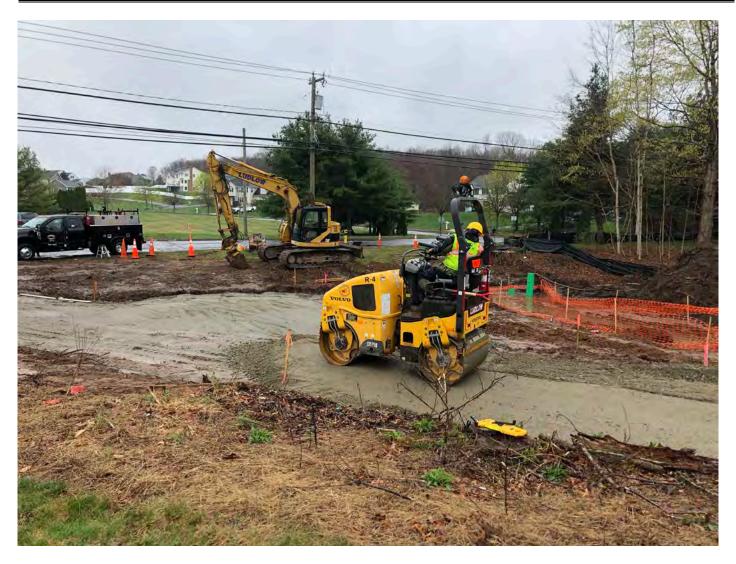
Picture 4: Ludlow compacting 1.25" gravel as they construct the bituminous concrete driveway at the booster station located at Station 750+63 in Middletown. View to the southeast.

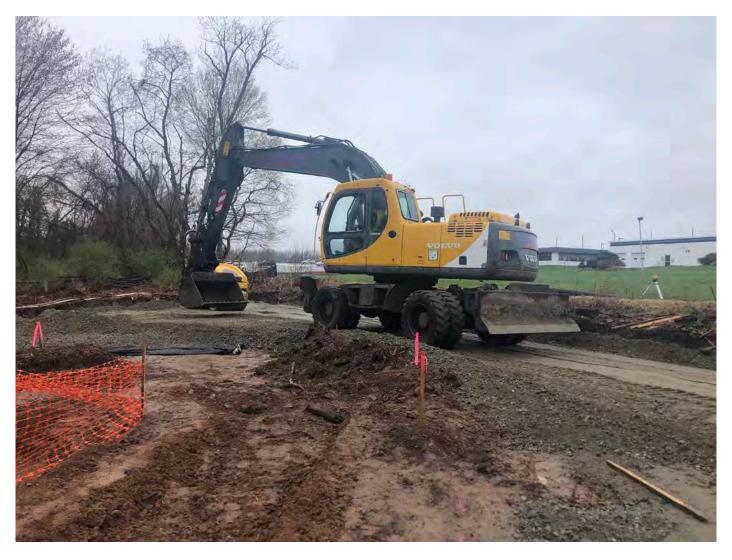
Picture 5: Ludlow grading 1.25" gravel as they construct the bituminous concrete driveway at the booster station located at Station 750+63 in Middletown. View to the west.

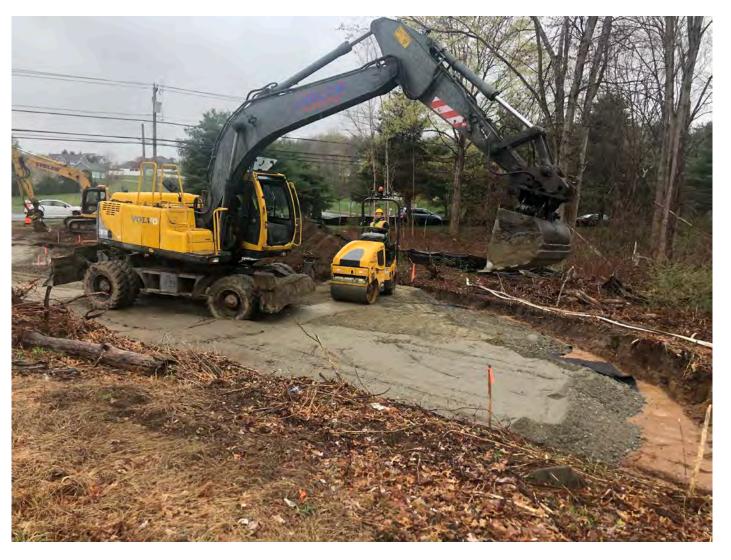
Picture 6: Ludlow grading 1.25" gravel as they construct the bituminous concrete driveway at the booster station located at Station 750+63 in Middletown. View to the southeast.
