Daily Report

Project:	Durham Meadows Pipeline Installation	Date:	April 20, 2021
Location:	Shared Access Driveway, Middletown	Day of Week:	Tuesday
Project #:	AECOM: 6061487	Report No:	225
Contractor:	Ludlow Construction	Page:	1 of 11

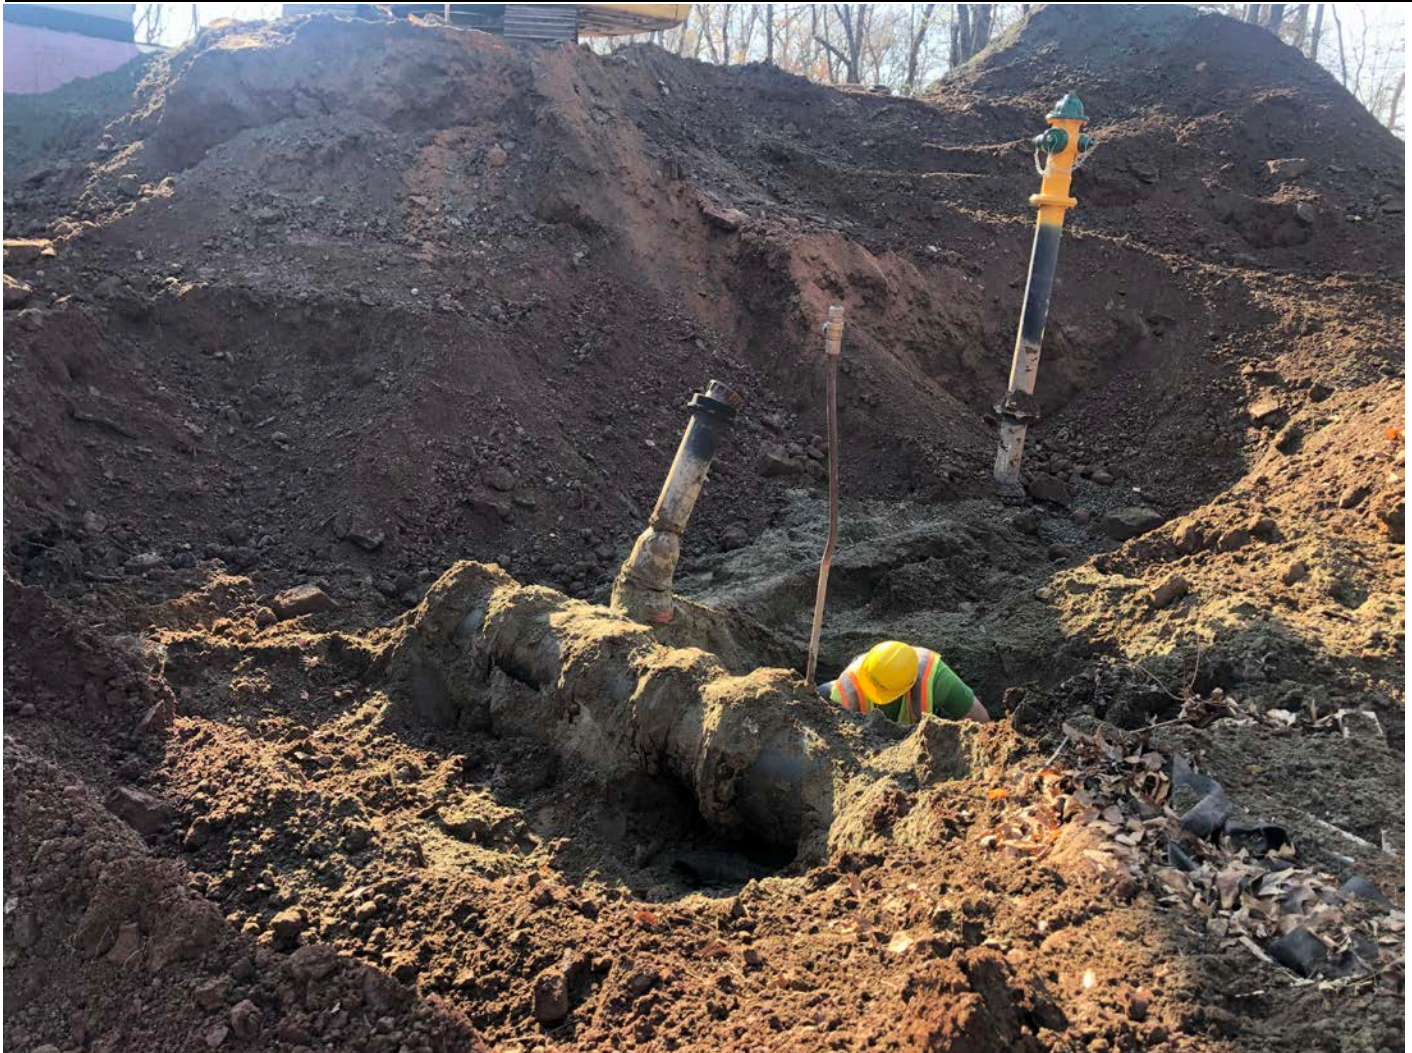
Picture 1: Section of 16" DIP (foreground) and 6" DIP (attached to the hydrant) that Ludlow daylighted as they prepare to remove the daylighted pipe. Location is west of the altitude valve vault and east of the Shared Access Driveway in Middletown. View to the south/southeast.

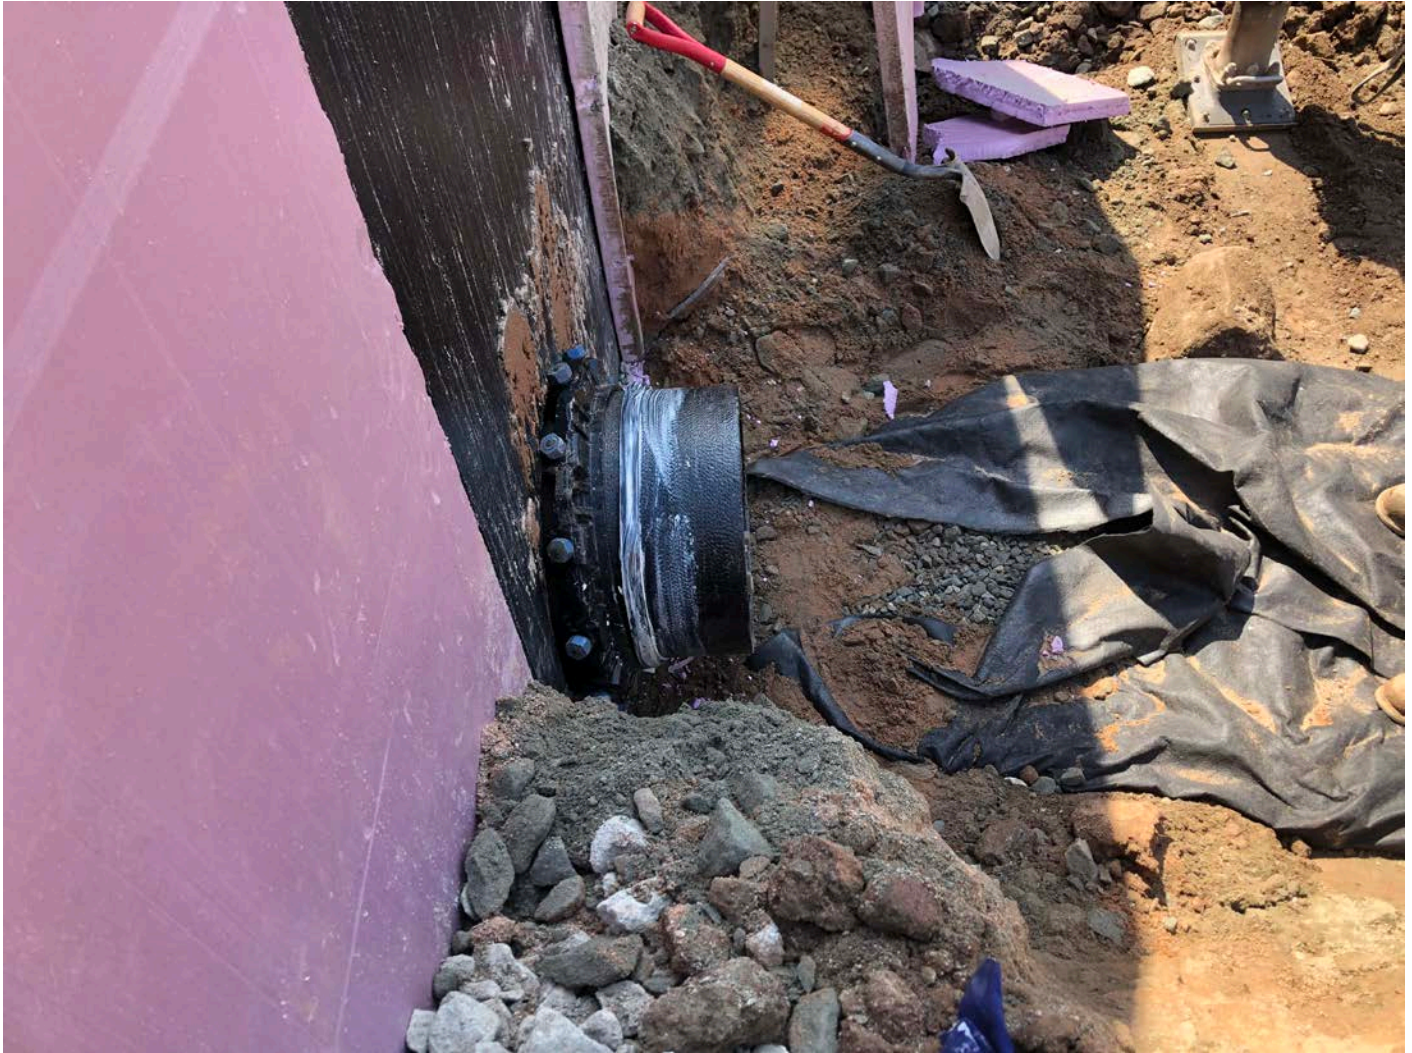
Picture 2: 16" DIP protruding from the west side of the altitude valve vault located east of the Shared Access Driveway in Middletown. Ludlow has placed a MJ gasket and a Megalug restrained gland onto the 16" DIP. View to the south.

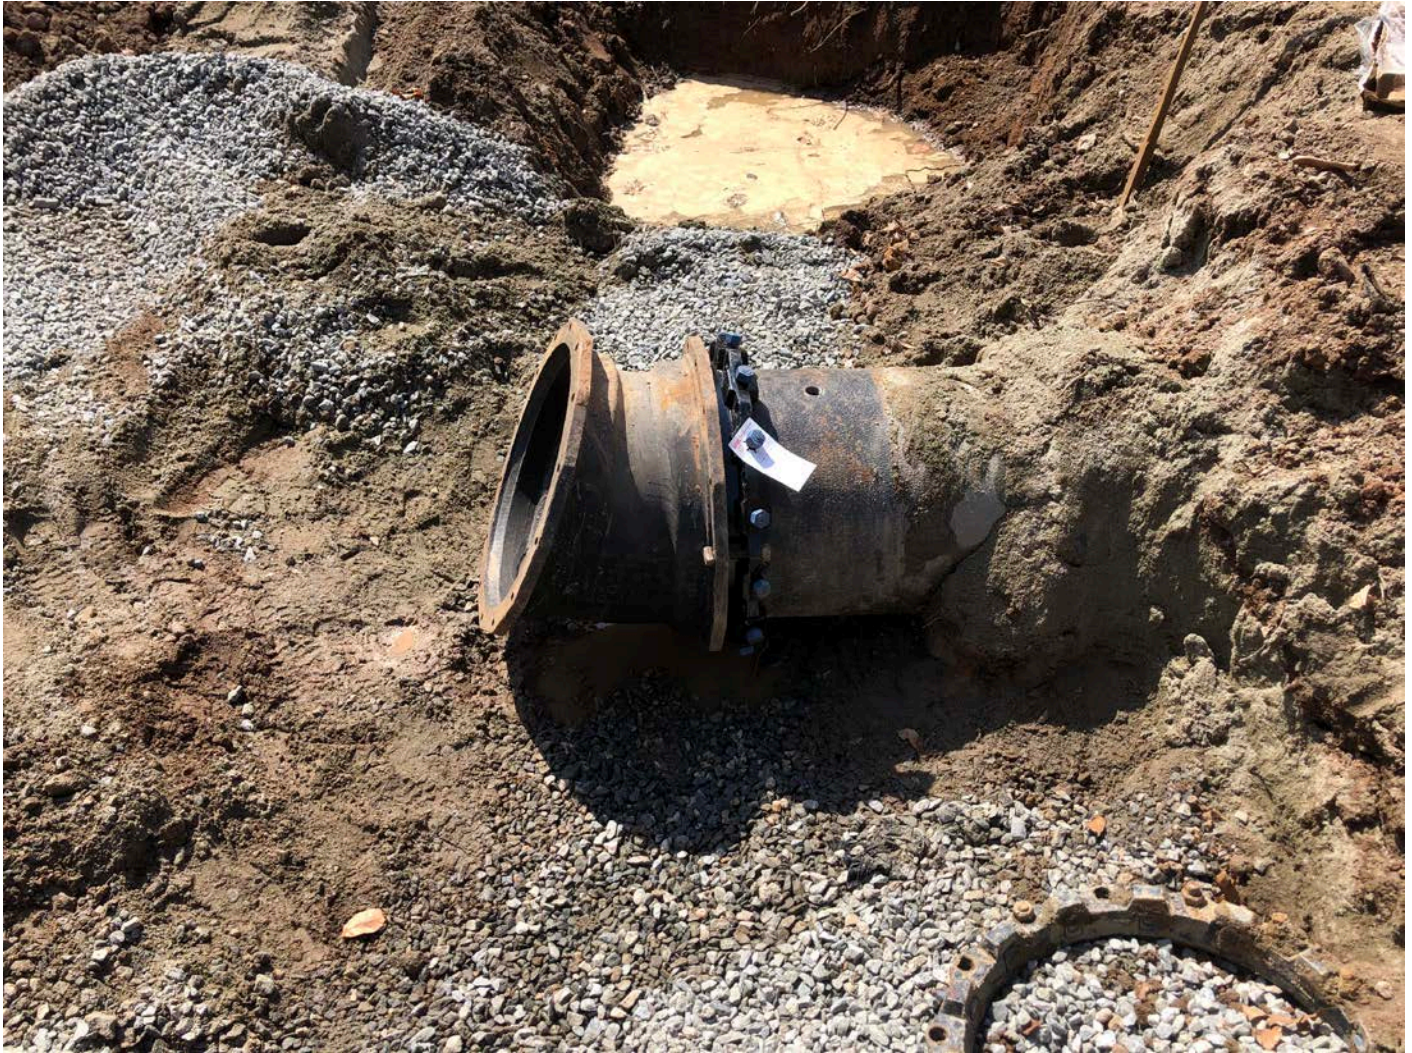
Picture 3: A 20", 22.5° MJ bend that Ludlow has attached to the east end of the 20" DIP that they installed last year at the water tank work zone. Location is west of the altitude valve vault and east of the Shared Access Driveway in Middletown. View to the south.

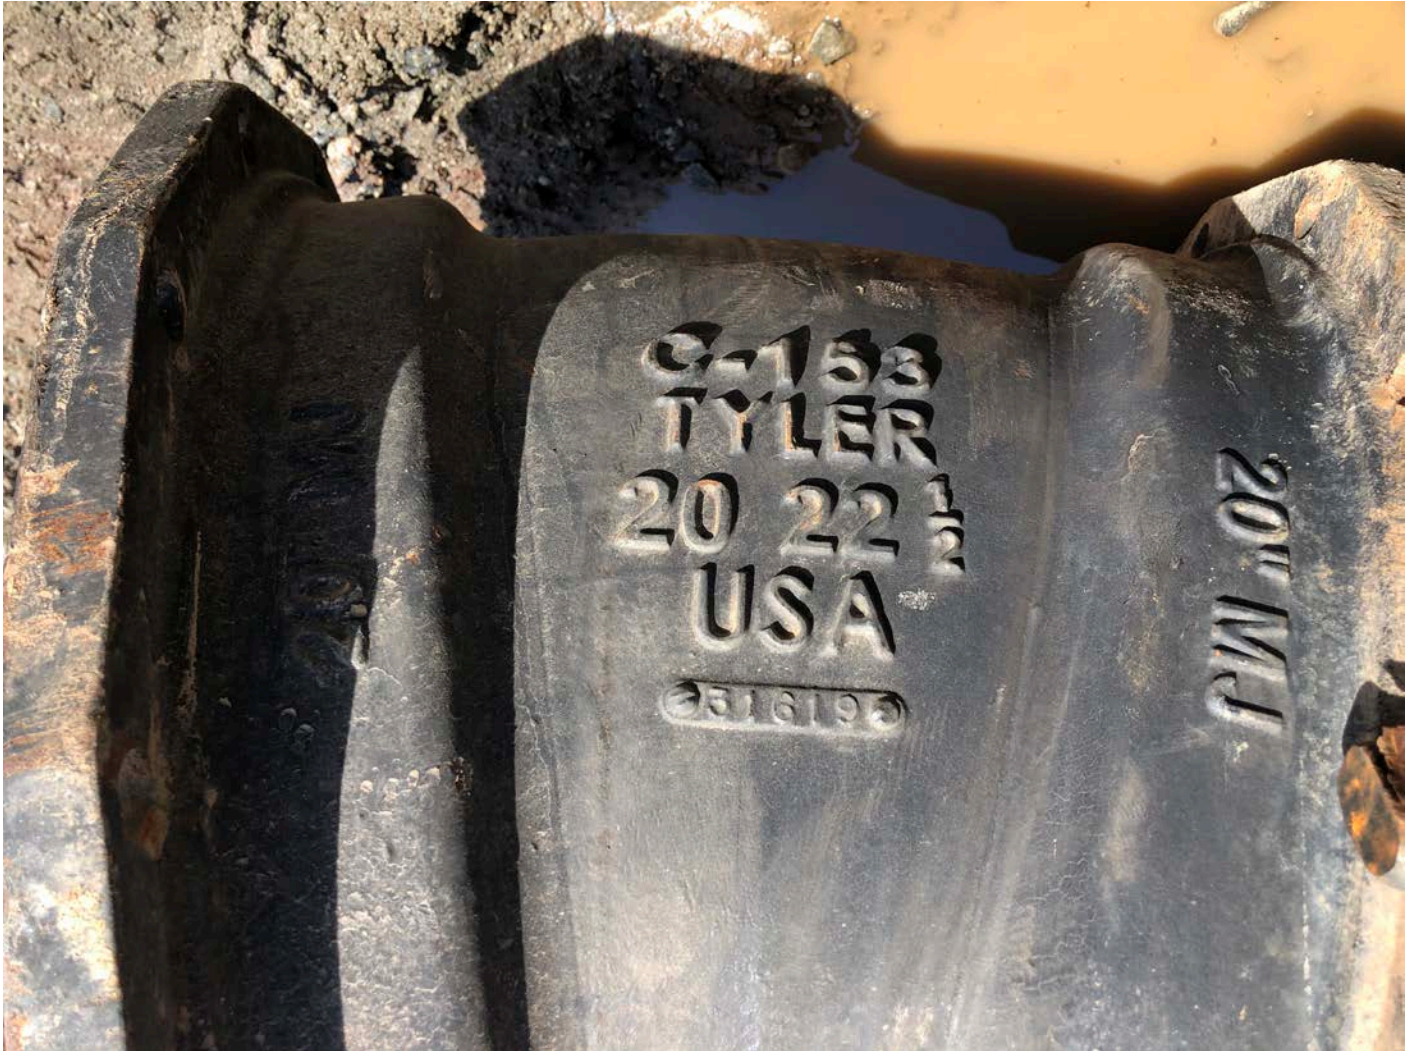
Picture 4: Close-up of the 20", 22.5° MJ DI bend that Ludlow attached to the east end of the 20" DIP they installed last year at the water tank work zone.

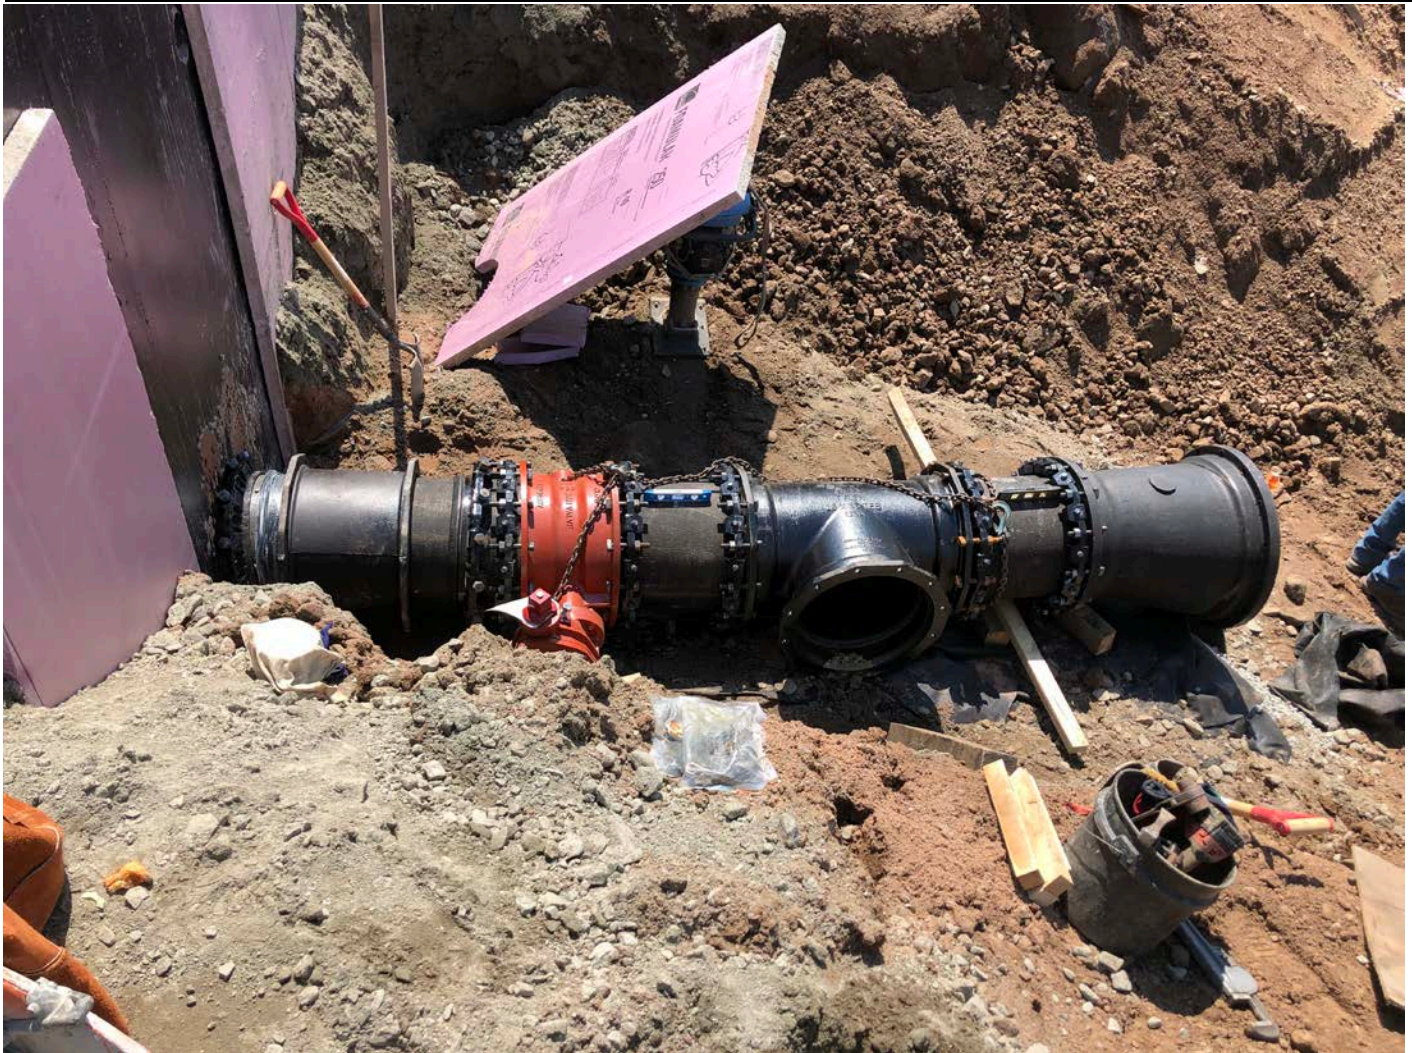
Picture 5: 16" DIP with a butterfly valve, a 16"x16"x16" TEE, and a 20"-to-16" reducer. that Ludlow connected to the 16" DIP protruding from the west side of the altitude valve vault located east of the Shared Access Driveway in Middletown. View to the south.

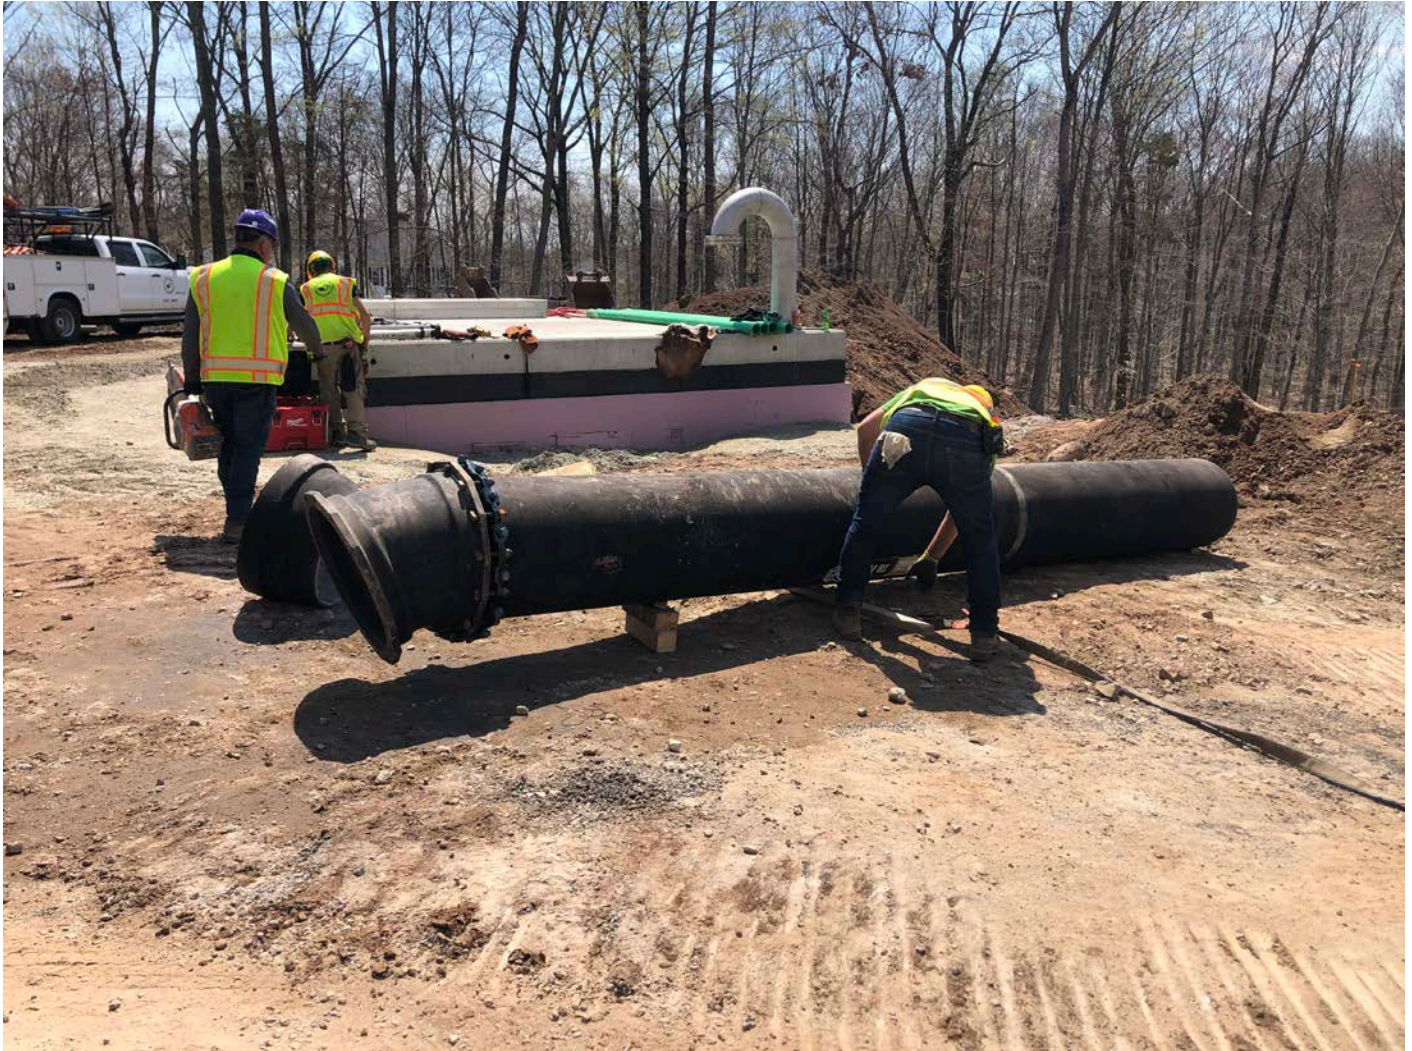
Picture 6: Ludlow placing lift strap on a section of 20" DIP, to which they connected a 22.5° DI MJ bend. Water tank work zone; view to the southwest.

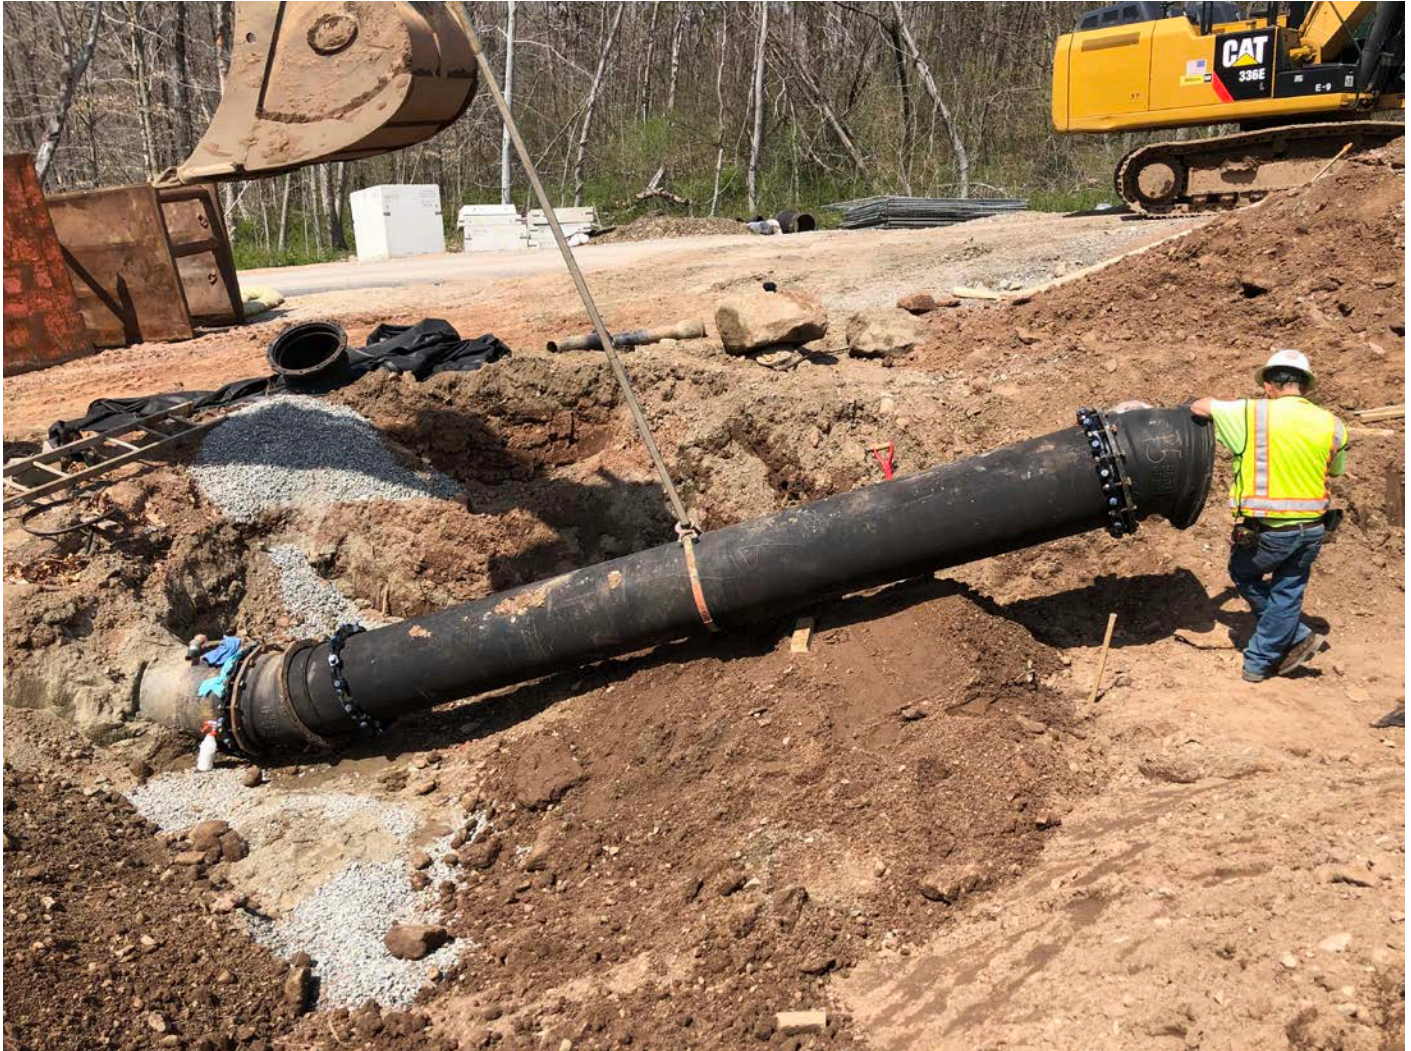
Picture 7: Ludlow connecting a section of 20" DIP (with a 22.5° DI MJ bend) to the previously-installed 20" DIP located west of the altitude valve vault at the water tank work zone located east of the Shared Access Driveway in Middletown.

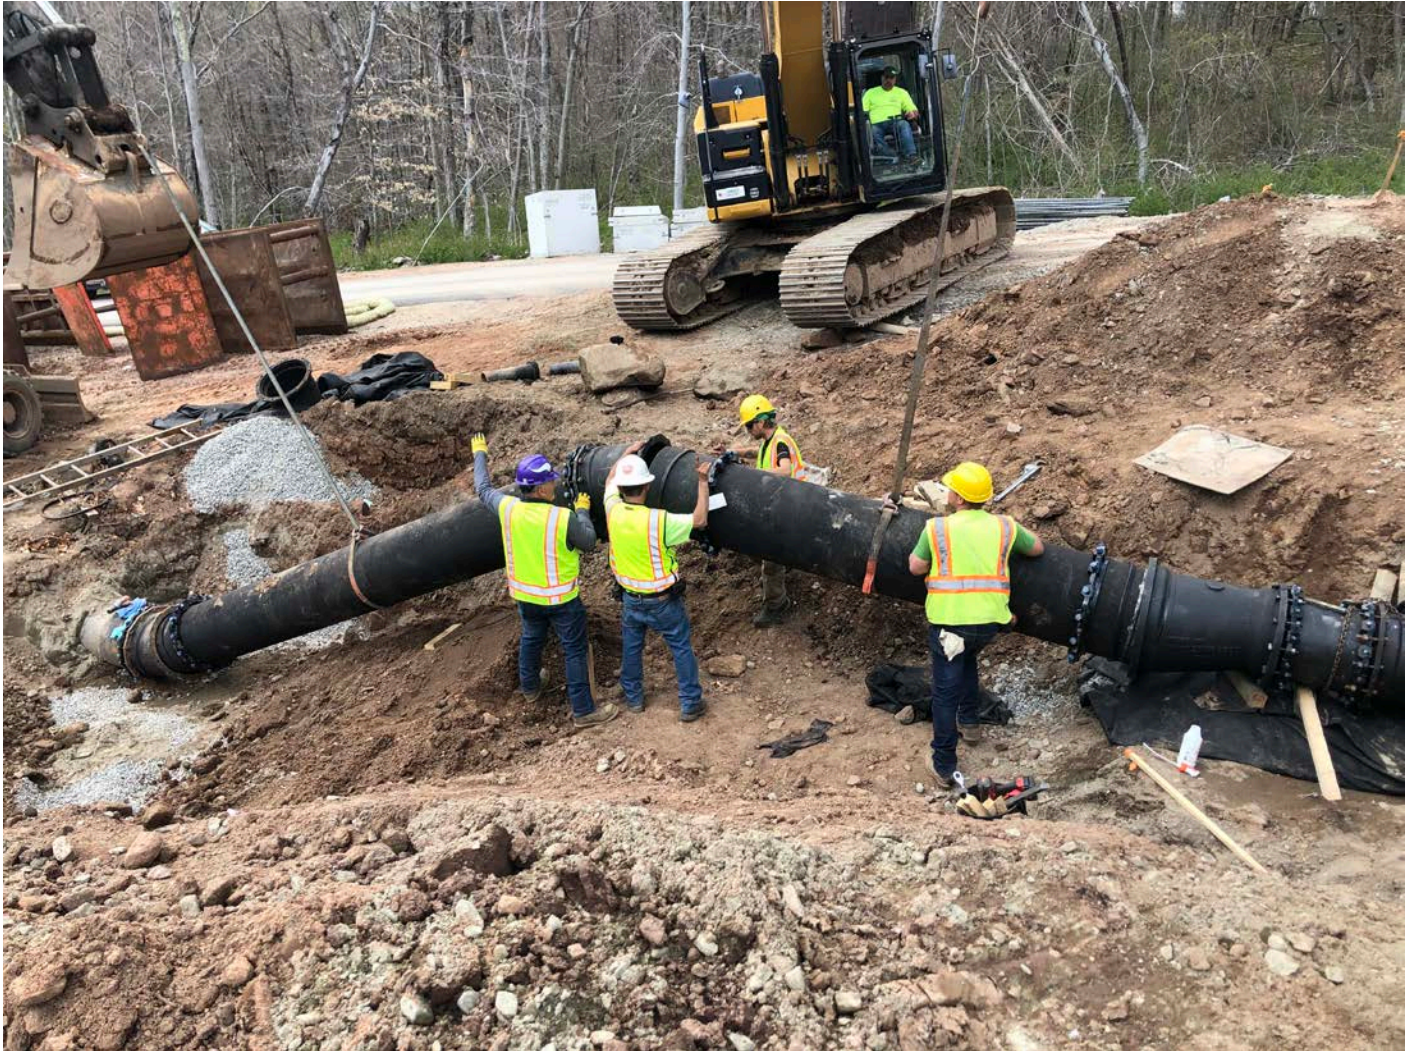
Picture 8: Ludlow finishing the connection between the previously-installed 20" DIP and the altitude valve vault with ~10' section of 20" DIP. View to the north/northwest.

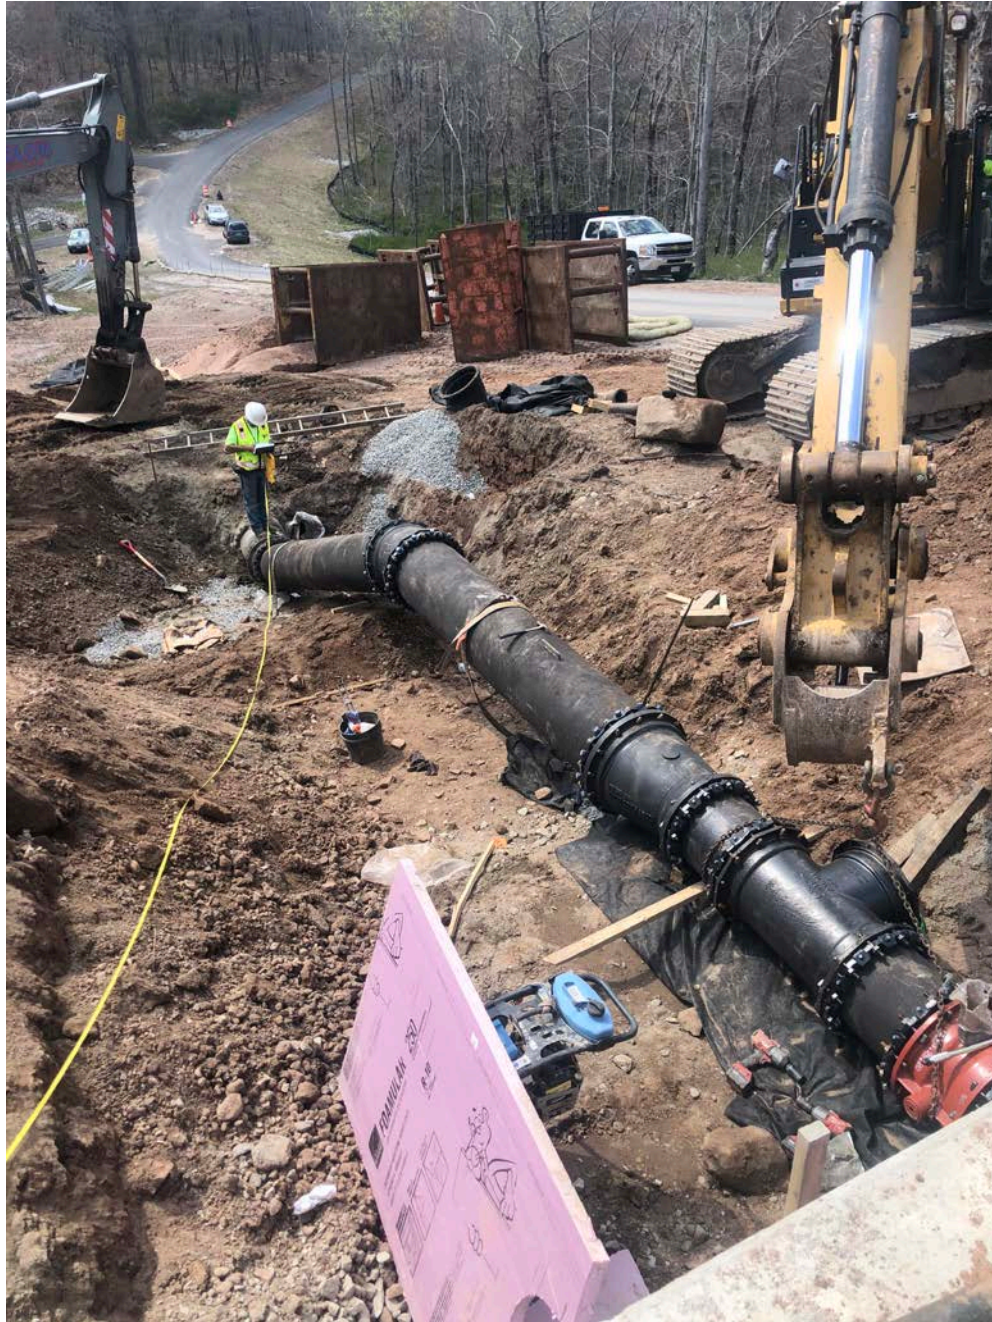
Picture 9: Overview of the 16" and 20" DIP that Ludlow installed today to connect the previously-installed 20" DIP to the altitude valve vault. View to the west.
