Daily Report

Project:	Durham Meadows Pipeline Installation	Date:	May 03, 2021
Location:	South Main Street, Middletown, Main Street, Maple Avenue, Durham	Day of Week:	Monday
Project #:	AECOM: 6061487	Report No:	234
Contractor:	Ludlow Construction	Page:	1 of 7

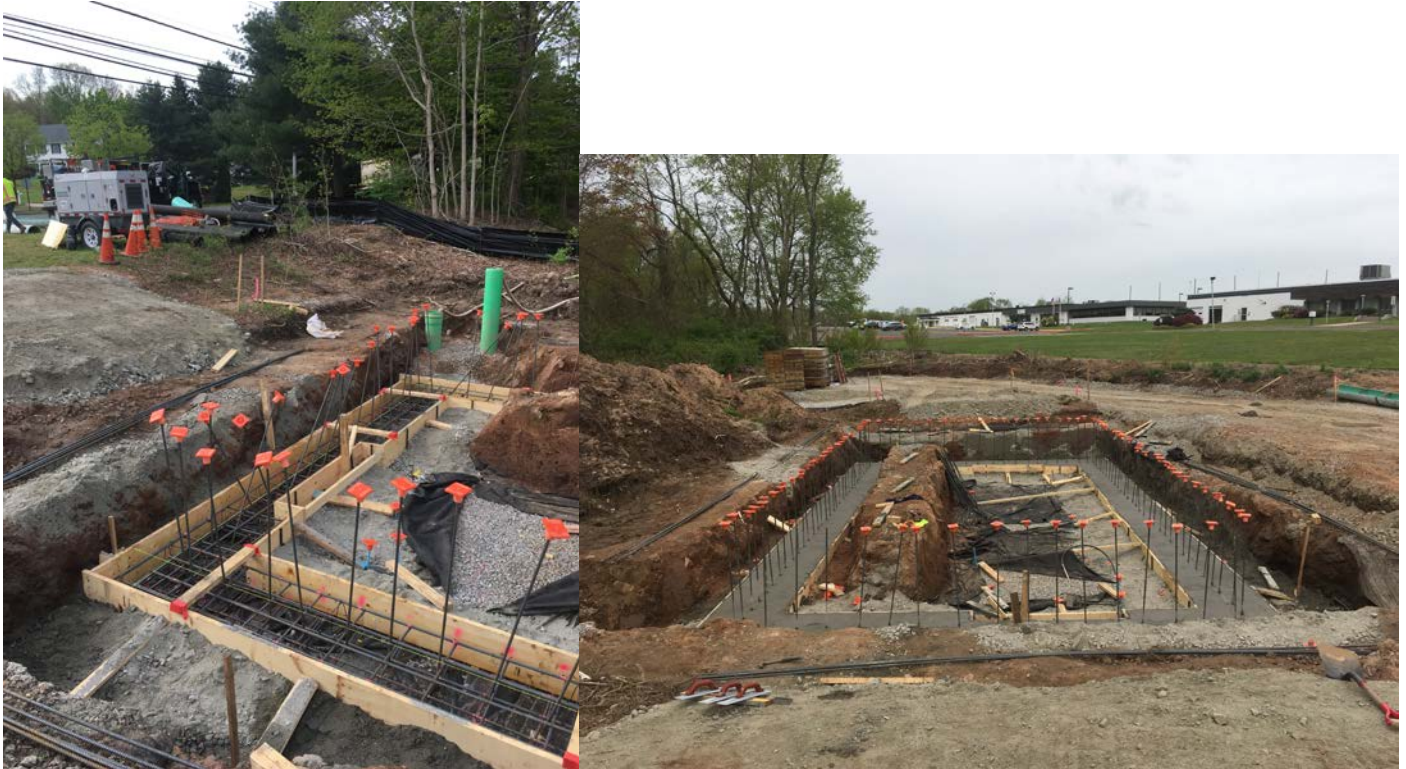
Picture 1: View of the booster station footprint before and after concrete footing is placed. Ludlow placed the concrete and positioned the rebar within the concrete to the proper configuration for the foundation walls of the booster station located at Station 750+63 South Main Street in Middletown. Views are to south and to the west.

0930: Placing of concrete footing begins. Concrete is placed into the forms followed by use of the concrete vibration tool. More concrete added as needed.

0945: Turner testing services arrive to test concrete. They perform an air test - 4.2 reading (range 4.5-7.5) - which is just below spec; two slump tests (range 4.5-6.5"), the first test failed (8" slump), however the particular sample seemed overly wet so a second test was done and resulted in 5.75 inch slump; and the last test was to collect 5 cylinders of concrete for compression/fracture testing.

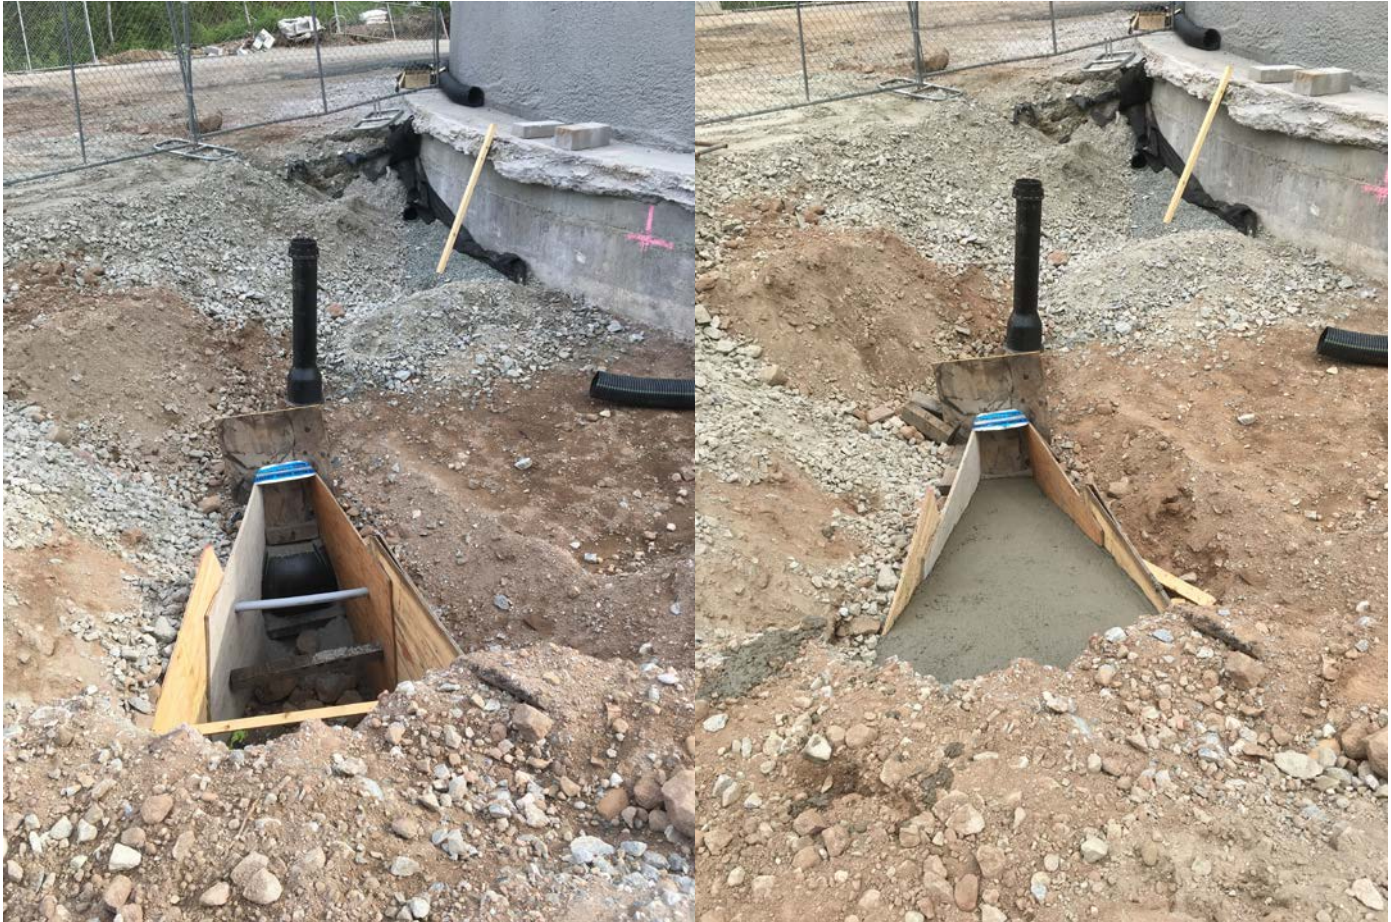
Picture 2: Thrust block form and pre and post concrete placement. Tank driveway is to the top left of the photo.

1040: The thrust block is poured up at the Water Tank.

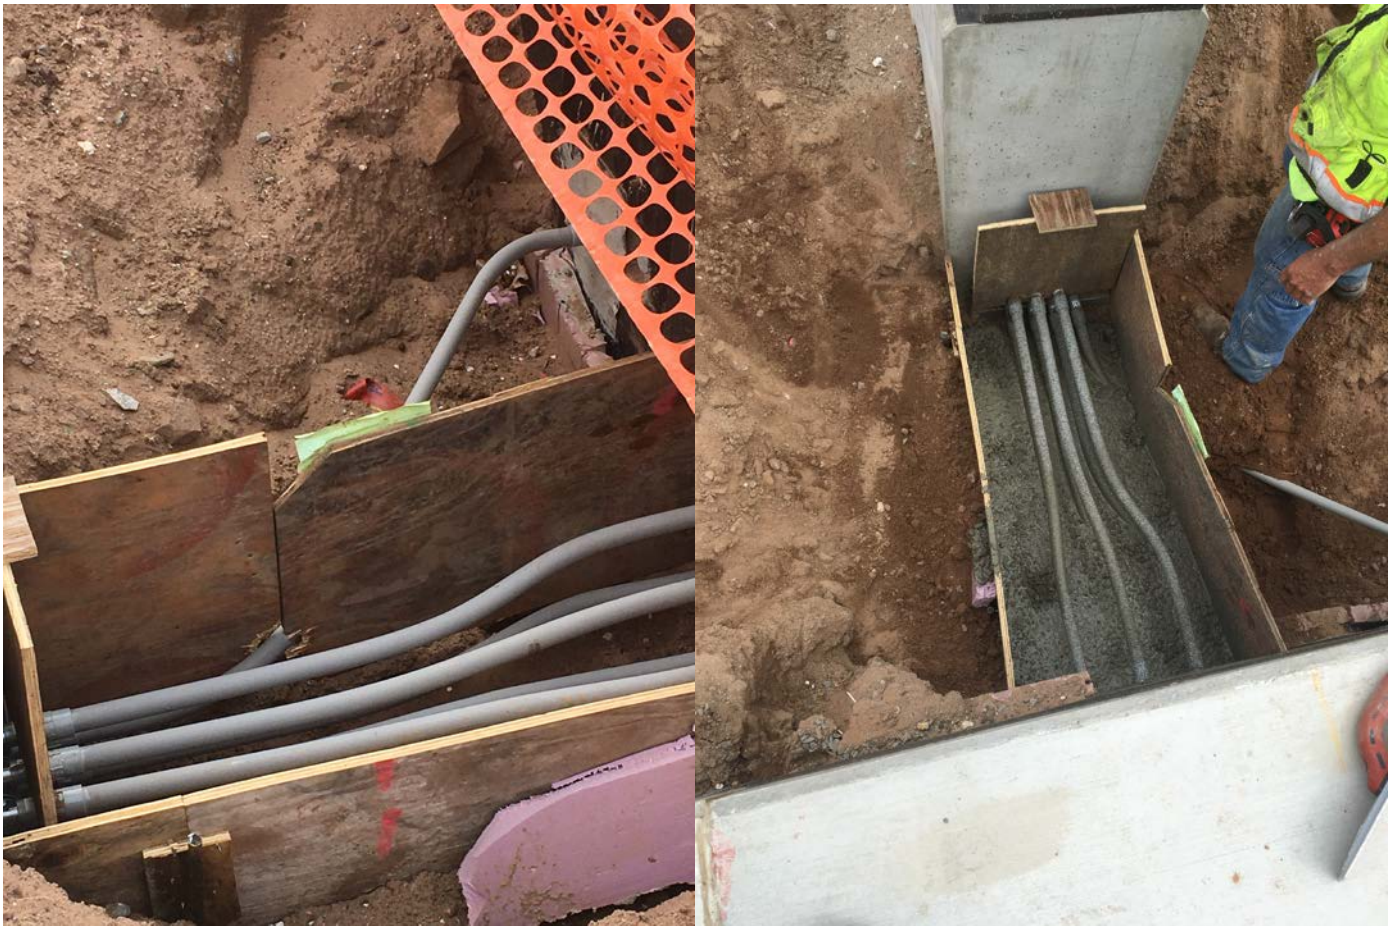
Picture 3: View of the form at the PRV vault near Routes 17 & 147. Note that Ludlow ran short of concrete and will need to complete the pour next week. The line not inside the form is the grounding line.

1055: Ludlow has mobilized the concrete truck to the PRV vault located near Routes 17 & 147. They begin place concrete but run out of concrete after only filling half of the form that is meant to prevent someone from accidentally excavating the communication/power conduits between the station and control panel. The conduit is still exposed just above the concrete. Ludlow says that they will complete next week when they have another concrete pour. Note that the grounding line is not in the form that protects the hot/active lines.

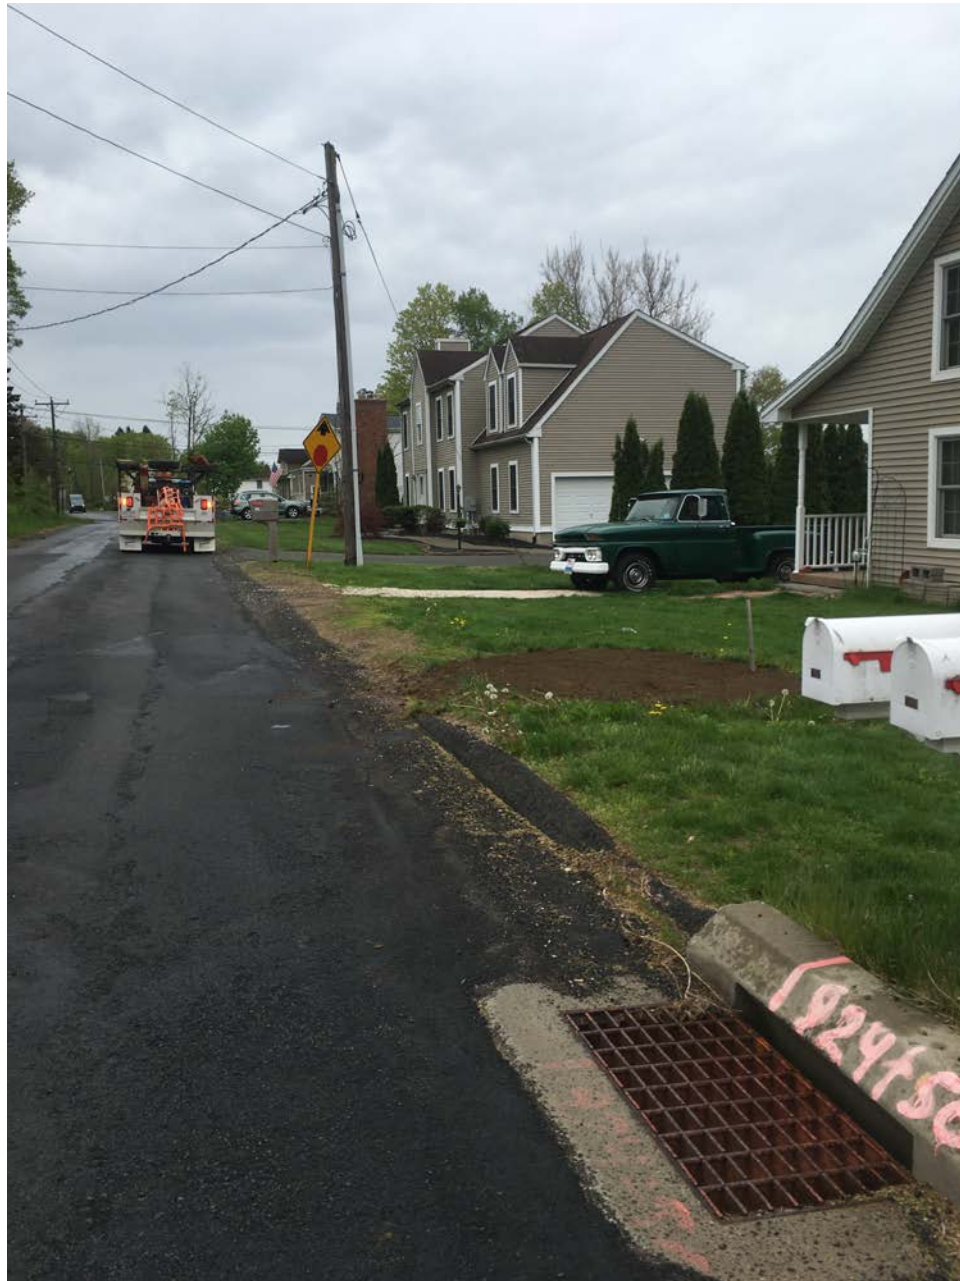
Picture 4: View to south. Ludlow restores water service trenches in response to complaints from homeowners at 166 Maple St. (foreground) and 172 Maple Street (in background).

1230: Ludlow prepares to head over to 166 and 172 Maple Street to repair lawns that have settled during the installation of water services.

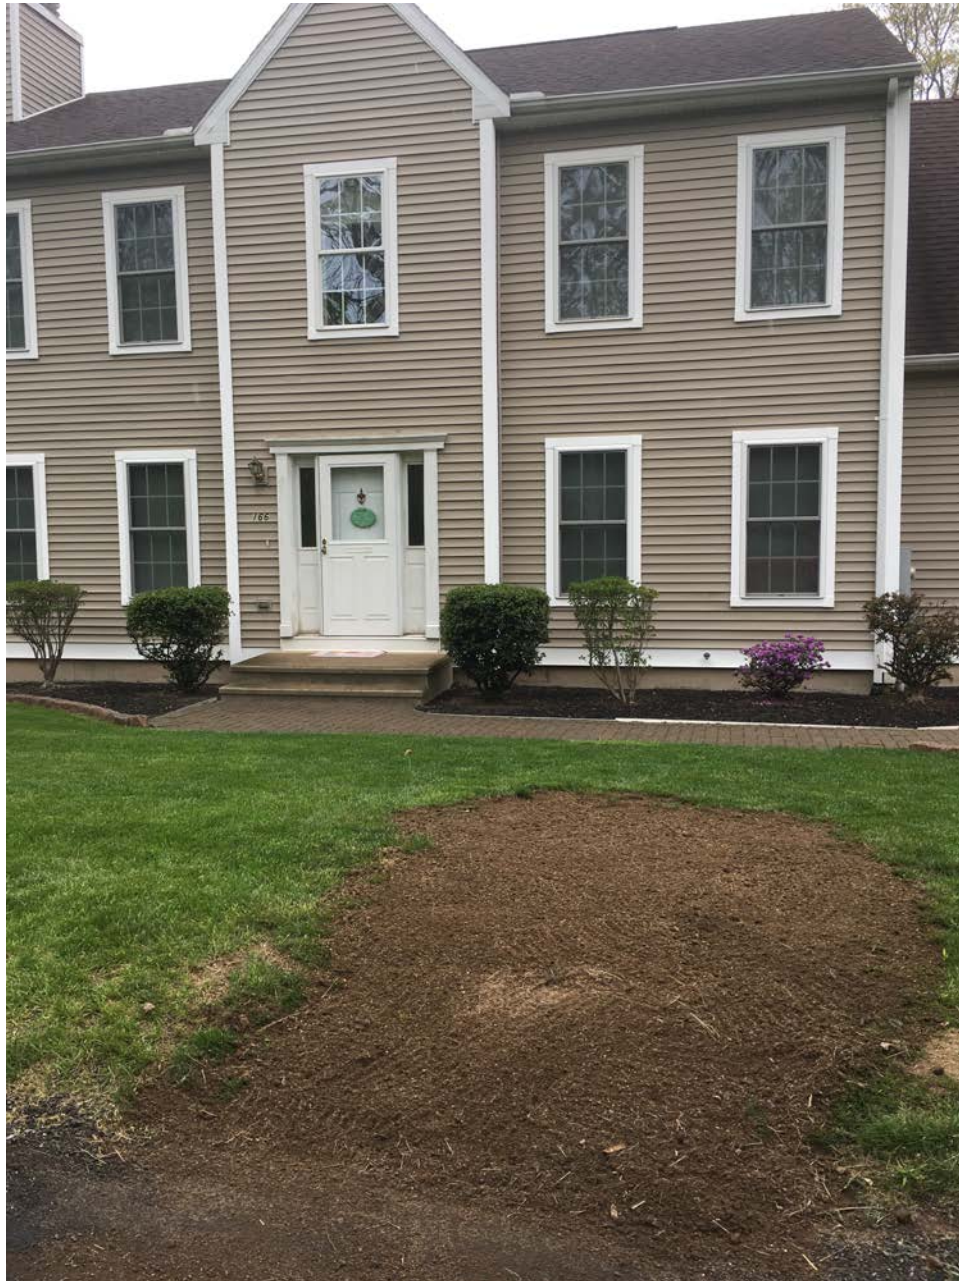
Picture 5: View to west of 172 Maple Street lawn repair. Water service trench settling was not acceptable to homeowner.

1350: Ludlow completes the Maple Street restorations and heads back to the Water Tank to make pipe preparations for continued 8" drainage work. They are not going to start any installation today due to time and rain starting.
