Daily Report

Project:	Durham Meadows Pipeline Installation	Date:	May 13, 2021
Location:	Booster Station Site, South Main Street, Middletown	Day of Week:	Thursday
Project #:	AECOM: 6061487	Report No:	242
Contractor:	Ludlow Construction	Page:	1 of 10

Pipe Connections, Installations, and Other Work

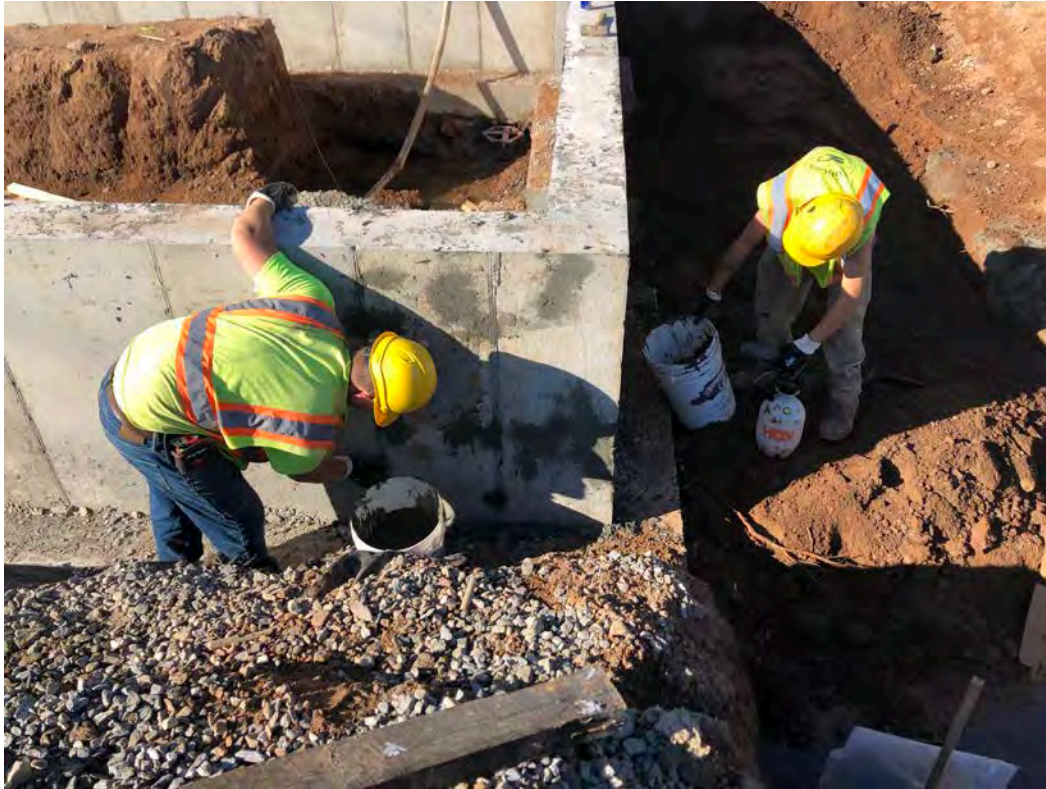
Picture 1: Ludlow filling minor imperfections on the exterior of the frost wall with grout.

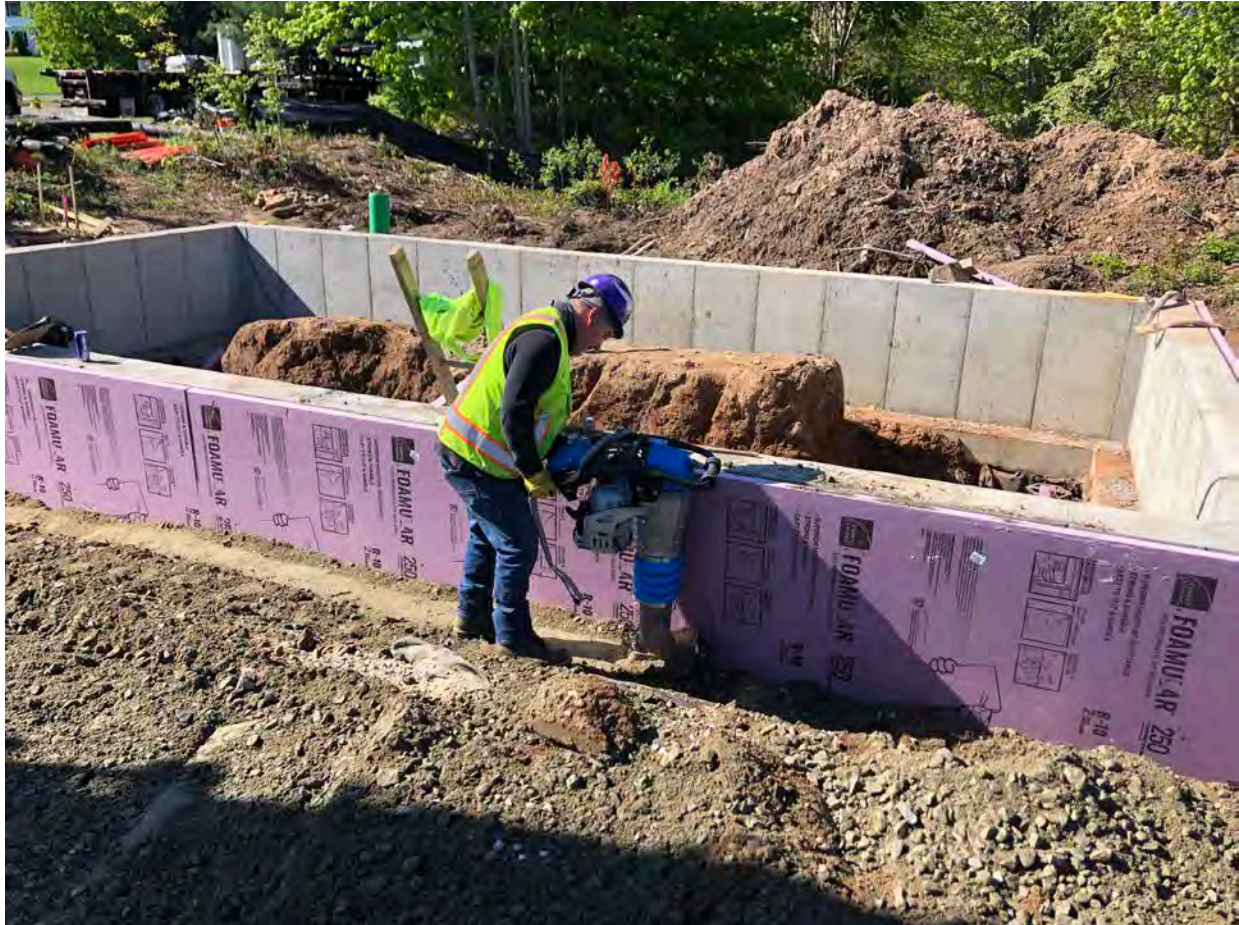
Picture 2: Ludlow compacting fill along the north side of the booster station with a jumping jack. Booster station work zone located at Station 750+63 South Main St. Middletown. View to the south.

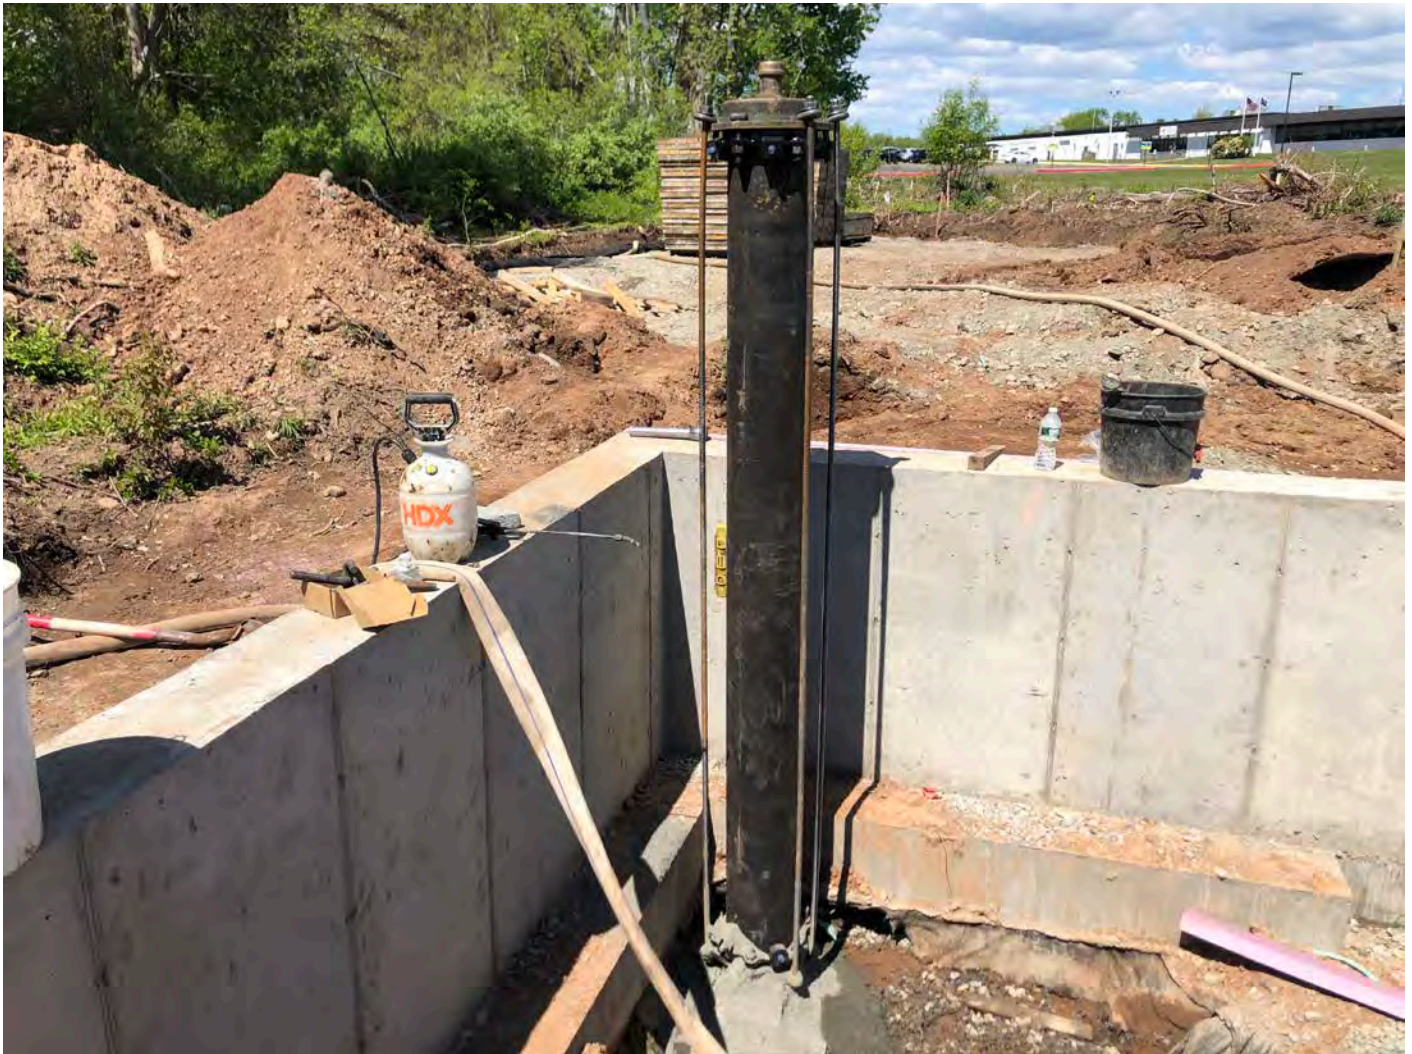
Picture 3: Section of 8" DIP that Ludlow installed on top of an 8" DIP 90° bend that is restrained with 1" threaded rods per United Concrete drawing A-3. Booster station work zone, Station 750+63, Middletown. View to the west.

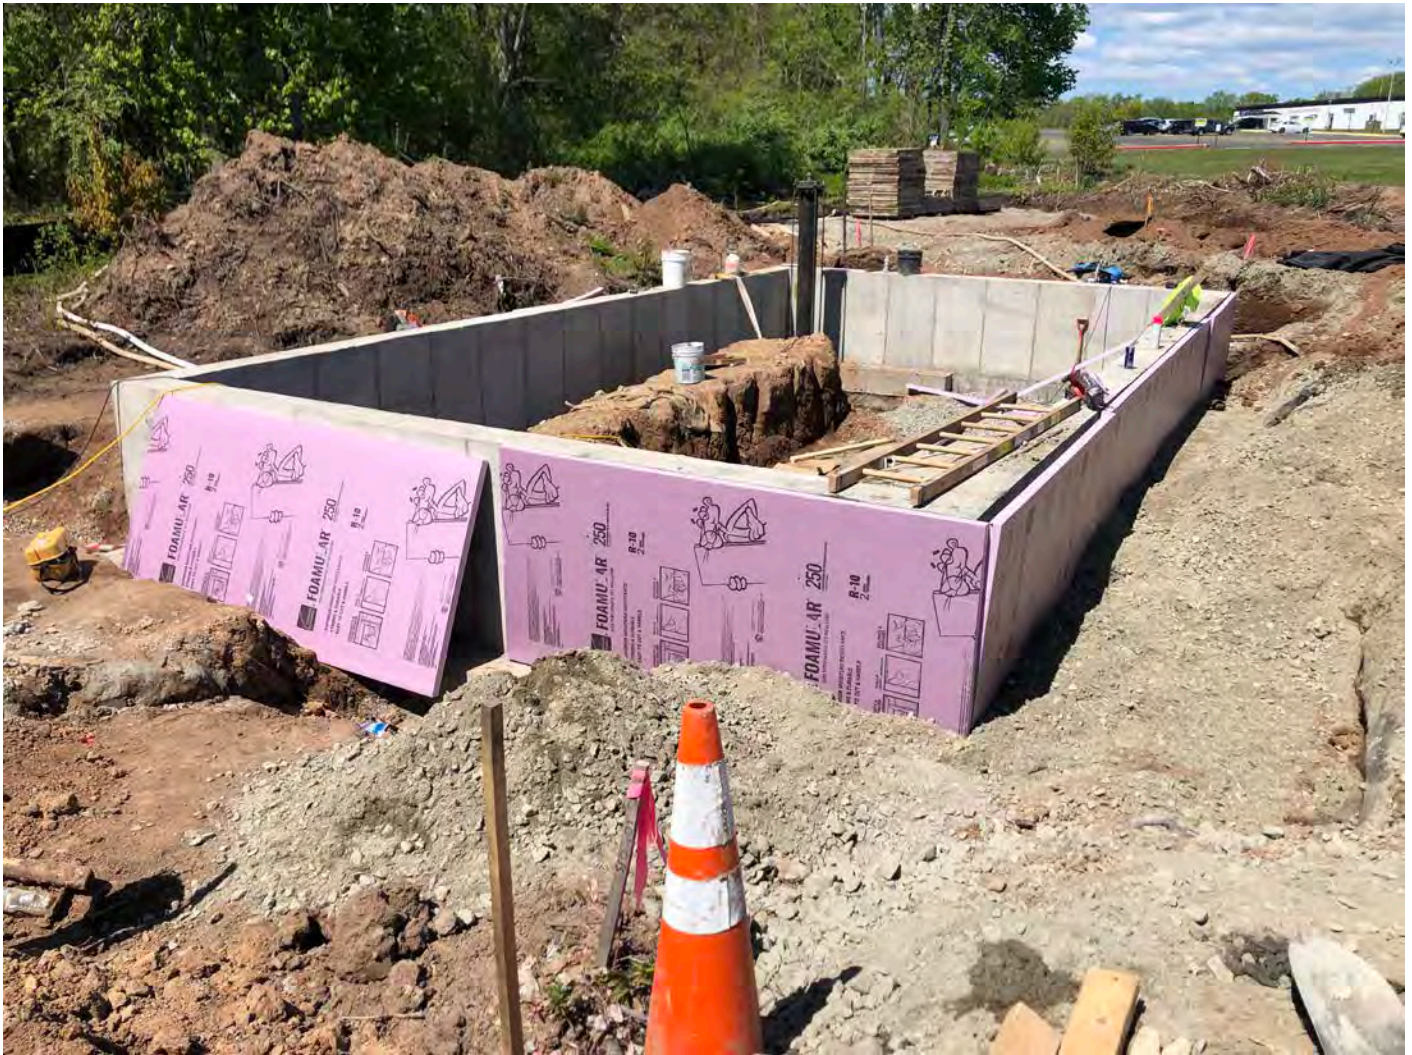
Picture 4: Booster station frost wall with 2" foam insulation panels being placed on the exterior. View to the west; booster station work zone located at Station 750+59 in Middletown.

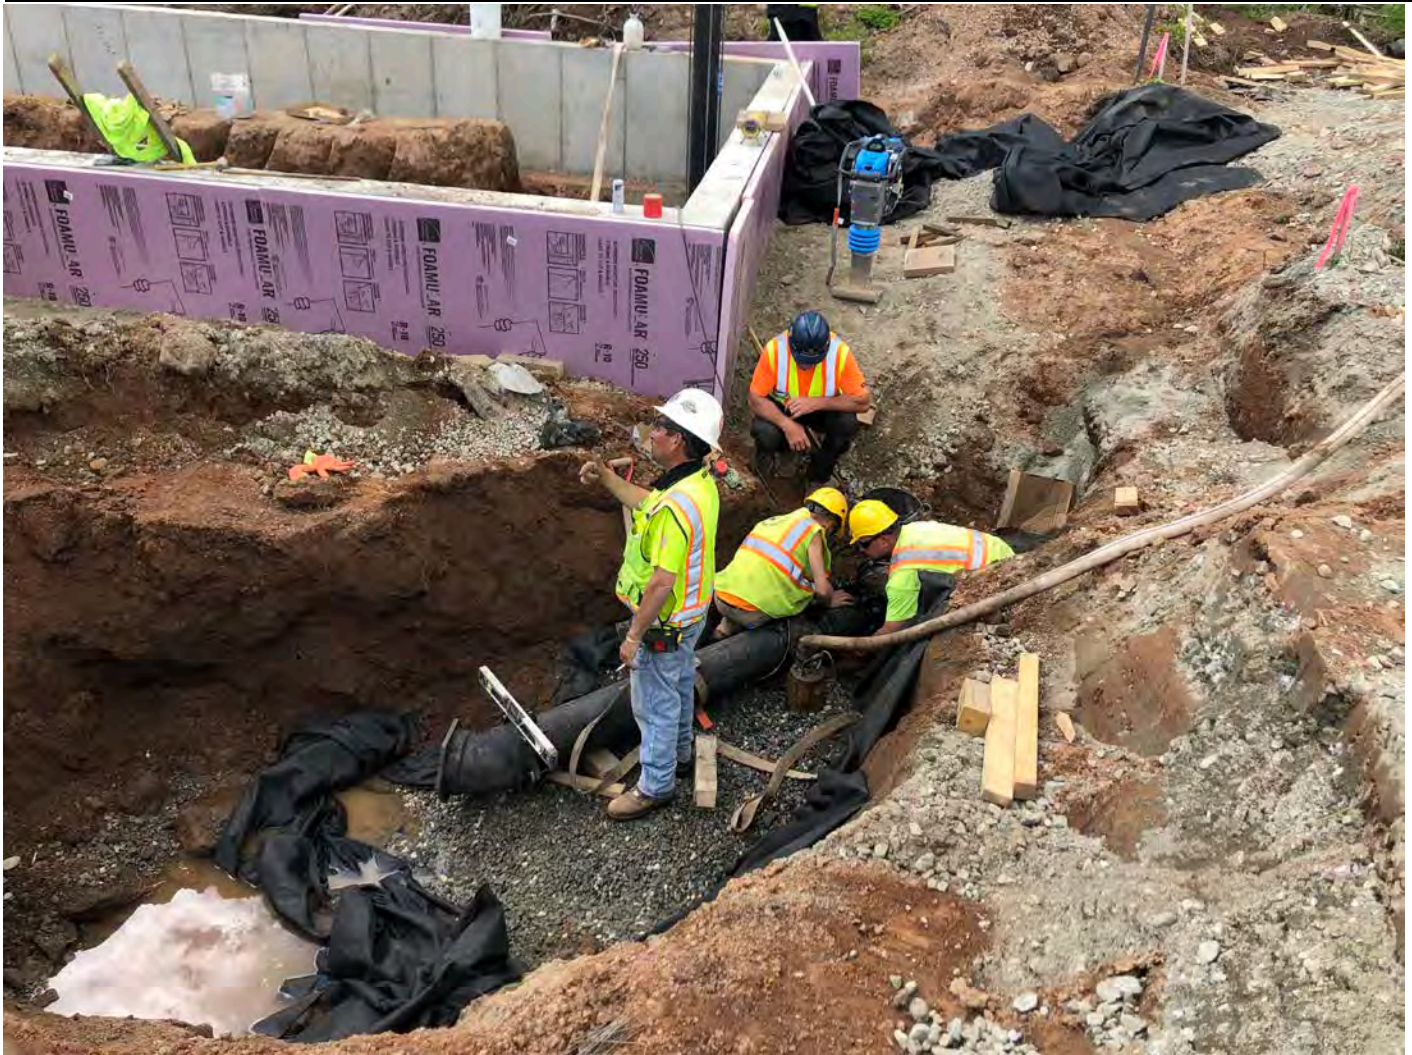
Picture 5: Ludlow installing 8" DIP with a 45° bend at the northwest corner of the booster station footprint. View to the southeast; Station 750+59 in Middletown.

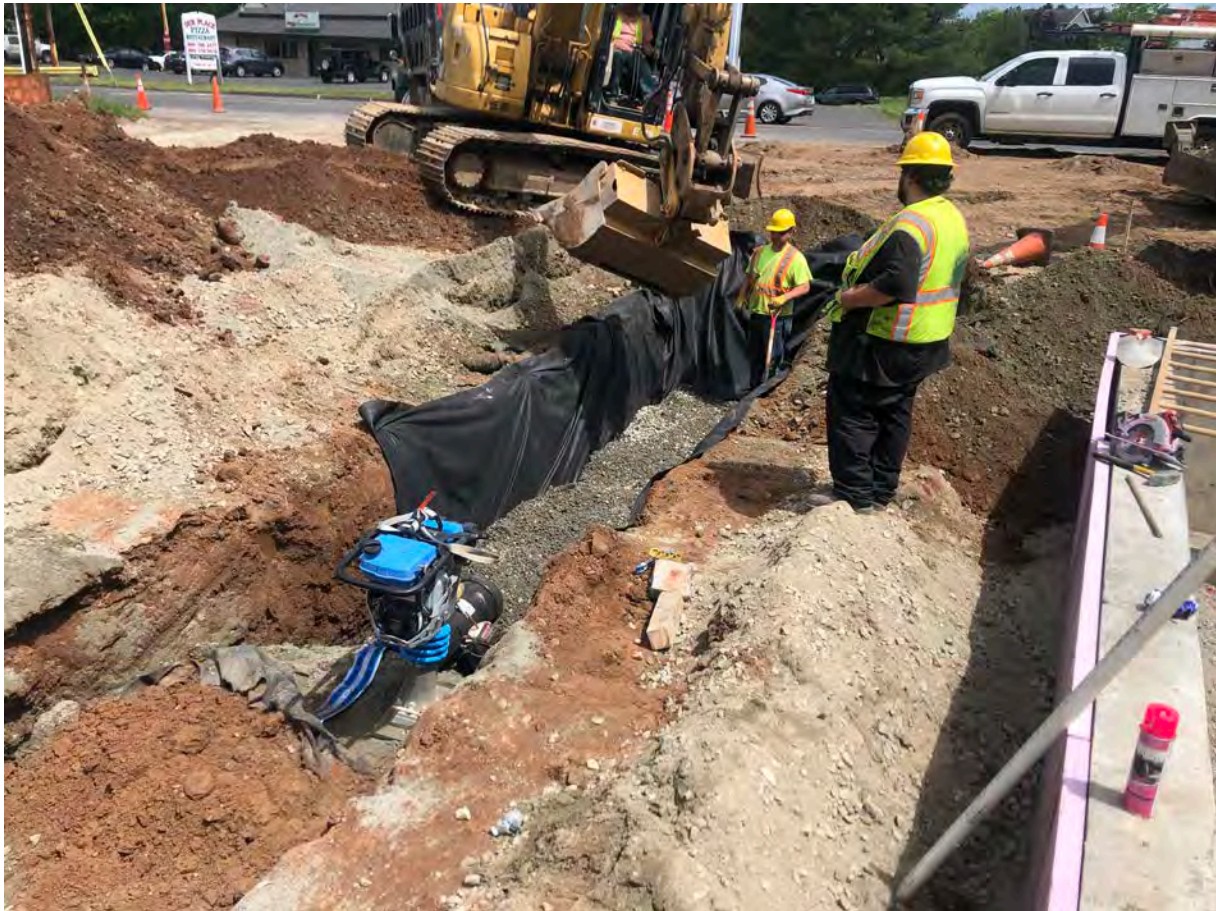
Picture 6: Ludlow placing geofabric and ¾" gravel as they prepare the bedding for the 8" DIP suction they are installing on the north side of the booster station located at Station 750+63. View to the east.

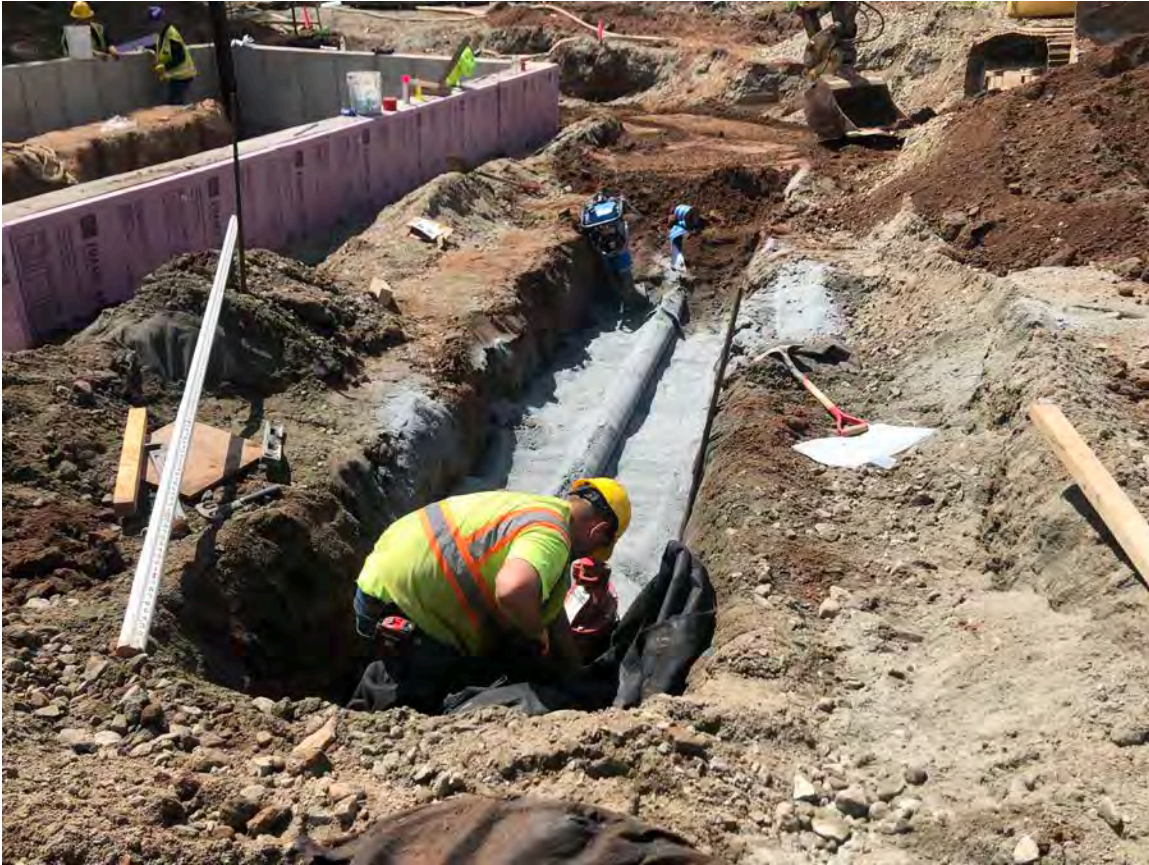
Picture 7: Ludlow in the process of installing 8" DIP on the north side of the booster station located at Station 750+63. View to the west.

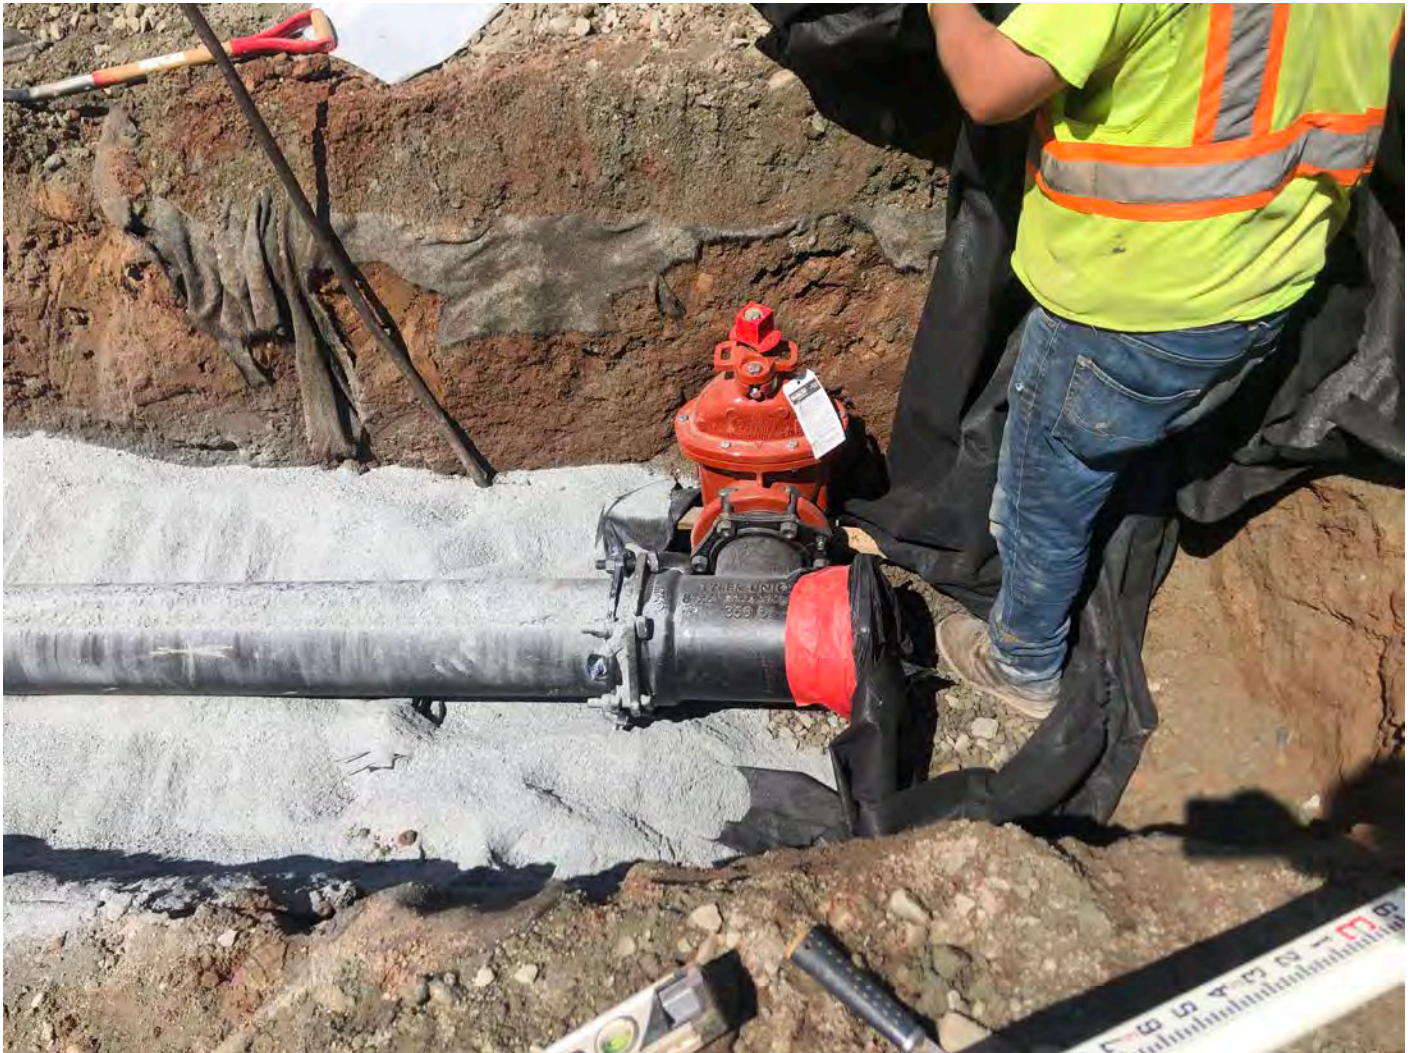
Picture 8: An 8"x8"x6" M.J. C.D.L.I. TEE with a 6" M.J gate valve that Ludlow installed on the 8" DIP line they are running along the north side of the booster station footprint. View to the north.
