## Daily Report

| <b>Project:</b> | Durham Meadows Pipeline Installation | <b>Date:</b> | June 1, 2021 |
| <b>Location:</b> | S. Main Street, Middletown | <b>Day of Week:</b> | Tuesday |
| <b>Project #:</b> | AECOM: 6061487 | <b>Report No:</b> | 254 |

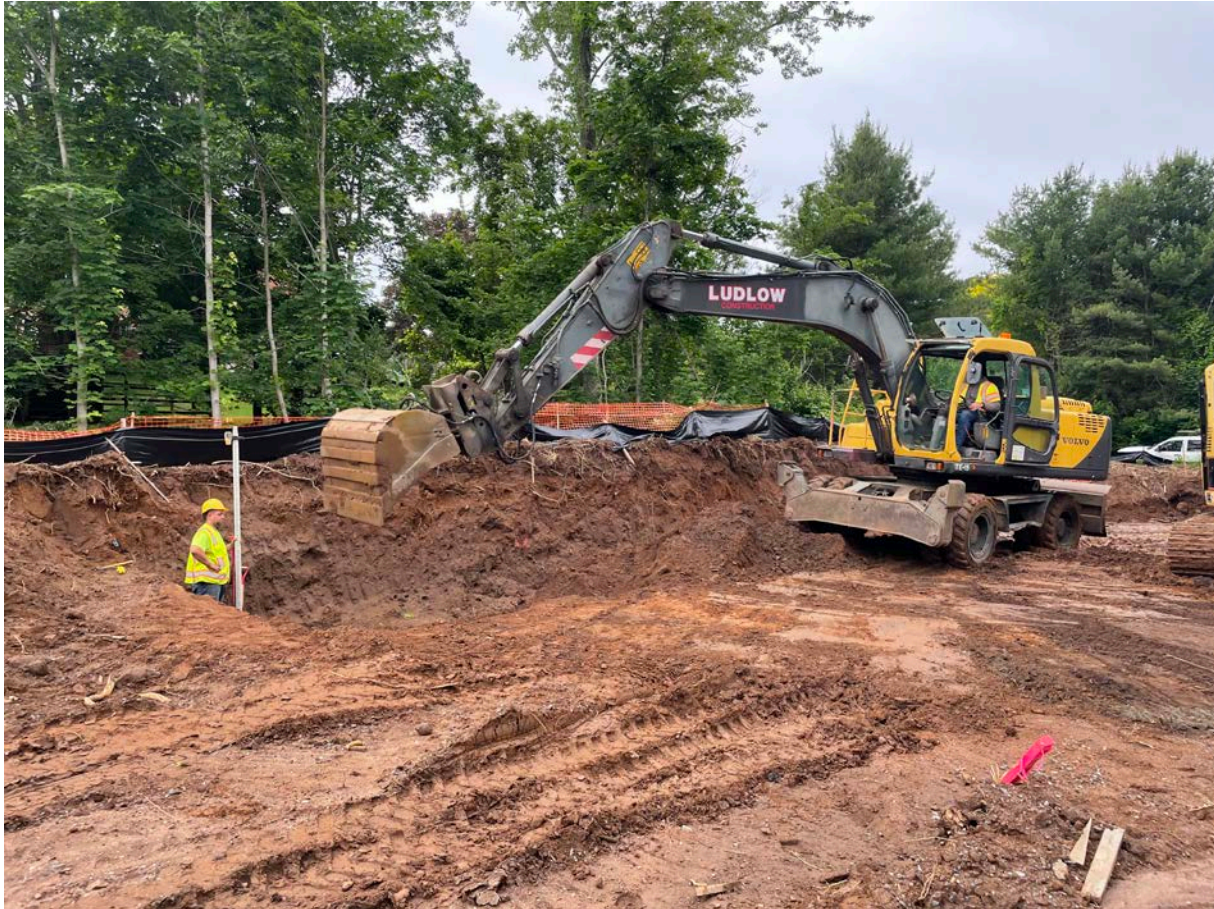
Picture 1: Ludlow continuing earthwork at the footprint of the water meter vault located at ~Station 124+80 on S. Main Street in Middletown. View to the south.

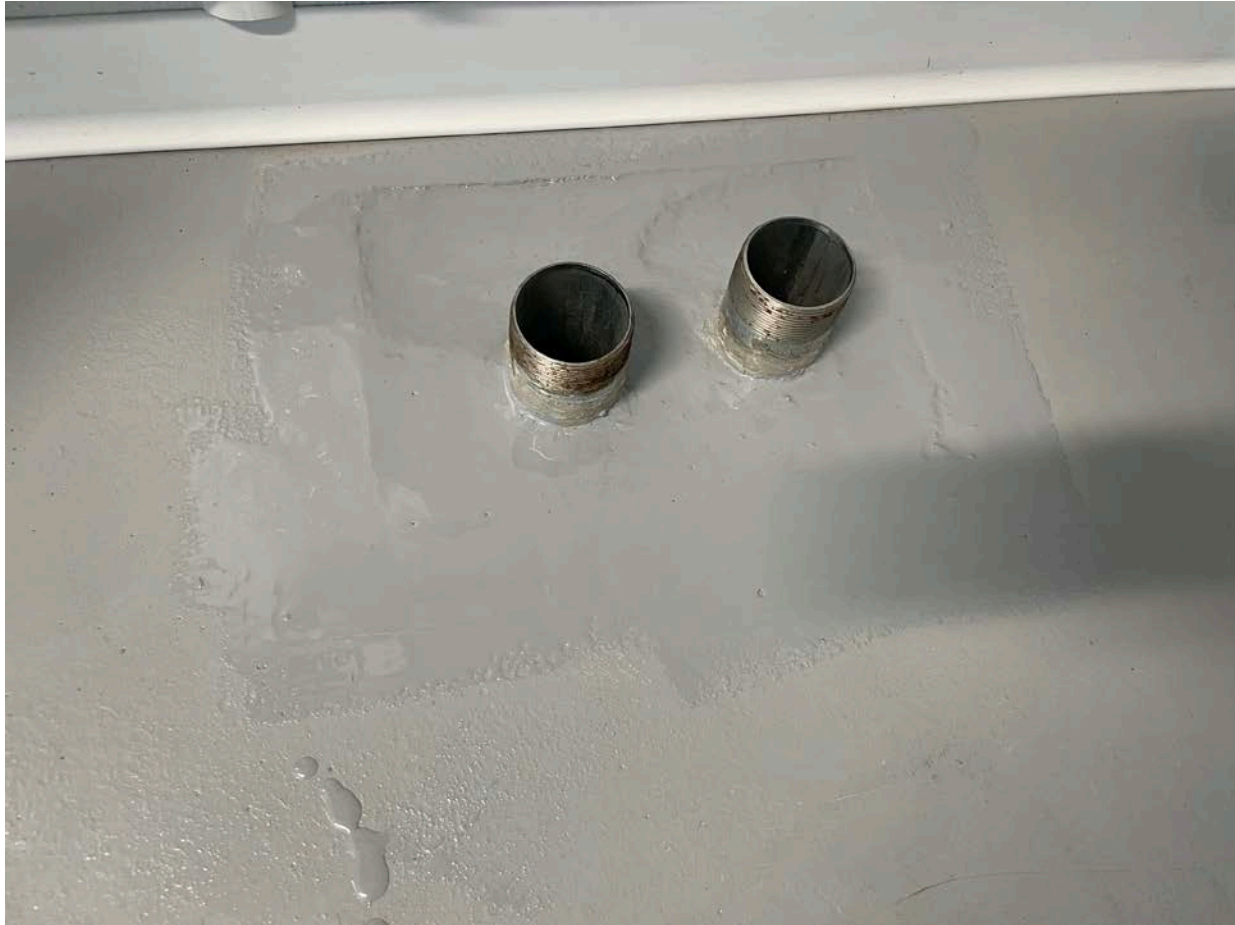
0910: United Concrete continues to install wire conduits on the underside of the PLC pump cabinet. AECOM noted that concrete patches around piping on the booster station floor have been coated with the same epoxy-based paint that the booster station floor was coated with.

**Picture 2: Concrete patch around conduits located on the floor of the booster station that were sealed off with the same epoxy-based paint that the booster station floor was coated with.**

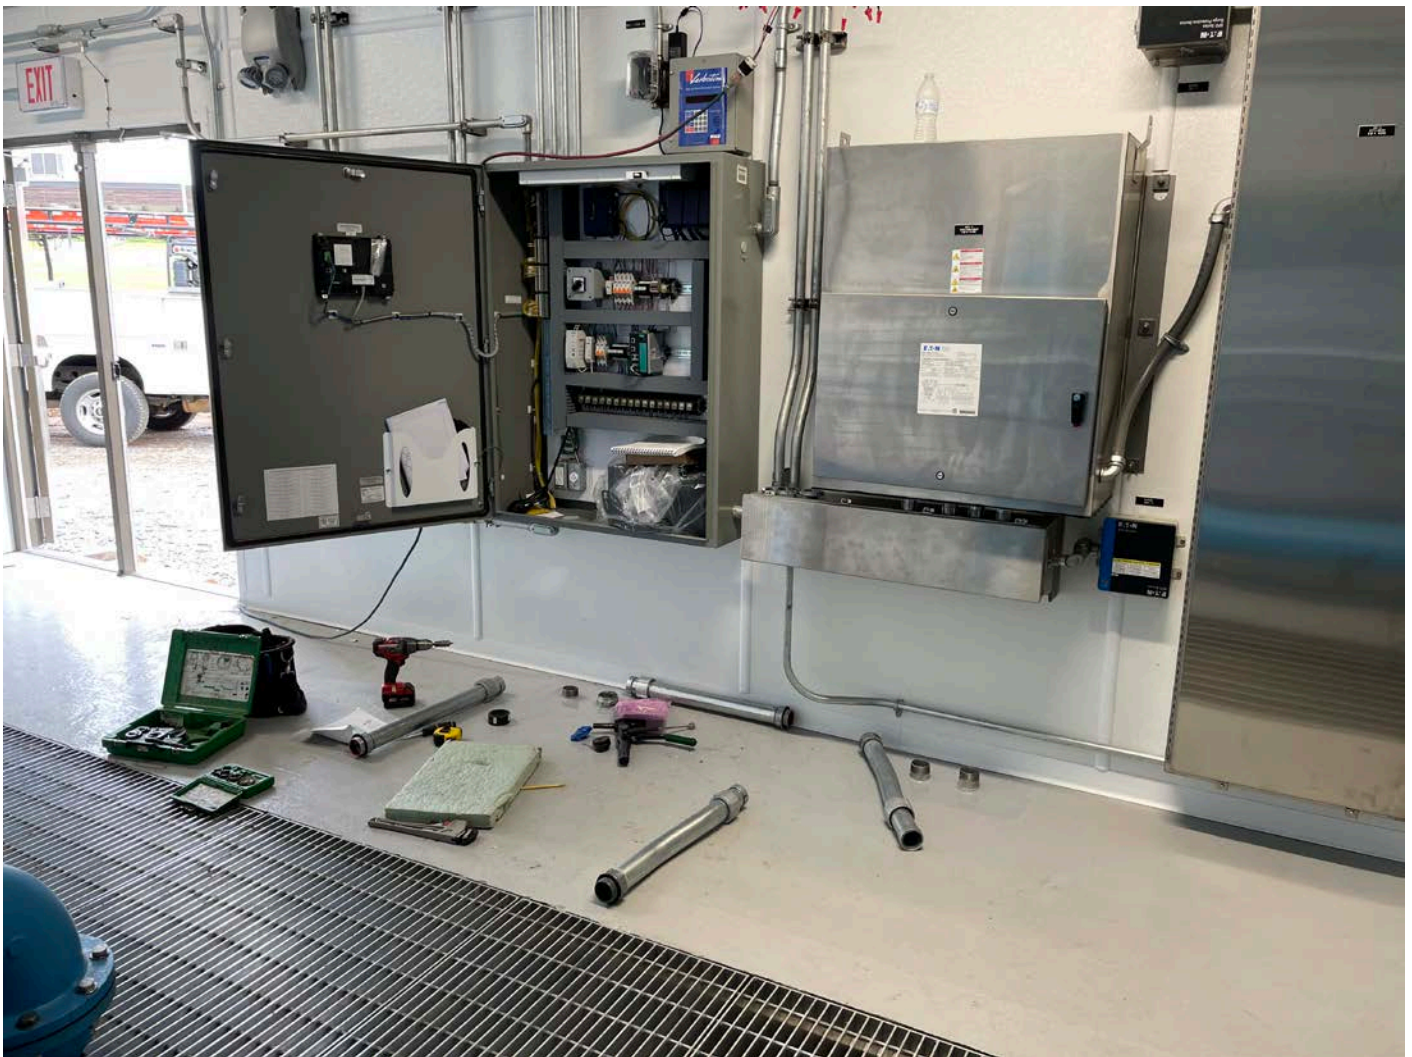
1041: United Concrete continues to install wire conduits on the underside of the PLC pump cabinet. They have one of the 2" steel conduits installed so far.

Picture 3: United Concrete installing conduits on the underside of the PLC pump cabinet located inside of the booster station at Station 750+63. View to the northwest.

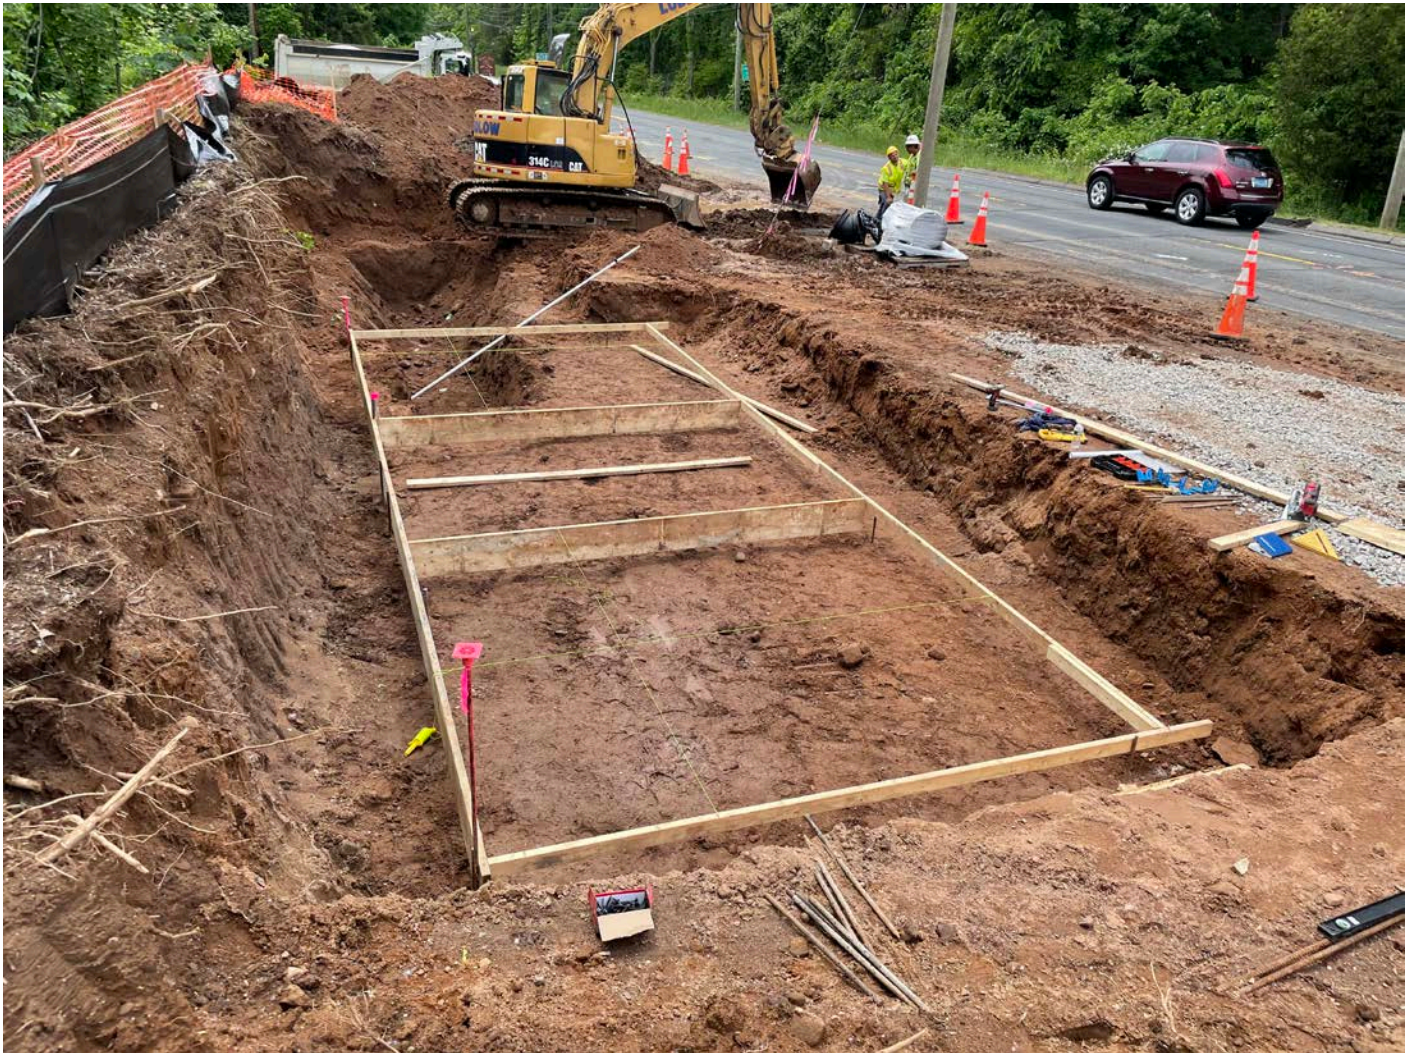
1029: Ludlow is laying out a wooden framework within the footprint of the water meter vault that will assist them in the accurate placement of piping going in and out of the vault.

**Picture 4: Ludlow in the process of laying out a wooden framework within the footprint of the water meter vault that will assist them in the accurate placement of piping going in and out of the vault. View to the southeast.**

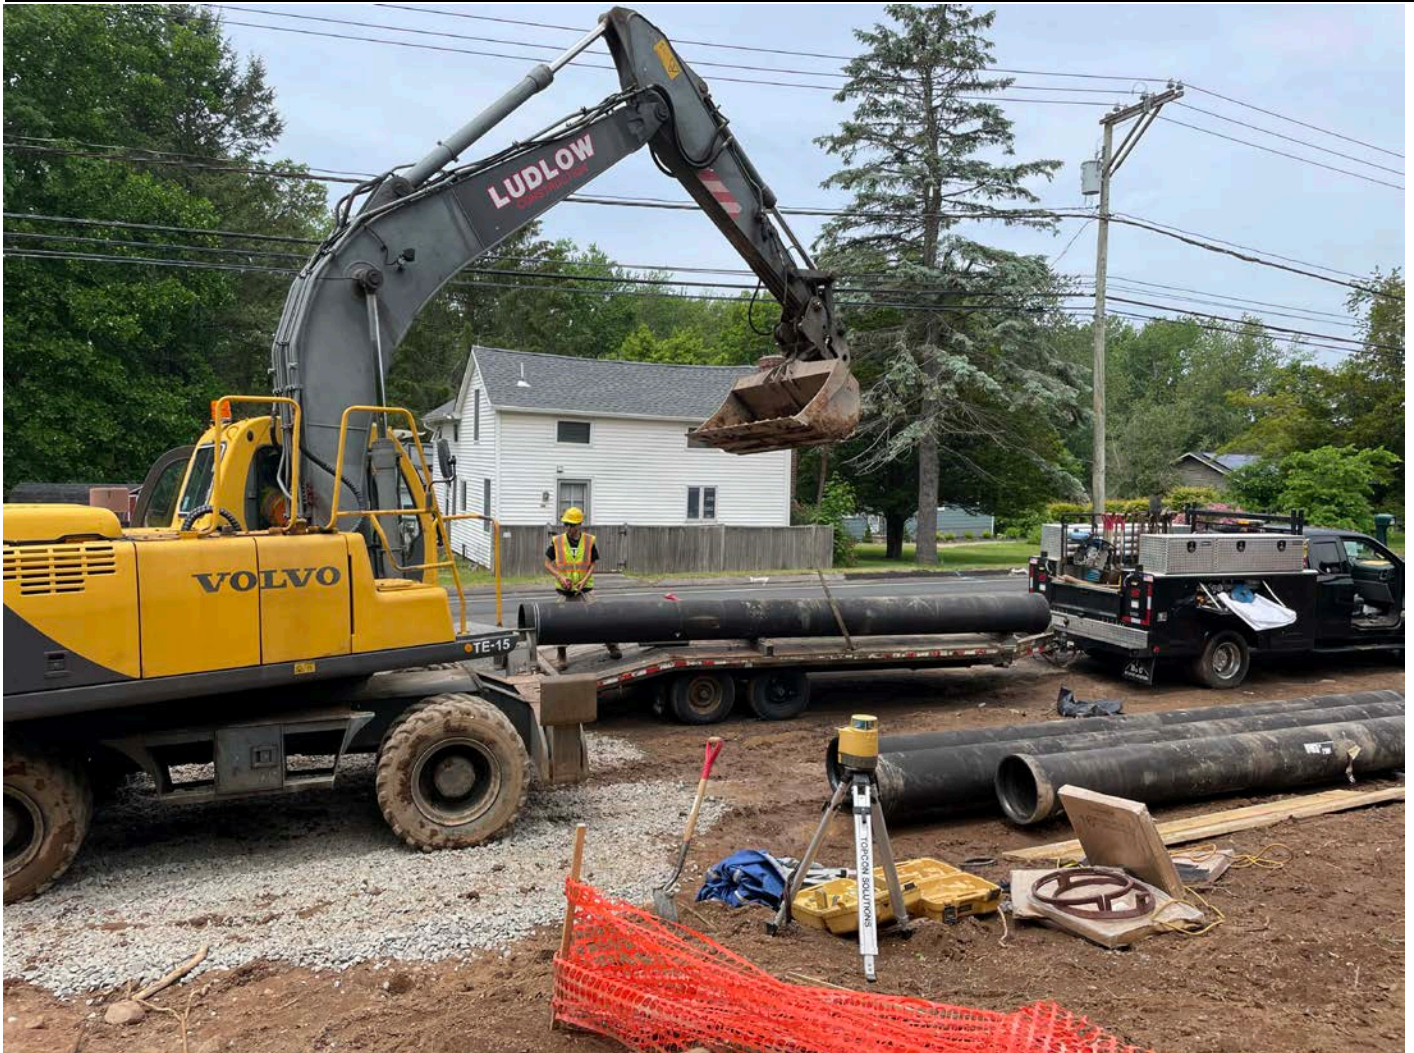
Picture 5: Ludlow offloading 16" DIP at the water meter vault work zone located at ~Station 124+80 on S. Main Street in Middletown. View to the northwest.

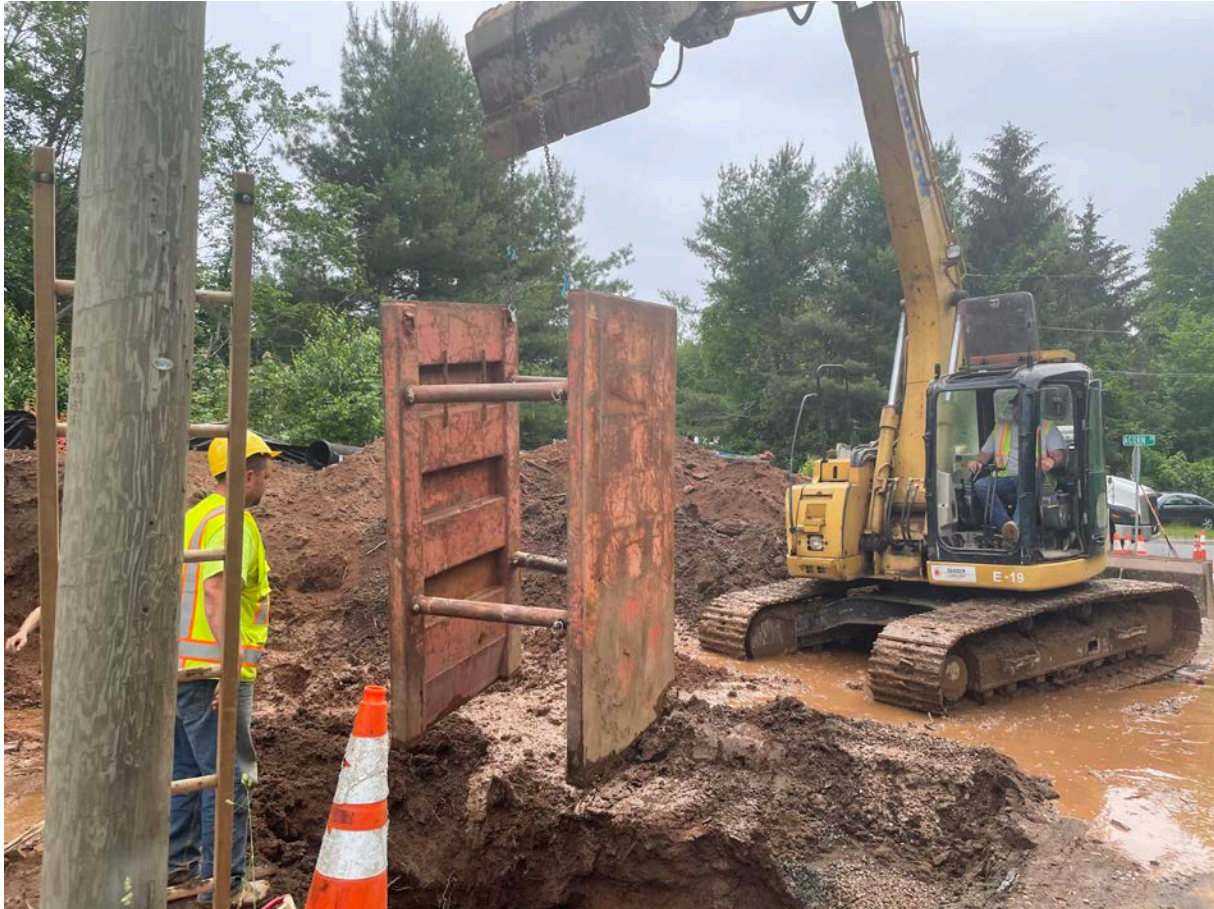
1305: Ludlow places a trench box in the excavation located at Station 125+20 where they have daylighted the section of 16" DIP.

Picture 6: Ludlow placing a trench box on the east side of S. Main Street in Middletown as they excavate at Station 125+20 for the installation of 16" DIP. View to the south.

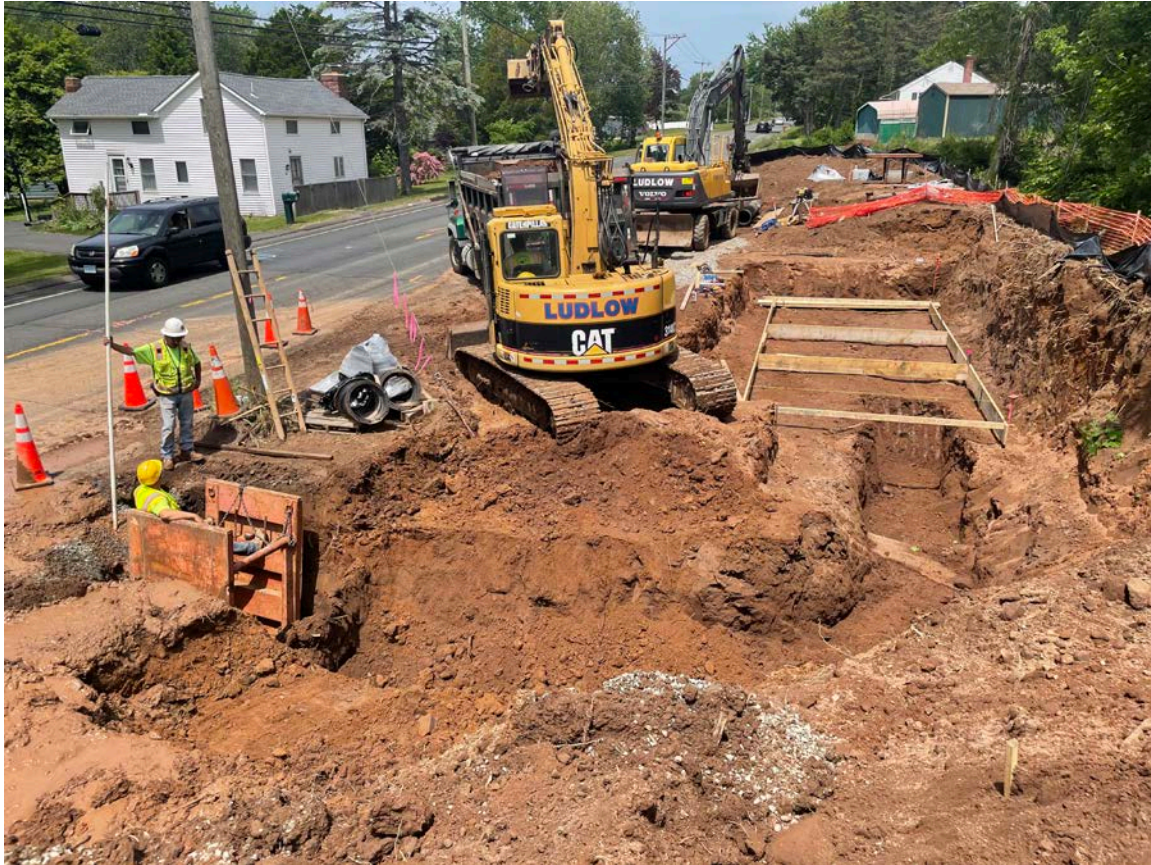
Picture 7: Overview of excavation activities at Station 125+20, and the water meter vault work zone. View to the northwest.

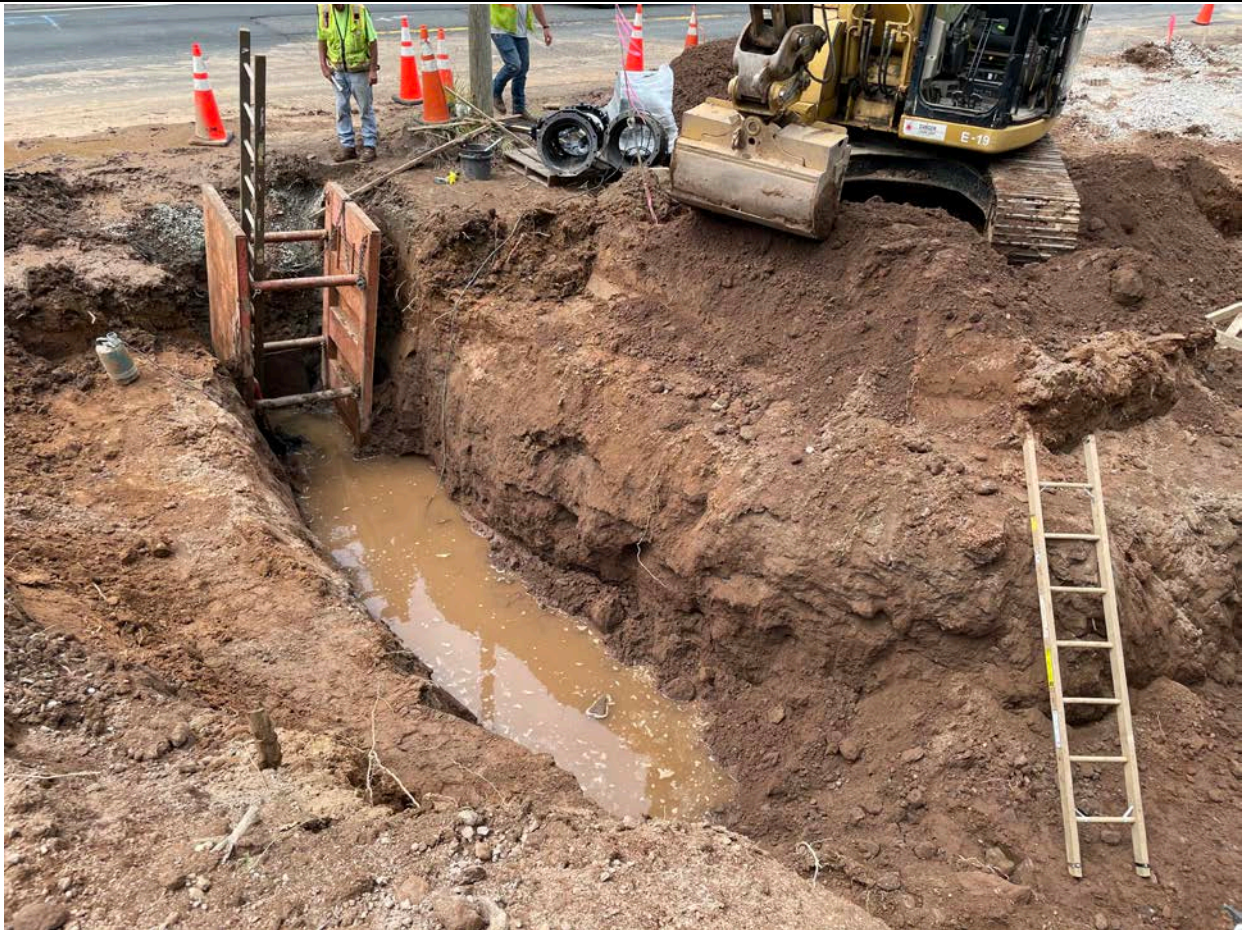
1428: The excavation at the water meter vault has some water running into it, coming from the bedding located beneath the 16" DIP that crosses under S. Main Street at Station 125+20. Ludlow places a pump in the excavation at Station 125+20 to move some of the water out of the trench.

**Picture 8: Water in the excavation located at the water meter vault work zone that came from beneath the 16” DIP that crosses S. Main Street at Station 125+20. View to the west.**

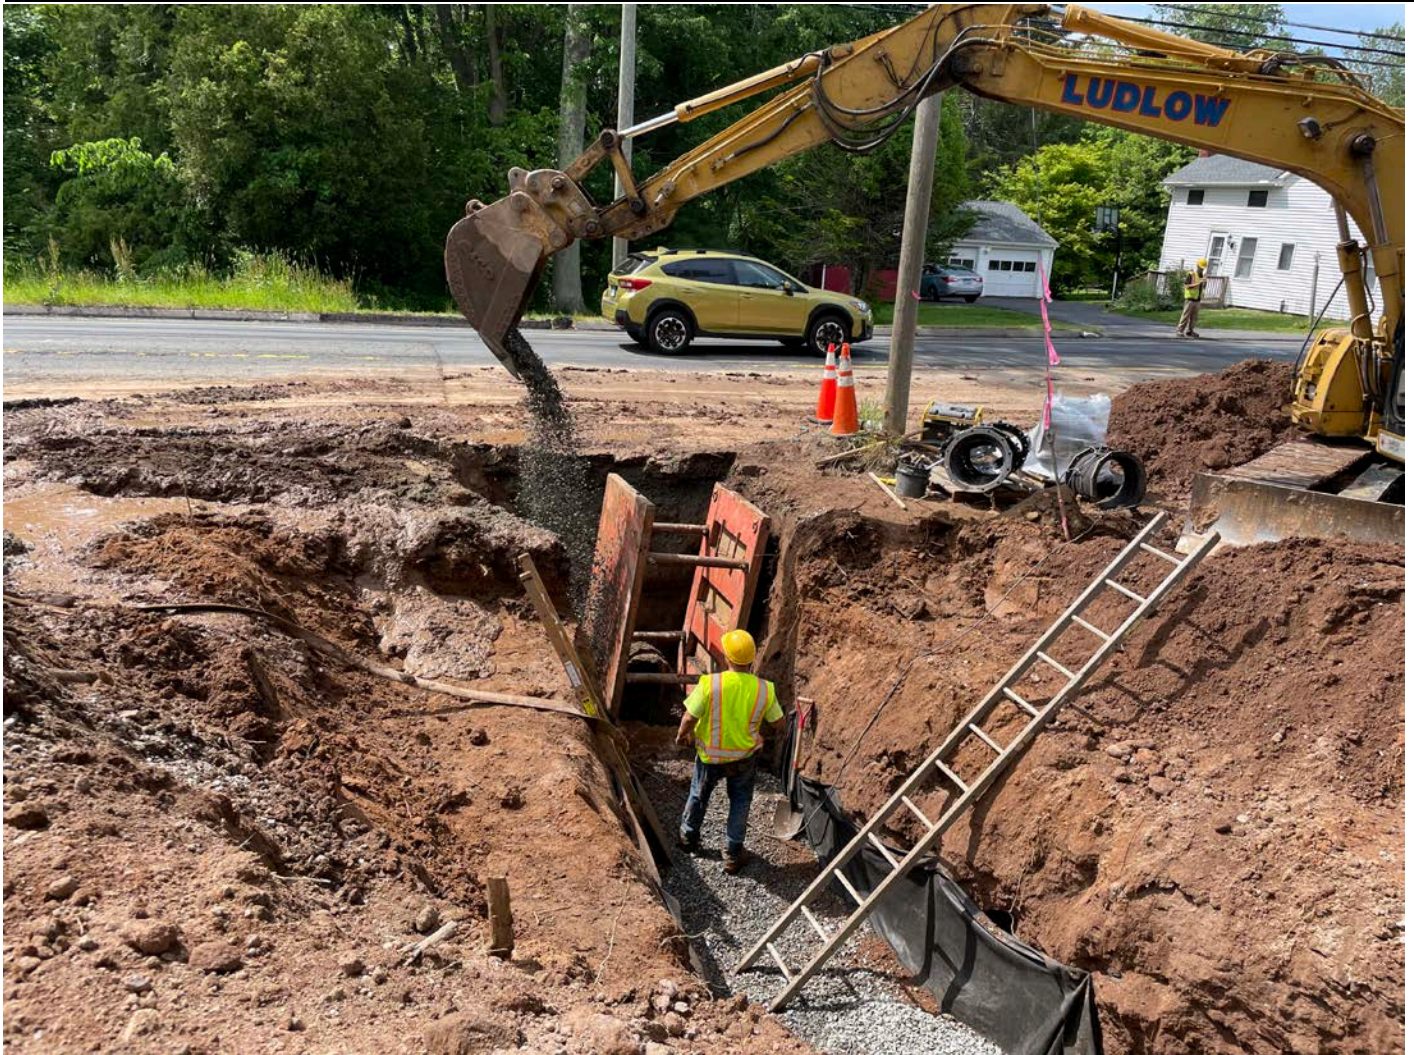
1435: Ludlow is preparing to pump water out of the excavation and into the catch basin located at ~Station 125+85. The catch basin has been covered with 2 layers of geofabric and a layer of ¾" stone.

Picture 9: Ludlow placing 3/4" stone around a pump that is moving water from the excavation at Station 125+20 on S. Main Street, Middletown. View to the west.
