Daily Report

Project:	Durham Meadows Pipeline Installation	Date:	June 3, 2021
Location:	S. Main Street and the Shared Access Driveway, Middletown	Day of Week:	Thursday
Project #:	AECOM: 6061487	Report No:	256
Contractor:	Ludlow Construction	Page:	1 of 9

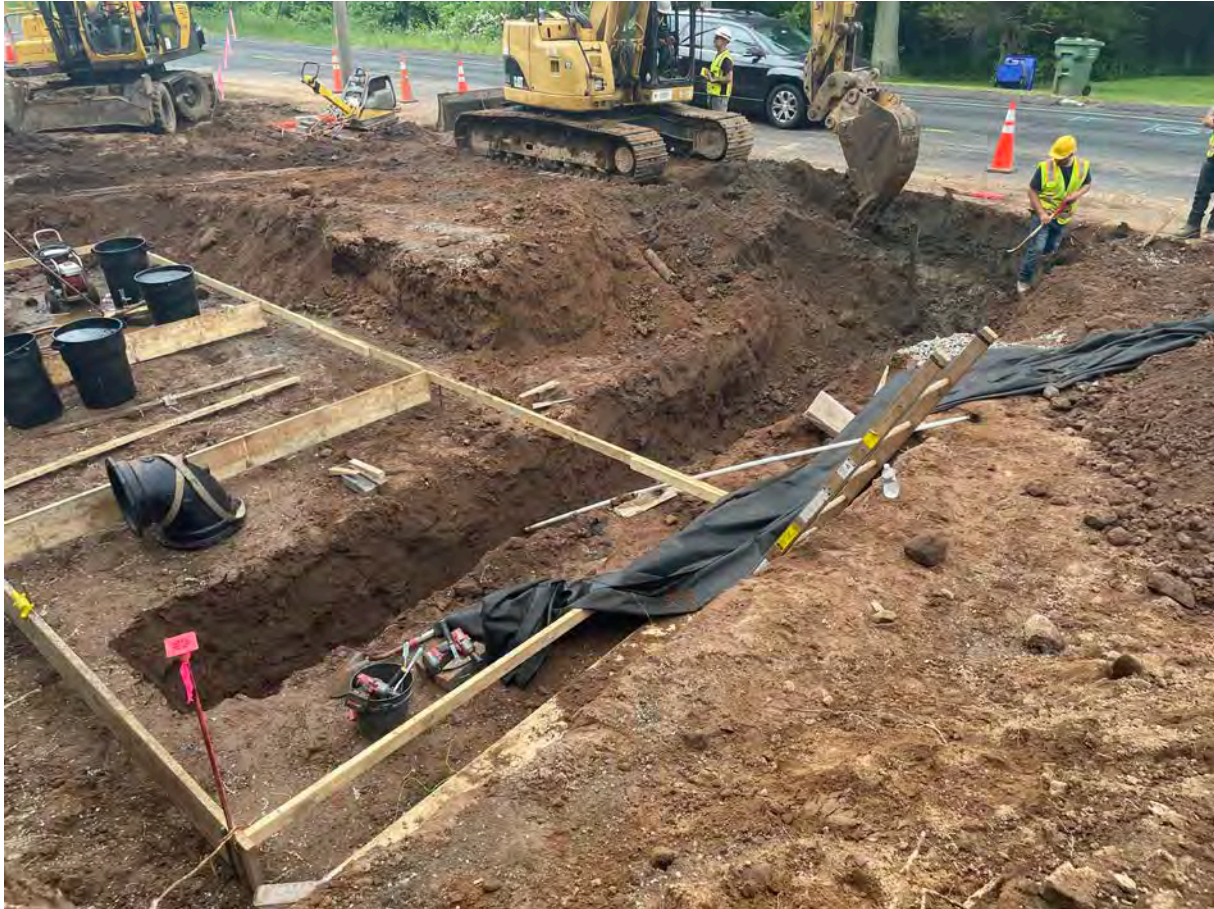
Picture 1: Ludlow excavating at and east of Station 801+00 for the installation of 16" DIP. View to the southwest.

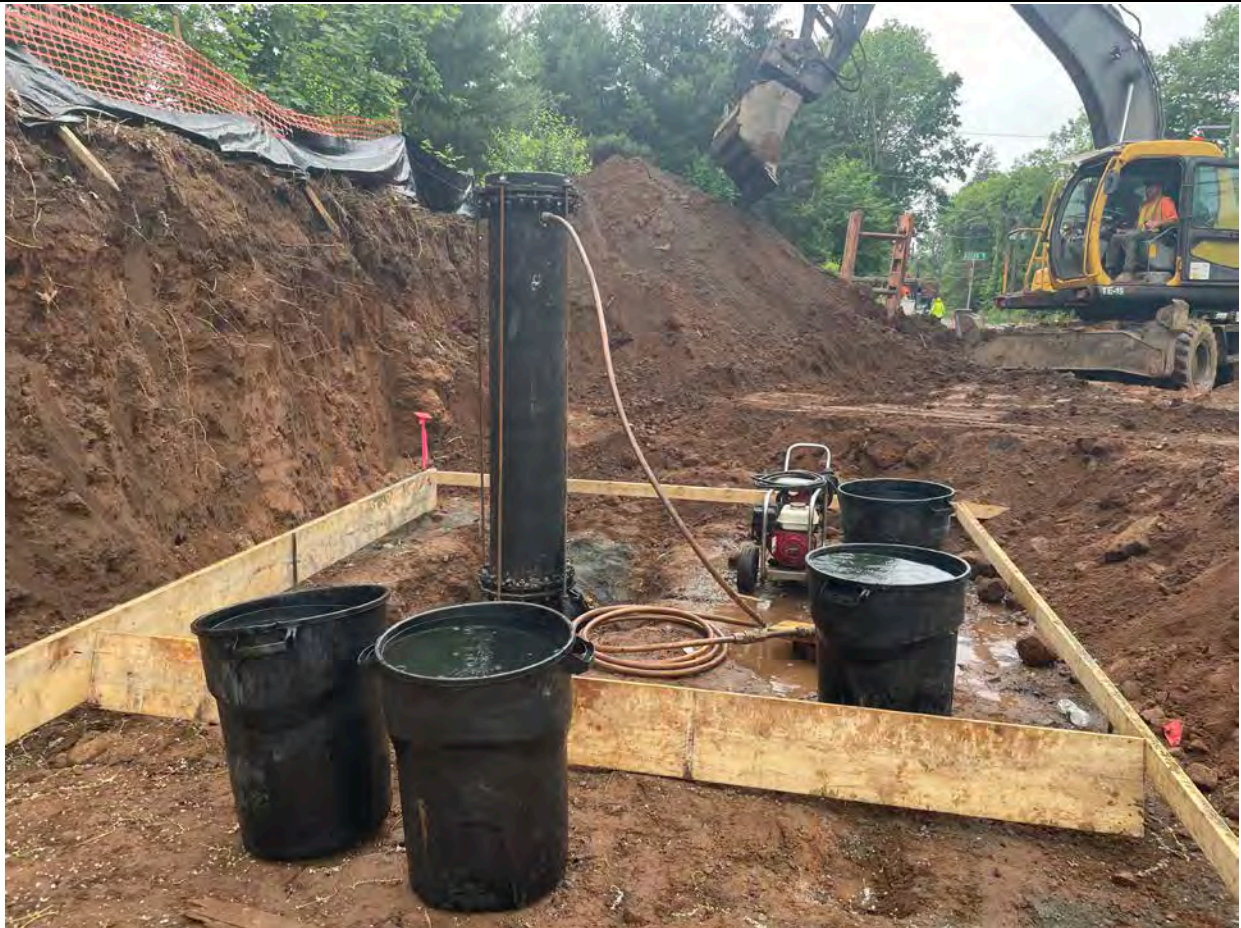
1000: Ludlow starts a pressure test on the section of 16" DIP that they previously installed on the south side of the water meter vault footprint. Starting pressure on the test is 150 PSI.

1209: Ludlow has ended the pressure test on the section of 16" DIP that they previously installed on the south side of the water meter vault footprint. The end pressure of the test was 148 PSI.

Picture 2: 16" Ludlow conducting a pressure test on the 16" DIP they previously installed on the south side of the water meter vault footprint. View to the south.

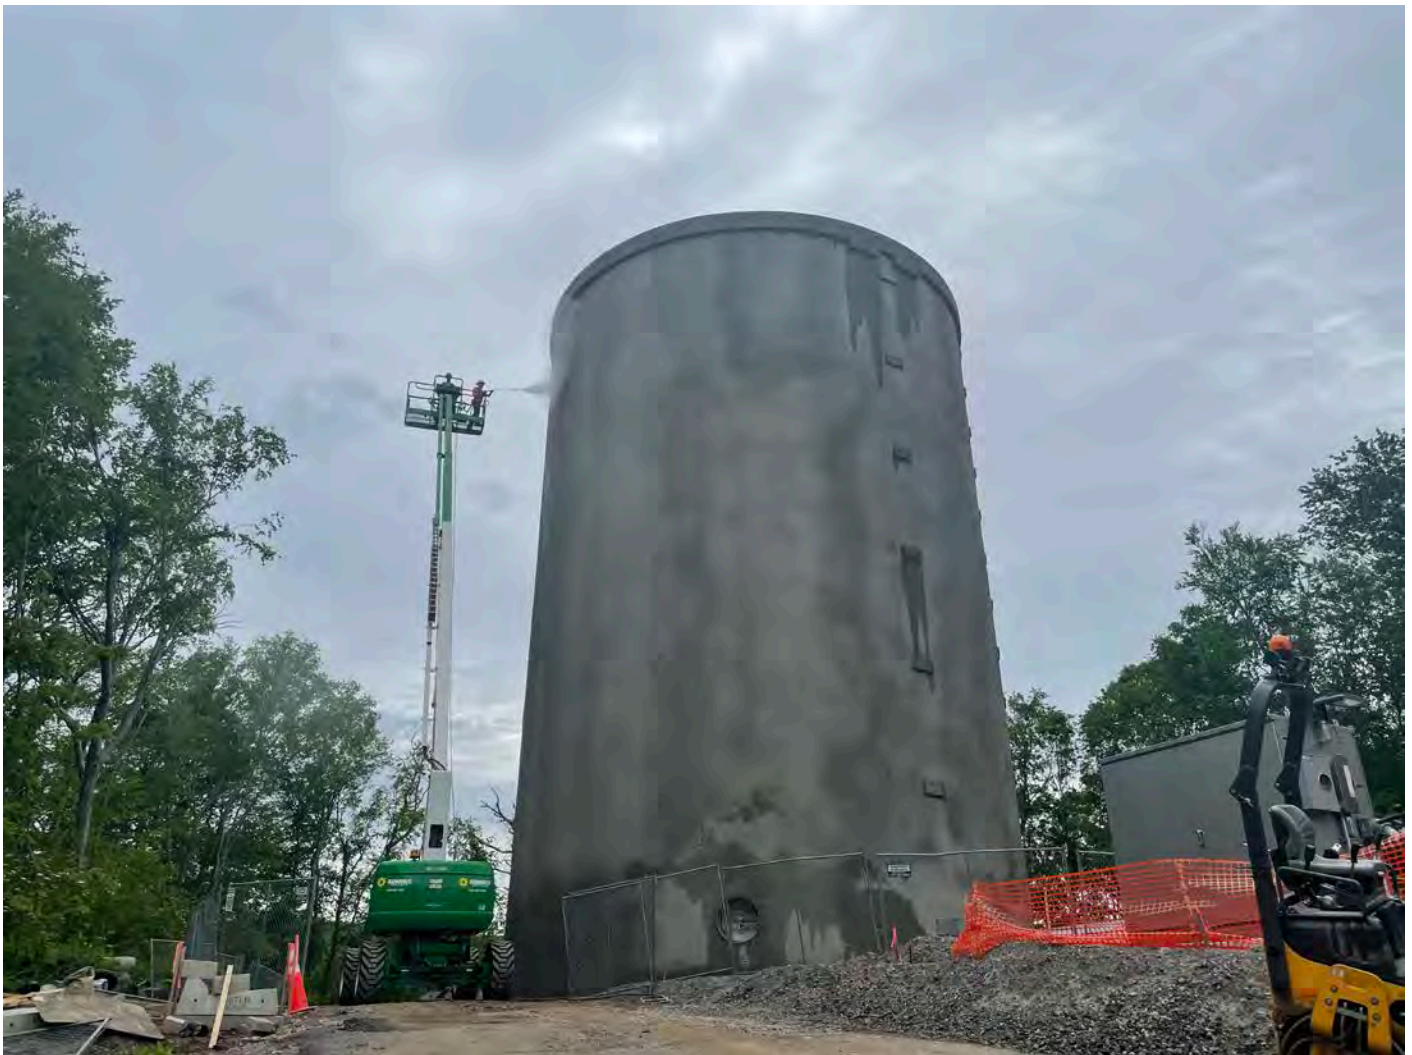
Picture 3: DN Tanks pressure washing the exterior of the water tank located east of the Shared Access Driveway in Middletown as they prepare to place the final coating on the tank. View to the east.

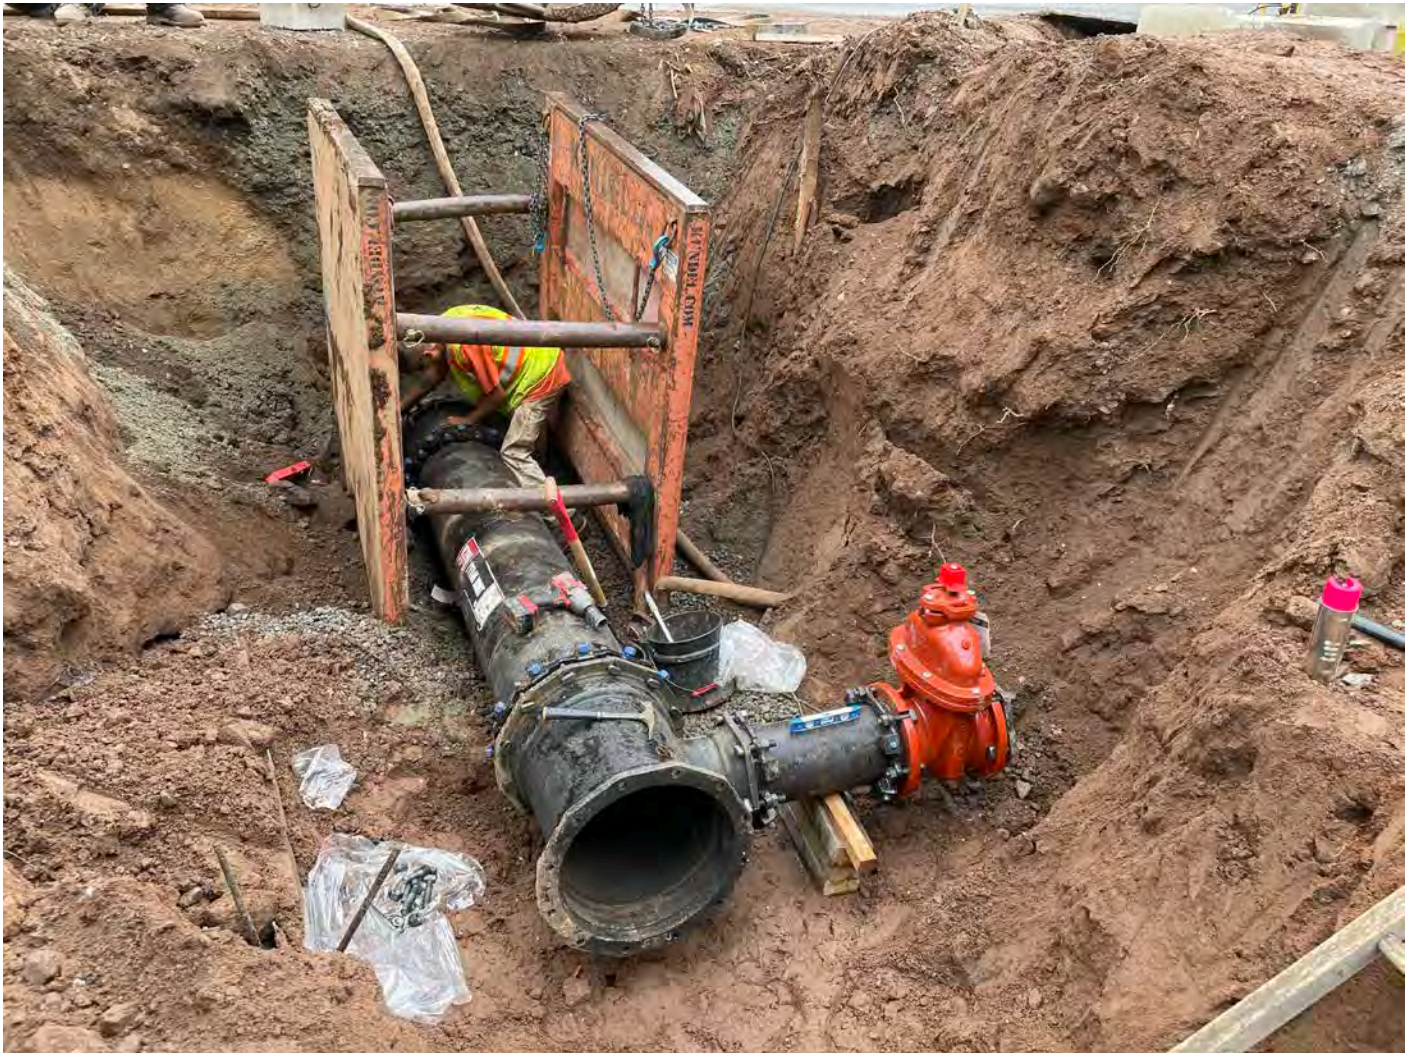
1225: Ludlow has installed ~8' of 16" DIP east of Station 800+00, with a 16x16x8 M.J. C.L.D.I. TEE and an M.J. 8" gate valve.

Picture 4: Ludlow installing 16" DIP with a 16x16x8 M.J. C.L.D.I. TEE and an M.J. 8" gate valve. View to the west.

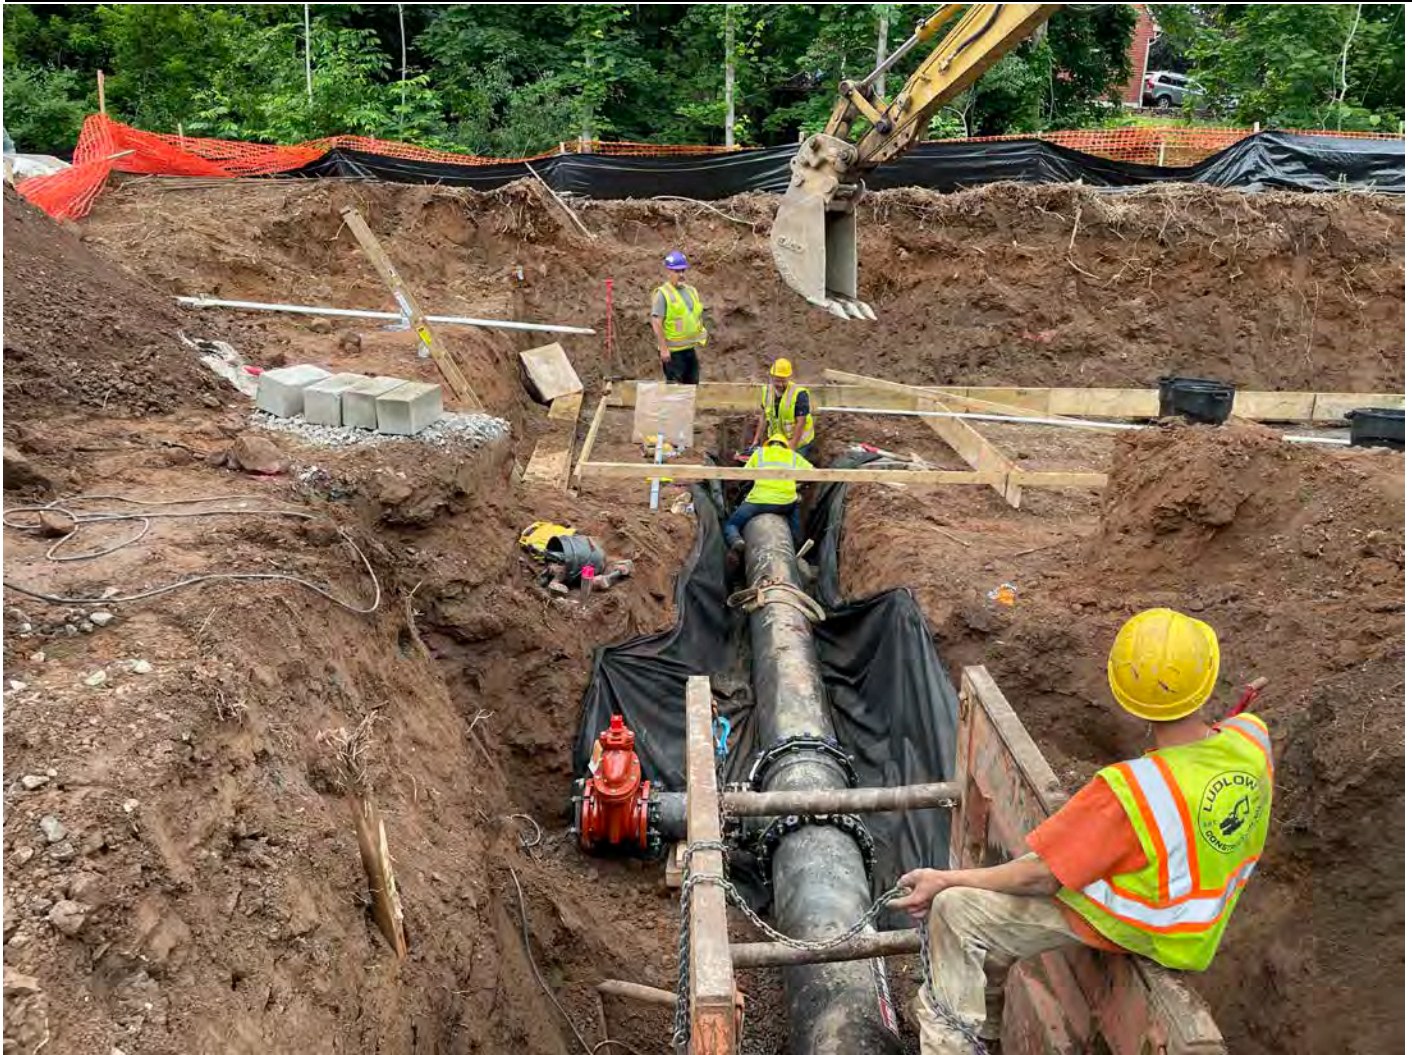
Picture 5: View of Ludlow installing 16" DIP east of Station 800+00 at the water meter vault work zone located at ~Station 124+80. View to the east.

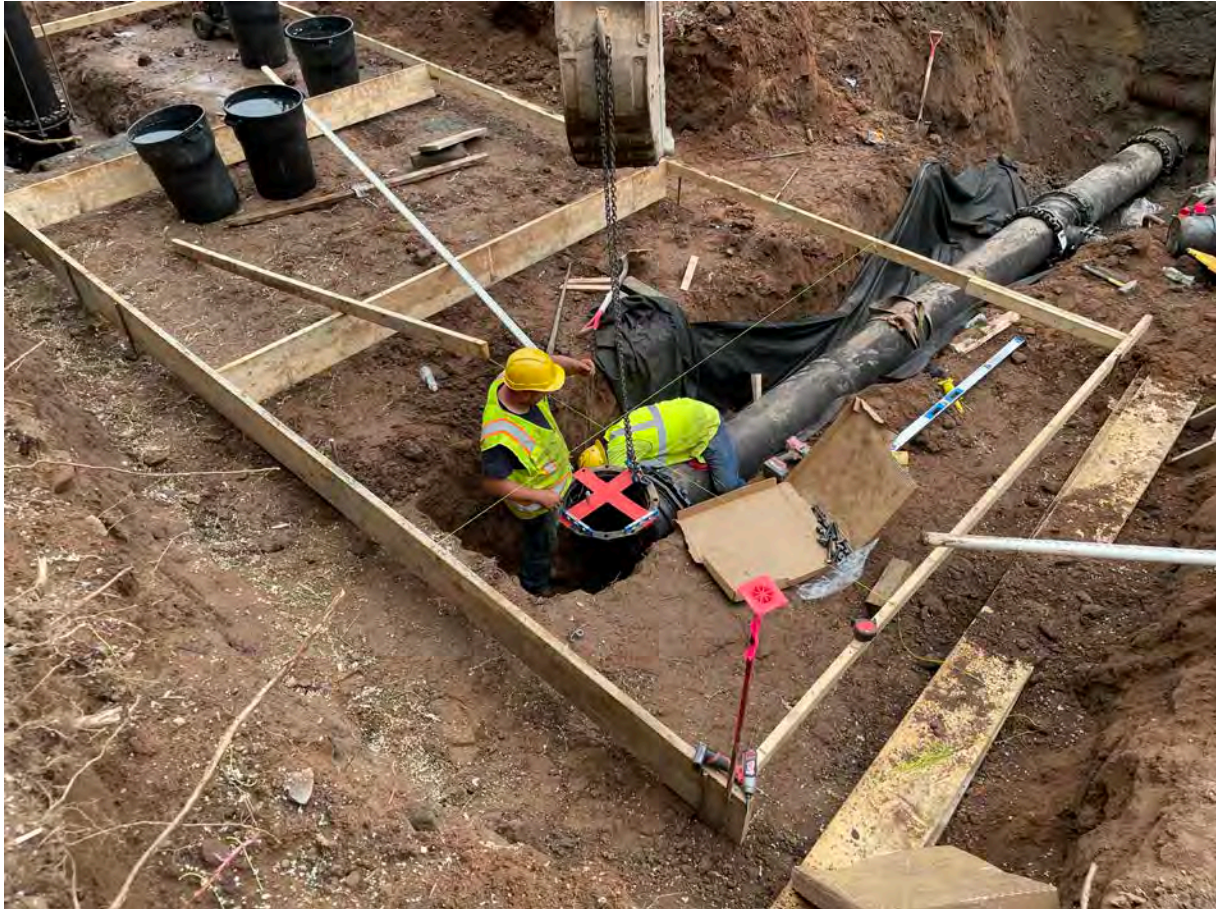
1418: Ludlow has installed 16" DIP from the edge of S, Main Street at Station 800+00 up to the northeast corner of the meter building footprint. Ludlow is currently installing an 90° bend onto the 16" DIP with the end of bend facing upwards.

Picture 6: Ludlow installing a 16" DIP 90° bend at the northeast corner of the water meter vault footprint located at ~Station 124+80. View to the southwest.

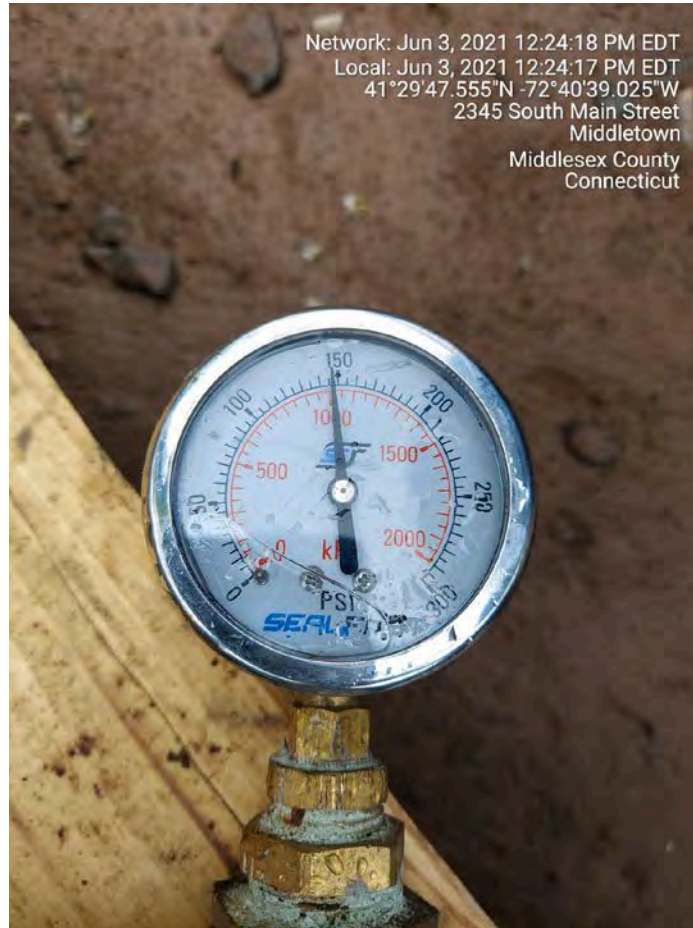
Picture 7: Final pressure of the pressure test that Ludlow performed today on the section of 16” DIP that Ludlow previously installed on the south side of the water meter vault footprint.
