Daily Report

Project:	Durham Meadows Pipeline Installation	Date:	July 28, 2021
Location:	Main Street and Maple Avenue, Durham	Day of Week:	Wednesday
Project #:	AECOM: 6061487	Report No:	290
Contractor:	Ludlow Construction	Page:	1 of 11

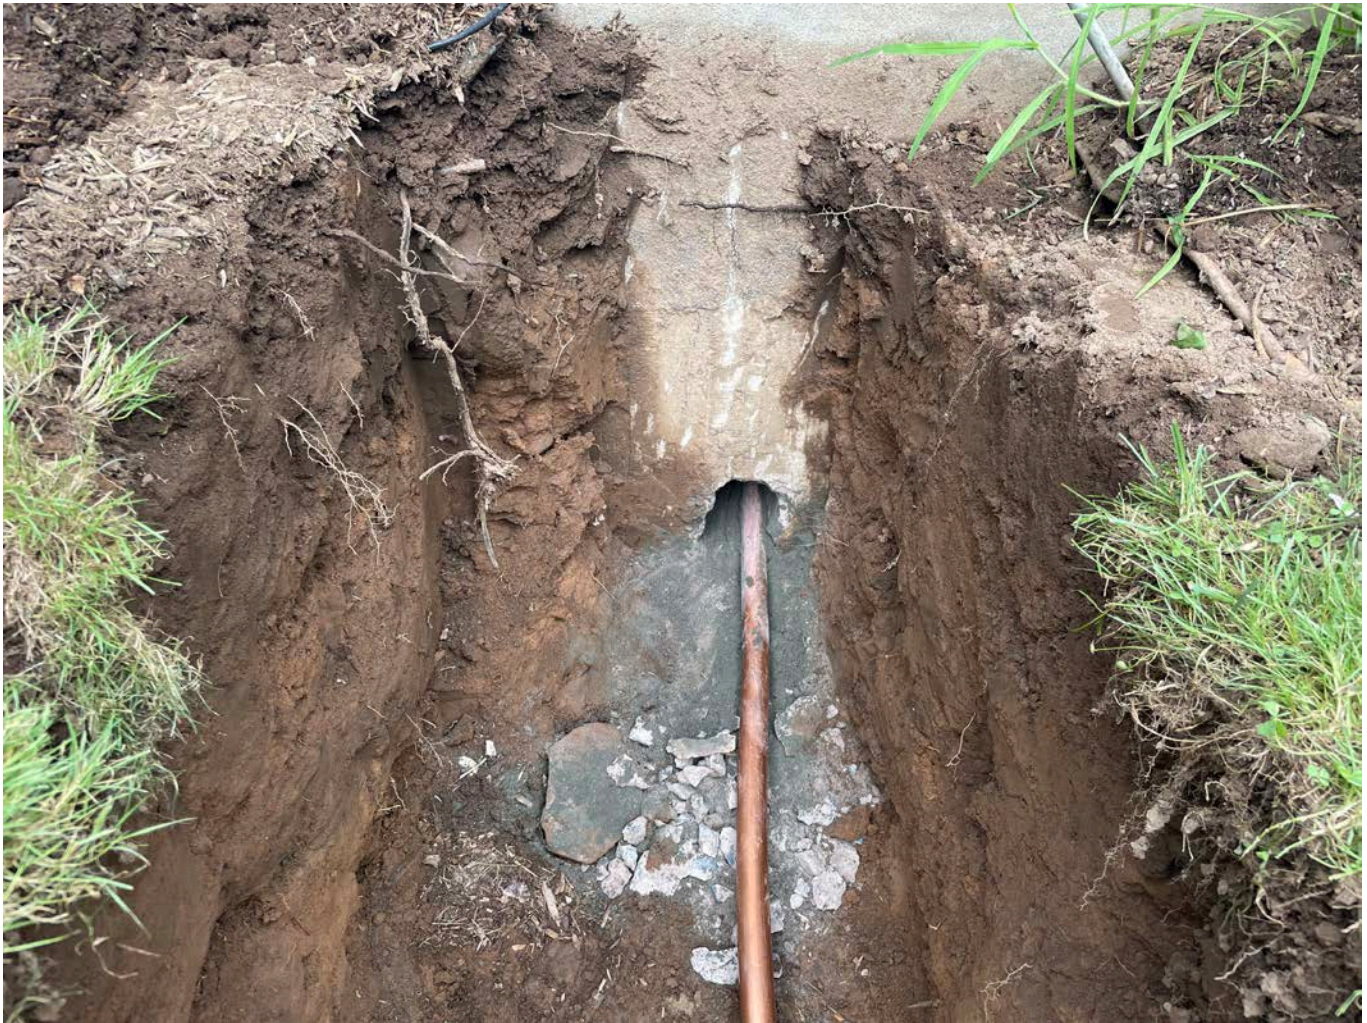
Picture 1: 1.5" copper water service line that was inserted through the east side of the foundation at 261 Main Street, Durham. View to the west.

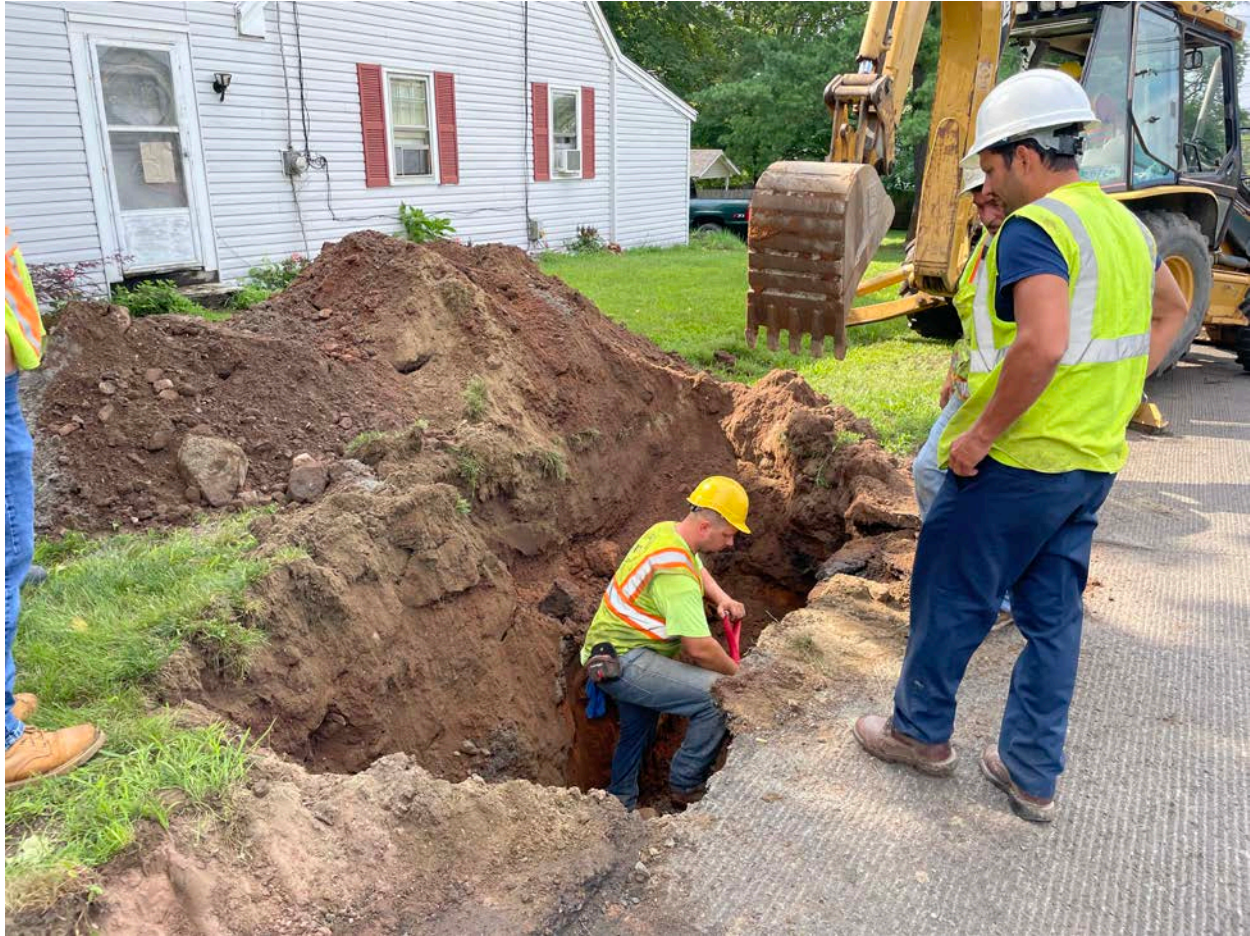
0756: Ludlow, AECOM, and USACE representatives investigate a sinkhole that has formed on the east side of the northbound lane of Main street, where sink hole has formed in front of the 397 Main Street residence. The sink hole is located in an area

where the soils were previously disturbed by the installation of a curb stop for the 397 Main Street residence. Personnel from CT DOT and Layden are also present to observe Ludlow excavating at the sink hole.

Picture 2: Ludlow excavating a sink hole on Main Street next to the 397 Main Street, Durham, residence. View to the south.

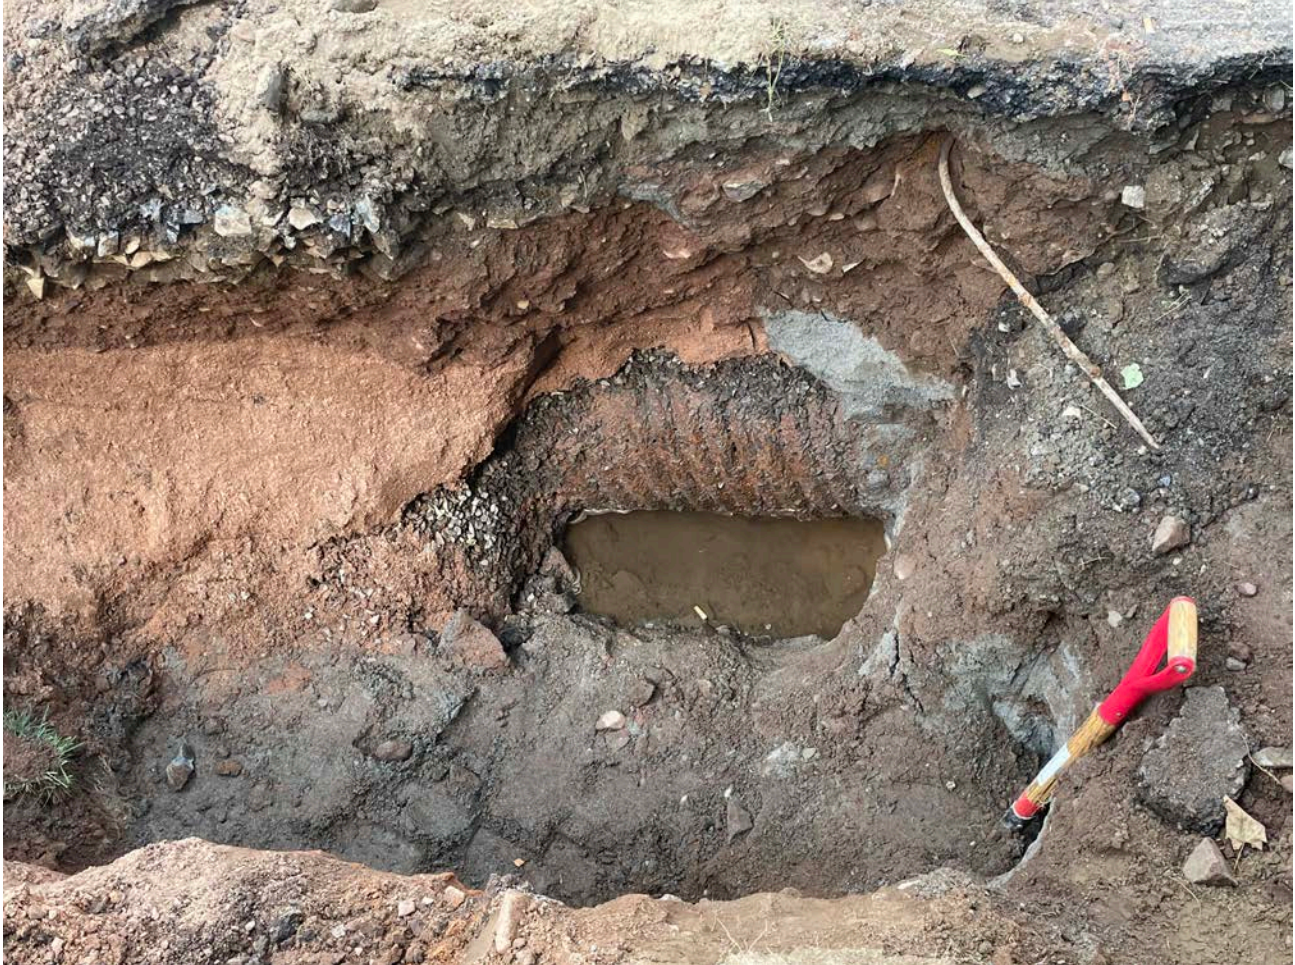
1012: Ludlow has daylighted a 16" corrugated metal storm drain line located on the east side of the northbound lane of Main Street in Durham. The pipe is riddled with holes: water is visible leaking from the pipe into the surrounding subsurface soils.

Picture 3: 16" metal storm drain that Ludlow daylighted when they investigated a sink hole on Main Street next to the 397 Main Street, Durham, residence. Note the holes that are visible on the side of the pipe. View to the west.

1034: Ludlow wraps the metal storm drain that they daylighted in front of the 397 Main Street residence with filter fabric and placed gravel over the fabric.

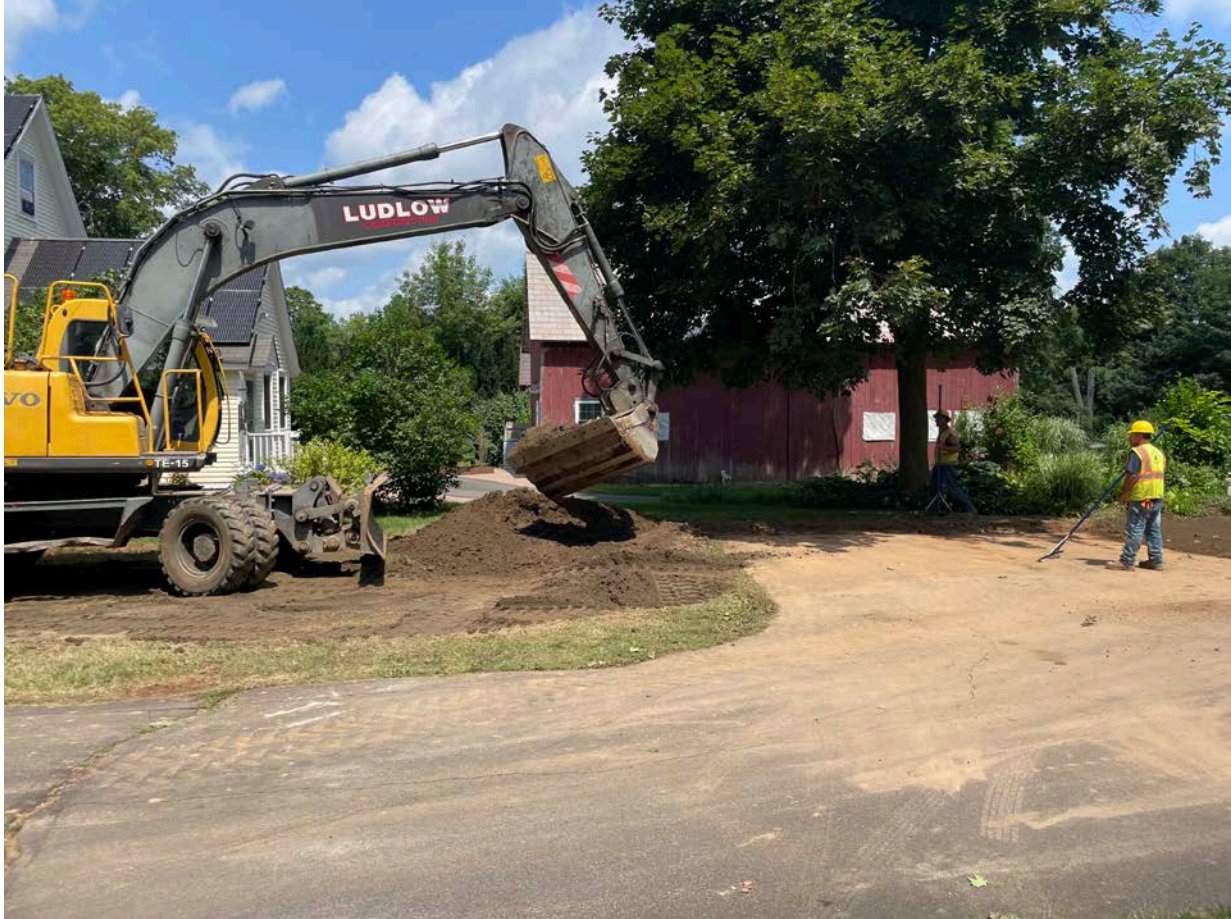
Picture 4: Ludlow placing loam on portions of the lawn at the 261 Main Street property that were disturbed during the installation of a 1.5" copper water service line. View to the east.

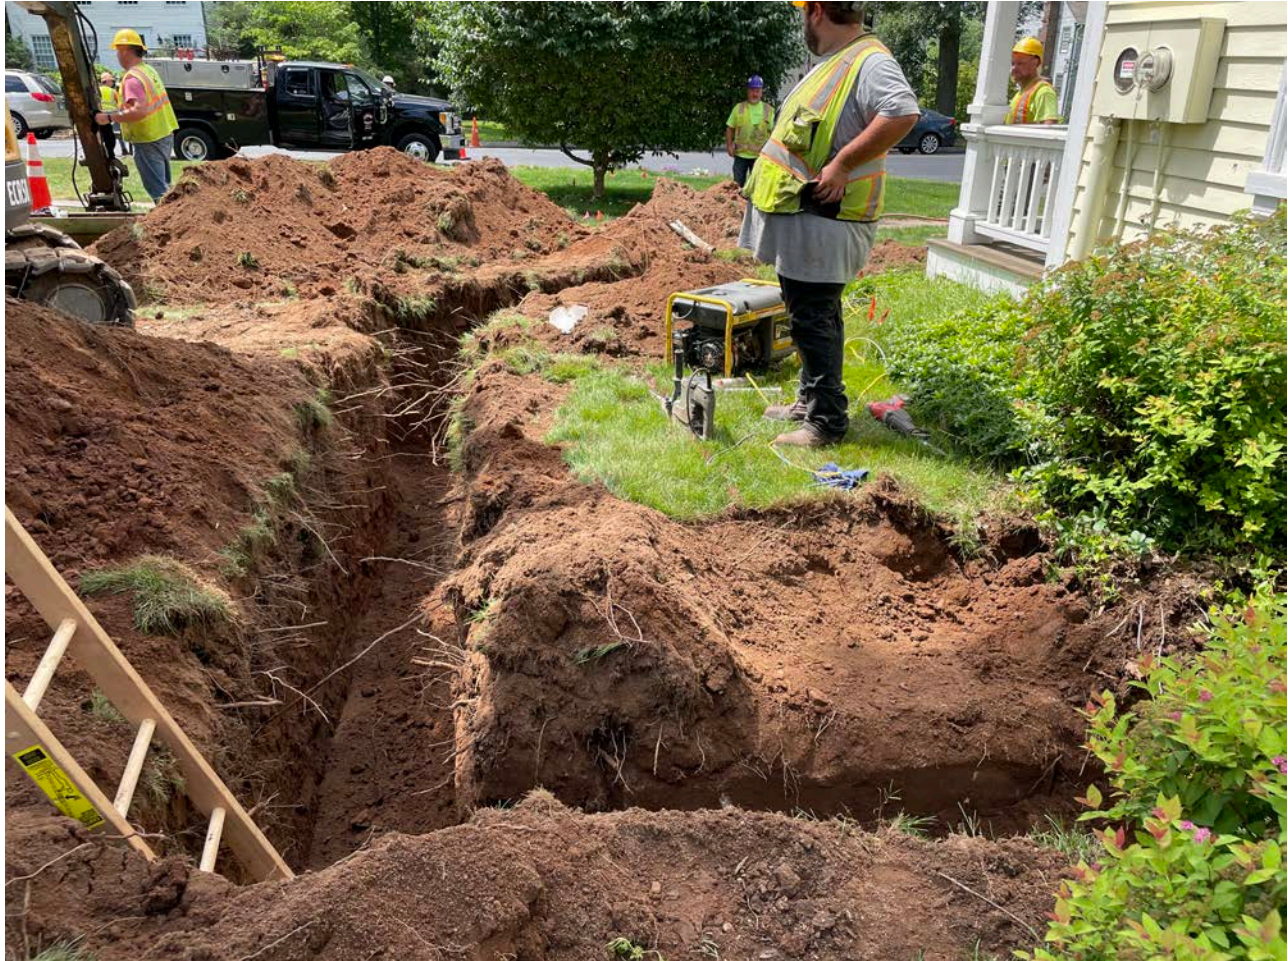
Picture 5: Ludlow excavating at the 257 Main Street property for the installation of a 1" copper water service line. View to the west.

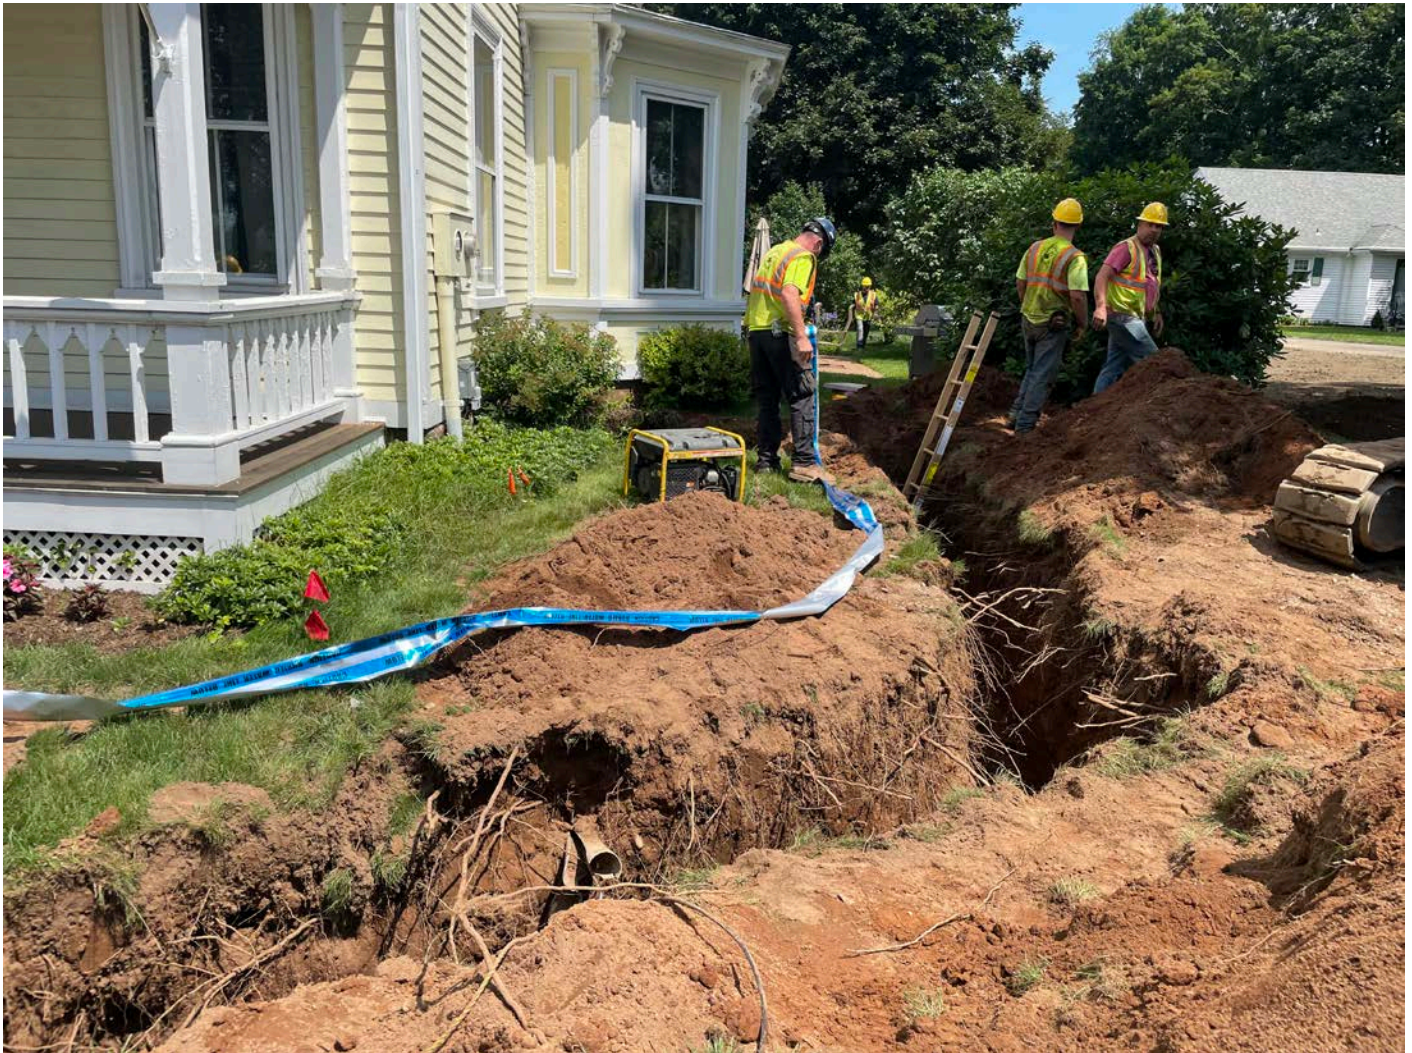
Picture 6: Ludlow about to place caution tape into the excavation at the 257 Main Street property for the installation of a 1" copper water service line. View to the east.

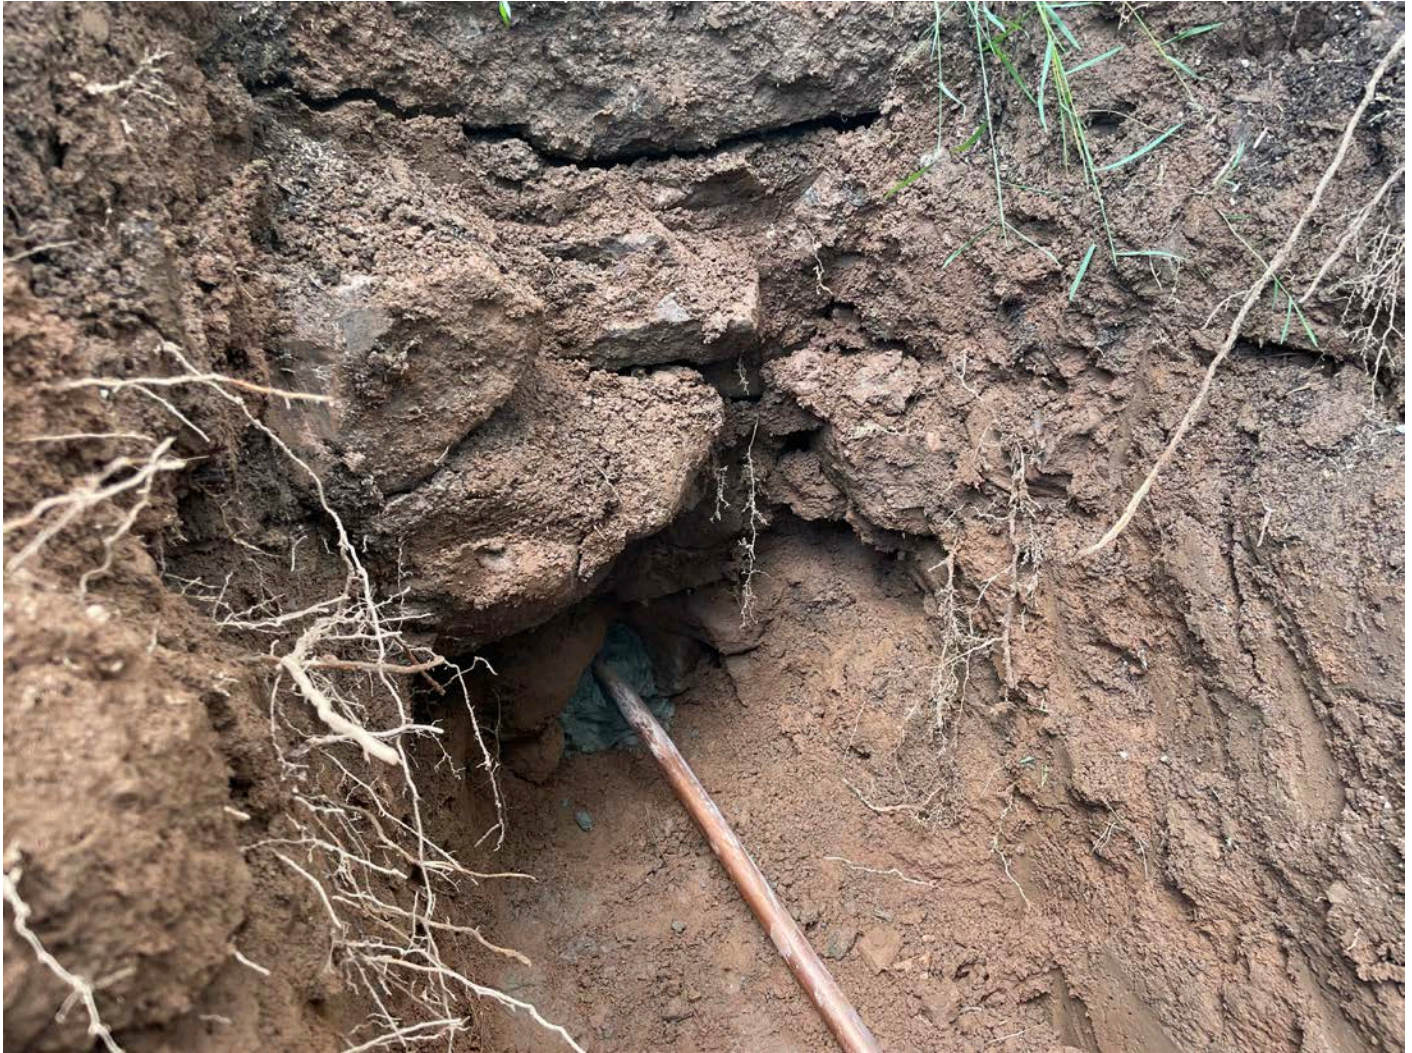
Picture 7: 1" copper water service line that was installed through the field stone foundation of the residence located at 257 Main Street, Durham. View to the north.

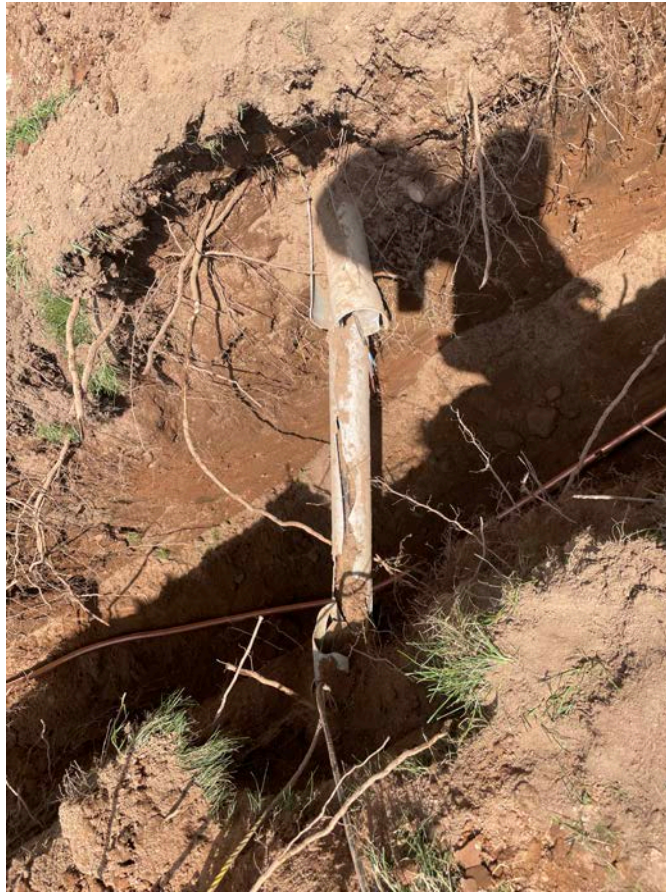
1501: Ludlow has finished work for the day at 265 Main Street. The installation of the 1" copper water service line is complete. Ludlow left a section of the trench open (but covered with a steel plate) where they severed a communications cable that will be fixed tomorrow morning.

Picture 8: Communications line that was severed during the installation of a 1" copper water service line at the 257 Main Street residence. View to the east.
