## Daily Report

<b>Project:</b>	Durham Meadows Pipeline Installation	<b>Date:</b>	August 16, 2021
<b>Location:</b>	Johns Way and Maple Avenue, Durham; S. Main Street, Middletown	<b>Day of Week:</b>	Monday
<b>Project #:</b>	AECOM: 6061487	<b>Report No:</b>	303
<b>Contractor:</b>	Ludlow Construction	<b>Page:</b>	1 of 10

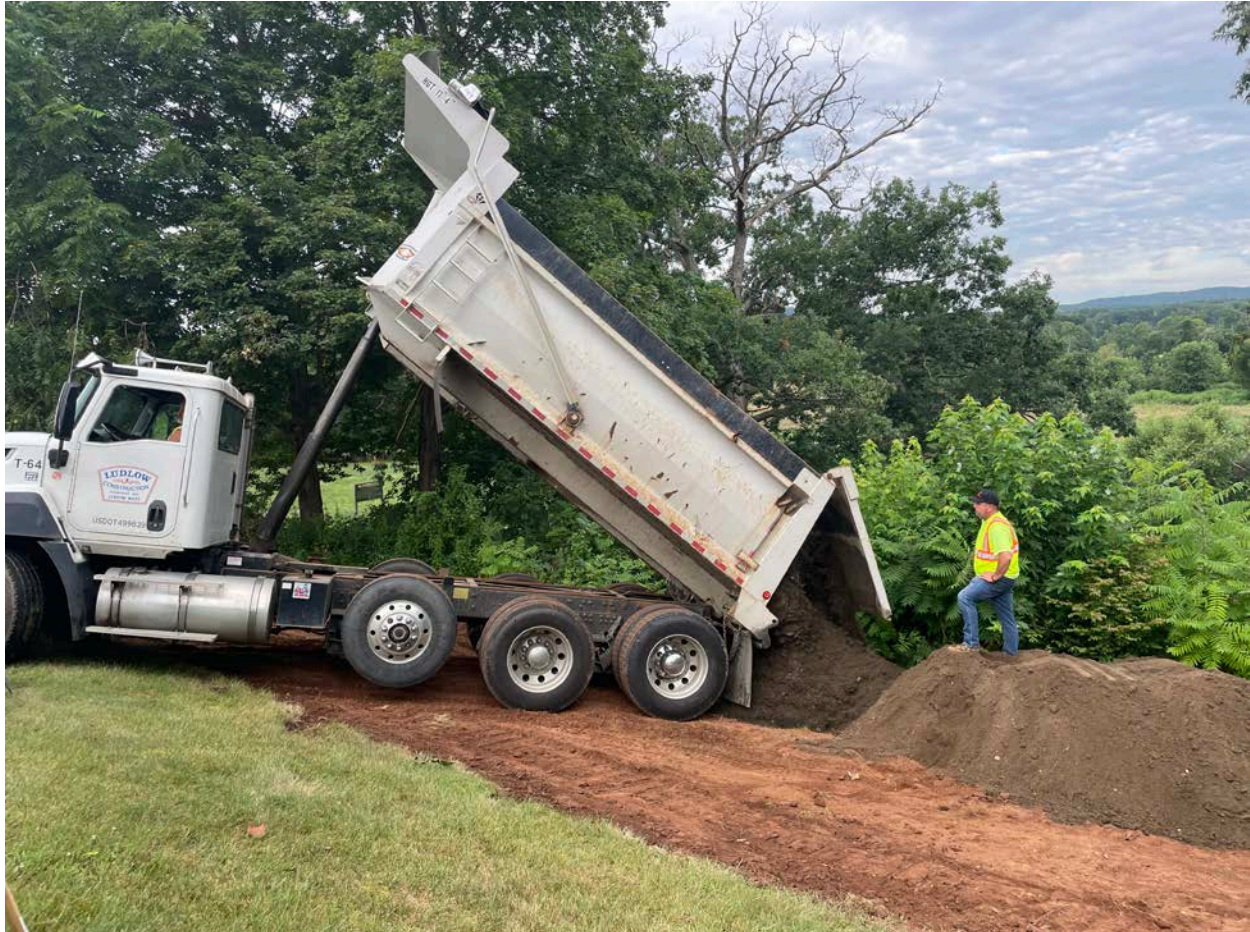
**Picture 1: Ludlow delivering loam to the 10 Johns Way property as they restore the areas disturbed during the installation of a 1.5" copper water service line. View to the west.**

0711: Ludlow has returned to the residence at 10 Johns Way, Durham, to restore the sections of the lawn that were disturbed during the installation of a 1.5" copper water service line on Friday.

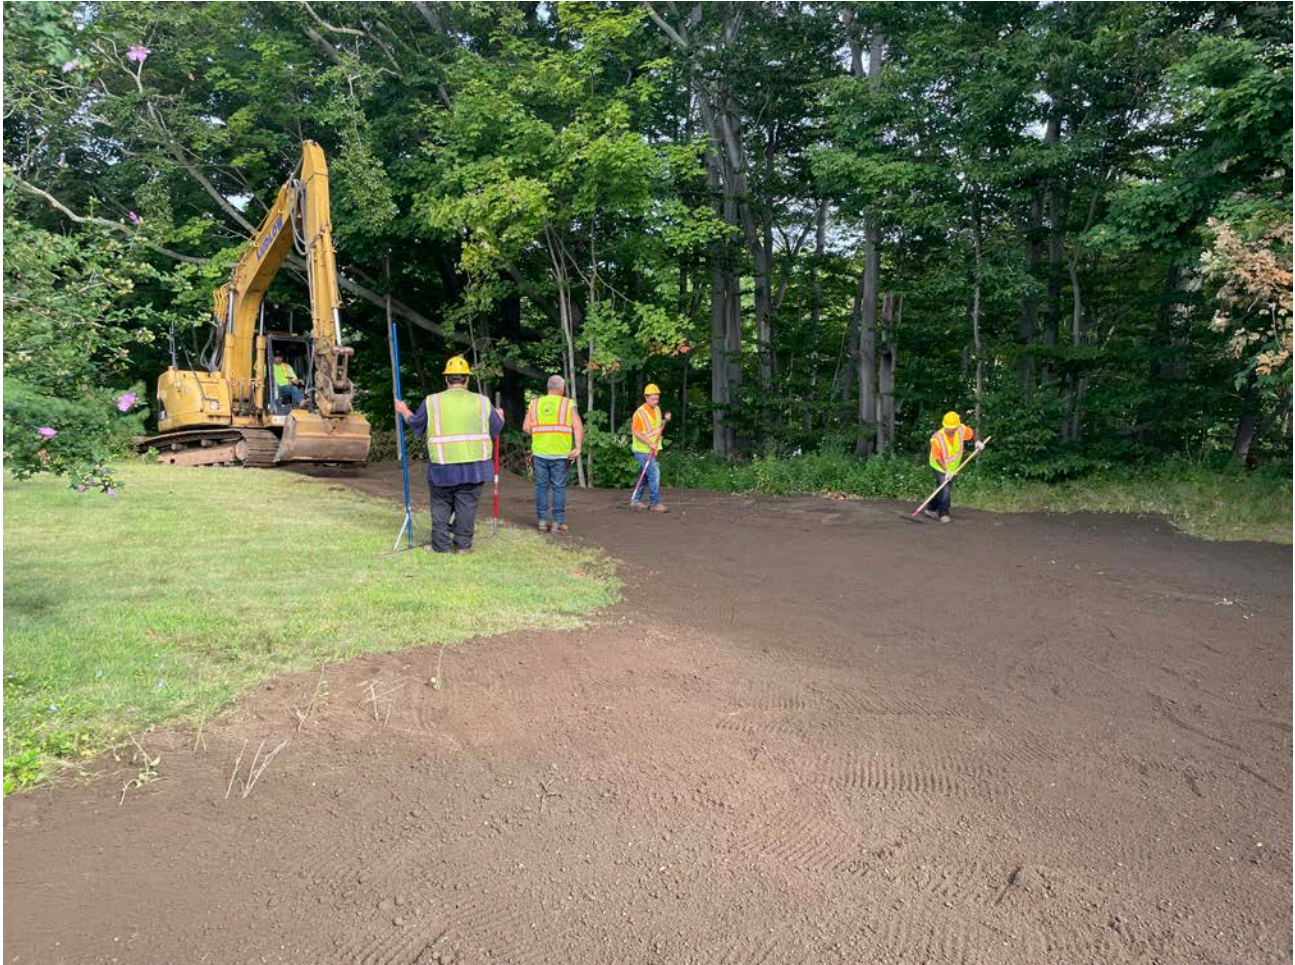
**Picture 2: Ludlow raking out loam at the 10 Johns Way property as they restore the areas disturbed during the installation of a 1.5" copper water service line. View to the northwest.**

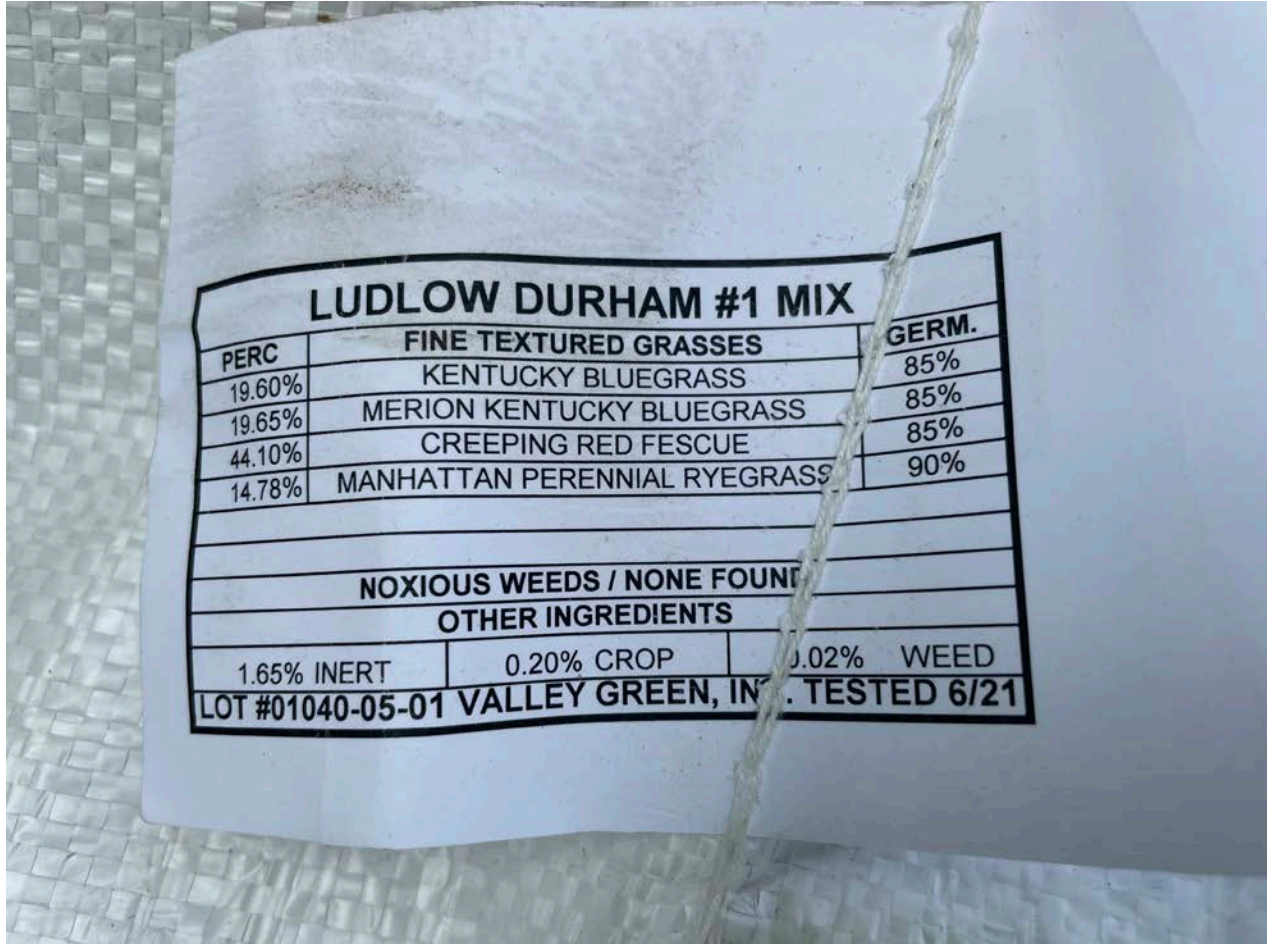
Picture 3: Grass seed mix that Ludlow is using when restoring areas disturbed during the installation of copper water service lines.

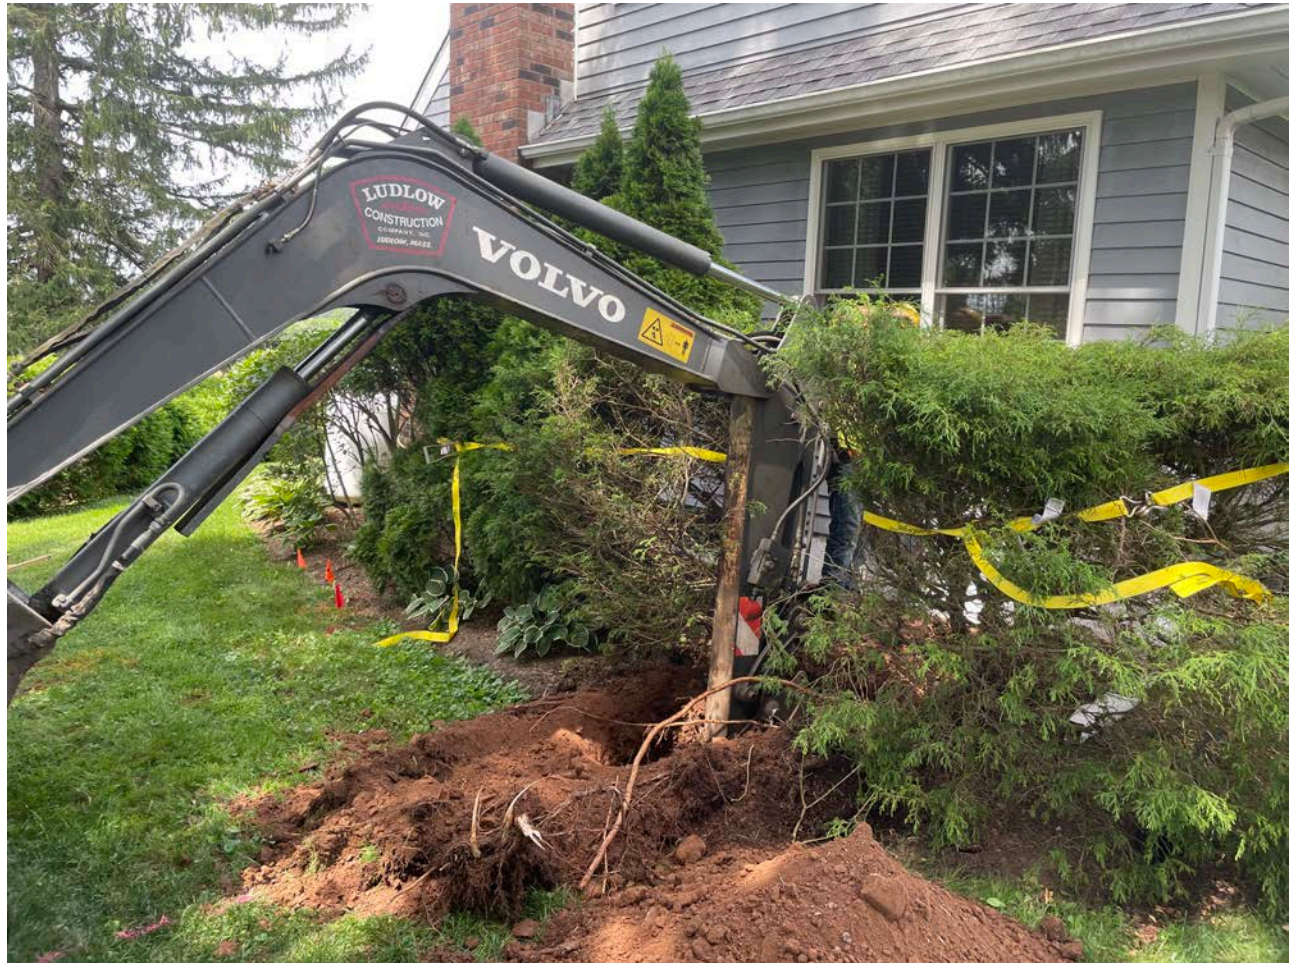
Picture 4: Ludlow excavating on the south side of the residence located at 29 Maple Avenue, Durham as they prepare to install a 1" copper water service line. View to the west.

1249: Ludlow begins excavating at the 29 Maple Avenue on the south side of the house.

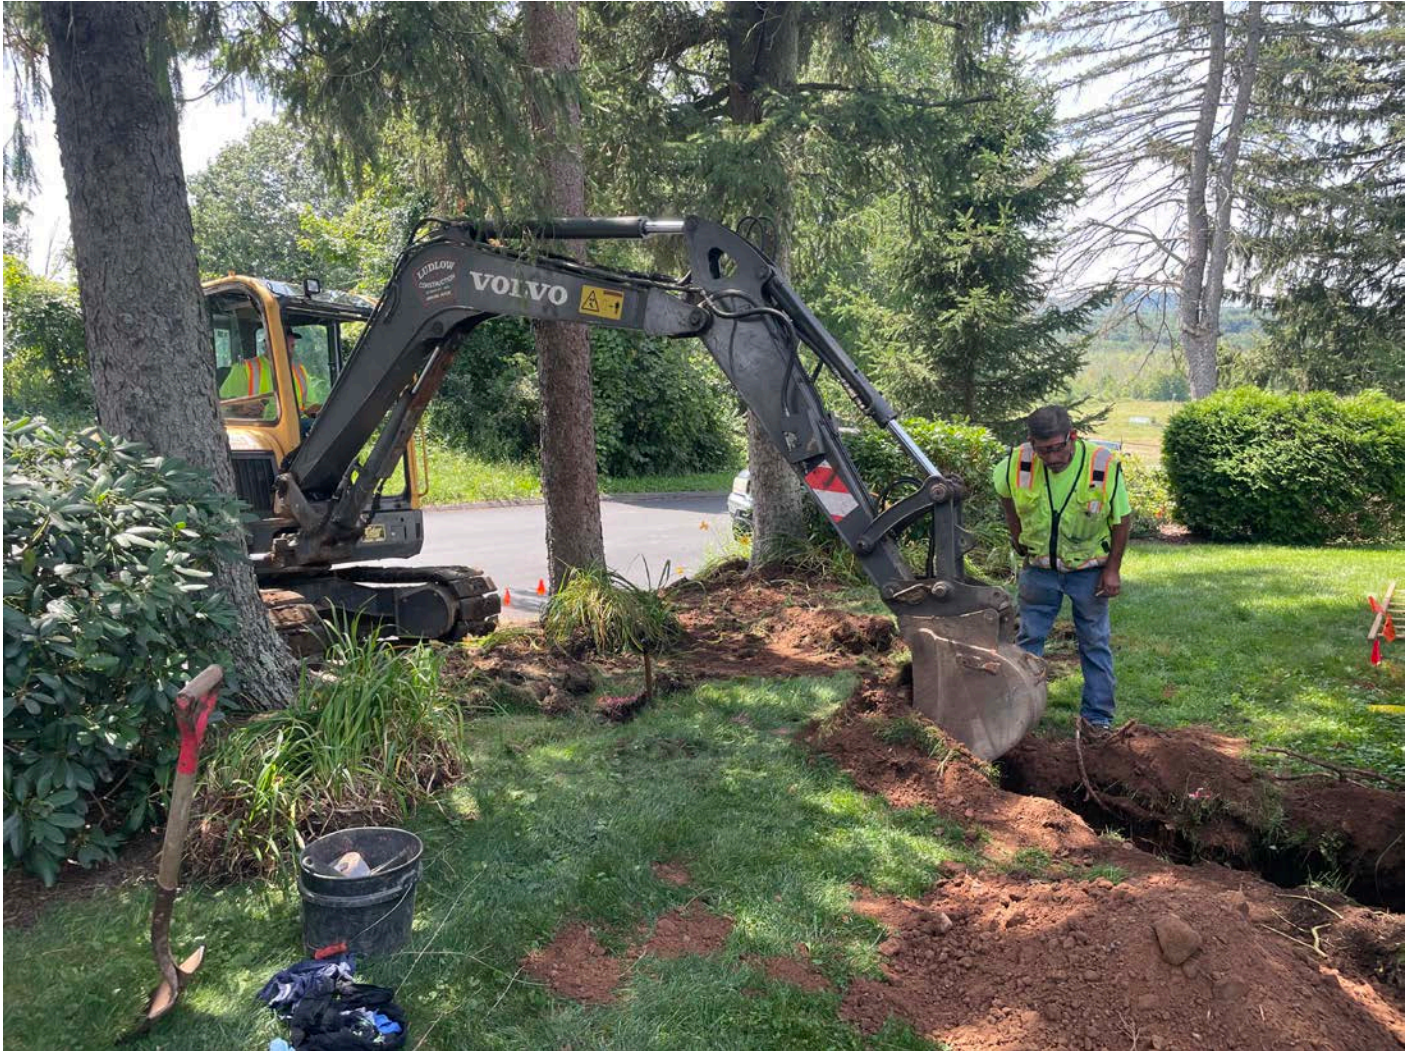
**Picture 5: Ludlow excavating to the south side of the residence located at 29 Maple Avenue, Durham as they prepare to install a 1" copper water service line. View to the west.**

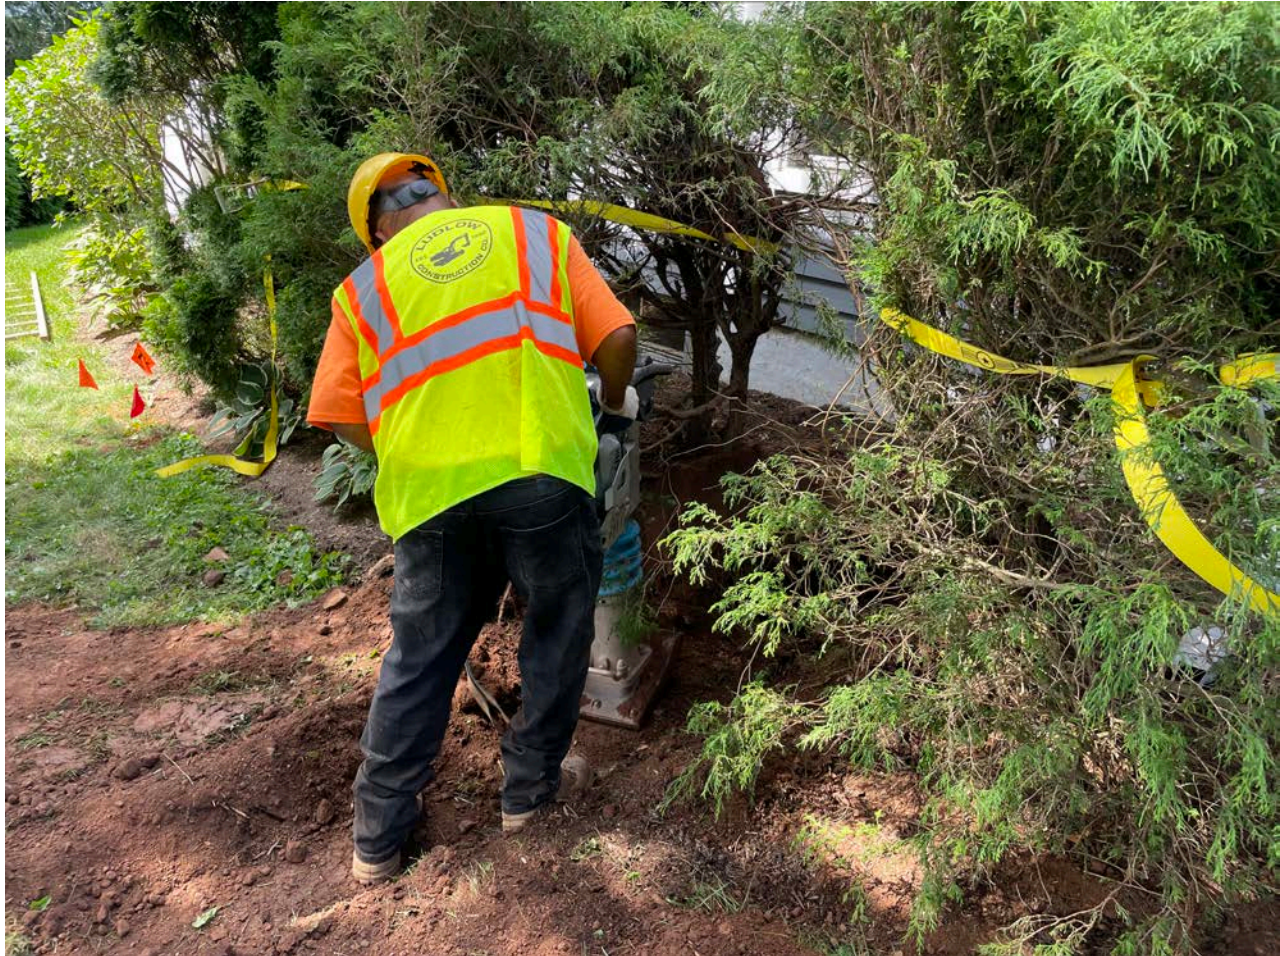
**Picture 6: Ludlow compacting backfill with a jumping jack after having installed a 1" copper water service line at the 29 Maple Avenue residence. View to the northwest.**

1441: Ludlow has the trench they excavated at the 29 Maple Street residence backfield with native soil placed and compacted in 1' lifts. Ludlow is placing and raking loam and preparing to place grass seed over the disturbed areas that they repaired.

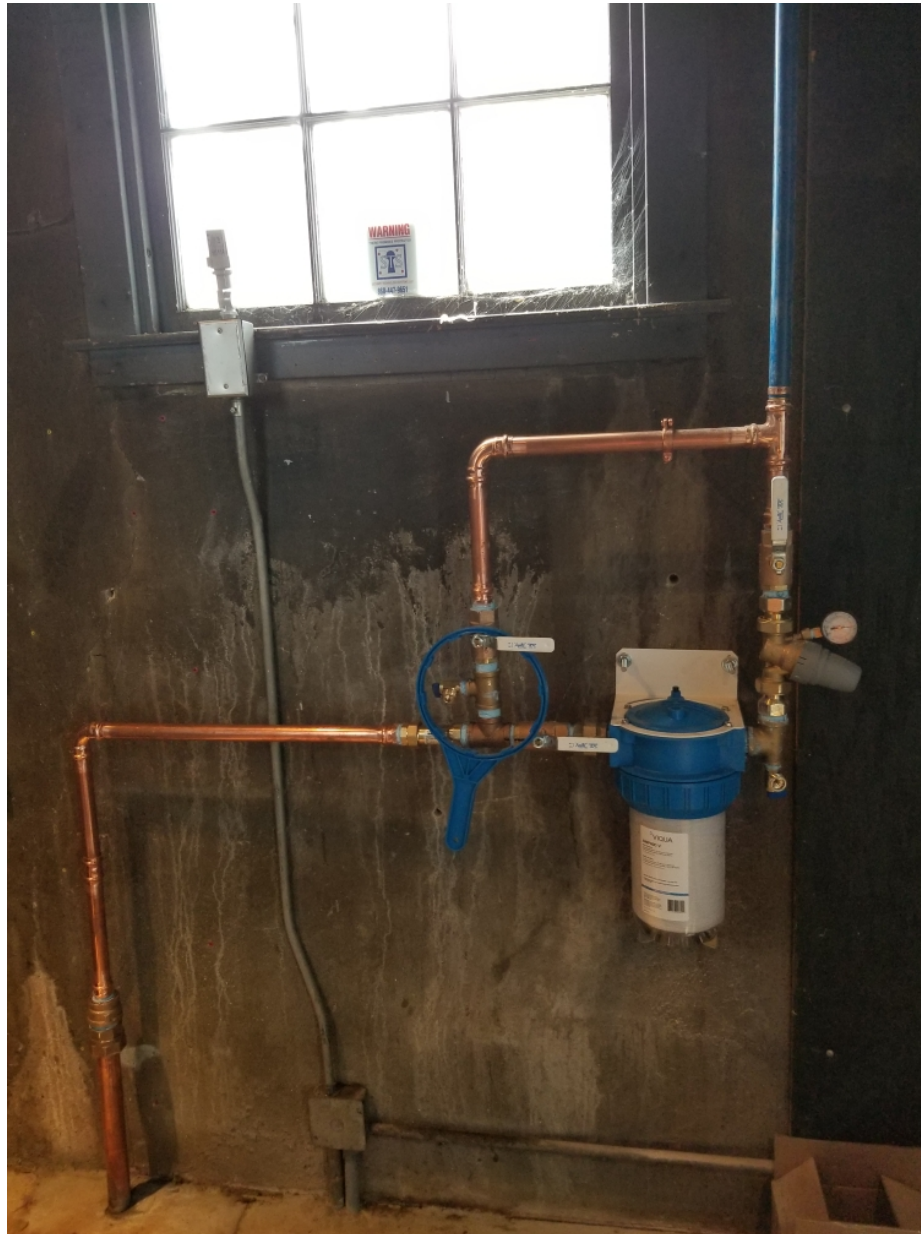
Picture 7: Final water service components that Fazzino Plumbing installed today at the residence located at 280 Main Street, Durham. View to the south.

0934: Fazzino Plumbing is installing final water service components at the 280 Main Street building. The components are being placed on the south wall of the building's foundation.
