Daily Report

Project:	Durham Meadows Pipeline Installation	Date:	August 20, 2021
Location:	Main Street and Maple Avenue, Durham	Day of Week:	Friday
Project #:	AECOM: 6061487	Report No:	307
Contractor:	Ludlow Construction	Page:	1 of 10

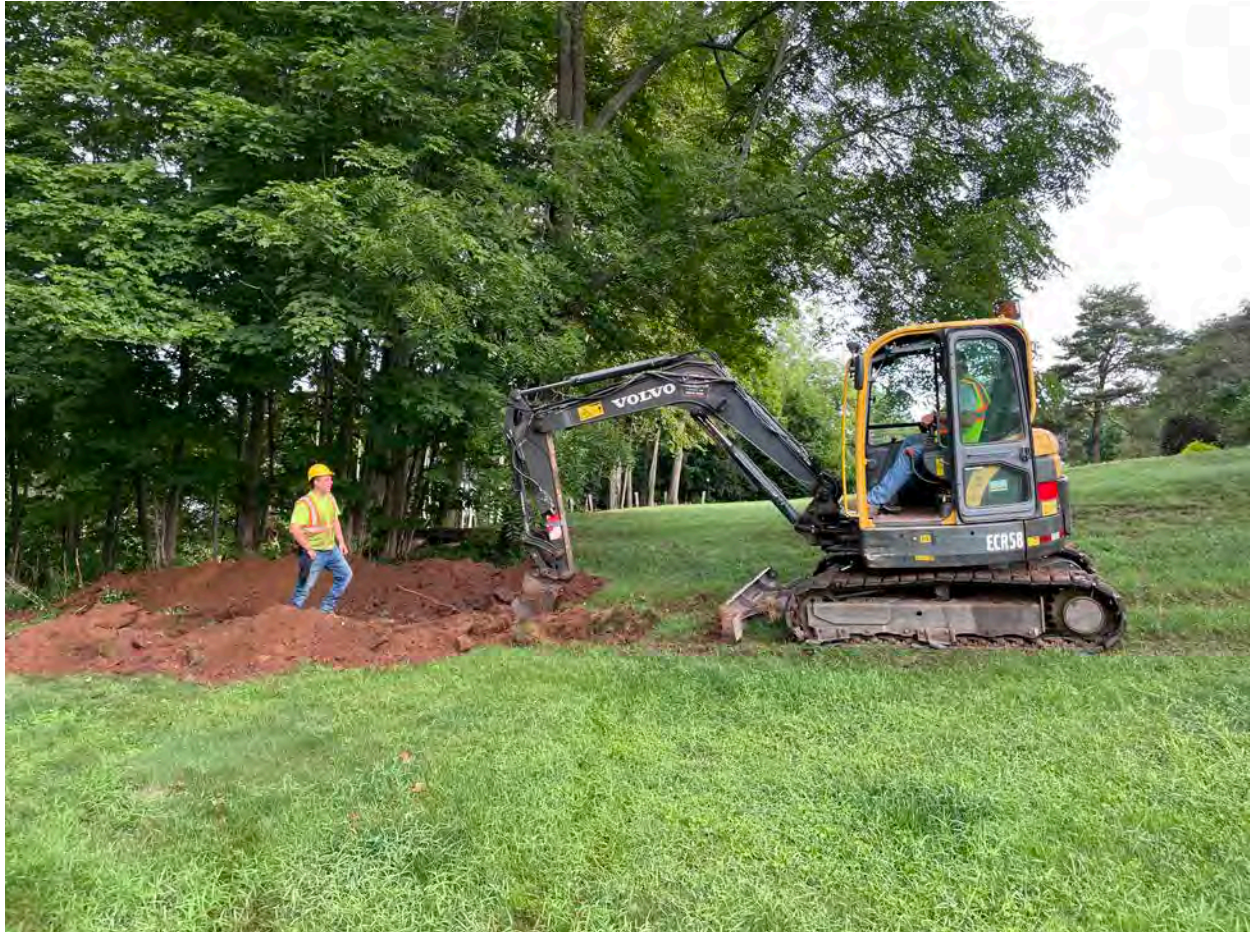
Picture 1: Ludlow excavating at the 95R Maple Avenue property for the installation for 2" copper water service line. View to the north.

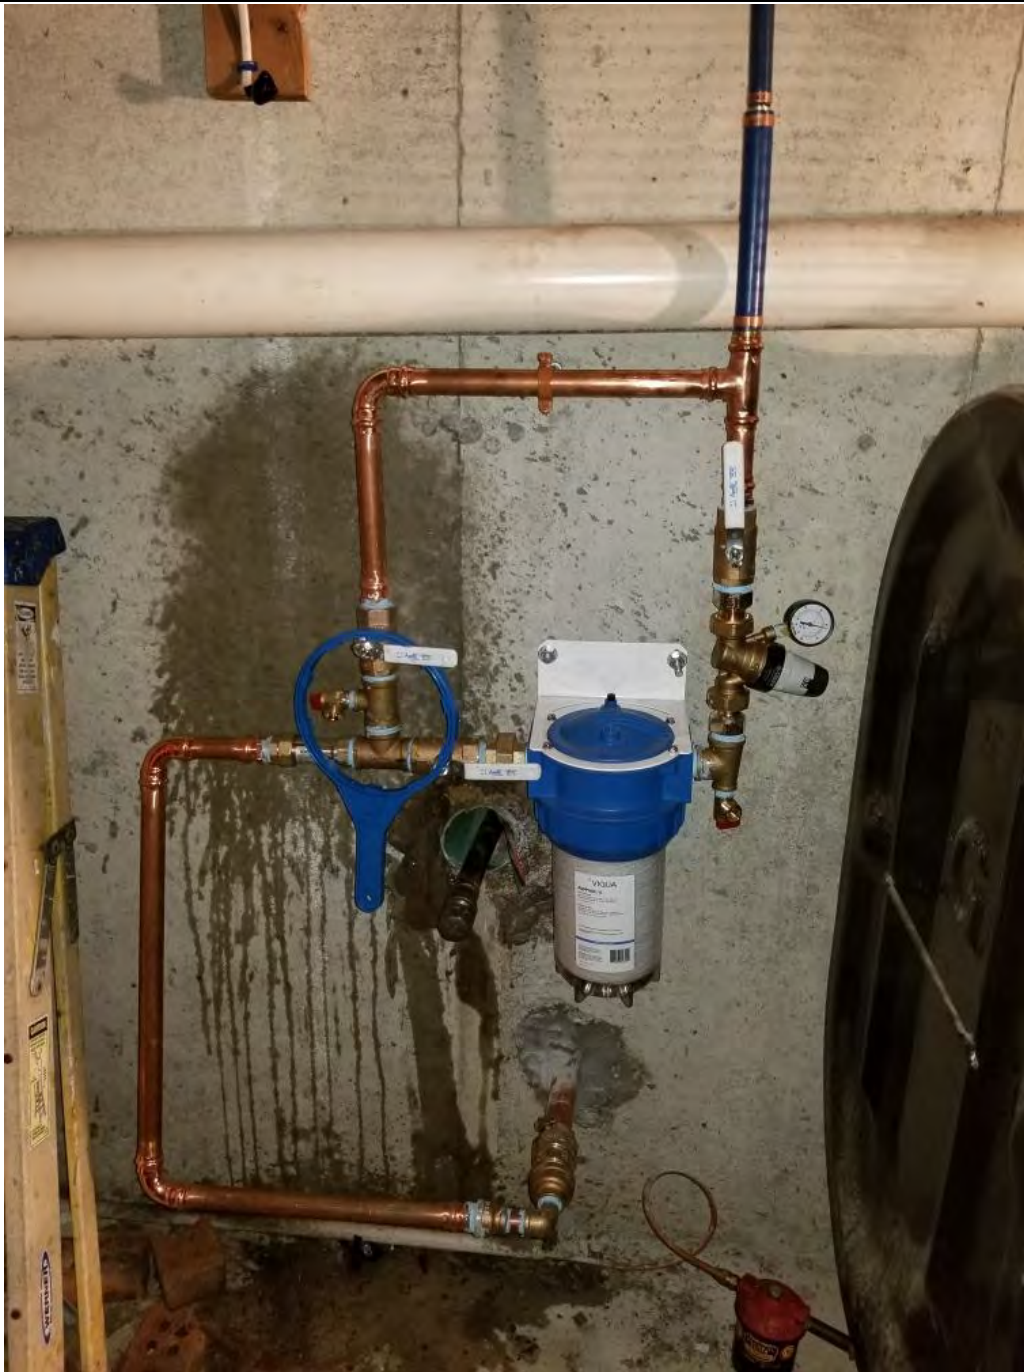
Picture 2: -Final water service components that Fazzino Plumbing installed at the 10 Johns Way residence in Durham.

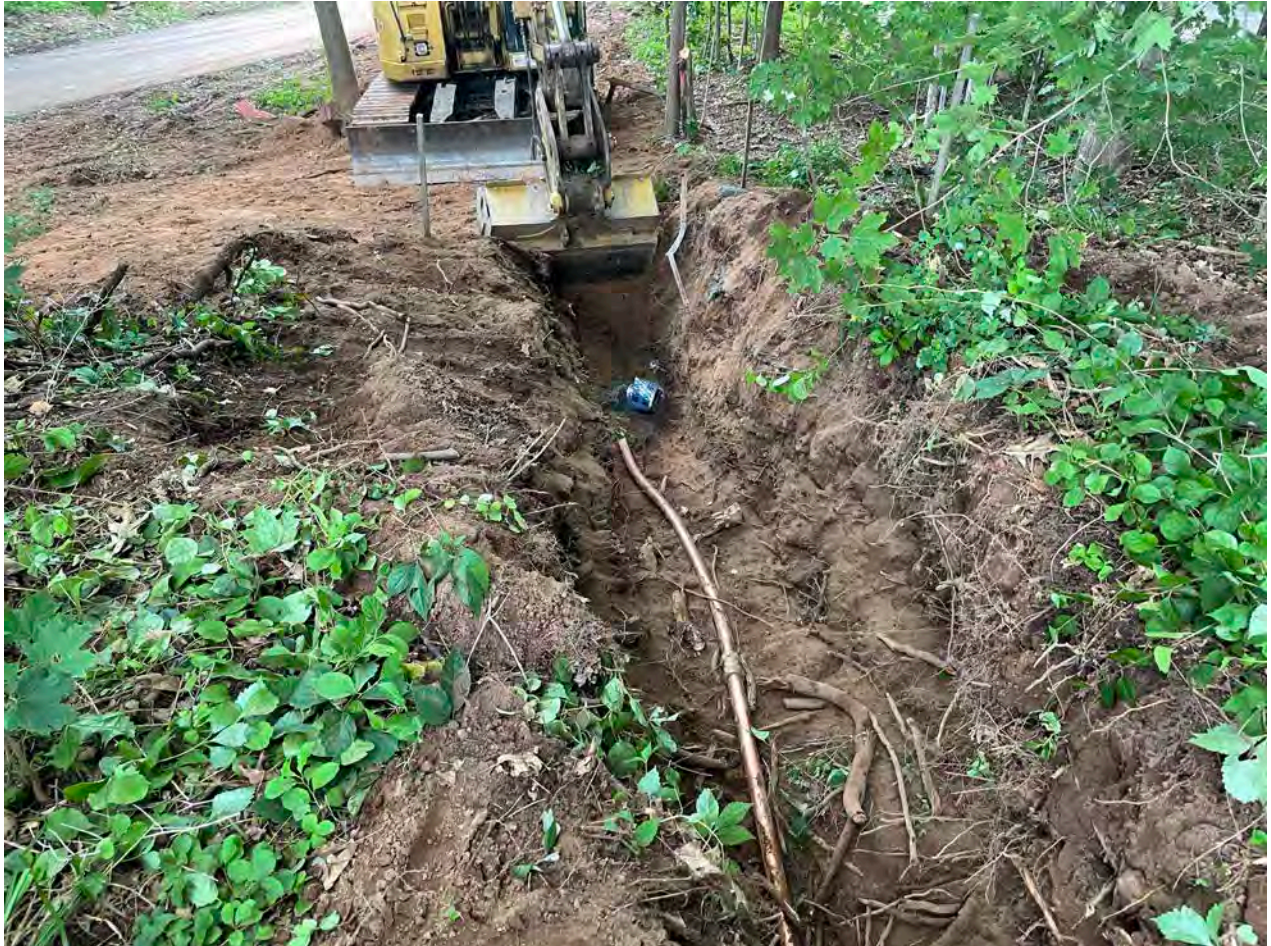
Picture 3: Ludlow installing 2" copper water service line next to Maple Avenue at 95R Maple Avenue in Durham. View to the west.

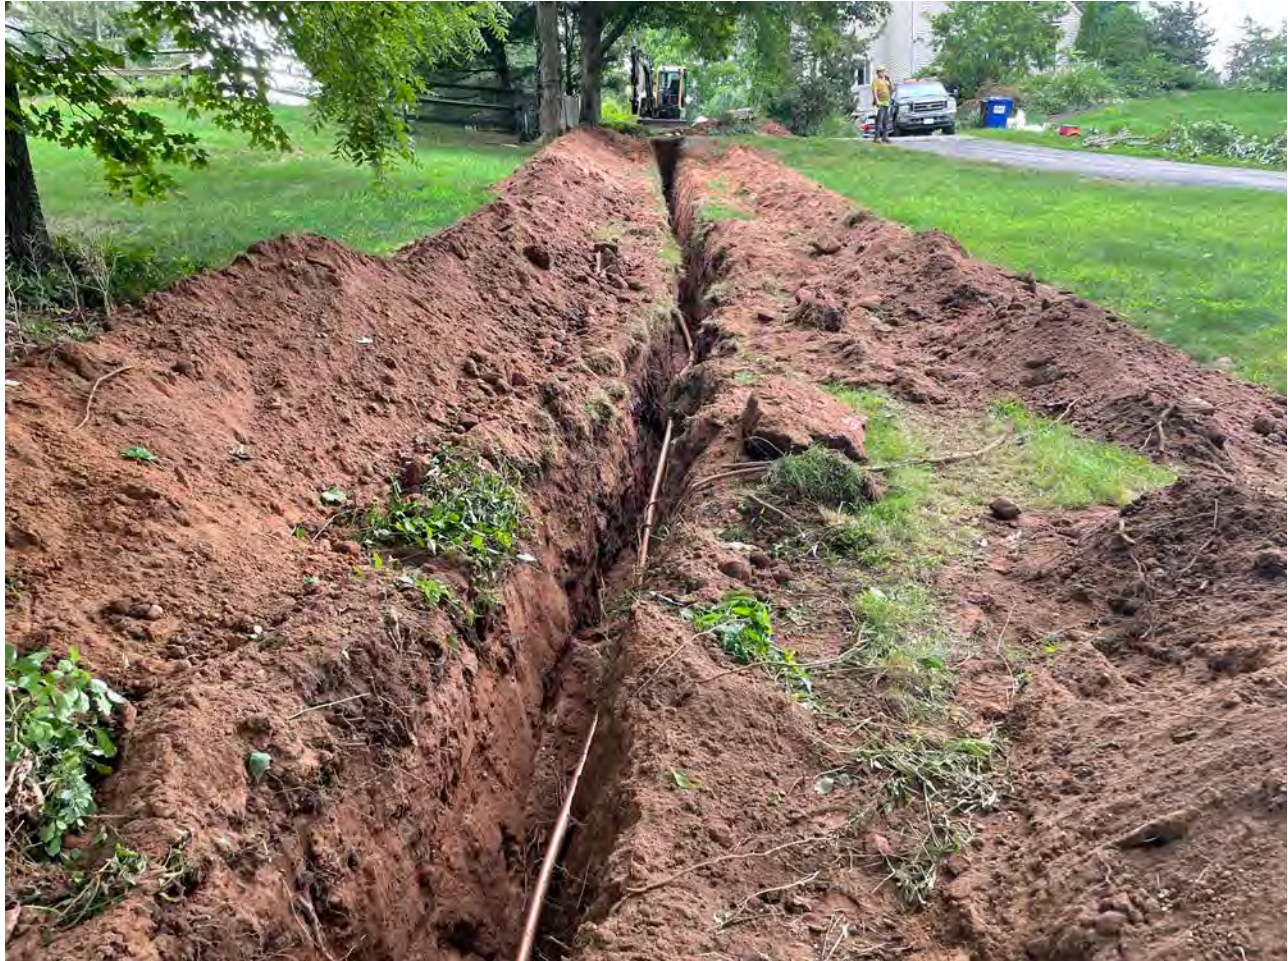
Picture 4: 2" copper pipe that Ludlow has placed in the trench they excavated at the 95R Maple Avenue property. View to the east.

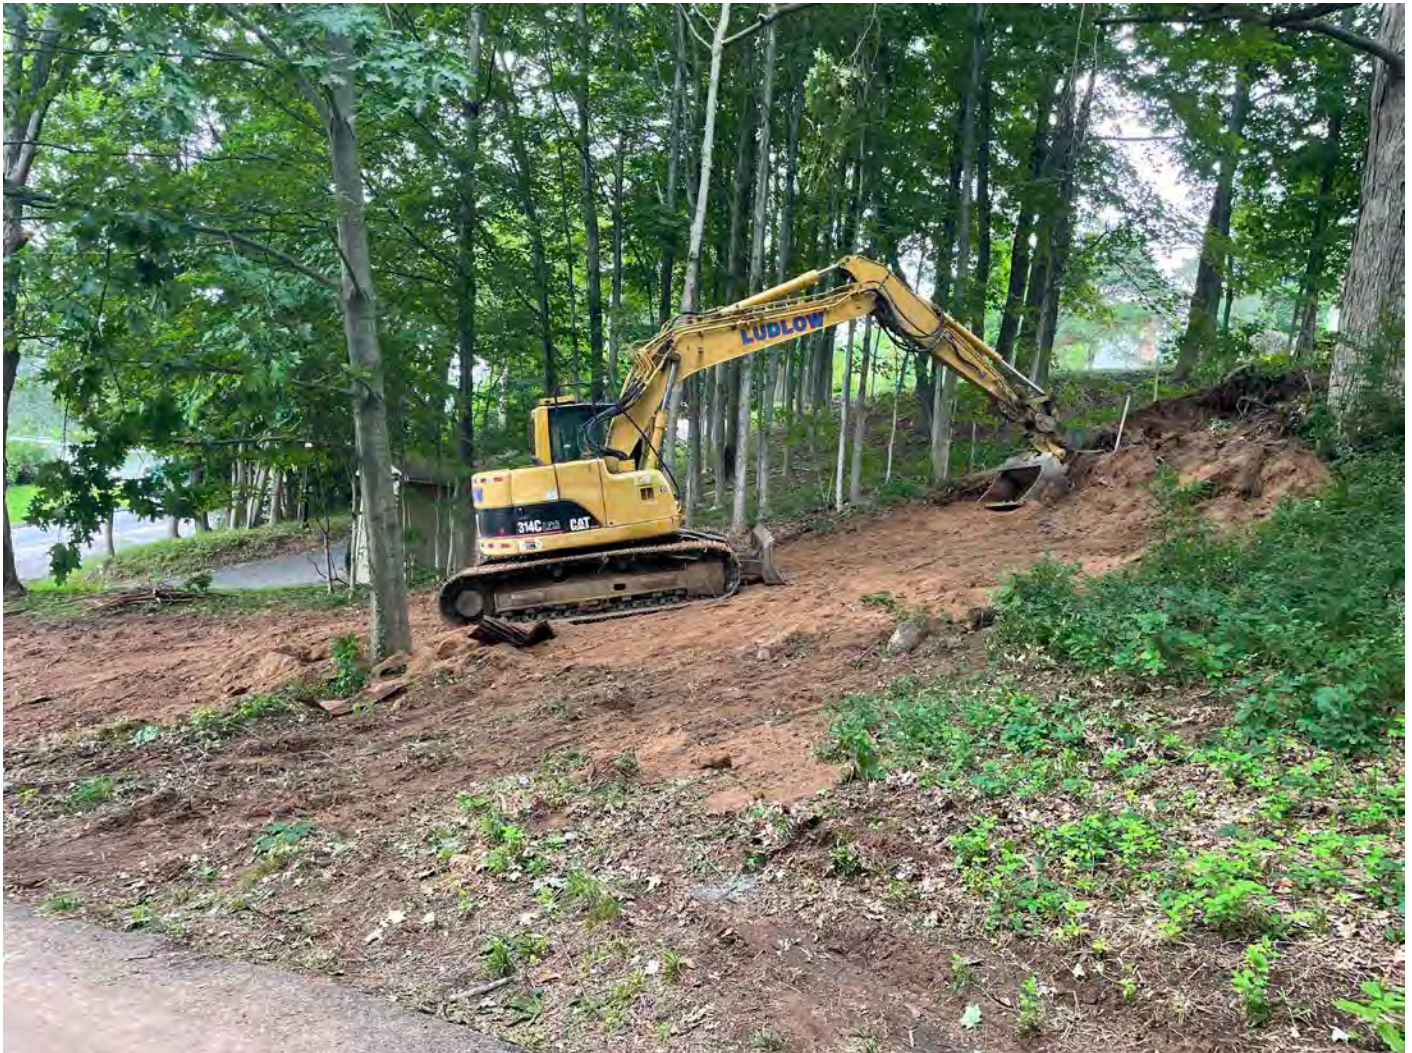
1409: Ludlow is placing native fill over the sand and caution tape that was placed over the 2" copper water line that has been installed at the 95R Maple Avenue property. The fill is being placed in 1' lifts and is being compacted with a jumping Jack.

Picture 5: Ludlow placing native fill over the 2" copper water service they installed line next to Maple Avenue at 95R Maple Avenue in Durham. View to the west.

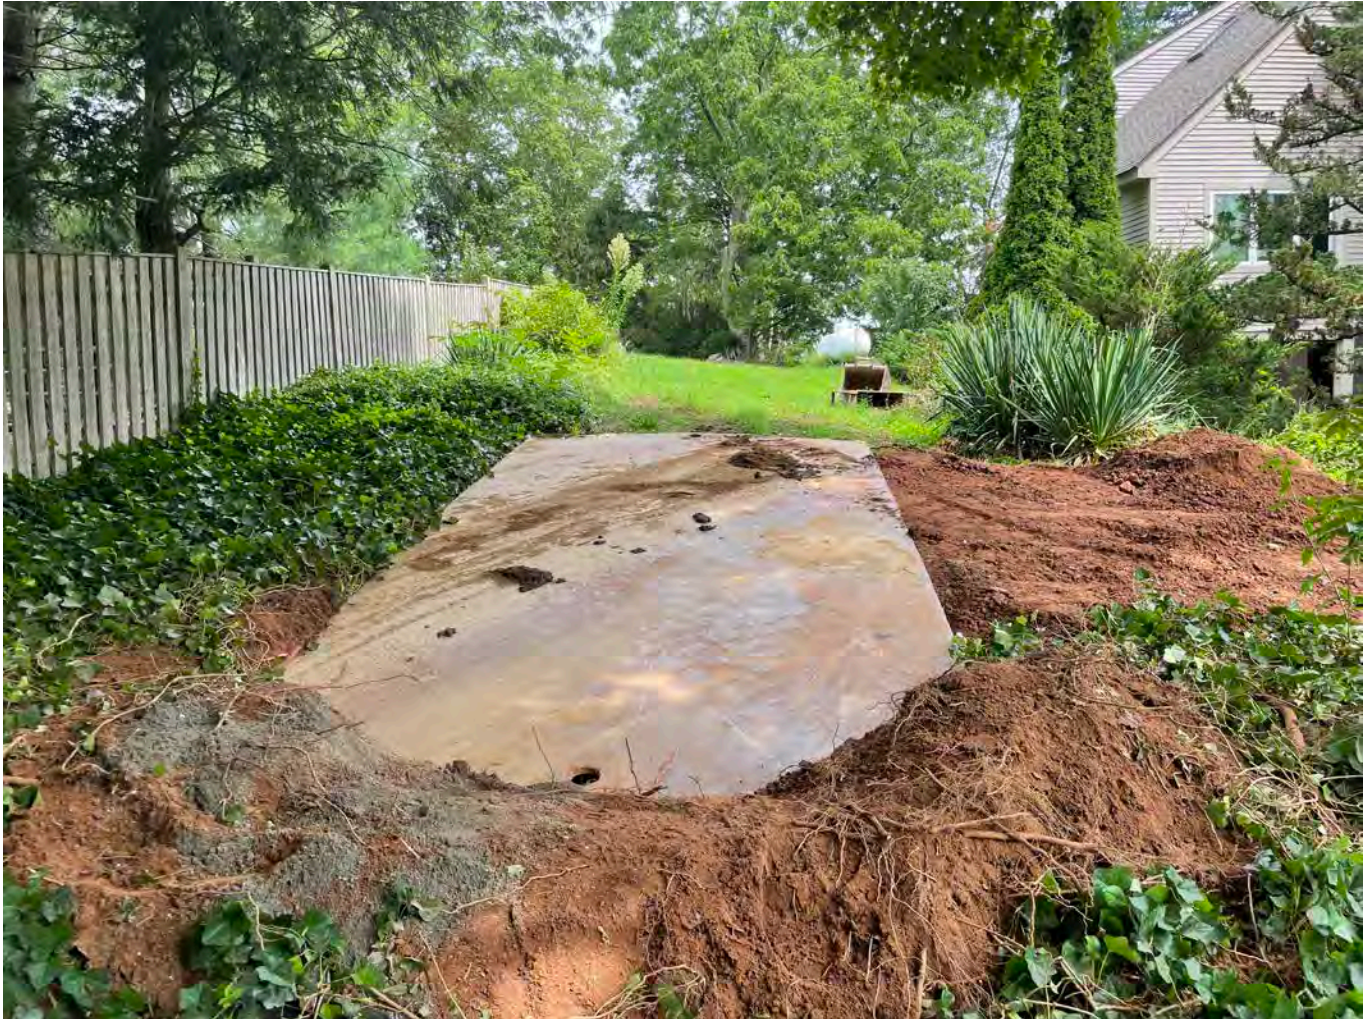
Picture 6: Steel plate that Ludlow placed over a portion of the excavation at the 95R Maple Avenue property. View to the east.

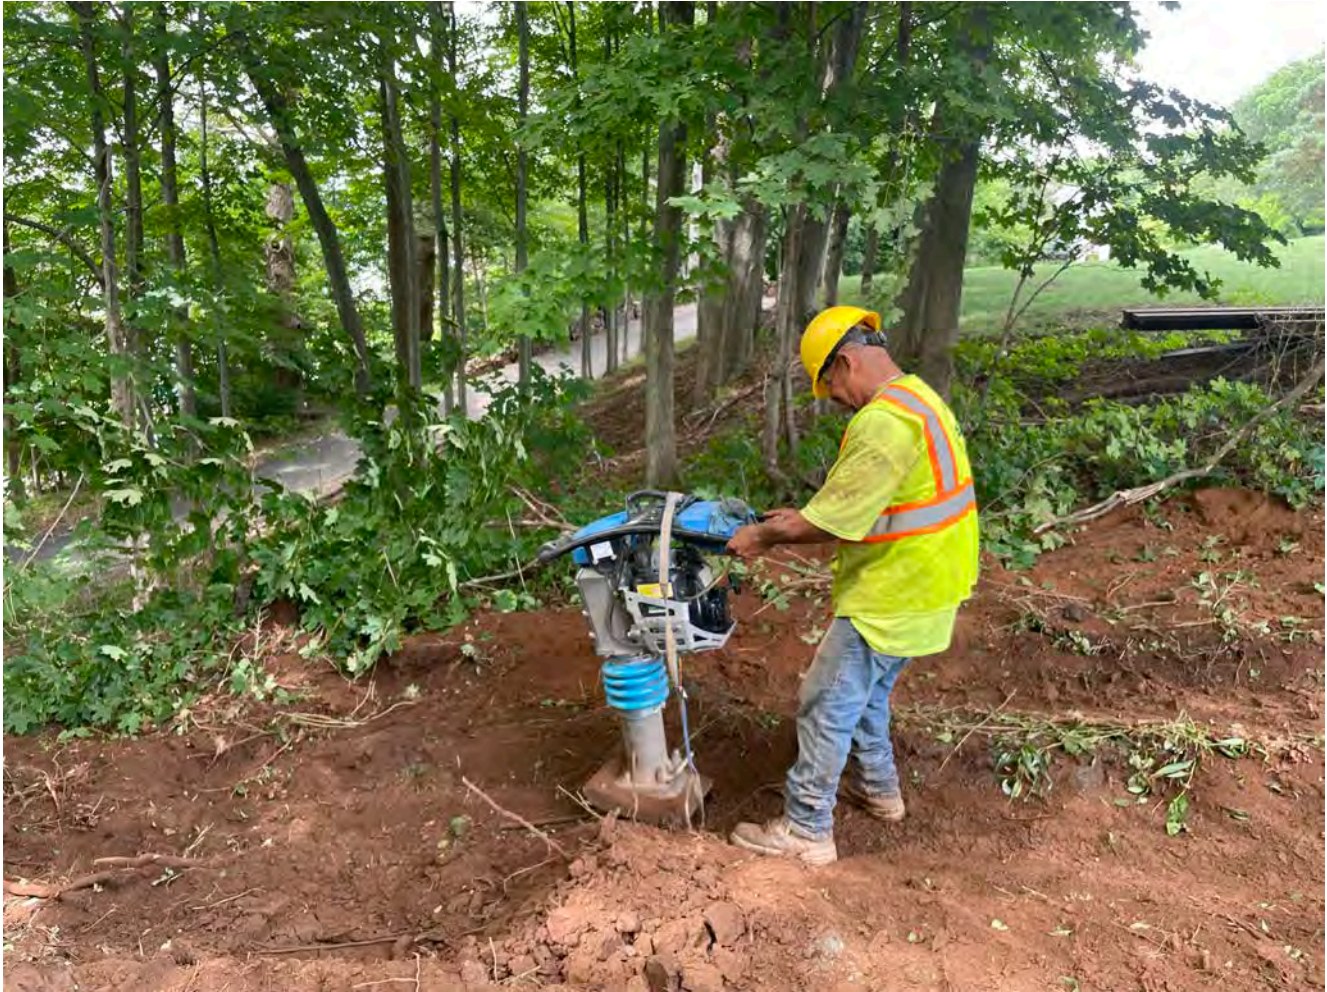
Picture 7: Ludlow compacting native fill that was placed back in the trench with a jumping jack. View to north.
